**REPORT NUMBER: SideNCAPPole-KAR-24-006**  
**NEW CAR ASSESSMENT PROGRAM (NCAP)**  
**SIDE IMPACT POLE TEST**

**HYUNDAI MOTOR CORPORATION**  
**2024 GENESIS G80 AWD 3.5T 4-DOOR SEDAN**

**NHTSA No: O20244200**

**FINAL REPORT**

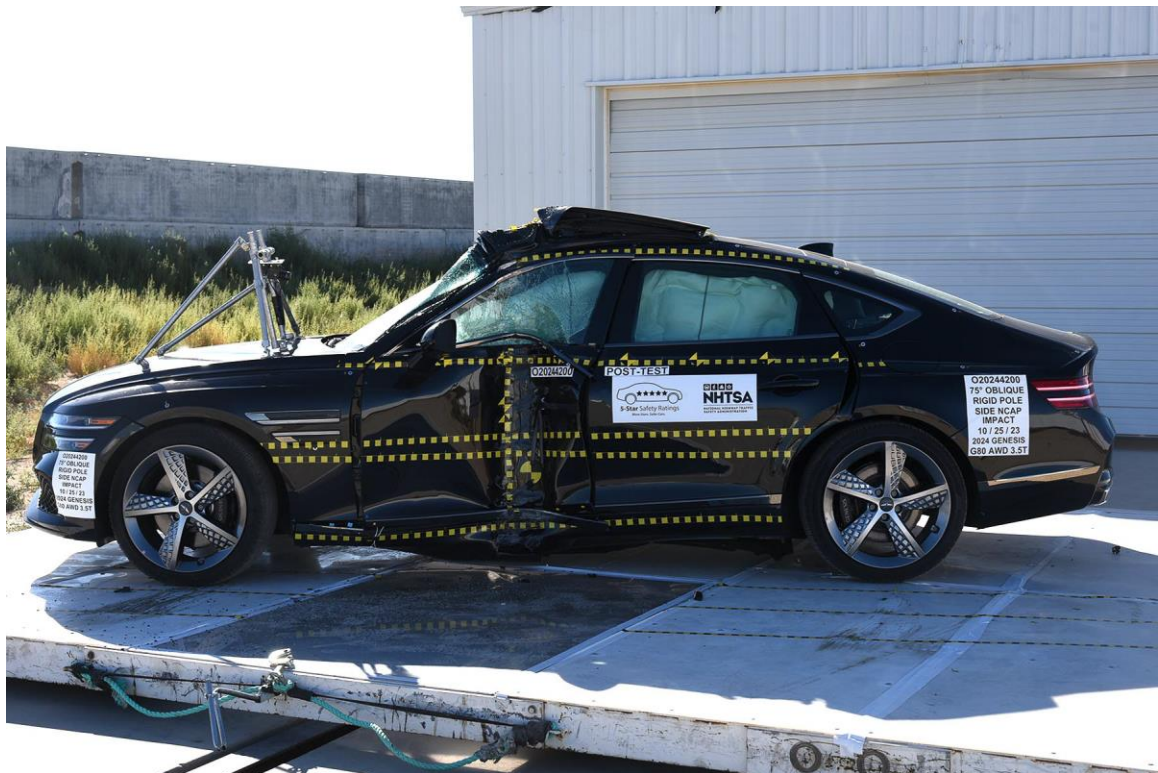
FIGURE 8. Post-Test Left Side View of Test Vehicle

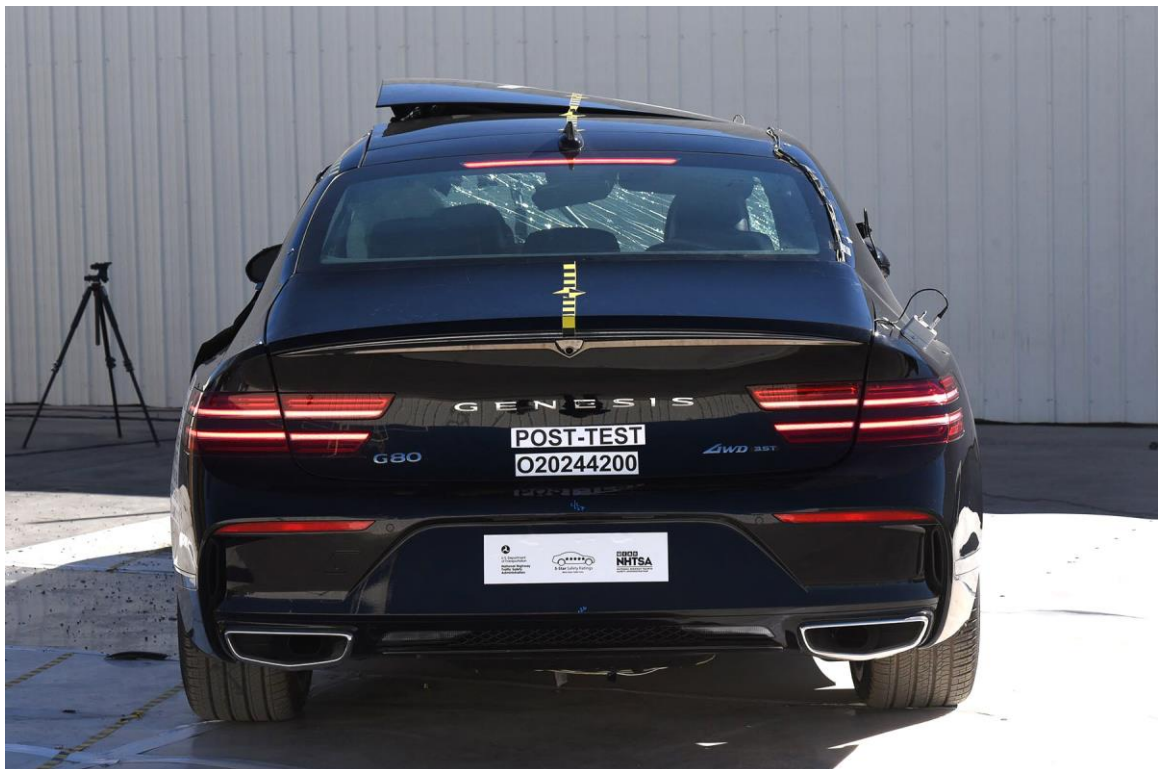
FIGURE 12. Post-Test Rear View of Test Vehicle

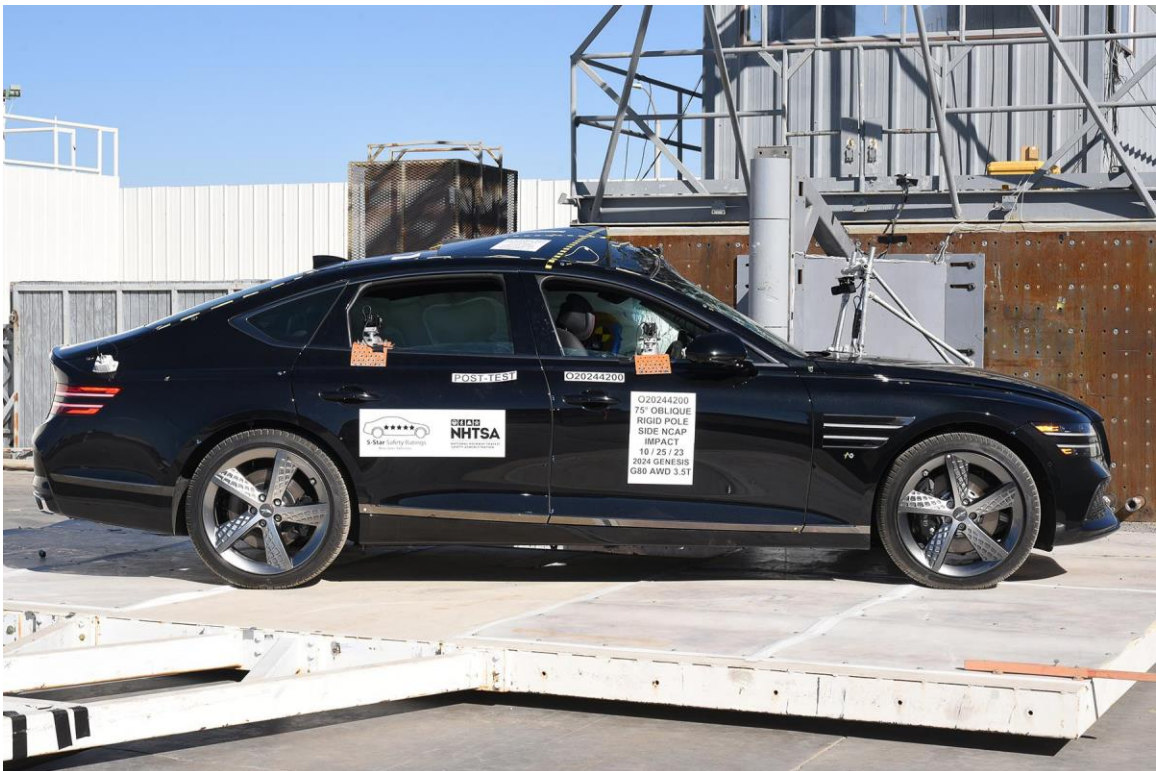
FIGURE 14. Post-Test Right Side View of Test Vehicle

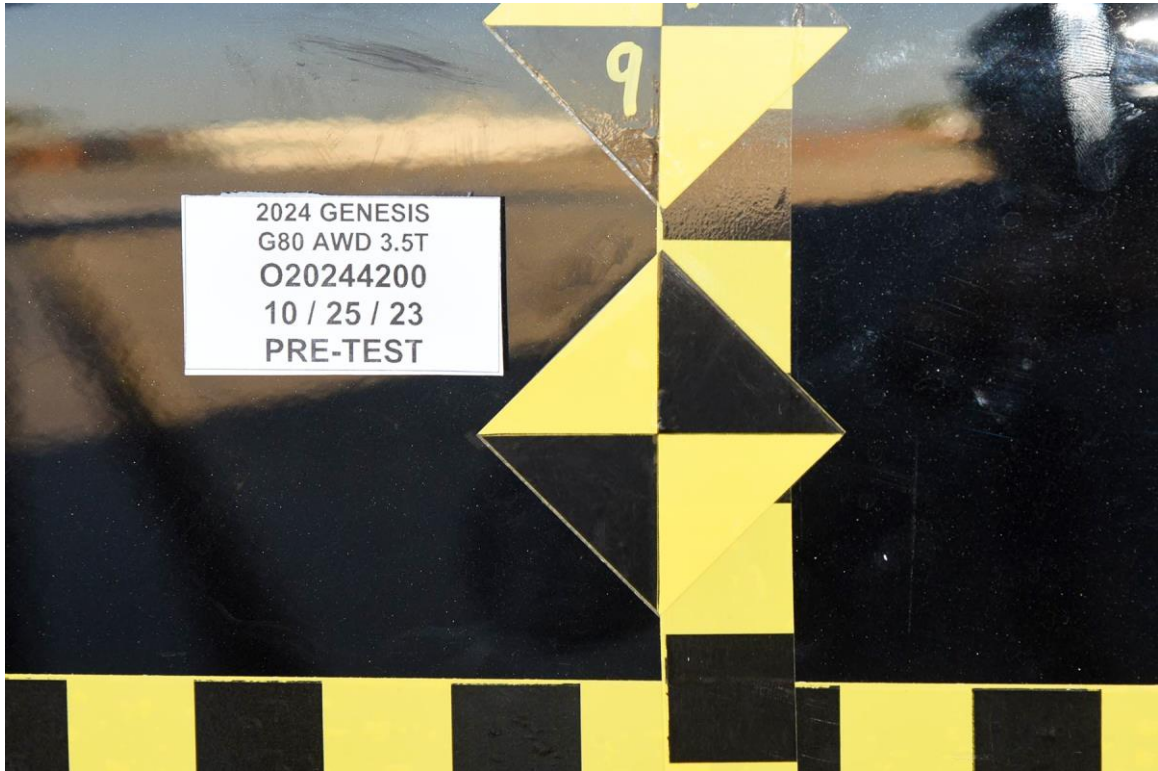
FIGURE 19. Pre-Test Close-Up View of Impact Point Target

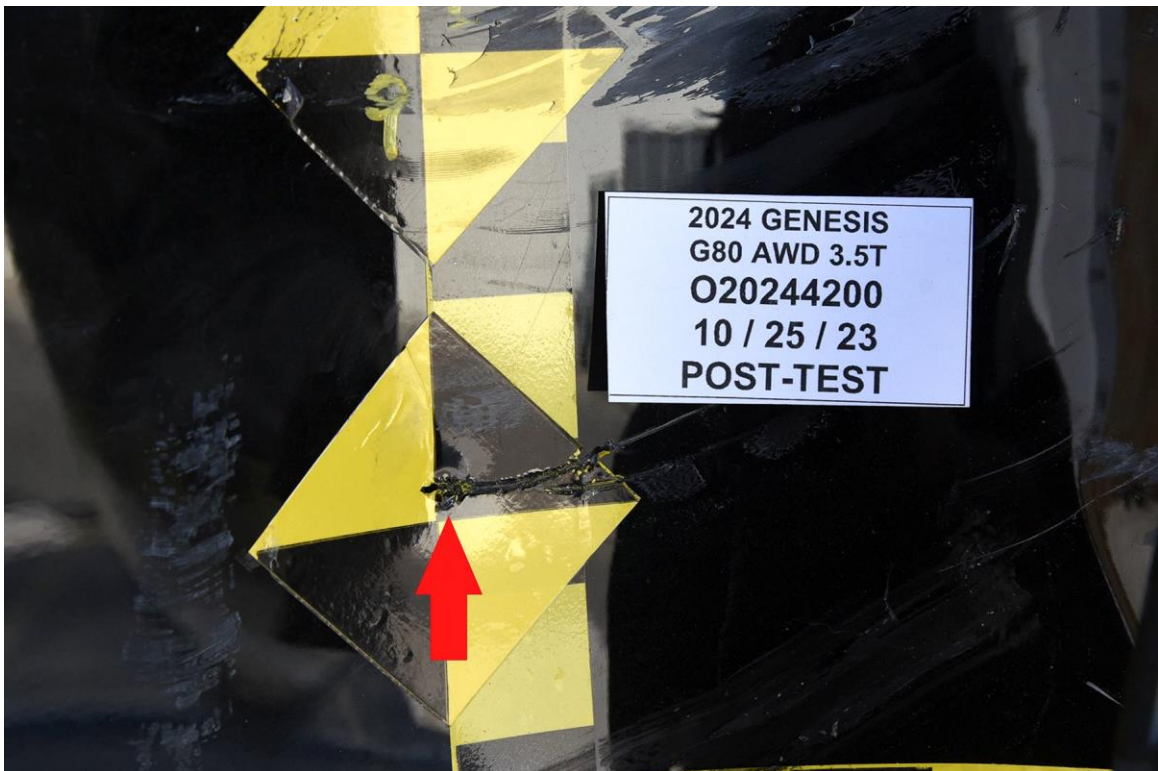
FIGURE 20. Post-Test Close-Up View of Impact Point Target Showing Impact Location

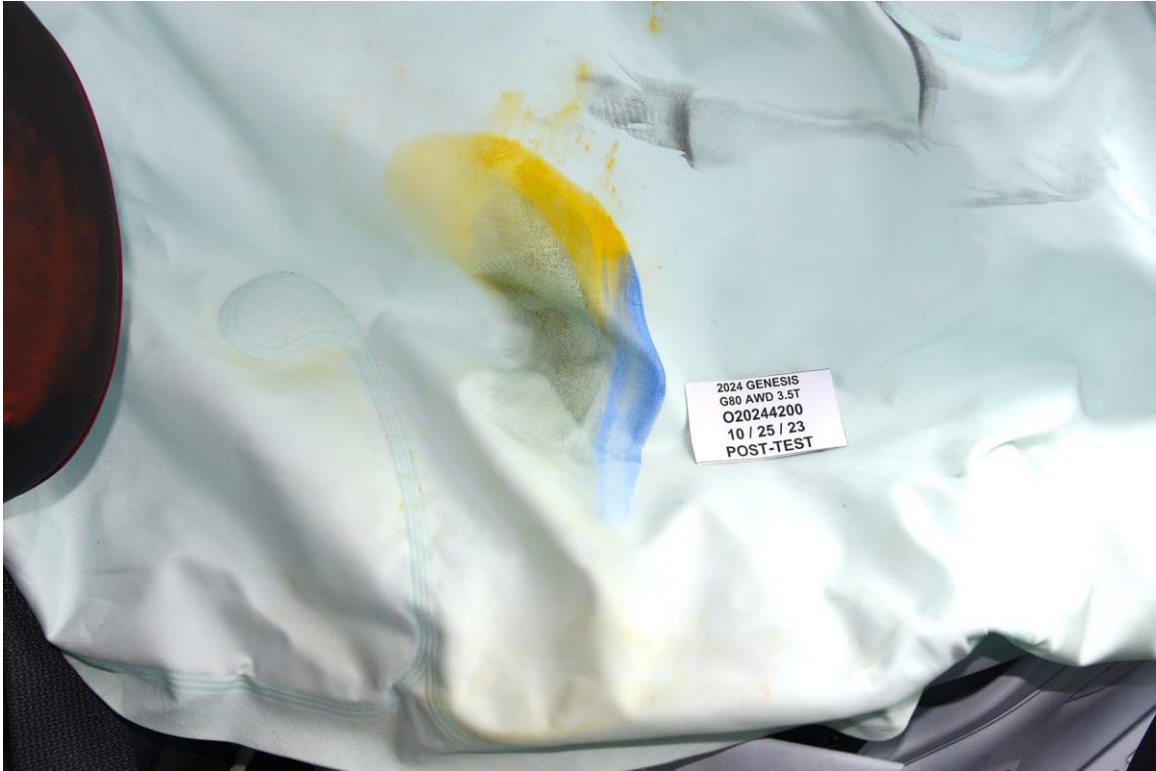
FIGURE 46. Post-Test Dummy Close-Up Head Contact with Vehicle Interior View

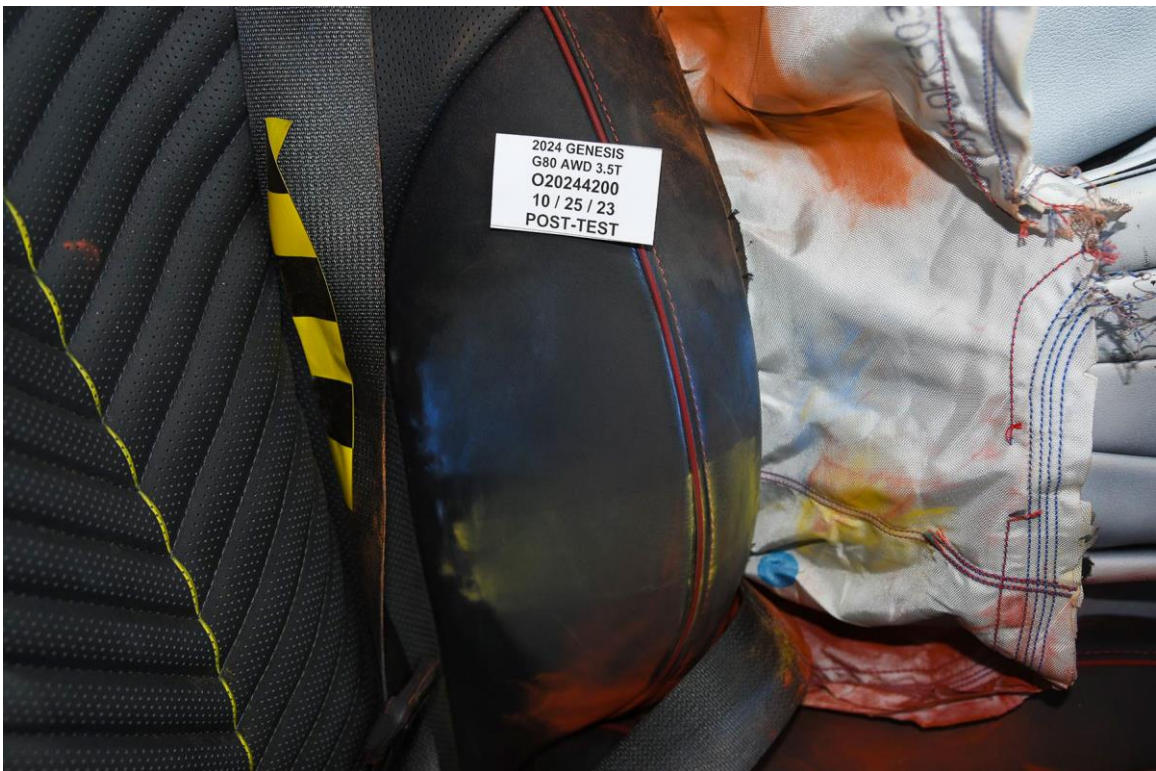
FIGURE 47. Post-Test Dummy Close-Up Head Contact With Side Airbag View

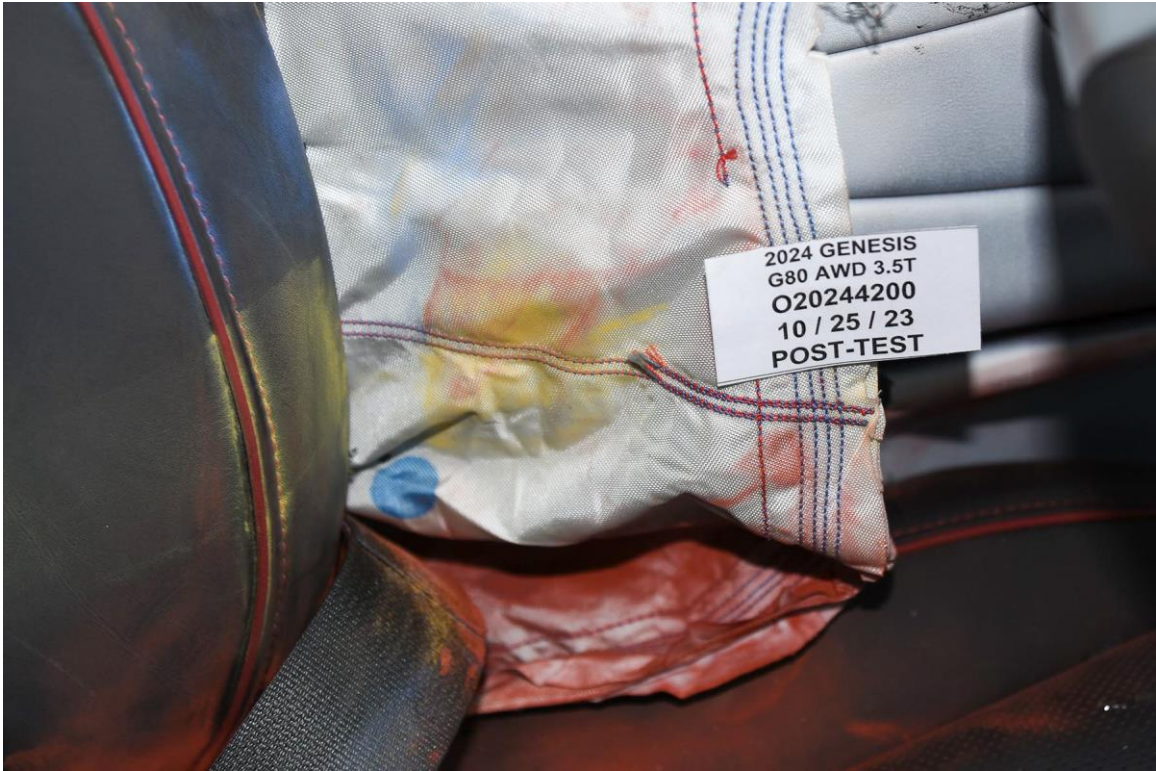
FIGURE 48. Post-Test Dummy Close-Up Torso Contact With Vehicle Interior View

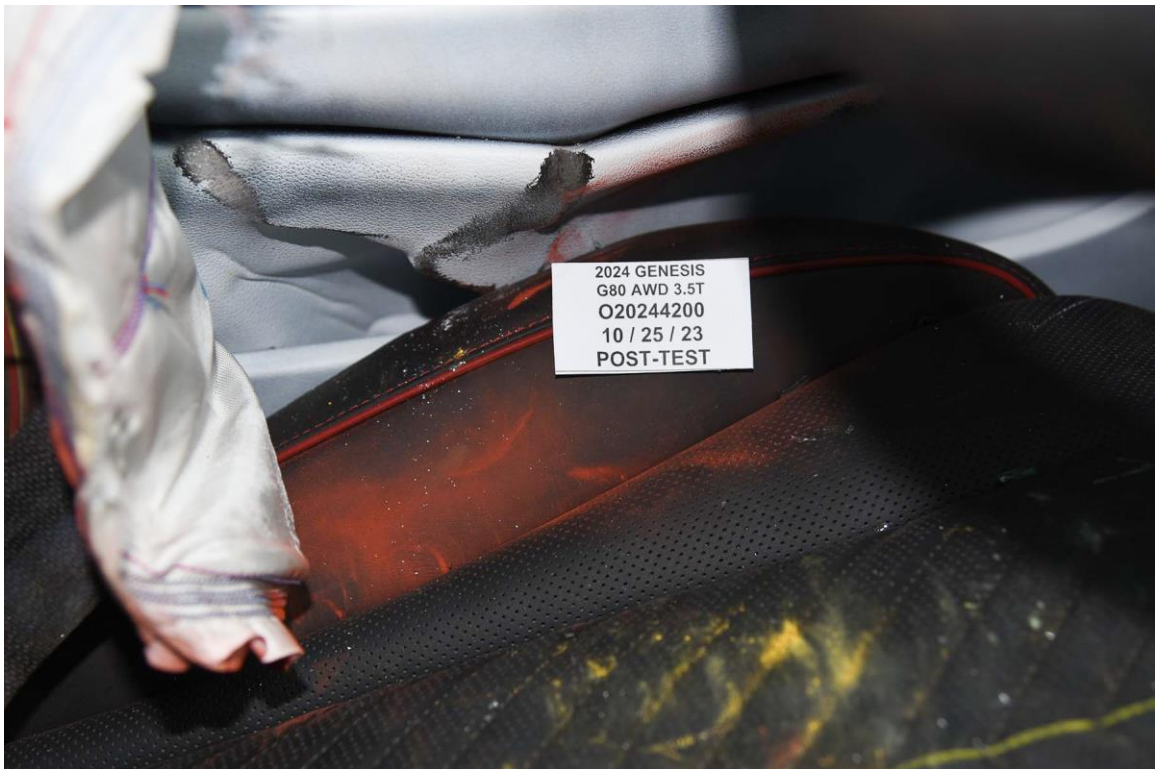
FIGURE 49. Post-Test Dummy Close-Up Torso Contact With Side Airbag View

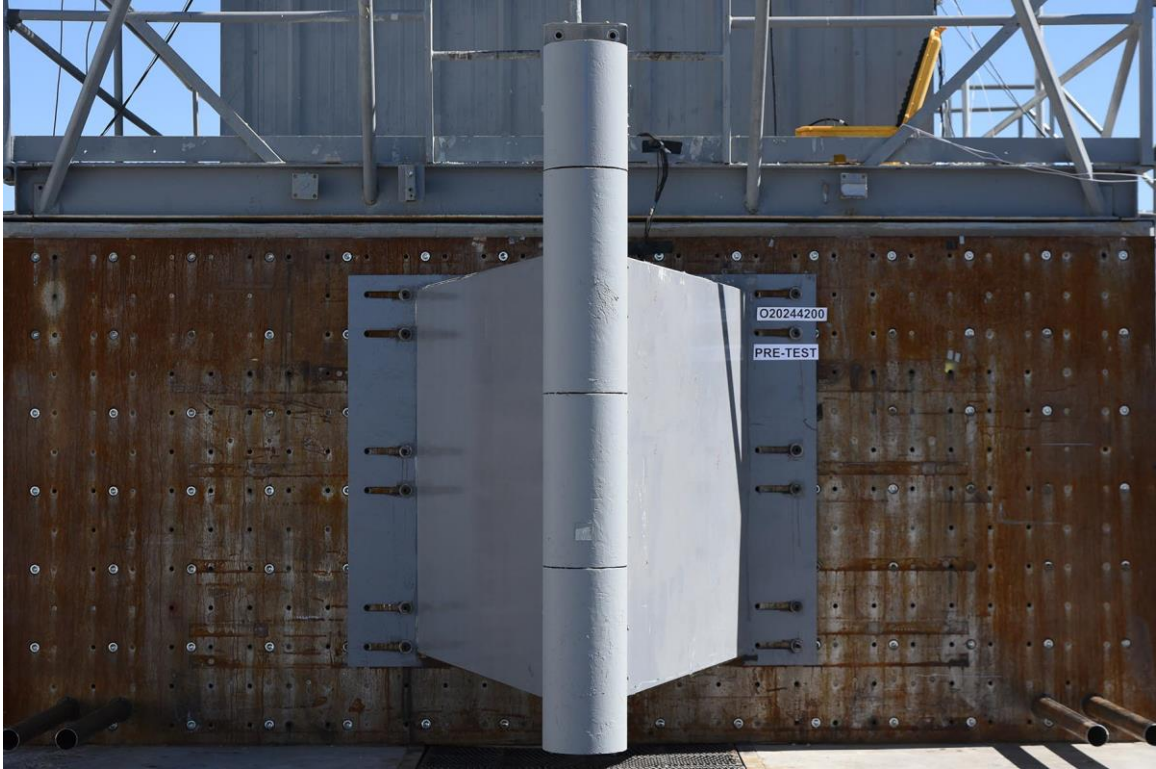
FIGURE 59. Pre-Test Pole Barrier Front View

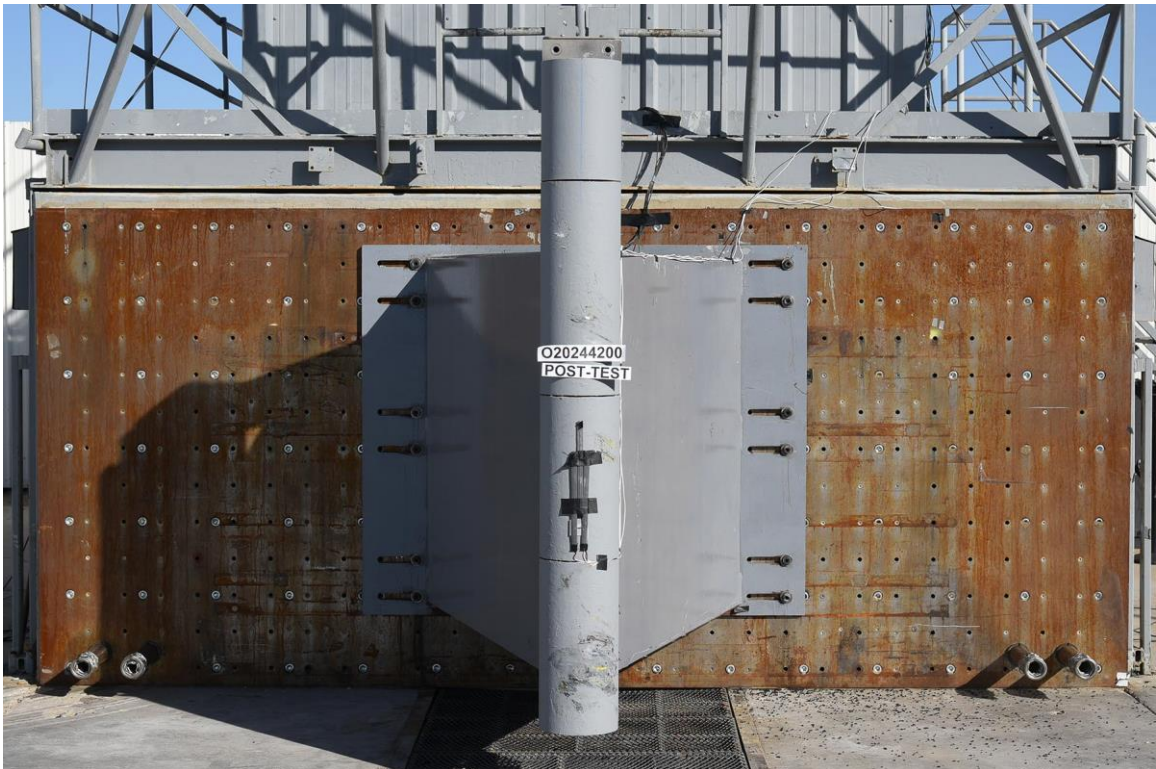
FIGURE 60. Post-Test Pole Barrier Front View
