**REPORT NUMBER: SideNCAPPole-MGA-23-035**

**NEW CAR ASSESSMENT PROGRAM (NCAP)  
Side Impact Pole Test**

**FCA US LLC  
2023 Jeep Wagoneer Series III 4x2  
NHTSA No.: M20230306**

**FINAL REPORT**

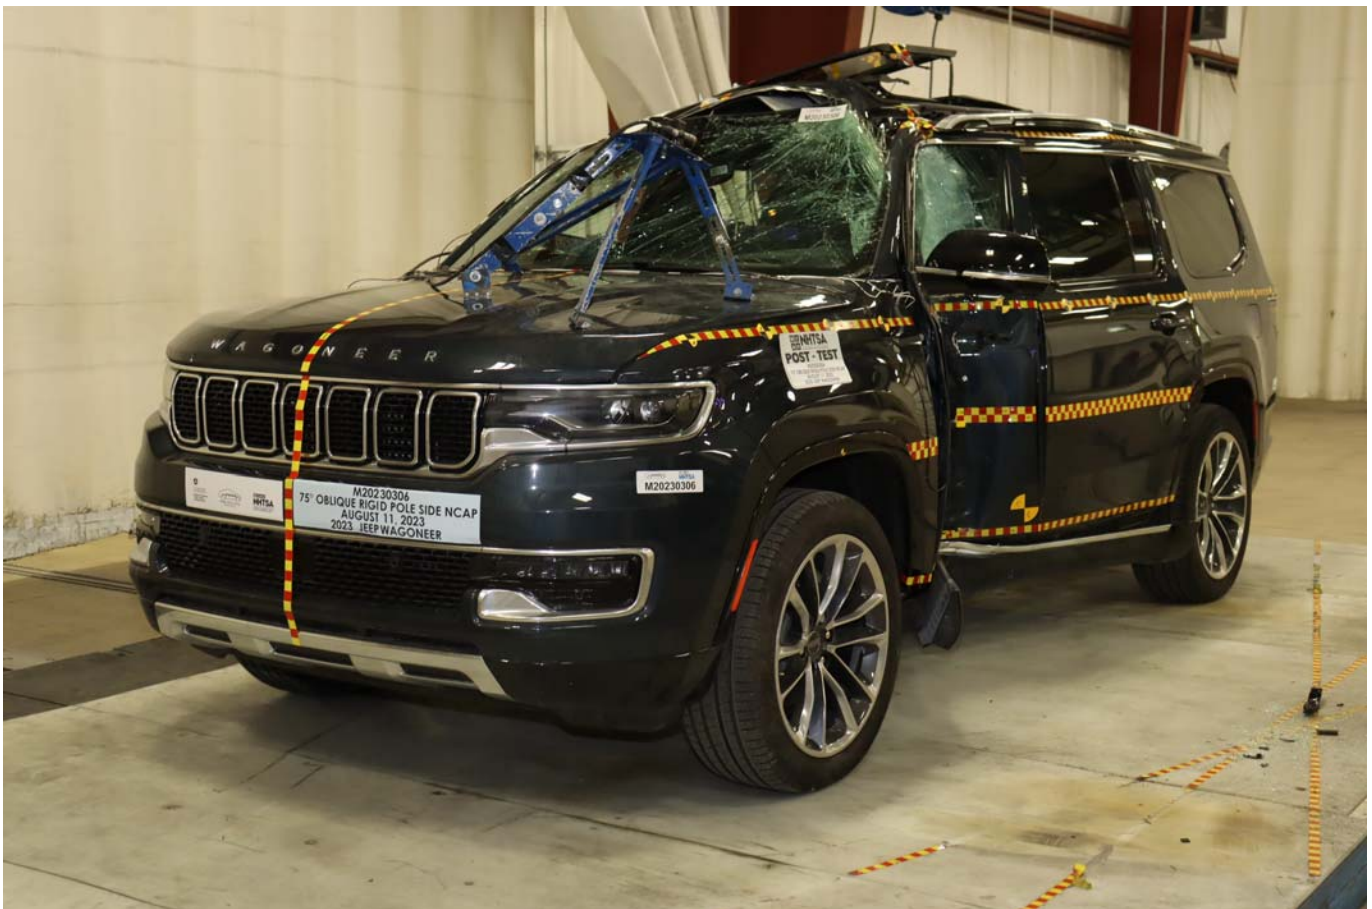
Photo No. 006 - Post-Test Left Front Three-Quarter View of Test Vehicle

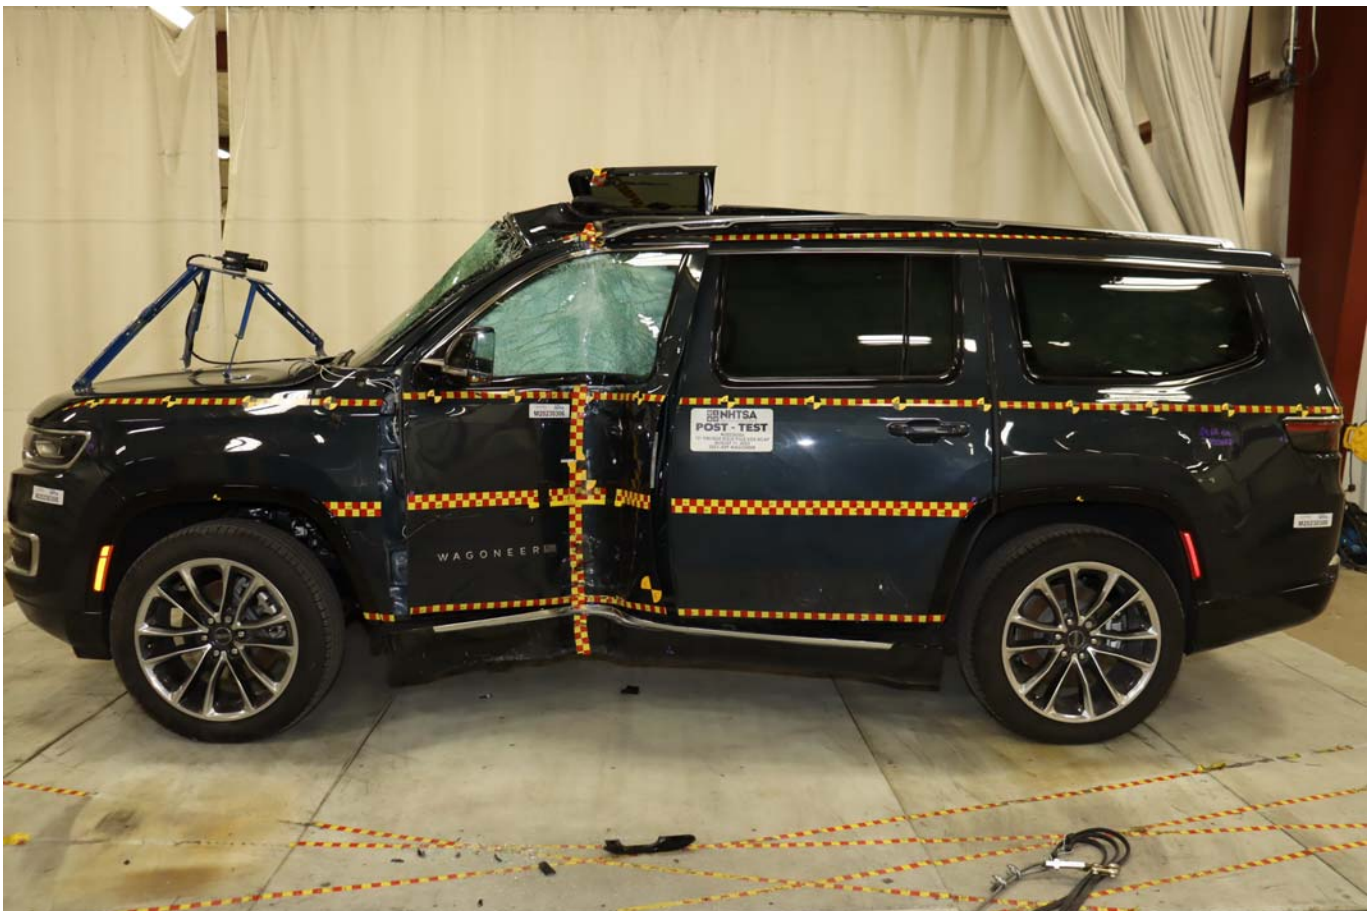
Photo No. 008 - Post-Test Left Side View of Test Vehicle

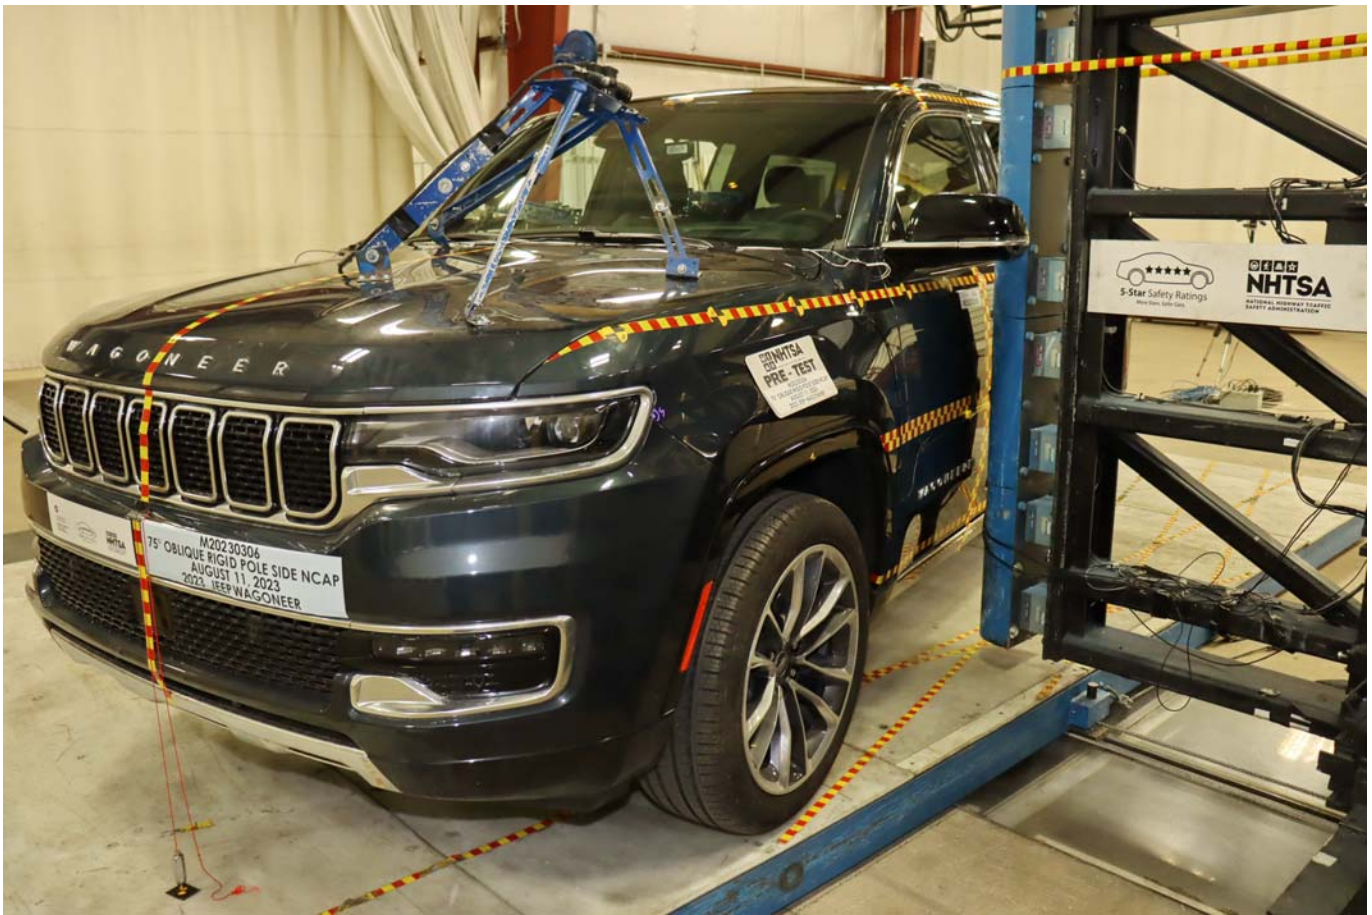
Photo No. 017 - Pre-Test Left Side View of Pole Positioned Against Side of Vehicle

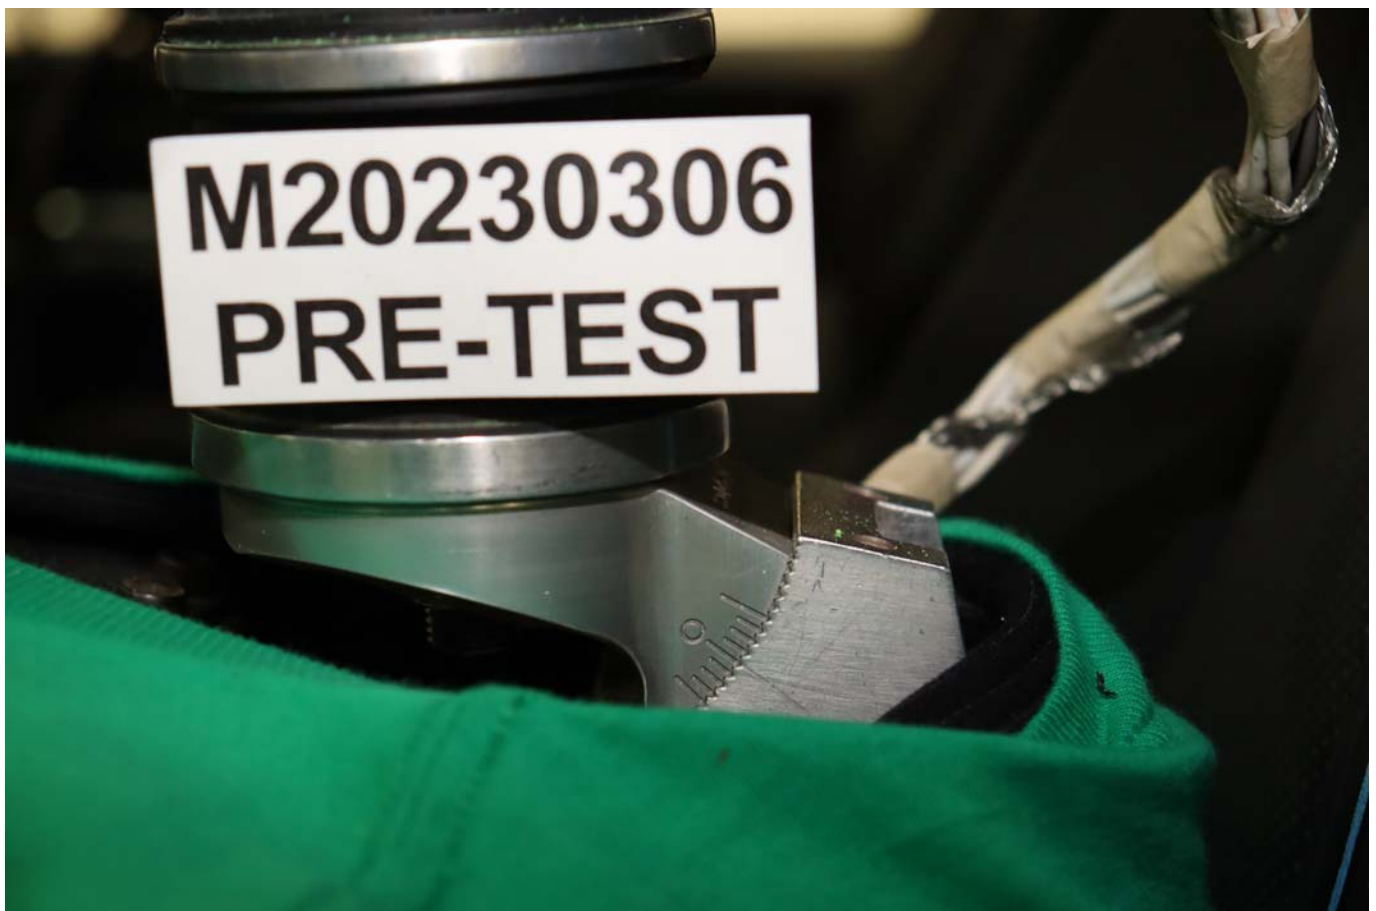
Photo No. 030 - Pre-Test Left Side View of Dummy's Neck Showing Position of Adjustable Neck Bracket

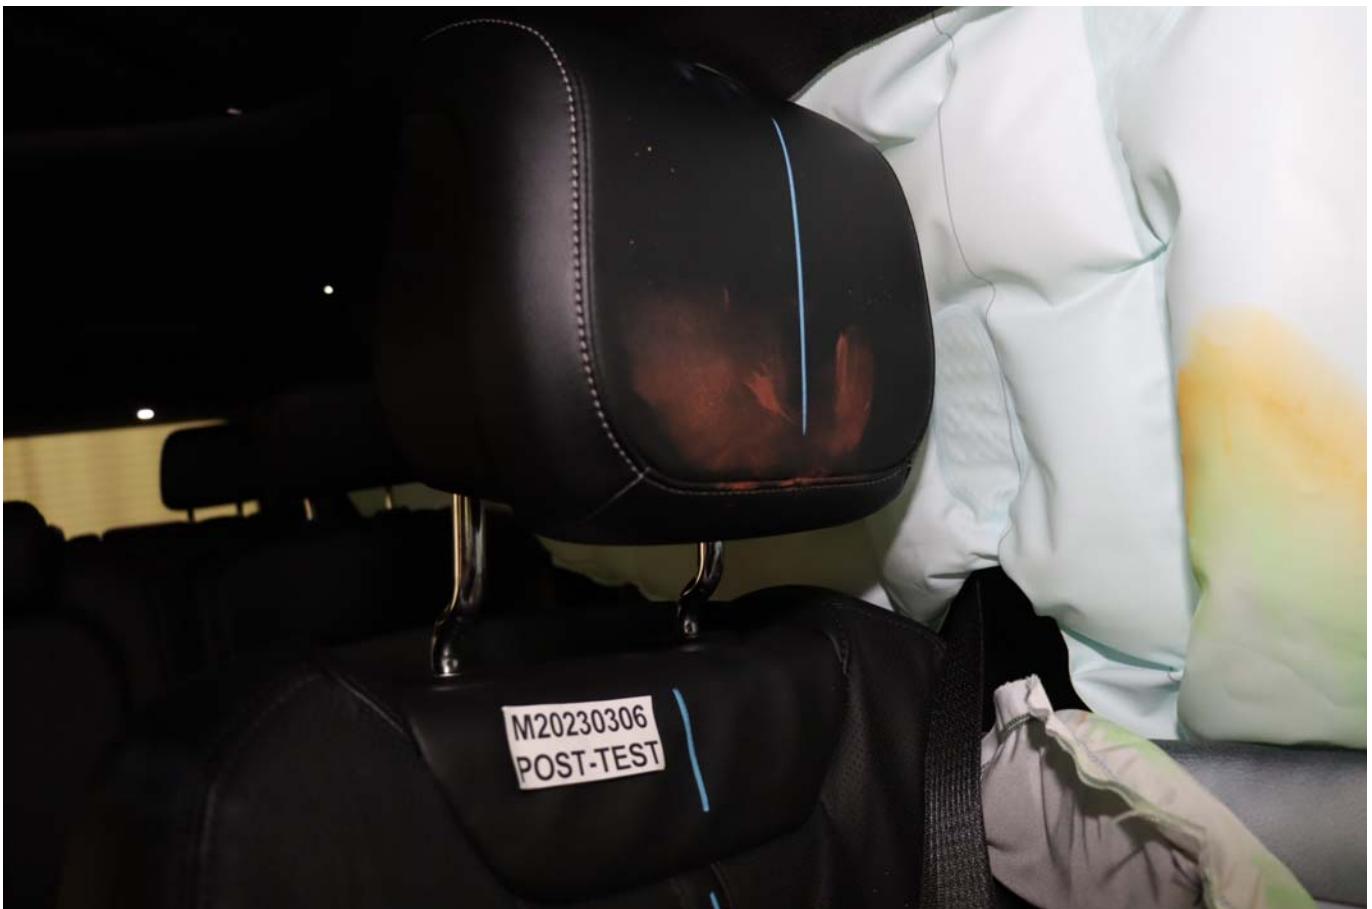
Photo No. 046 - Post-Test Dummy Close-Up Head Contact with Vehicle Interior View

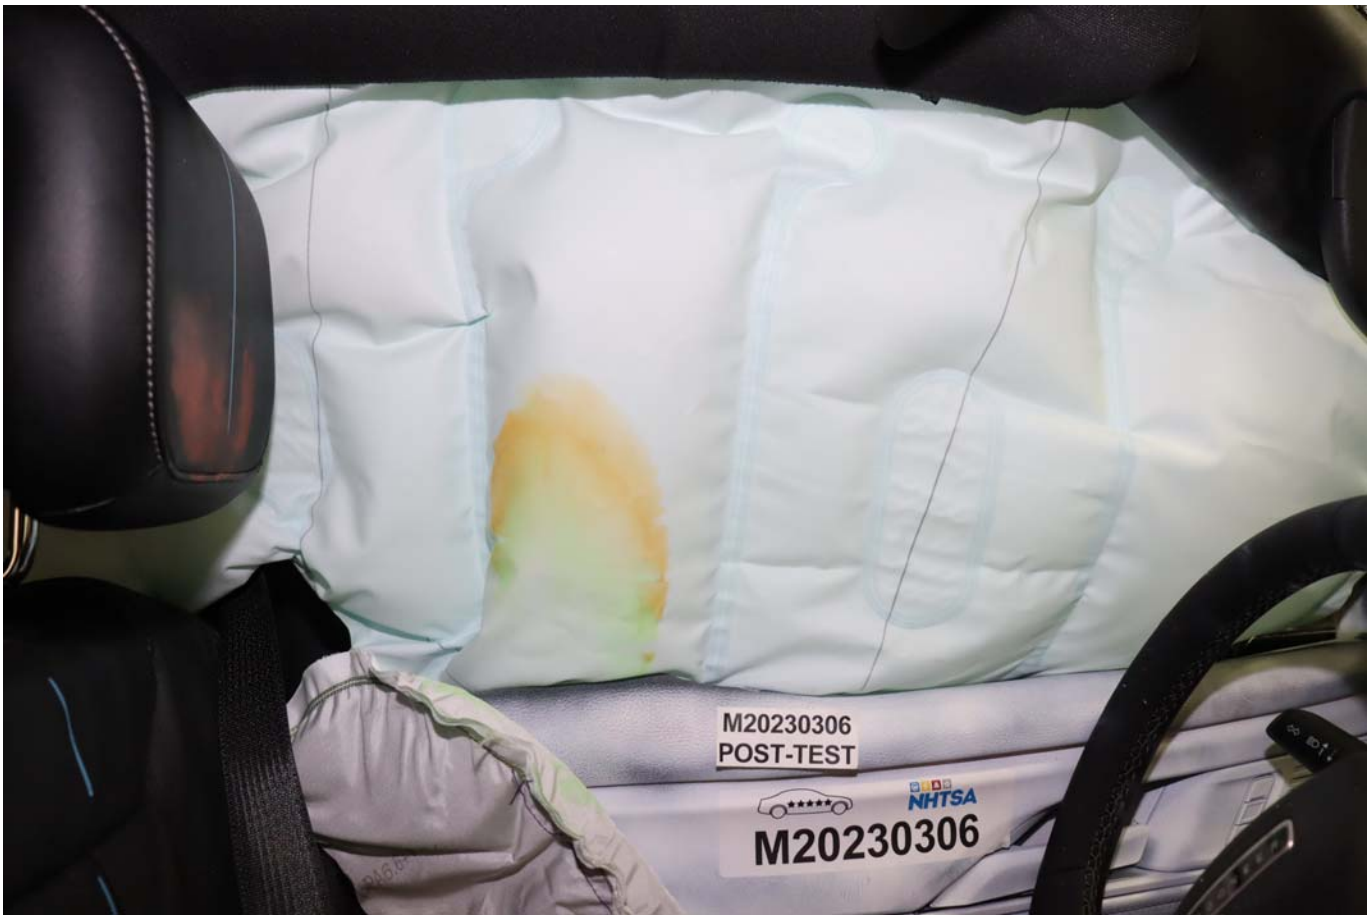
Photo No. 047 - Post-Test Dummy Close-Up Head Contact with Side Air Bag View

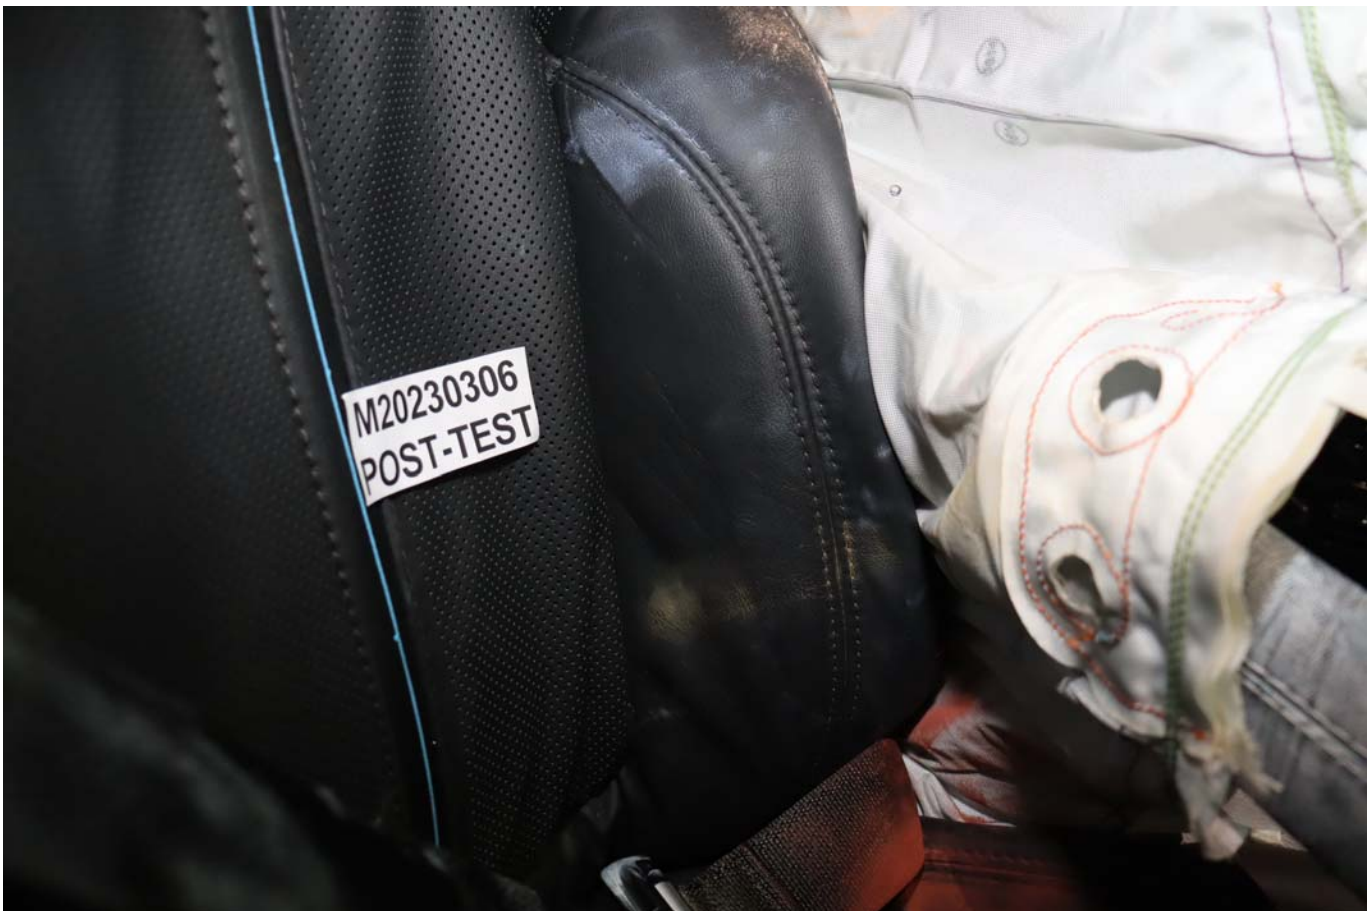
Photo No. 048 - Post-Test Dummy Close-Up Torso Contact with Vehicle Interior View

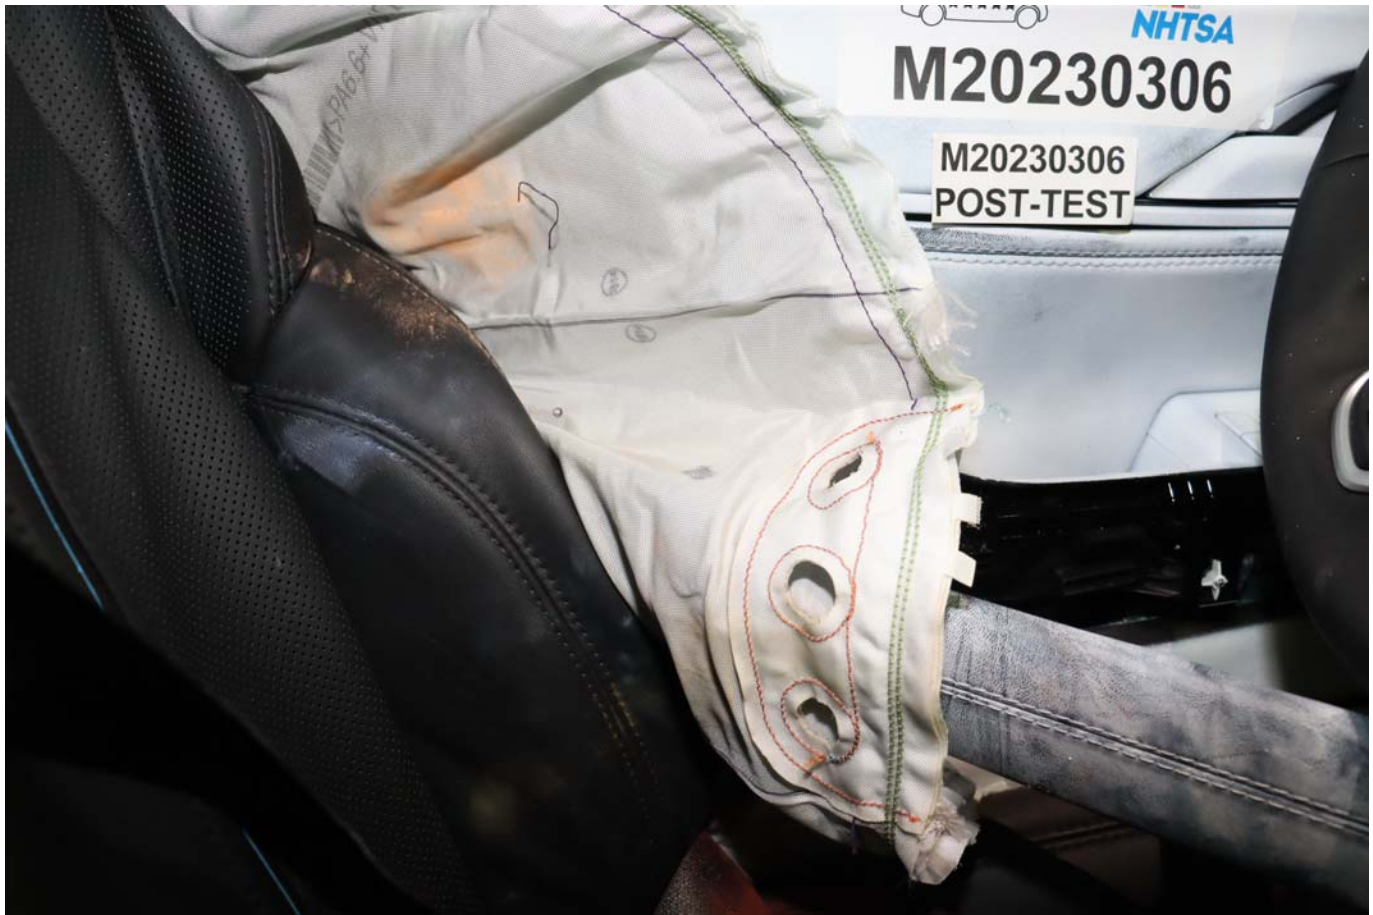
Photo No. 049 - Post-Test Dummy Close-Up Torso Contact with Side Air Bag View

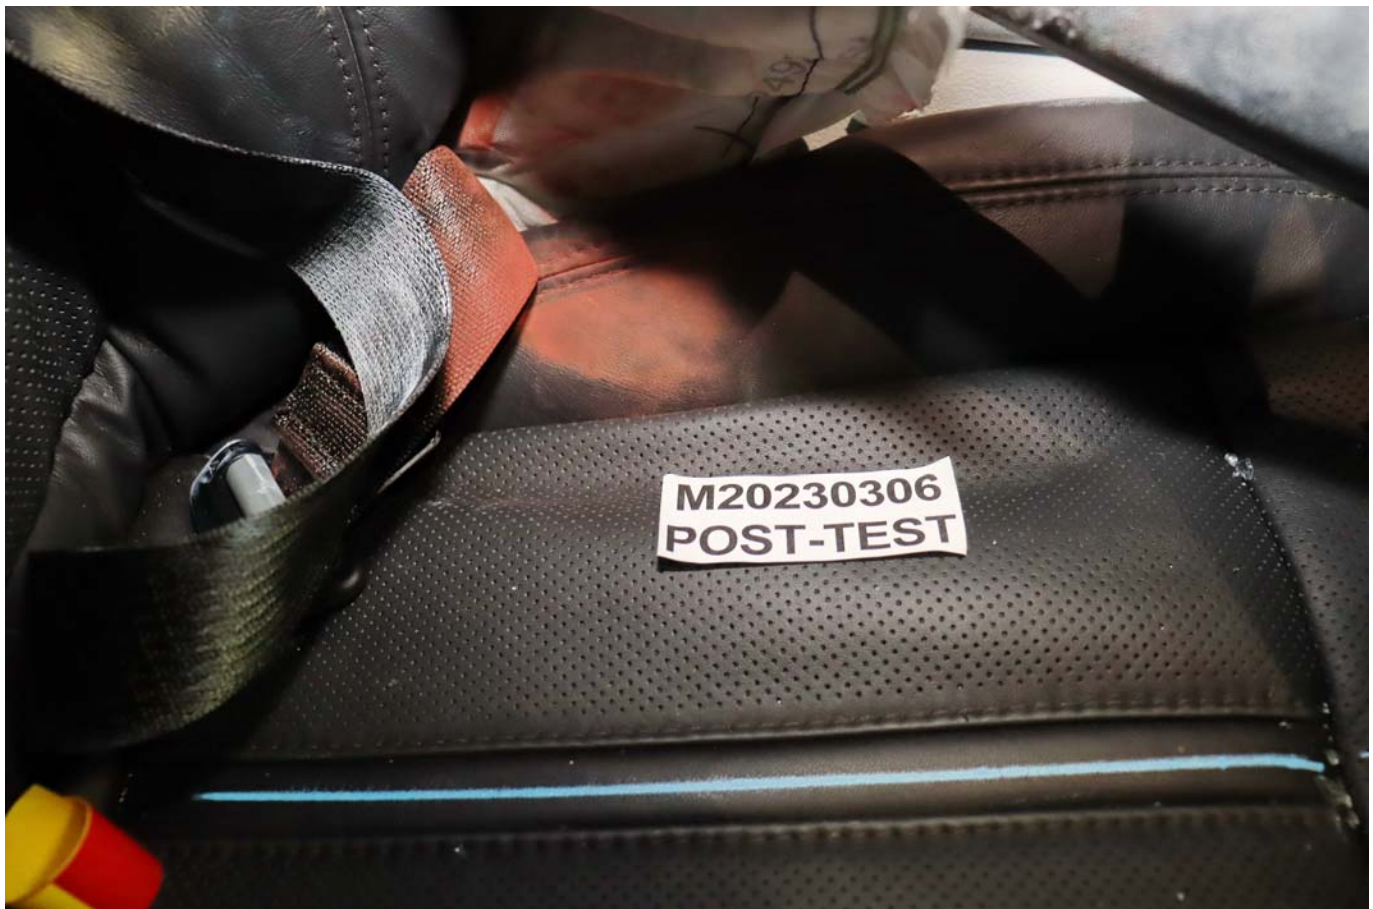
Photo No. 050 - Post-Test Dummy Close-Up Pelvis Contact with Vehicle Interior View

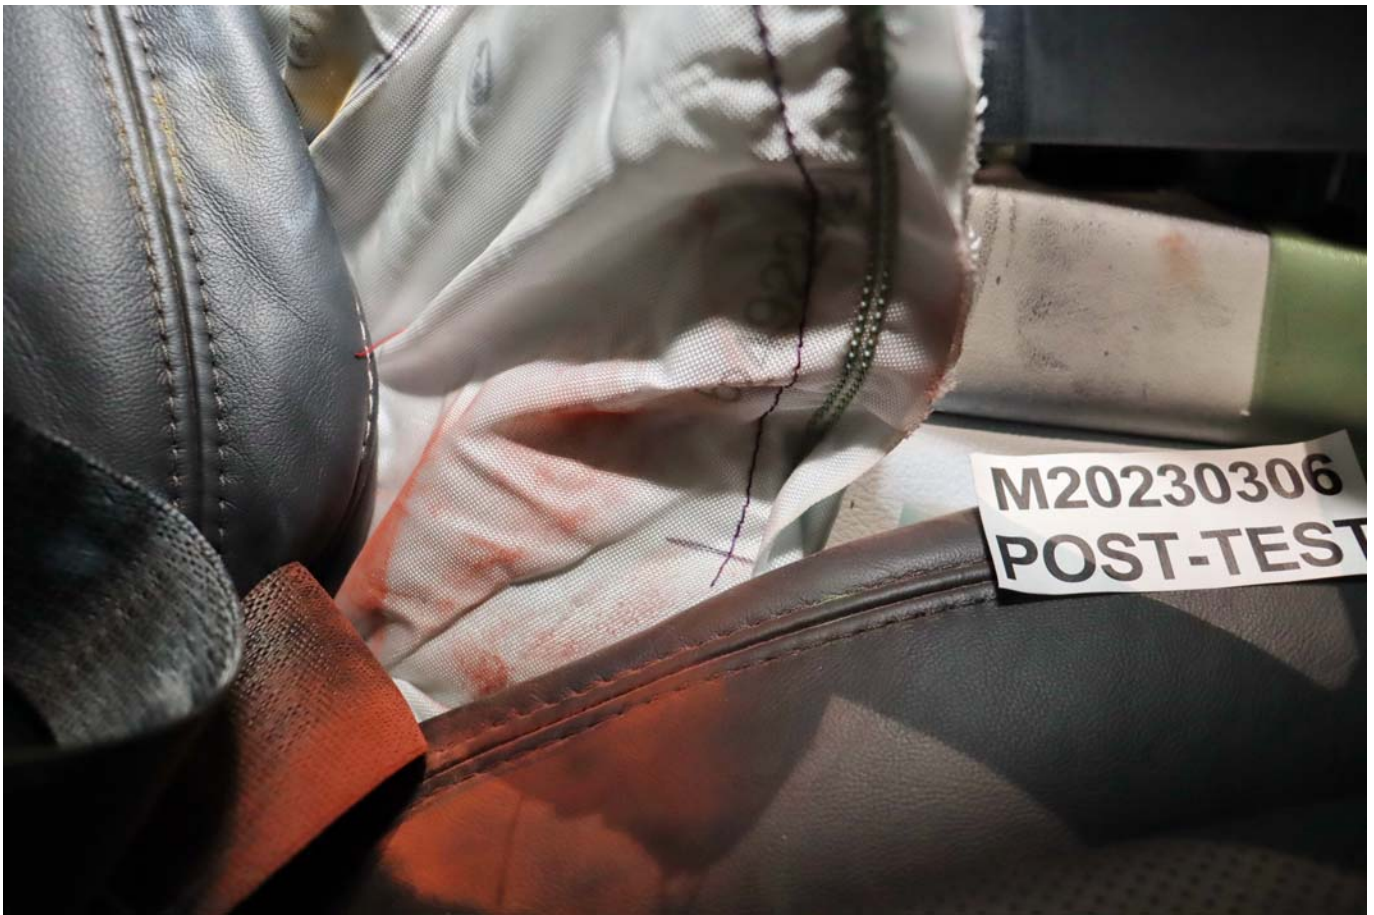
Photo No. 051 - Post-Test Dummy Close-Up Pelvis Contact with Side Air Bag View

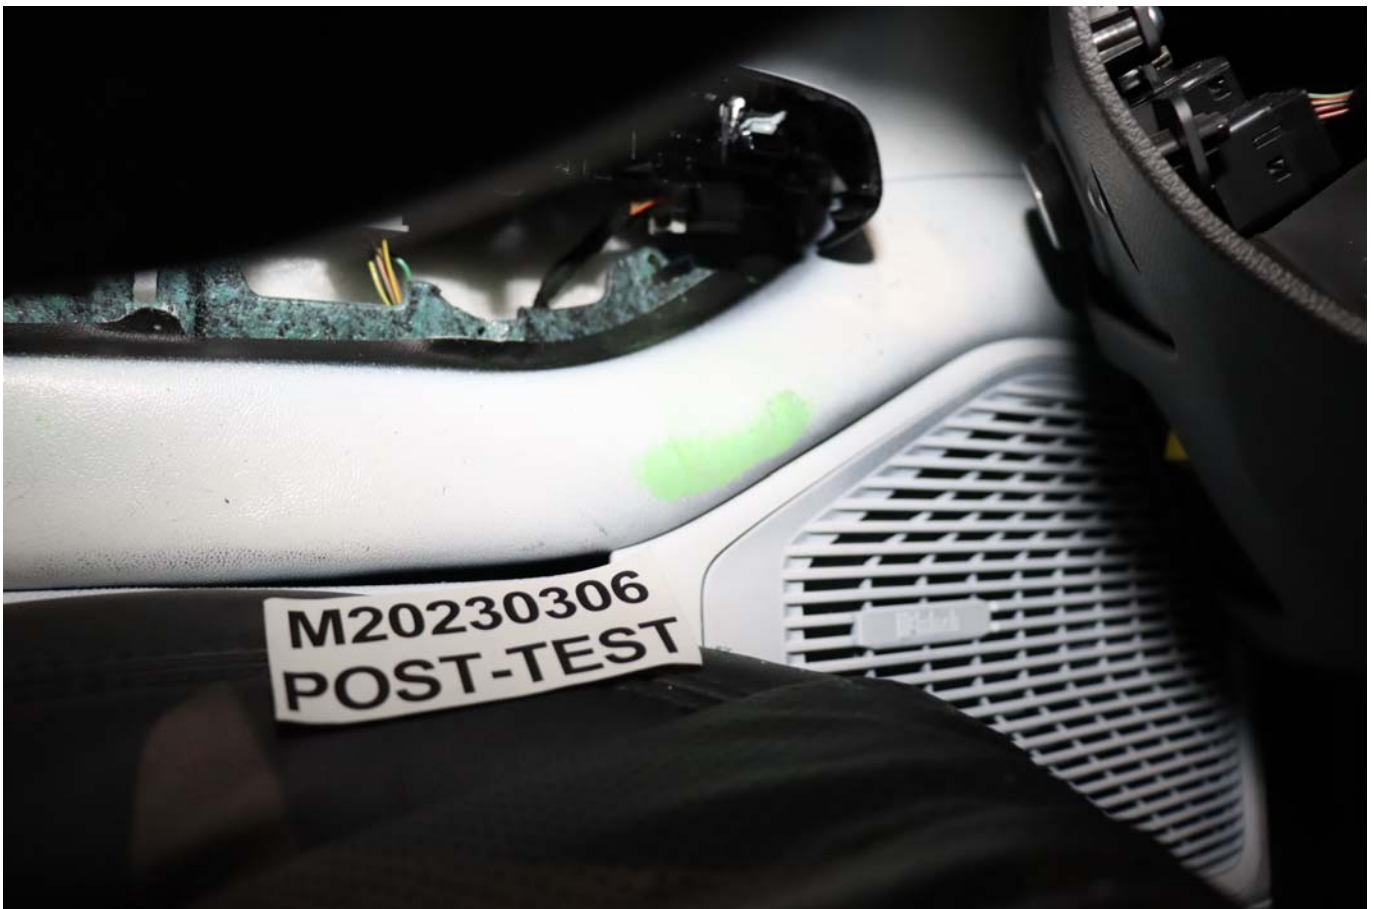
Photo No. 052 - Post-Test Dummy Close-Up Knee Contact with Vehicle Interior View

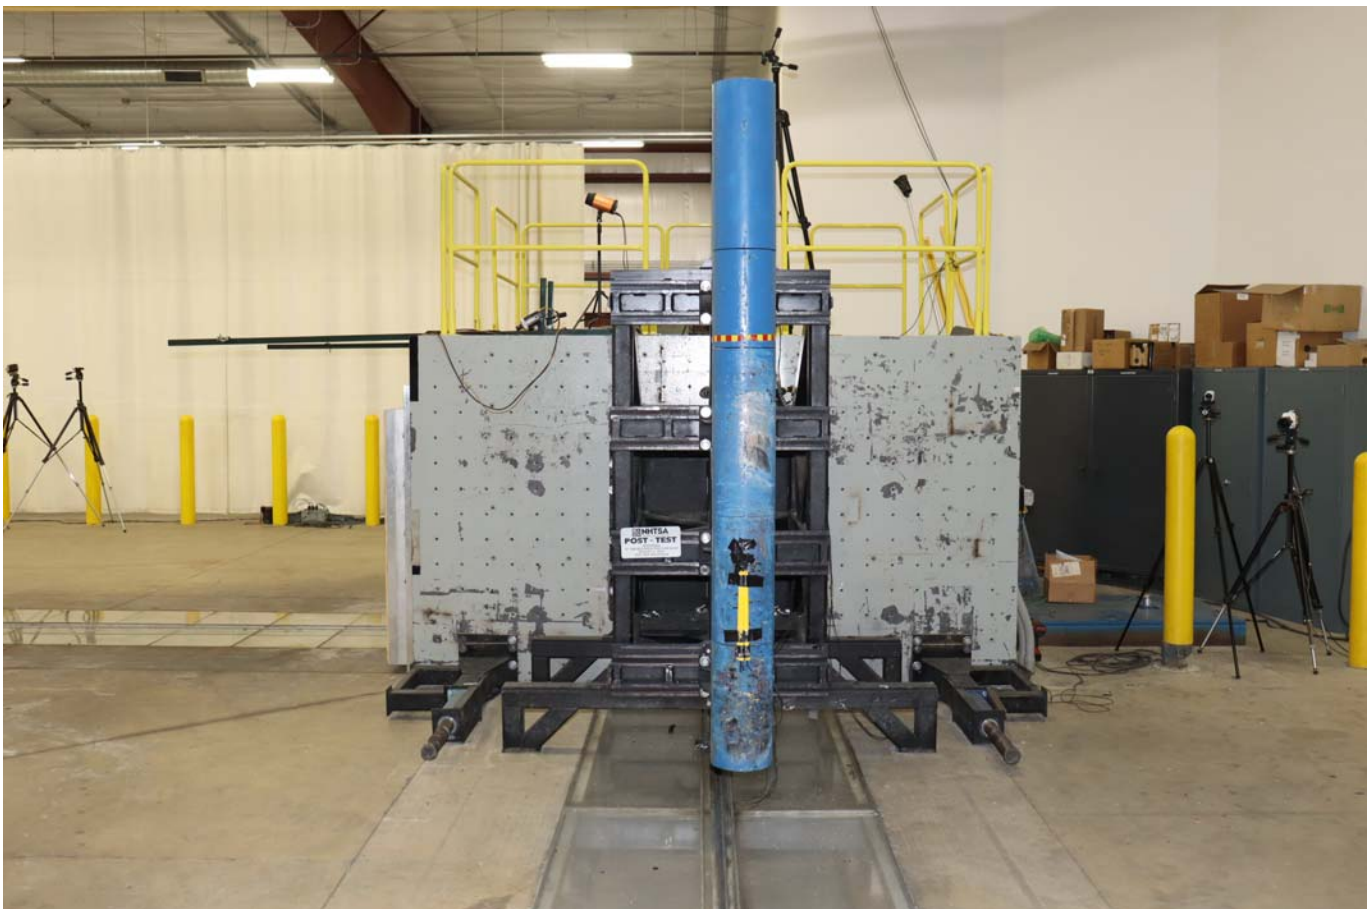
Photo No. 060 - Post-Test Pole Barrier Front View

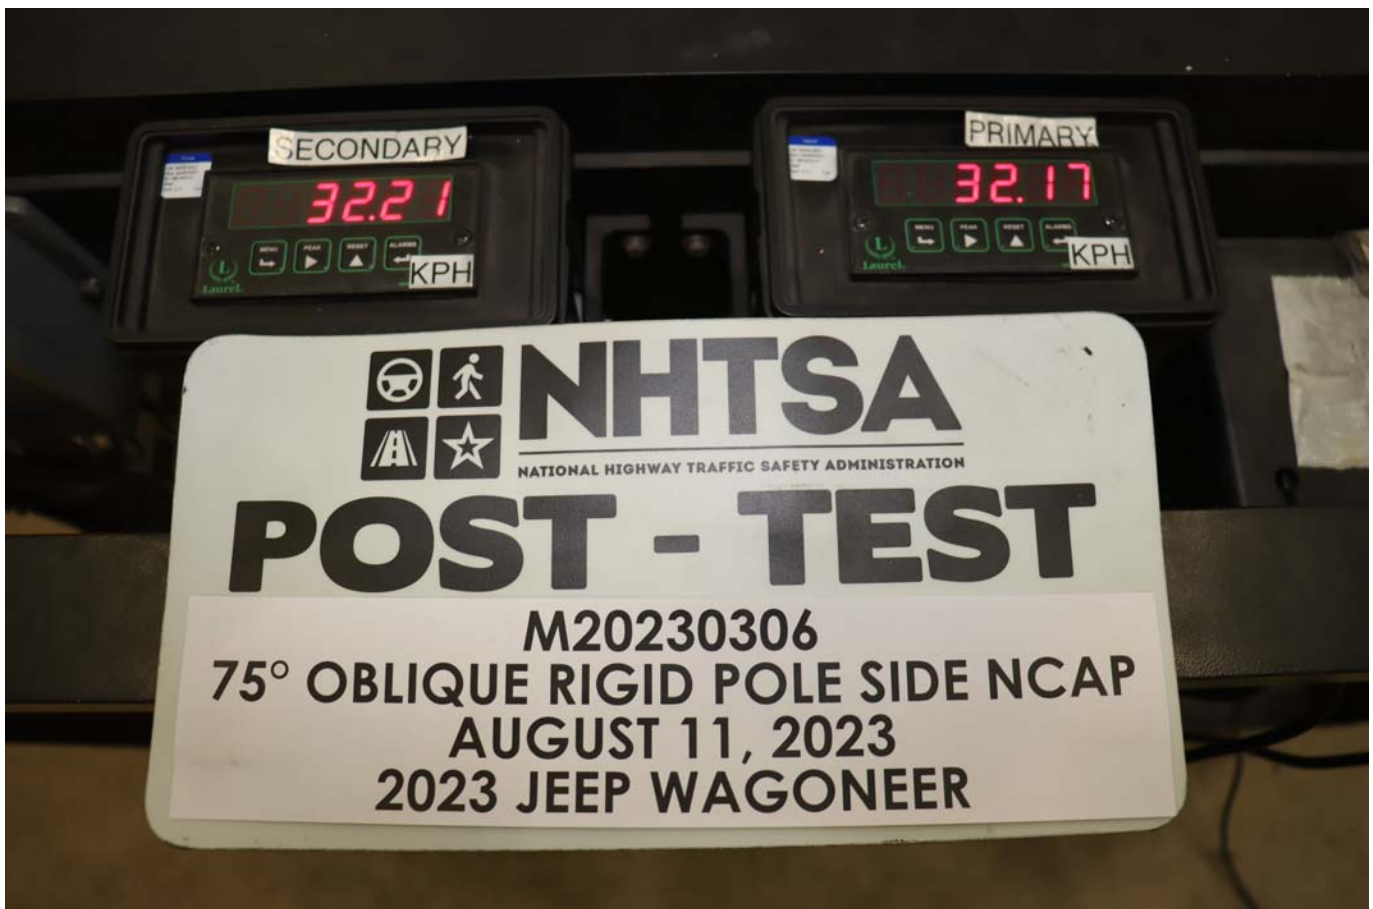
Photo No. 064 - Post-Test Primary and Redundant Speed Trap Read-Out

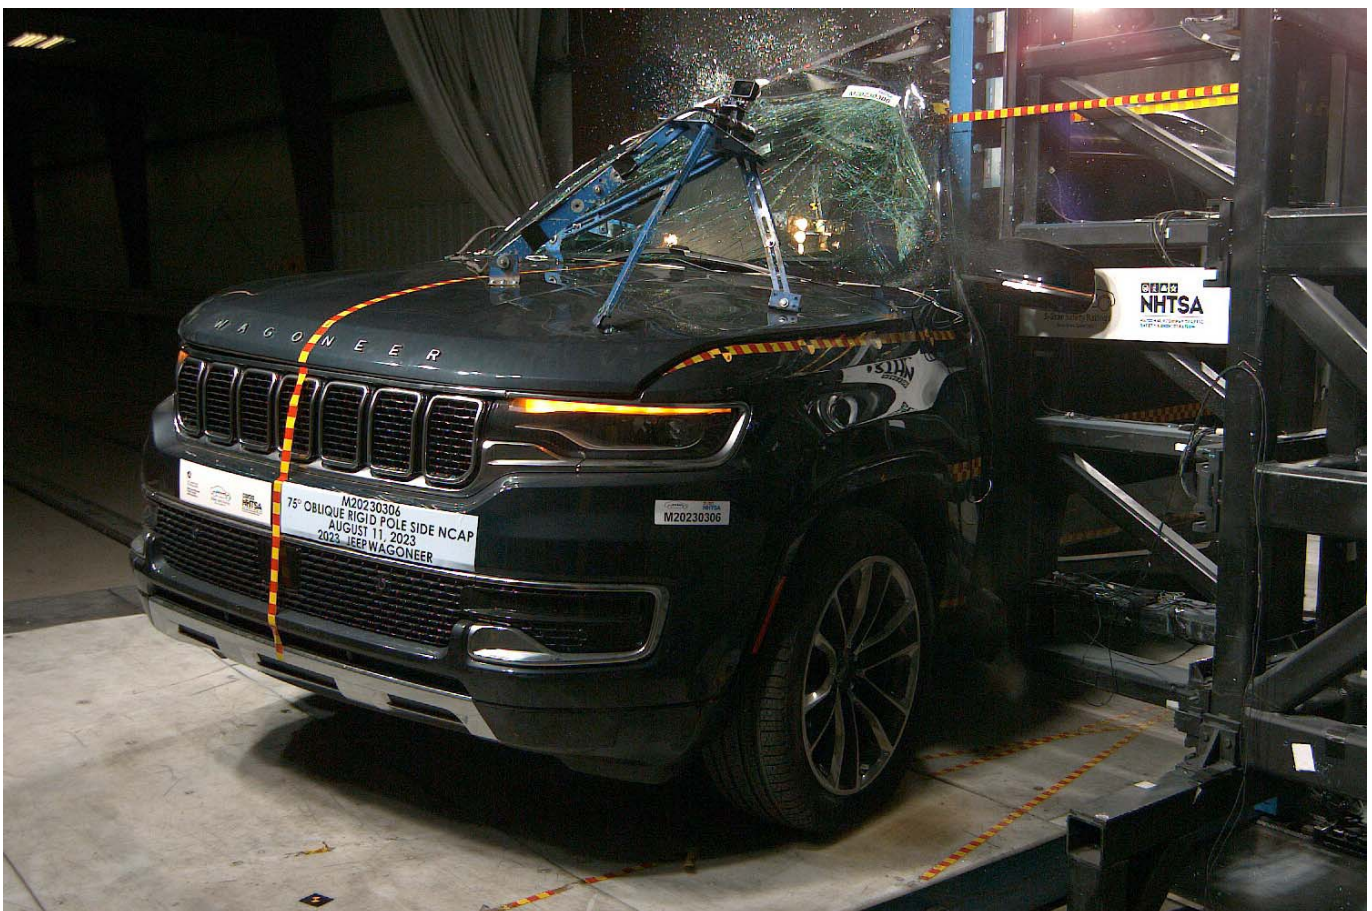
Photo No. 070 - Impact Event

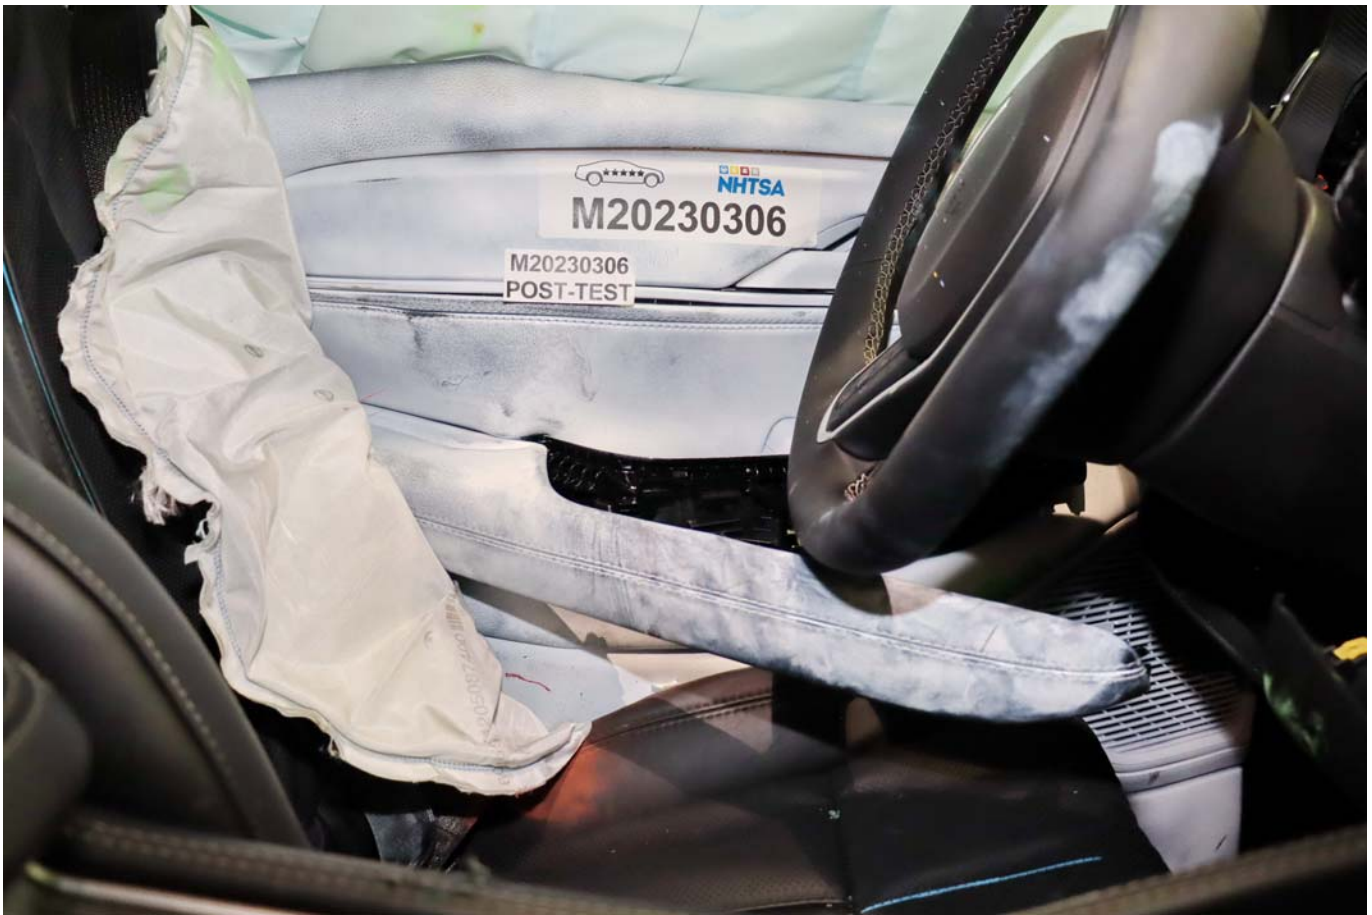
Photo No. 073 - Post-Test View of Shattered Vehicle Inner Door Panel
