**REPORT NUMBER: NCAP-MGA-23-036**

**NEW CAR ASSESSMENT PROGRAM (NCAP)  
Frontal Barrier Impact Test**

**TOYOTA MOTOR CORPORATION  
2023 Toyota RAV4 Prime SE AWD 5-Door SUV  
NHTSA No.: M20235100**

**MGA RESEARCH CORPORATION  
5000 Warren Road  
Burlington, WI 53105**

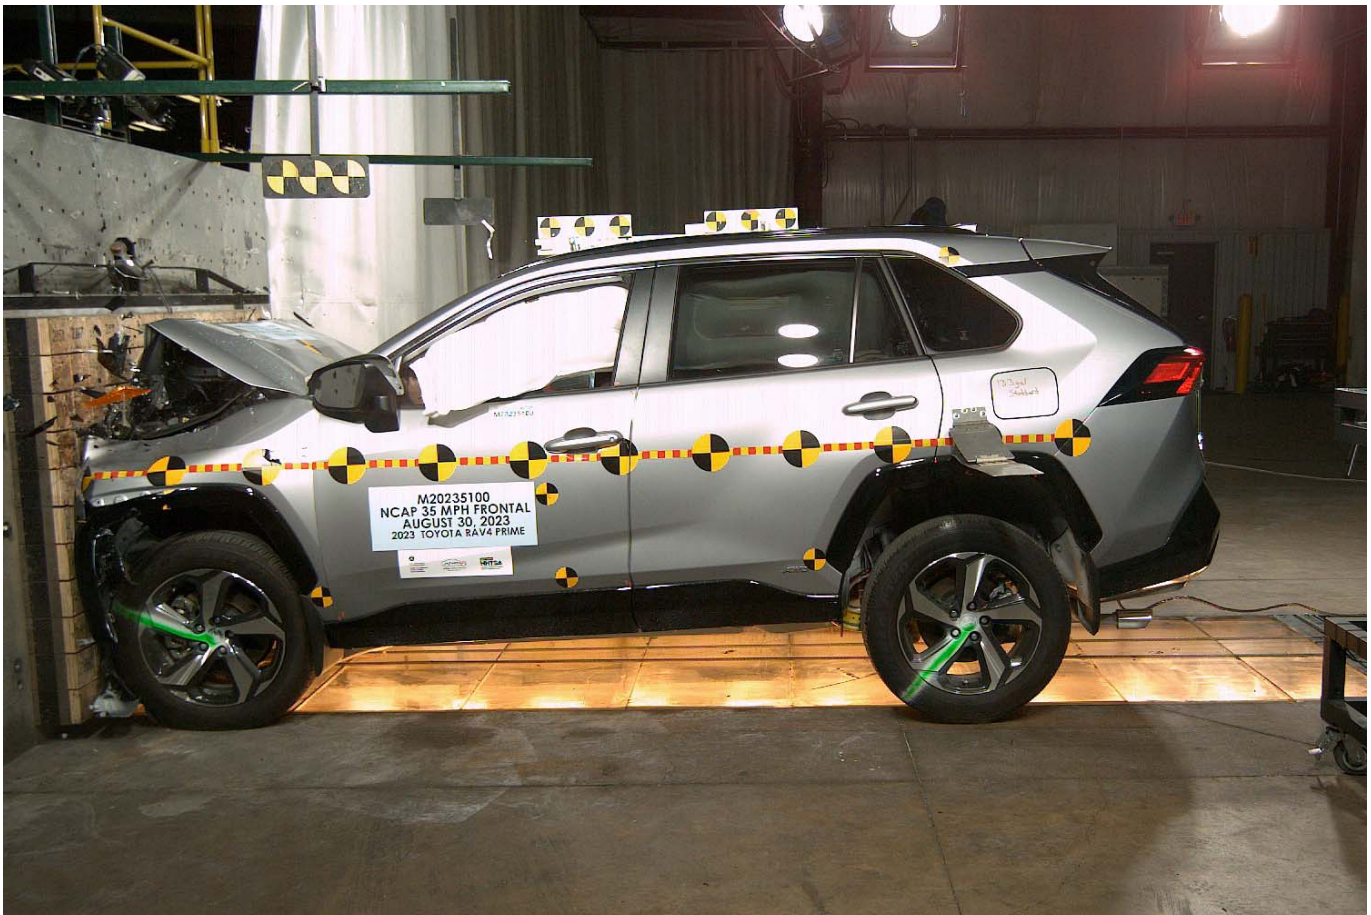
Photo No. 082 - 2023 Toyota RAV4 Prime SE AWD 5-Door SUV Frontal Impact Event

A load cell barrier consisting of 176 load cells was impacted by a 2023 Toyota RAV4 Prime SE AWD 5-Door SUV at a velocity of 56.50 km/h. The test was performed at MGA Research Corporation on August 30, 2023. Pre-test and post-test photographs of the vehicle and dummies can be found in Appendix A.
