**REPORT NUMBER: SideNCAPMDB-MGA-23-025**

**NEW CAR ASSESSMENT PROGRAM (NCAP)  
Moving Deformable Barrier Side Impact Test**

**HONDA DEVELOPMENT & MANUFACTURING OF AMERICA, LLC  
2023 Honda CR-V Hybrid Sport 5-Door SUV  
NHTSA No.: O20235308**

**FINAL REPORT**

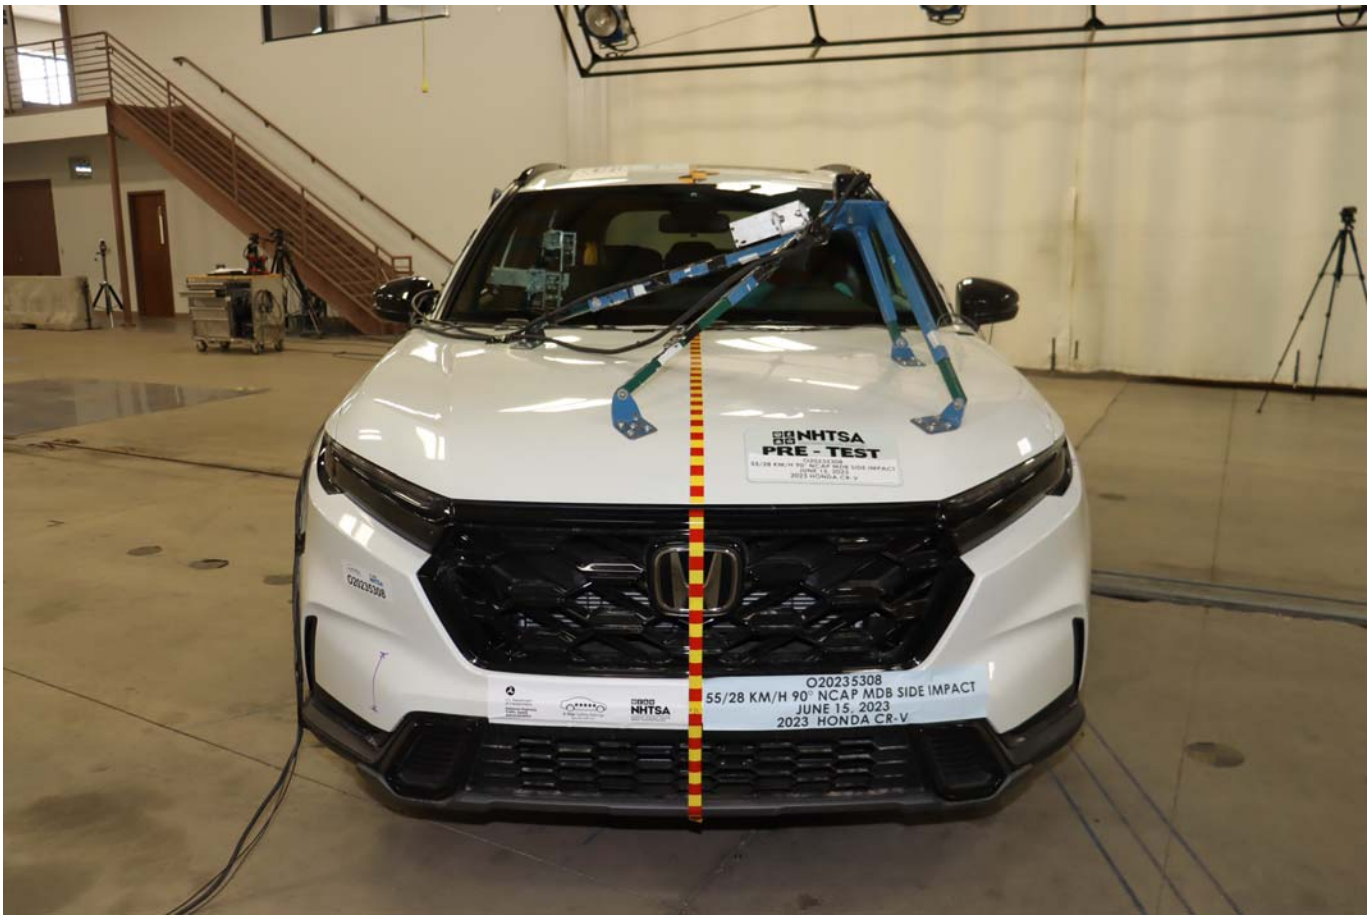
Photo No. 003 - Pre-Test Frontal View of Test Vehicle

Photo No. 004 - Post-Test Frontal View of Test Vehicle

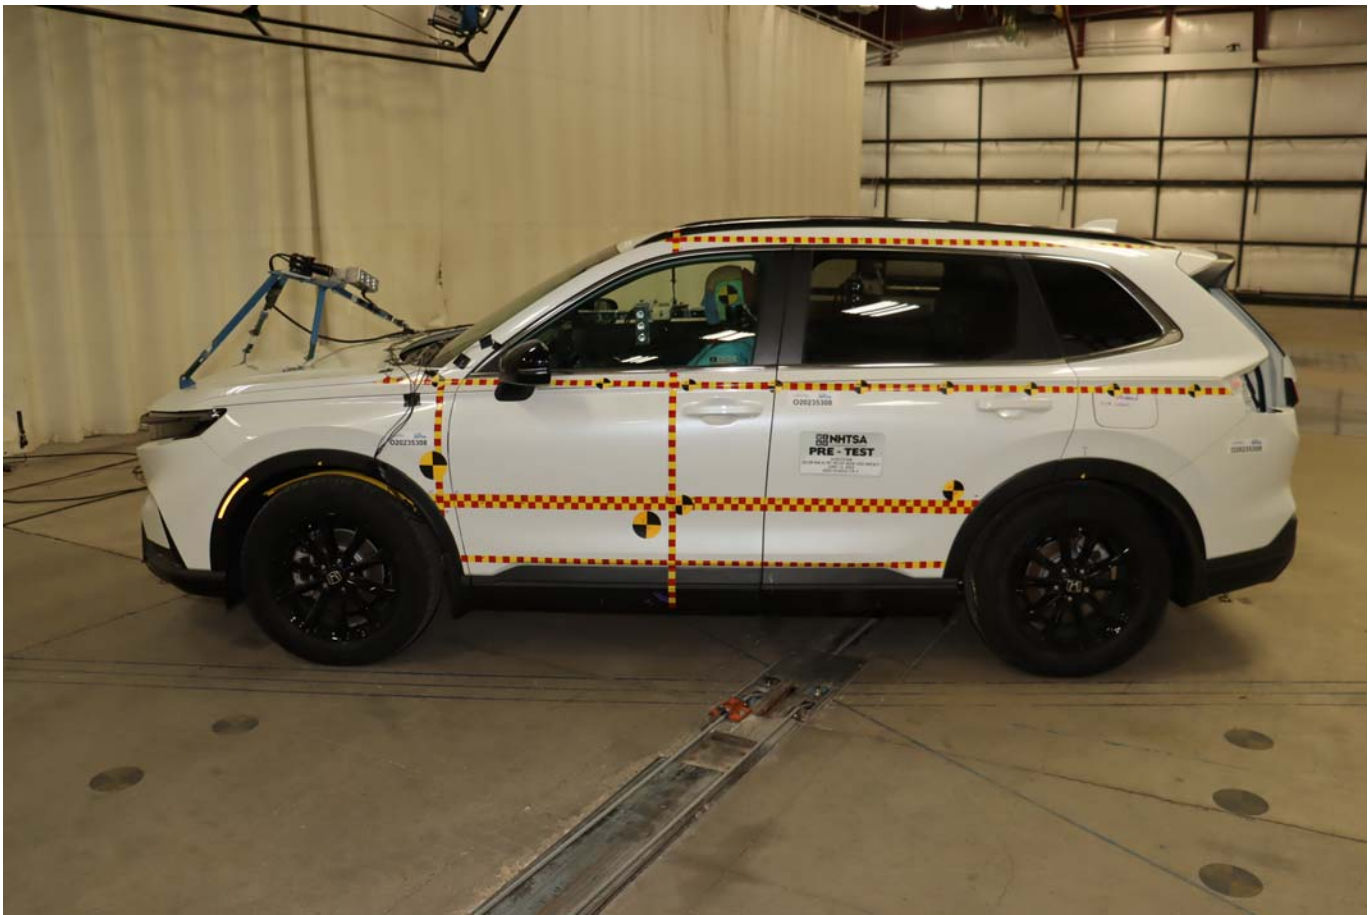
Photo No. 007 - Pre-Test Left Side View of Test Vehicle

Photo No. 008 - Post-Test Left Side View of Test Vehicle

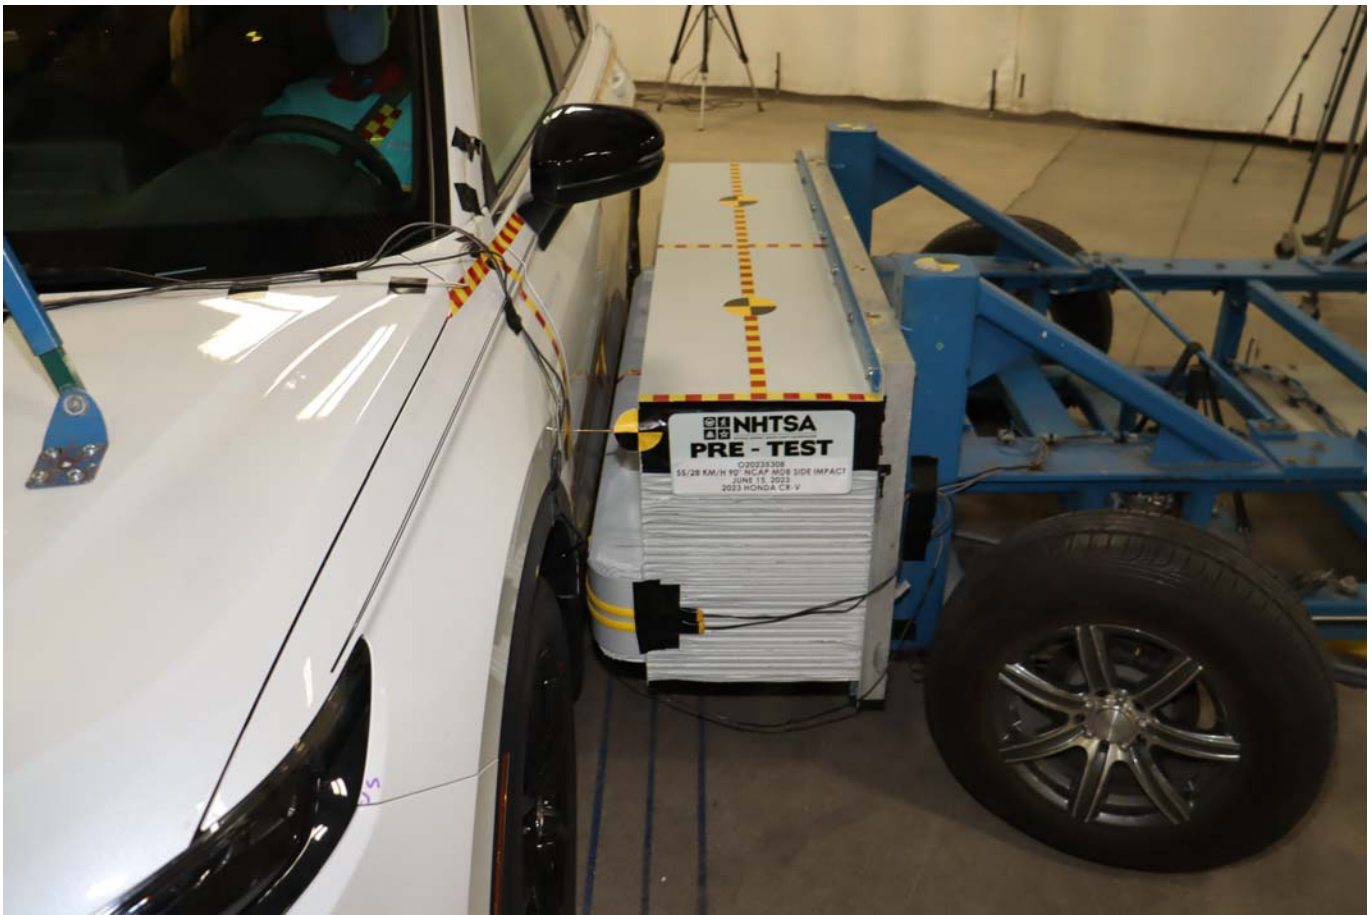
Photo No. 017 - Pre-Test Left Side View of MDB Positioned Against Side of Test Vehicle

Photo No. 018 - Pre-Test Right Side View of MDB Positioned Against Side of Test Vehicle

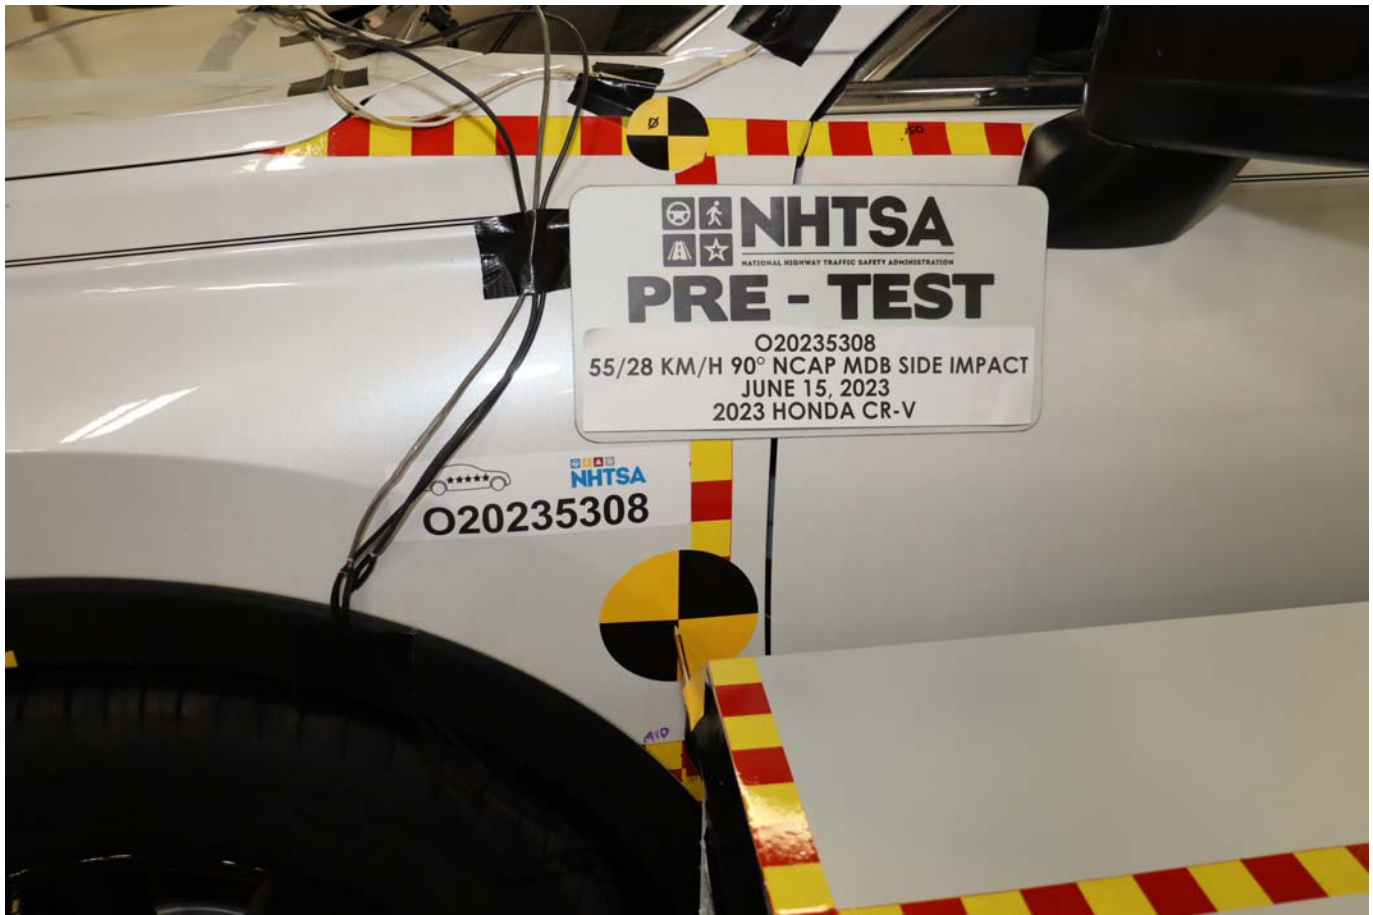
Photo No. 019 - Pre-Test Close-Up View of Impact Point Target

Photo No. 020 - Post-Test Close-Up View of Impact Point Target

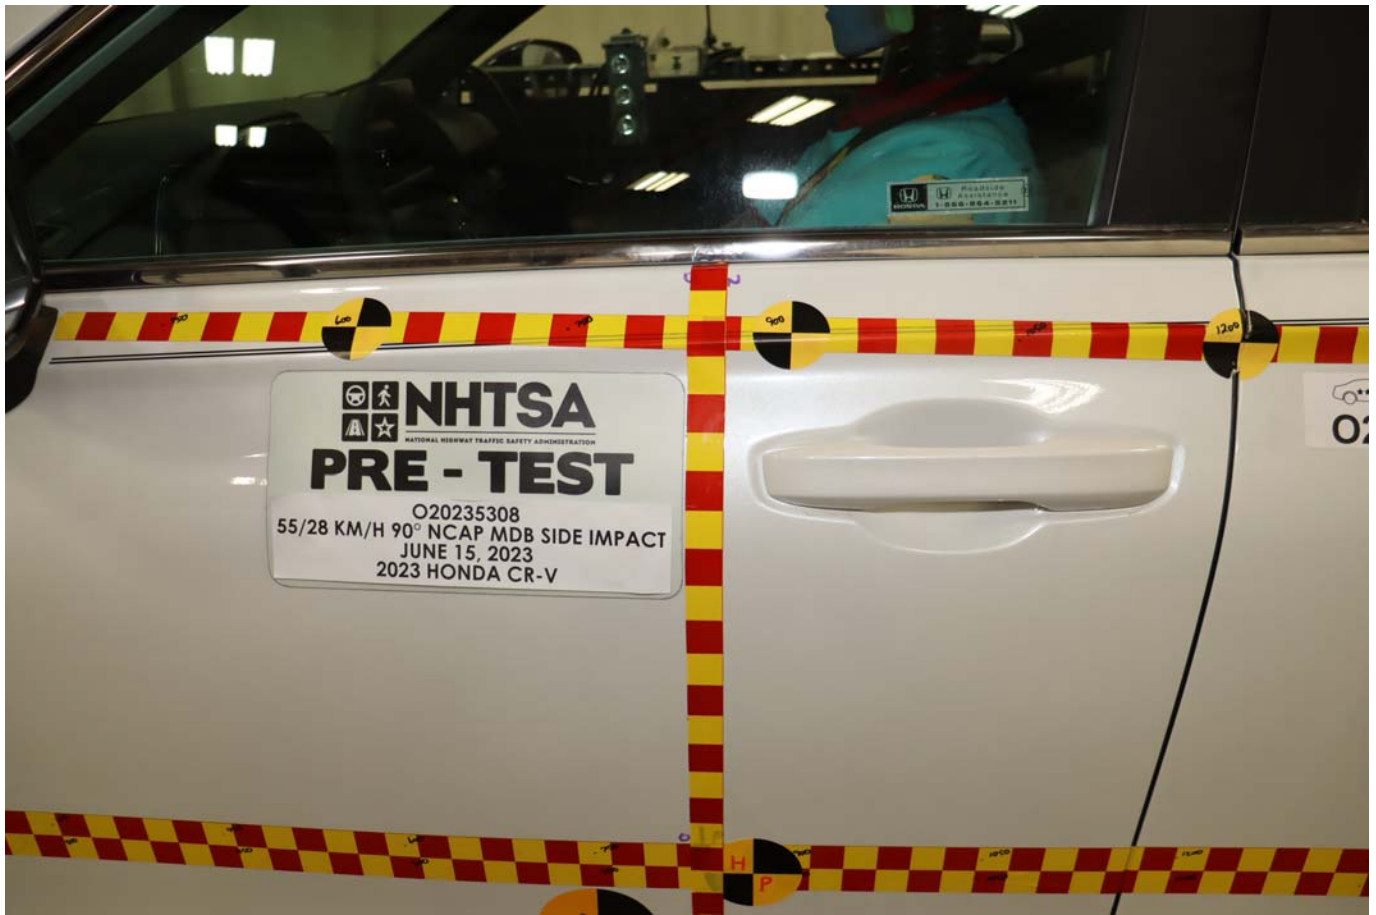
Photo No. 021 - Pre-Test Left Front Door Latch Close-Up

Photo No. 022 - Post-Test Left Front Door Latch Close-Up

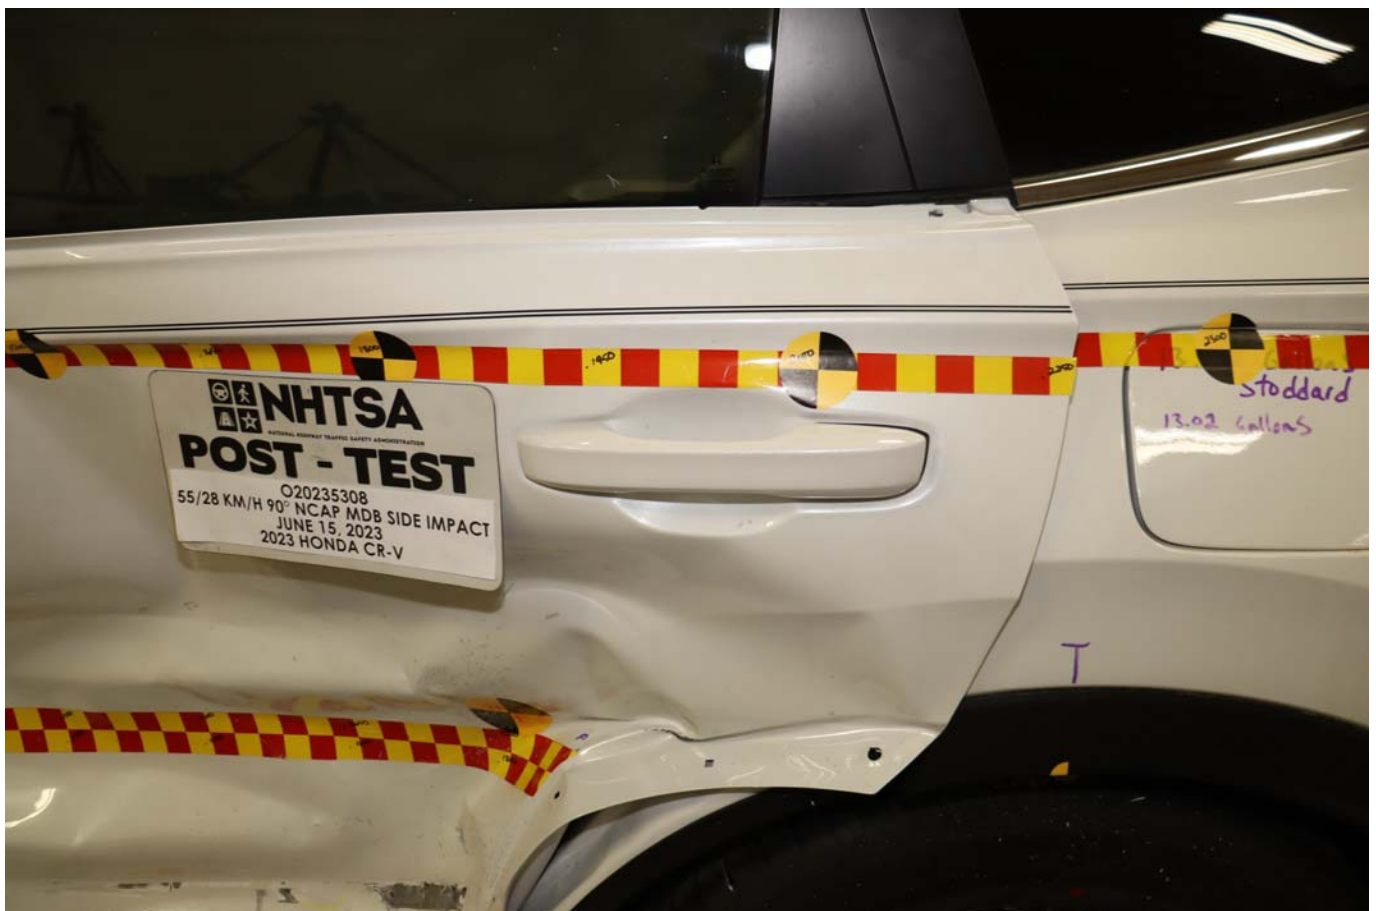
Photo No. 024 - Post-Test Left Rear Door Latch Close-Up

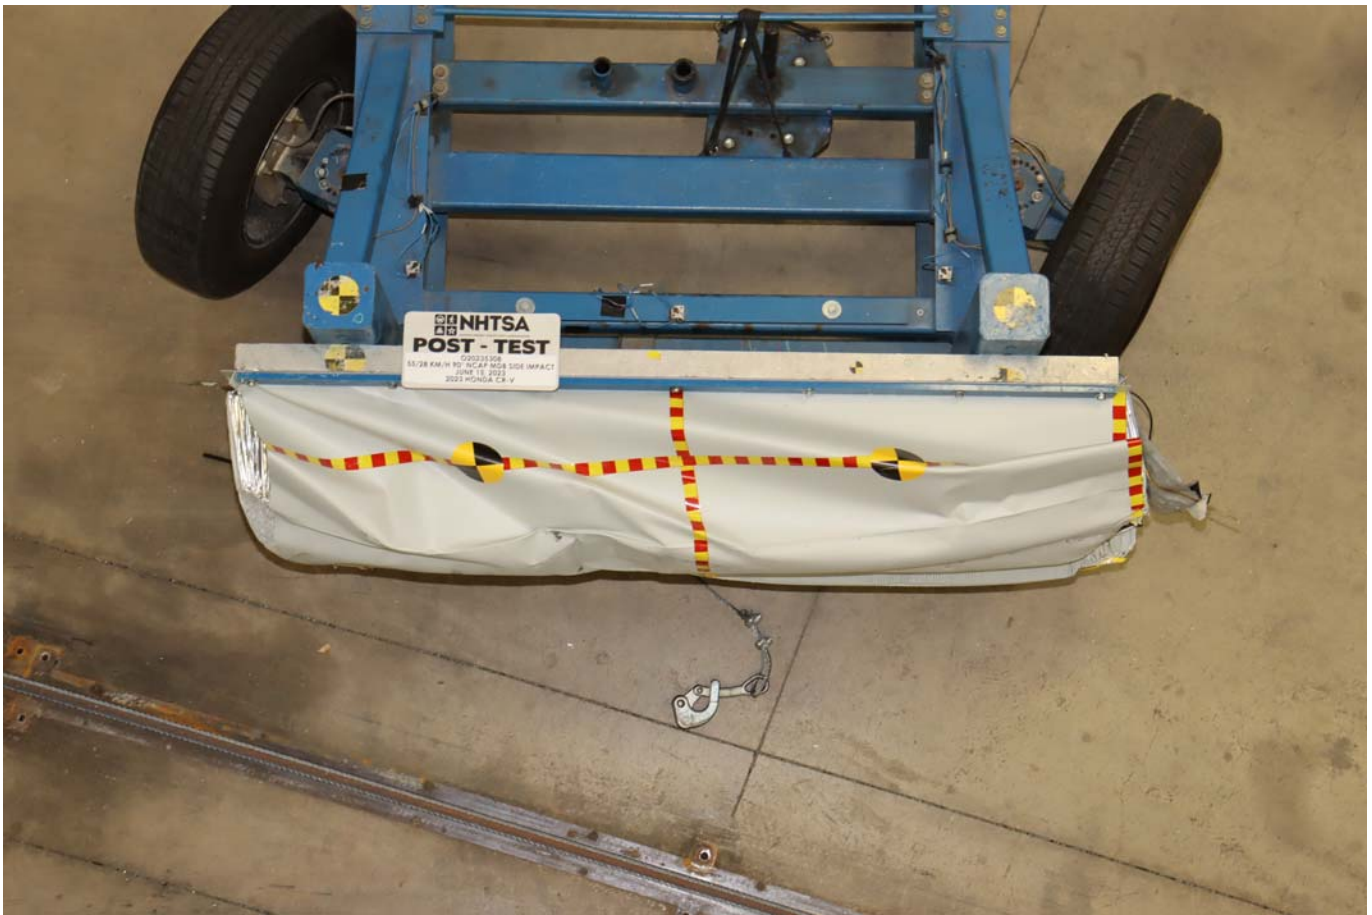
Photo No. 087 - Post-Test Top View of MDB Impactor Face

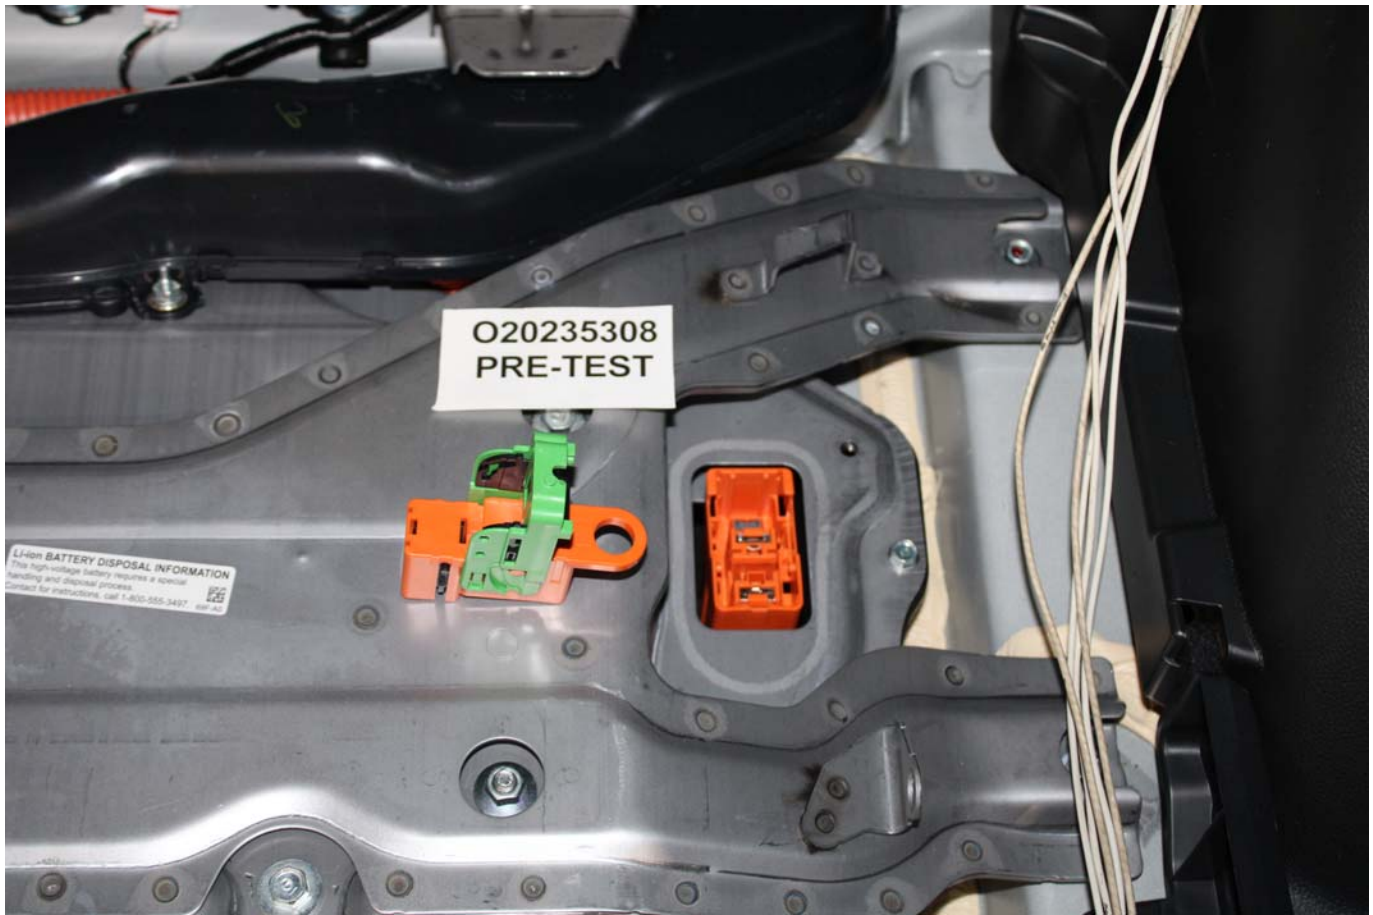
Photo No. 305-07 - Manual High Voltage Service Disconnect Removed

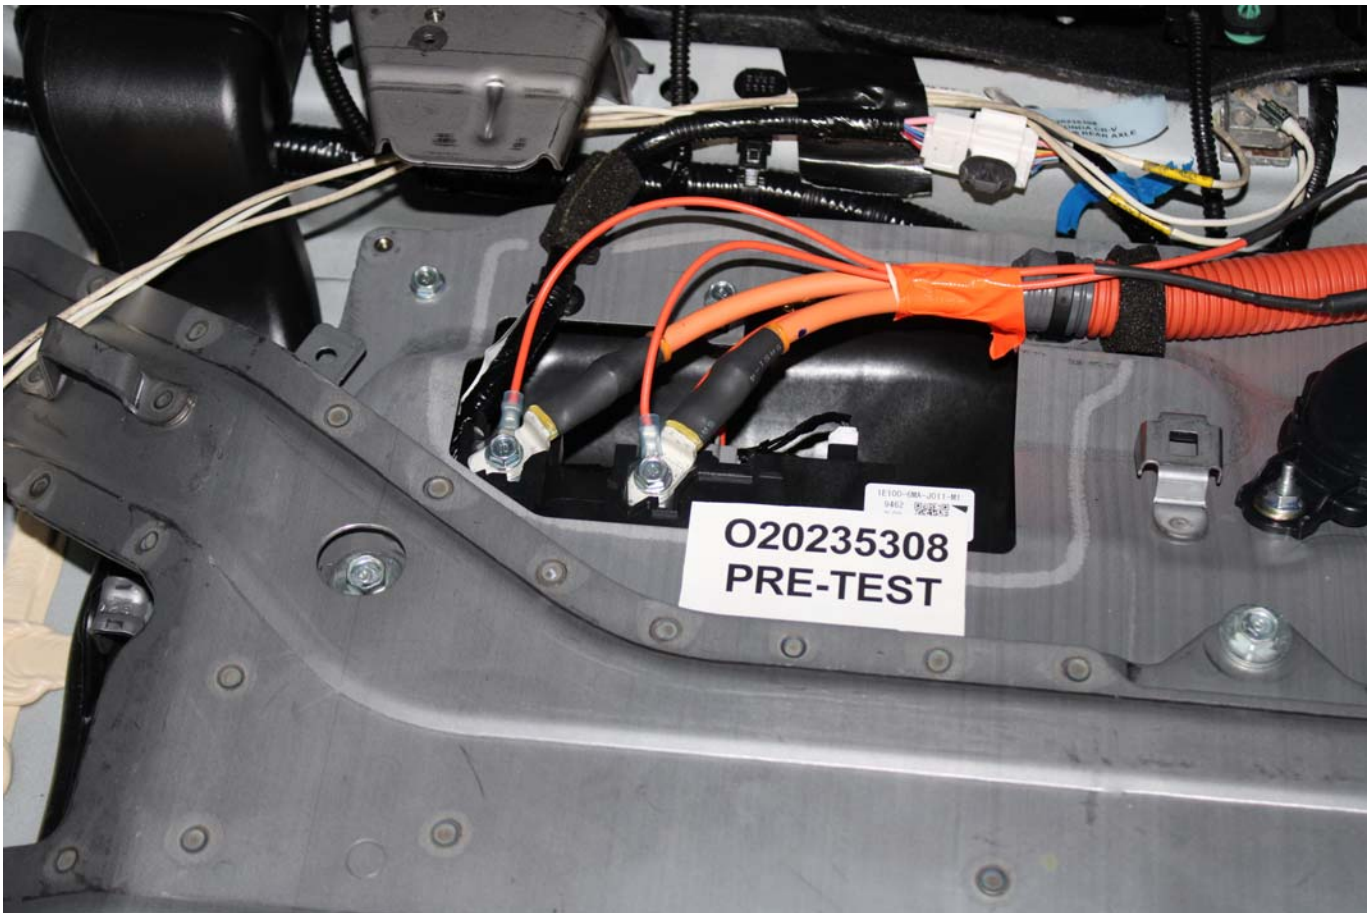
Photo No. 305-23 - Pre-Impact Close-Up View of High Voltage Leads Attached
