**REPORT NUMBER: SideNCAPPole-MGA-24-004**

**NEW CAR ASSESSMENT PROGRAM (NCAP)  
Side Impact Pole Test**

**MAZDA MOTOR CORPORATION  
2024 Mazda CX-90 PHEV Premium Plus 5-Door SUV  
NHTSA No.: O20245404**

**MGA RESEARCH CORPORATION  
5000 Warren Road  
Burlington, WI 53105**

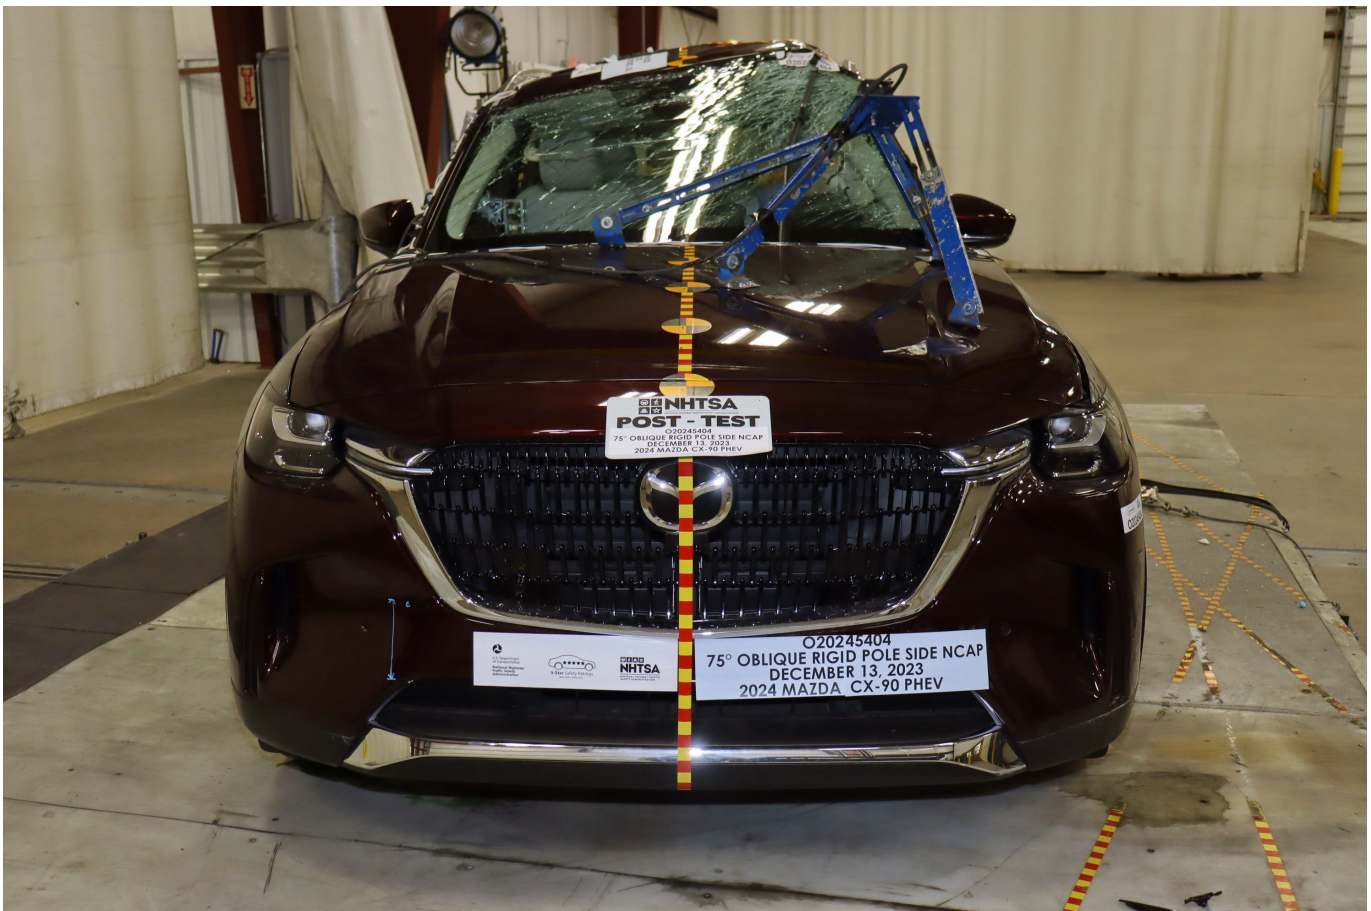
Photo No. 004 - Post-Test Frontal View of Test Vehicle

Critical Areas of Performance	Observations and Conclusions
Pillar Performance	No Separation
Sill Separation	None
Windshield Damage	Cracked
Side Window Damage	LF window cracked
Other Notable Effects	None
