**REPORT NUMBER: SideNCAPMDB-MGA-23-054**

**NEW CAR ASSESSMENT PROGRAM (NCAP)  
Moving Deformable Barrier Side Impact Test**

**HYUNDAI MOTOR COMPANY  
2023 Hyundai Palisade Calligraphy 5-Door SUV  
NHTSA No.: O20234204**

**FINAL REPORT**

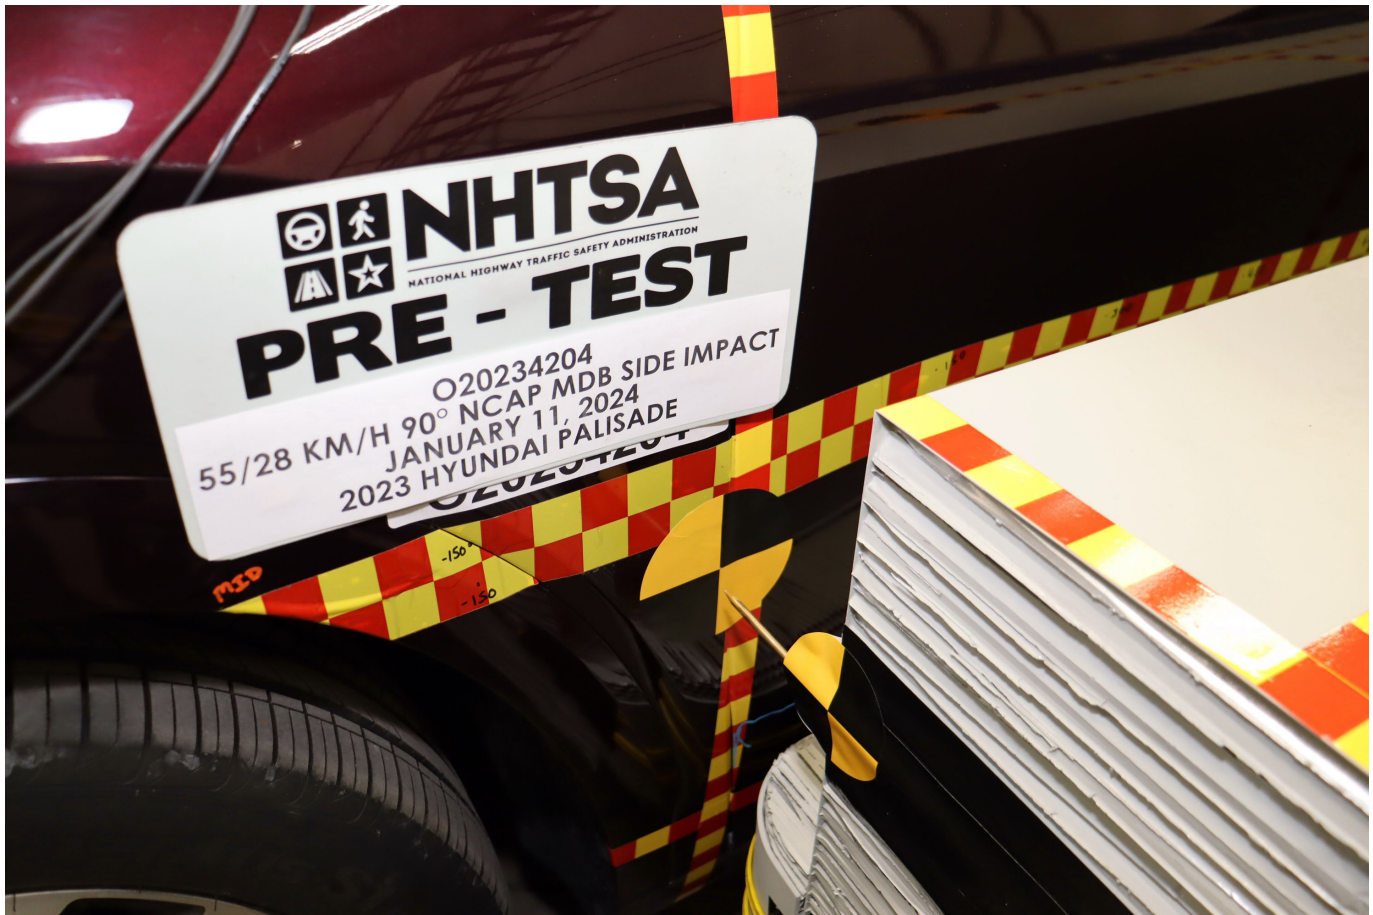
Photo No. 019 - Pre-Test Close-Up View of Impact Point Target

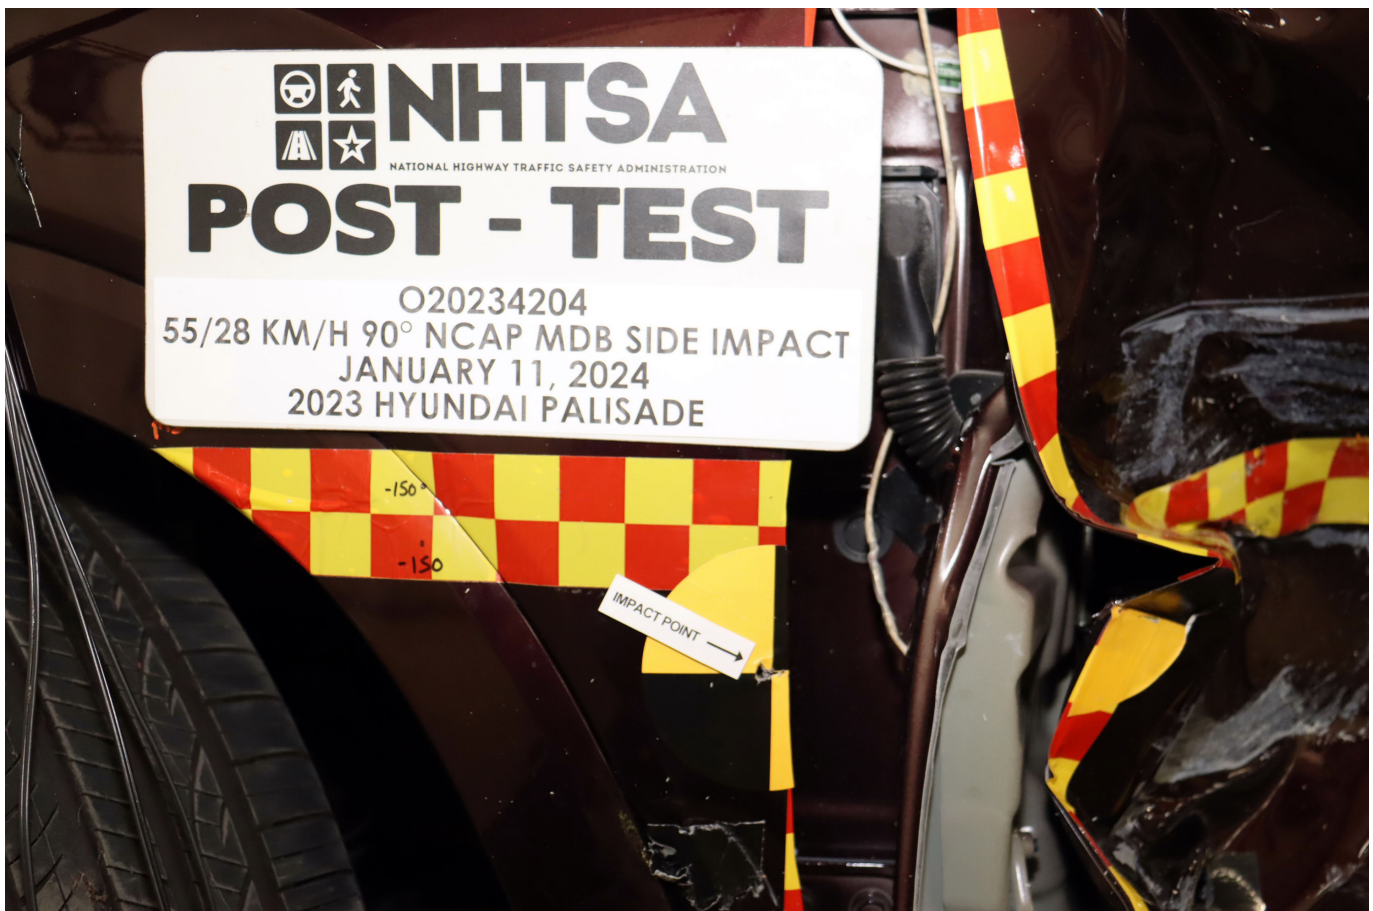
Photo No. 020 - Post-Test Close-Up View of Impact Point Target

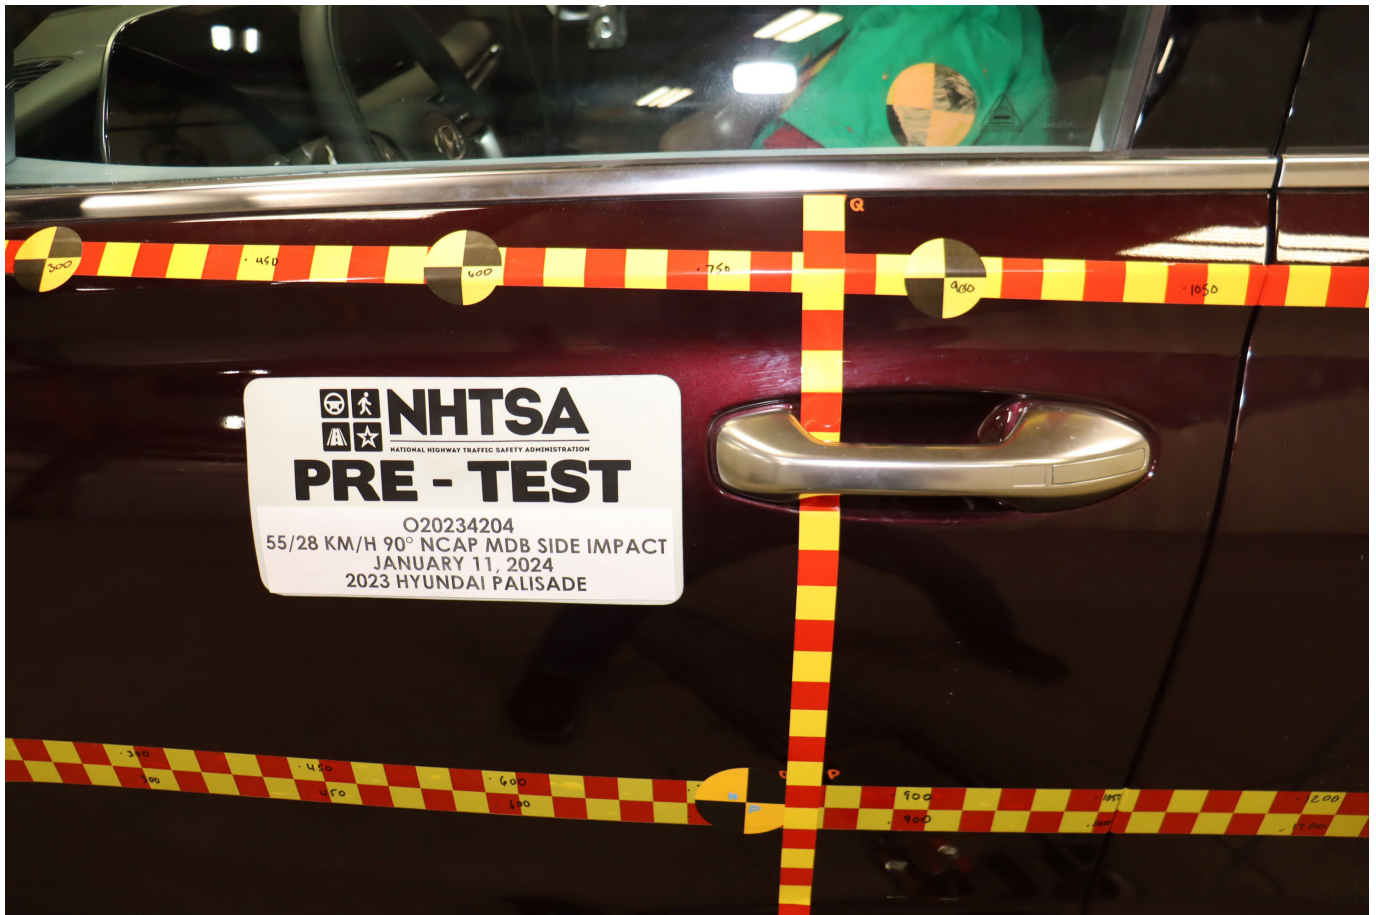
Photo No. 021 - Pre-Test Left Front Door Latch Close-Up

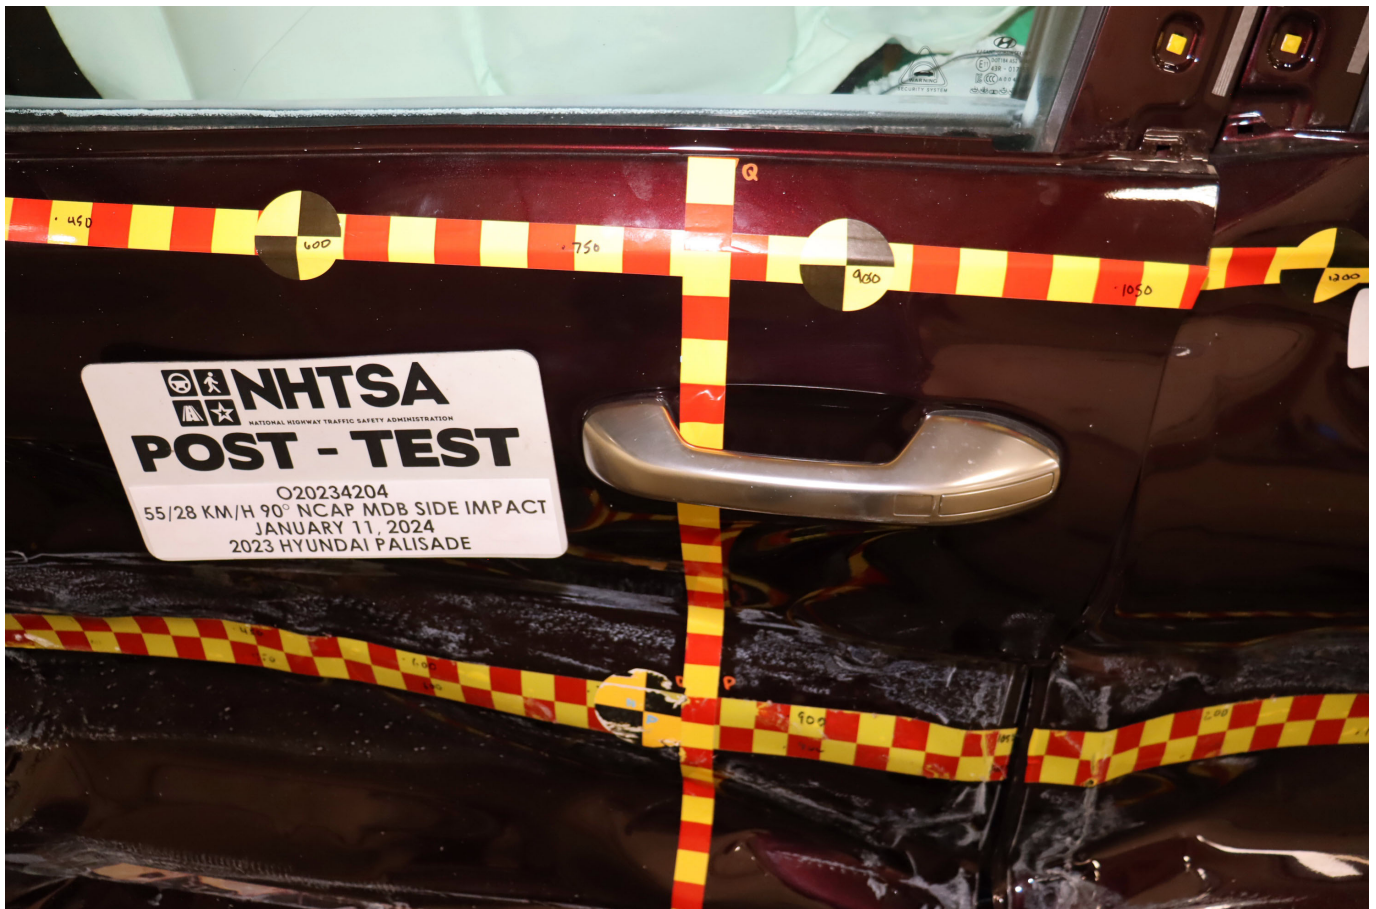
Photo No. 022 - Post-Test Left Front Door Latch Close-Up

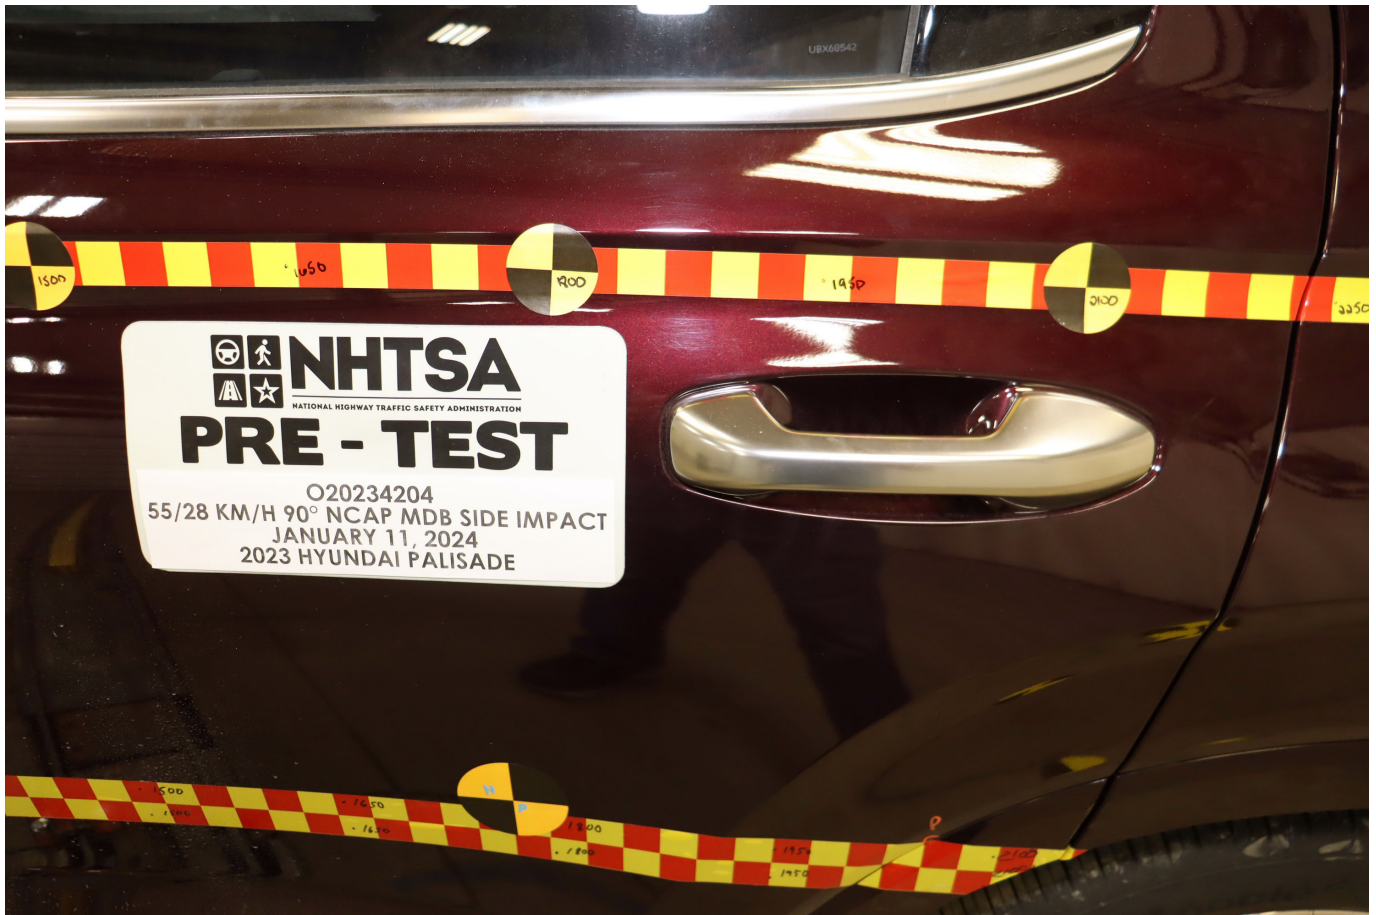
Photo No. 023 - Pre-Test Left Rear Door Latch Close-Up

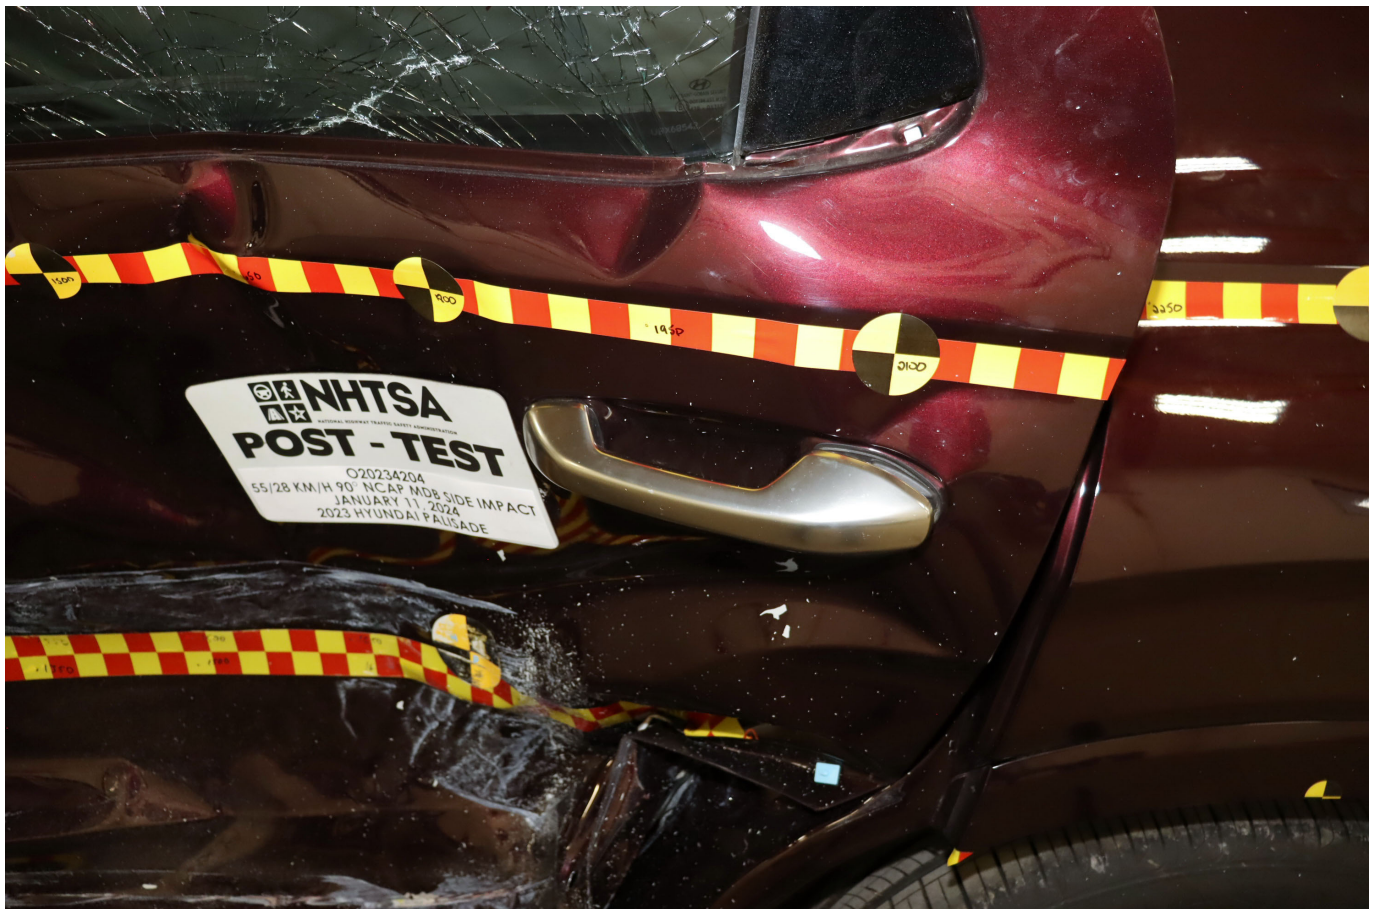
Photo No. 024 - Post-Test Left Rear Door Latch Close-Up

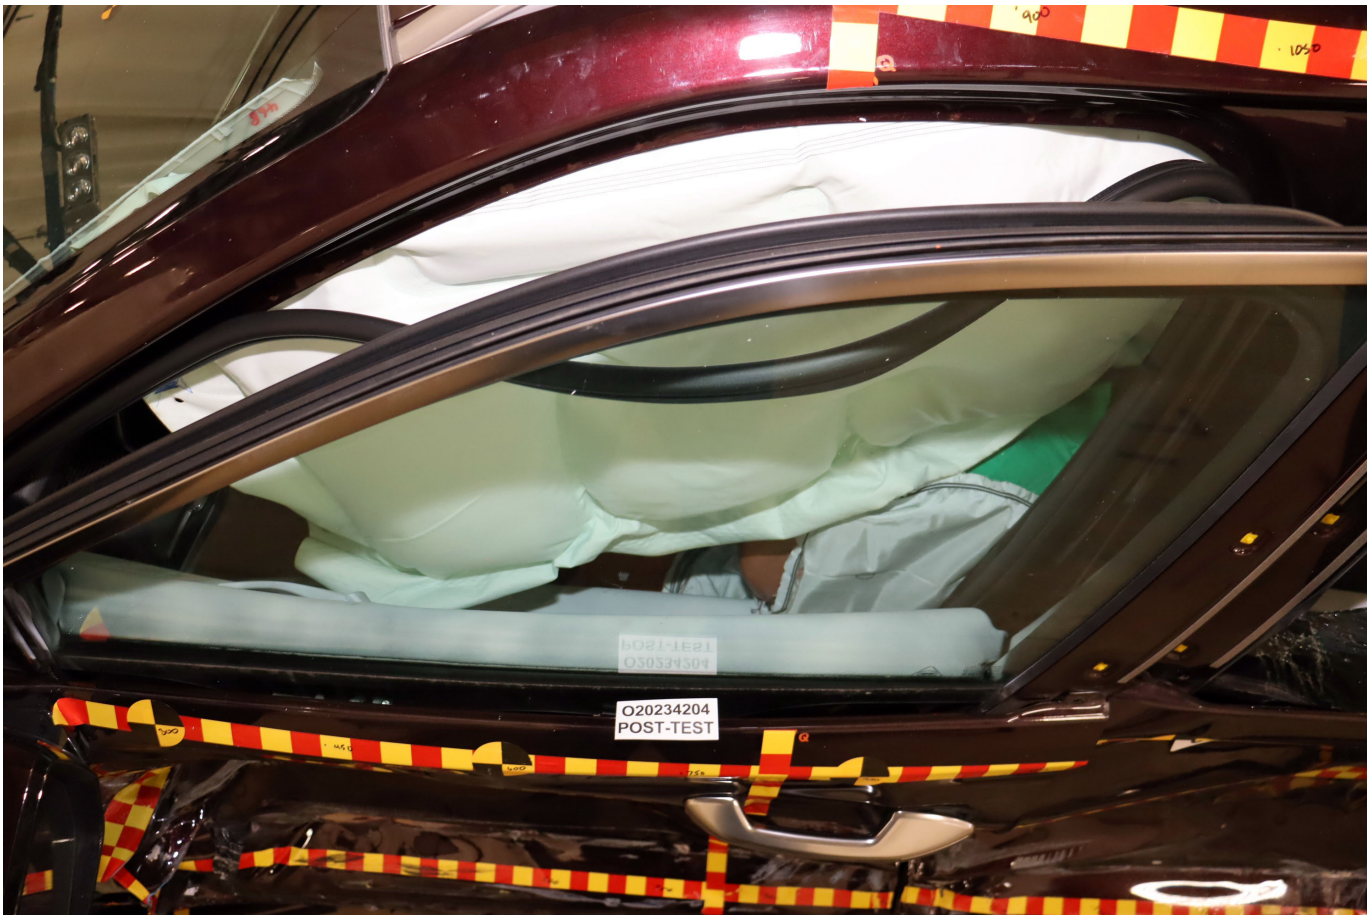
Photo No. 043 - Post-Test Driver Dummy and Door Clearance View

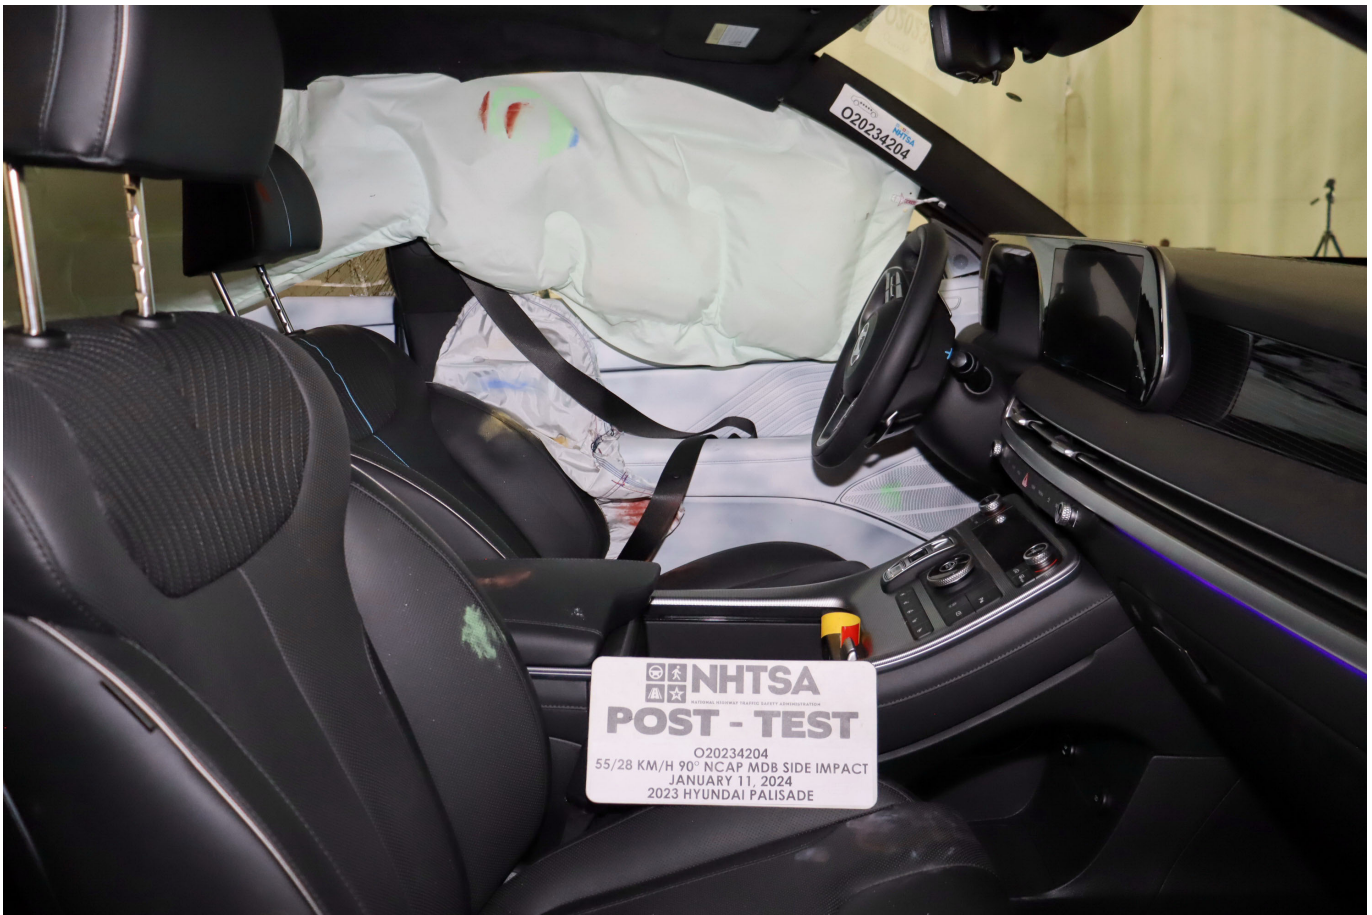
Photo No. 047 - Post-Test Driver Inner Door Panel View

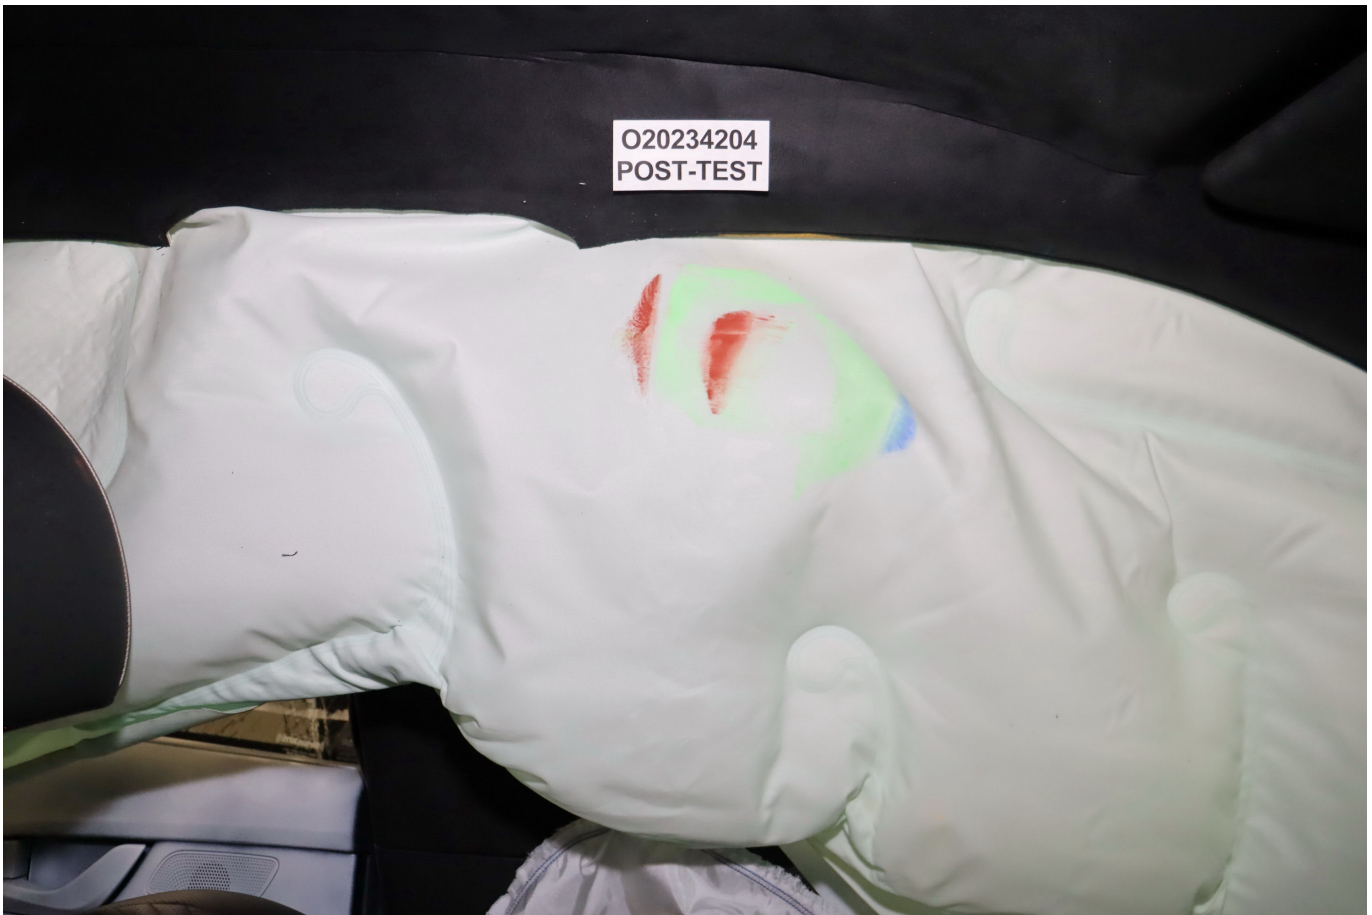
Photo No. 049 - Post-Test Driver Dummy Close-Up Head Contact with Side Airbag View

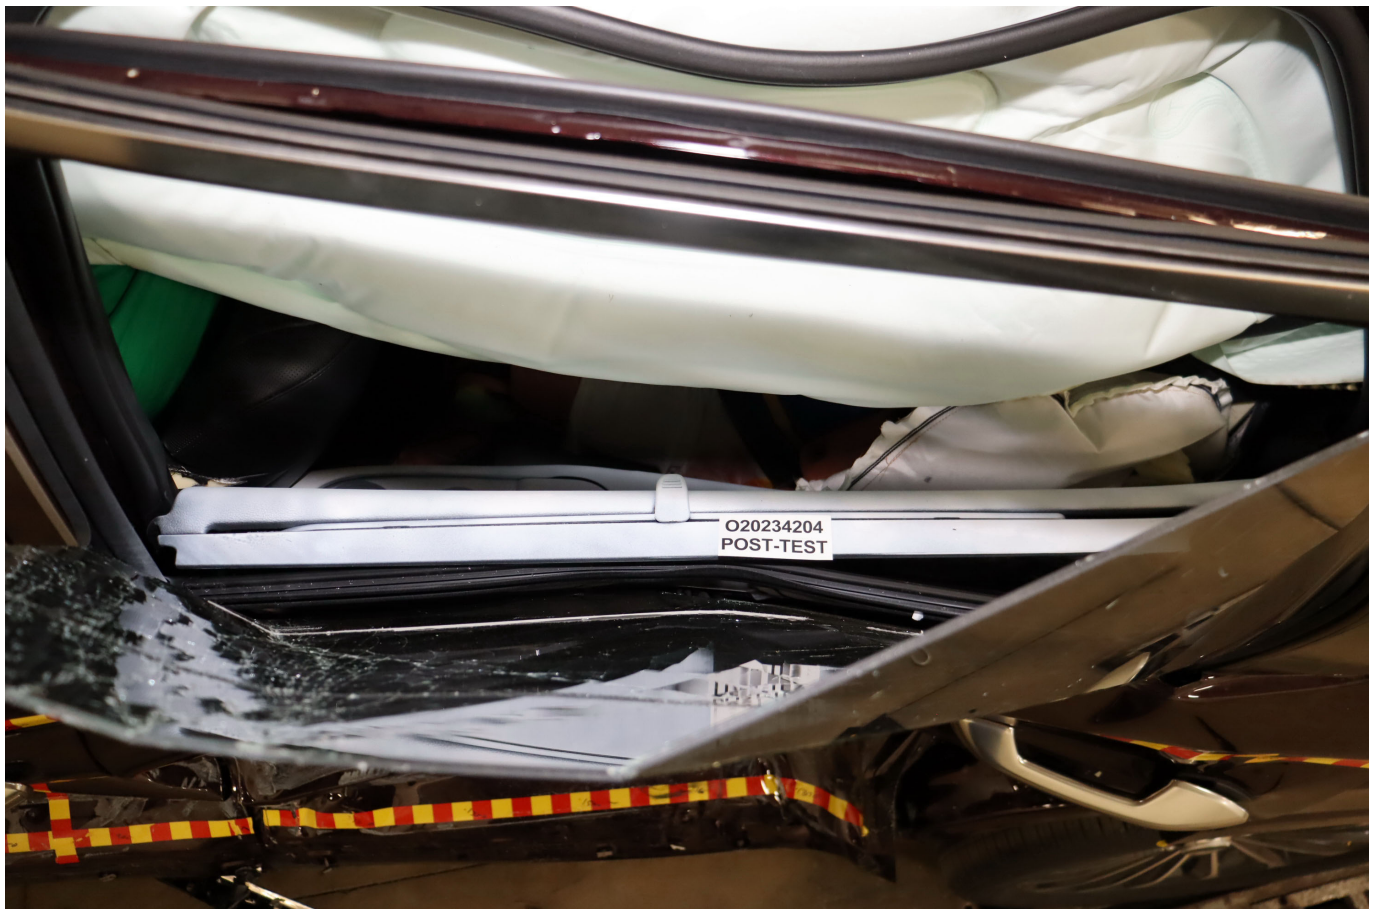
Photo No. 070 - Post-Test Rear Passenger Dummy and Door Clearance View

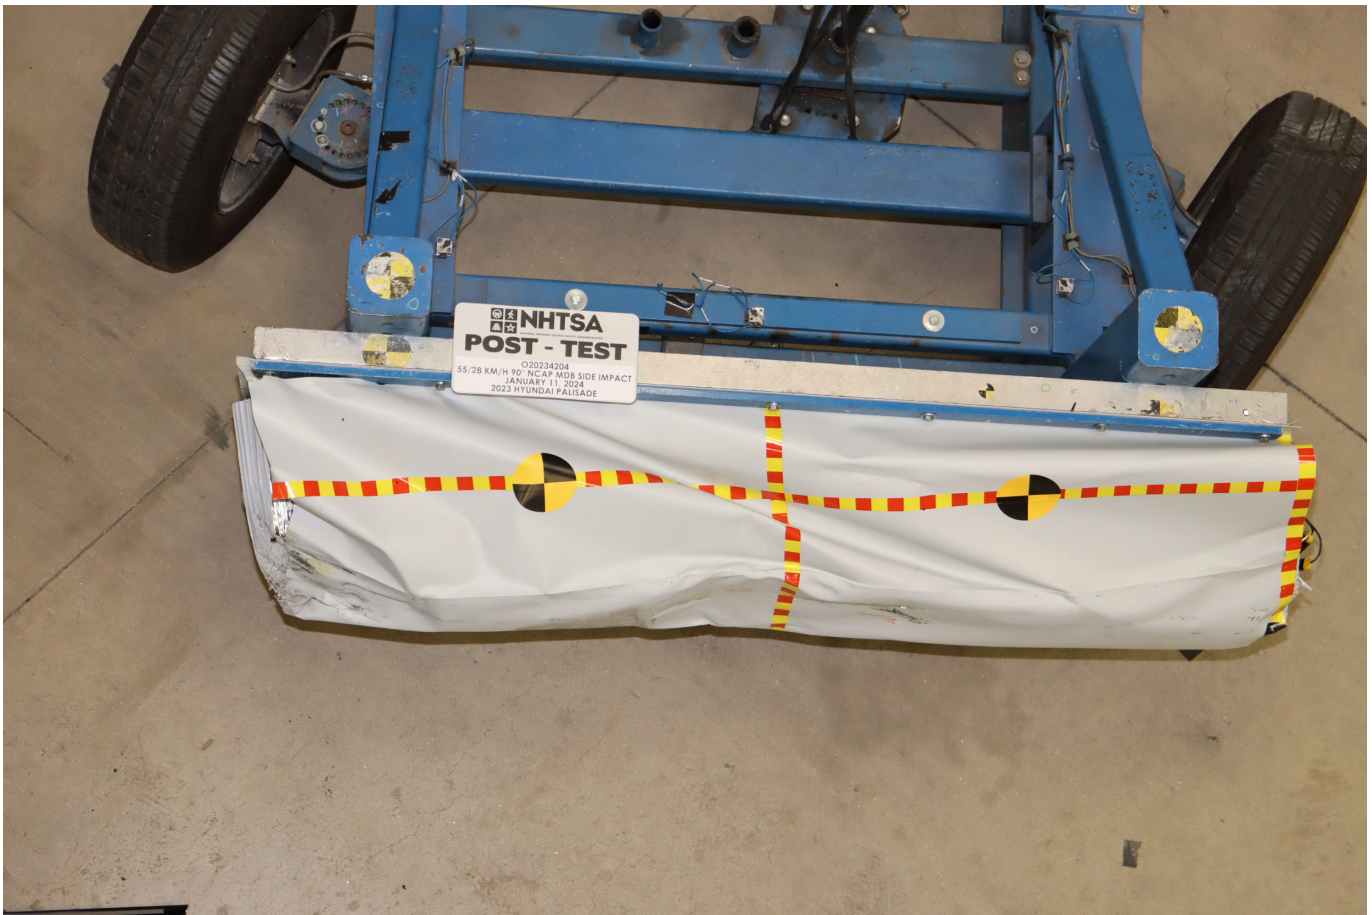
Photo No. 087 - Post-Test Top View of MDB Impactor Face

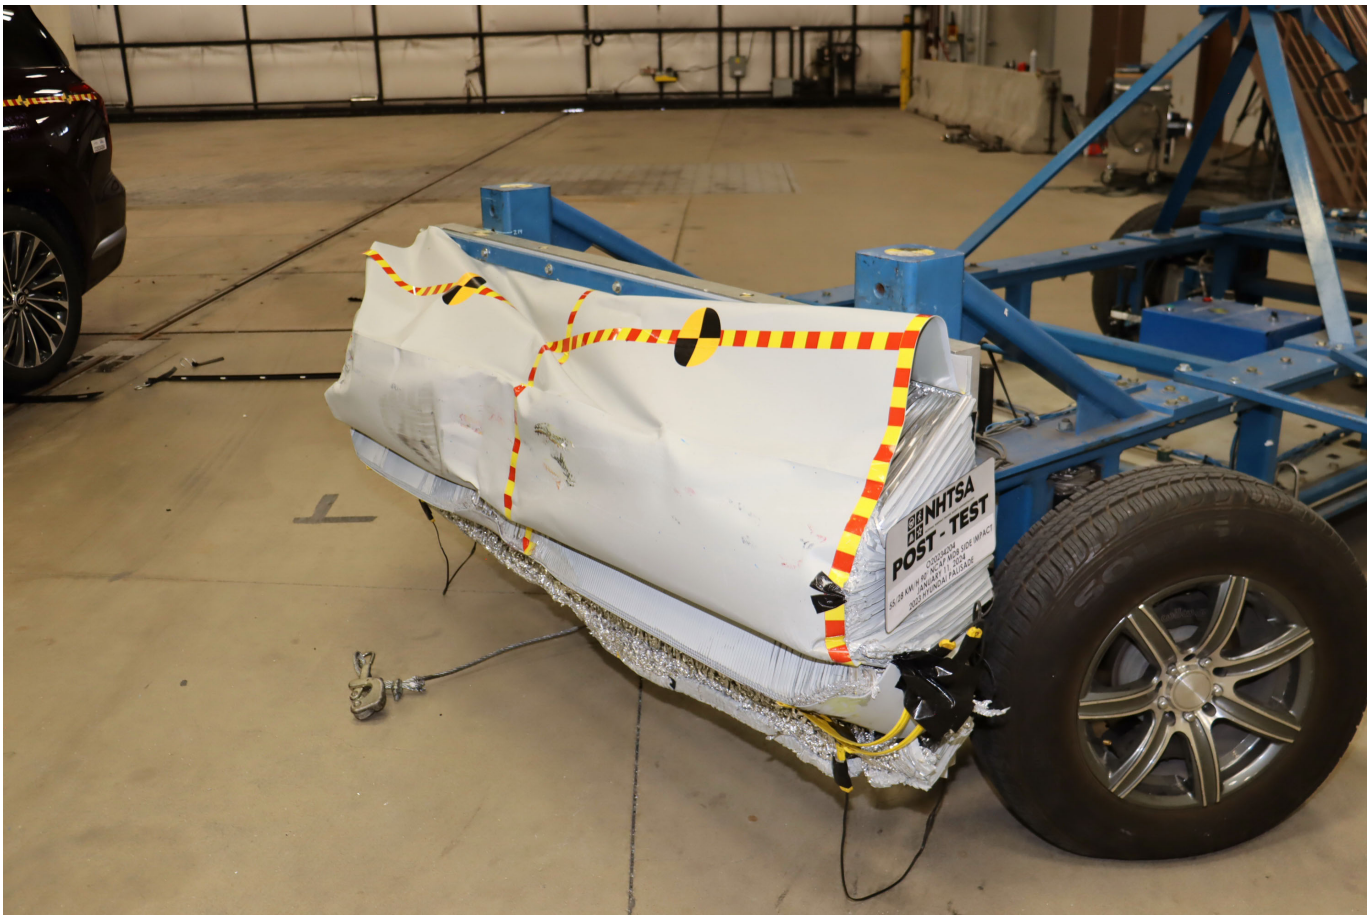
Photo No. 089 - Post-Test Left Side View of MDB Impactor Face

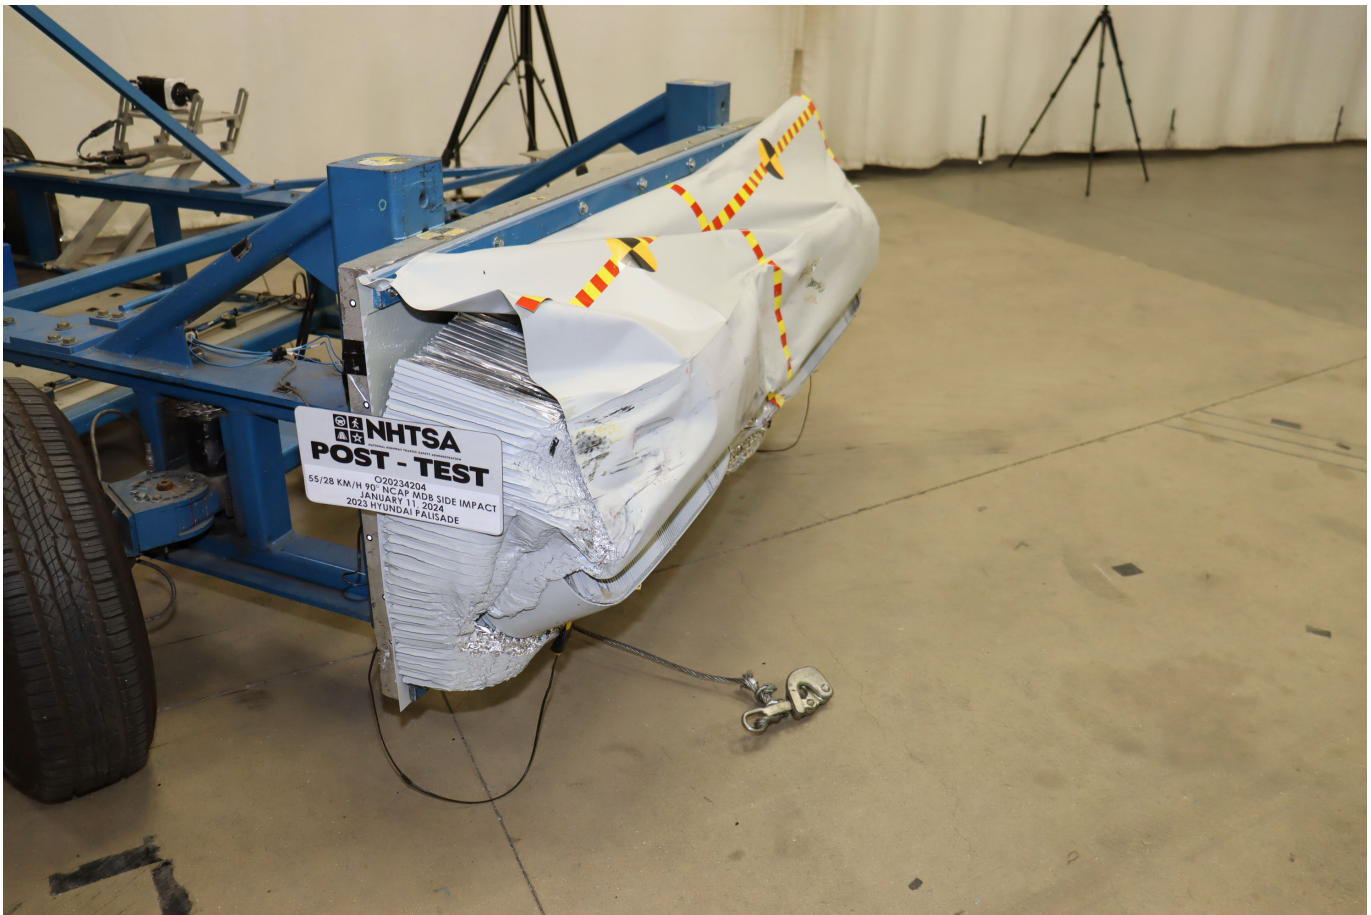
Photo No. 091 - Post-Test Right Side View of MDB Impactor Face

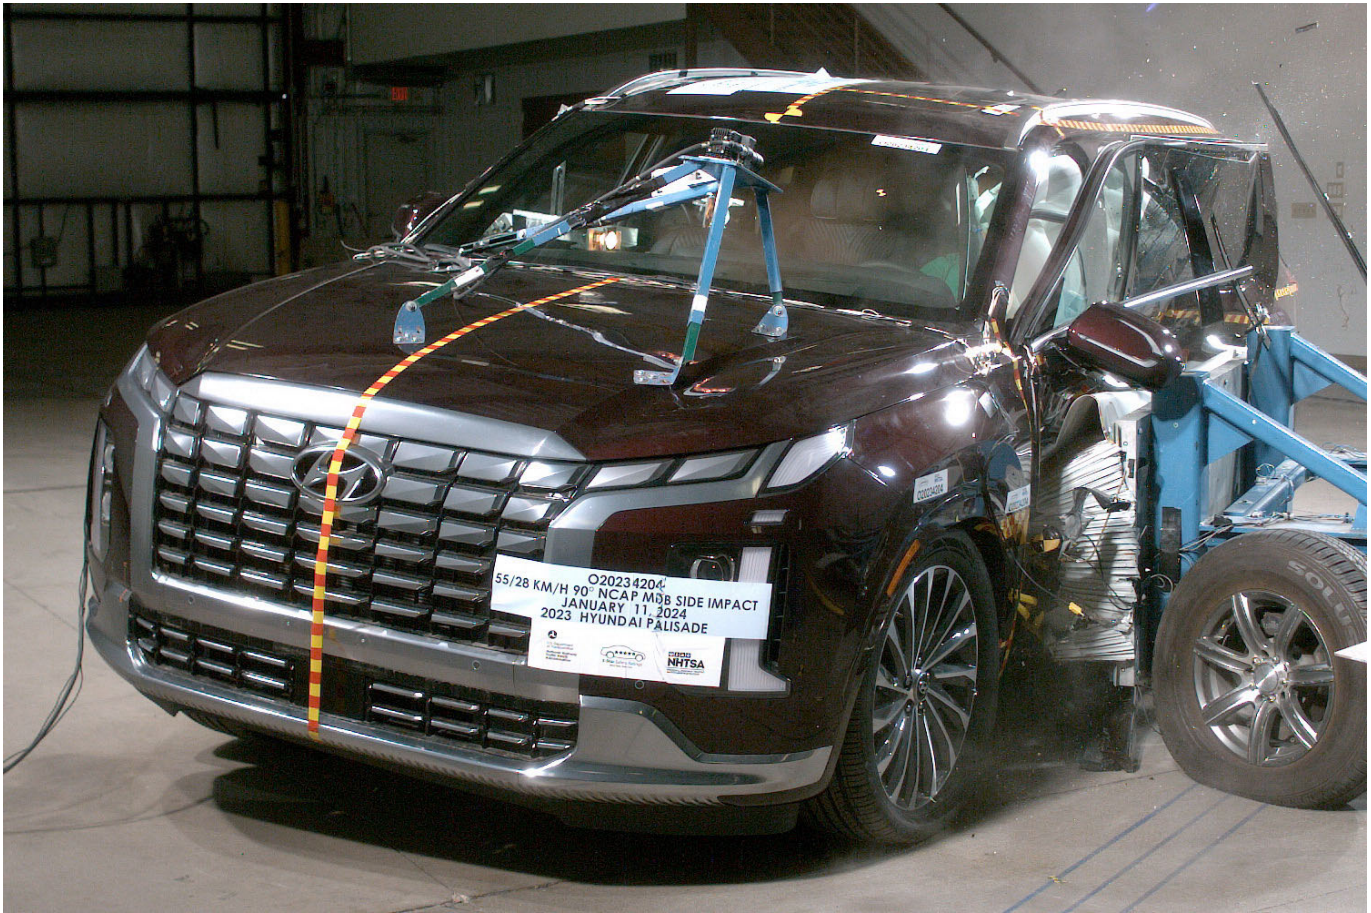
Photo No. 101 - Impact Event
