**REPORT NUMBER: SideNCAPMDB-MGA-24-008**

**NEW CAR ASSESSMENT PROGRAM (NCAP)  
Moving Deformable Barrier Side Impact Test**

**HYUNDAI MOTOR COMPANY  
2024 Hyundai Elantra SEL 4-Door Sedan  
NHTSA No.: O20244205**

**MGA RESEARCH CORPORATION  
5000 Warren Road  
Burlington, WI 53105**

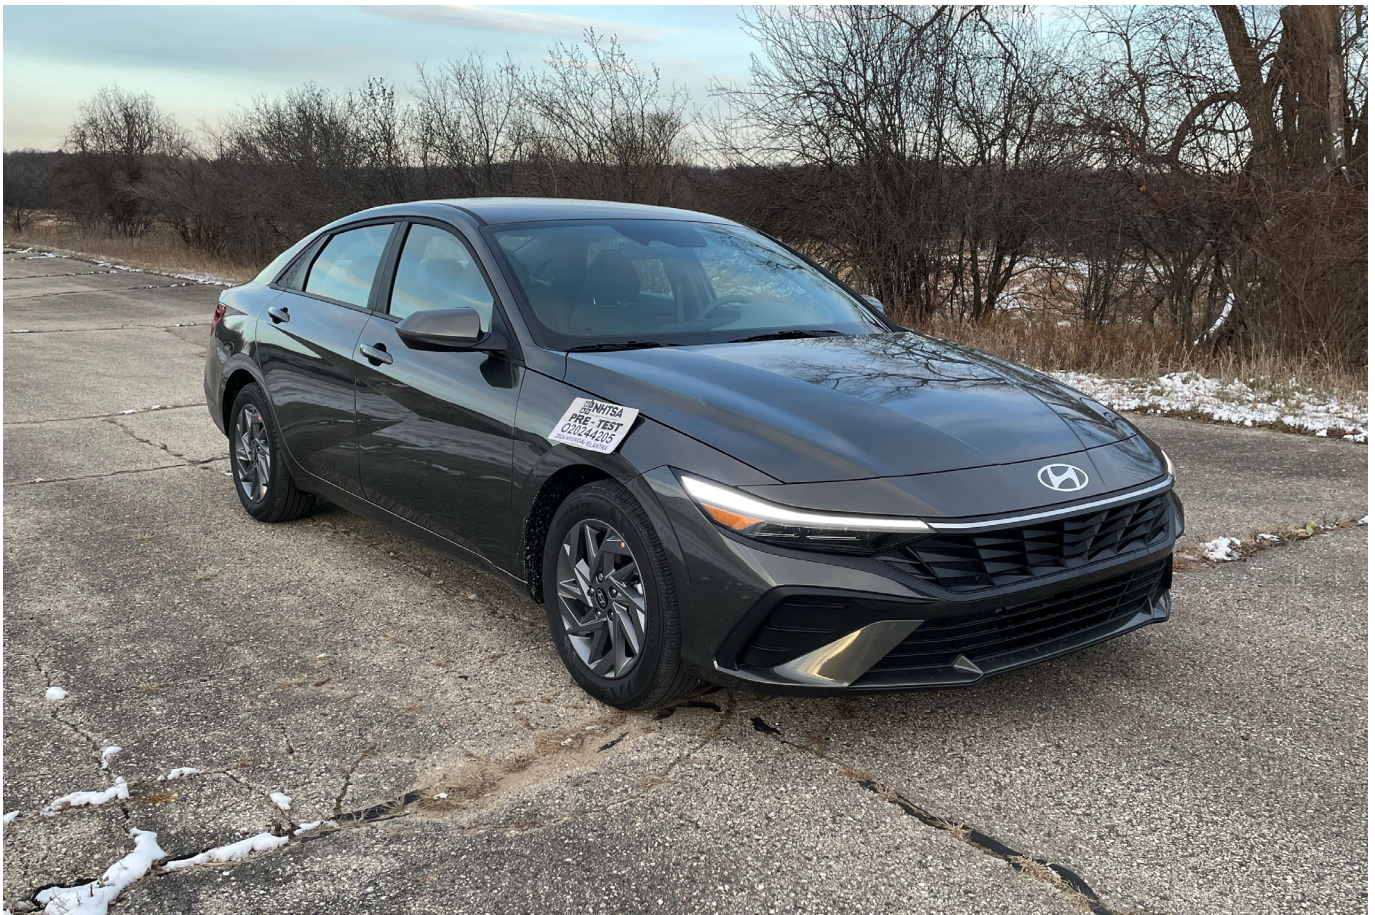
Photo No. 001 - As Delivered Right Front Three-Quarter View of Test Vehicle

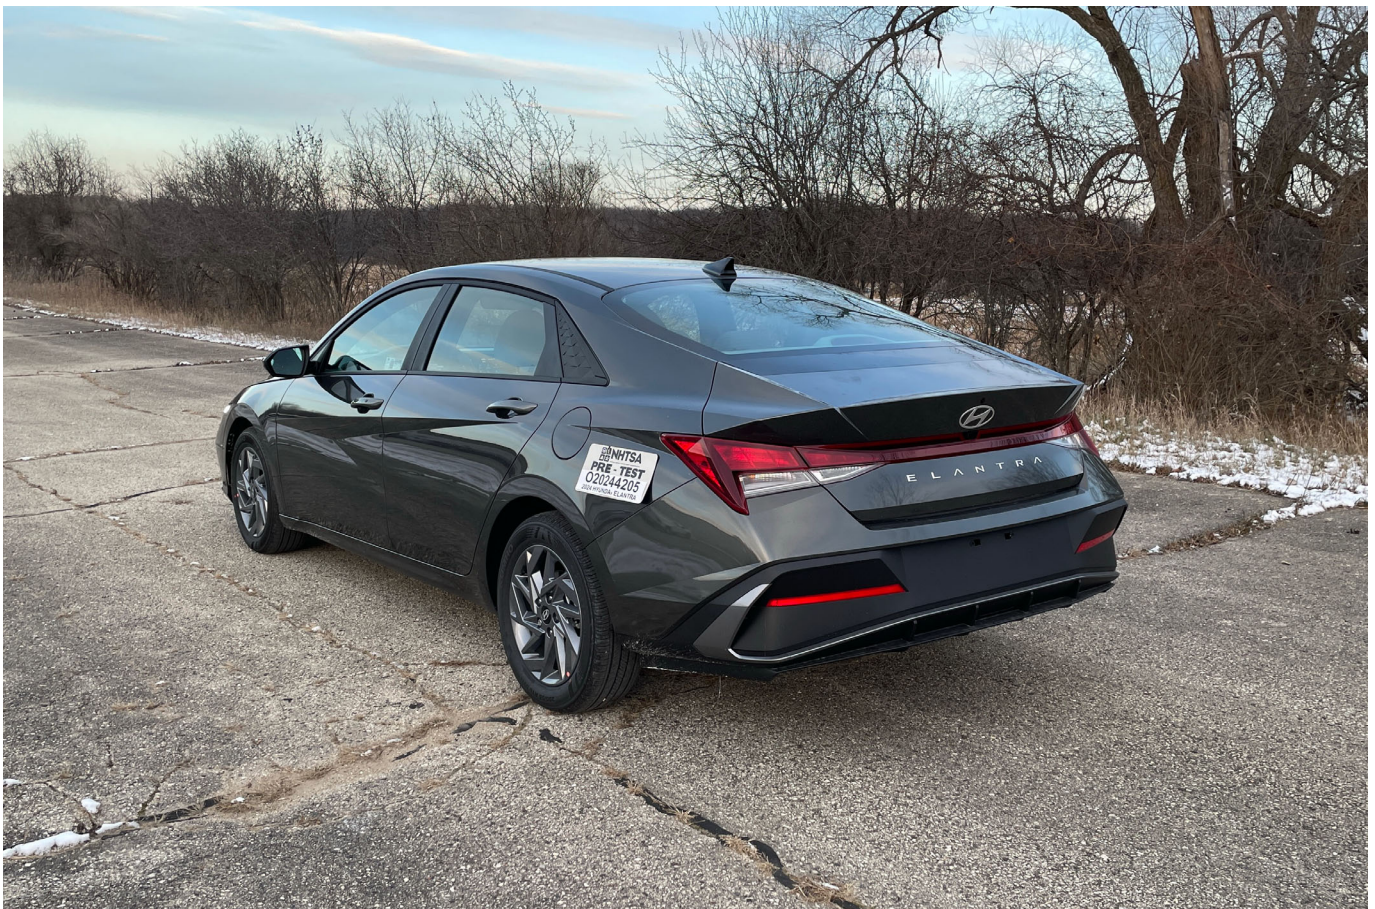
Photo No. 002 - As Delivered Left Rear Three-Quarter View of Test Vehicle

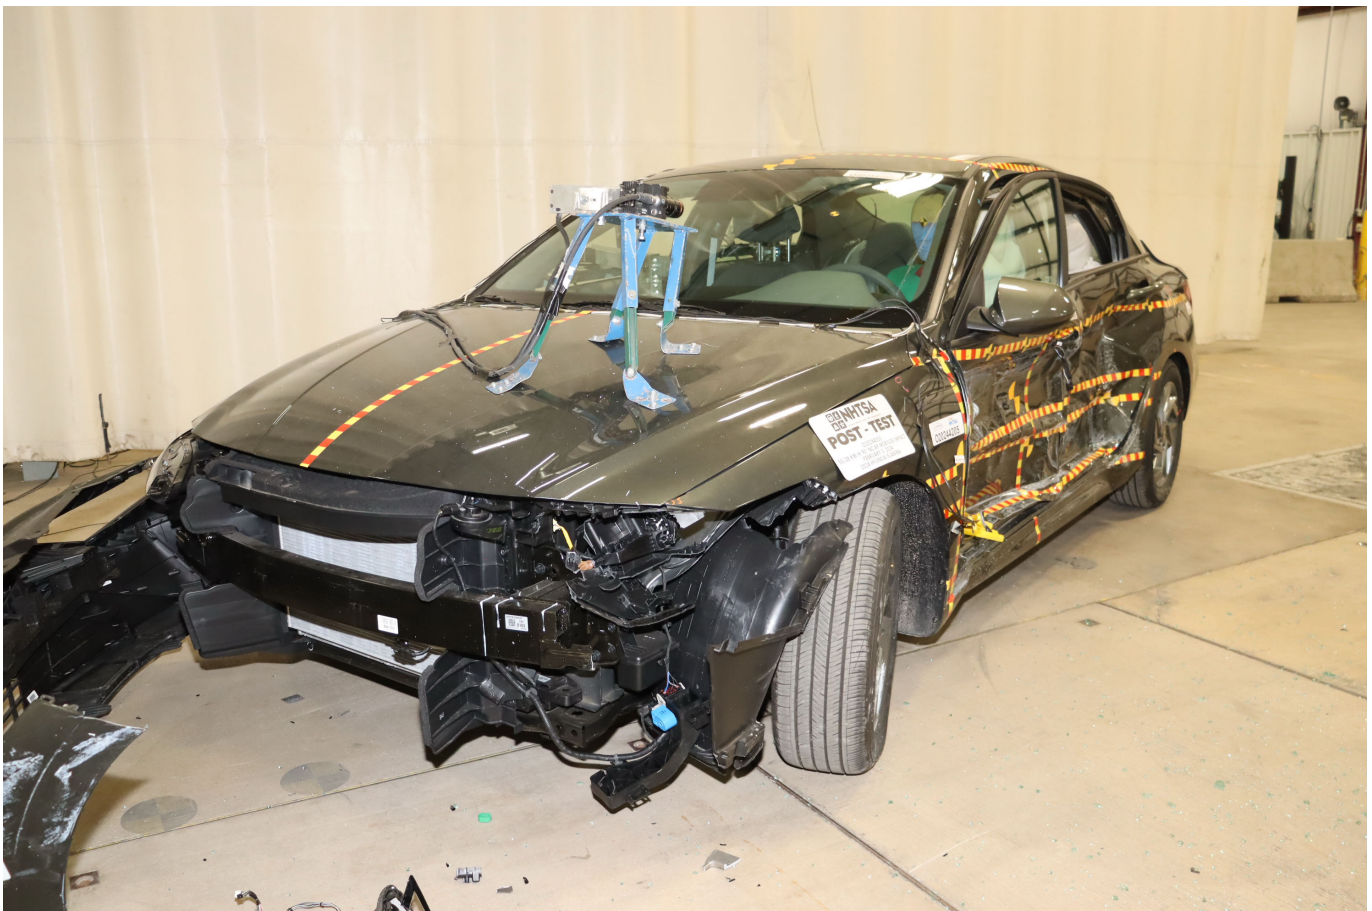
Photo No. 006 - Post-Test Left Front Three-Quarter View of Test Vehicle

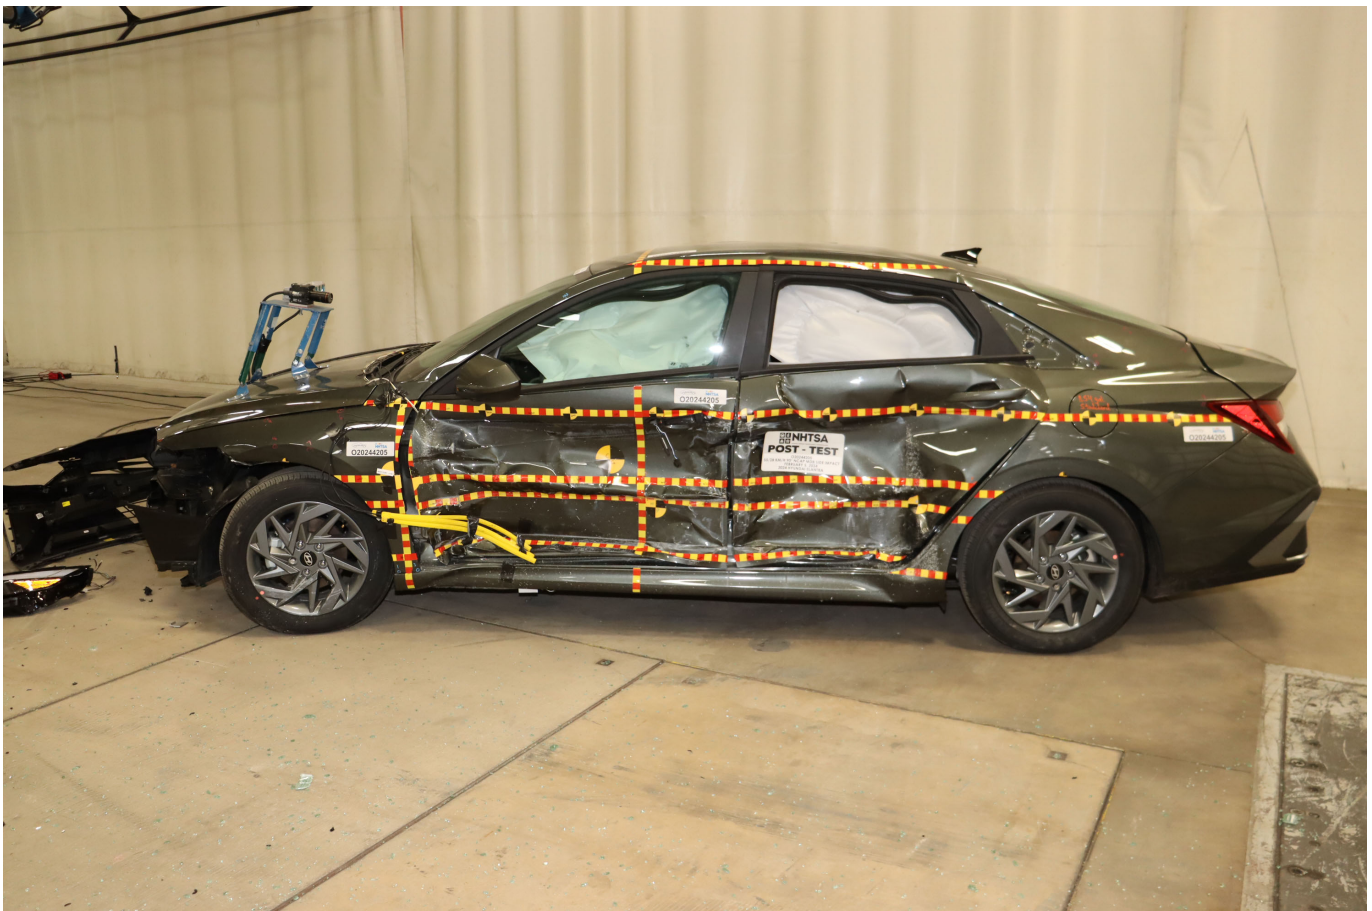
Photo No. 008 - Post-Test Left Side View of Test Vehicle

| Critical Areas of Performance | Observations and Conclusions |
|---|---|
| Side Window Damage | LR window broken |

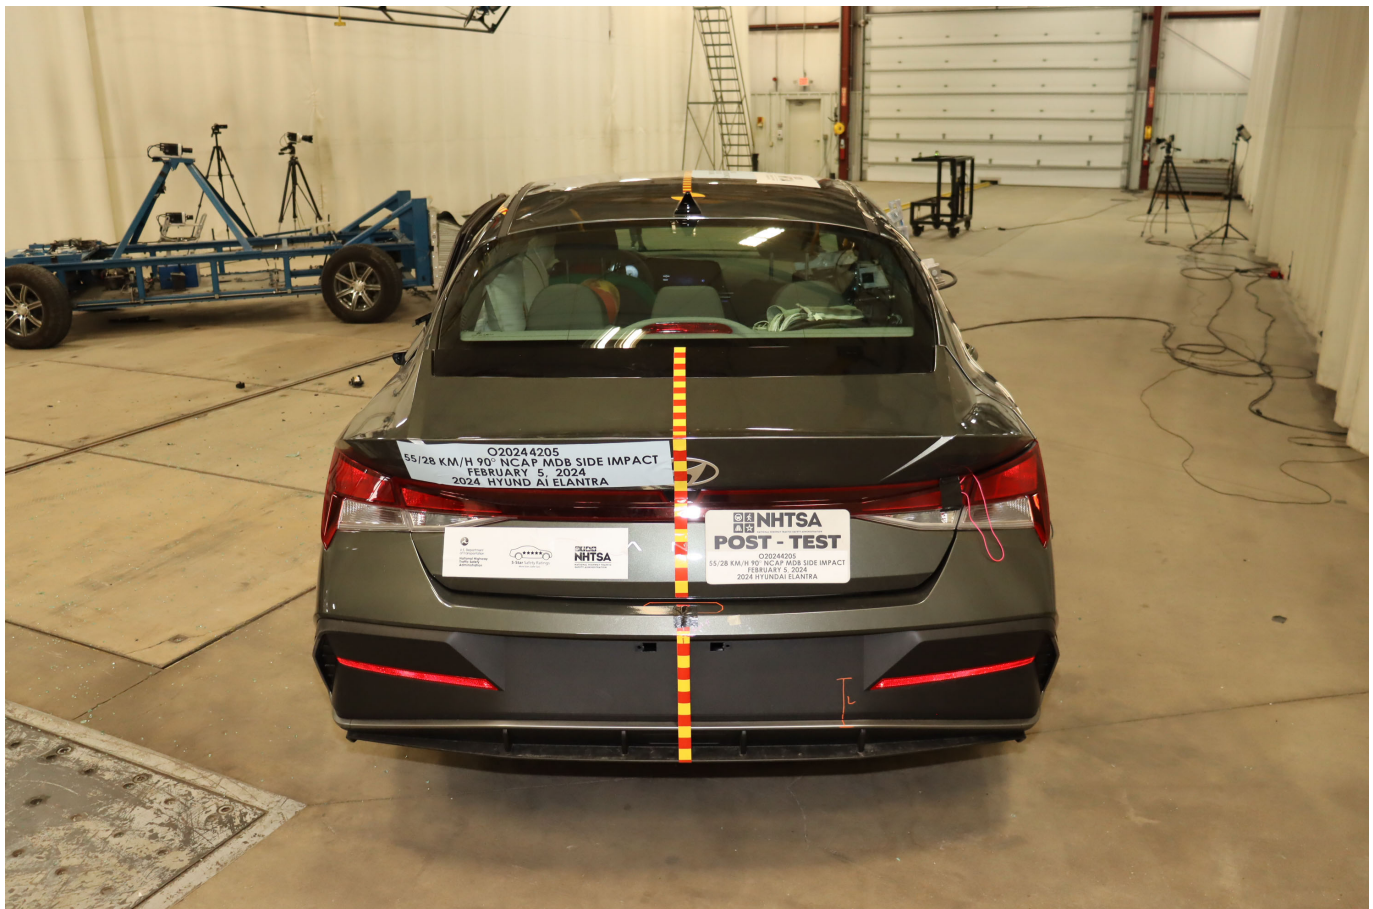
Photo No. 012 - Post-Test Rear View of Test Vehicle

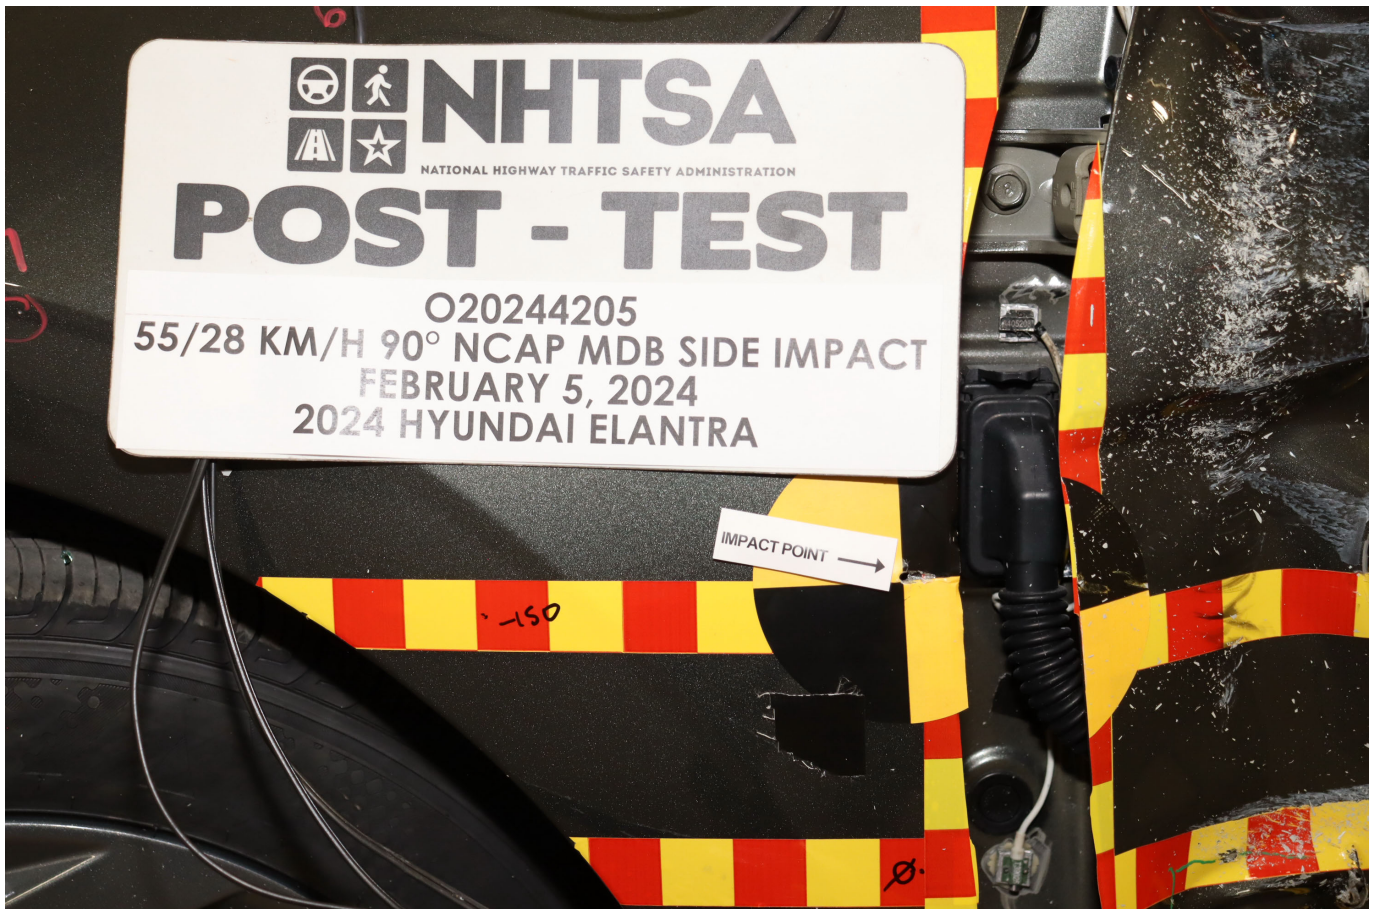
Photo No. 020 - Post-Test Close-Up View of Impact Point Target

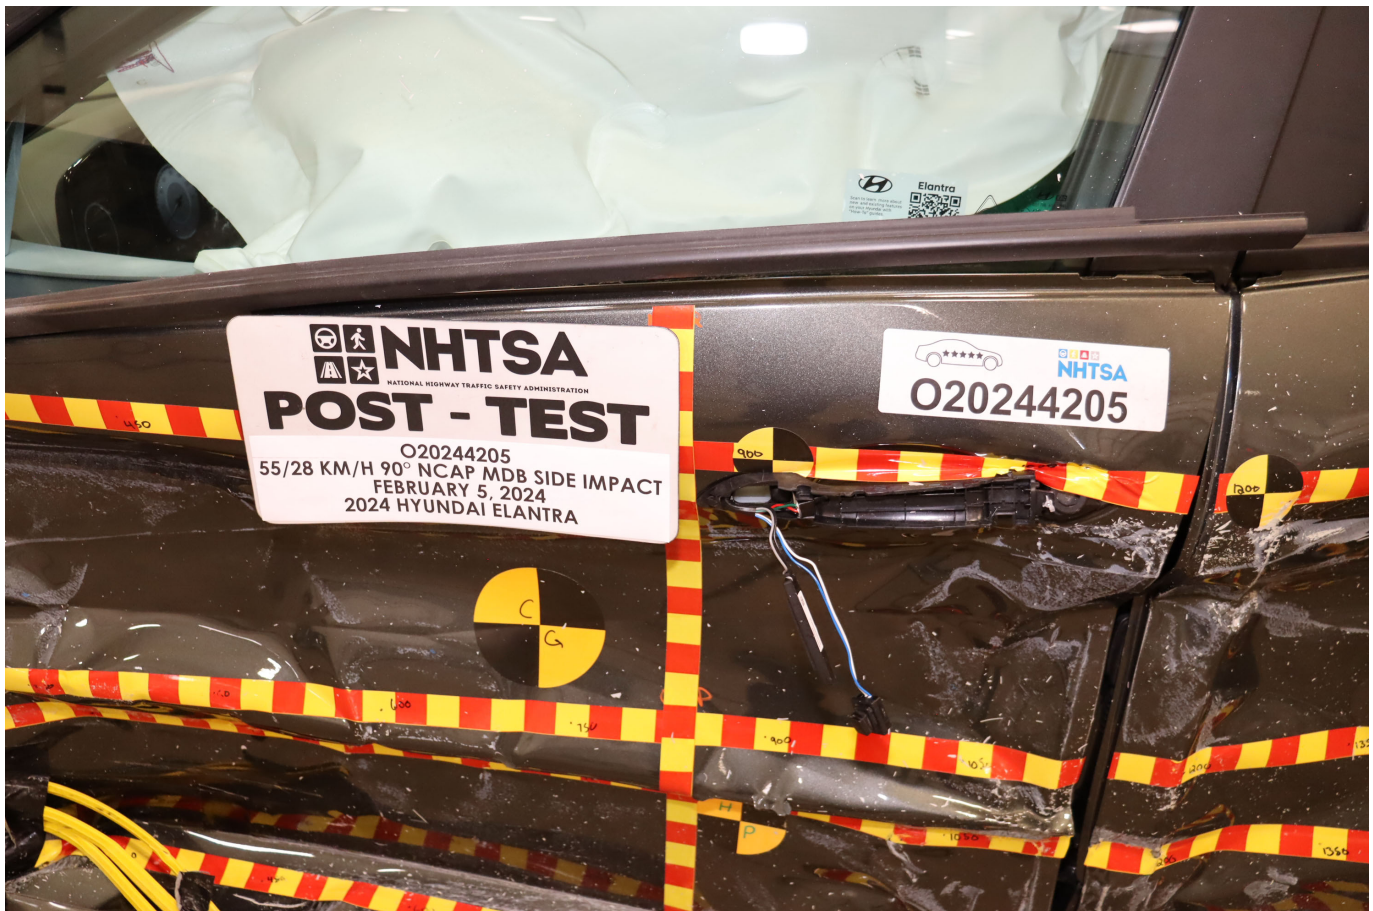
Photo No. 022 - Post-Test Left Front Door Latch Close-Up

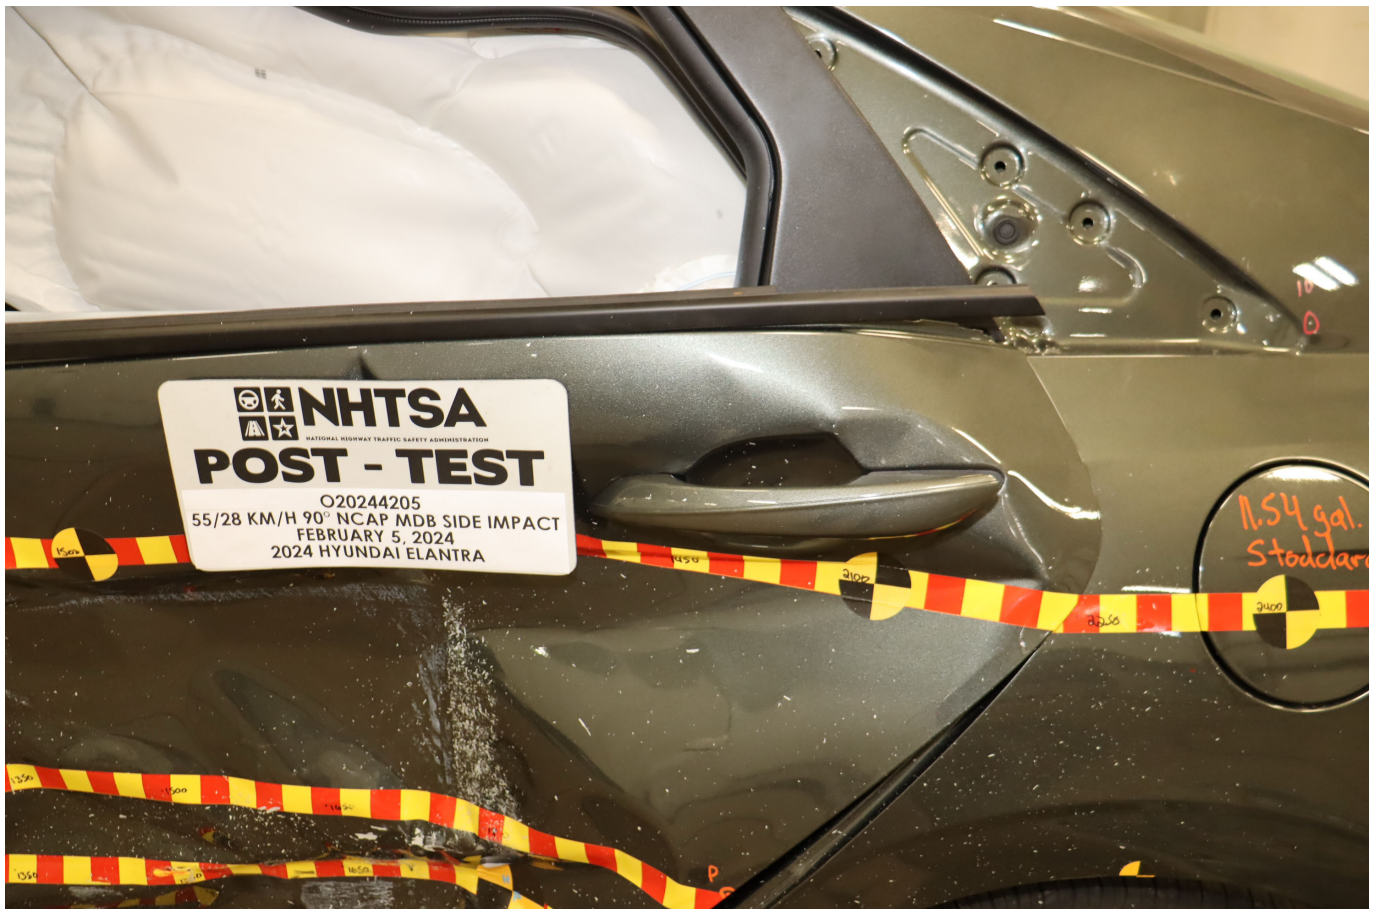
Photo No. 024 - Post-Test Left Rear Door Latch Close-Up

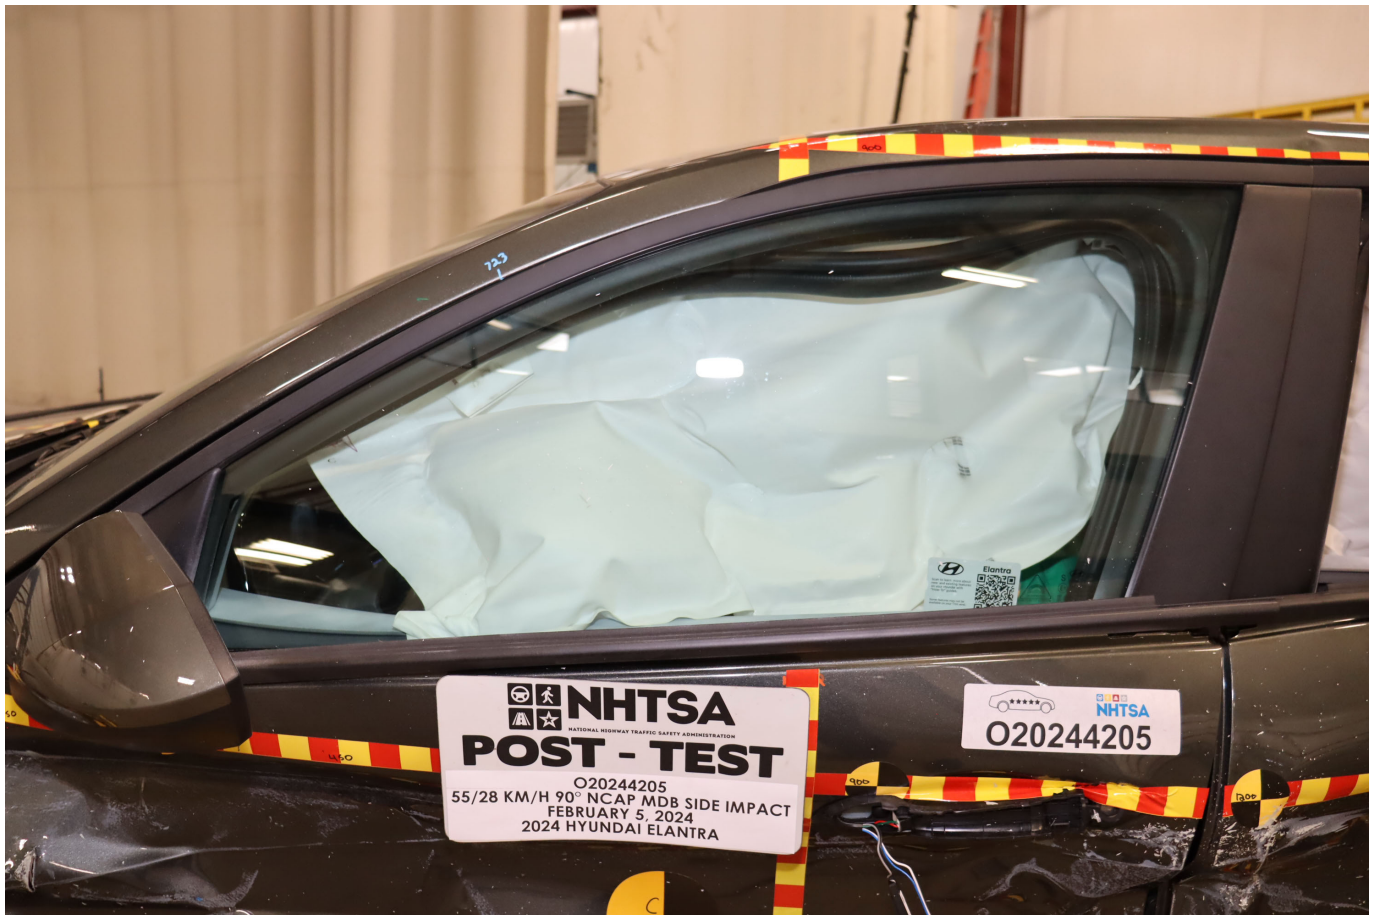
Photo No. 029 - Post-Test Left Side View of Driver Dummy Shoulder and Door Top View

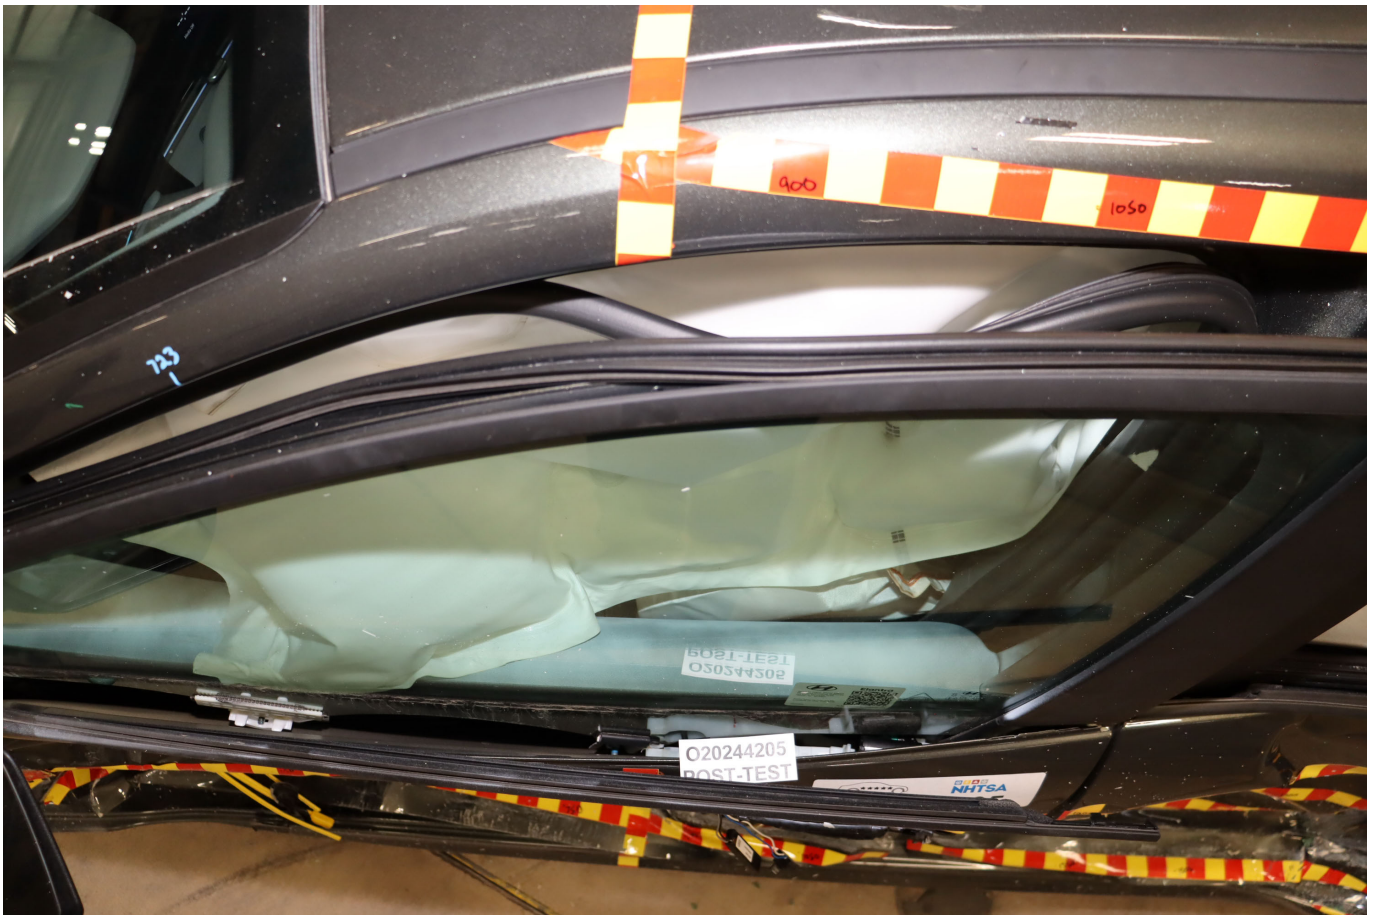
Photo No. 043 - Post-Test Driver Dummy and Door Clearance View

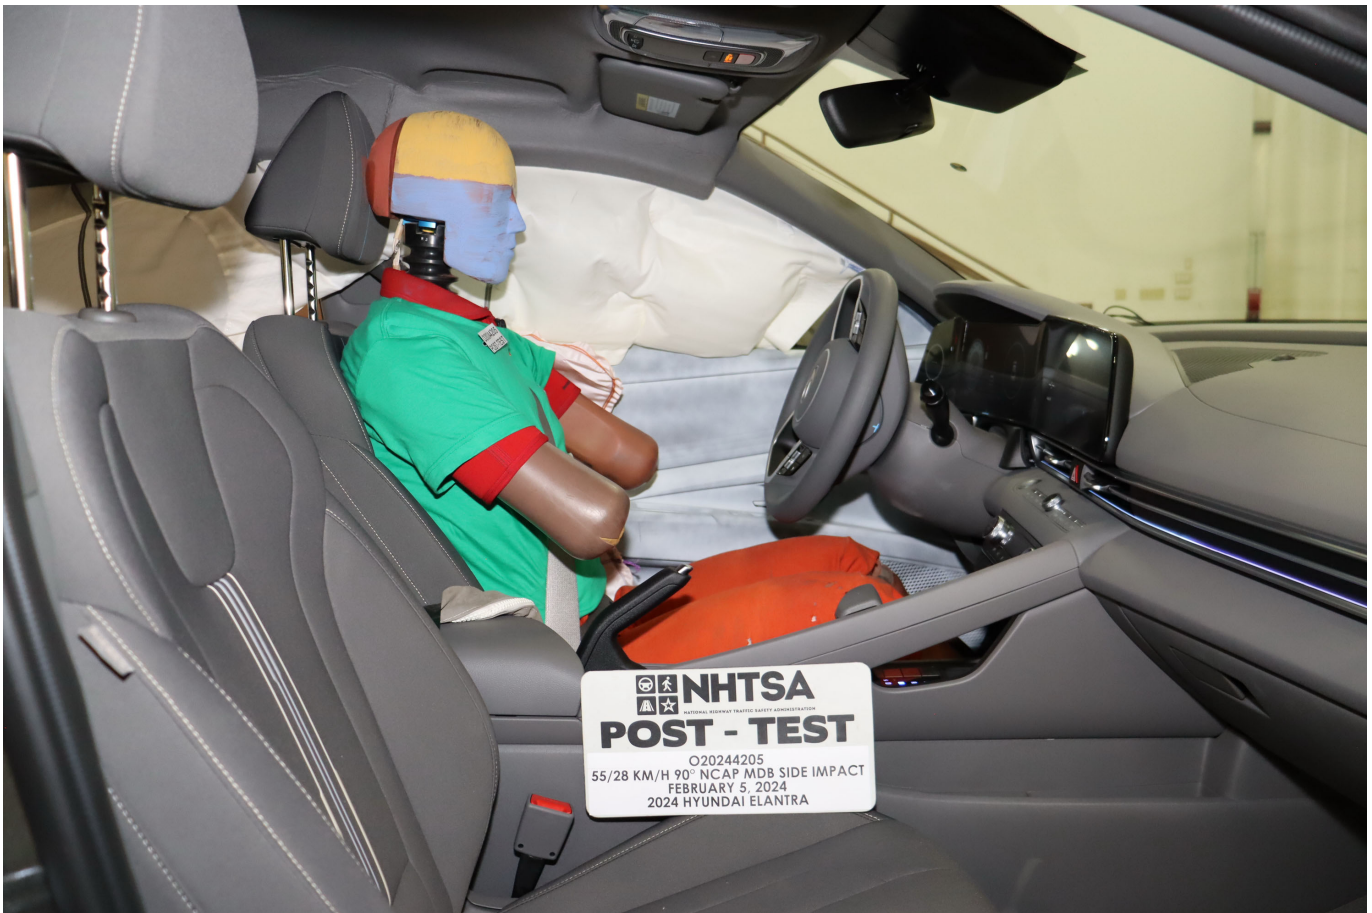
Photo No. 045 - Post-Test Right Side View of Driver Dummy and Front Seat of Occupant Compartment

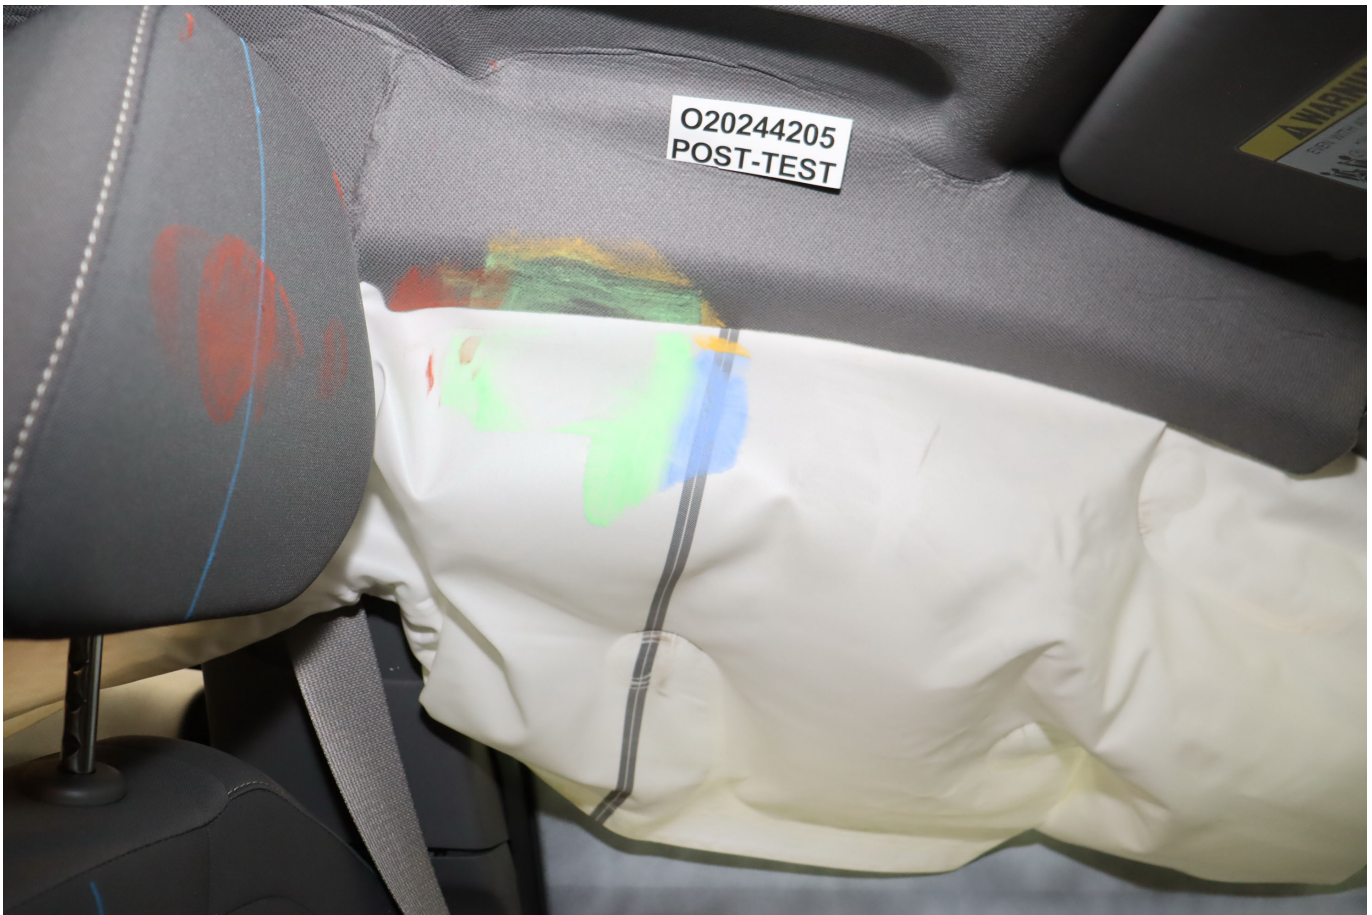
Photo No. 049 - Post-Test Driver Dummy Close-Up Head Contact with Side Airbag View

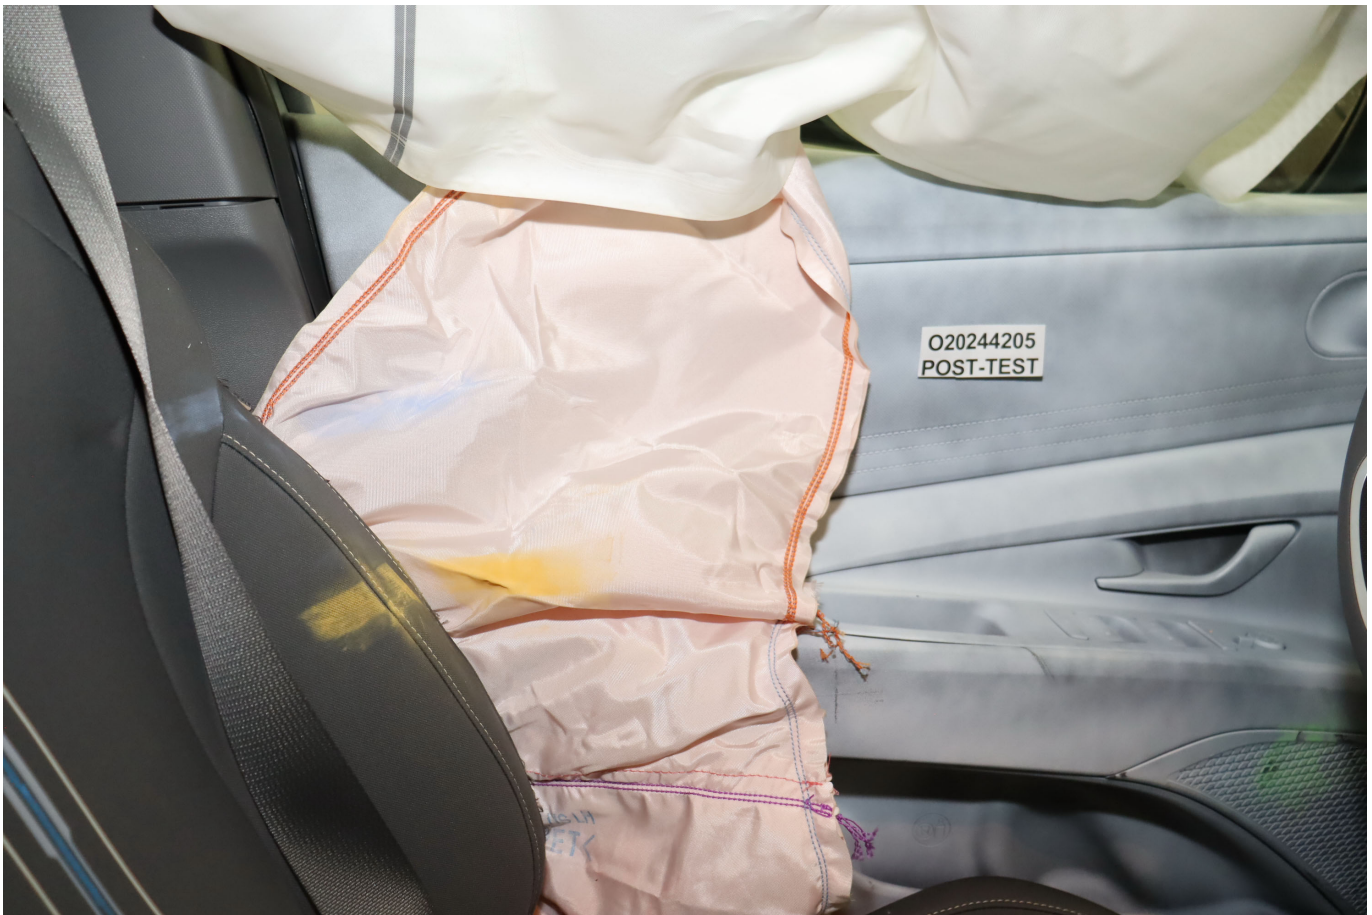
Photo No. 051 - Post-Test Driver Dummy Close-Up Torso Contact with Side Airbag View

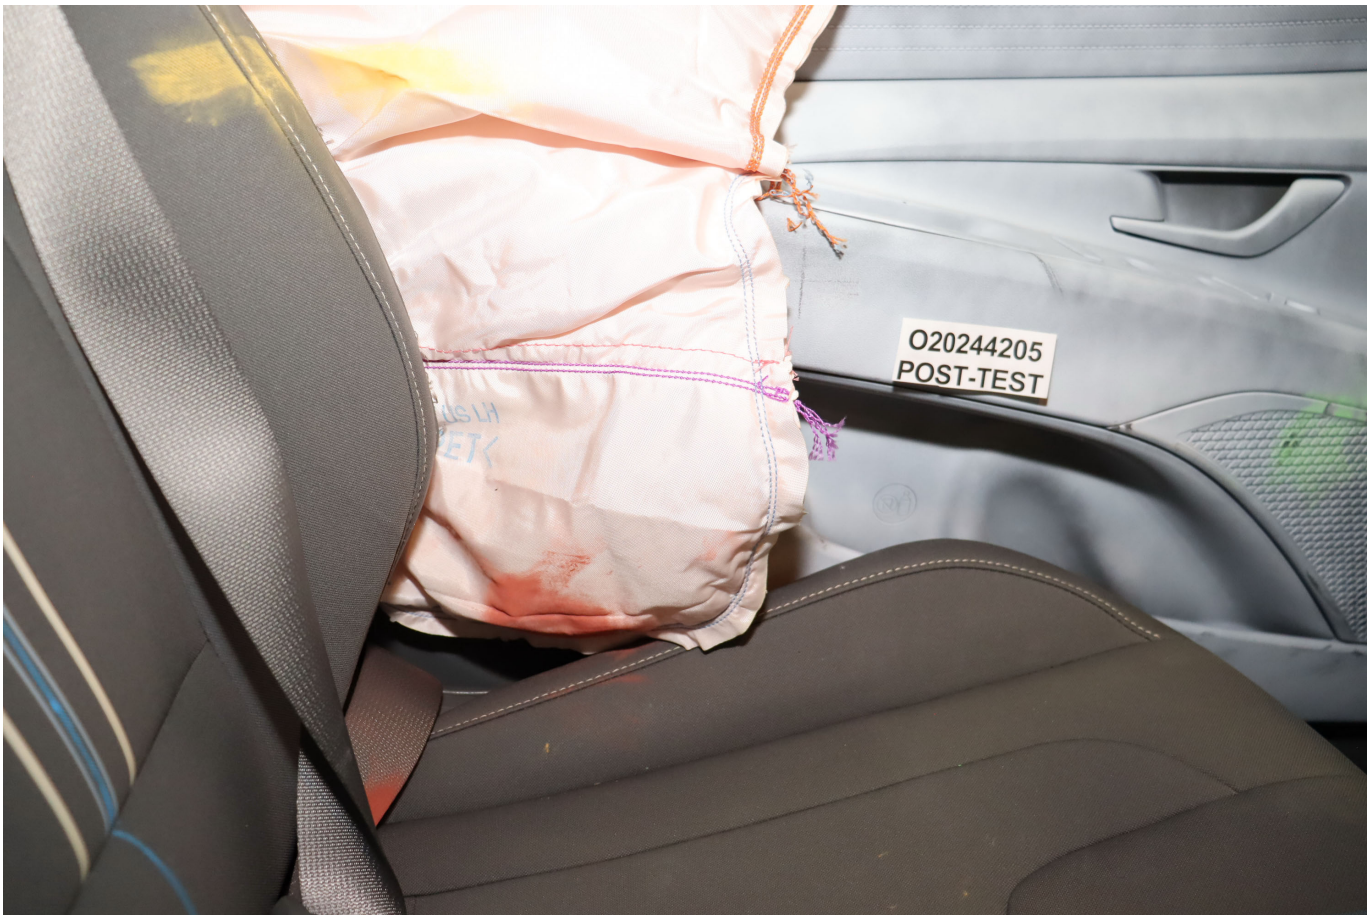
Photo No. 053 - Post-Test Driver Dummy Close-Up Pelvis Contact with Side Airbag View

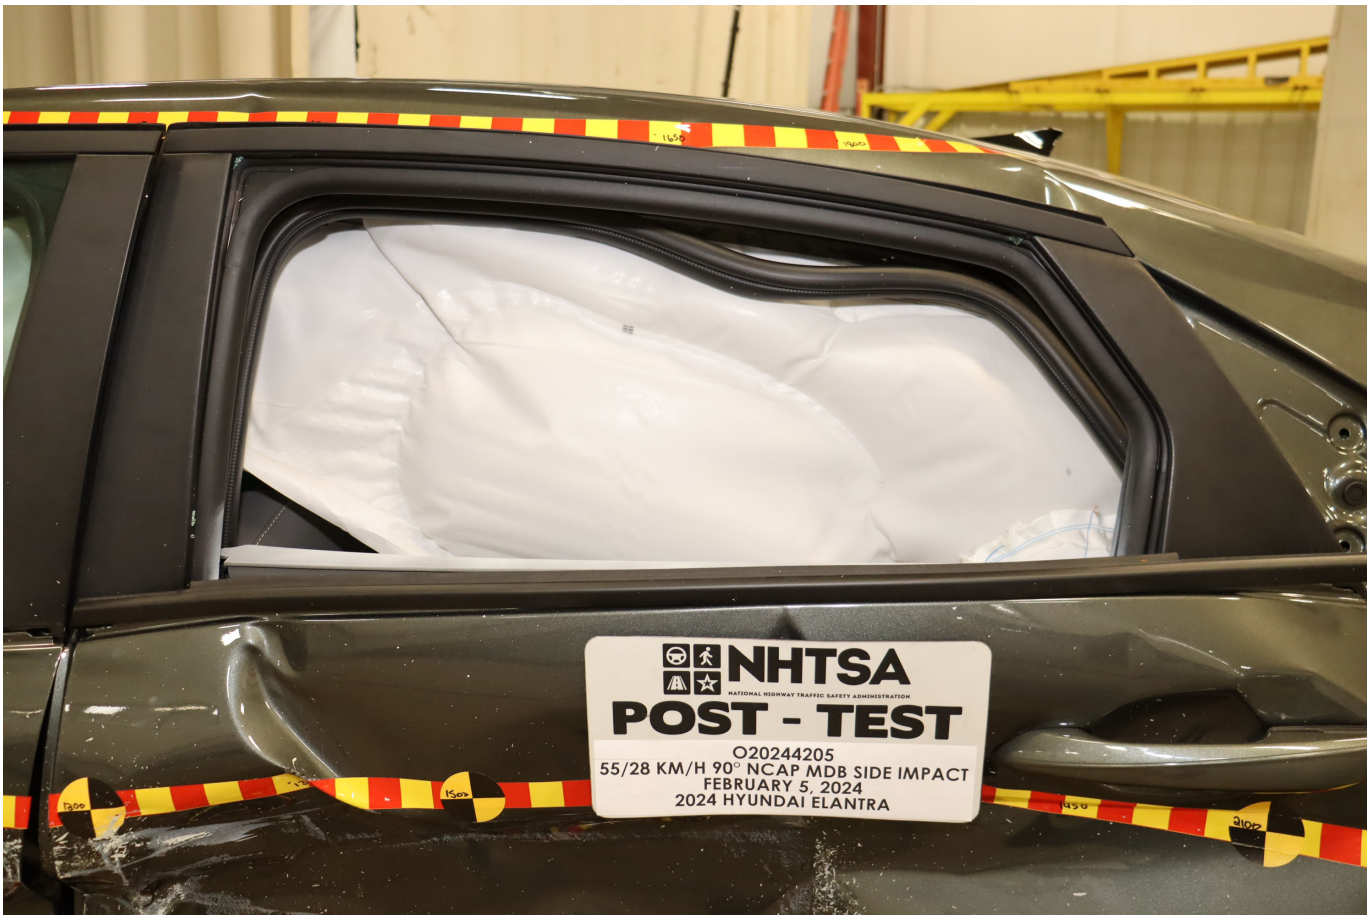
Photo No. 057 - Post-Test Left Side View of Rear Passenger Dummy Shoulder and Door Top View

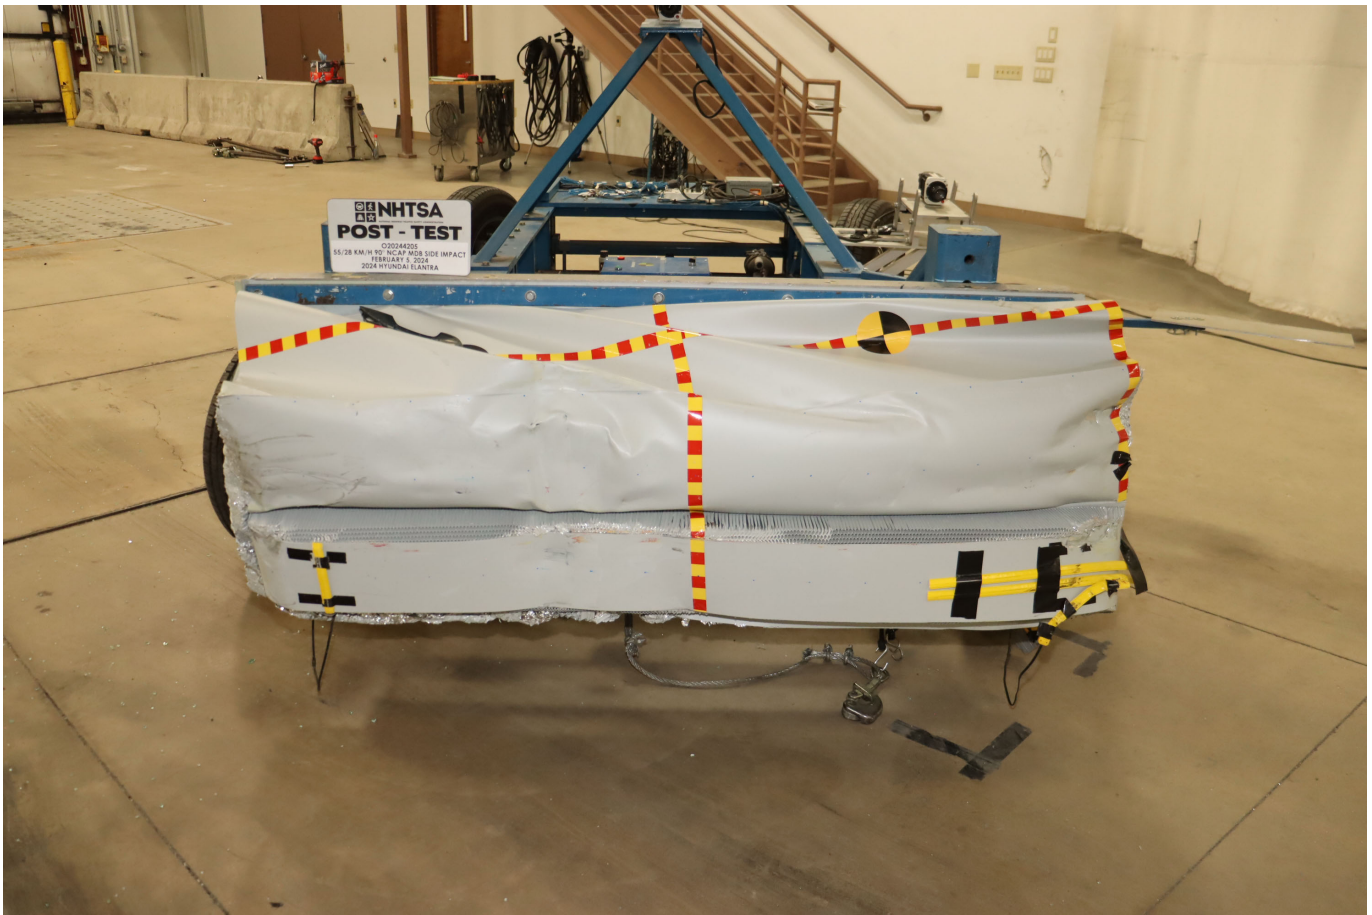
Photo No. 085 - Post-Test Front View of MDB Impactor Face

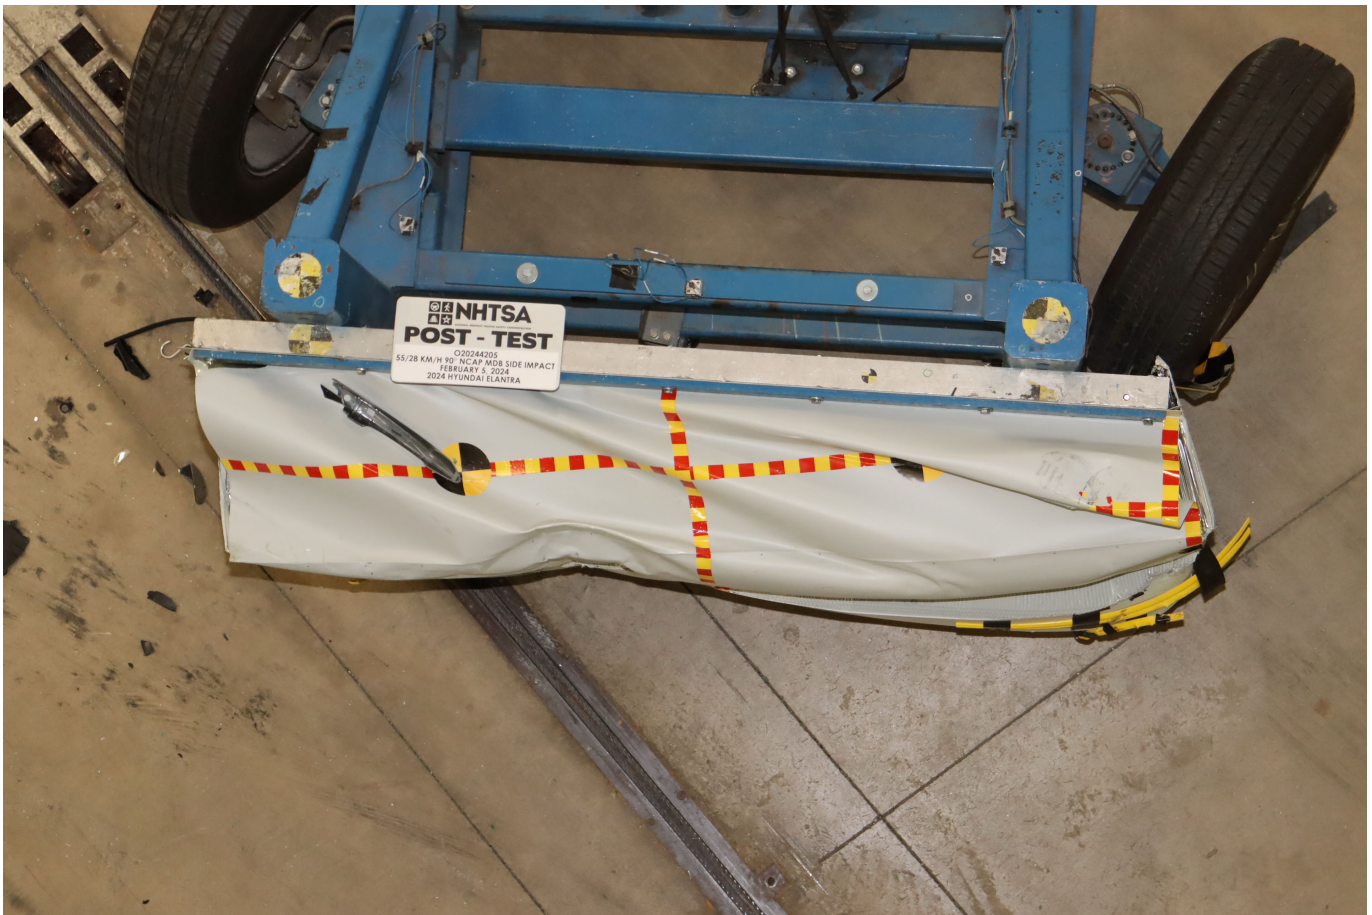
Photo No. 087 - Post-Test Top View of MDB Impactor Face

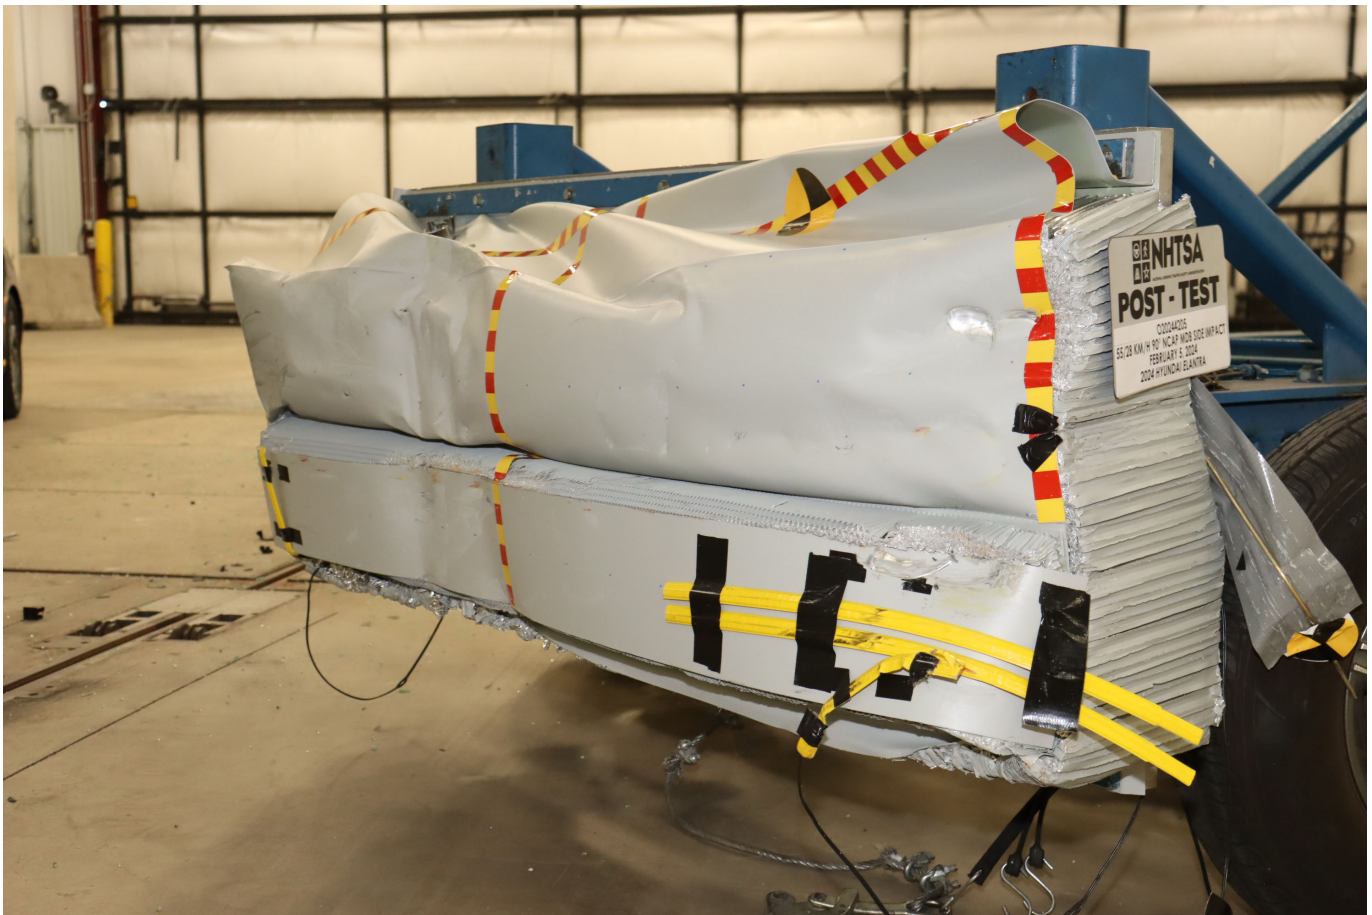
Photo No. 089 - Post-Test Left Side View of MDB Impactor Face
