**REPORT NUMBER: SideNCAPMDB-MGA-24-008**

**NEW CAR ASSESSMENT PROGRAM (NCAP)  
Moving Deformable Barrier Side Impact Test**

**HYUNDAI MOTOR COMPANY  
2024 Hyundai Elantra SEL 4-Door Sedan  
NHTSA No.: O20244205**

**MGA RESEARCH CORPORATION  
5000 Warren Road  
Burlington, WI 53105**

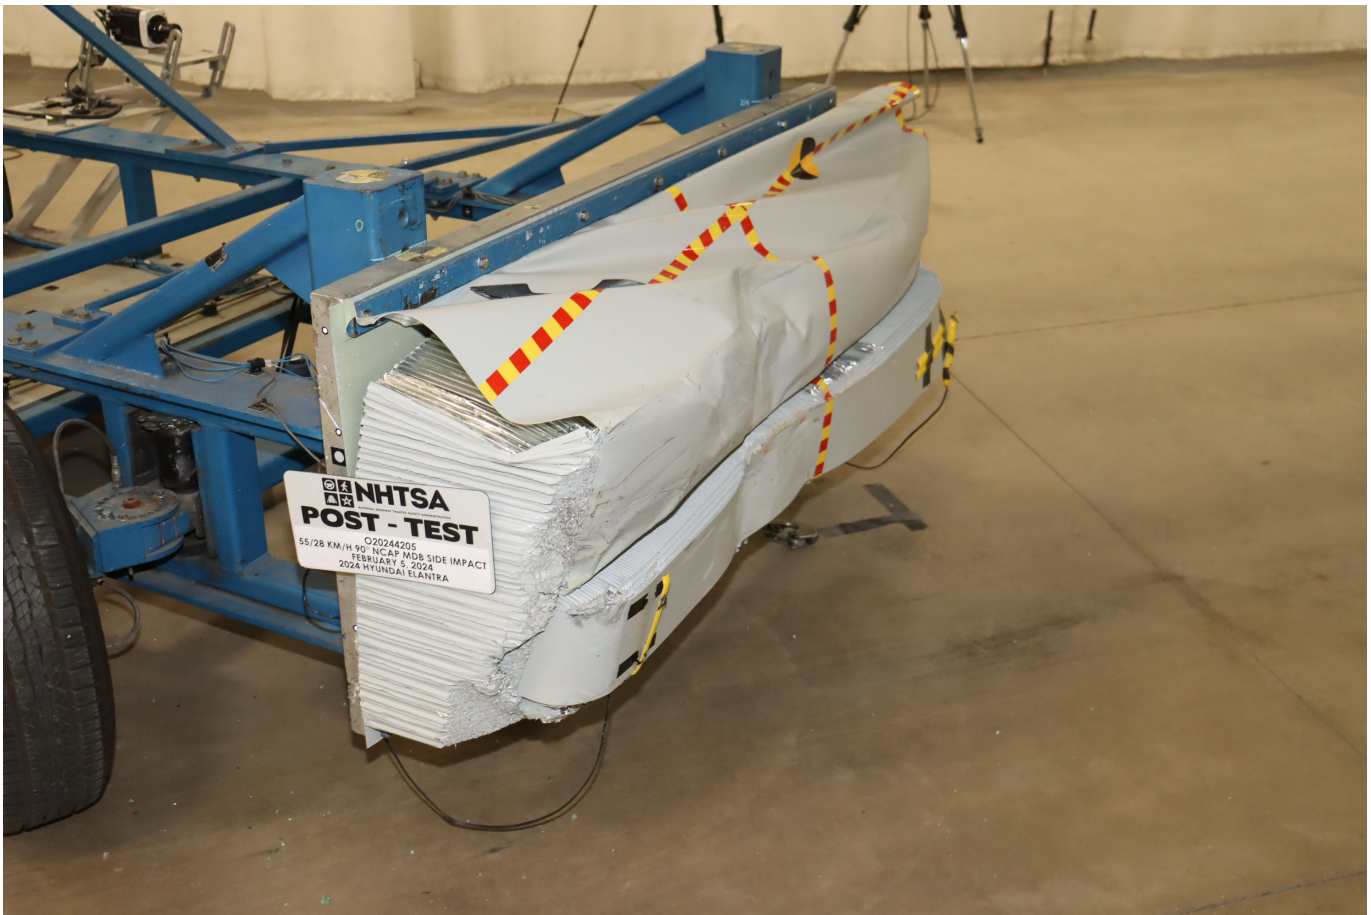
Photo No. 091 - Post-Test Right Side View of MDB Impactor Face
