REPORT NUMBER: NCAP-MGA-23-058

**NEW CAR ASSESSMENT PROGRAM (NCAP)
Frontal Barrier Impact Test**

**LUCID USA, INC.
2023 Lucid Air 4-Door Sedan
NHTSA No.: O20234600**

**MGA RESEARCH CORPORATION
5000 Warren Road
Burlington, WI 53105**

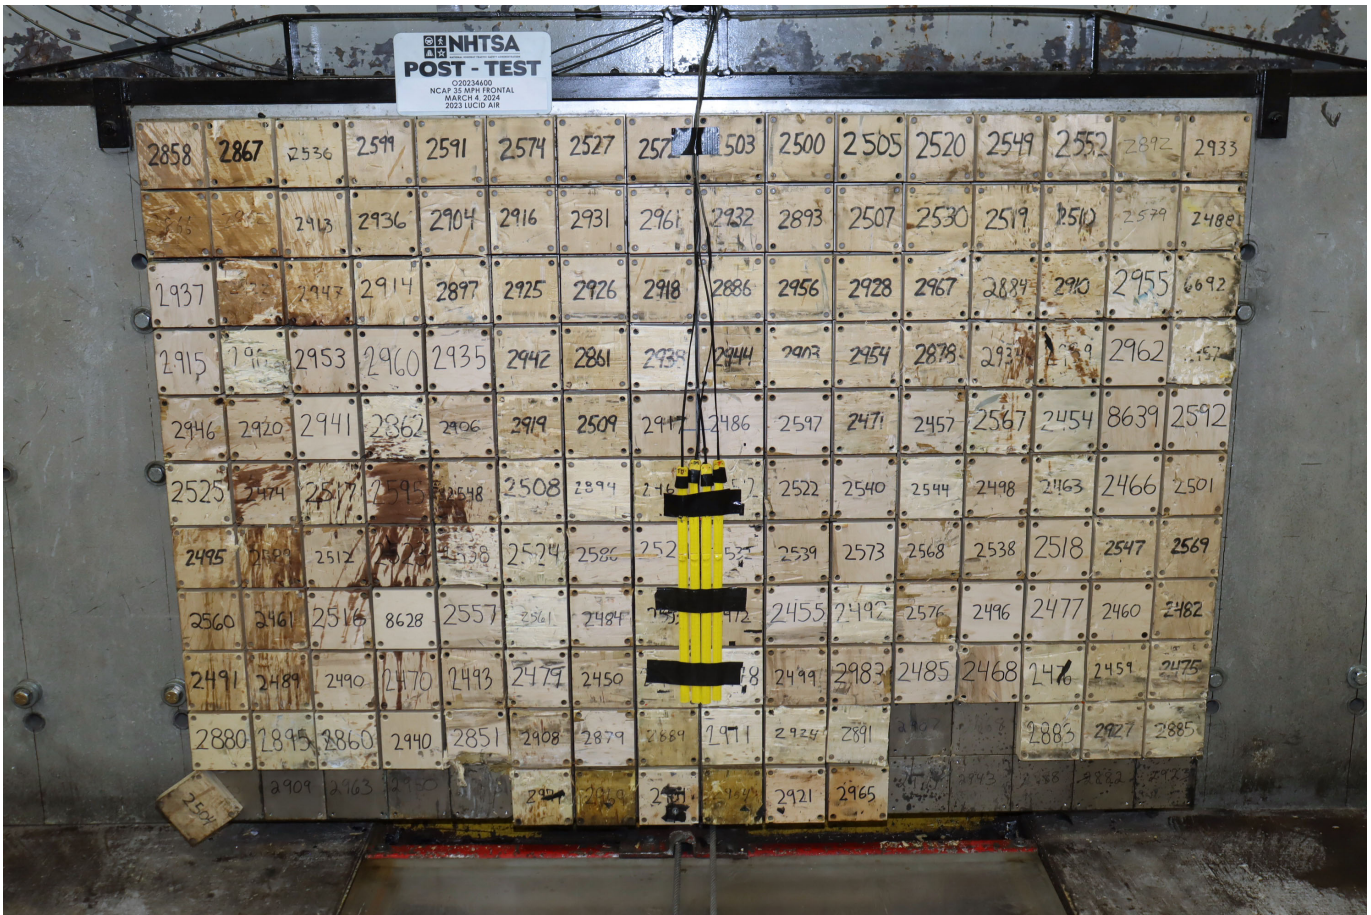
Photo No. 003 - Post-Test Load Cell Wall

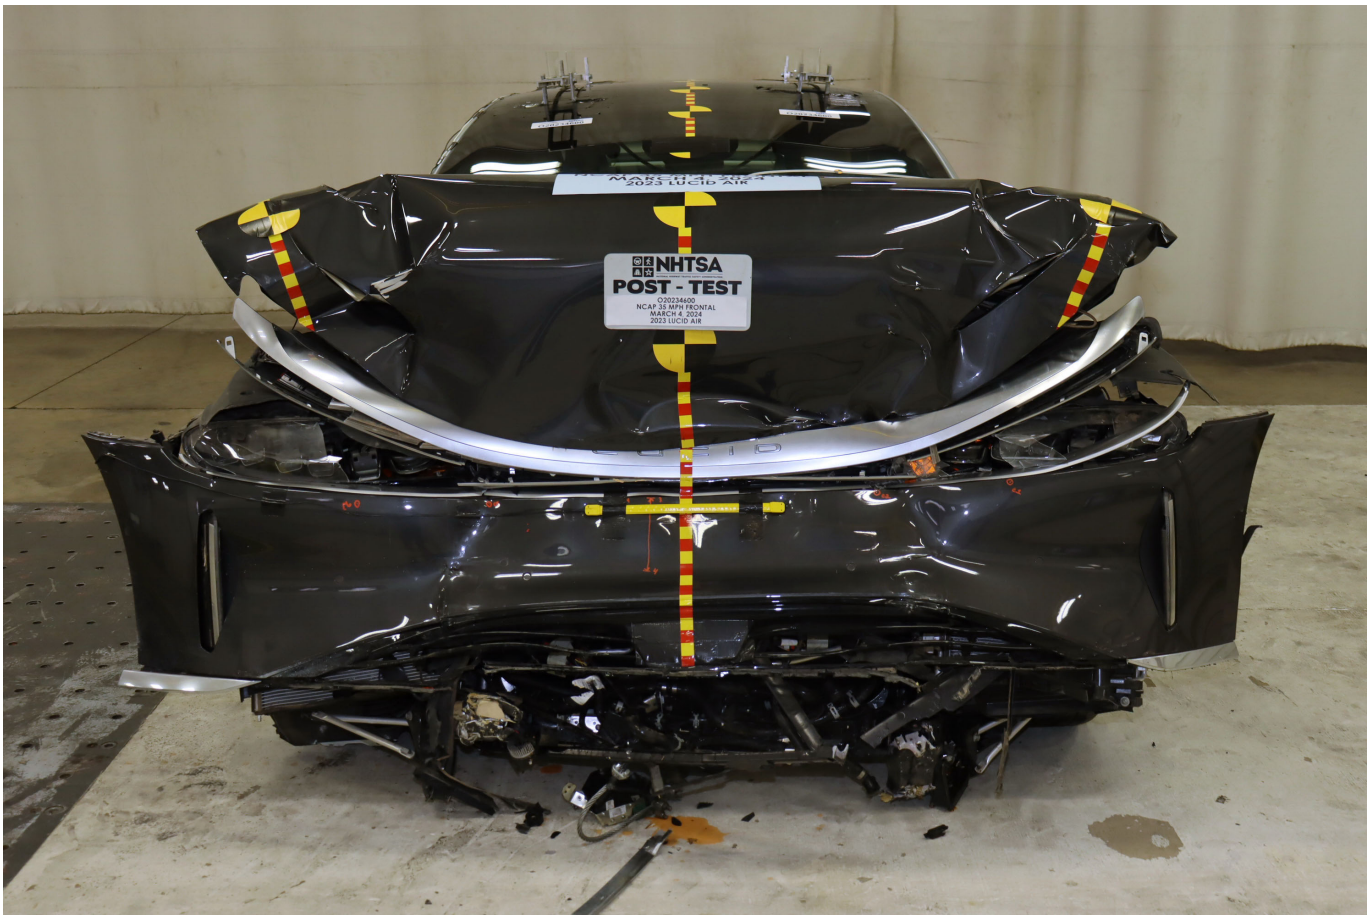
Photo No. 009 - Post-Test Front View of Test Vehicle

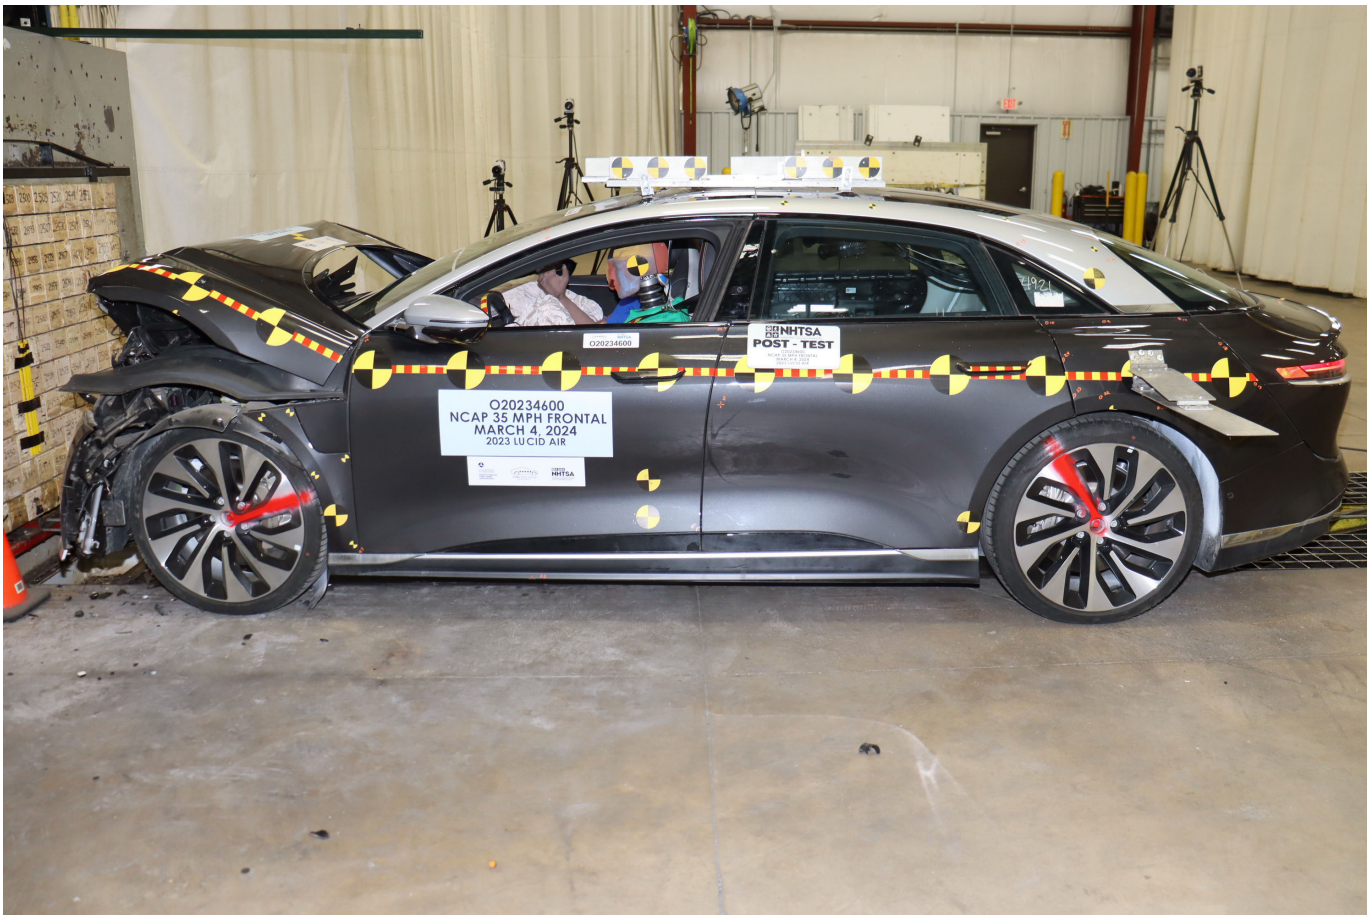
Photo No. 011 - Post-Test Left View of Test Vehicle

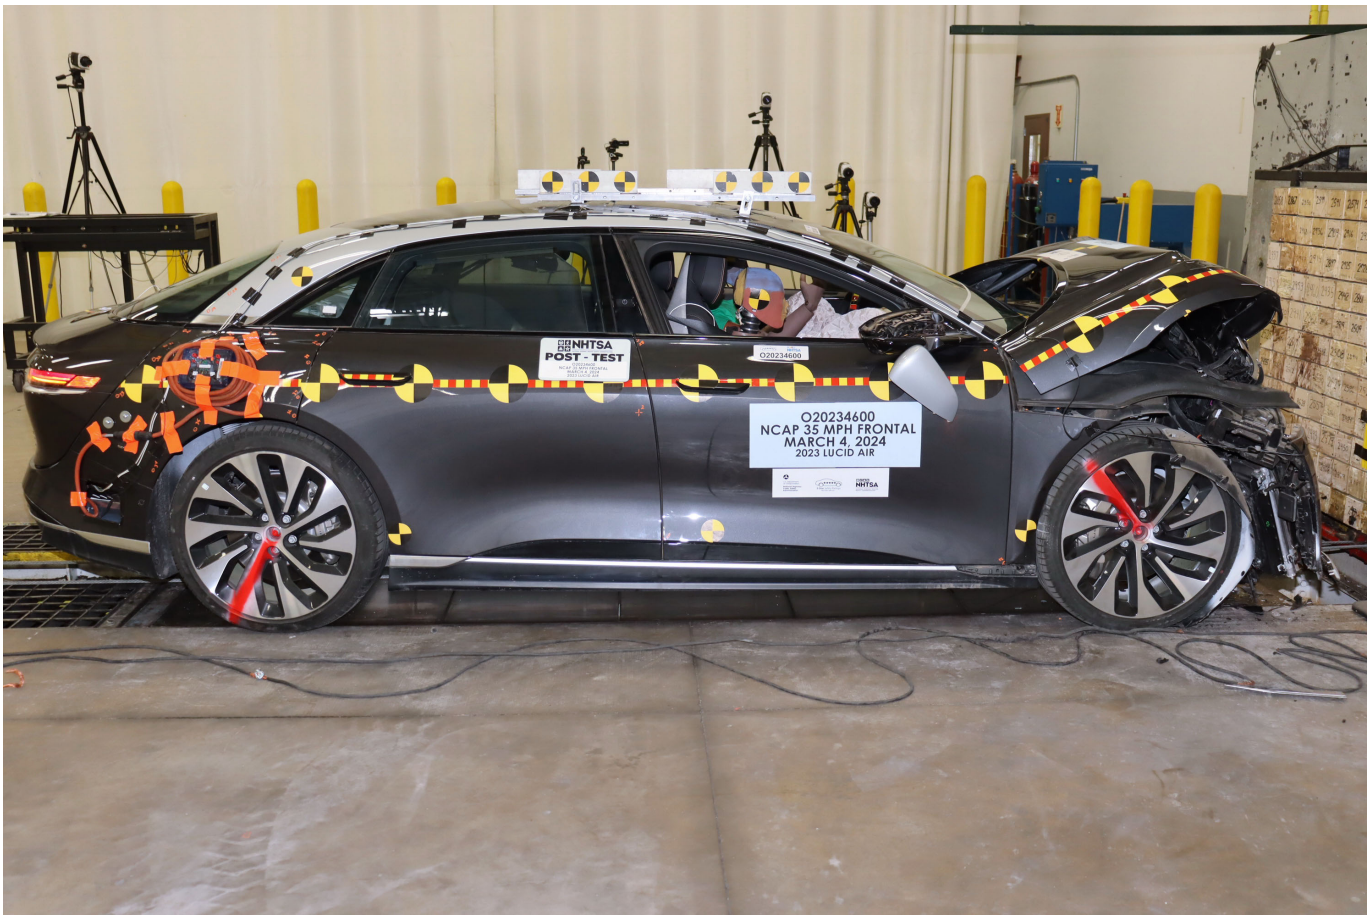
Photo No. 013 - Post-Test Right View of Test Vehicle

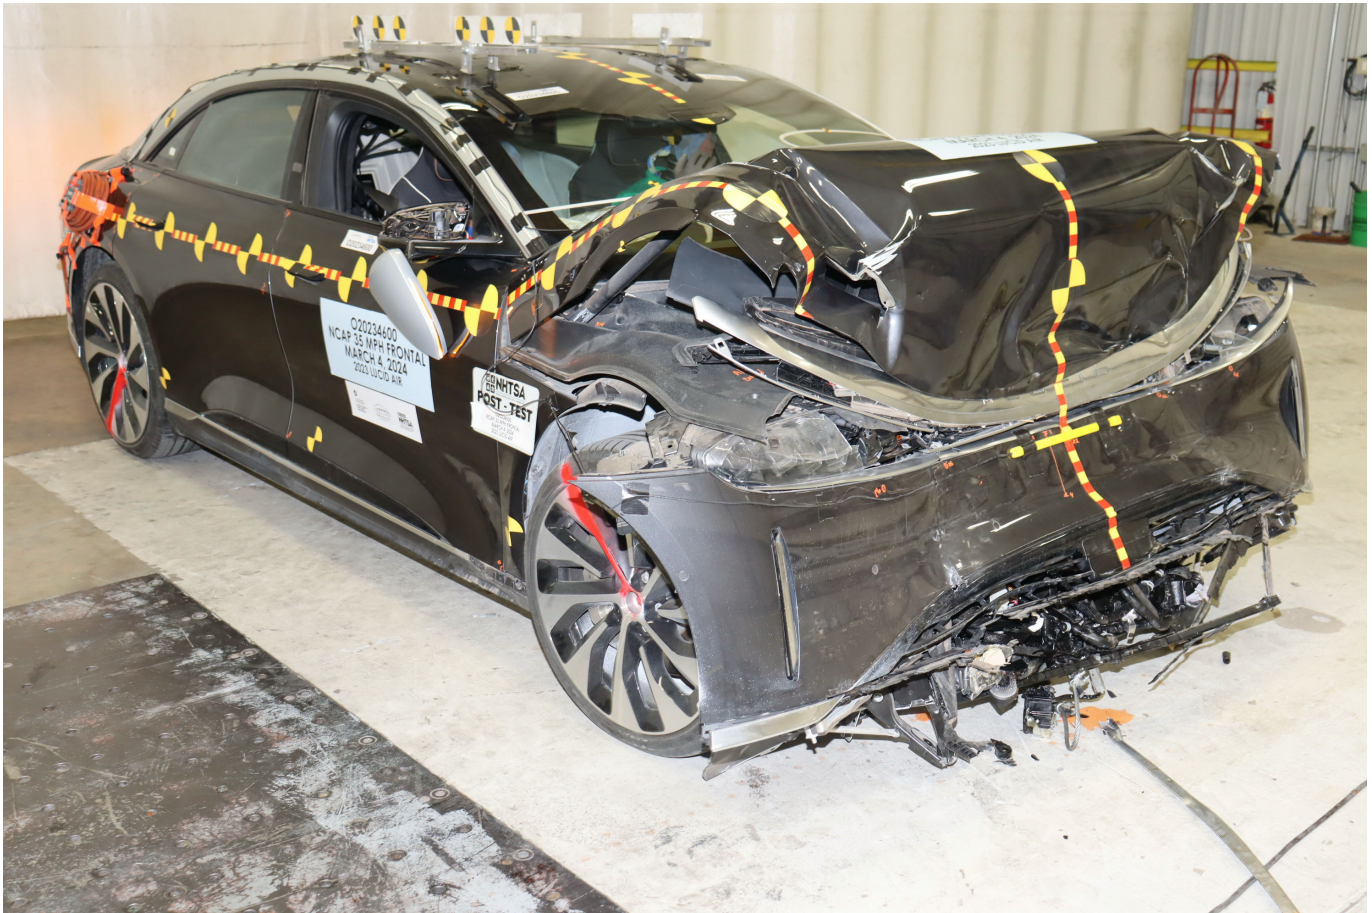
Photo No. 015 - Post-Test Right Front 3-4 View

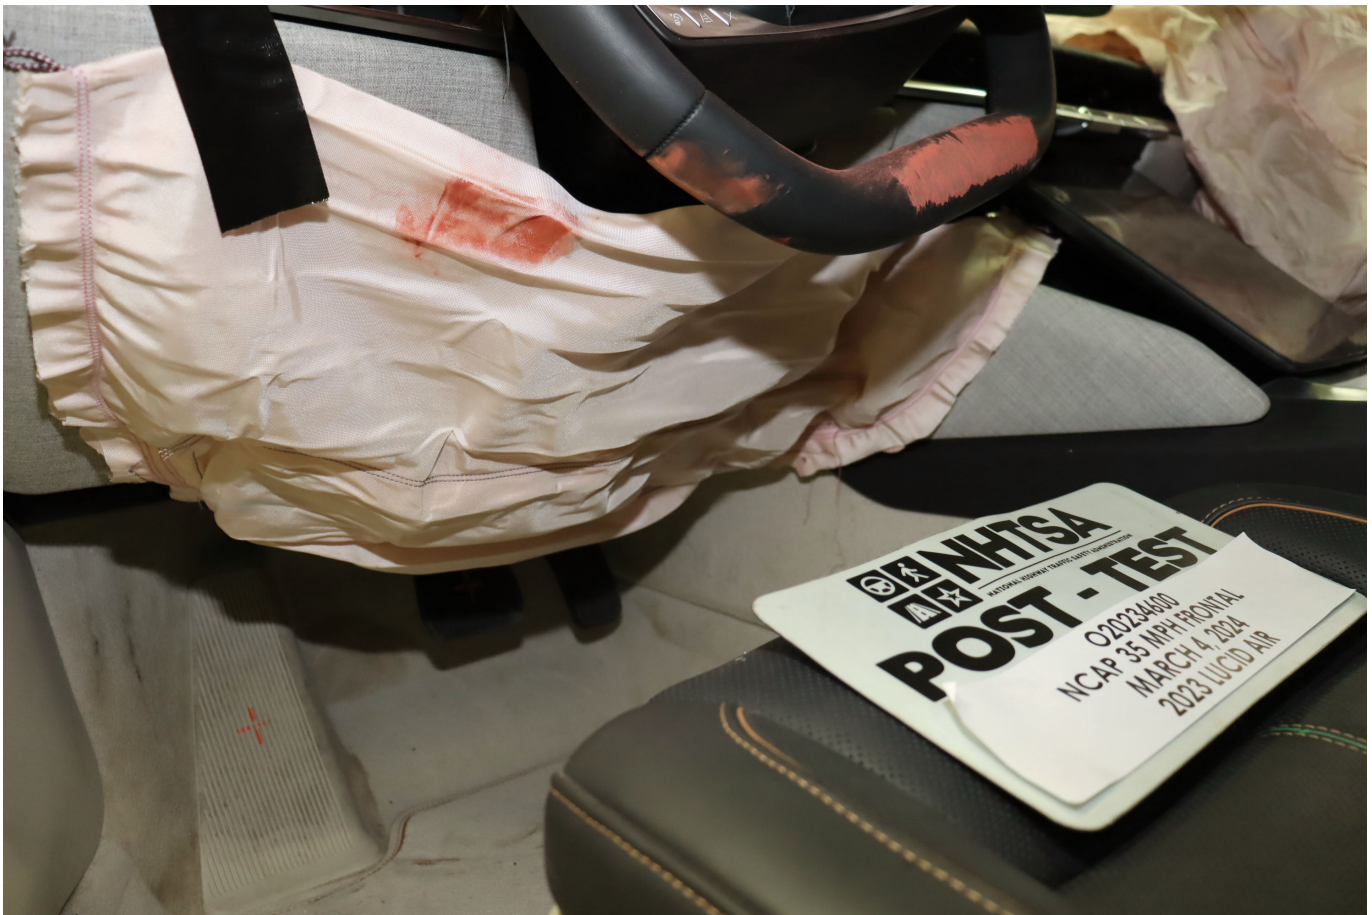
Photo No. 045 - Post-Test Driver's Side Knee Bolster

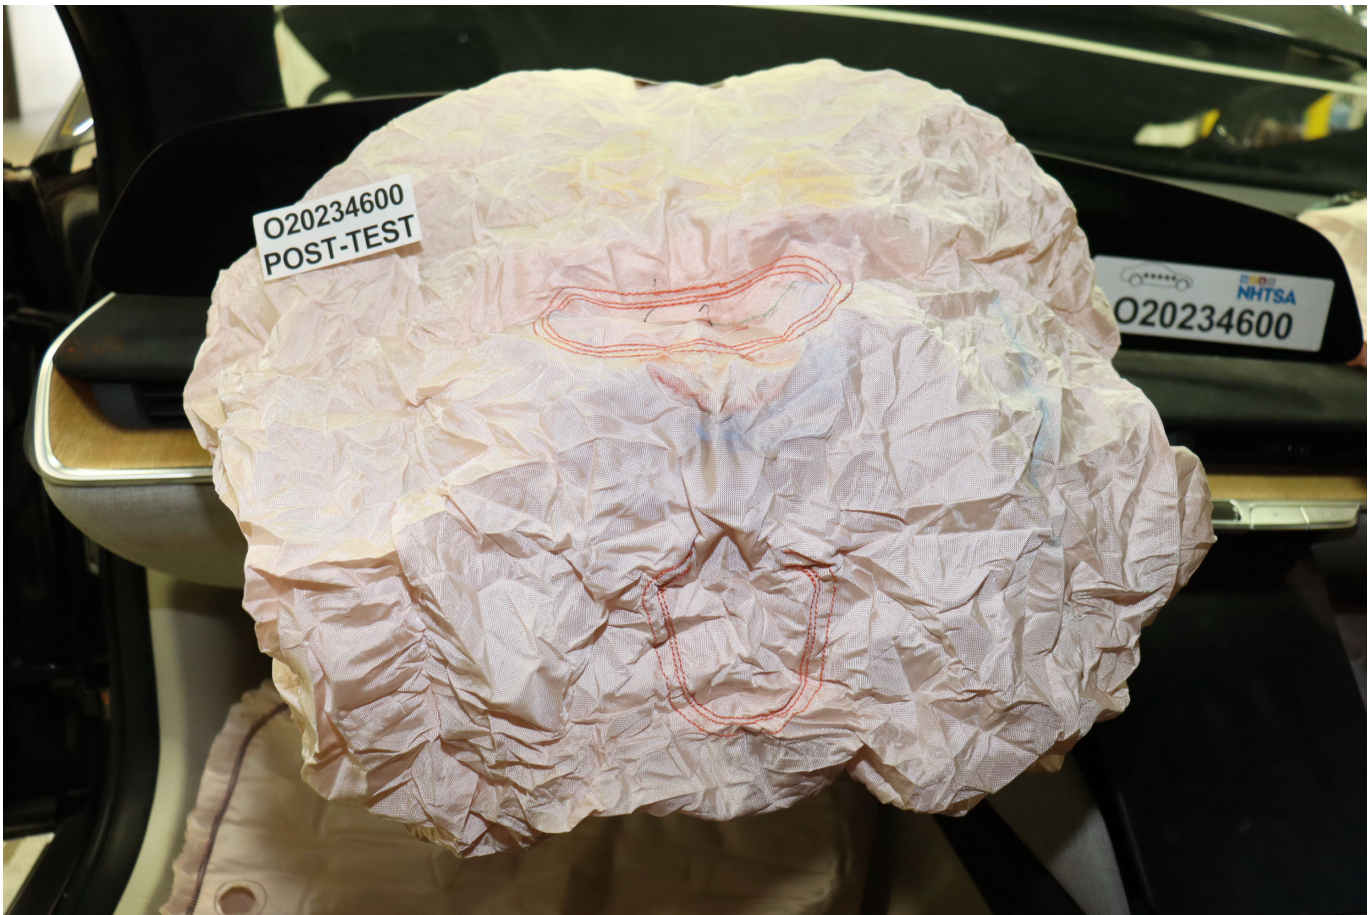
Photo No. 049 - Post-Test Driver Dummy Contact with Airbag

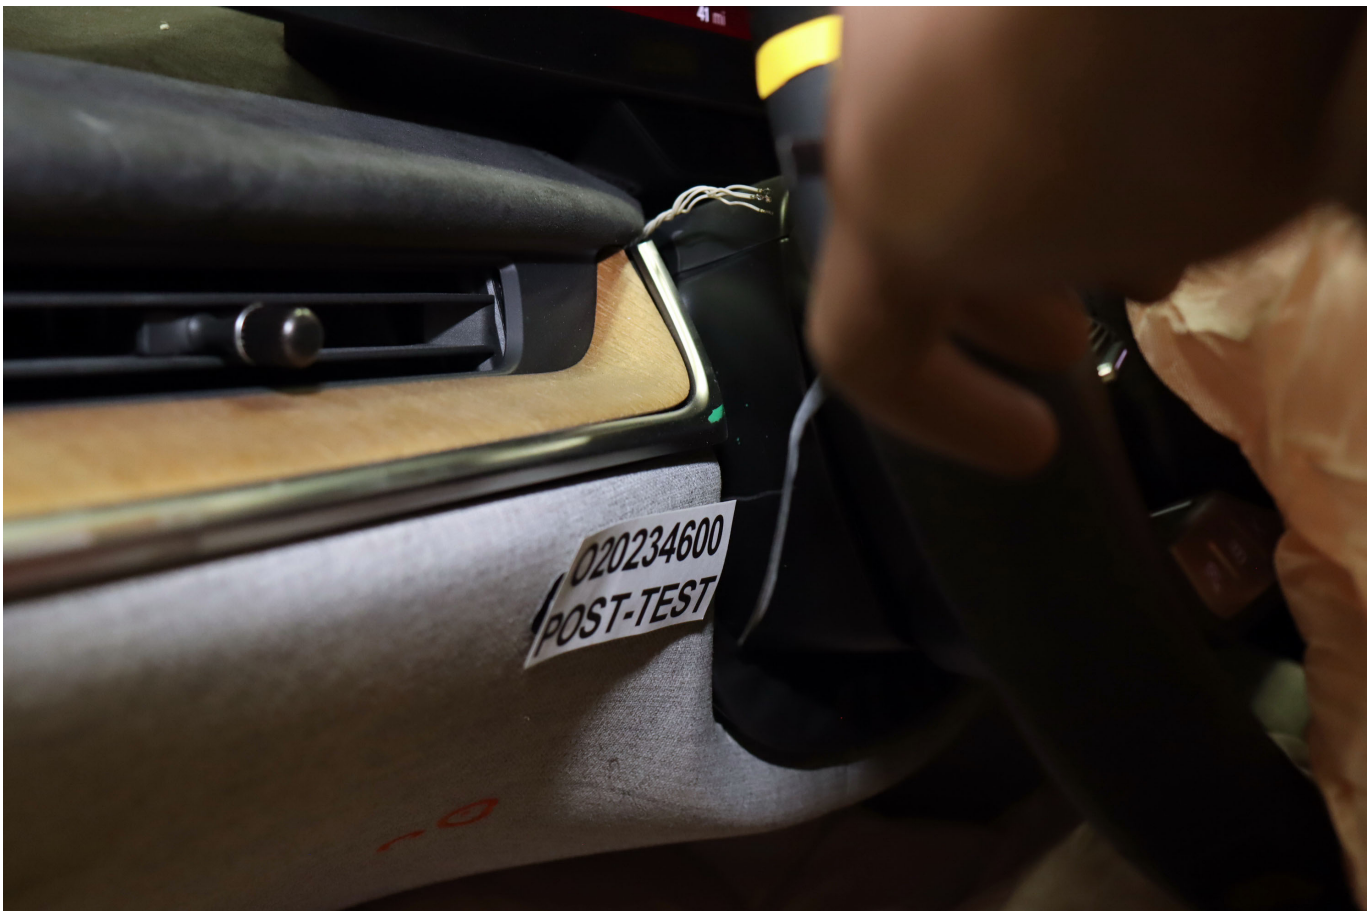
Photo No. 052 - Post-Test View of the Steering Wheel

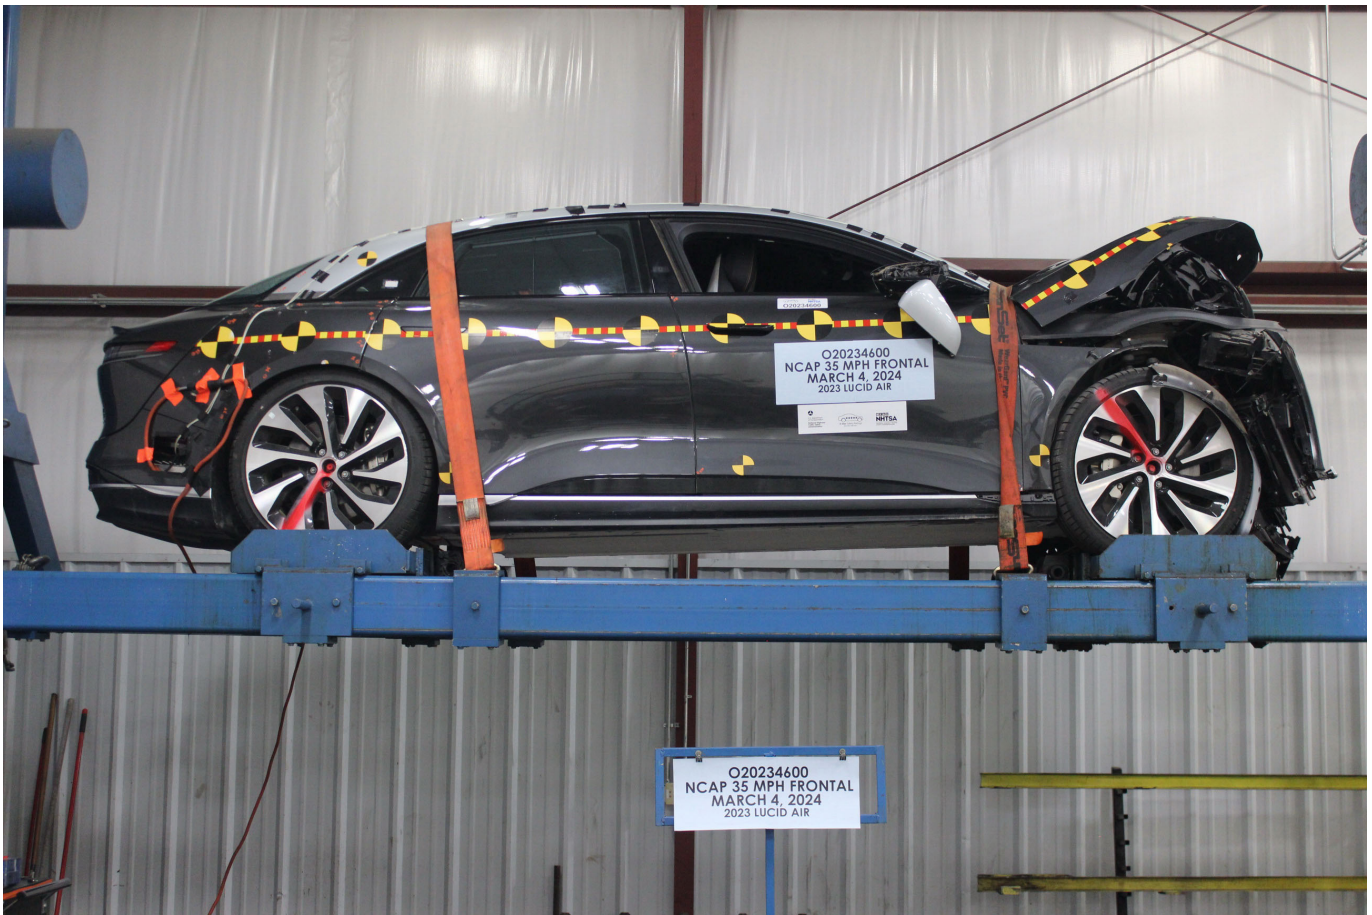
Photo No. 077 - Vehicle at 0 Degrees on Static Rollover Device

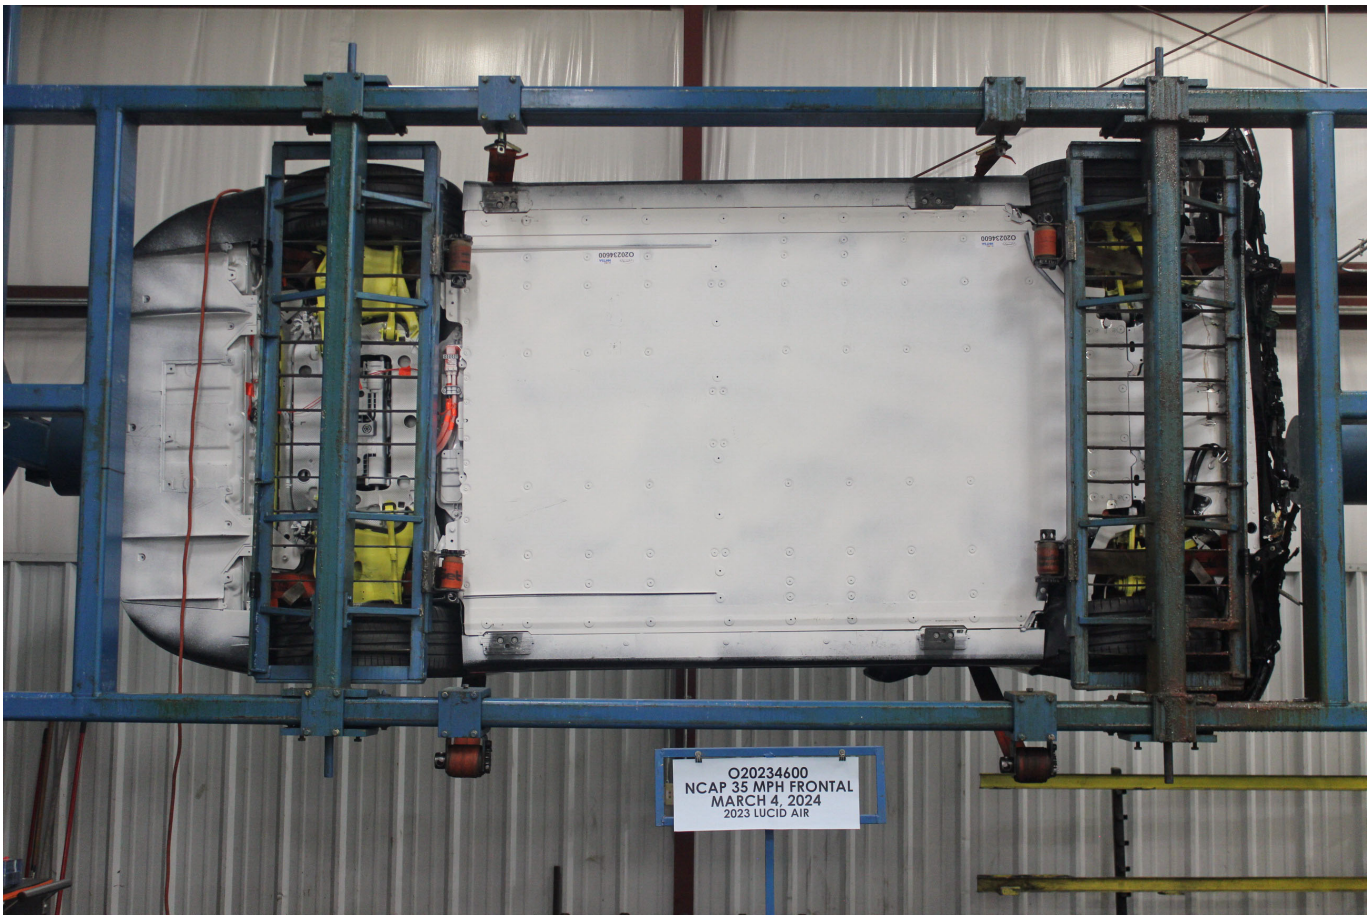
Photo No. 305-28 - FMVSS No. 305 Static Rollover at 90 Degrees
