**REPORT NUMBER: SideNCAPPole-MGA-24-010**

**NEW CAR ASSESSMENT PROGRAM (NCAP)  
Side Impact Pole Test**

**HYUNDAI MOTOR COMPANY  
2024 Hyundai Sonata SEL 4-Door Sedan  
NHTSA No.: O20244213**

**FINAL REPORT**

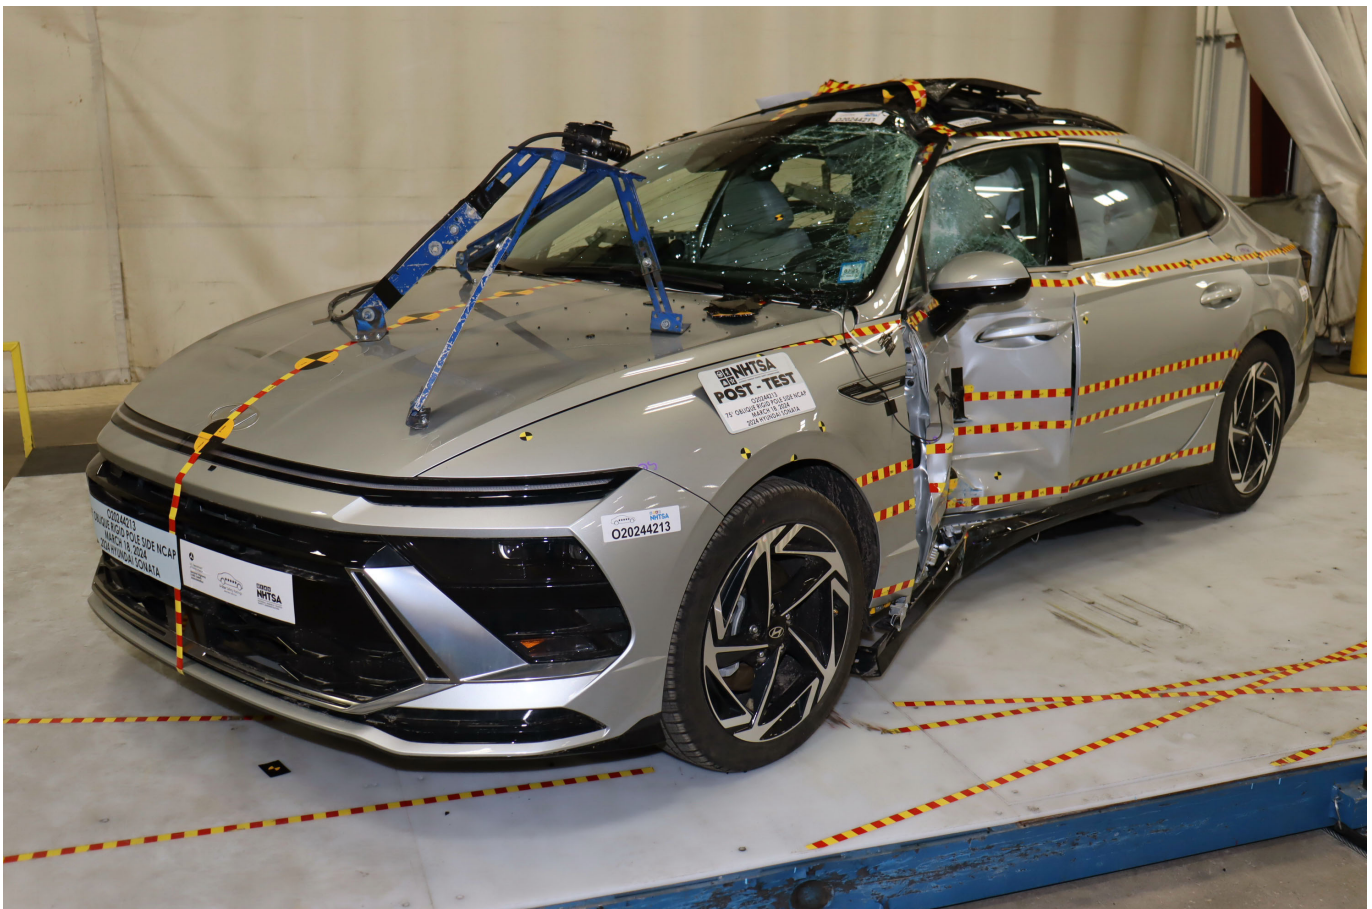
Photo No. 006 - Post-Test Left Front Three-Quarter View of Test Vehicle

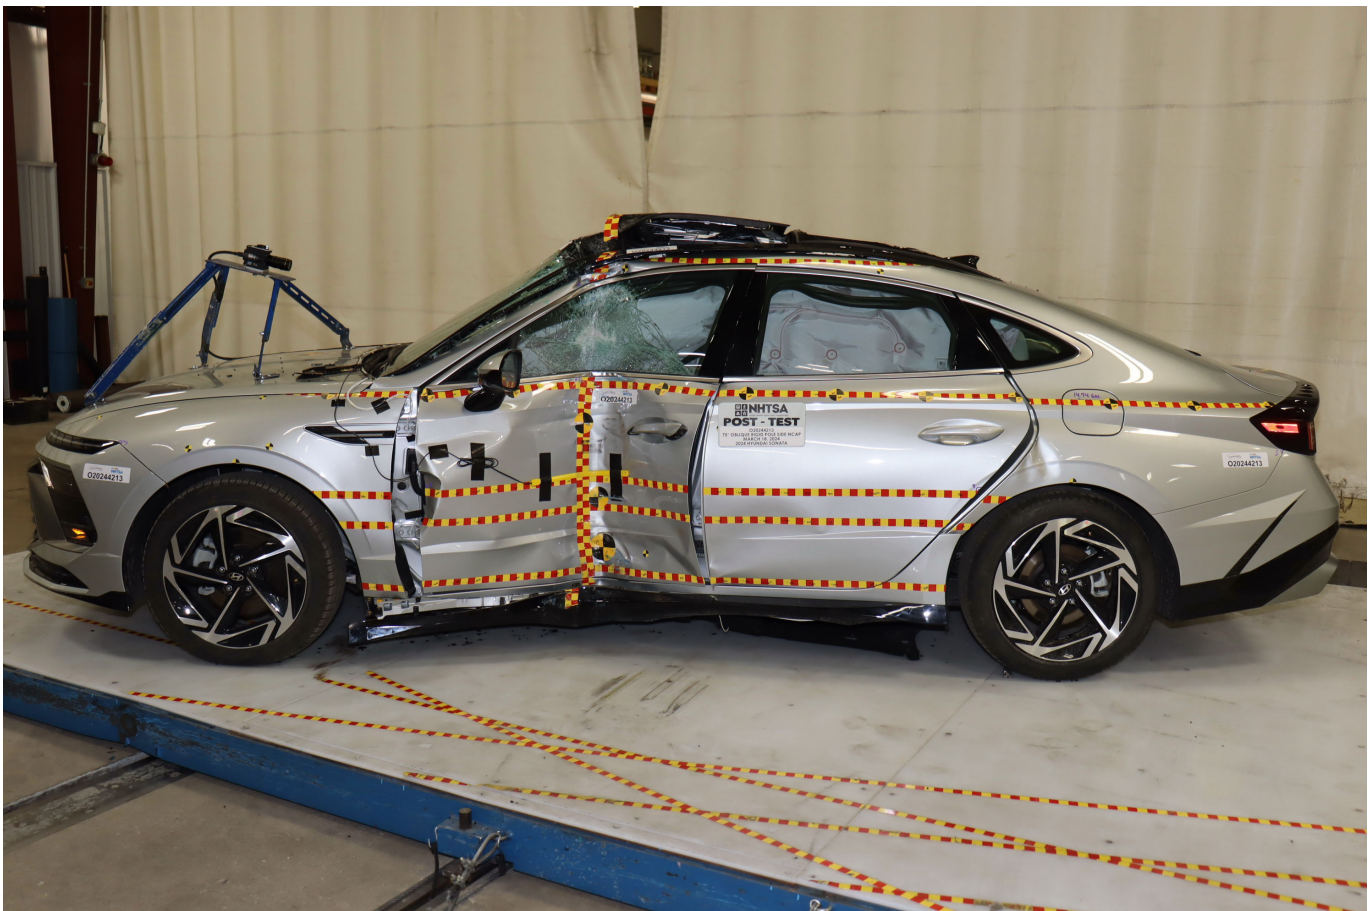
Photo No. 008 - Post-Test Left Side View of Test Vehicle

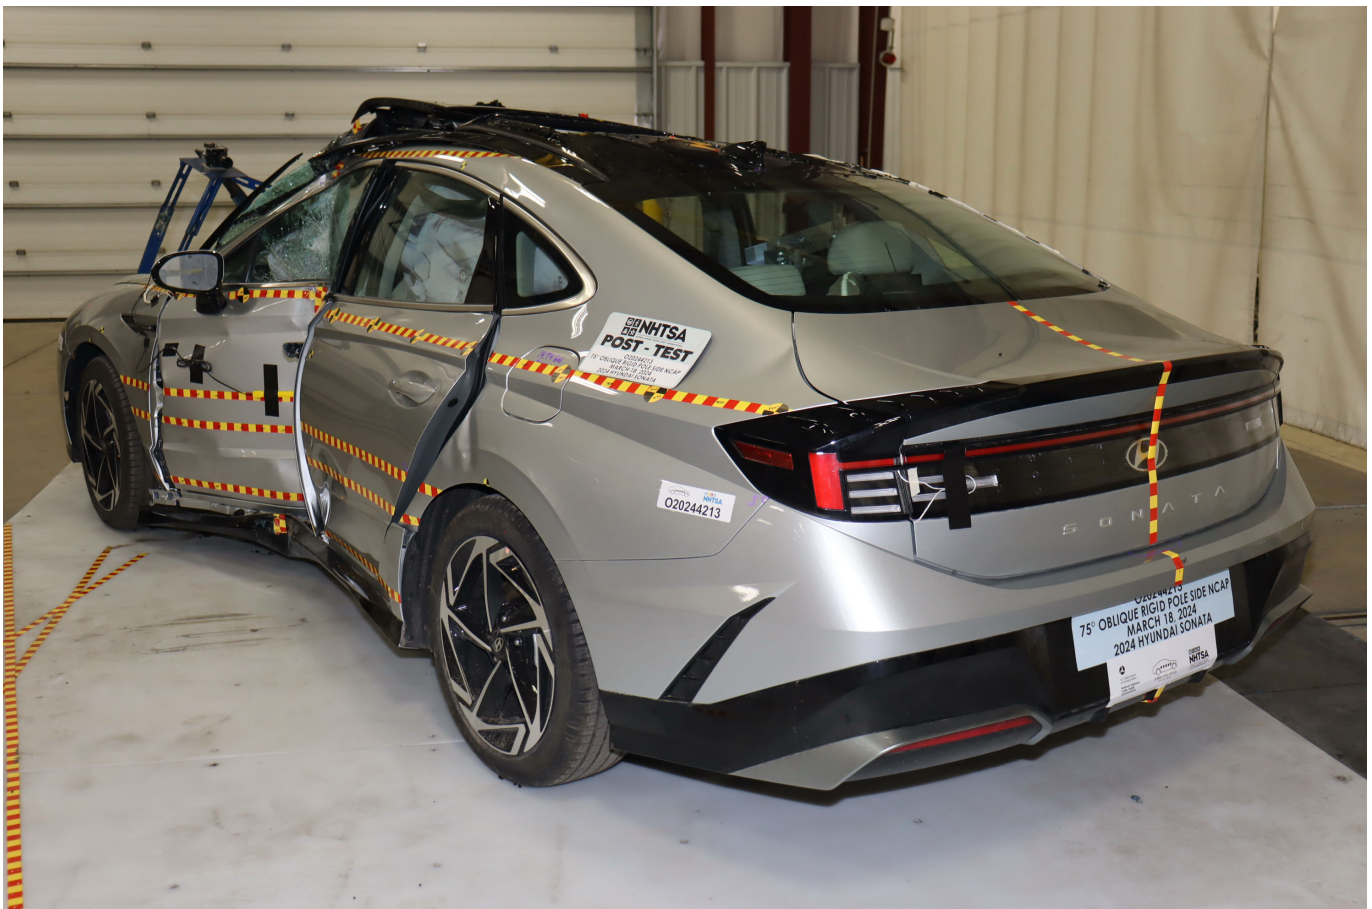
Photo No. 010 - Post-Test Left Rear Three-Quarter View of Test Vehicle

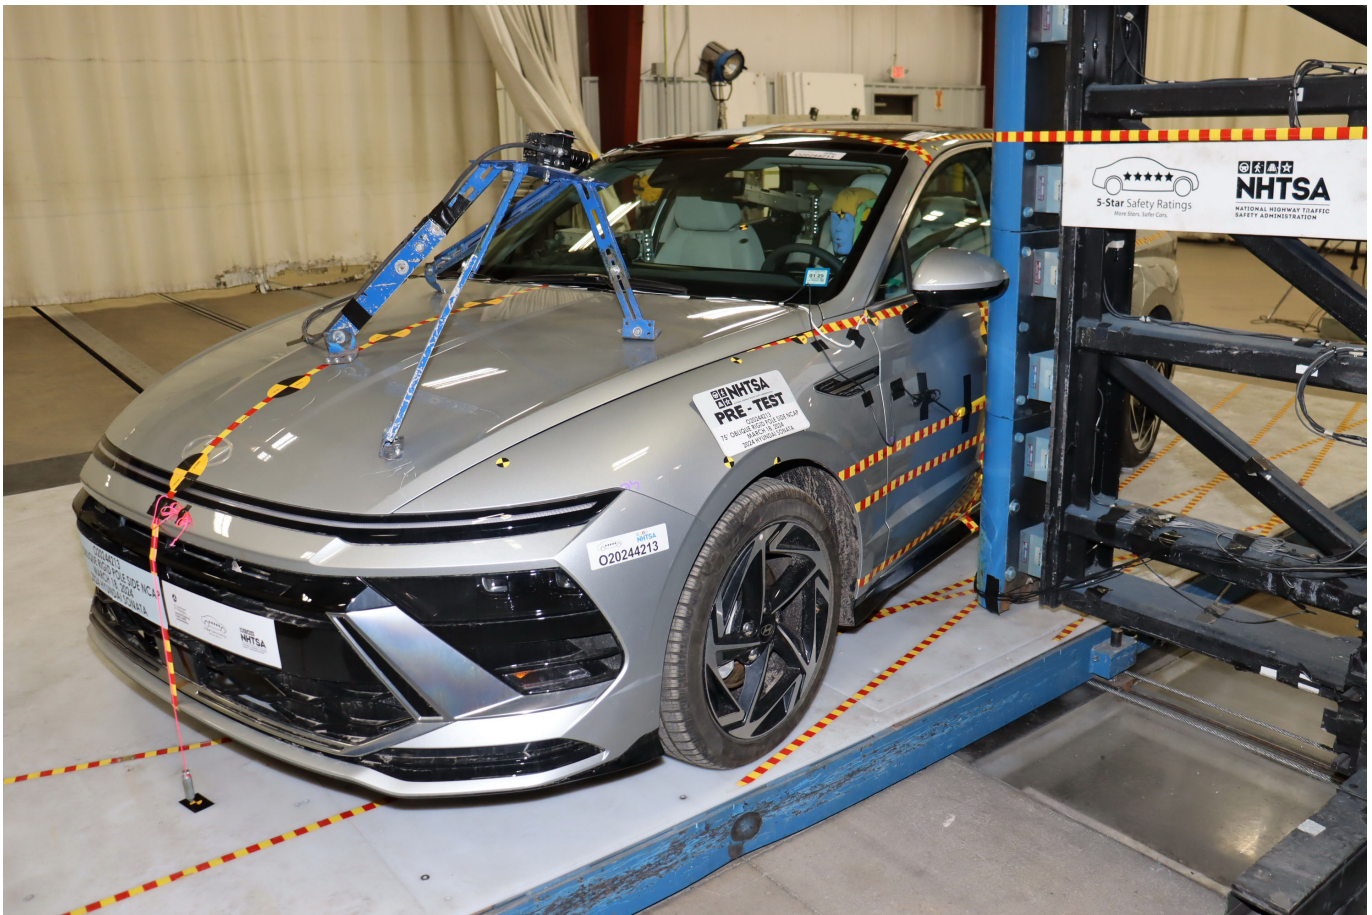
Photo No. 017 - Pre-Test Left Side View of Pole Positioned Against Side of Vehicle

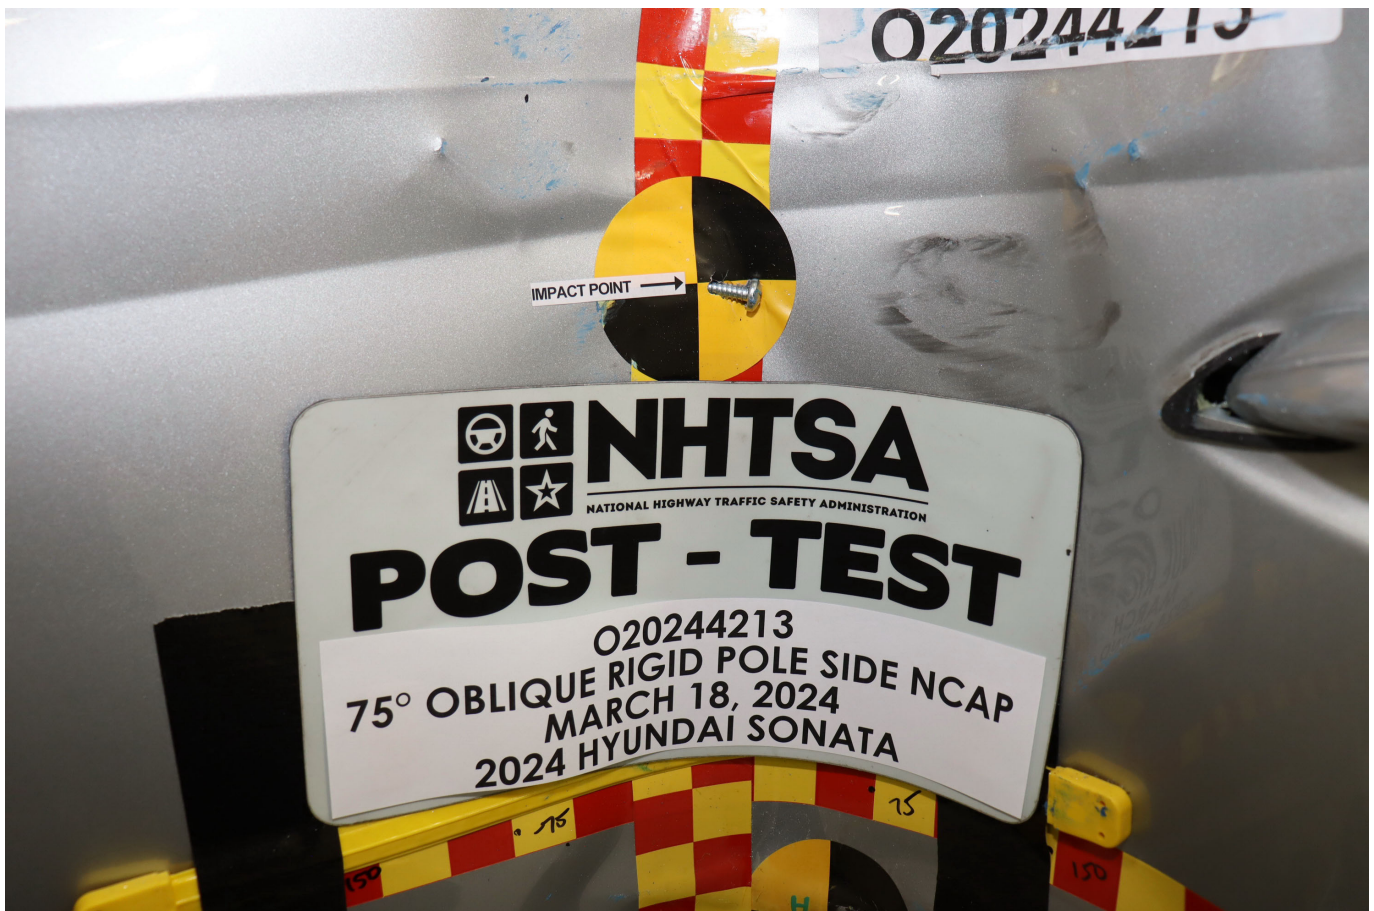
Photo No. 020 - Post-Test Close-Up View of Impact Point Target Showing Impact Location

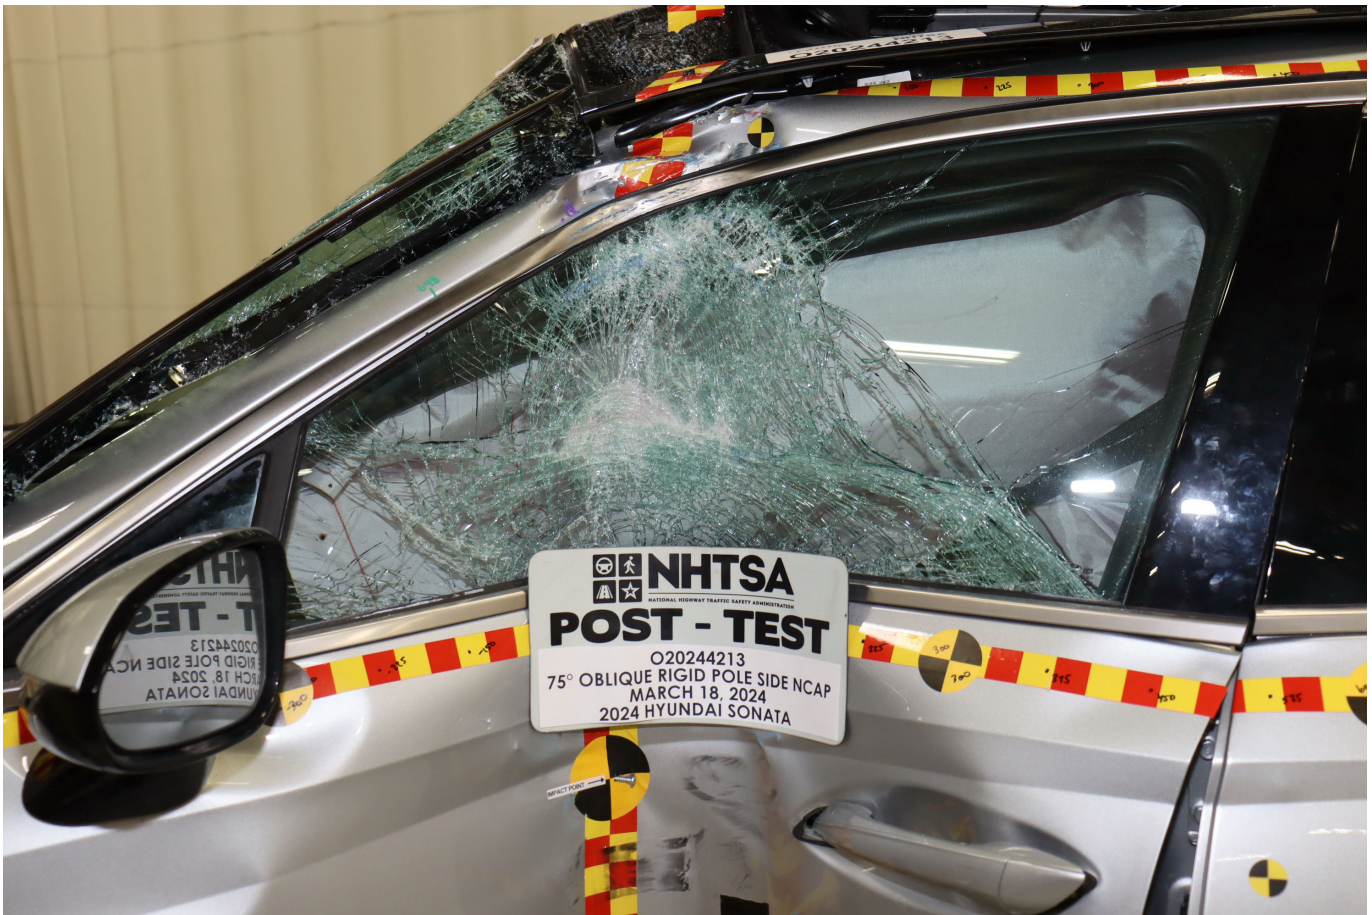
Photo No. 025 - Post-Test Left Side View of Dummy Shoulder and Door Top View

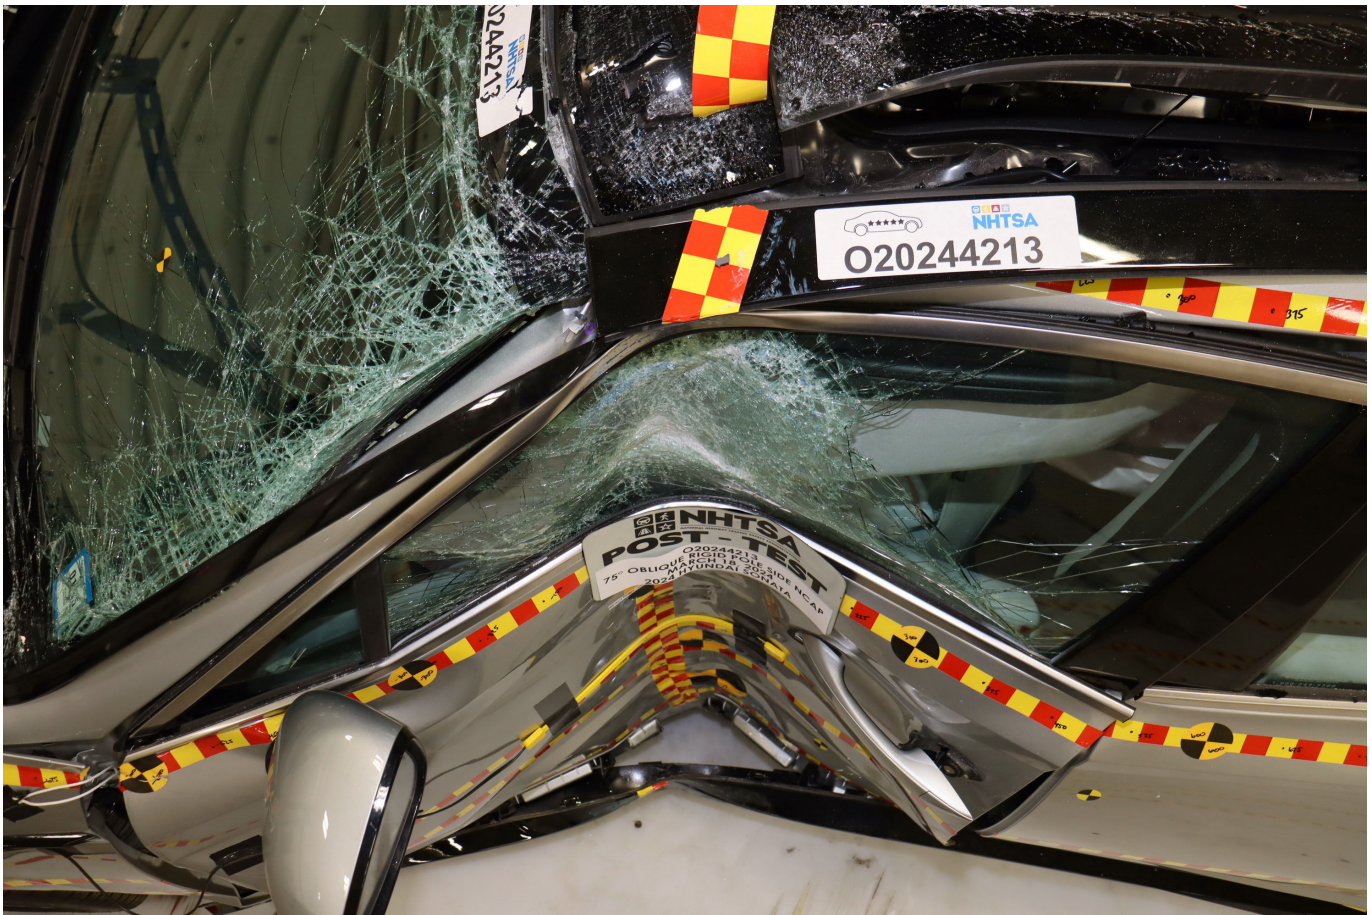
Photo No. 041 - Post-Test Dummy and Door Clearance View

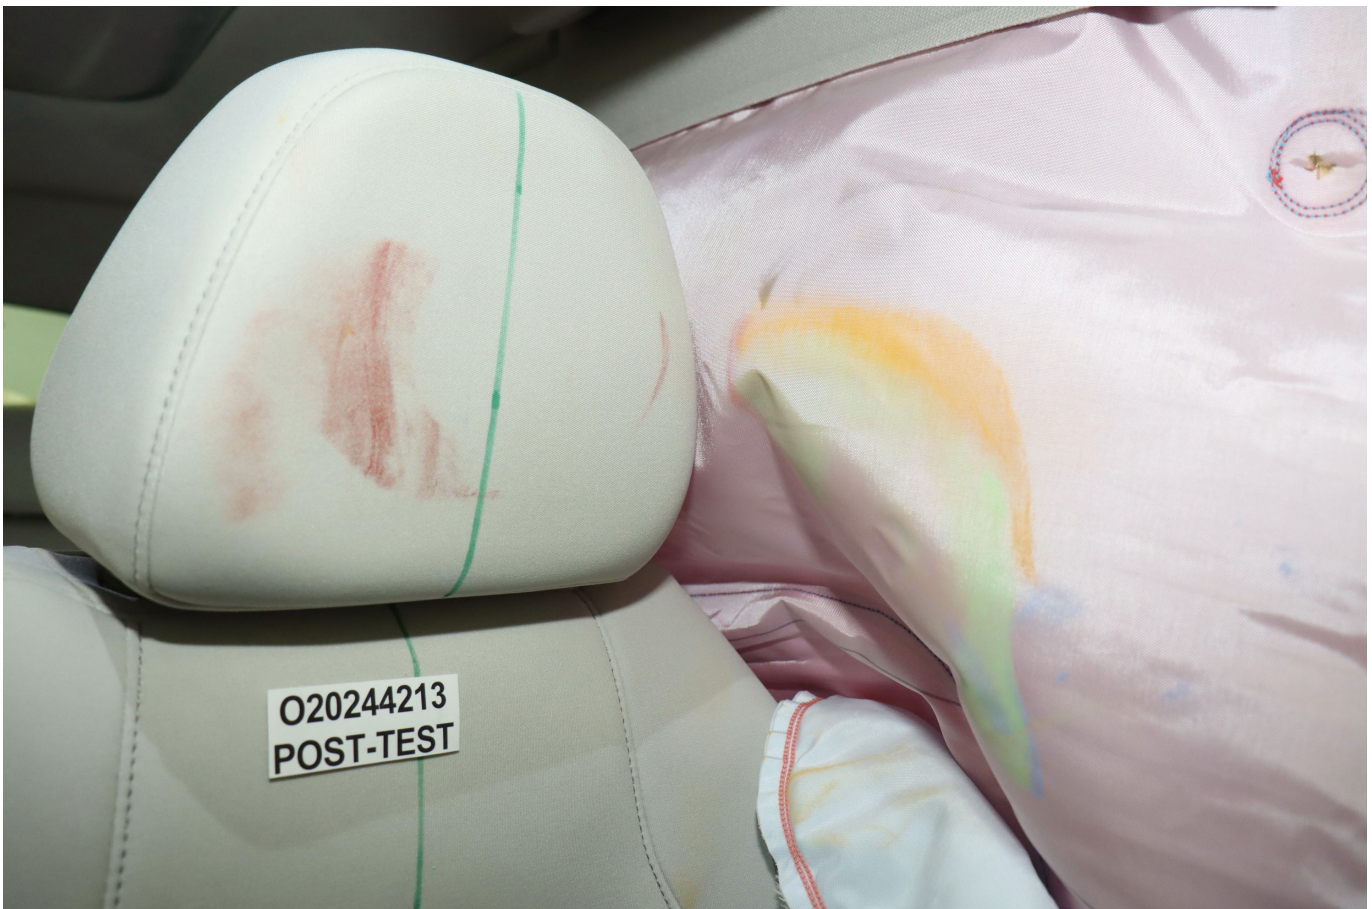
Photo No. 046 - Post-Test Dummy Close-Up Head Contact with Vehicle Interior View

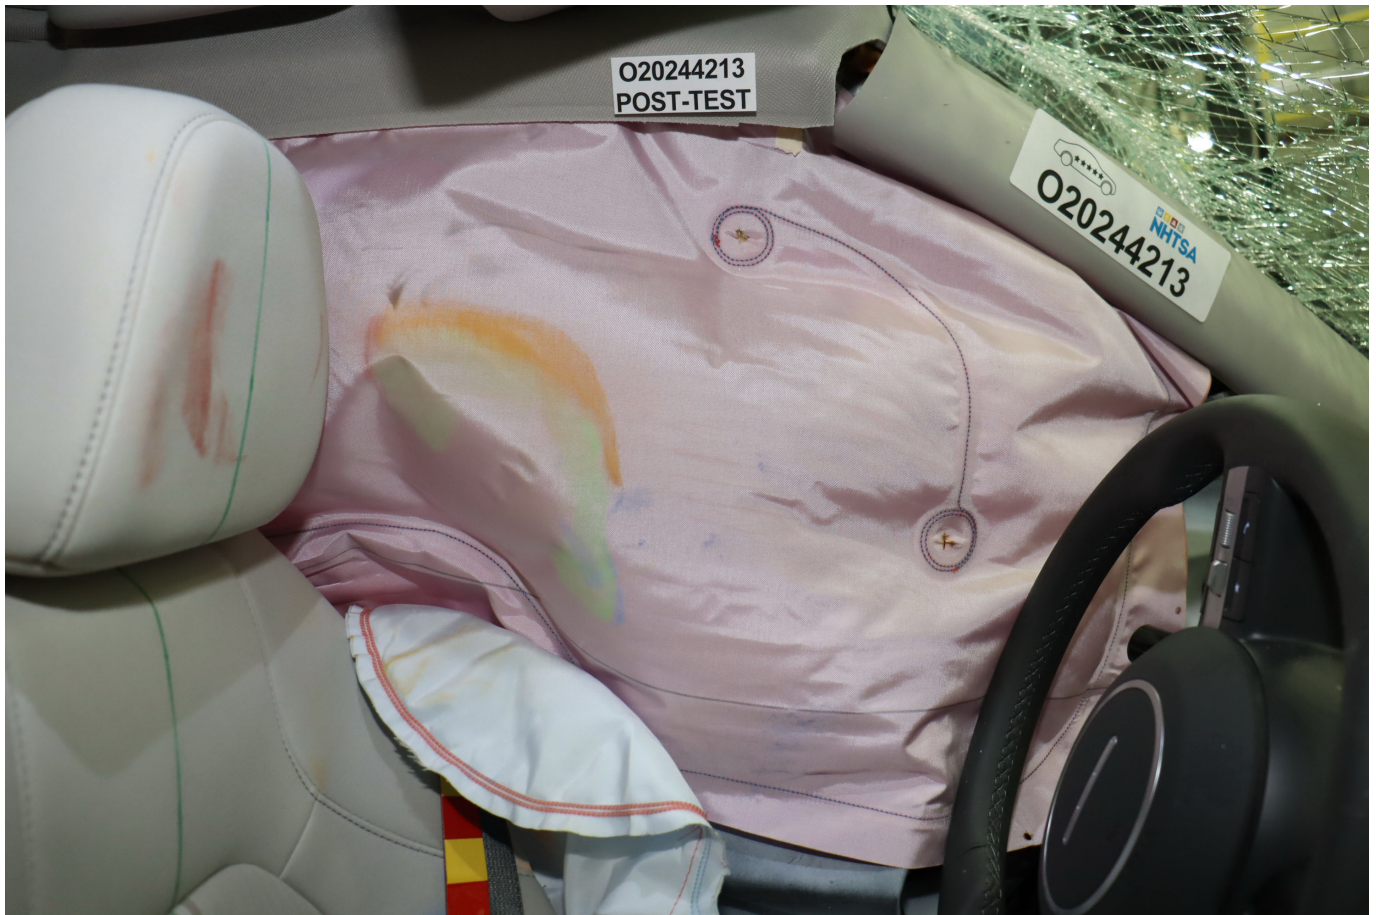
Photo No. 047 - Post-Test Dummy Close-Up Head Contact with Side Air Bag View

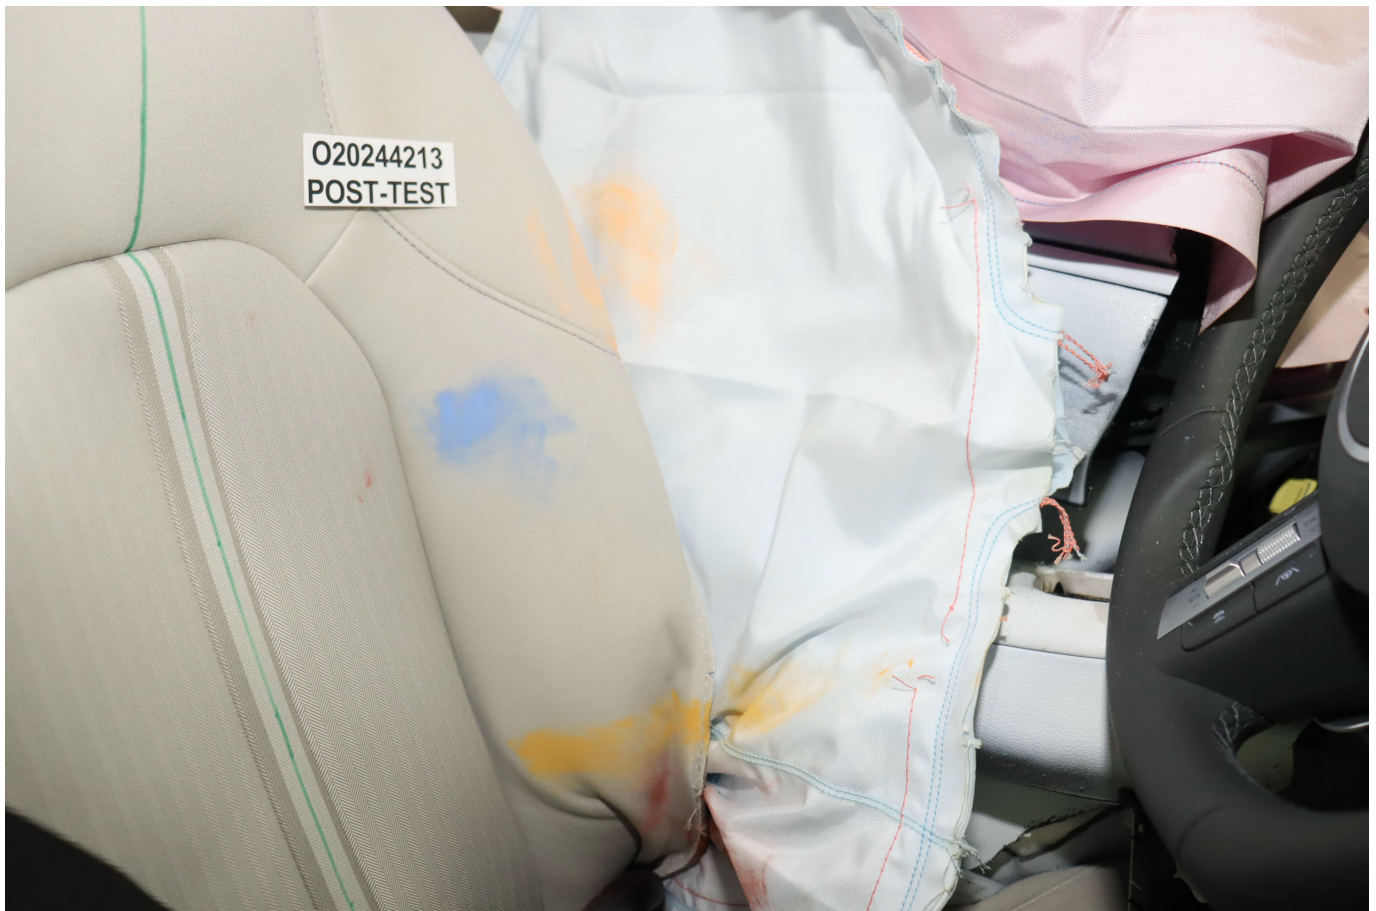
Photo No. 048 - Post-Test Dummy Close-Up Torso Contact with Vehicle Interior View

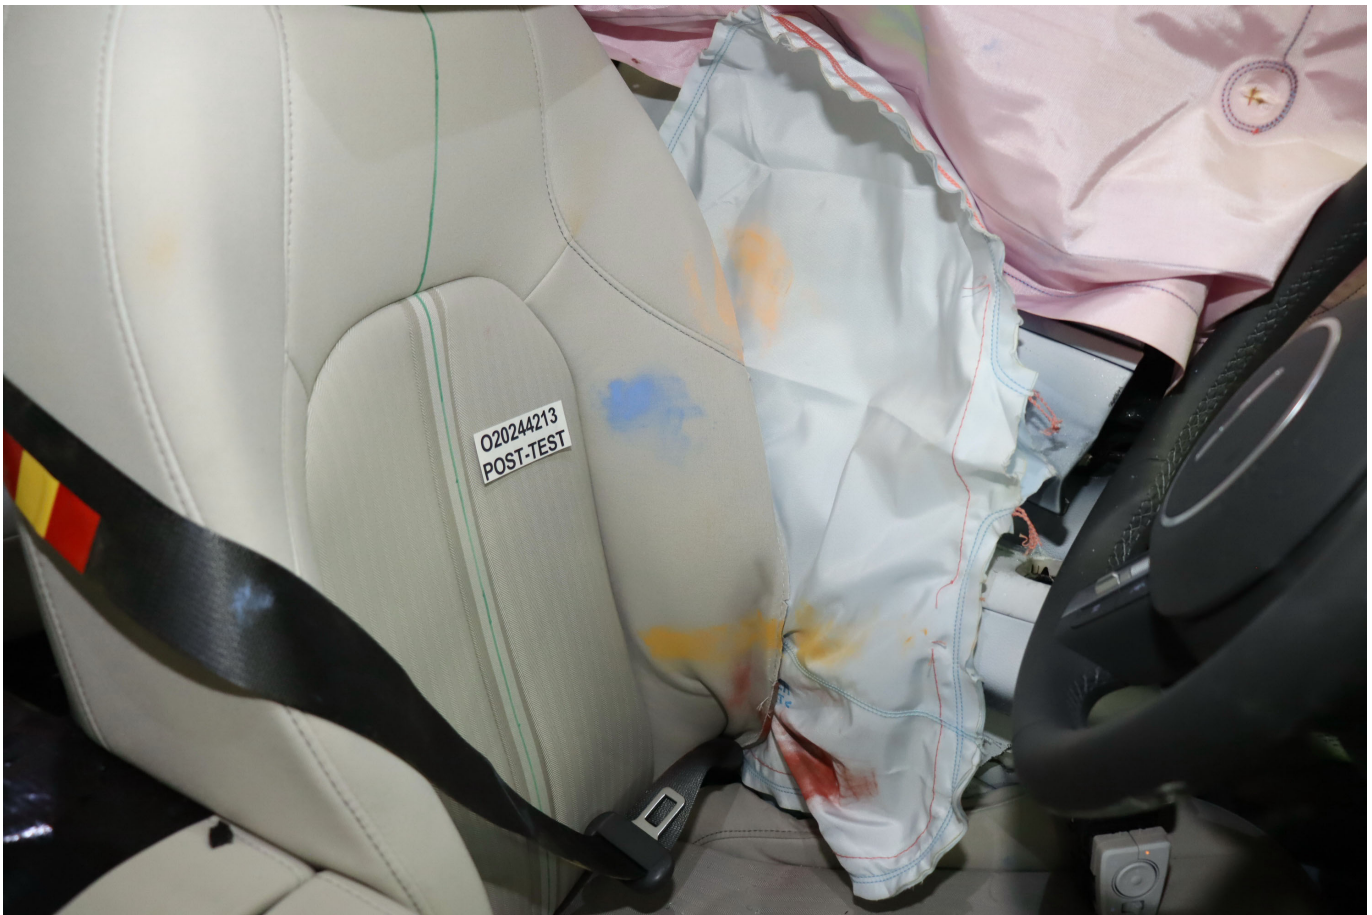
Photo No. 049 - Post-Test Dummy Close-Up Torso Contact with Side Air Bag View

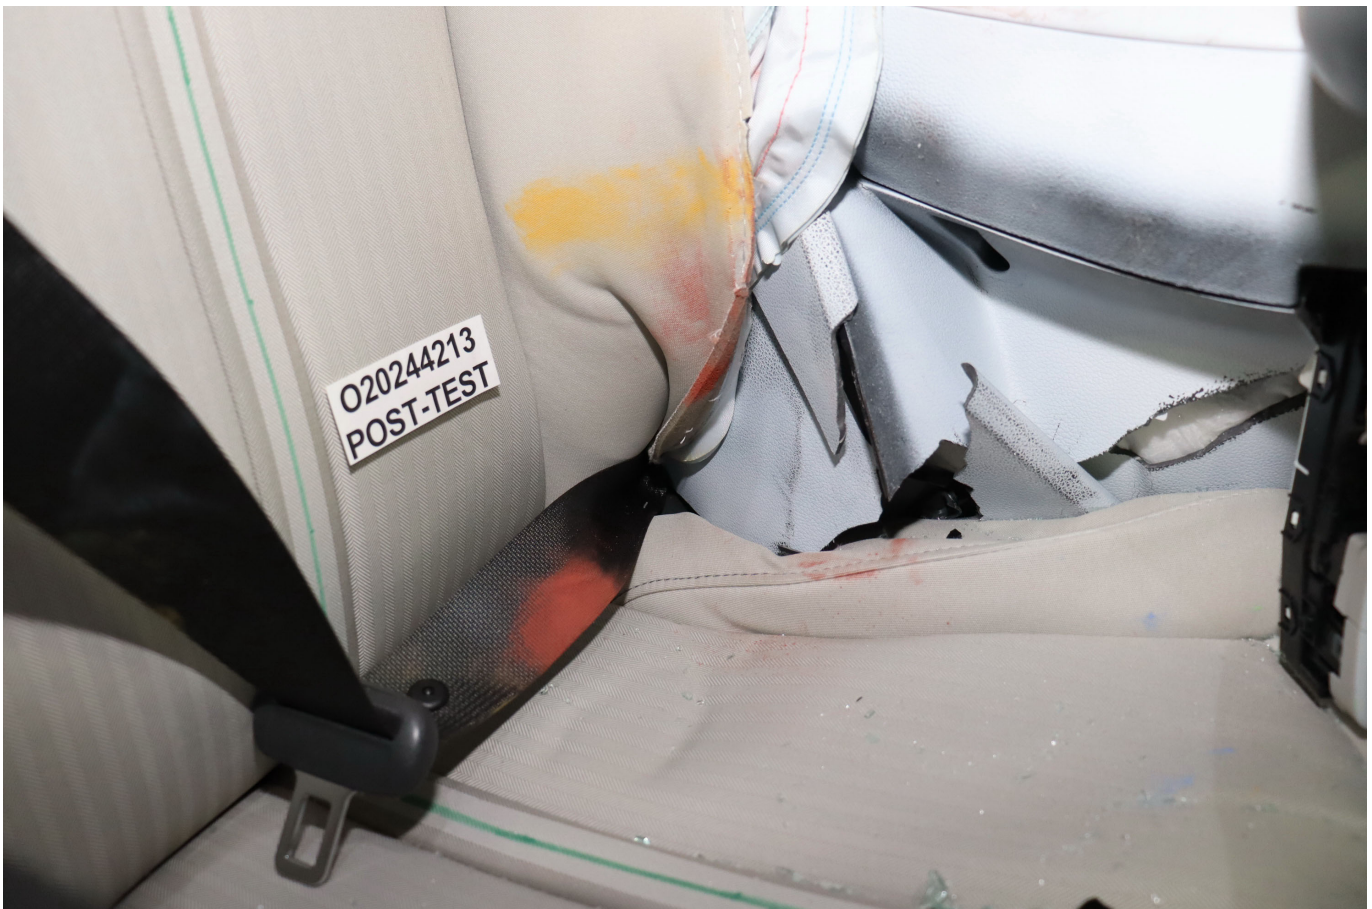
Photo No. 050 - Post-Test Dummy Close-Up Pelvis Contact with Vehicle Interior View

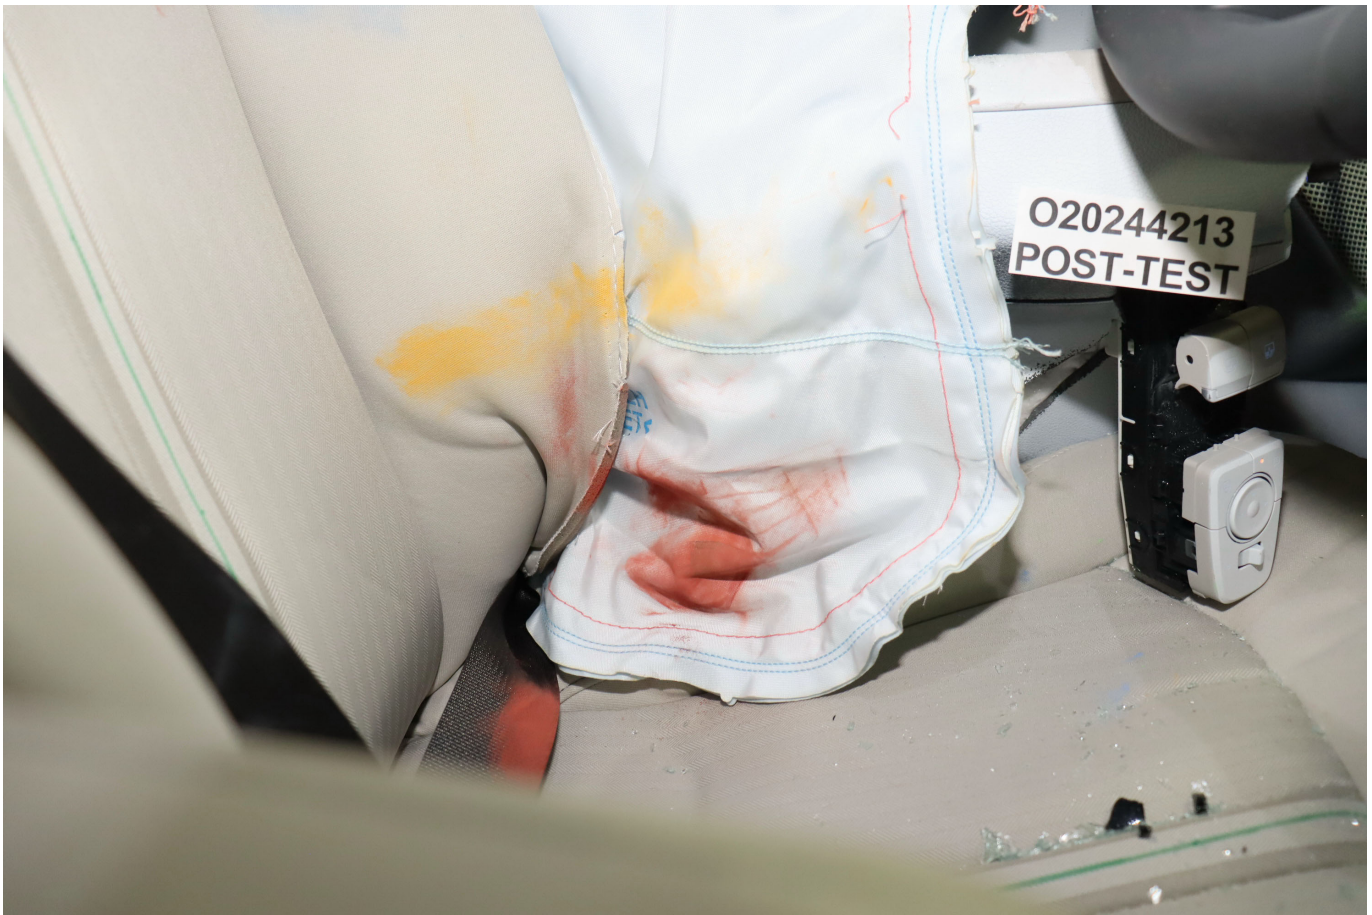
Photo No. 051 - Post-Test Dummy Close-Up Pelvis Contact with Side Air Bag View

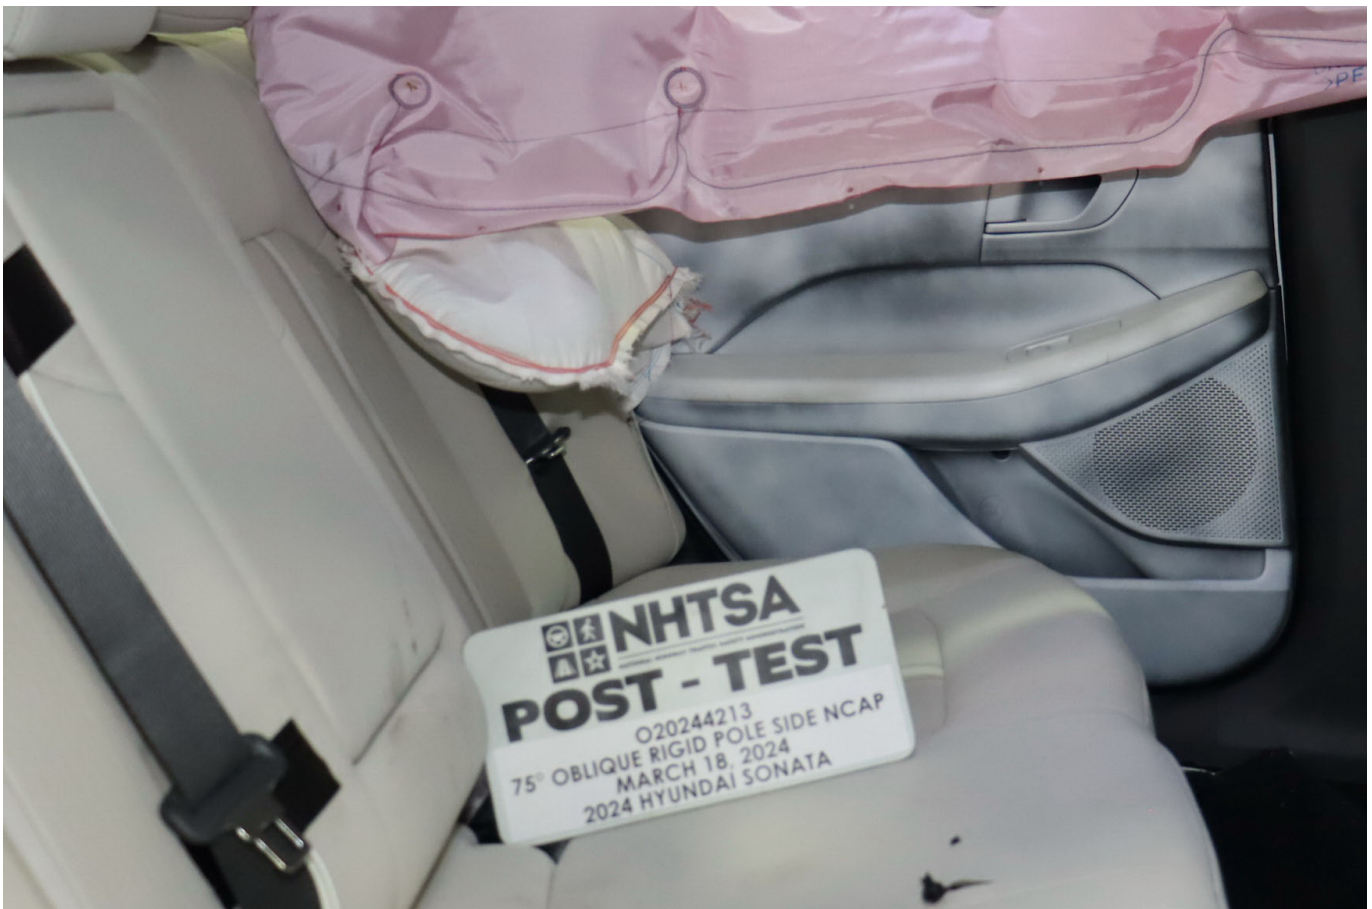
Photo No. 054 - Post-Test Inner Rear Passenger Torso Air Bag Deployment View

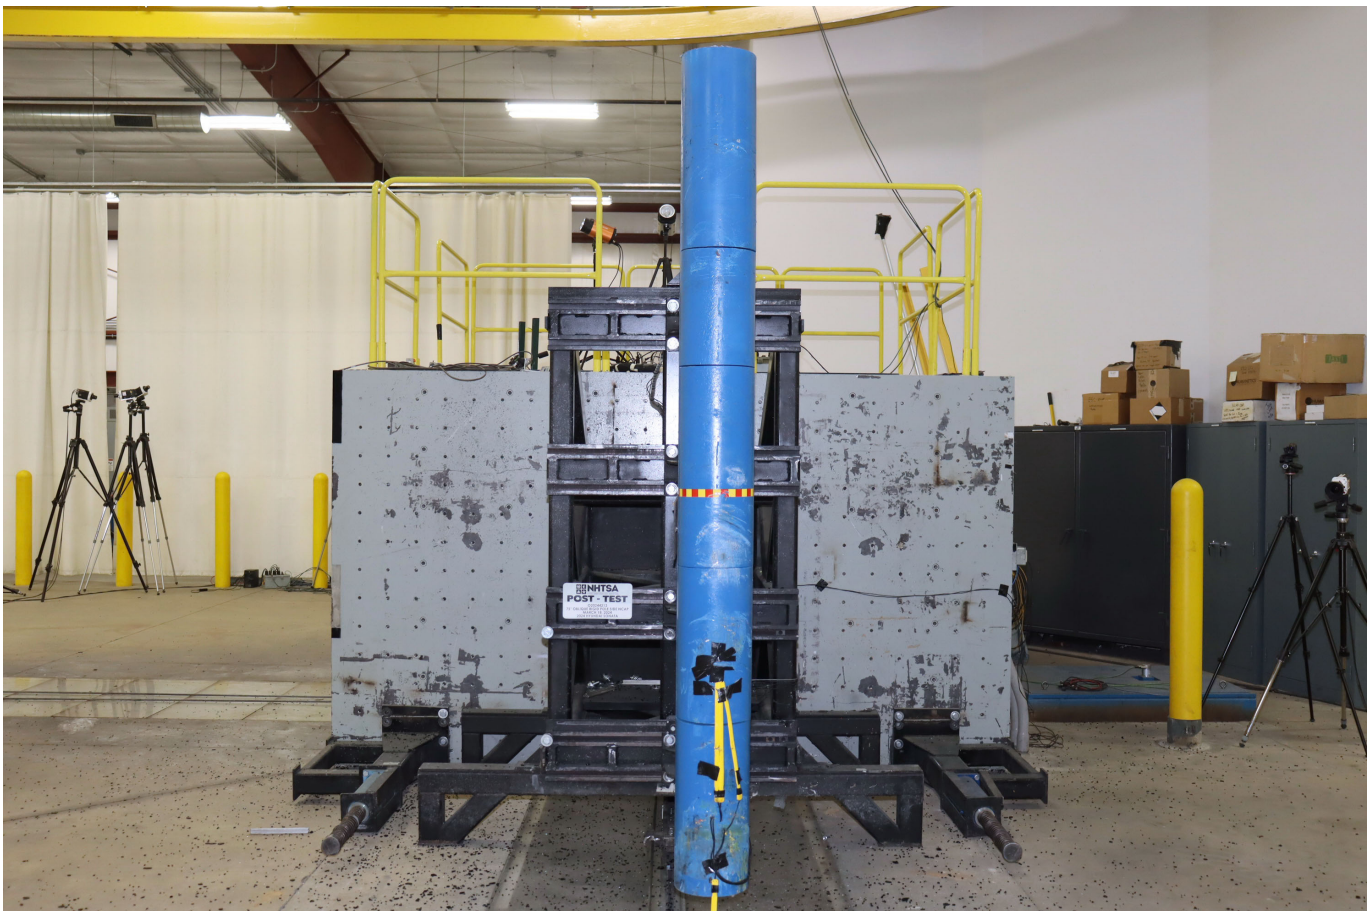
Photo No. 060 - Post-Test Pole Barrier Front View

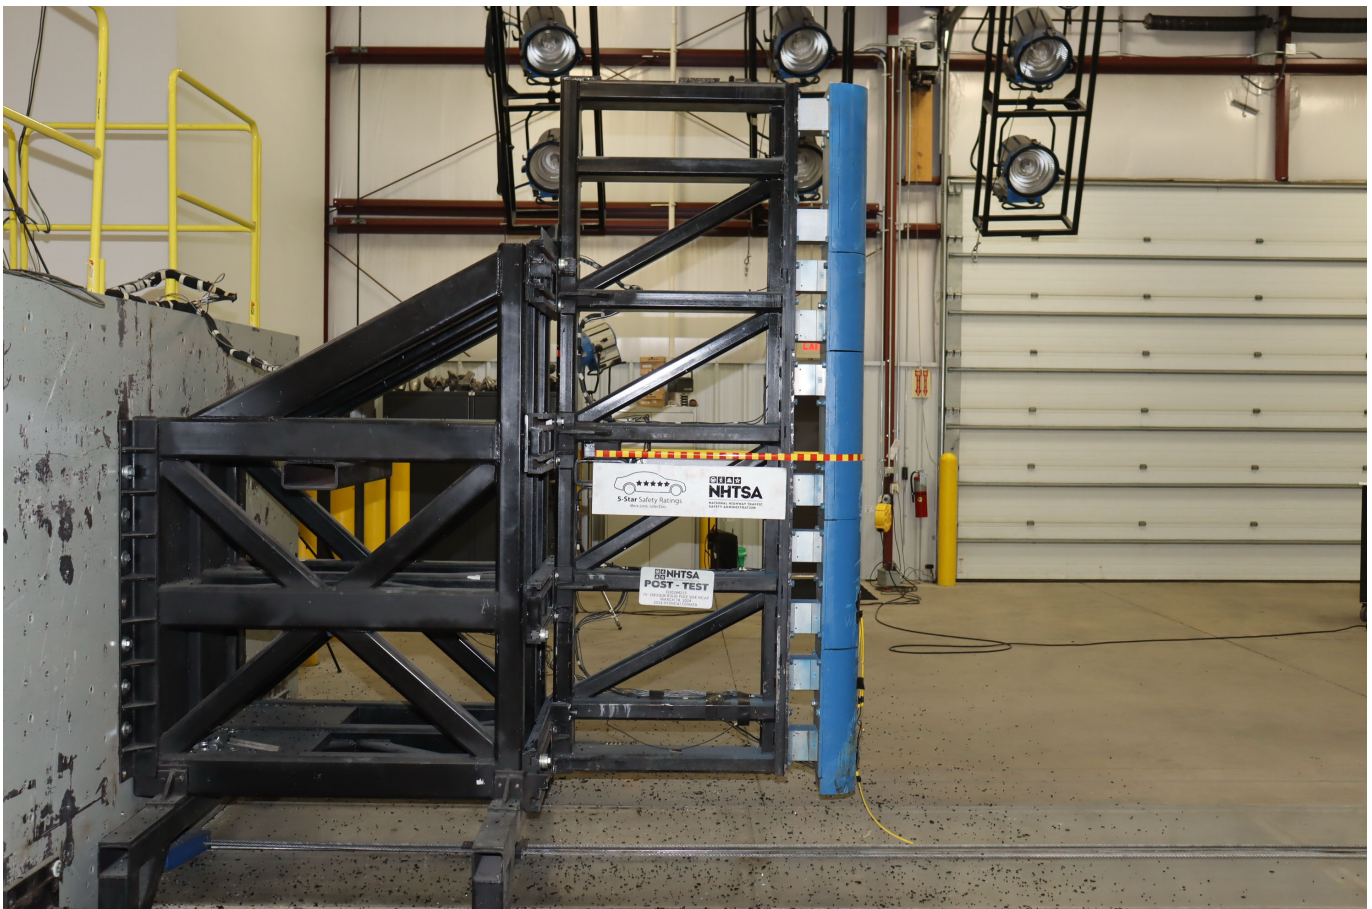
Photo No. 062 - Post-Test Pole Barrier Side View

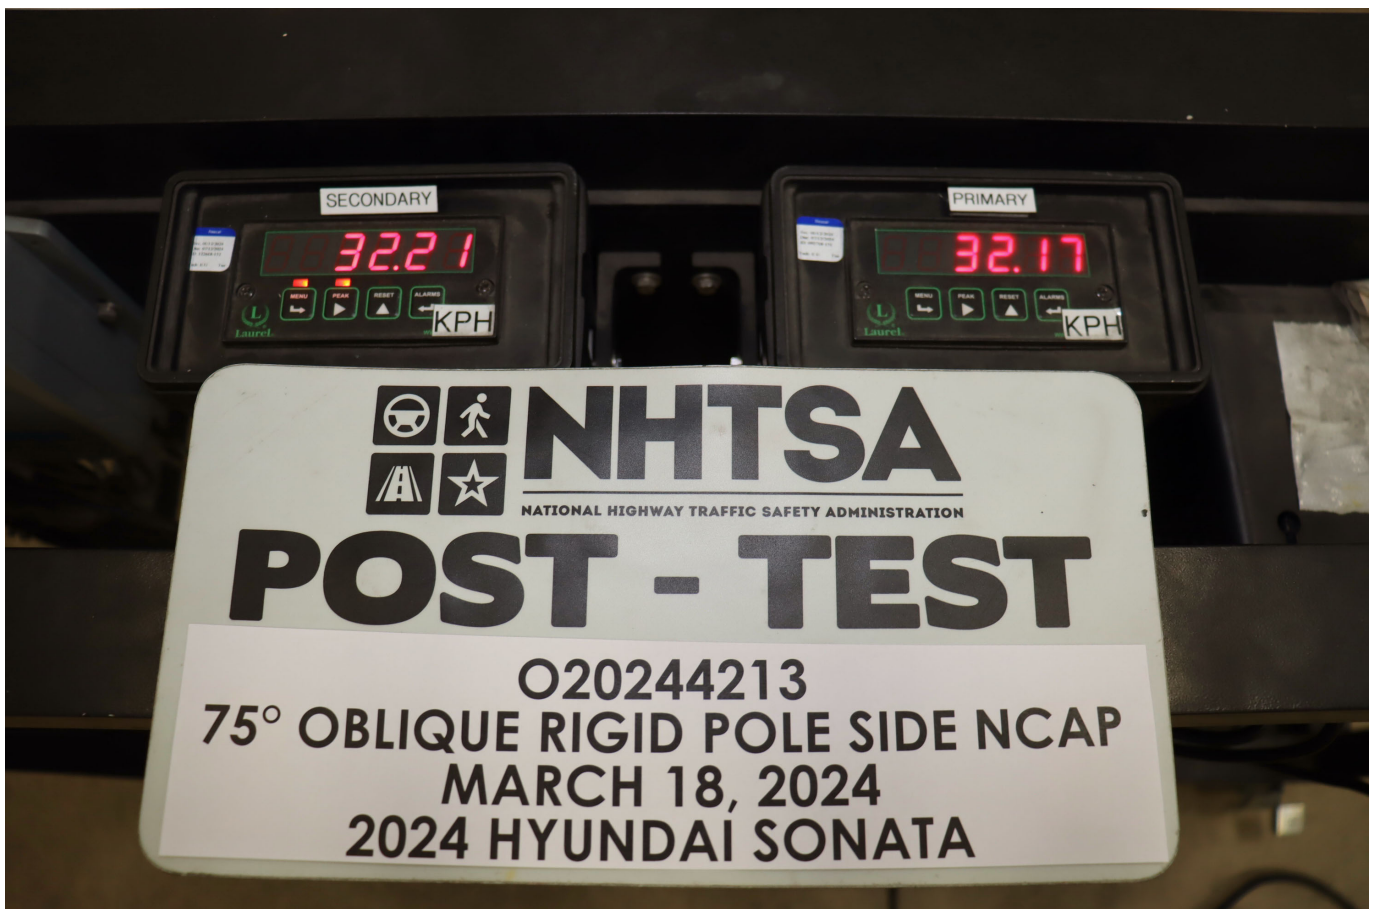
Photo No. 064 - Post-Test Primary and Redundant Speed Trap Read-Out

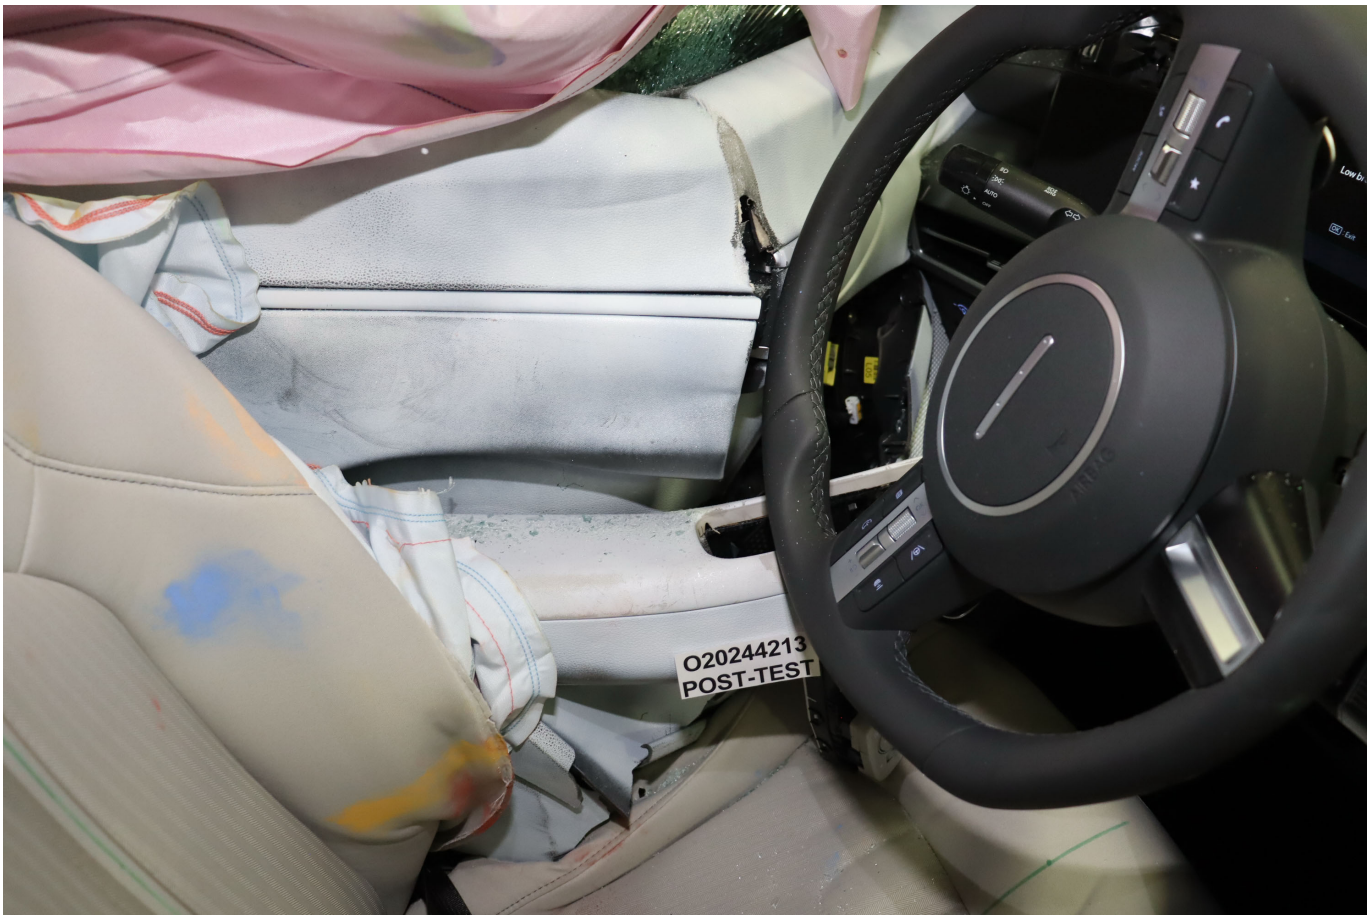
Photo No. 073 - Post-Test View of Shattered Vehicle Inner Door Panel

| Critical Areas of Performance | Observations and Conclusions |
|---|---|
| Side Window Damage | LF window cracked |
