**REPORT NUMBER: SideNCAPMDB-MGA-24-011**

**NEW CAR ASSESSMENT PROGRAM (NCAP)  
Moving Deformable Barrier Side Impact Test**

**HYUNDAI MOTOR COMPANY  
2024 Hyundai Sonata SEL 4-Door Sedan  
NHTSA No.: O20244214**

**FINAL REPORT**

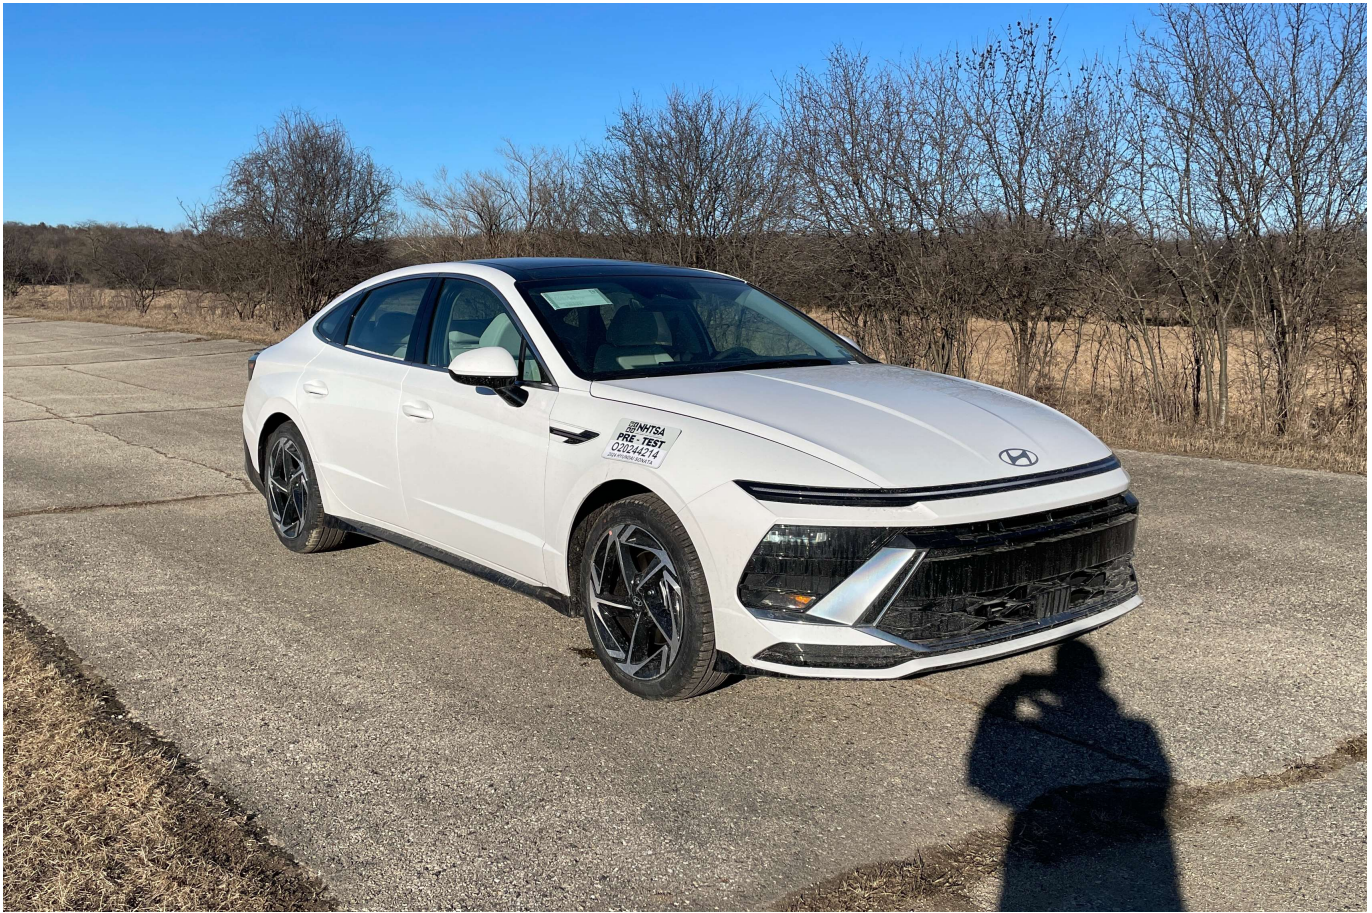
Photo No. 001 - As Delivered Right Front Three-Quarter View of Test Vehicle

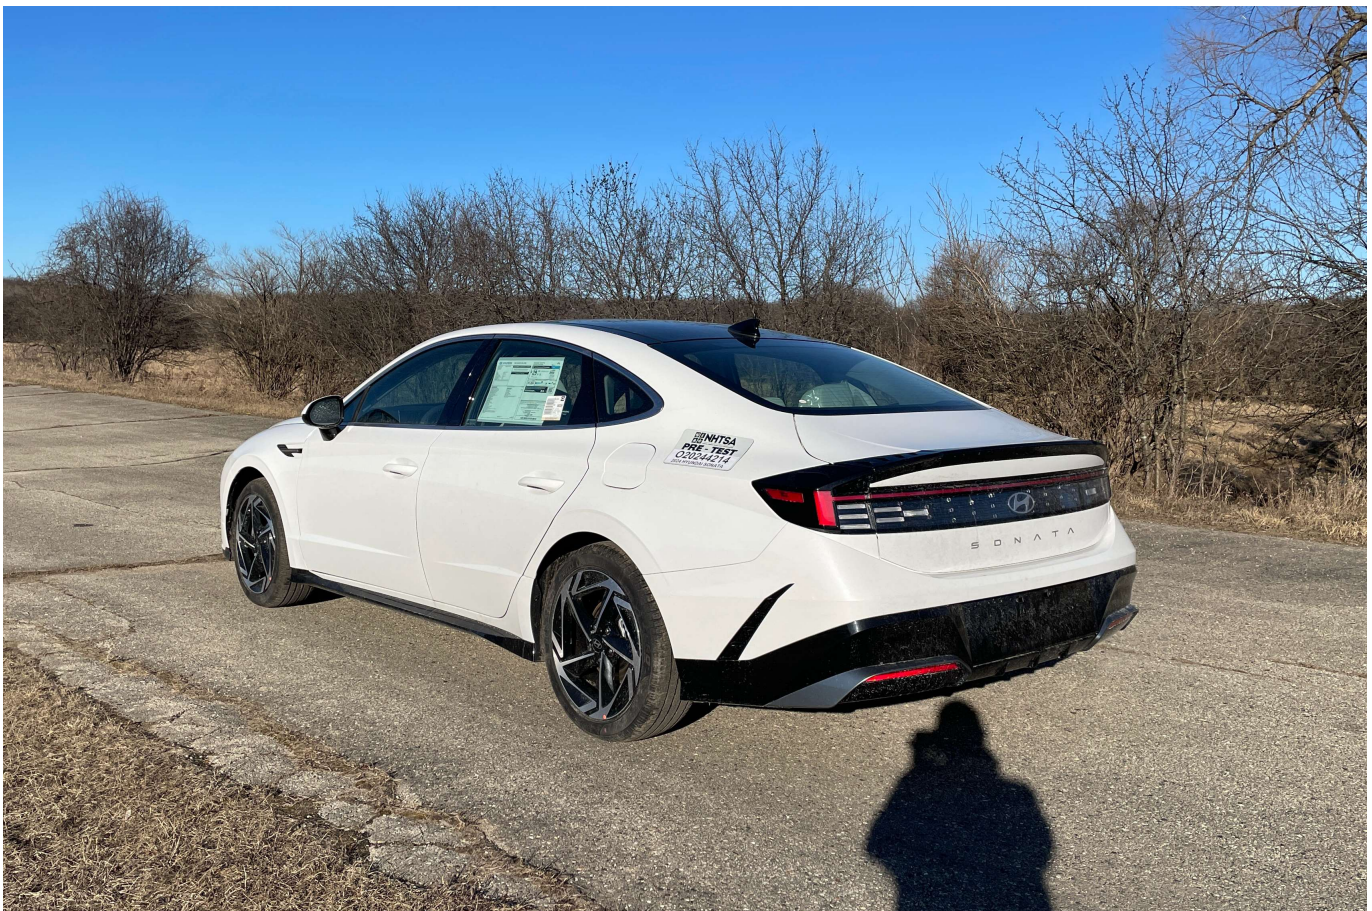
Photo No. 002 - As Delivered Left Rear Three-Quarter View of Test Vehicle

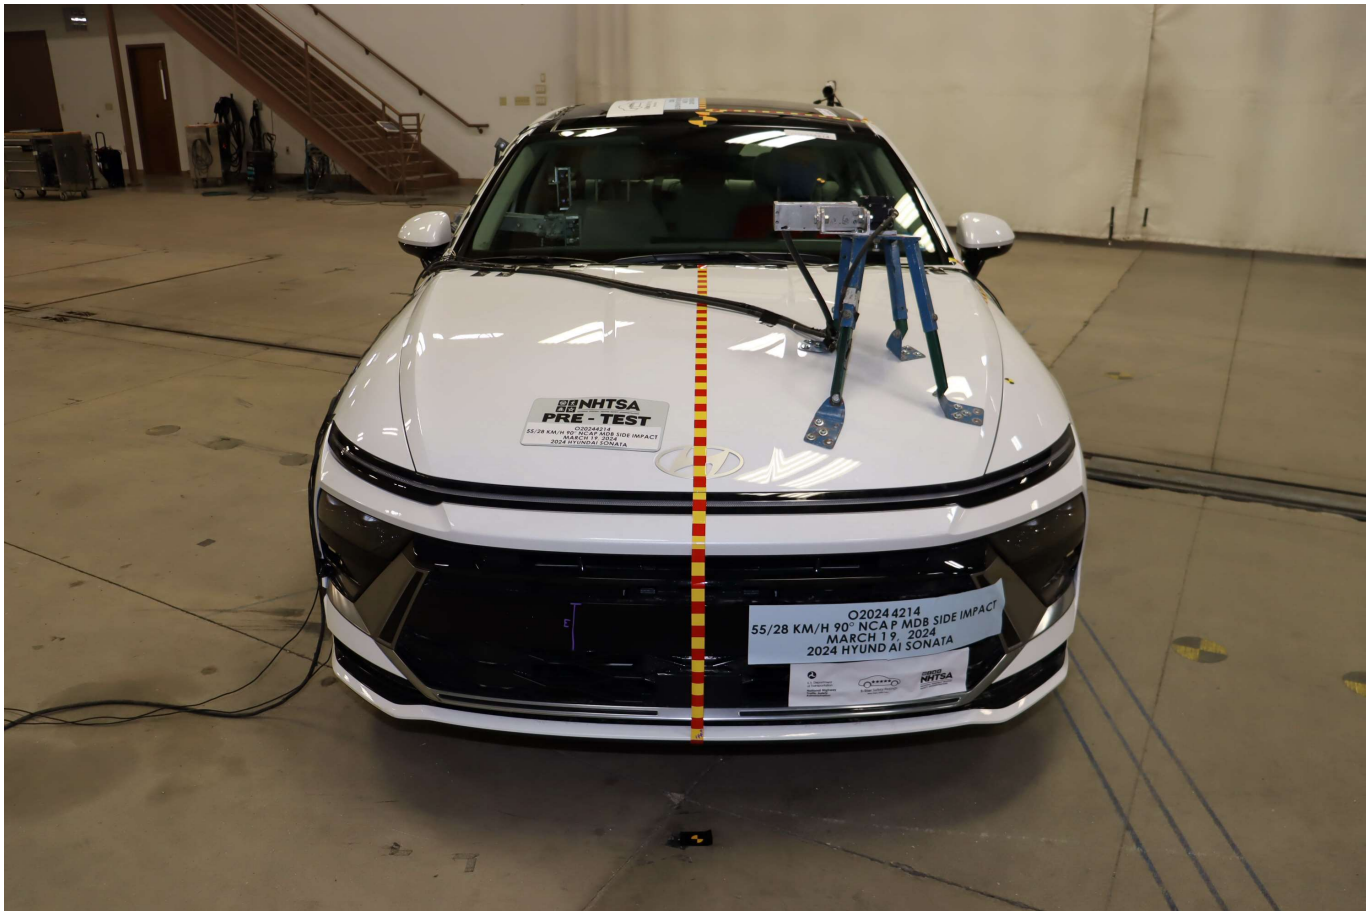
Photo No. 003 - Pre-Test Frontal View of Test Vehicle

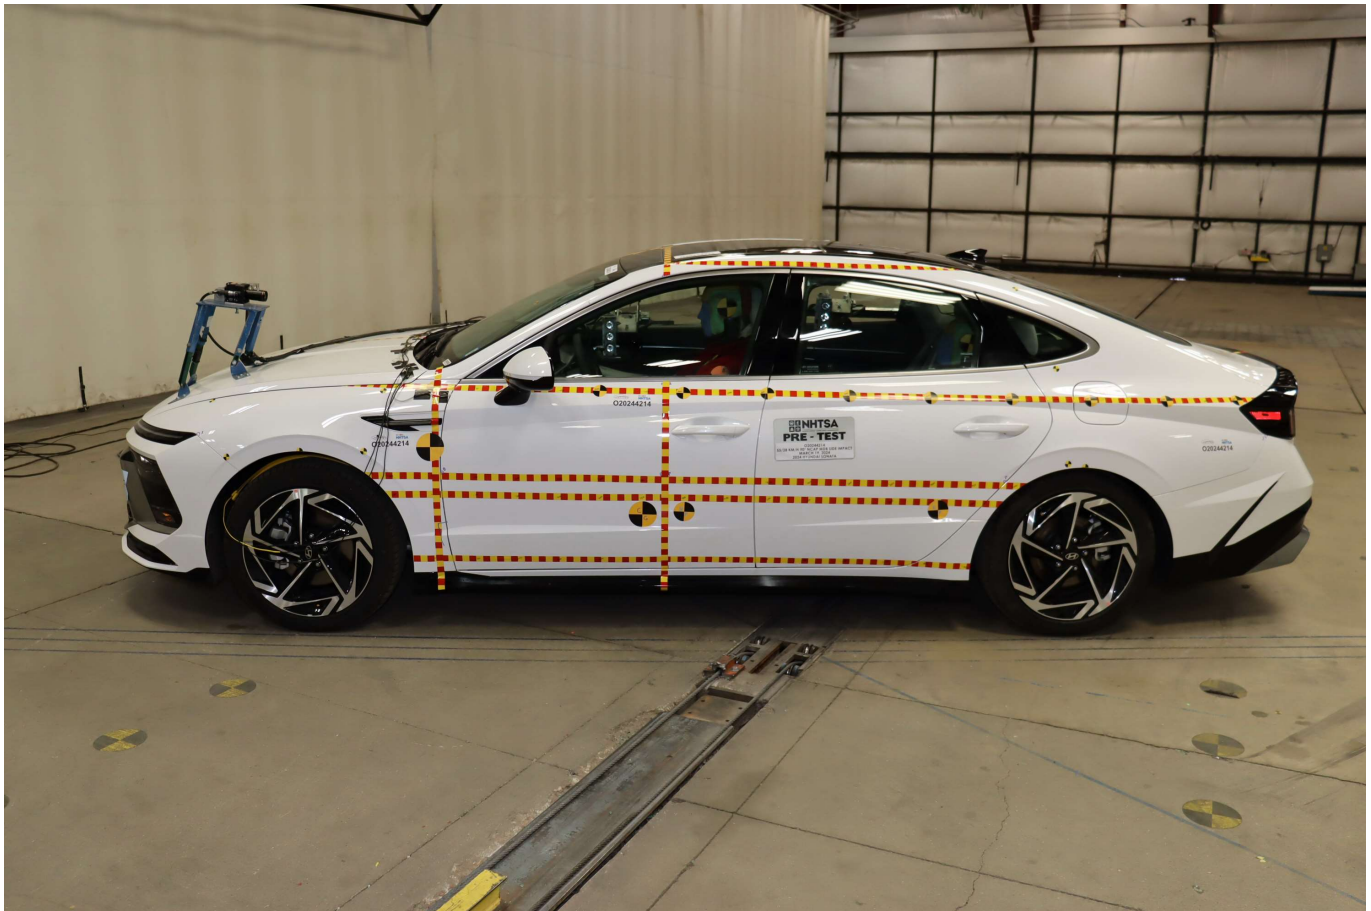
Photo No. 007 - Pre-Test Left Side View of Test Vehicle

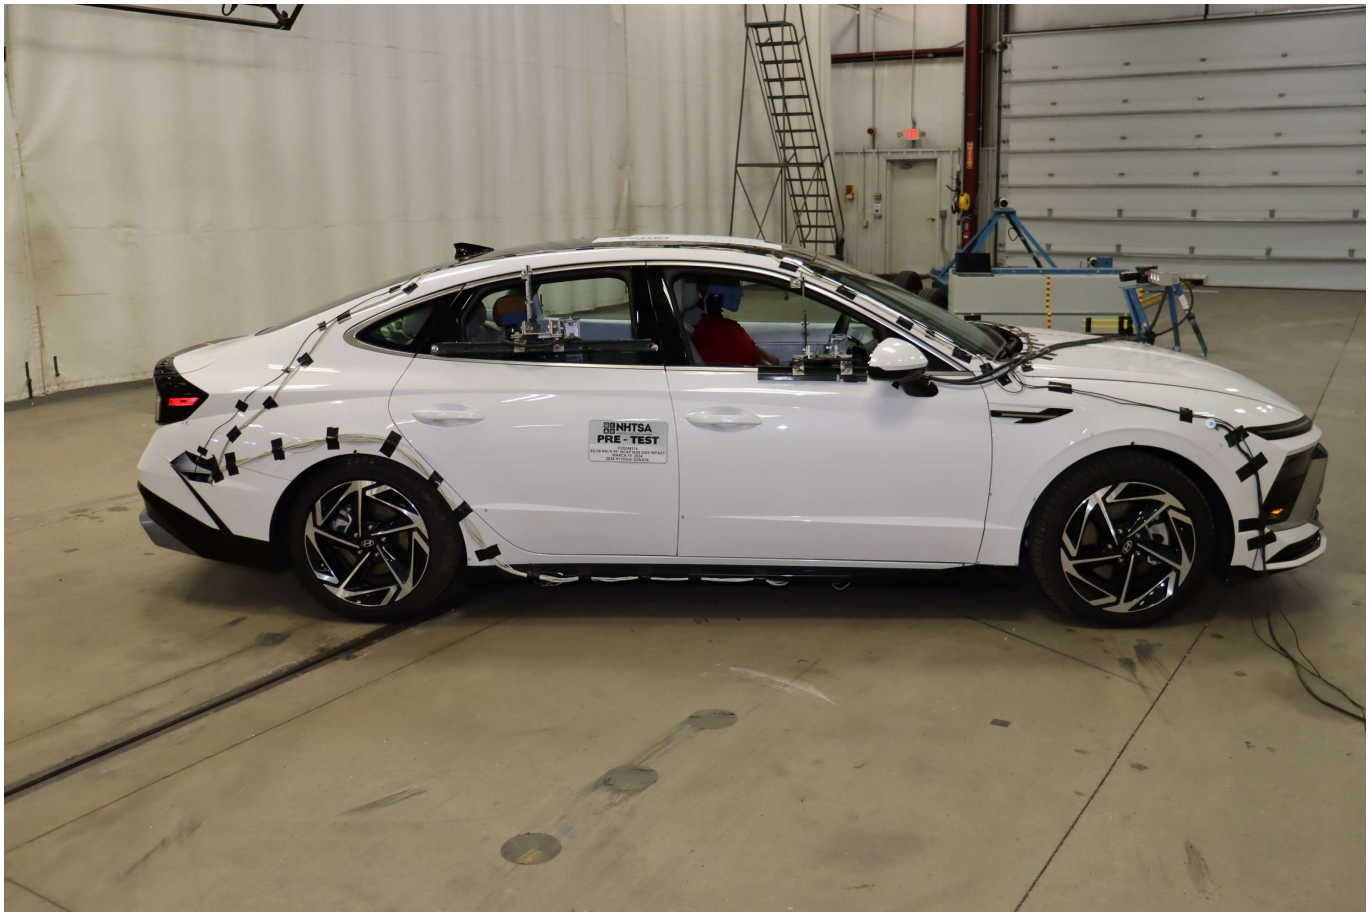
Photo No. 013 - Pre-Test Right Side View of Test Vehicle

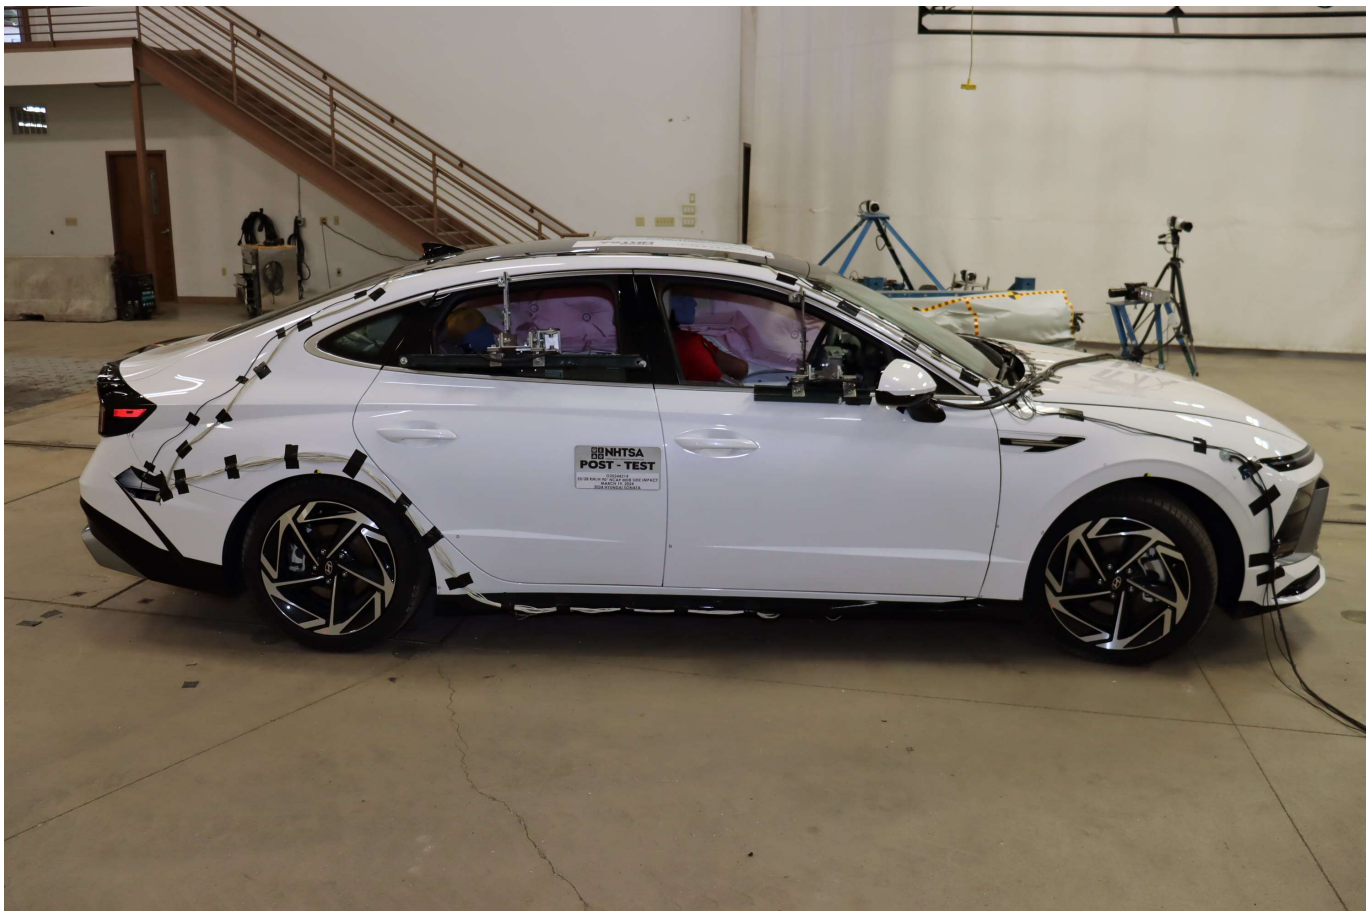
Photo No. 014 - Post-Test Right Side View of Test Vehicle

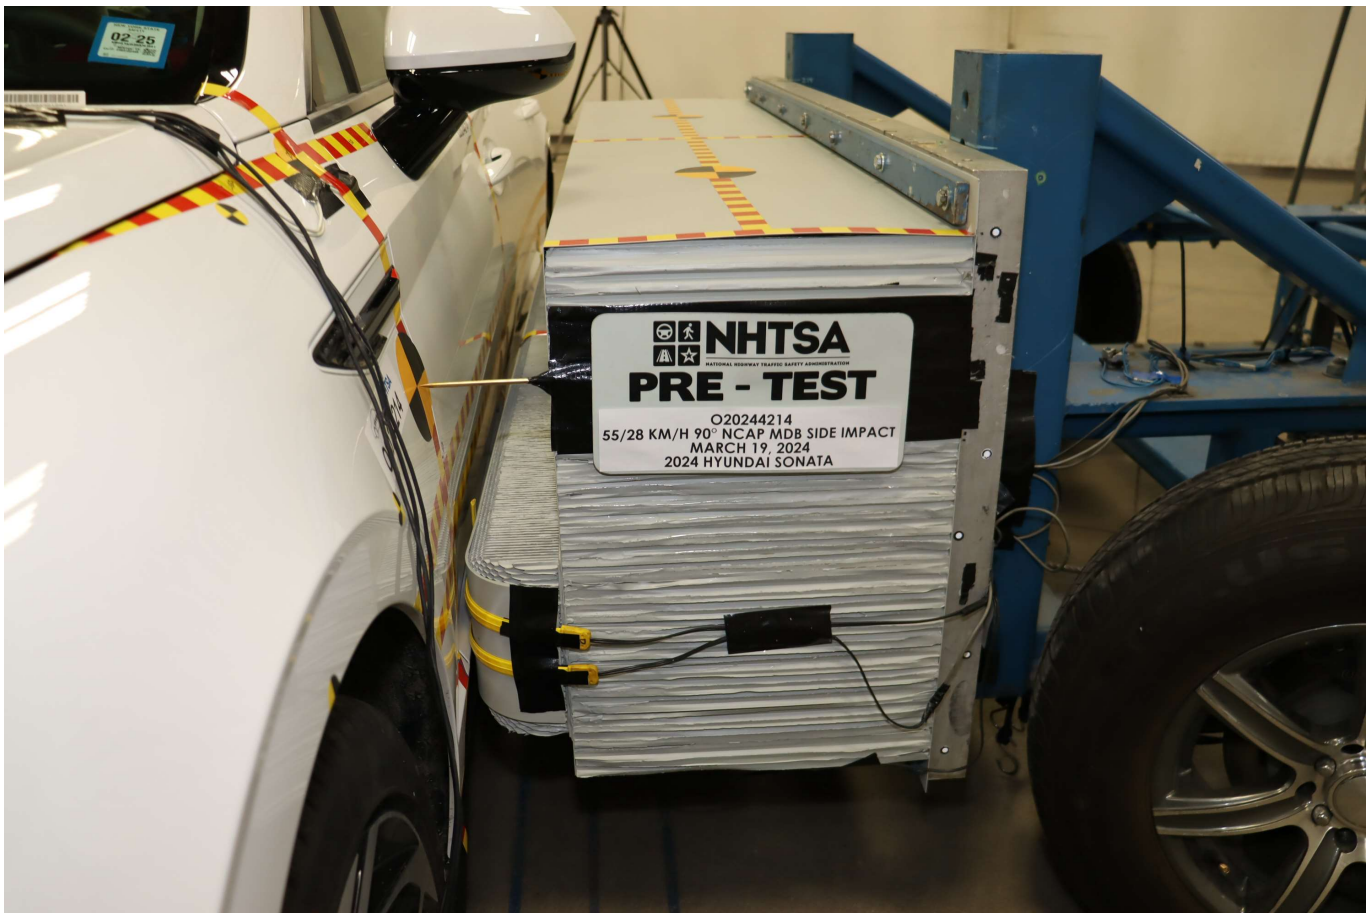
Photo No. 017 - Pre-Test Left Side View of MDB Positioned Against Side of Test Vehicle

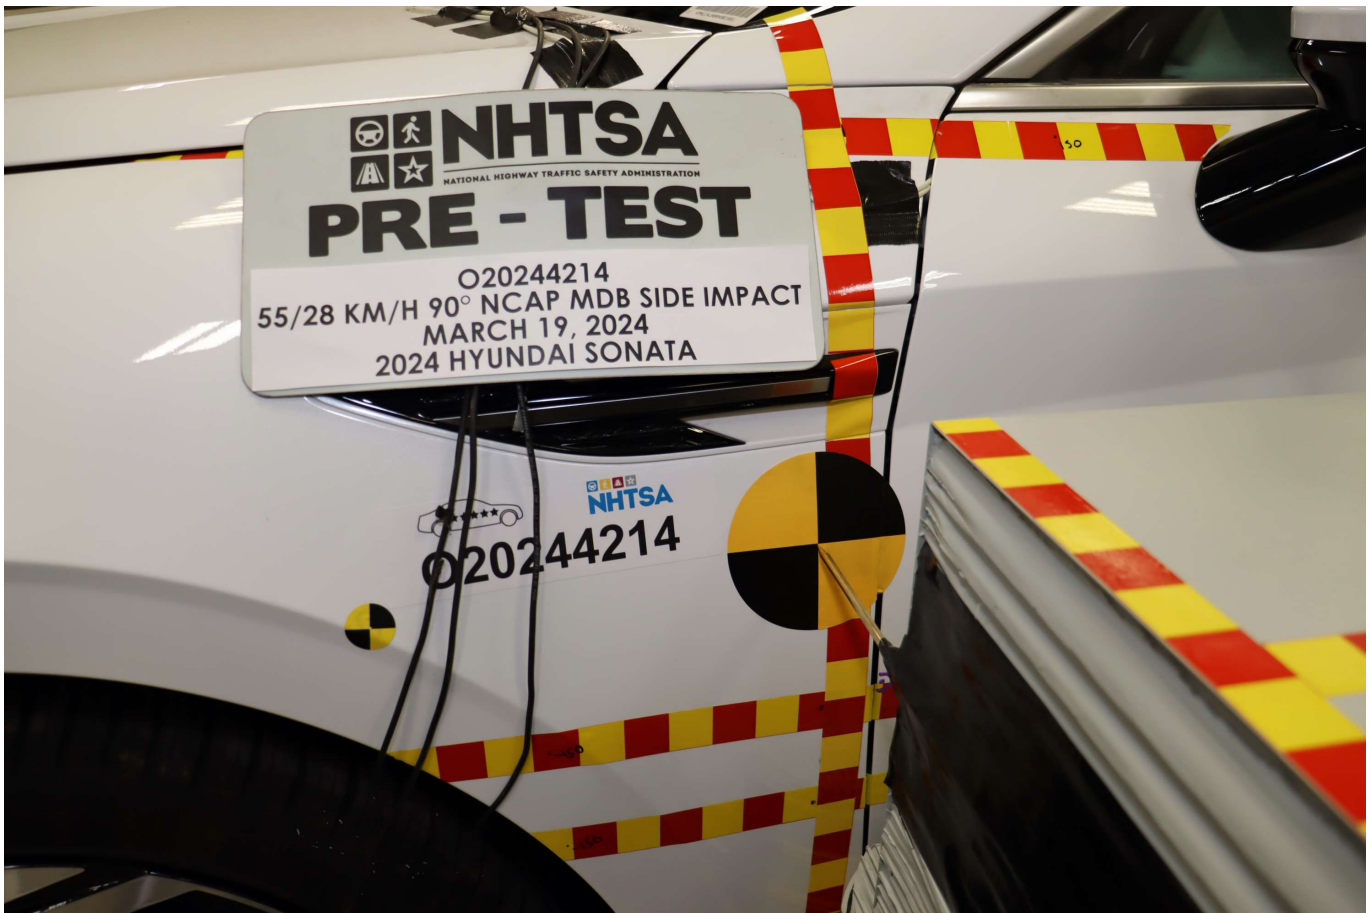
Photo No. 019 - Pre-Test Close-Up View of Impact Point Target

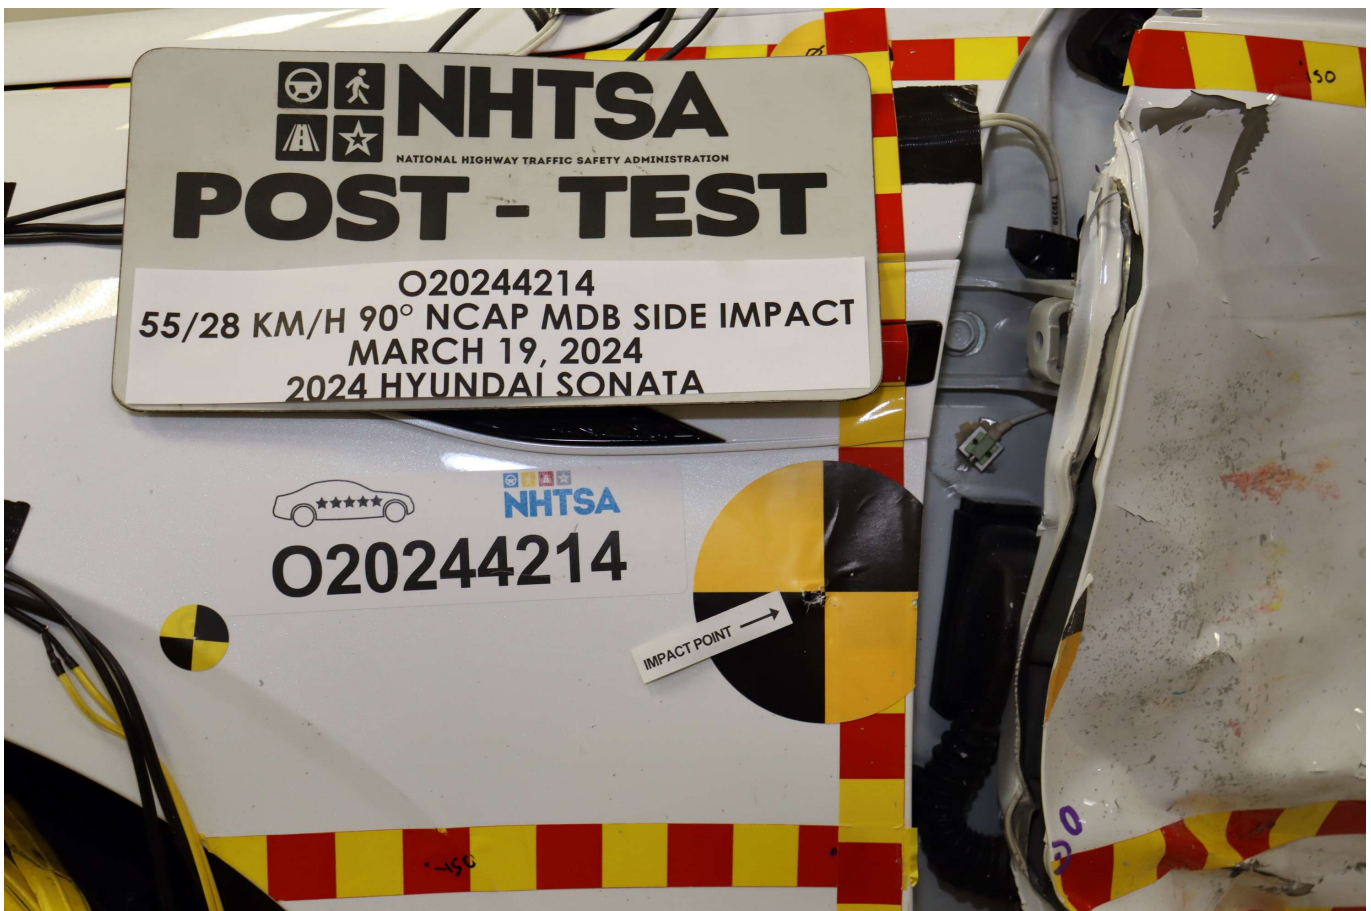
Photo No. 020 - Post-Test Close-Up View of Impact Point Target

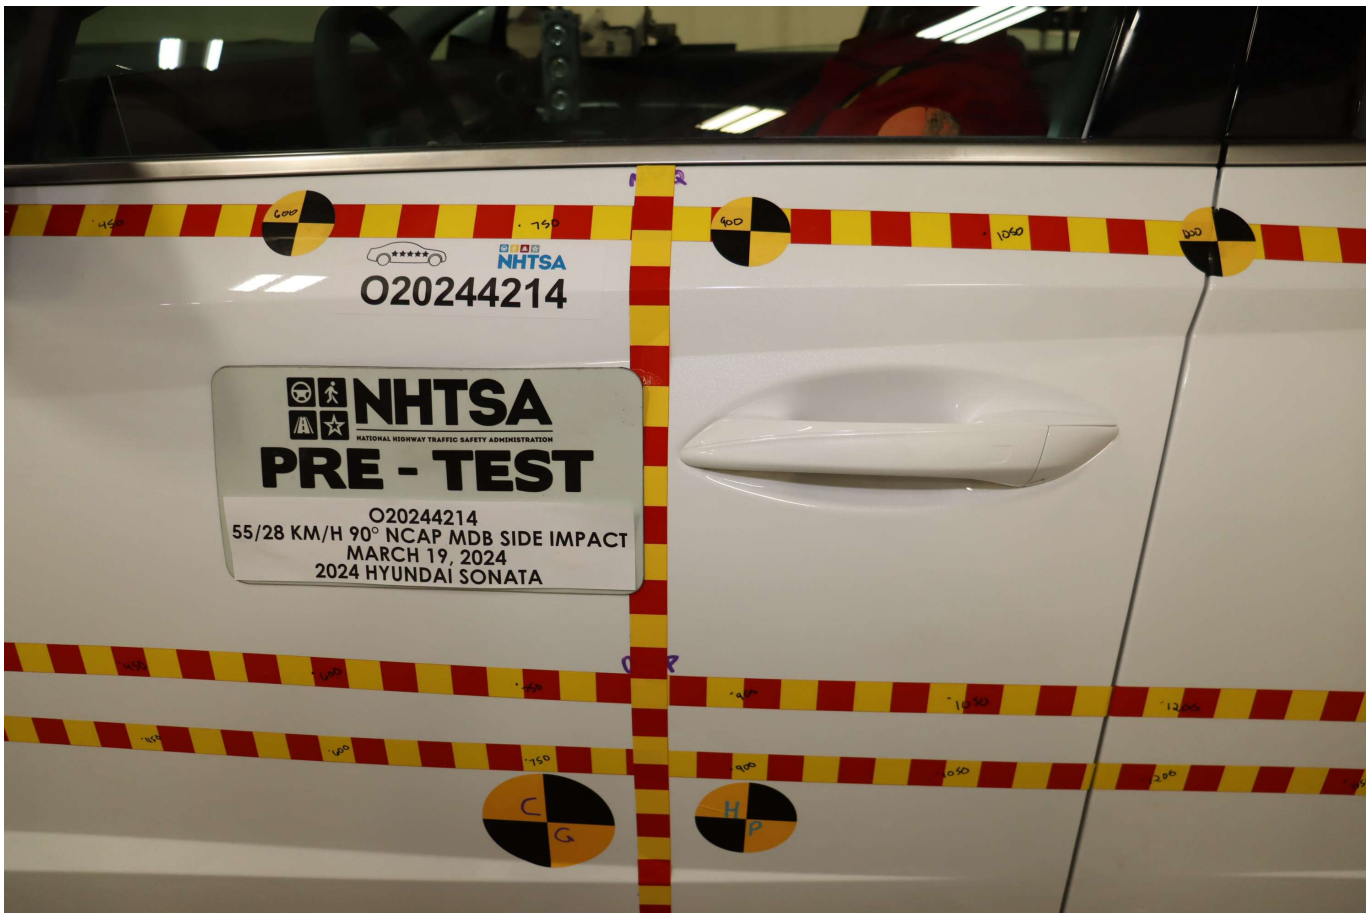
Photo No. 021 - Pre-Test Left Front Door Latch Close-Up

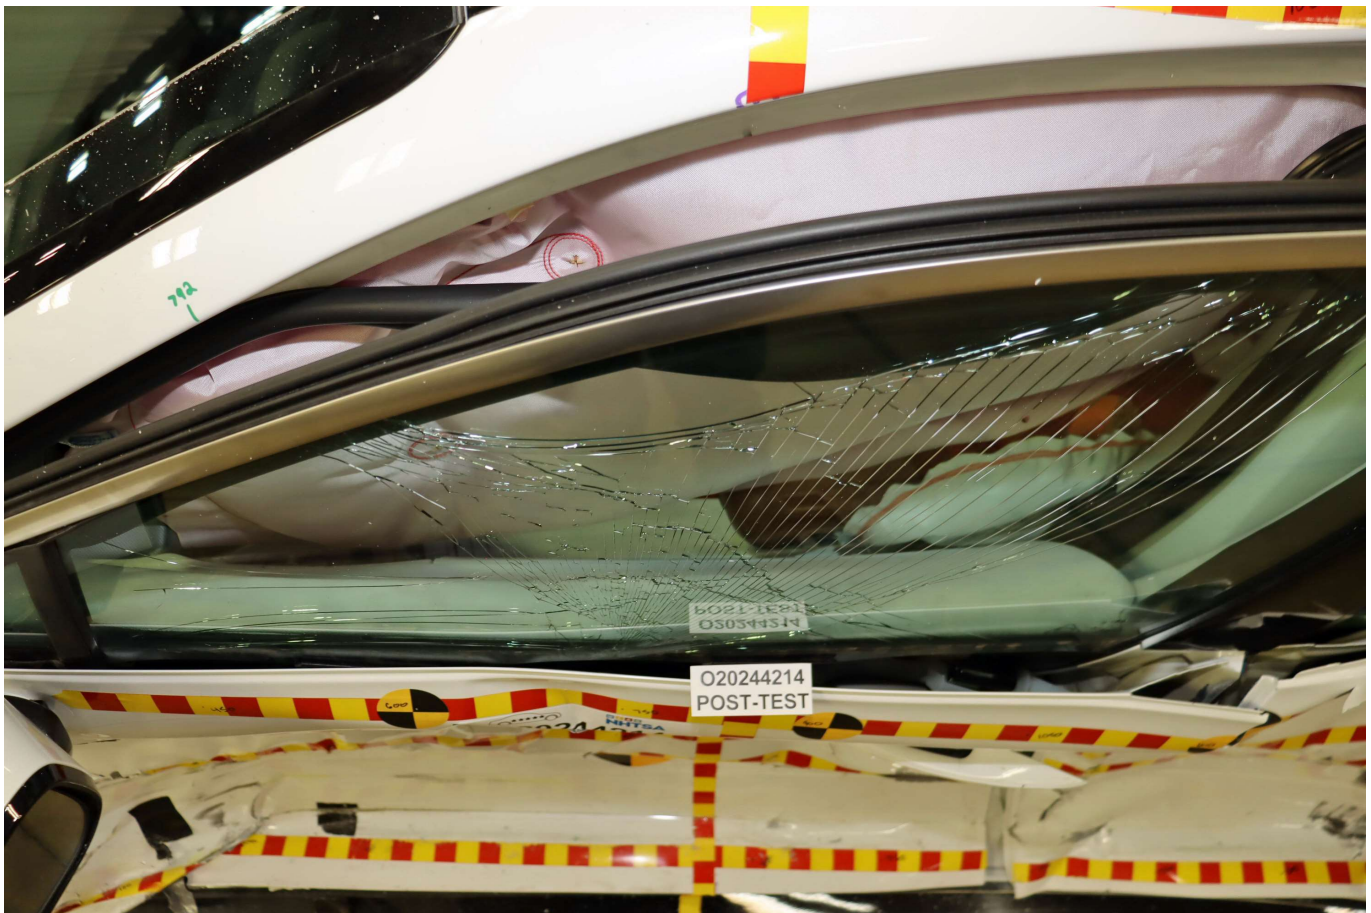
Photo No. 043 - Post-Test Driver Dummy and Door Clearance View

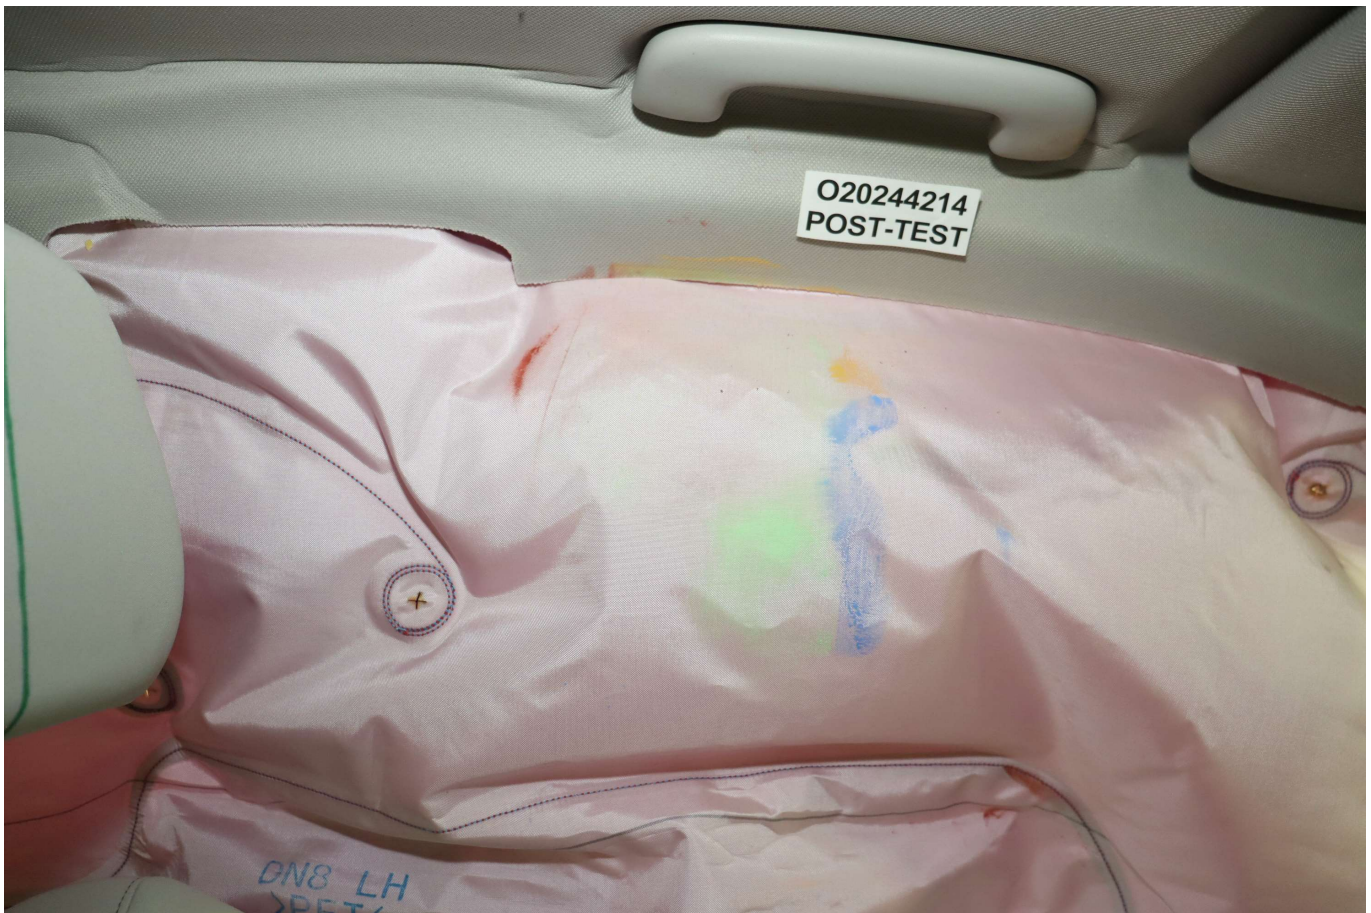
Photo No. 049 - Post-Test Driver Dummy Close-Up Head Contact with Side Airbag View

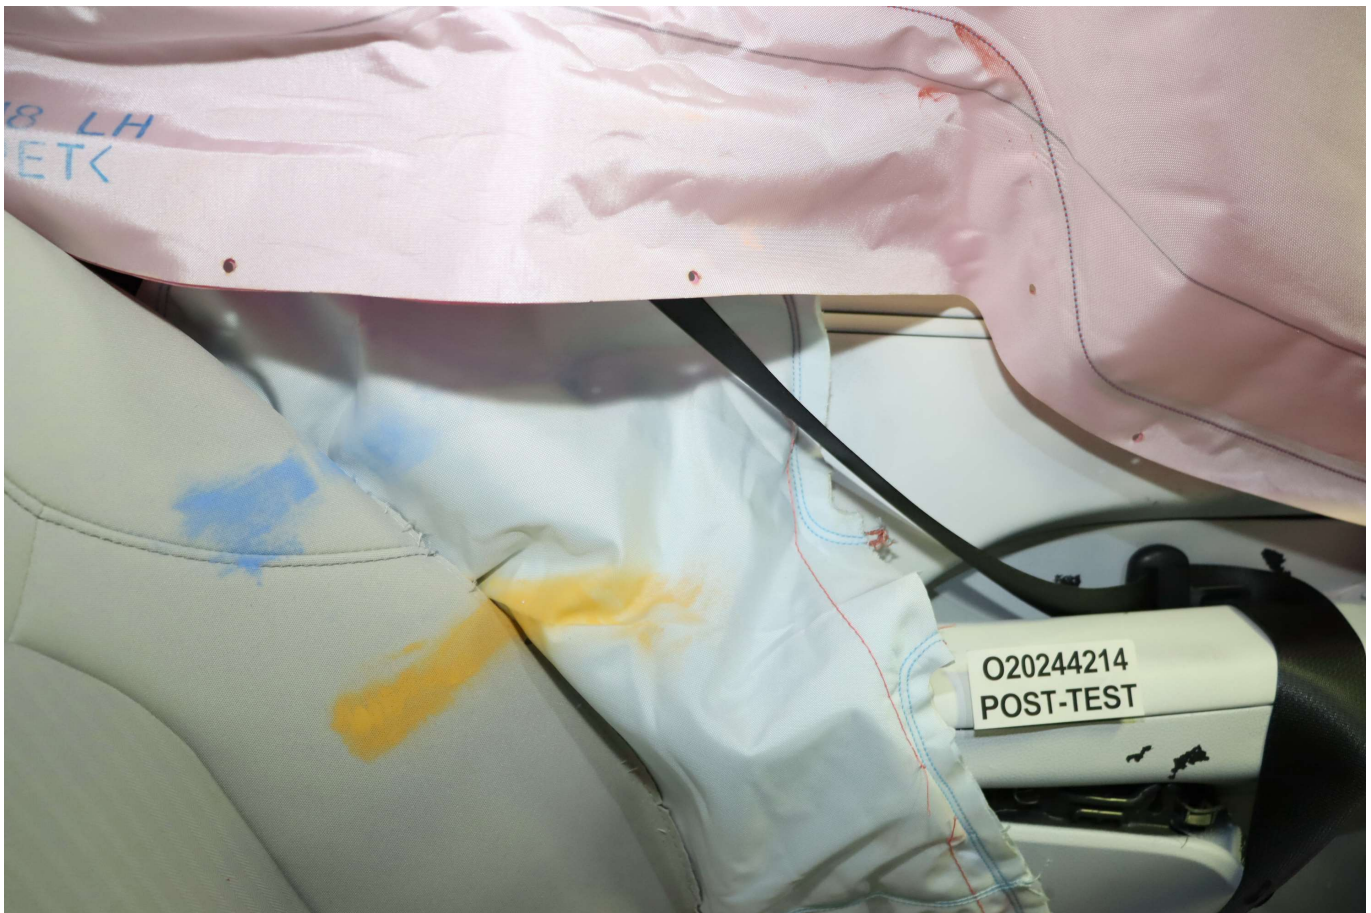
Photo No. 051 - Post-Test Driver Dummy Close-Up Torso Contact with Side Airbag View

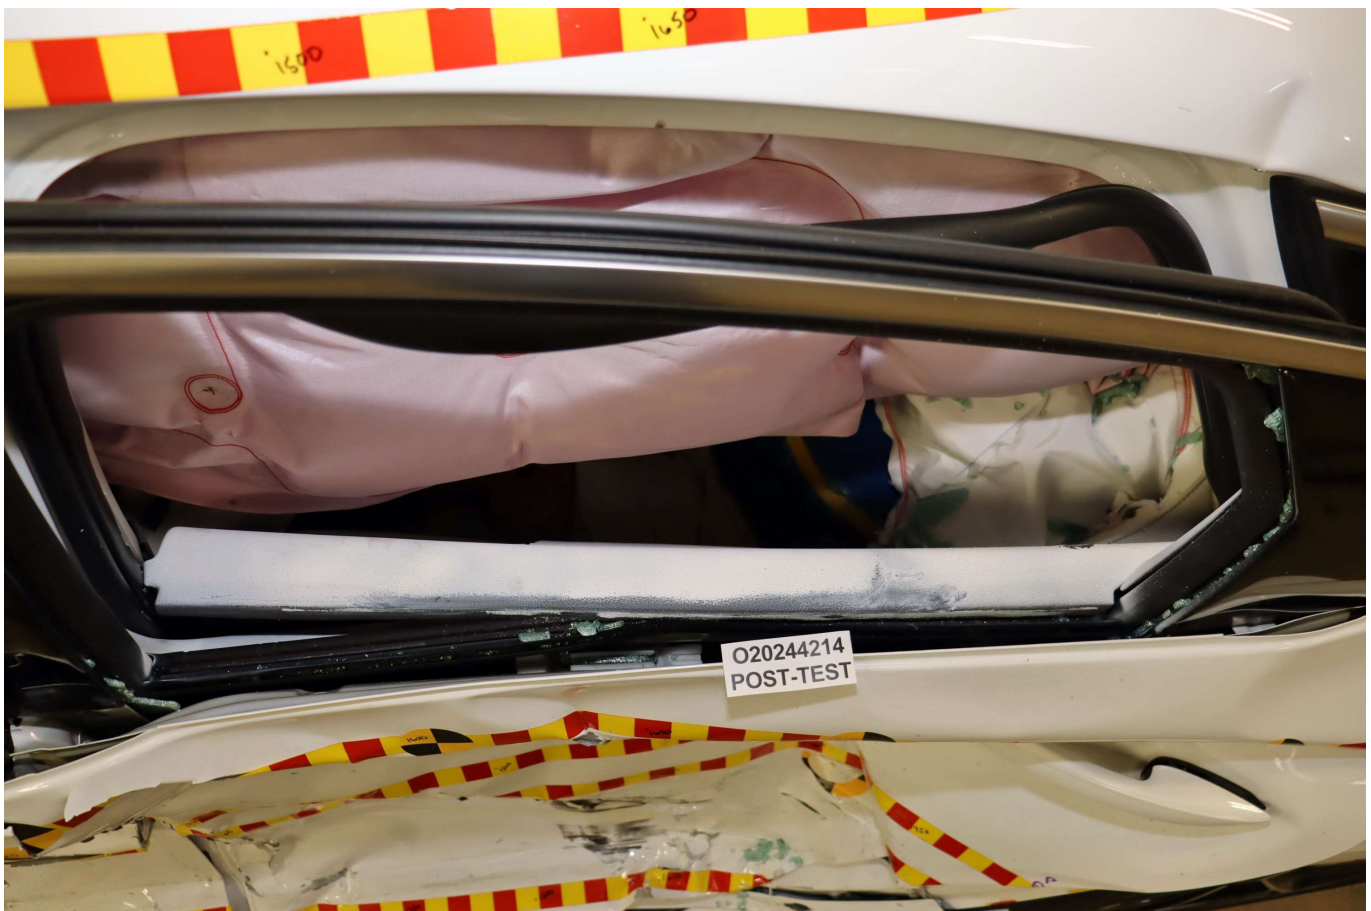
Photo No. 070 - Post-Test Rear Passenger Dummy and Door Clearance View

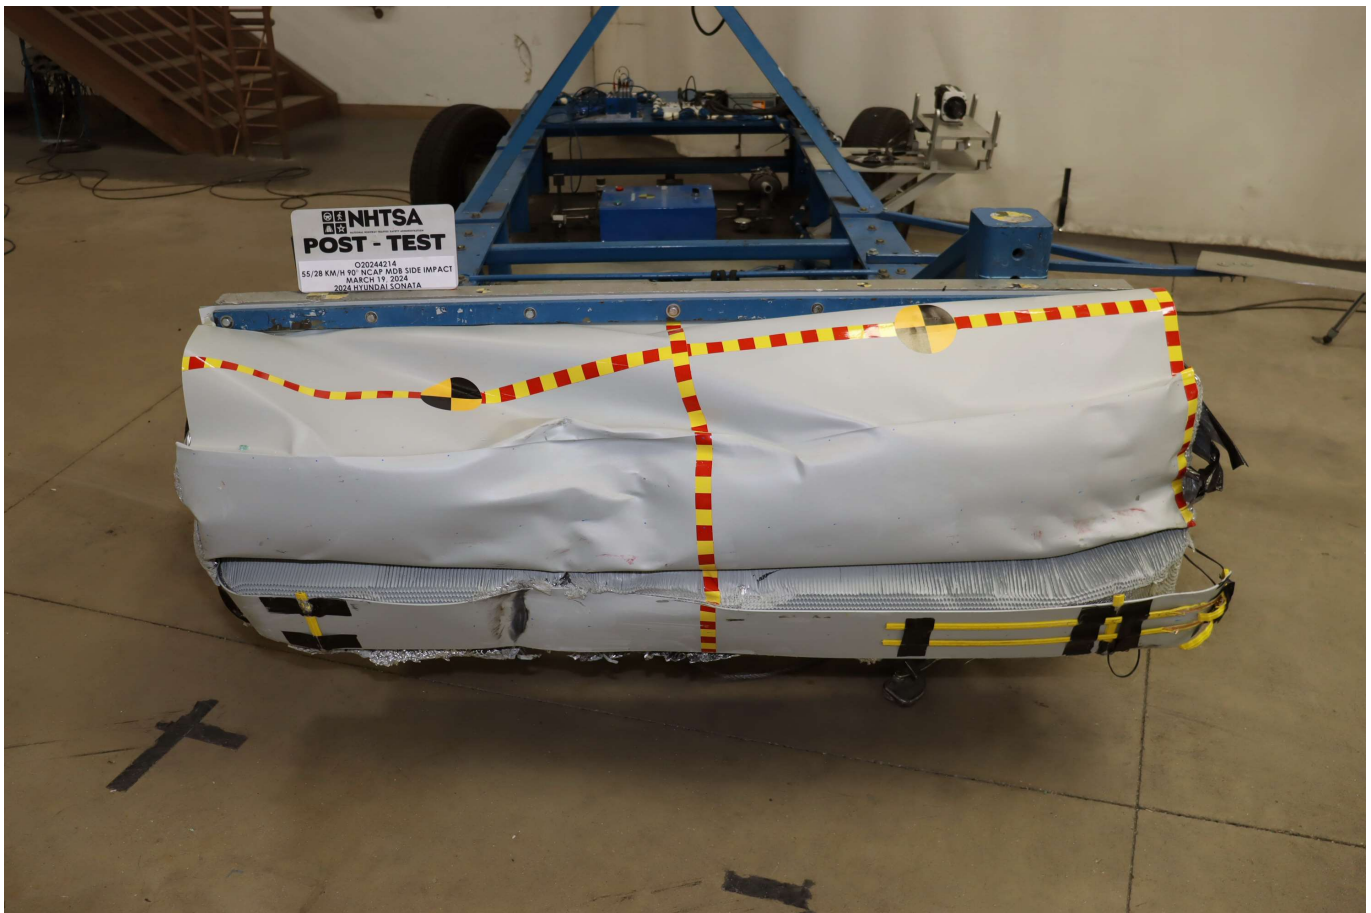
Photo No. 085 - Post-Test Front View of MDB Impactor Face

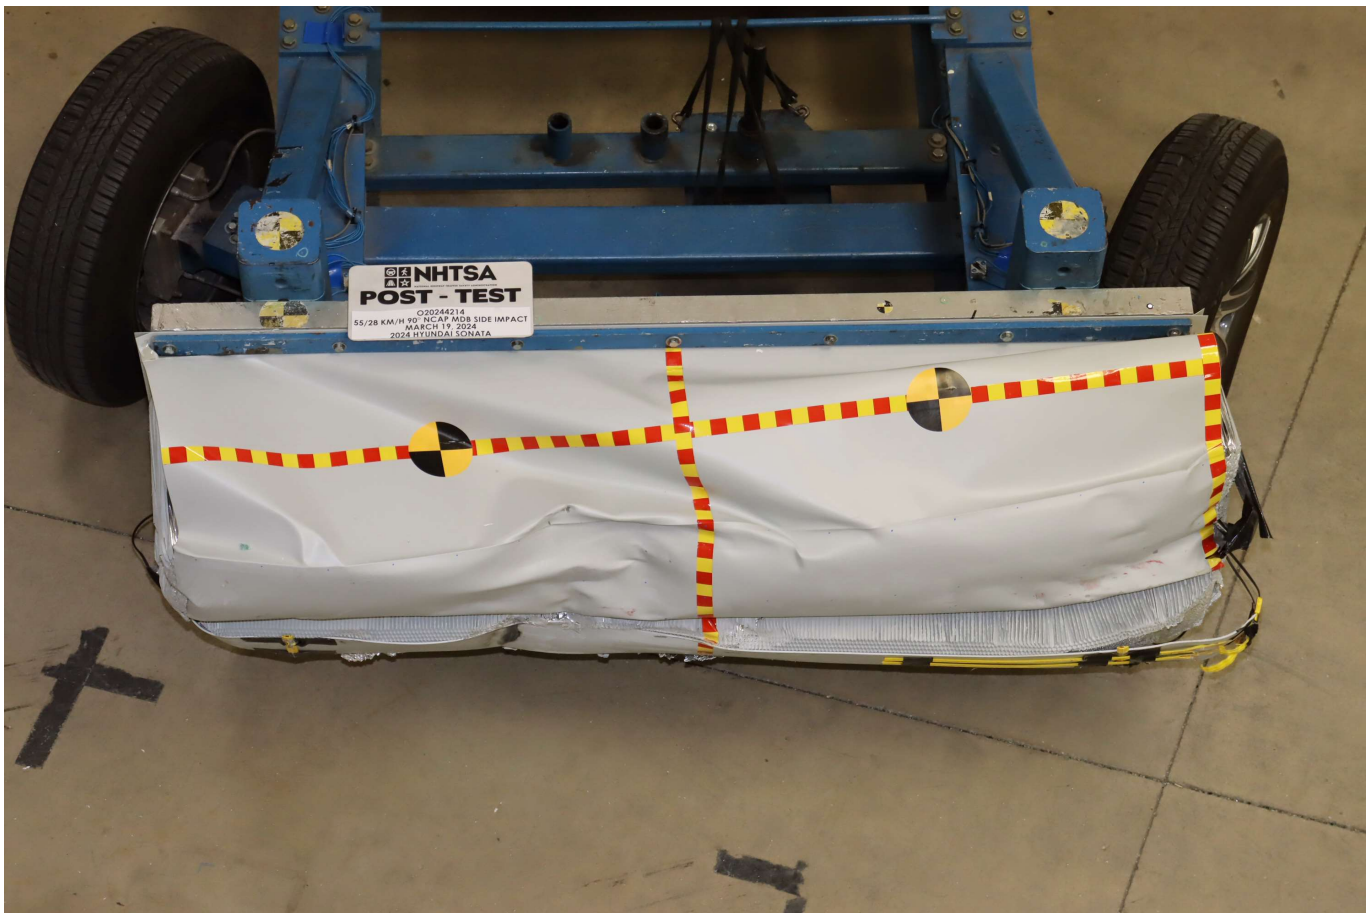
Photo No. 087 - Post-Test Top View of MDB Impactor Face

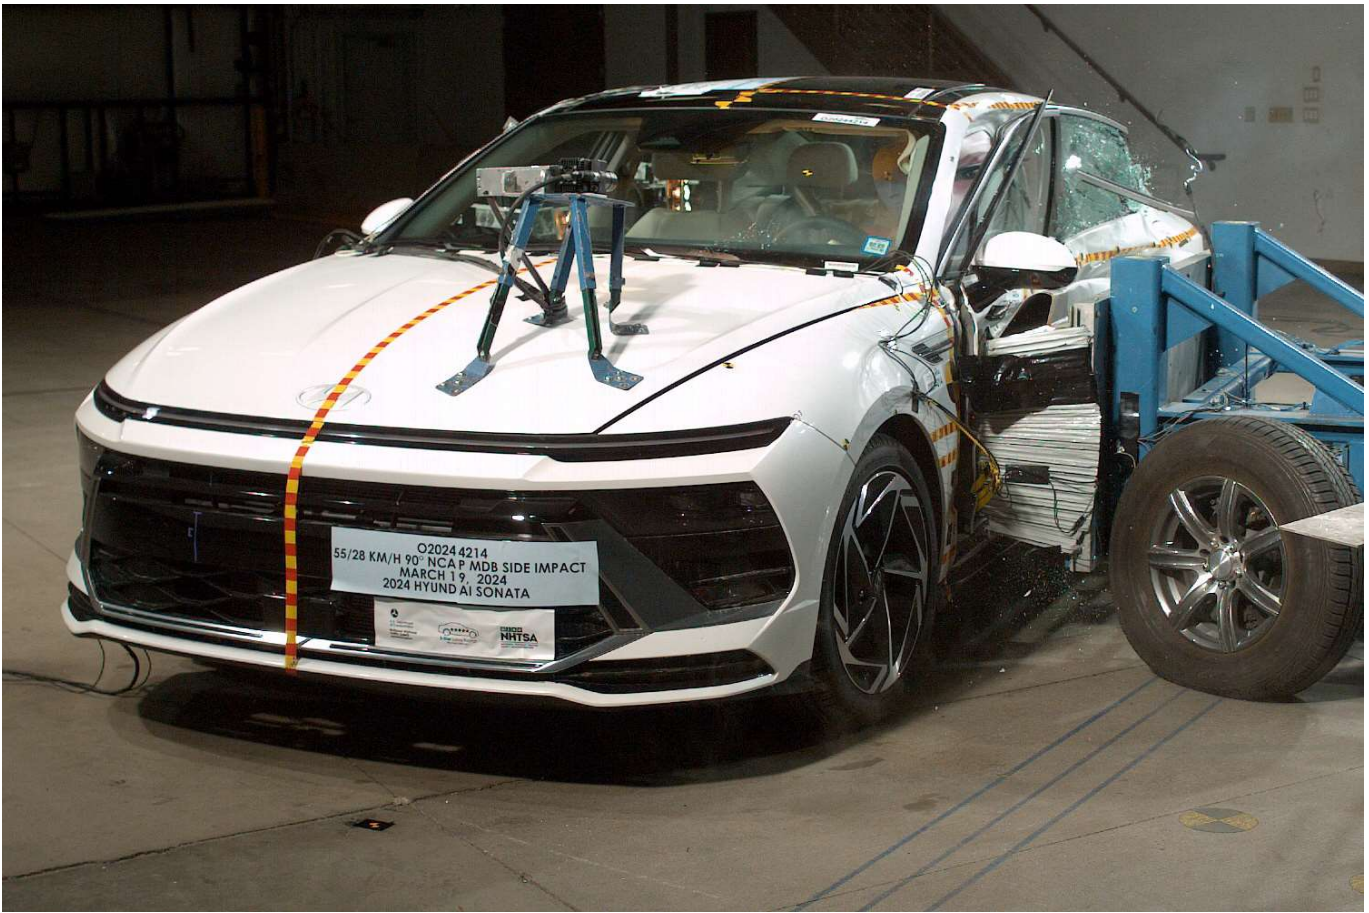
Photo No. 101 - Impact Event
