**REPORT NUMBER: SPNCAP-CAL-24-002**

**NEW CAR ASSESSMENT PROGRAM (NCAP)  
SIDE IMPACT POLE TEST**

**Hyundai Motor Company  
2024 Hyundai Kona  
5 Door SUV**

**FINAL REPORT**

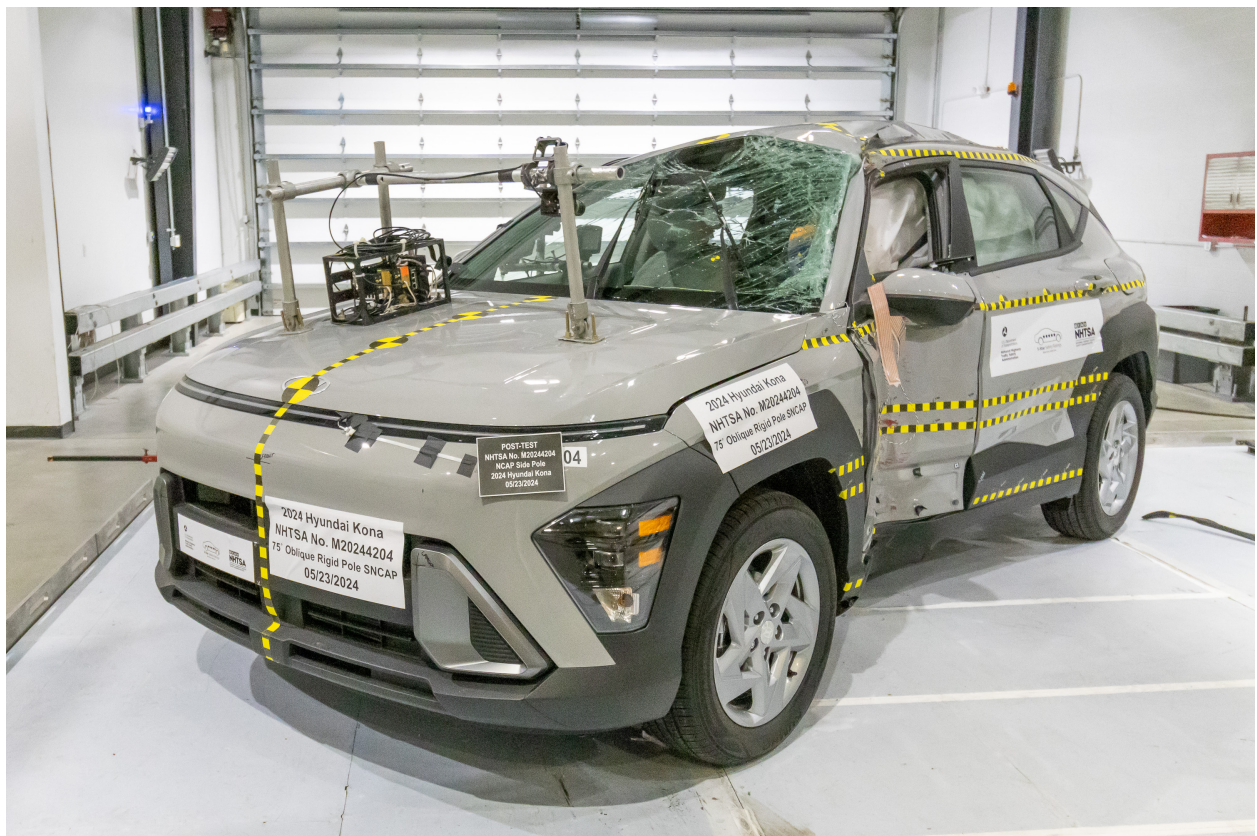
**Figure A-6: Post-Test Left Front  $\frac{3}{4}$  View of Test Vehicle**

| Critical Areas of Performance | Observations and Conclusions |
|---|---|
| Windshield Damage | Cracked throughout with some separation along top edge |

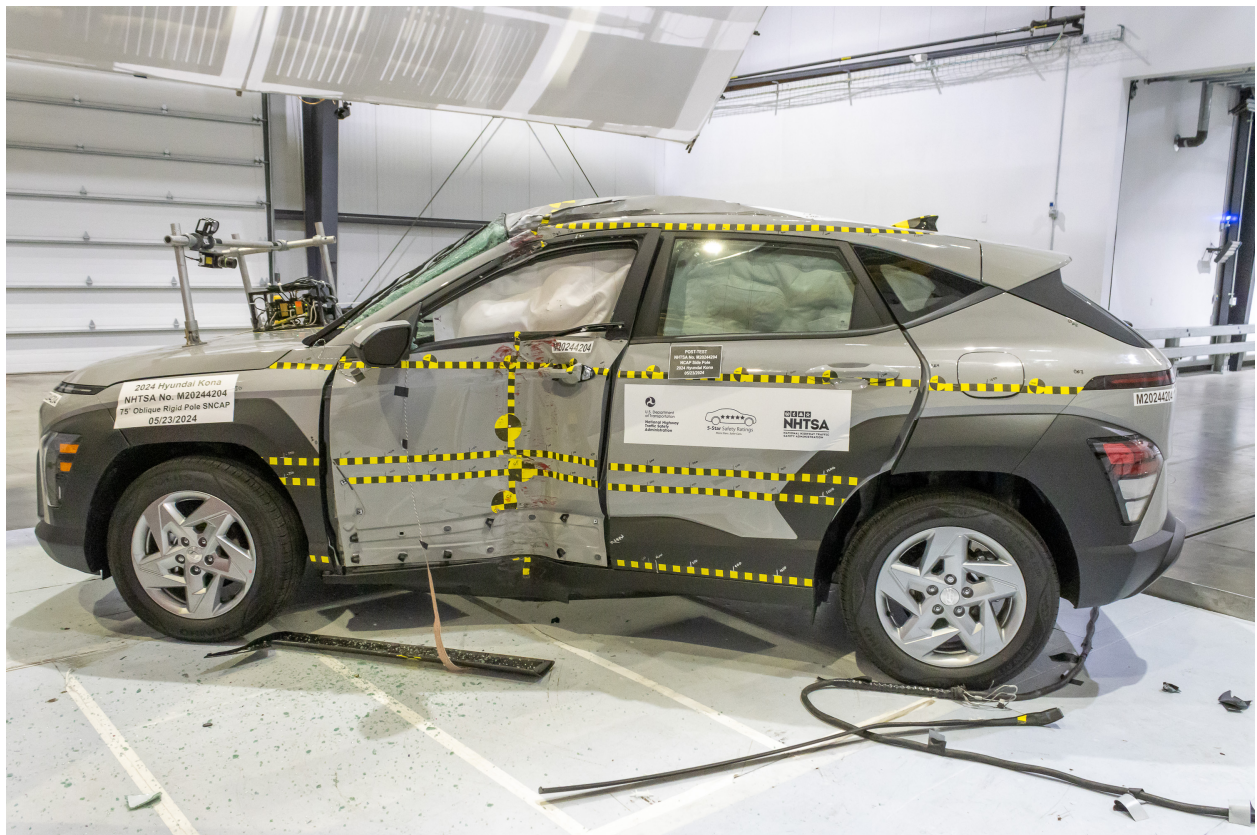
**Figure A-8: Post-Test Left Side View of Test Vehicle**

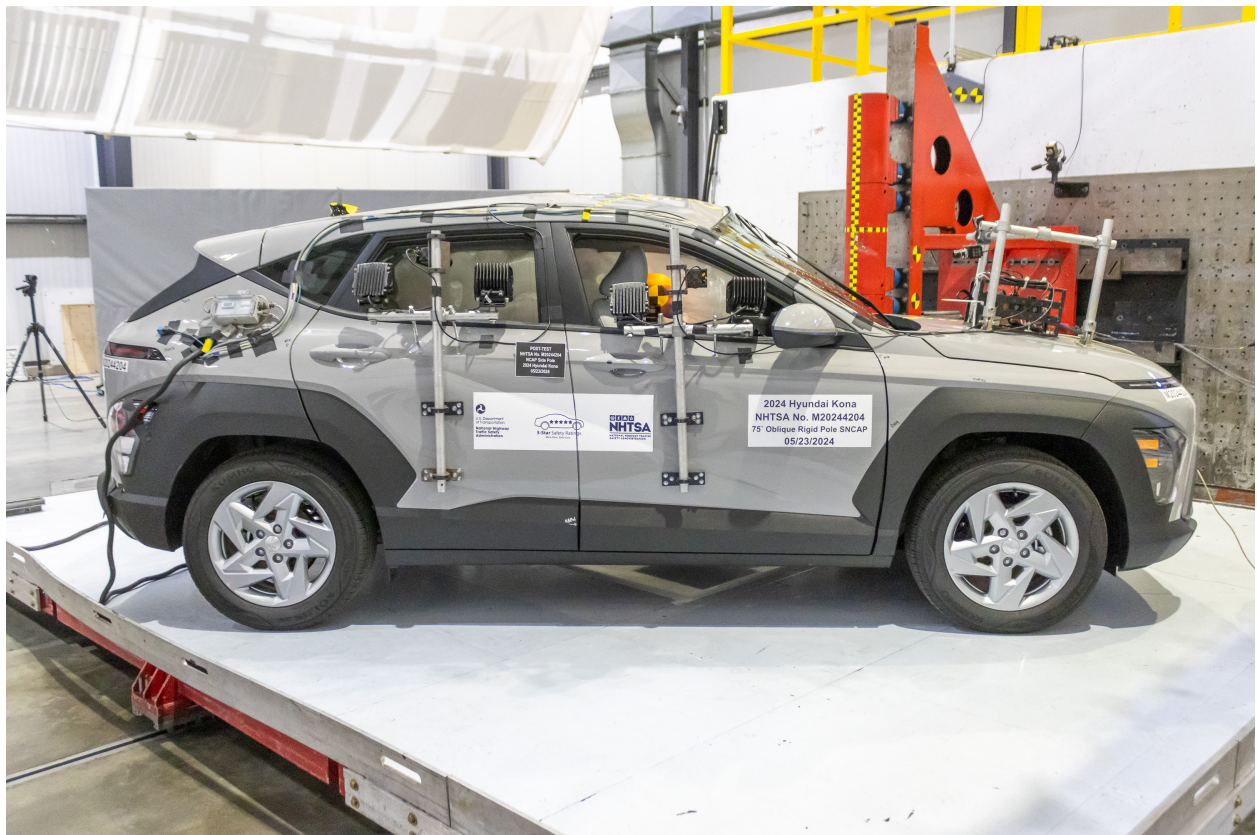
**Figure A-14: Post-Test Right Side View of Test Vehicle**

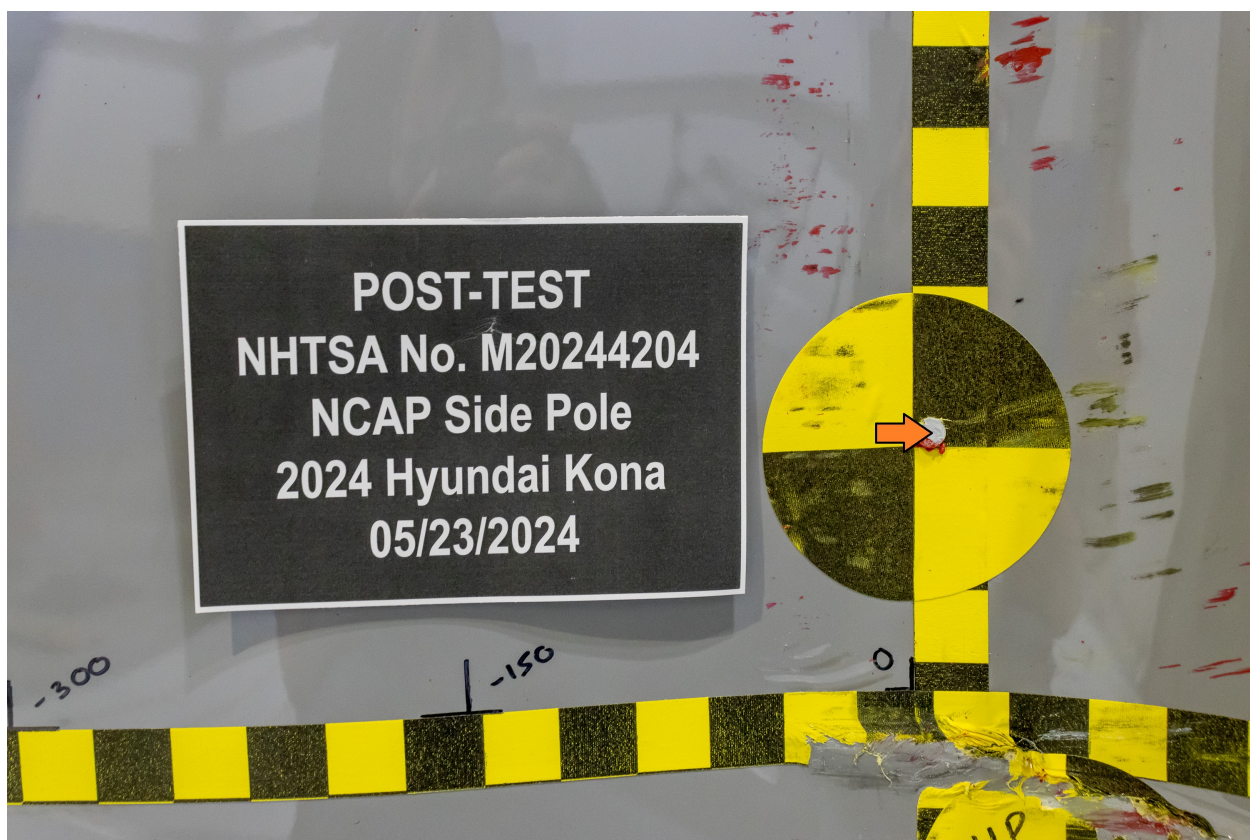
Figure A-20: Post-Test Close-Up View of Impact Point Target Showing Impact Location

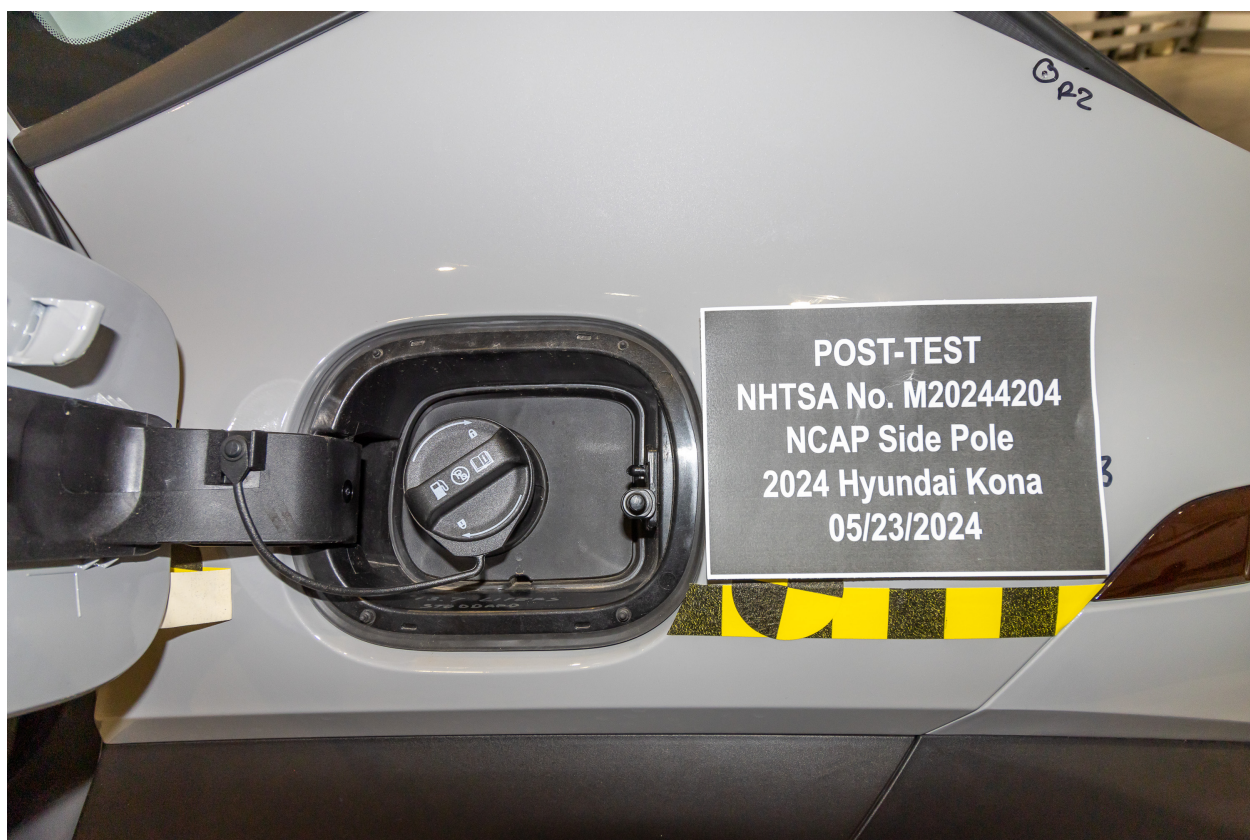
**Figure A-56: Post-Test View of Fuel Filler Cap or Fuel Filler Neck**

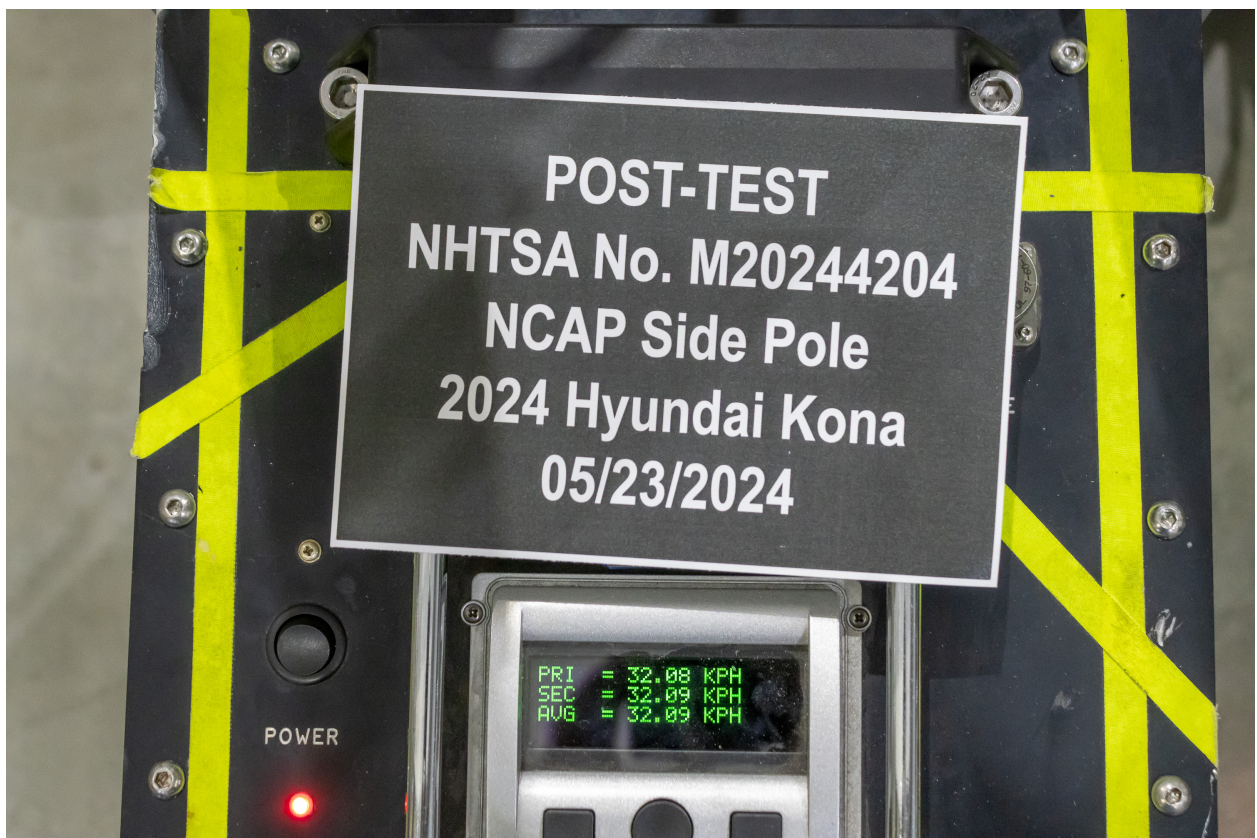
**Figure A-64: Post-Test Primary and Redundant Speed Trap Read-Out**
