**REPORT NUMBER: 214P-CAL-23-003**

**RESEARCH SIDE IMPACT POLE TEST**

**KIA Motors Mexico S.A DE C.V.  
2019 Hyundai Accent  
4 Door Sedan**

**FINAL REPORT**

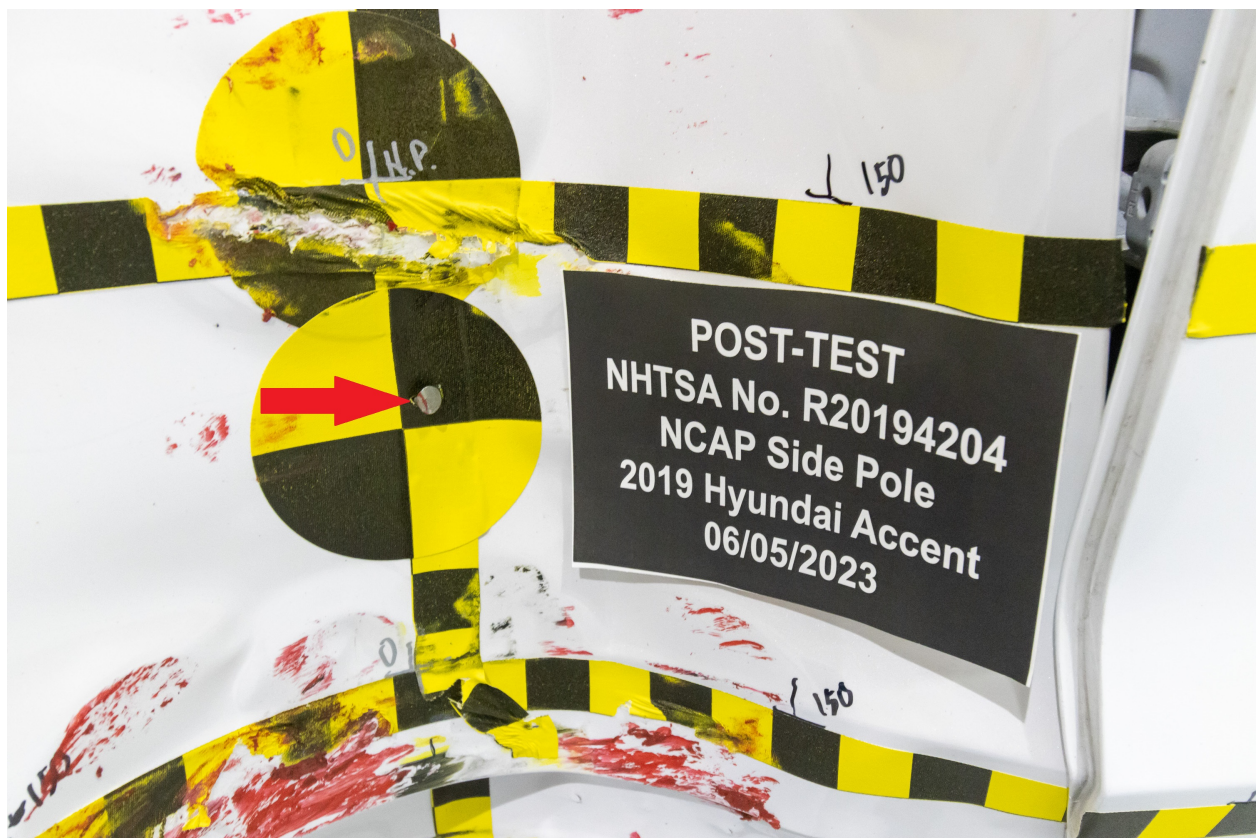
Figure A-20: Post-Test Close-Up View of Impact Point Target Showing Impact Location

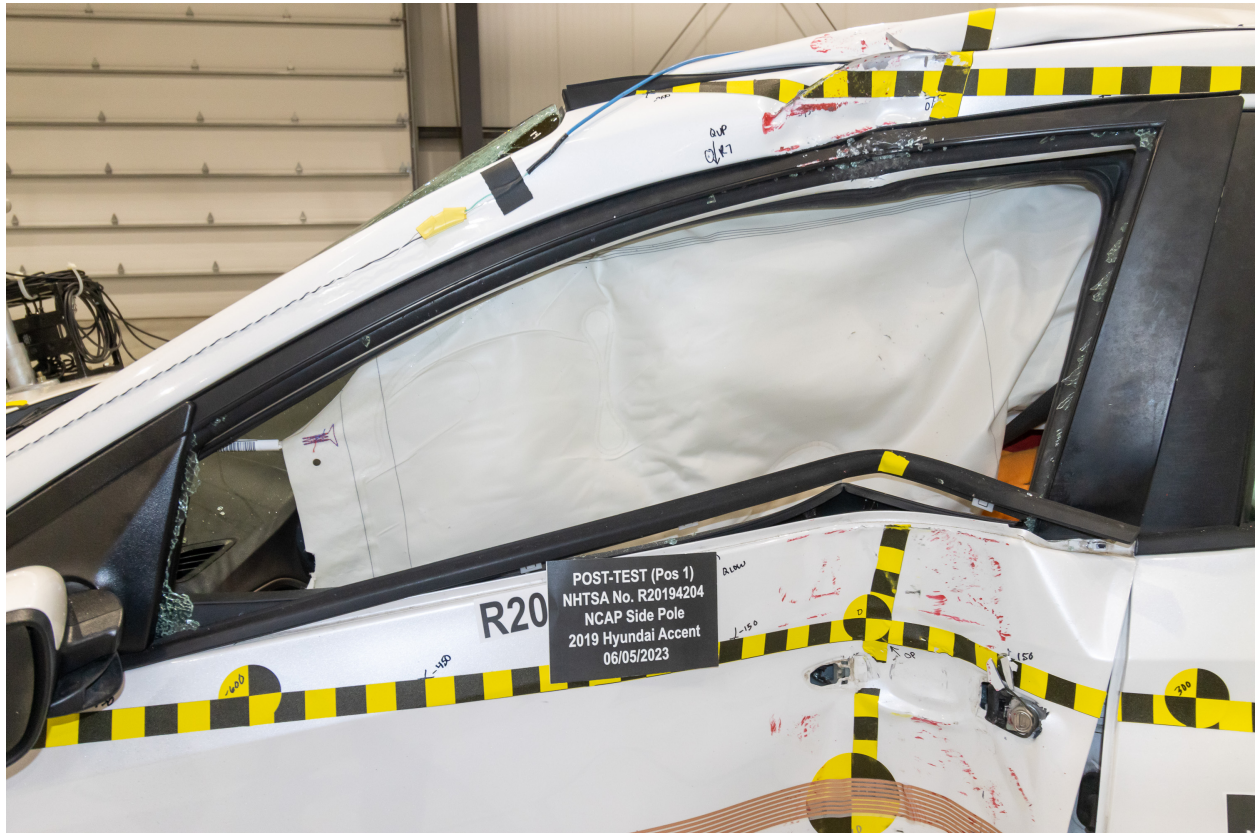
**Figure A-25: Post-Test Left Side View of Dummy Shoulder and Door Top View**

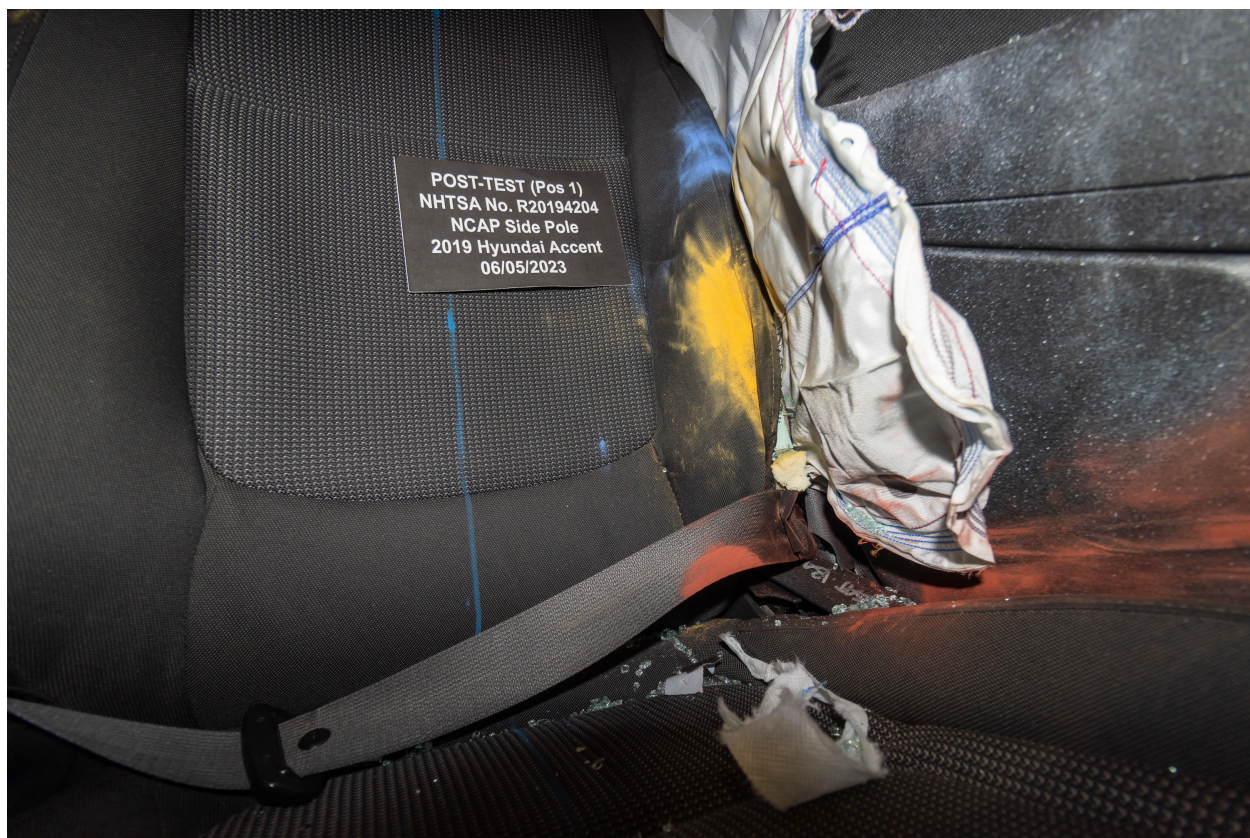
**Figure A-48: Post-Test Dummy Close-Up Torso Contact with Vehicle Interior View**

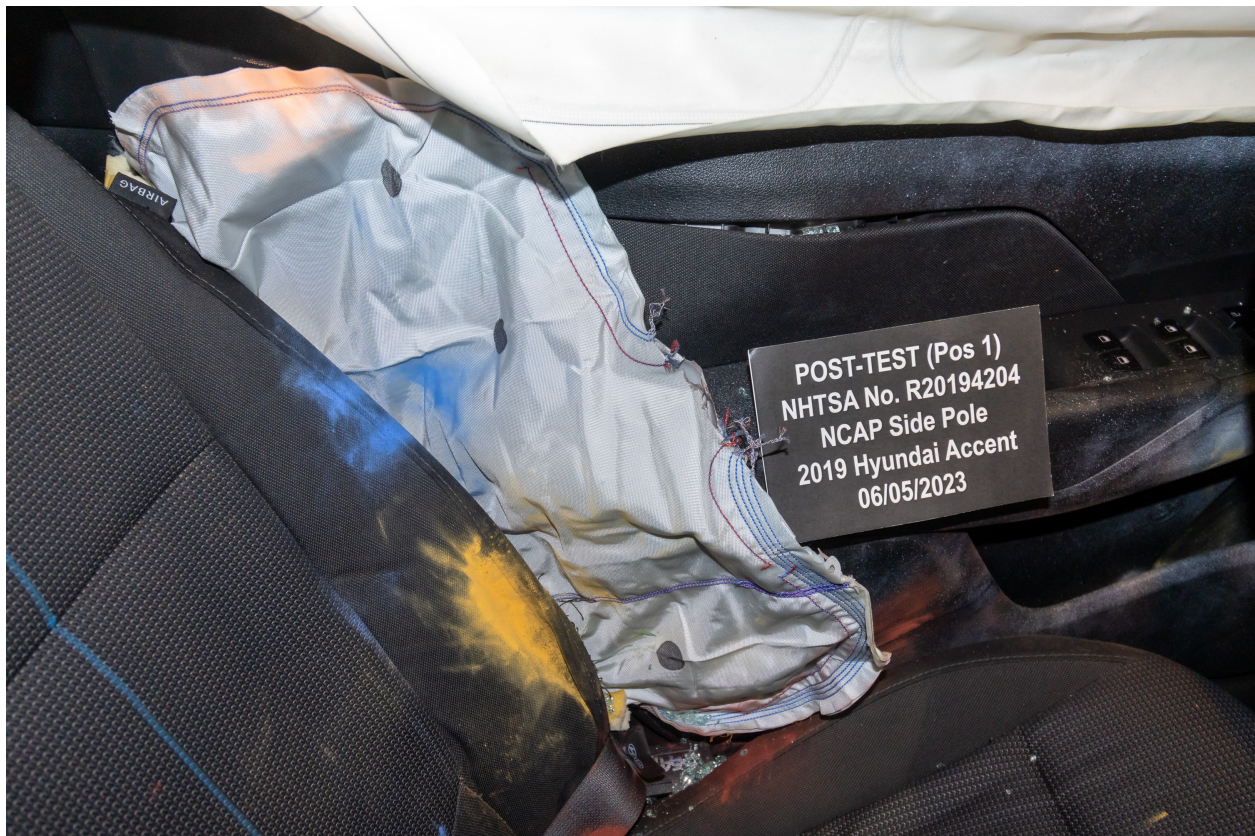
**Figure A-49: Post-Test Dummy Close-Up Torso Contact with Side Airbag View**

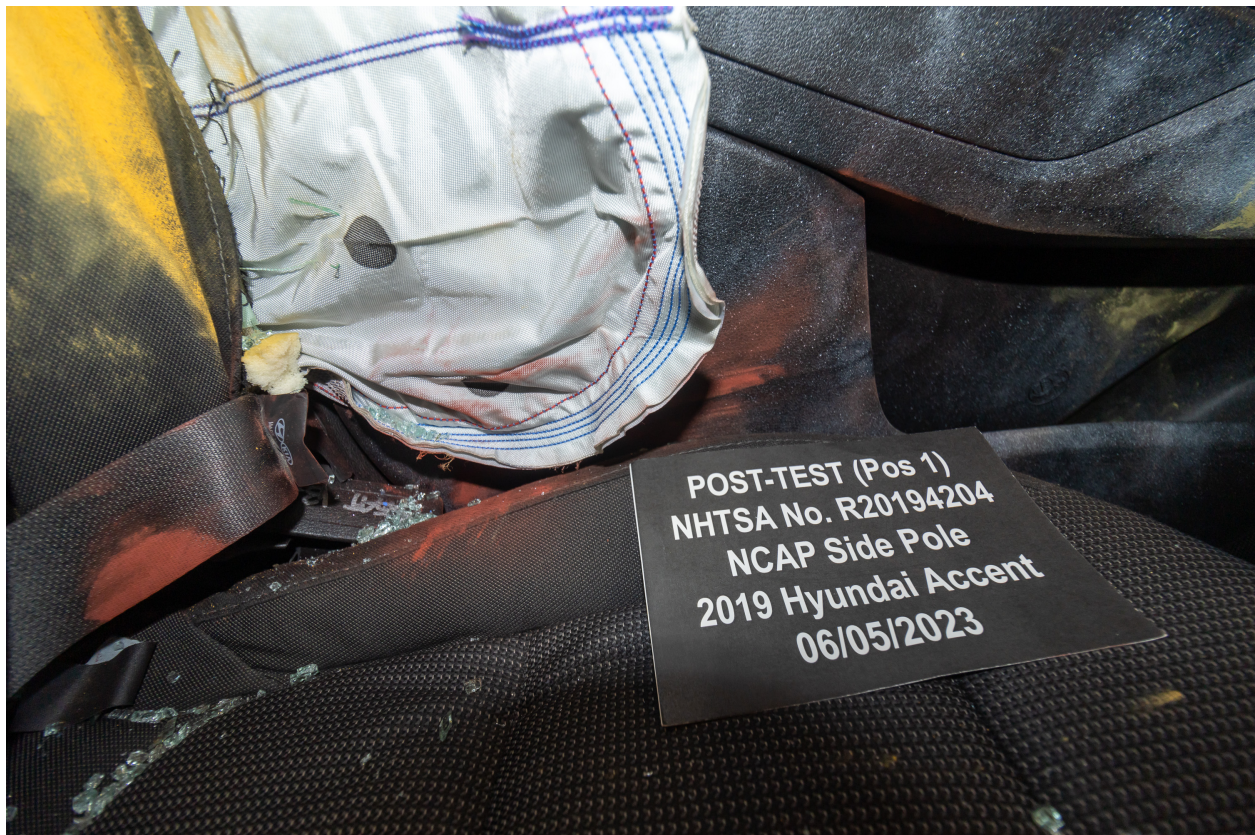
**Figure A-50: Post-Test Dummy Close-Up Pelvis Contact with Vehicle Interior View**

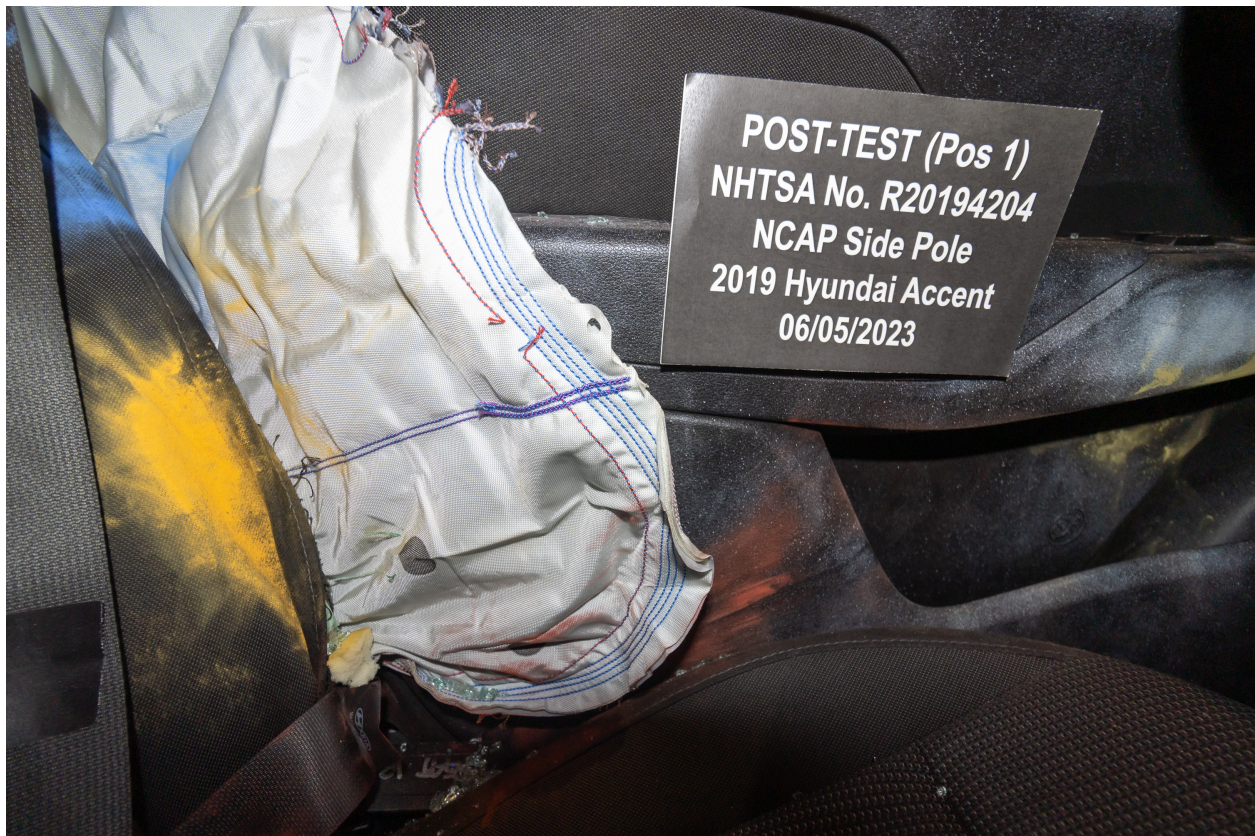
**Figure A-51: Post-Test Dummy Close-Up Pelvis Contact with Side Airbag View**

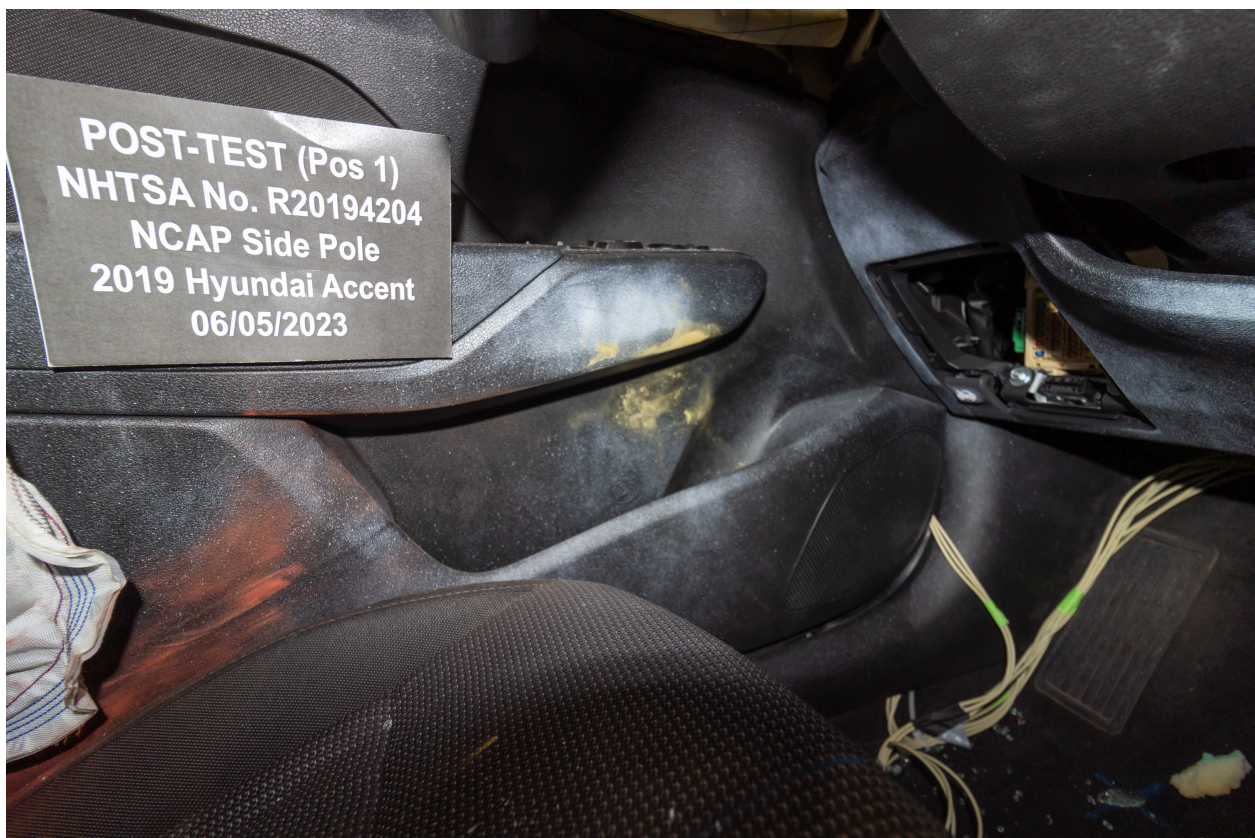
**Figure A-52: Post-Test Dummy Close-Up Knee Contact with Vehicle Interior View**

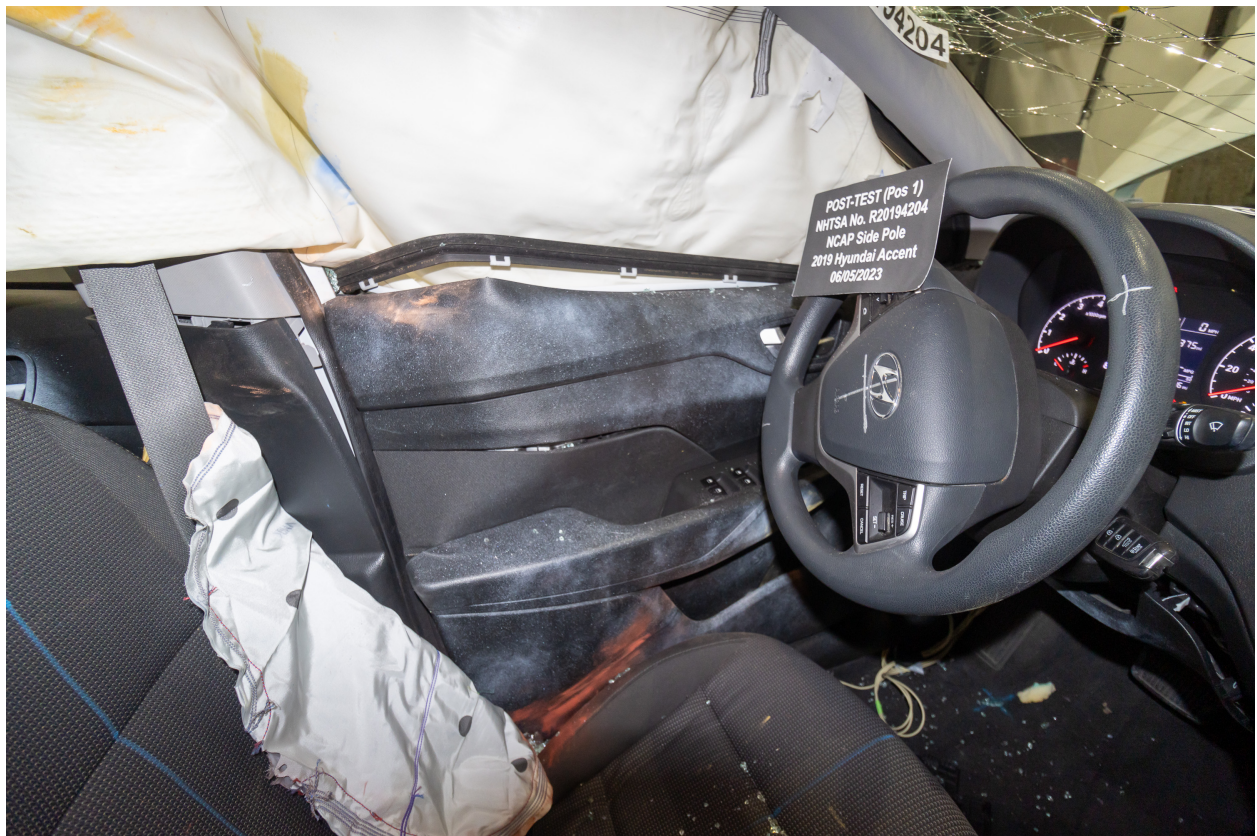
**Figure A-73: Post-Test View of Shattered Vehicle Inner Door Panel**

| Critical Areas of Performance | Observations and Conclusions |
|---|---|
| Side Window Damage | Driver window shattered during impact event |
