**REPORT NUMBER: 214P-CAL-23-004**

**RESEARCH SIDE IMPACT POLE TEST**

**Toyota Motor Manufacturing , Texas, Inc.  
2019 Toyota Tacoma  
4 Door Truck**

**FINAL REPORT**

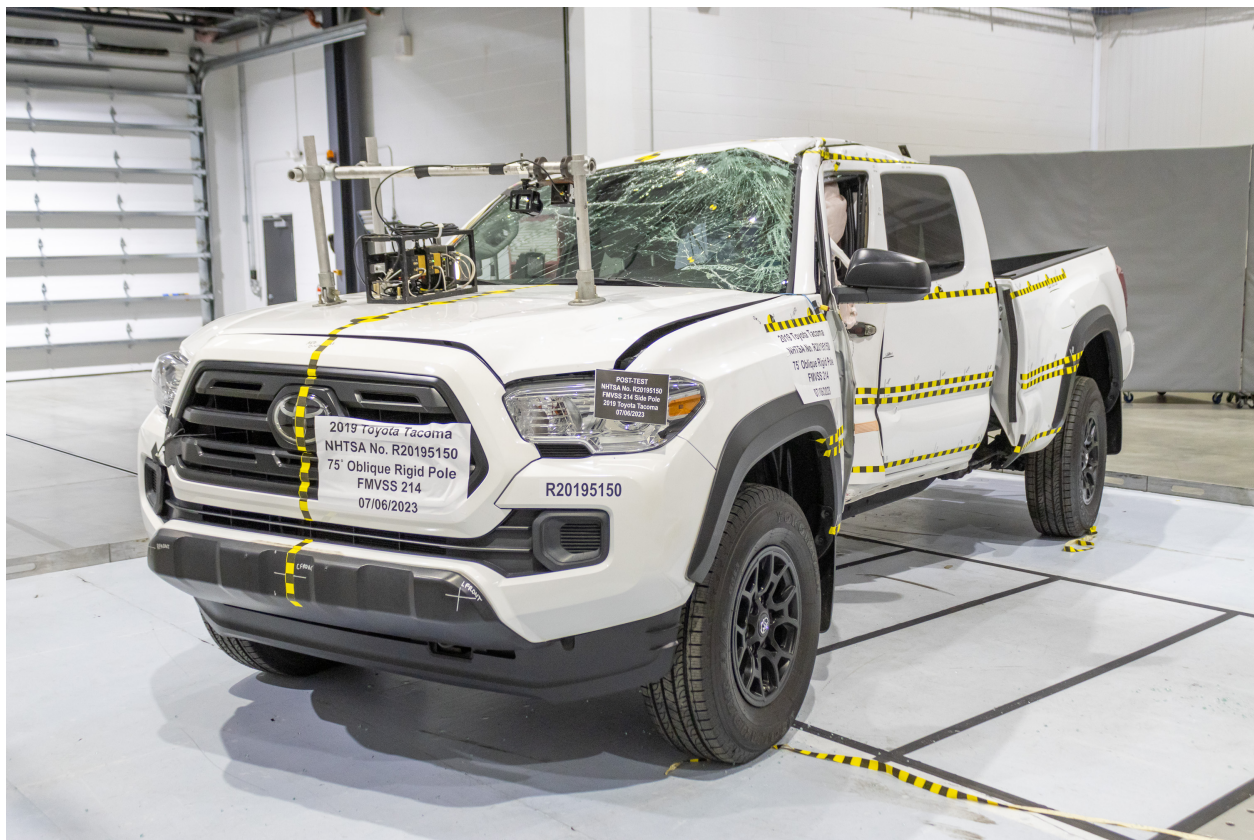
**Figure A-6: Post-Test Left Front  $\frac{3}{4}$  View of Test Vehicle**

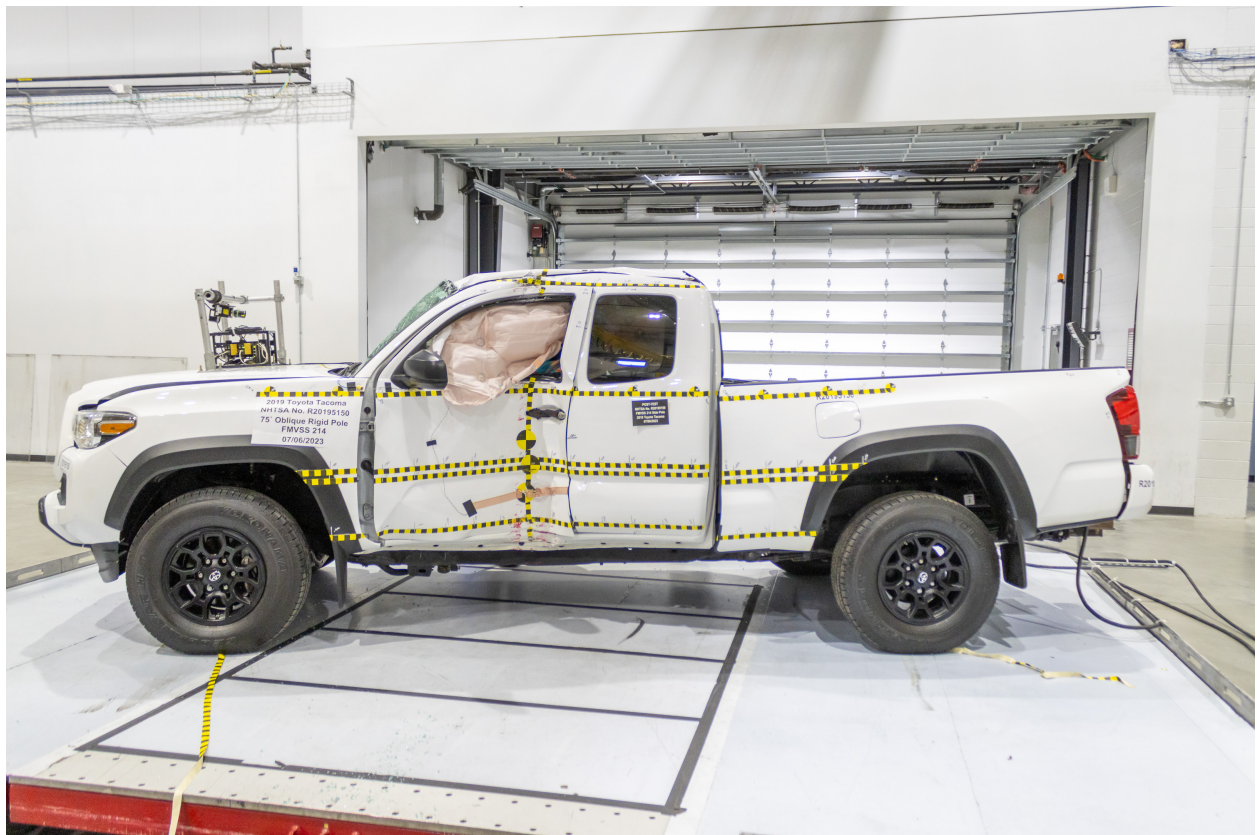
**Figure A-8: Post-Test Left Side View of Test Vehicle**

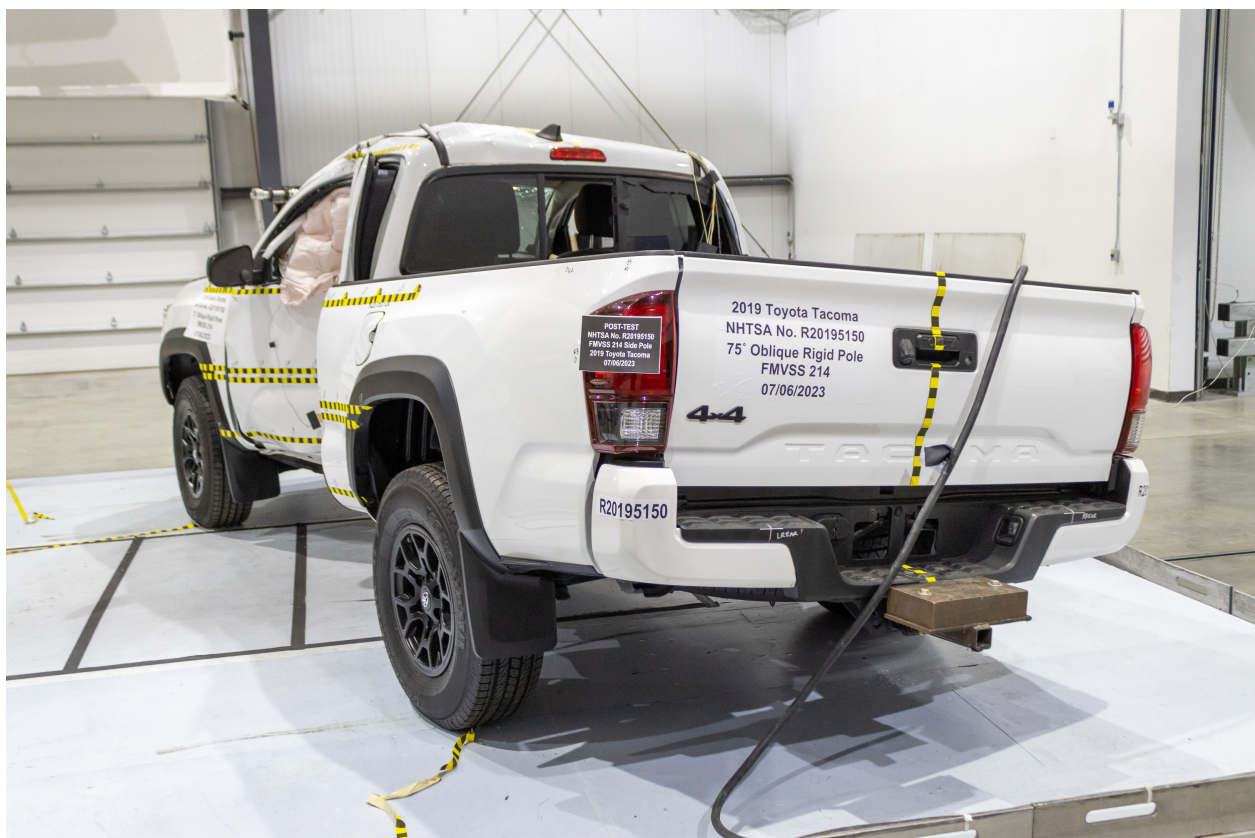
**Figure A-10: Post-Test Left Rear  $\frac{3}{4}$  View of Test Vehicle**

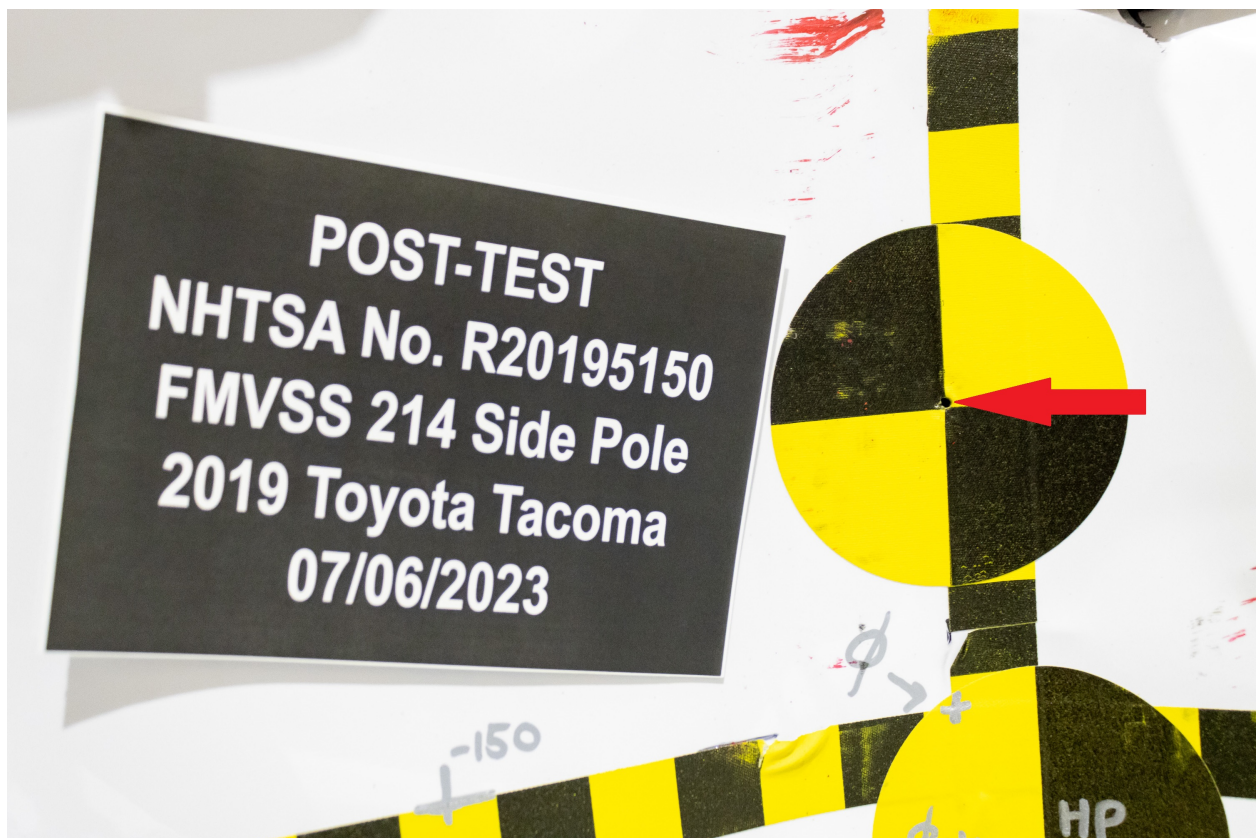
Figure A-20: Post-Test Close-Up View of Impact Point Target Showing Impact Location

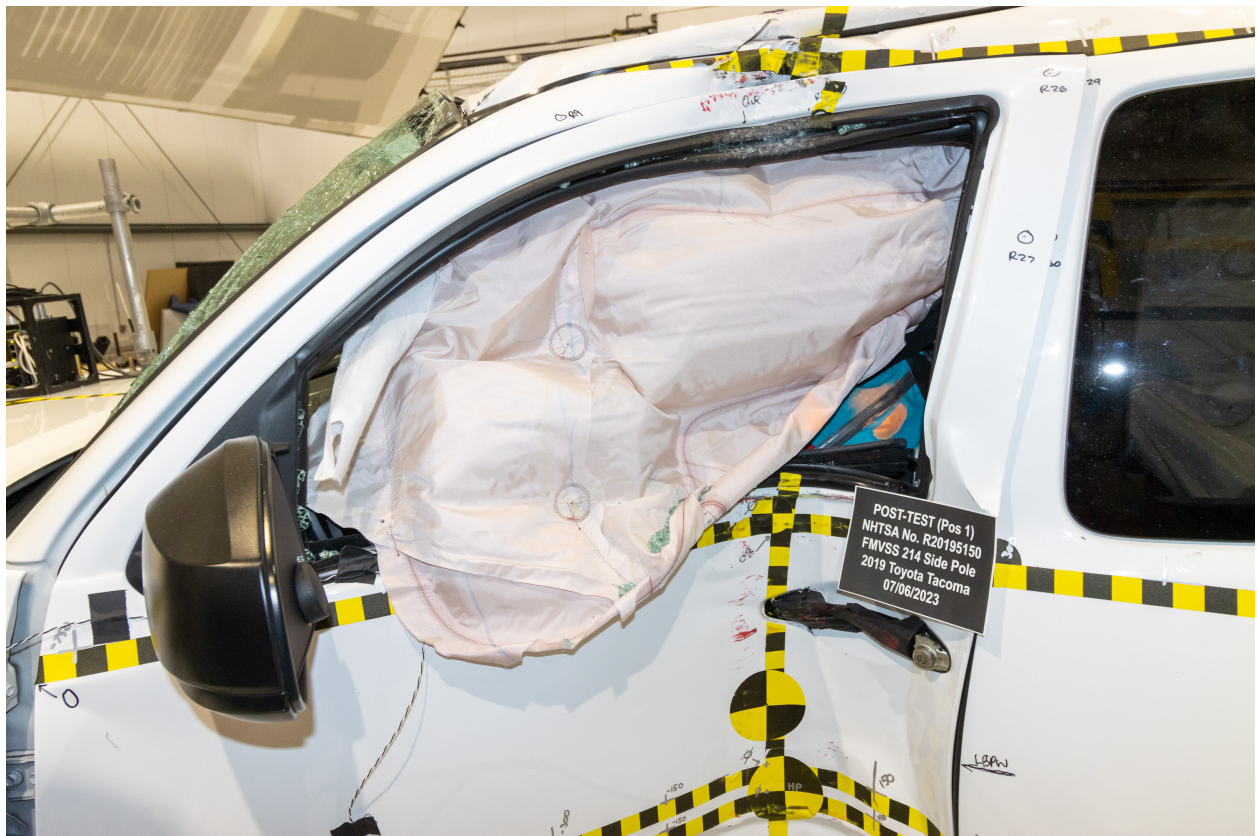
**Figure A-25: Post-Test Left Side View of Dummy Shoulder and Door Top View**

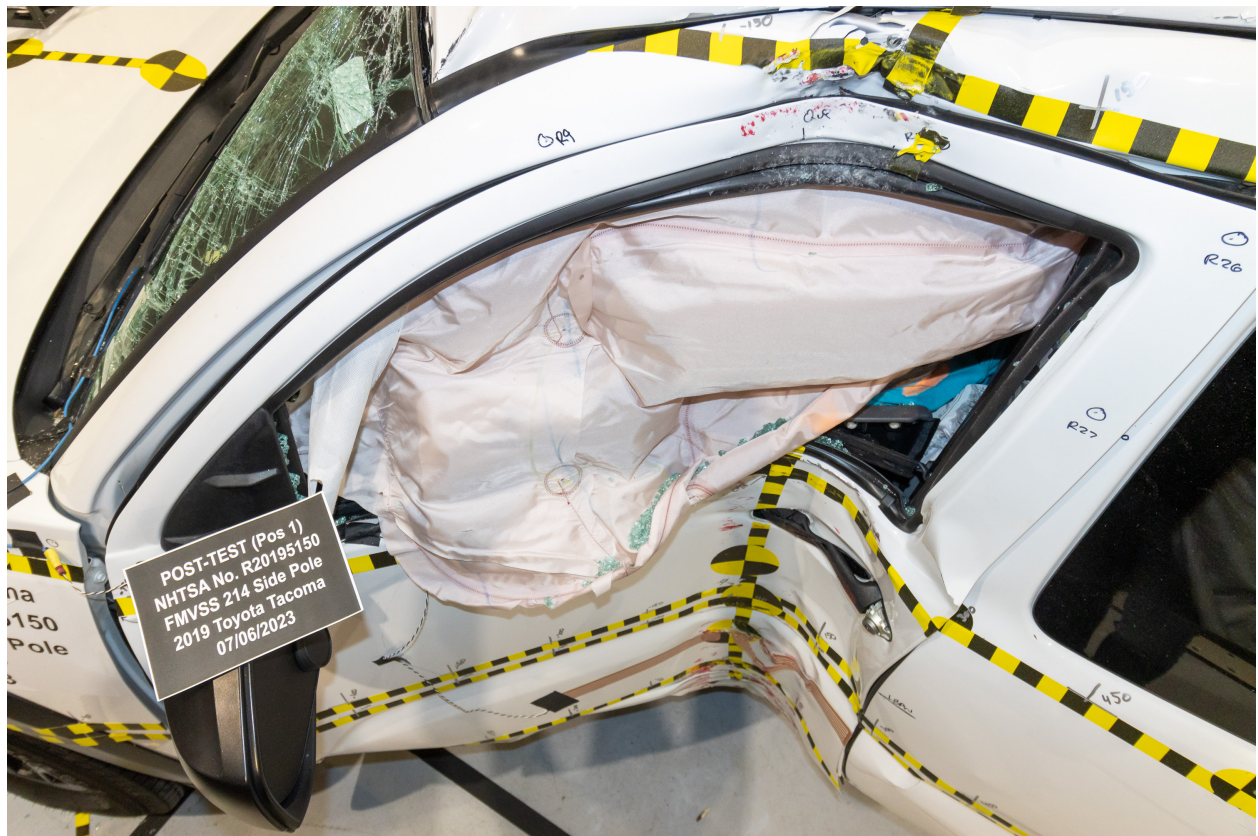
**Figure A-41: Post-Test Dummy and Door Clearance View**

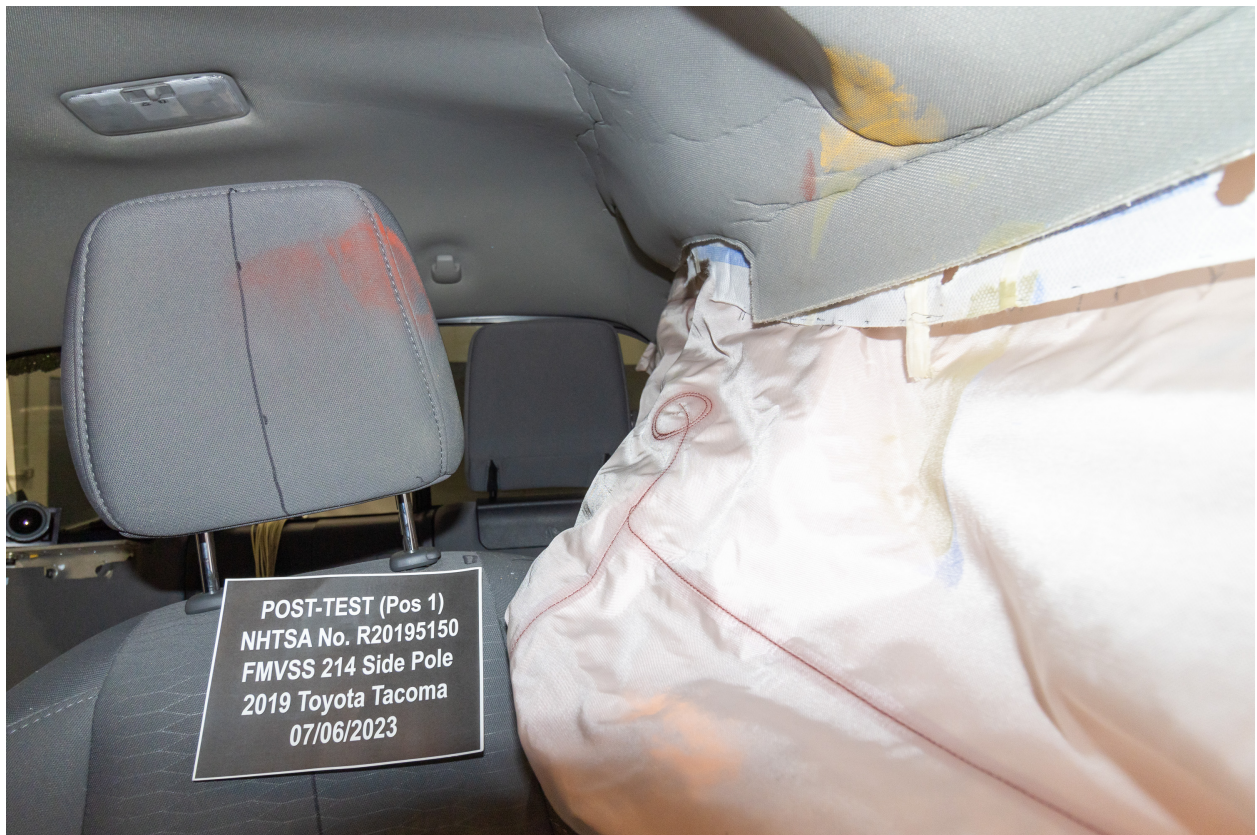
**Figure A-46: Post-Test Dummy Close-Up Head Contact with Vehicle Interior View**

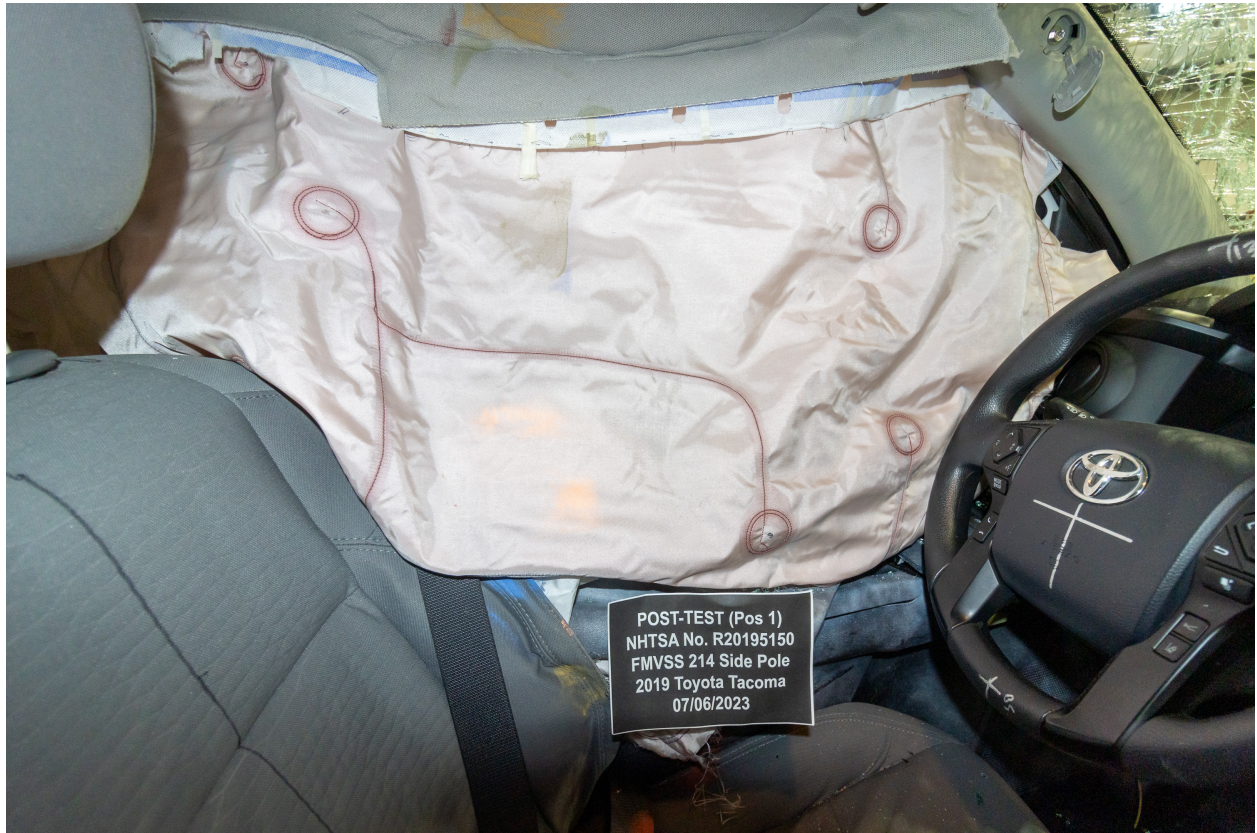
**Figure A-47: Post-Test Dummy Close-Up Head Contact with Side Airbag View**

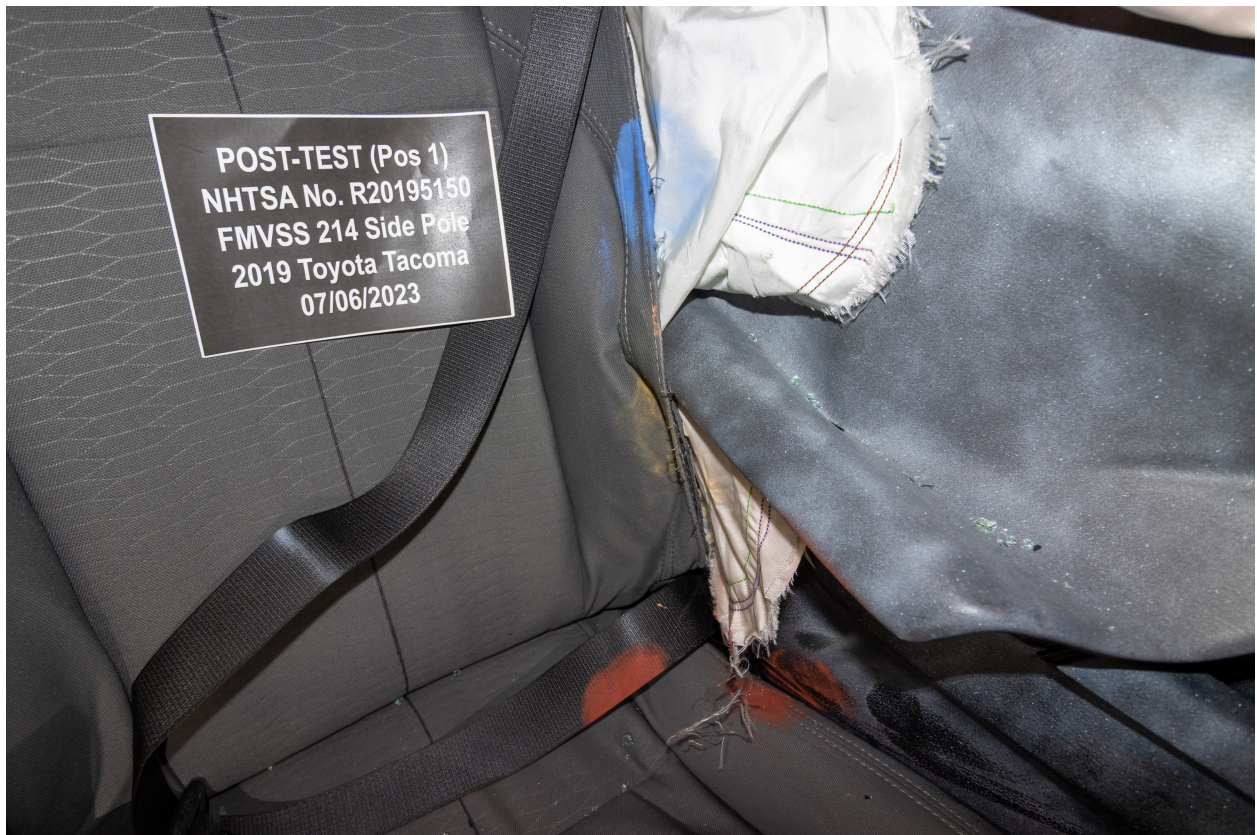
**Figure A-48: Post-Test Dummy Close-Up Torso Contact with Vehicle Interior View**

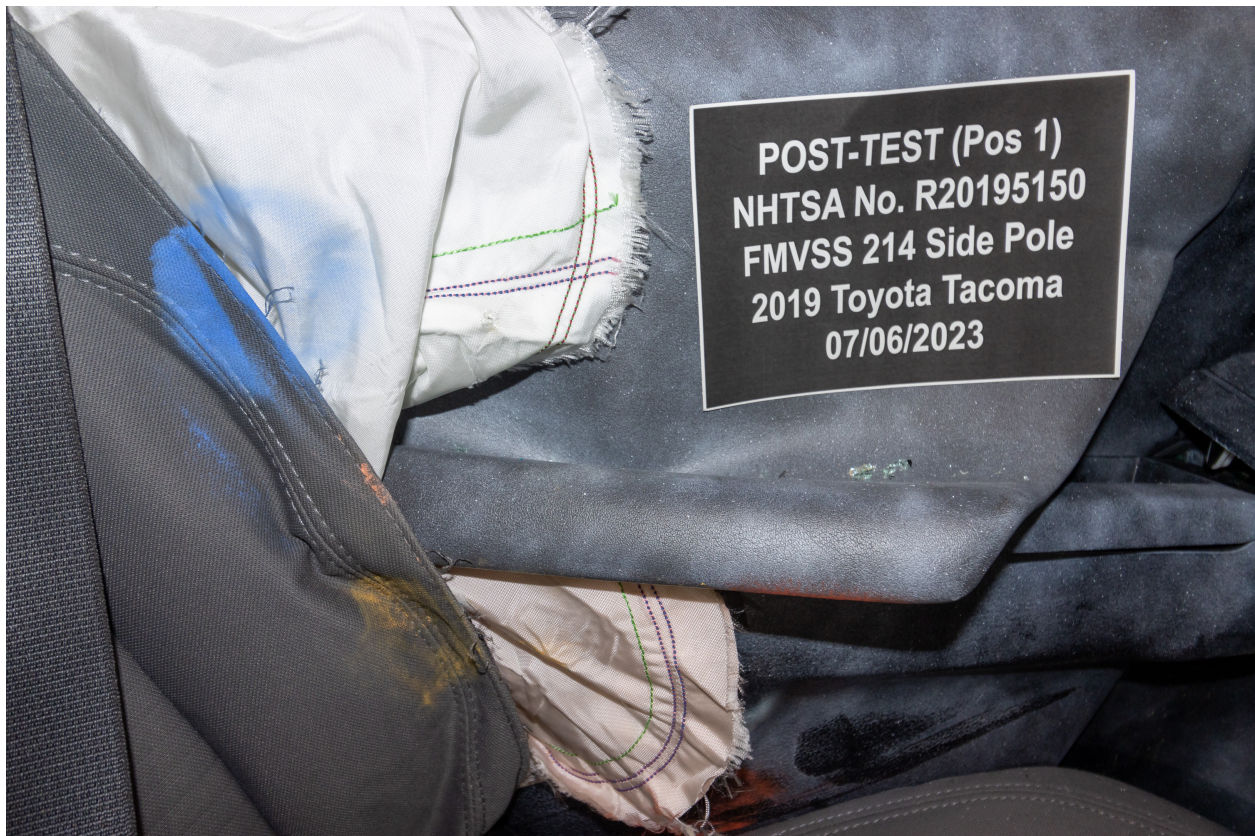
**Figure A-49: Post-Test Dummy Close-Up Torso Contact with Side Airbag View**

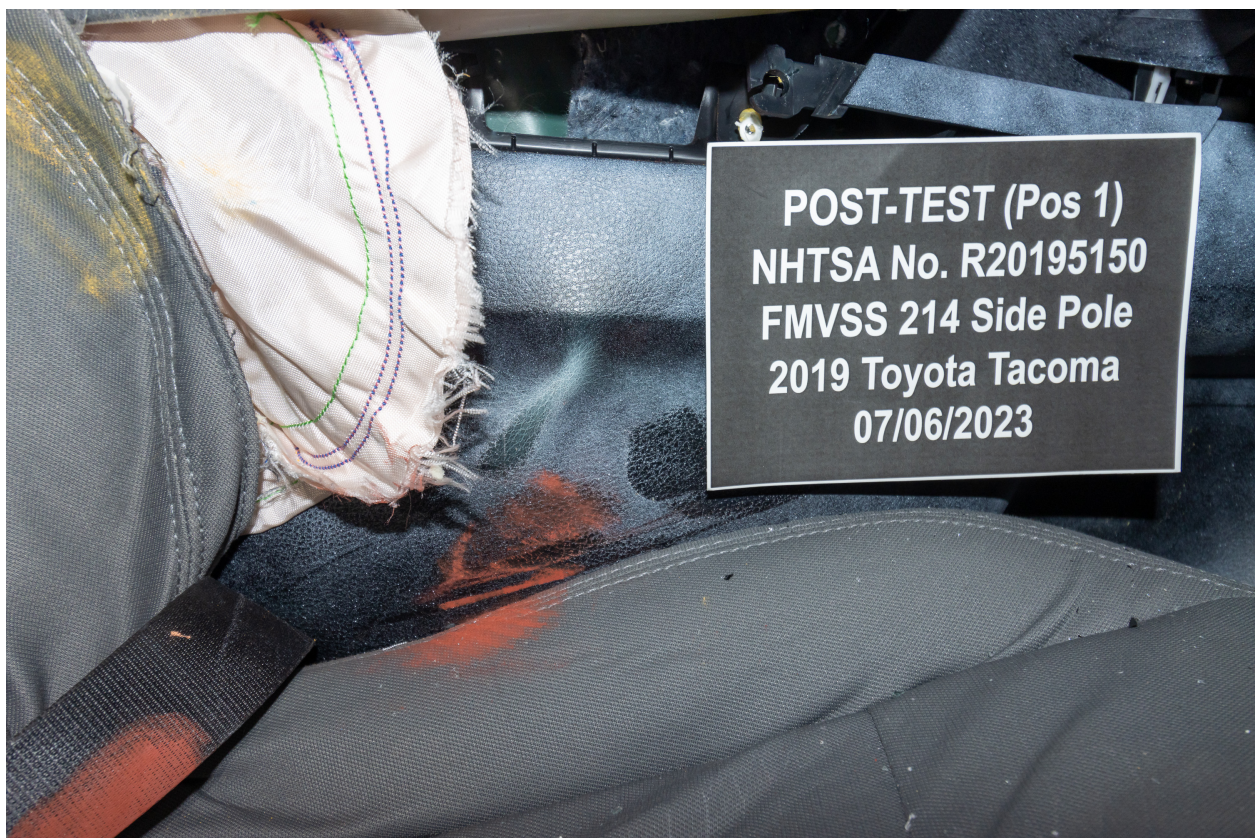
**Figure A-50: Post-Test Dummy Close-Up Pelvis Contact with Vehicle Interior View**

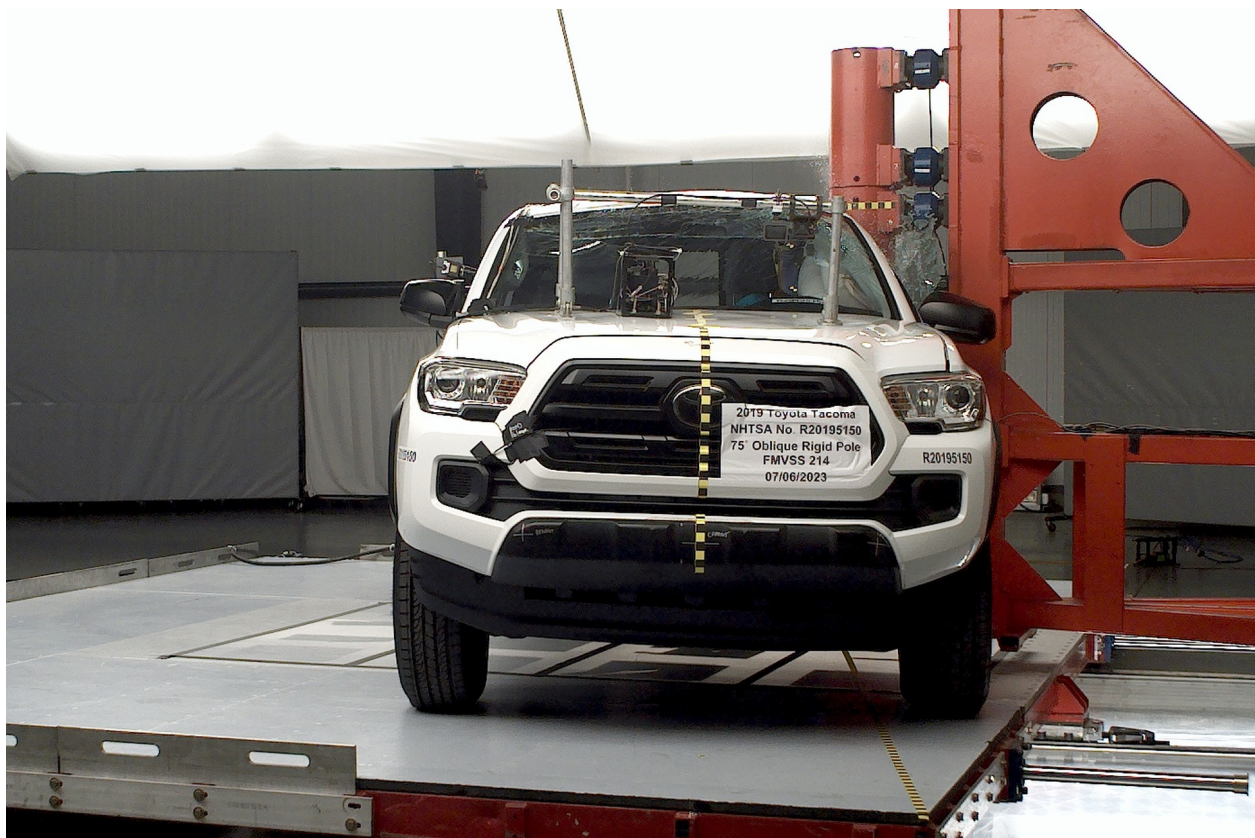
**Figure A-70: Impact Event**
