**REPORT NUMBER: SideNCAPPole-MGA-23-038**

**NEW CAR ASSESSMENT PROGRAM (NCAP)  
Side Impact Pole Test**

**TOYOTA MOTOR CORPORATION  
2023 RAV4 Prime SE AWD 5-Door SUV  
NHTSA No.: M20235101**

**FINAL REPORT**

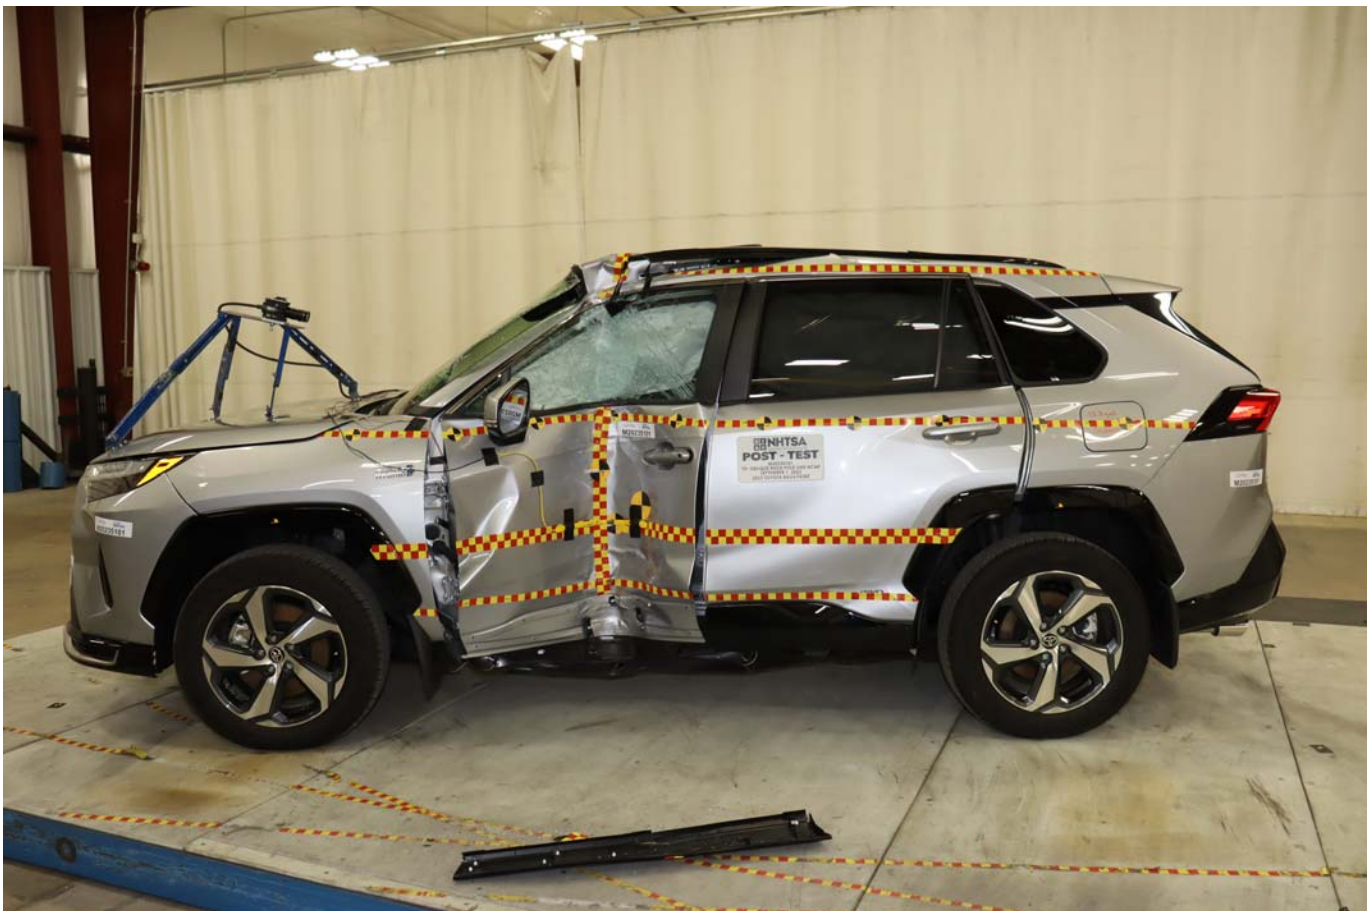
Photo No. 008 - Post-Test Left Side View of Test Vehicle

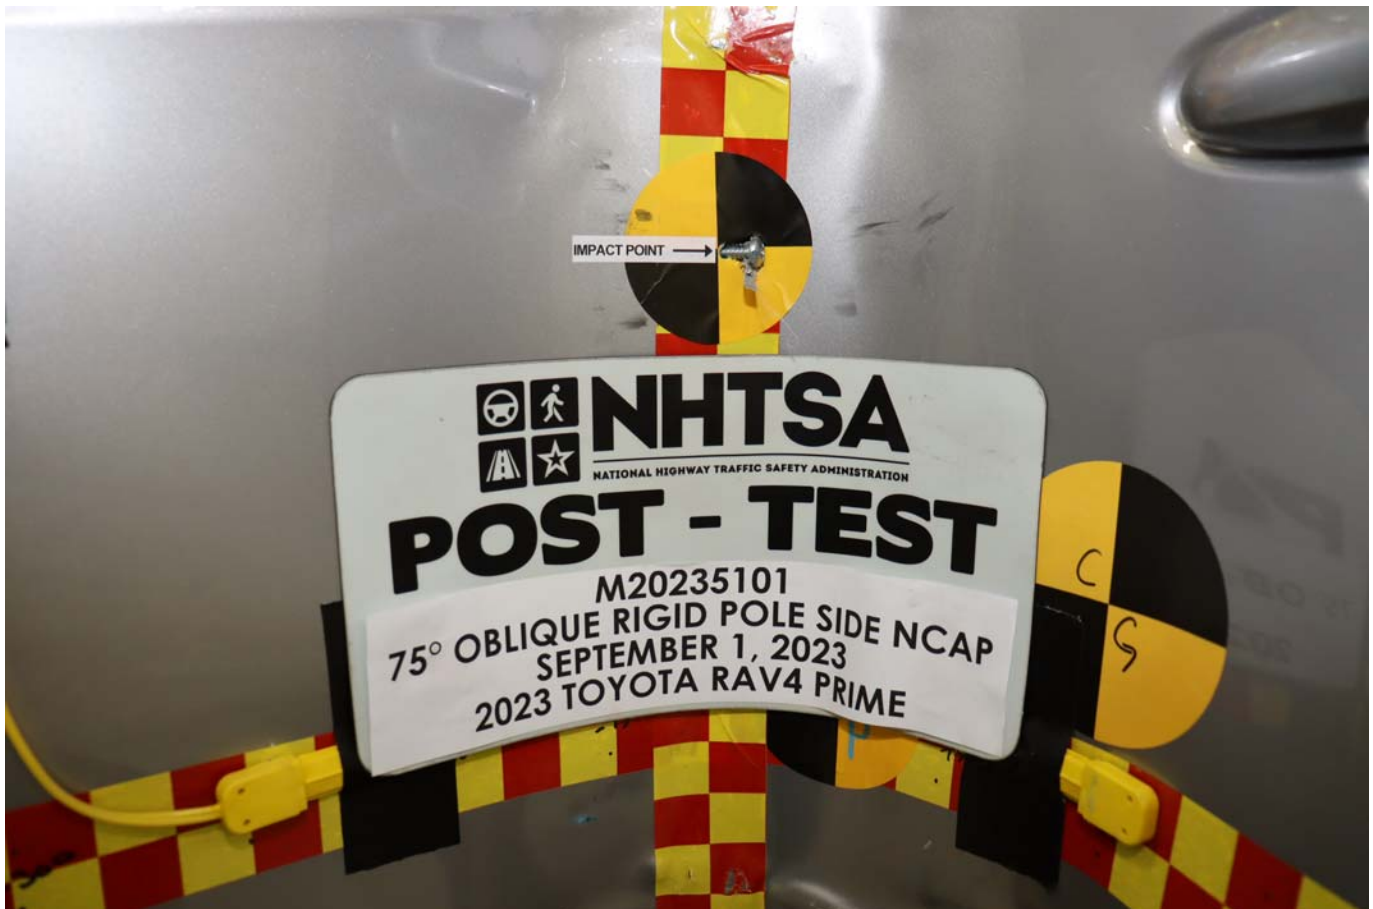
Photo No. 020 - Post-Test Close-Up View of Impact Point Target Showing Impact Location

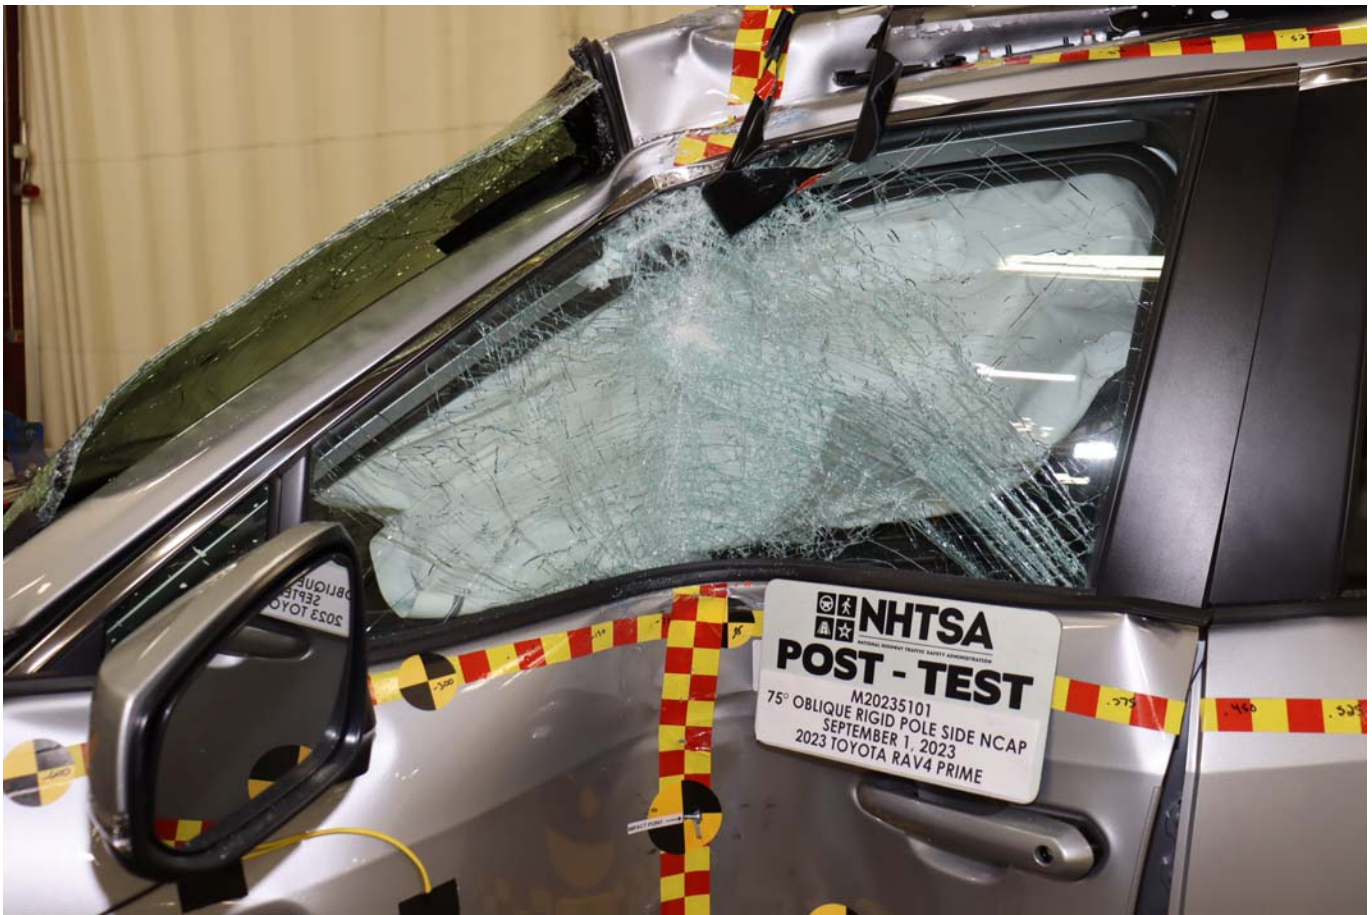
Photo No. 025 - Post-Test Left Side View of Dummy Shoulder and Door Top View

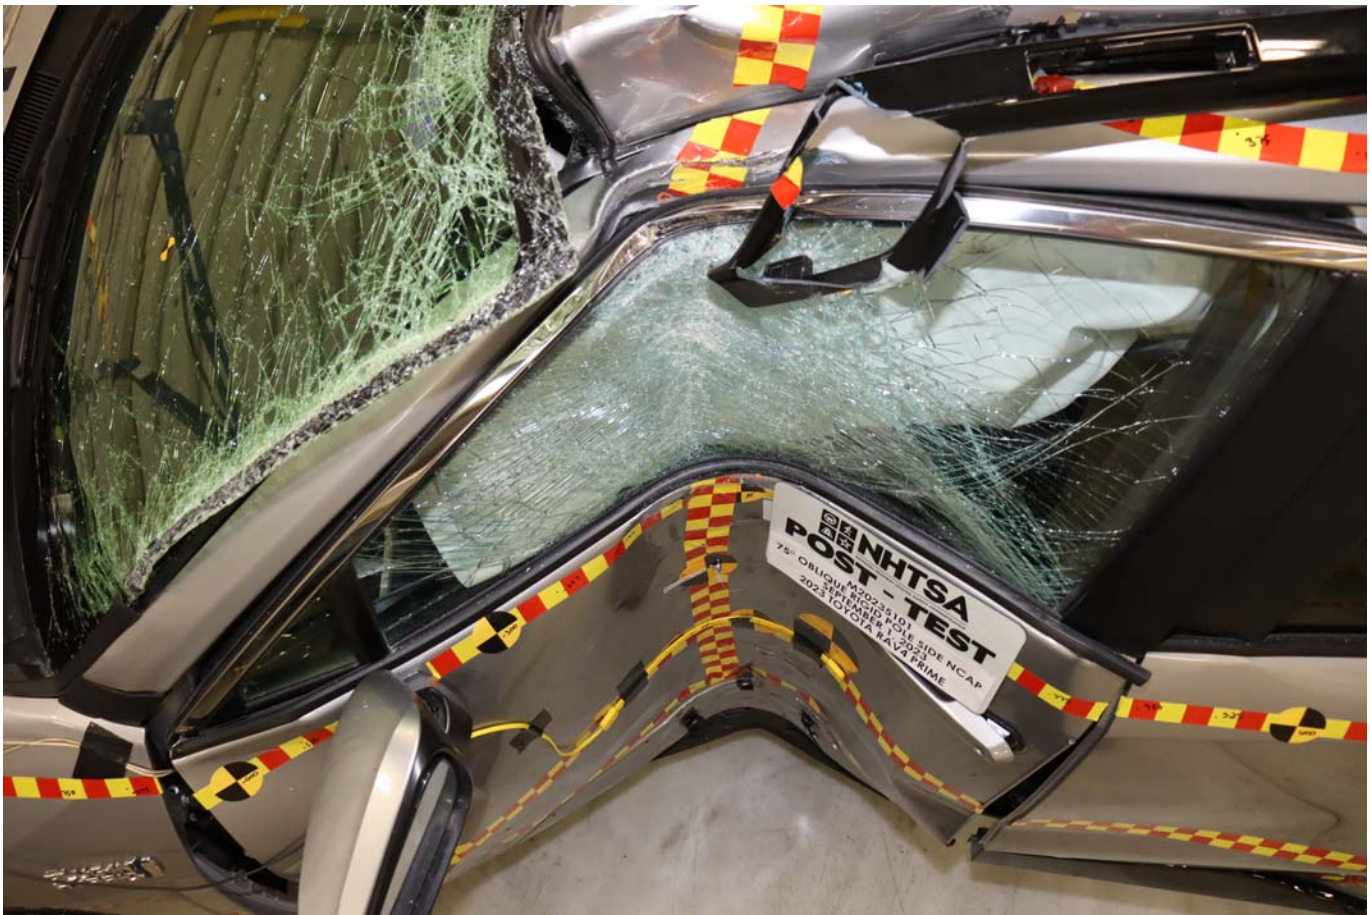
Photo No. 041 - Post-Test Dummy and Door Clearance View

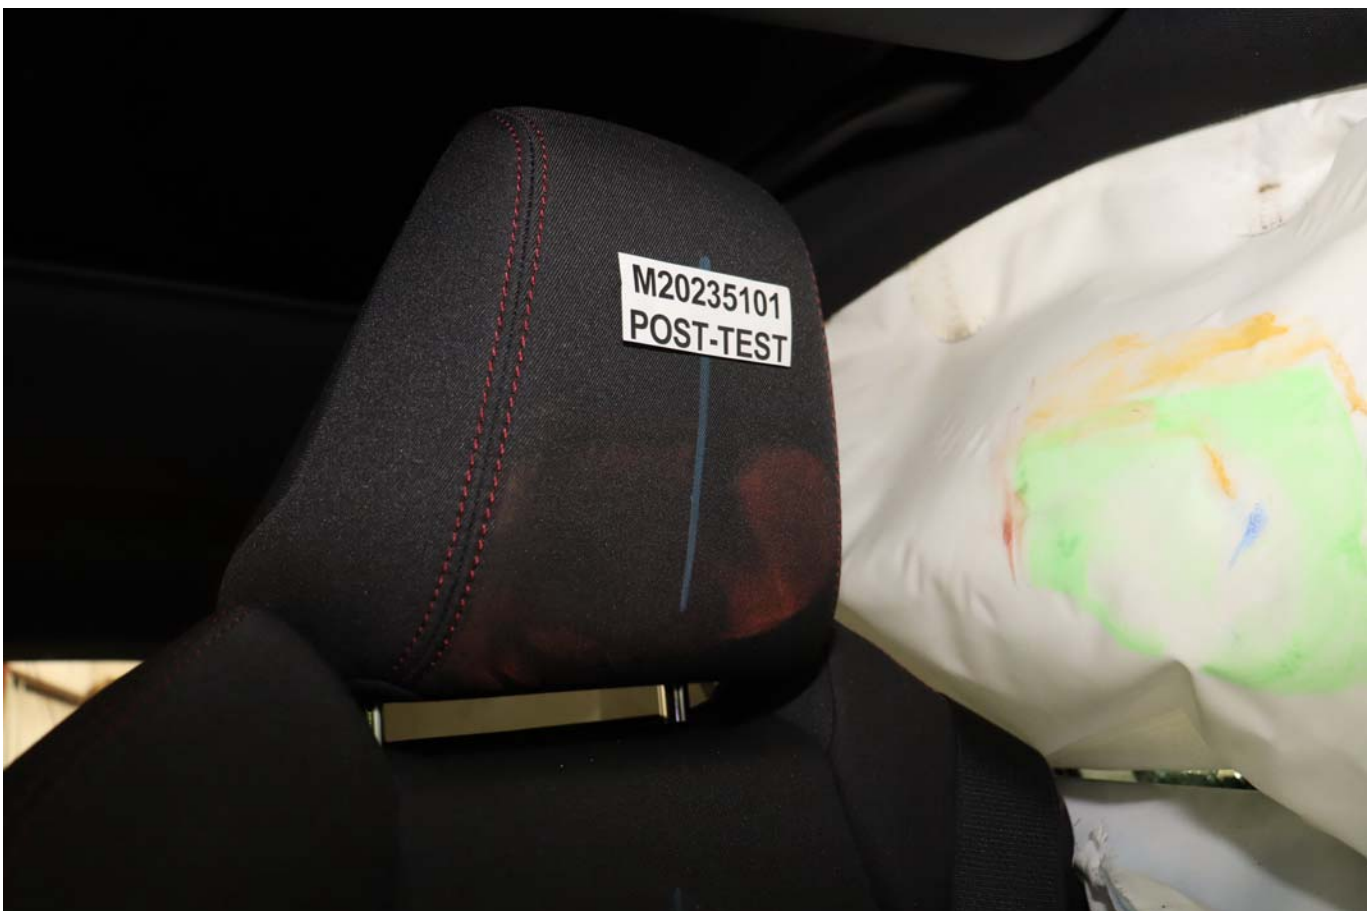
Photo No. 046 - Post-Test Dummy Close-Up Head Contact with Vehicle Interior View

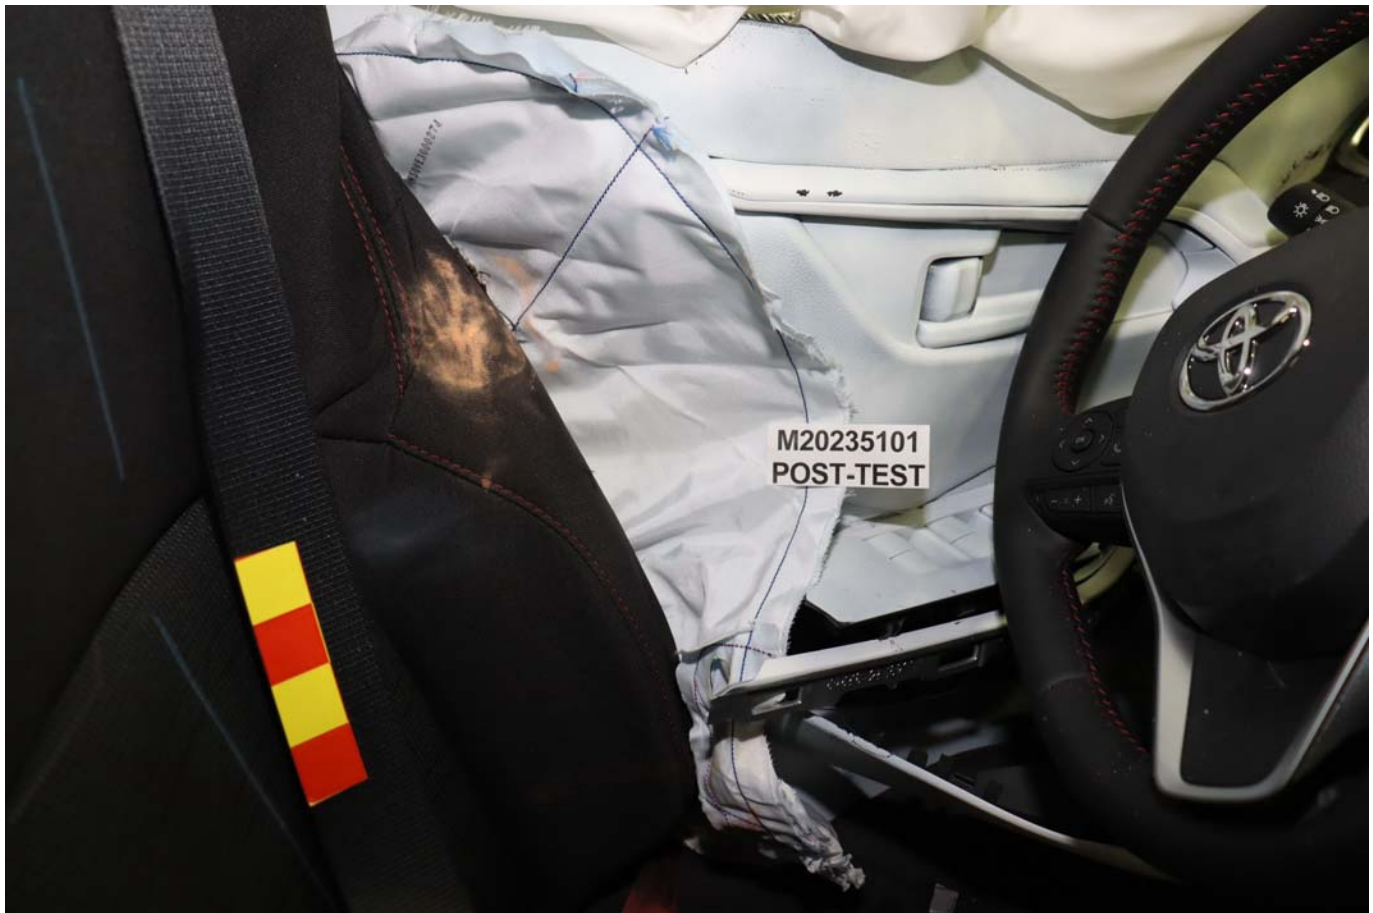
Photo No. 049 - Post-Test Dummy Close-Up Torso Contact with Side Air Bag View

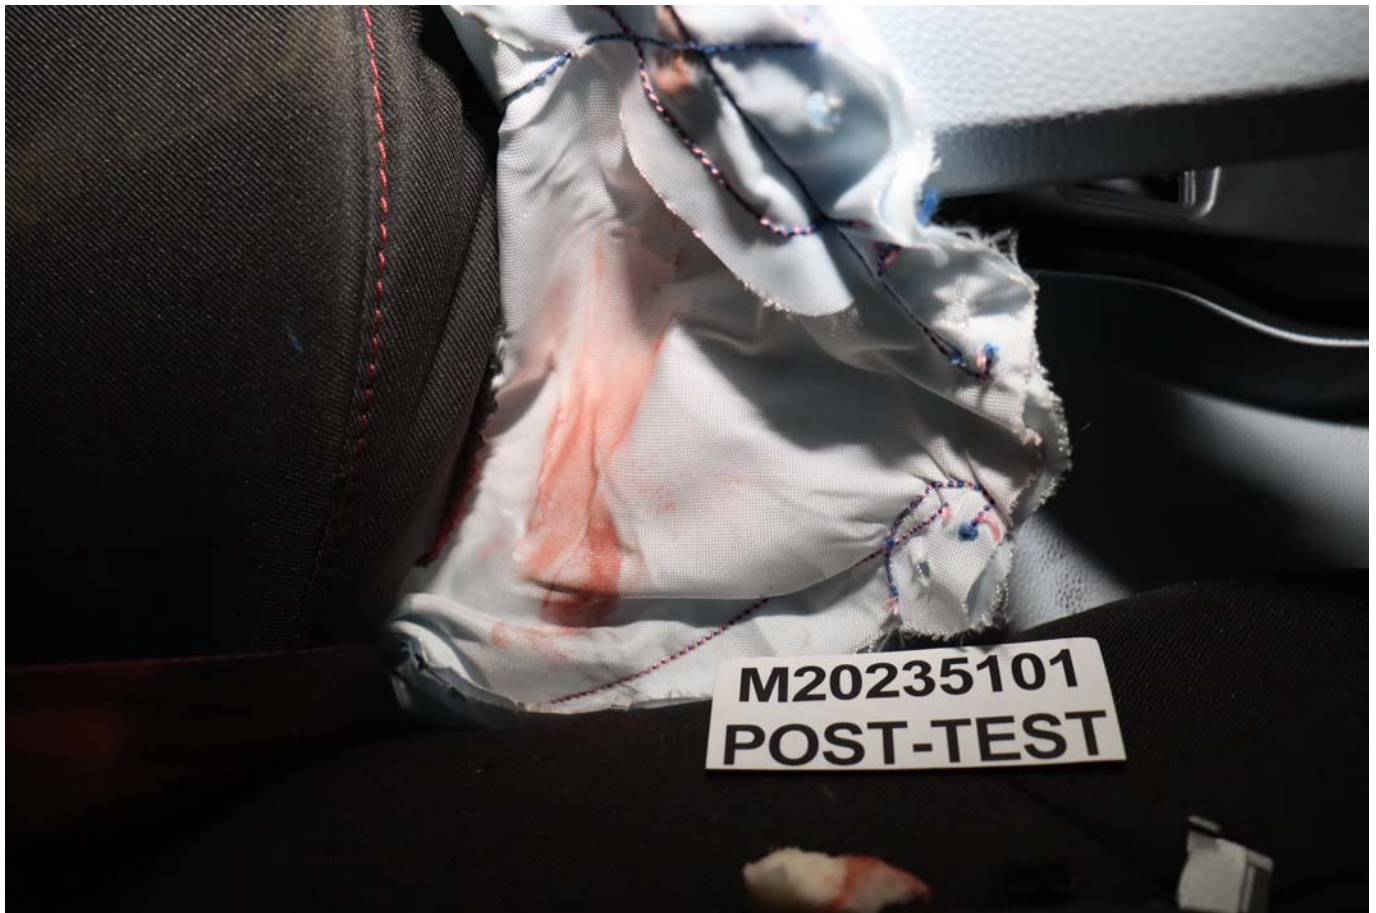
Photo No. 051 - Post-Test Dummy Close-Up Pelvis Contact with Side Air Bag View

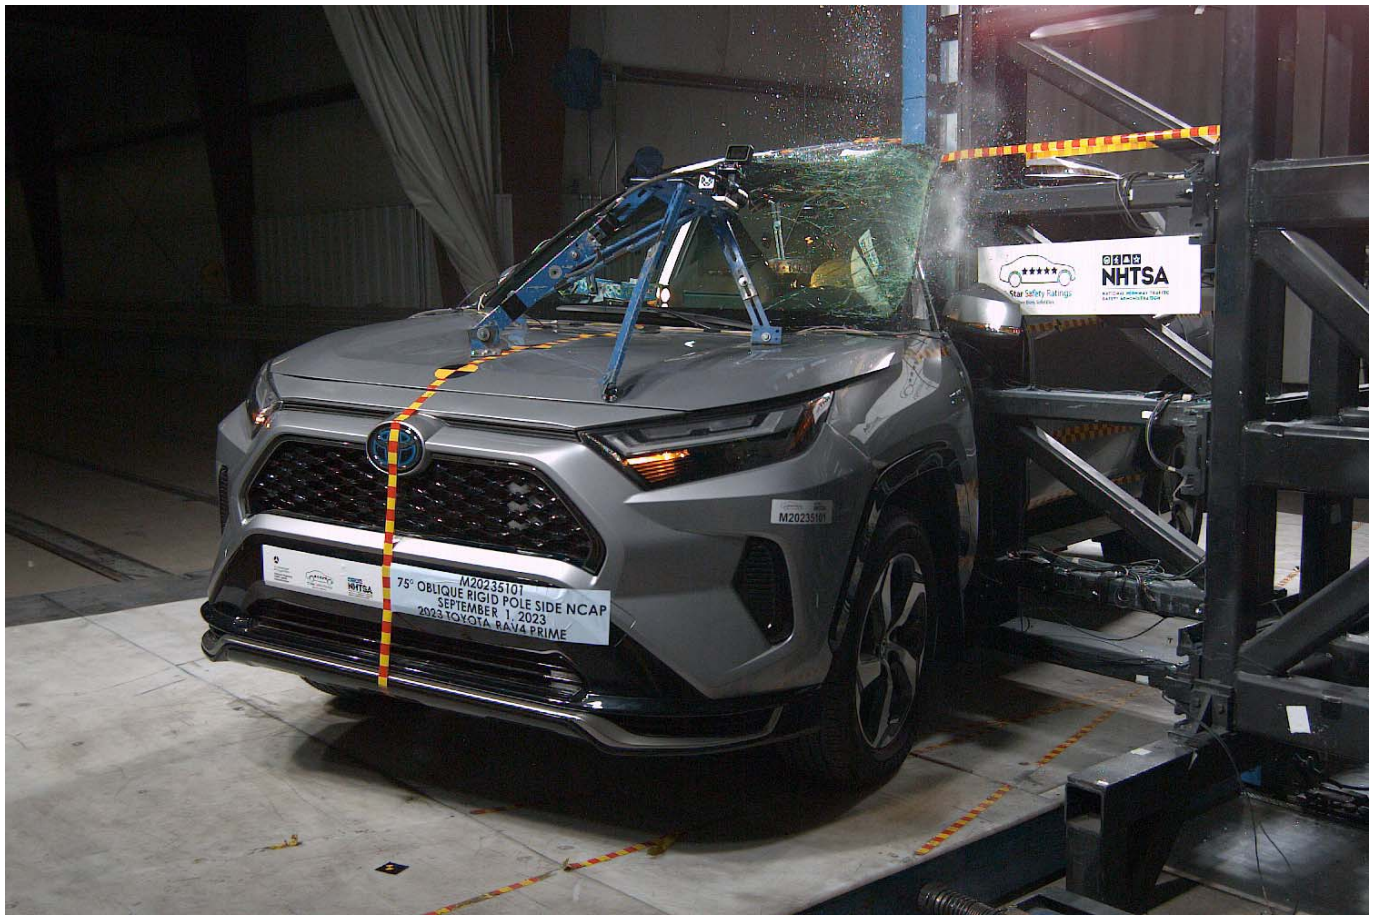
Photo No. 070 - Impact Event

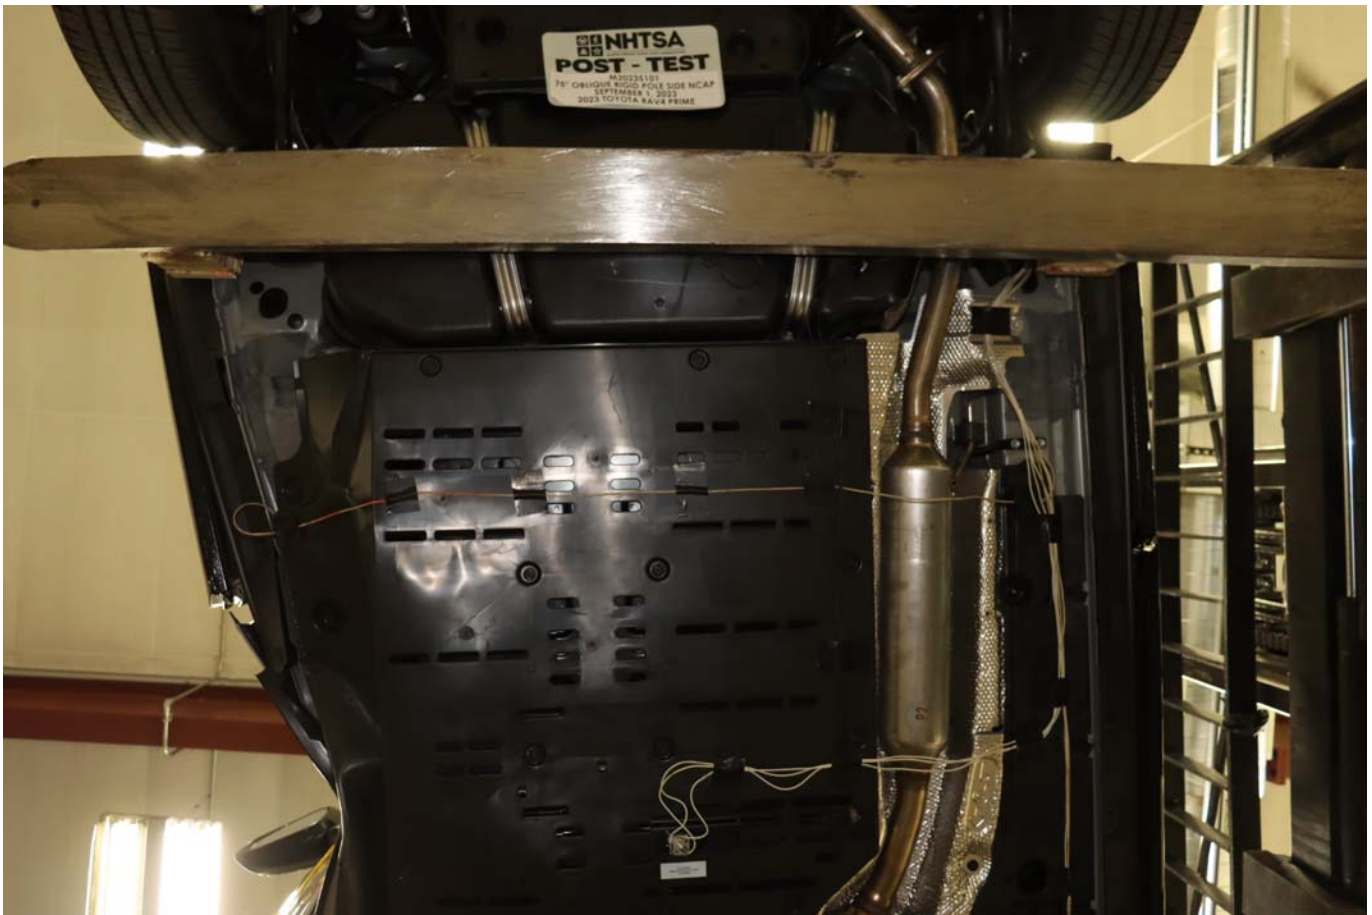
Photo No. 305-11 - Post-Impact Rear View of Propulsion Battery

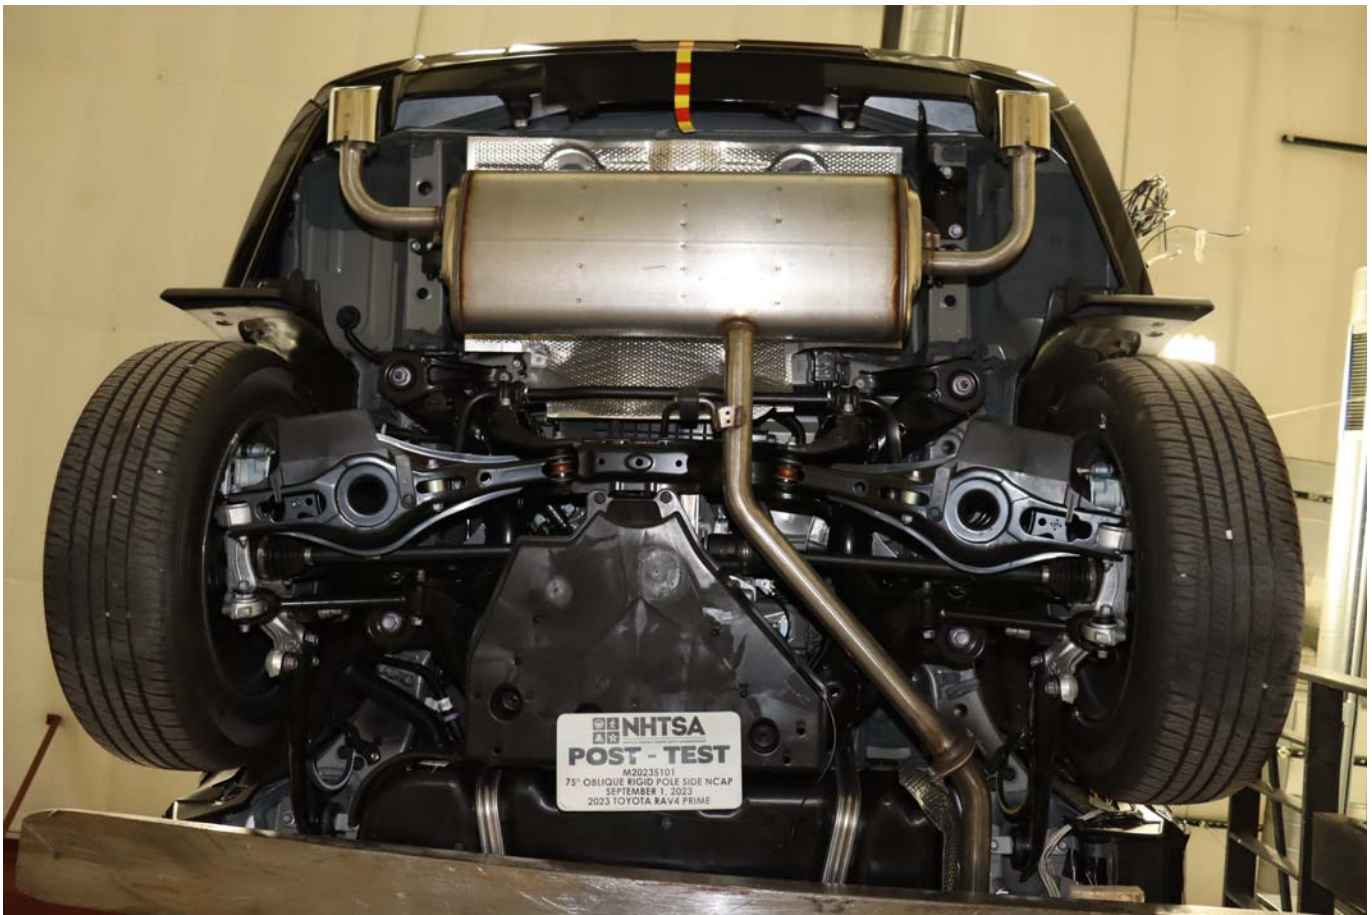
Photo No. 305-17 - Post-Impact View of Electric Propulsion Drive
