REPORT NUMBER: 214D-CAL-24-002

**NEW CAR ASSESSMENT PROGRAM (NCAP)
SIDE IMPACT POLE TEST**

**Hyundai Motor Company
2024 Genesis GV60
5 Door SUV**

NHTSA No: O20244209

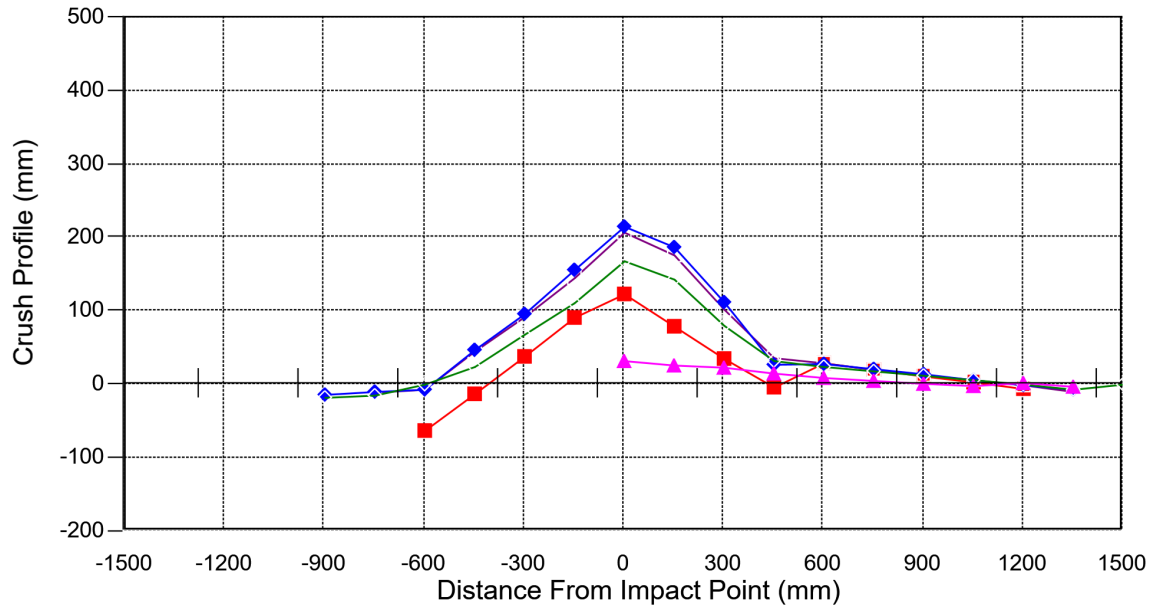
Vehicle Exterior Crush Measurements - Visual Representation

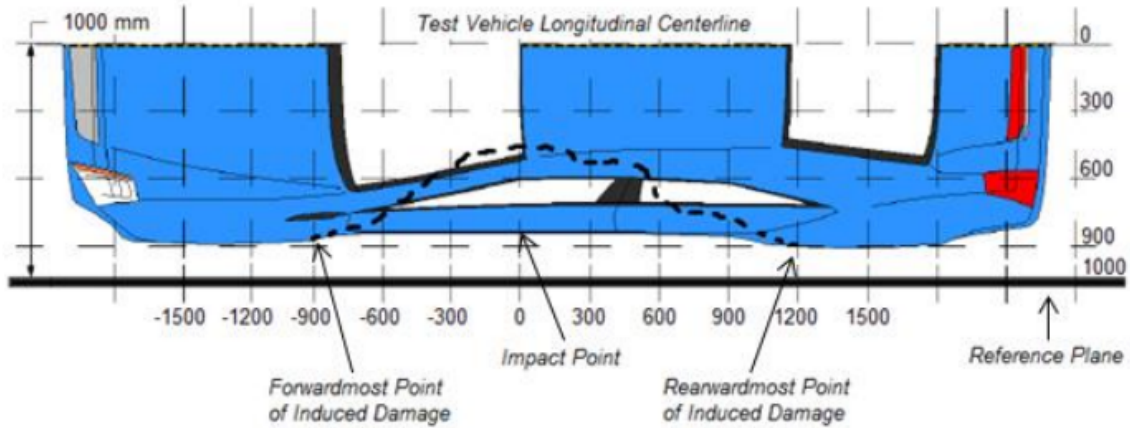
Overhead View

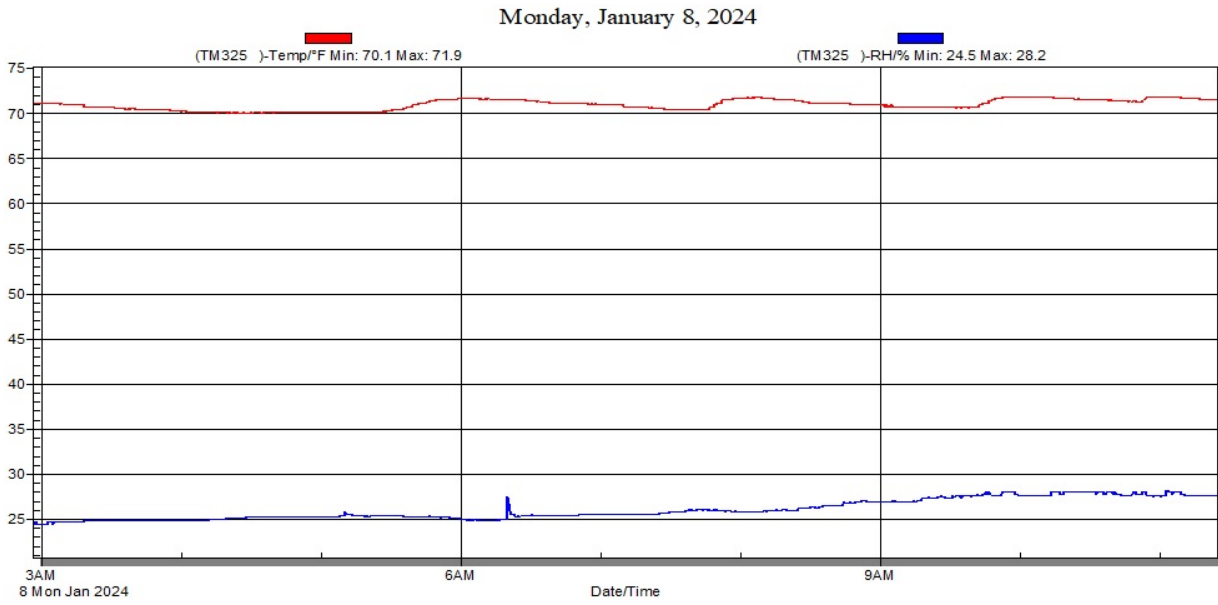
Temperature and Humidity Stabilization Chart/Data for Dummies and Test Vehicle

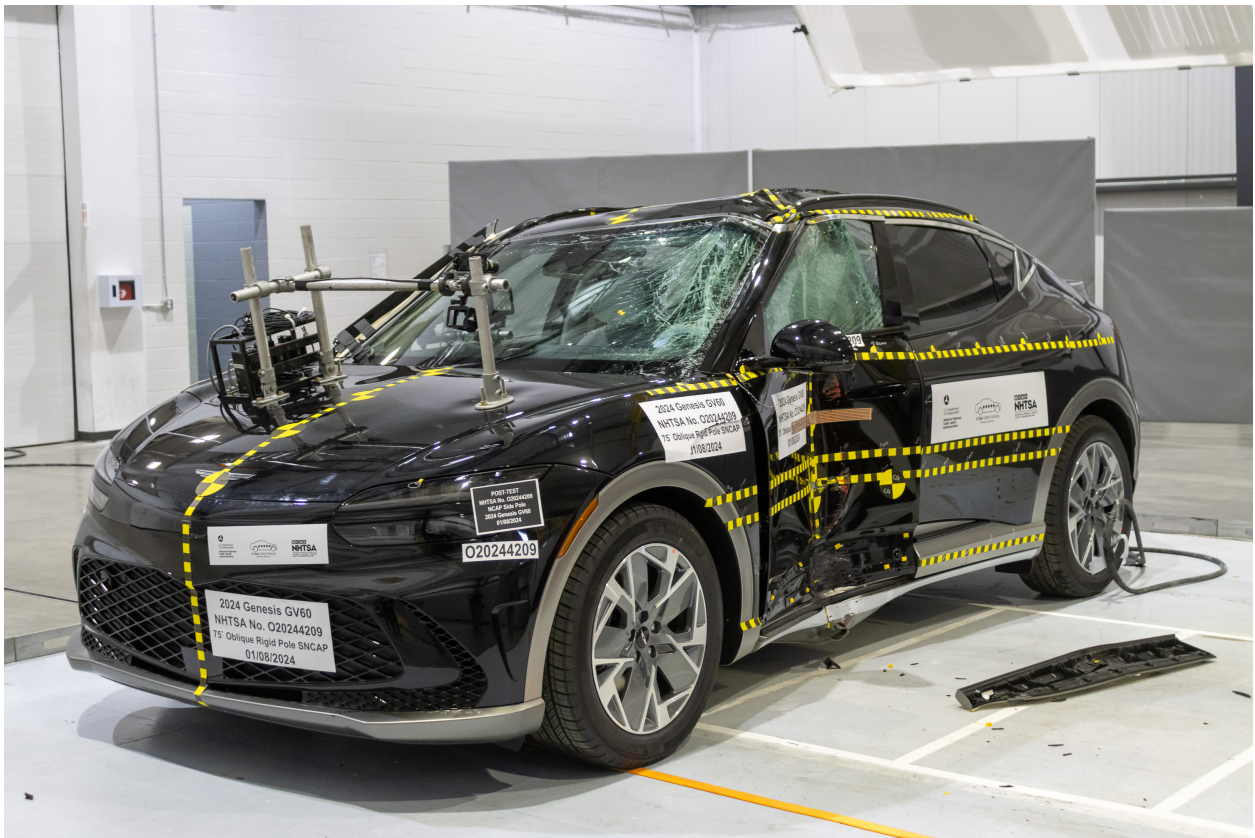
Figure A-6: Post-Test Left Front $\frac{3}{4}$ View of Test Vehicle

Critical Areas of Performance	Observations and Conclusions
Pillar Performance	A-Pillar Buckled
Sill Separation	None
Windshield Damage	Cracked throughout
Side Window Damage	Driver window cracked throughout
Other Notable Effects	Seatback reclined after impact event

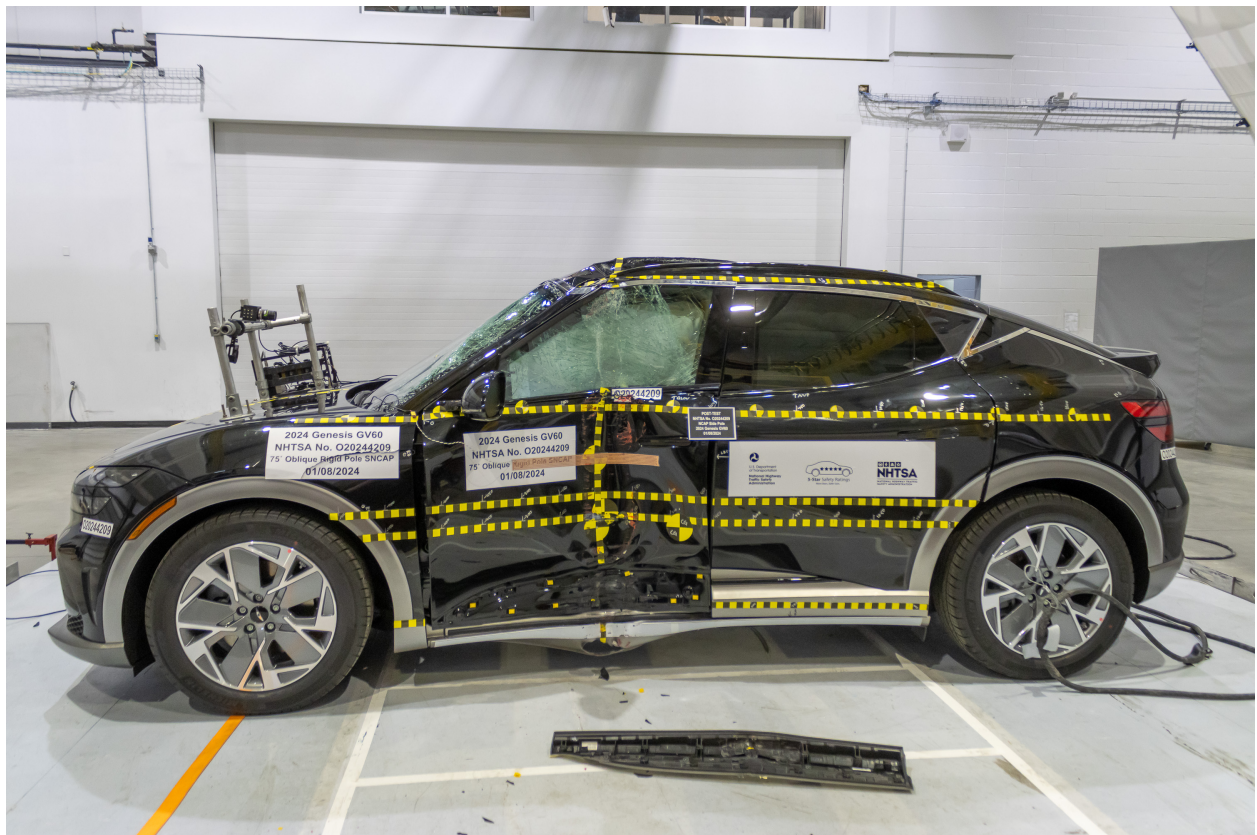
Figure A-8: Post-Test Left Side View of Test Vehicle

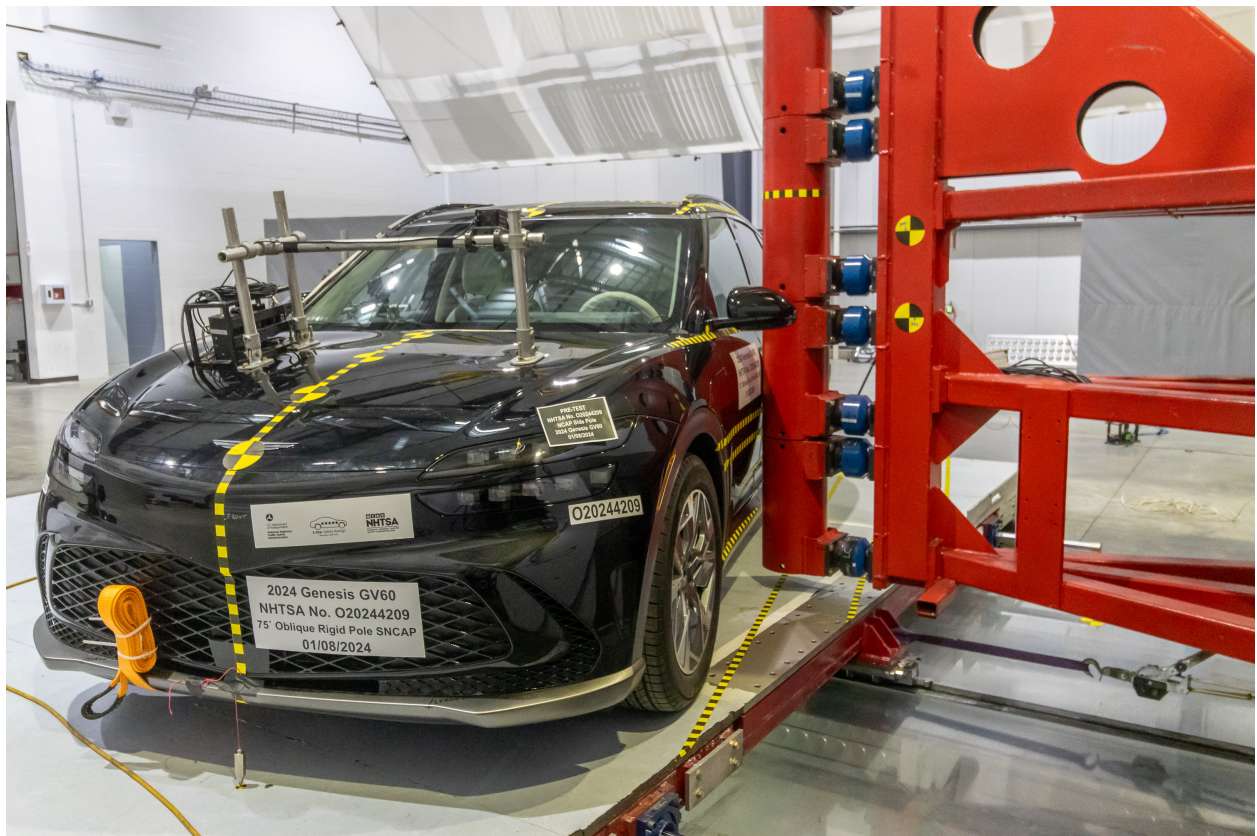
Figure A-17: Pre-Test Left Side View of Pole Positioned Against Side of Vehicle

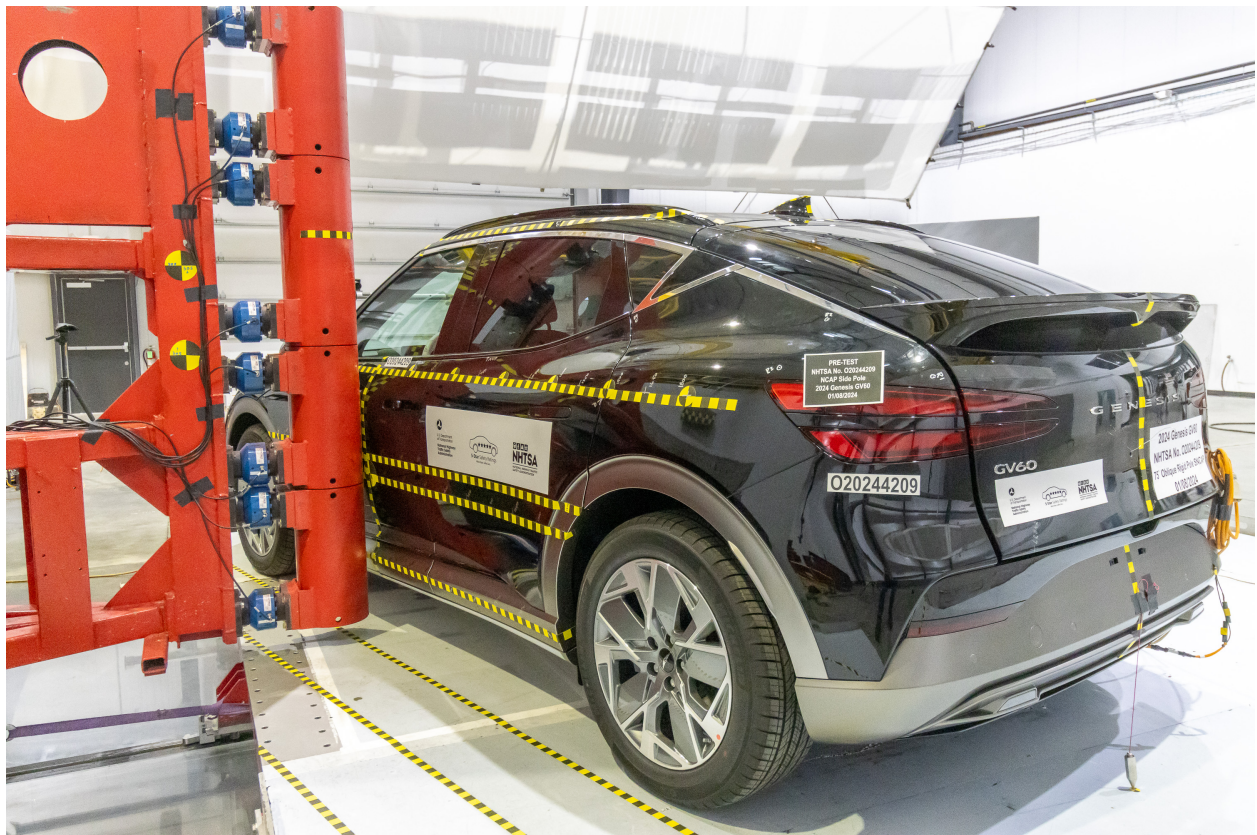
Figure A-18: Pre-Test Right Side View of Pole Positioned Against Side of Vehicle

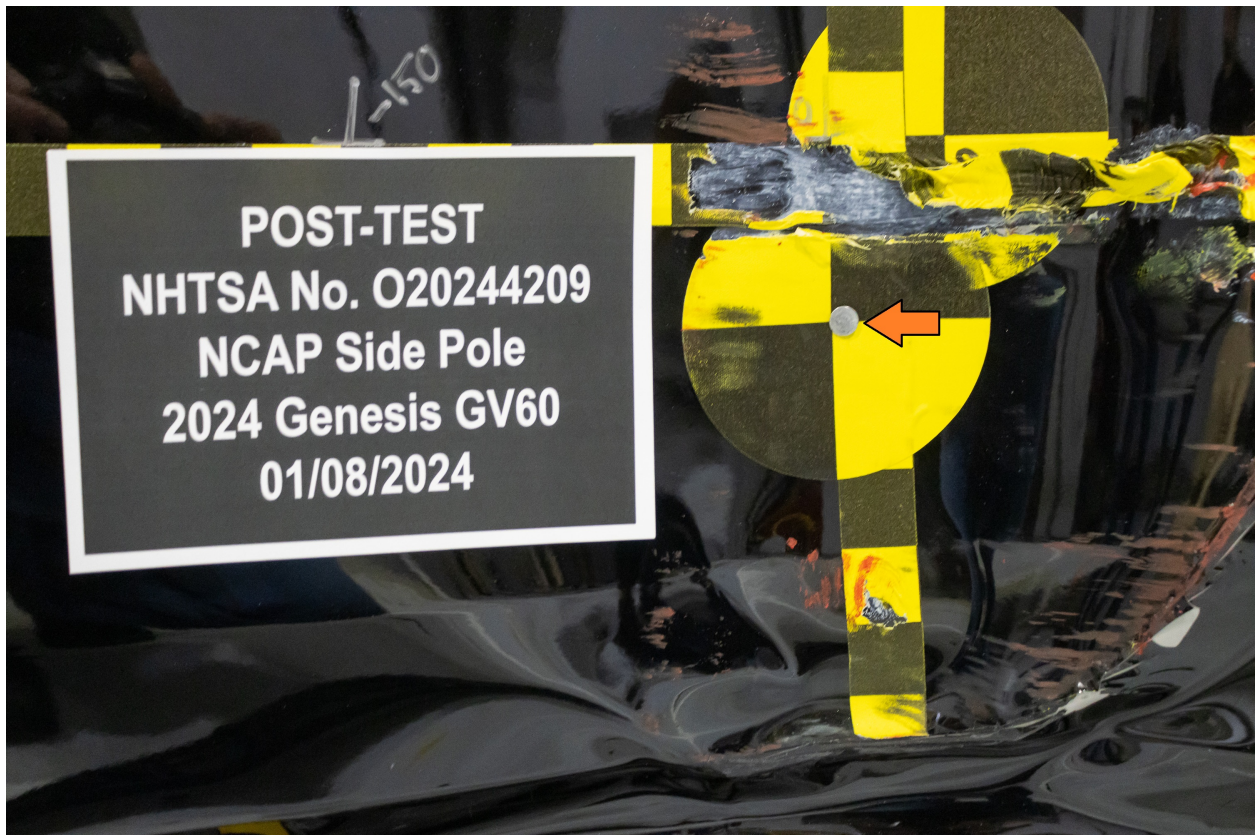
Figure A-20: Post-Test Close-Up View of Impact Point Target Showing Impact Location

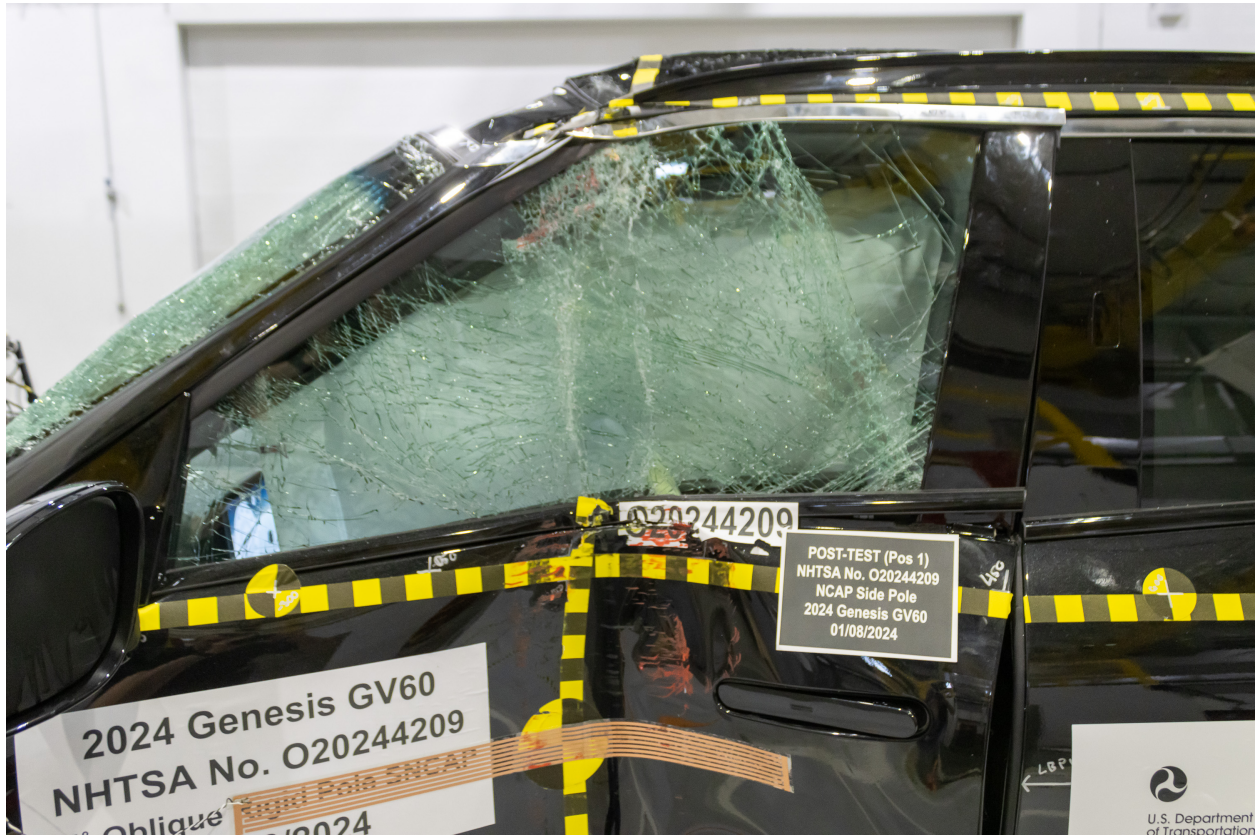
Figure A-25: Post-Test Left Side View of Dummy Shoulder and Door Top View

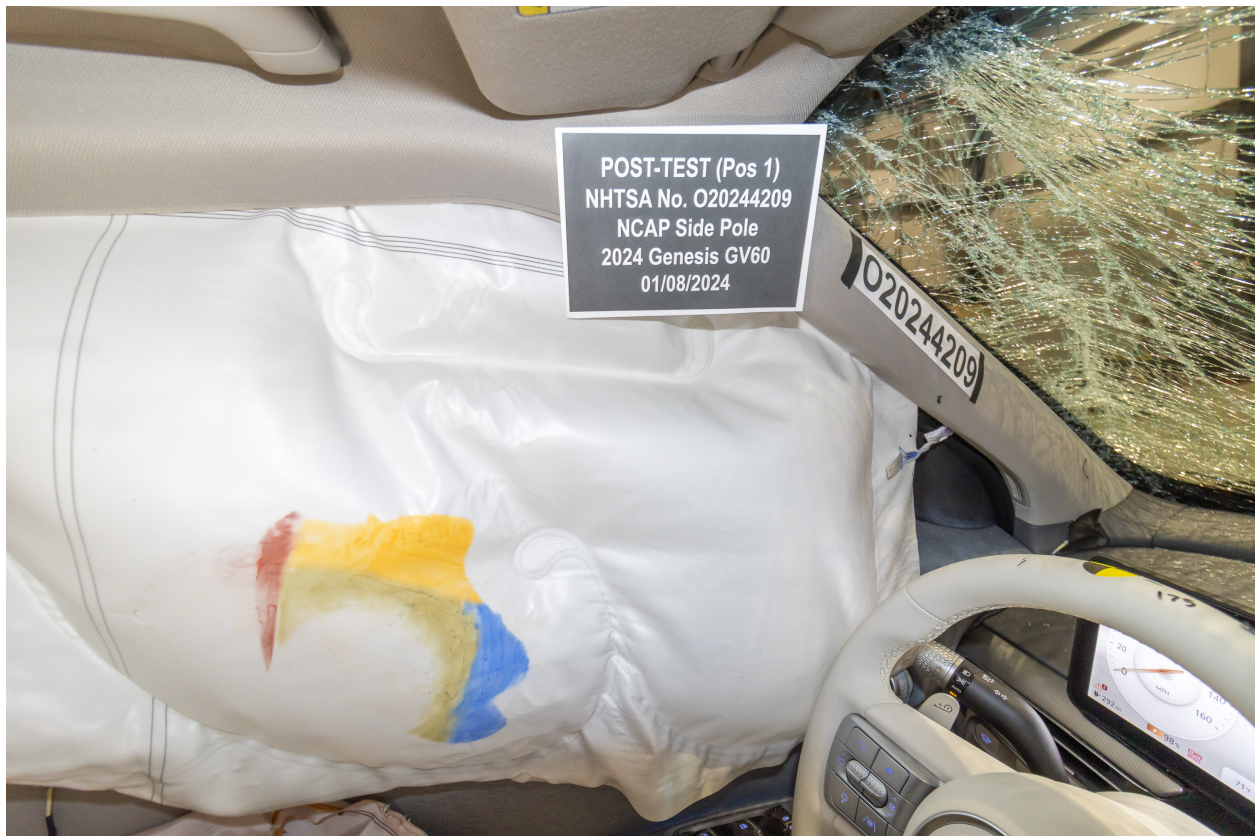
Figure A-47: Post-Test Dummy Close-Up Head Contact with Side Airbag View

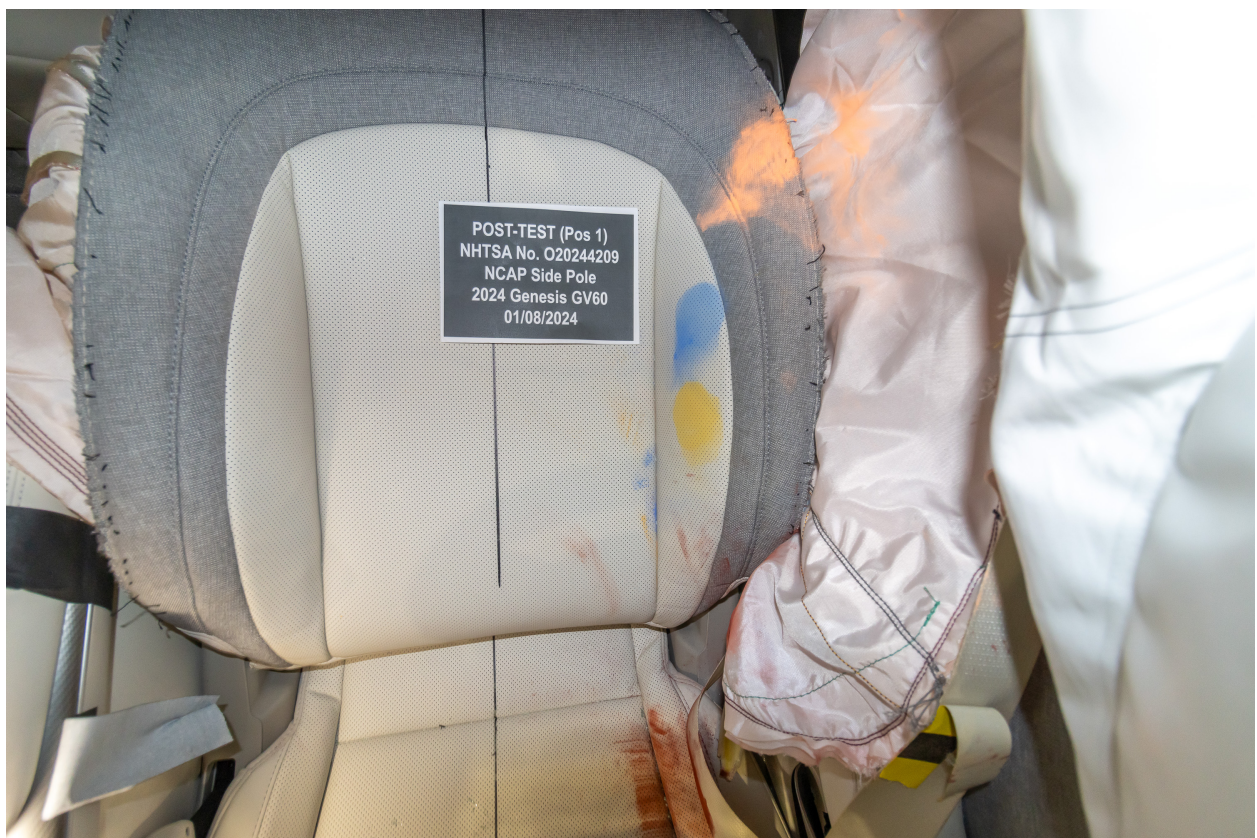
Figure A-48: Post-Test Dummy Close-Up Torso Contact with Vehicle Interior View

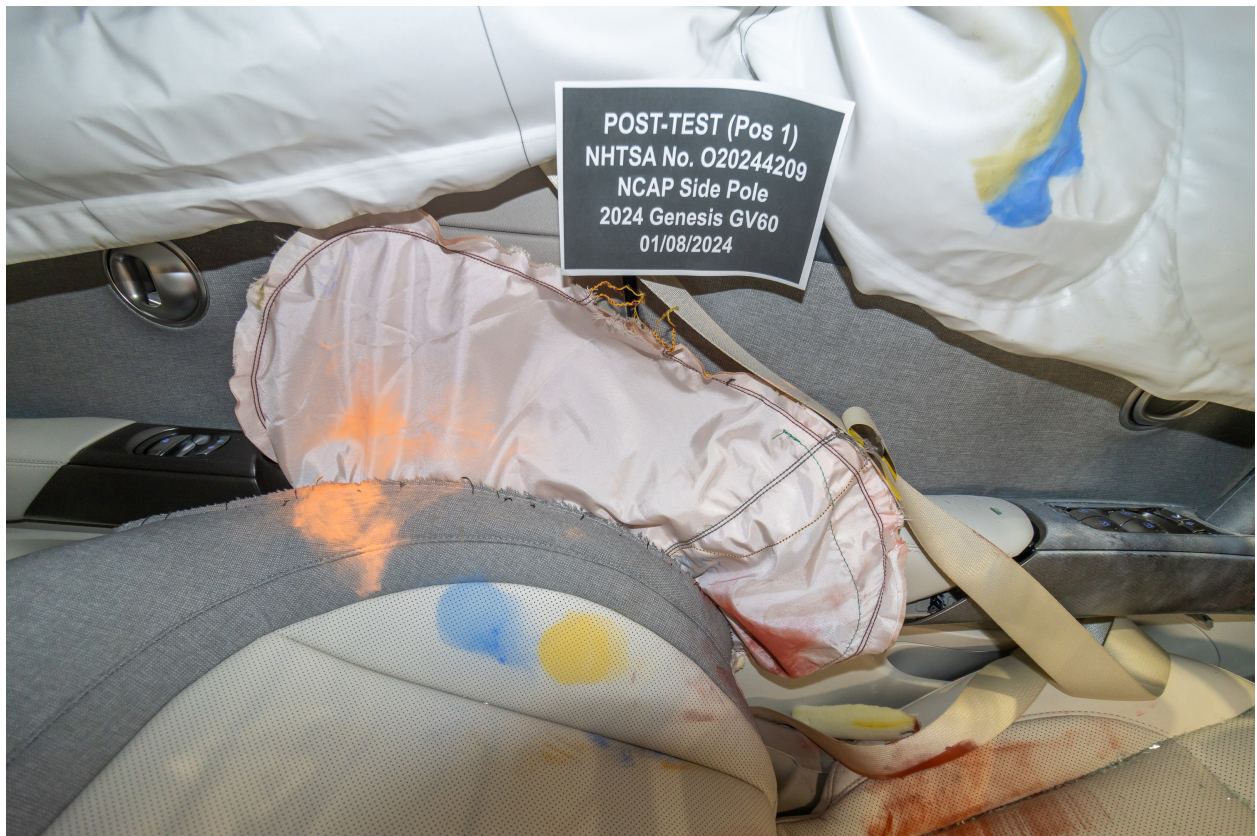
Figure A-49: Post-Test Dummy Close-Up Torso Contact with Side Airbag View

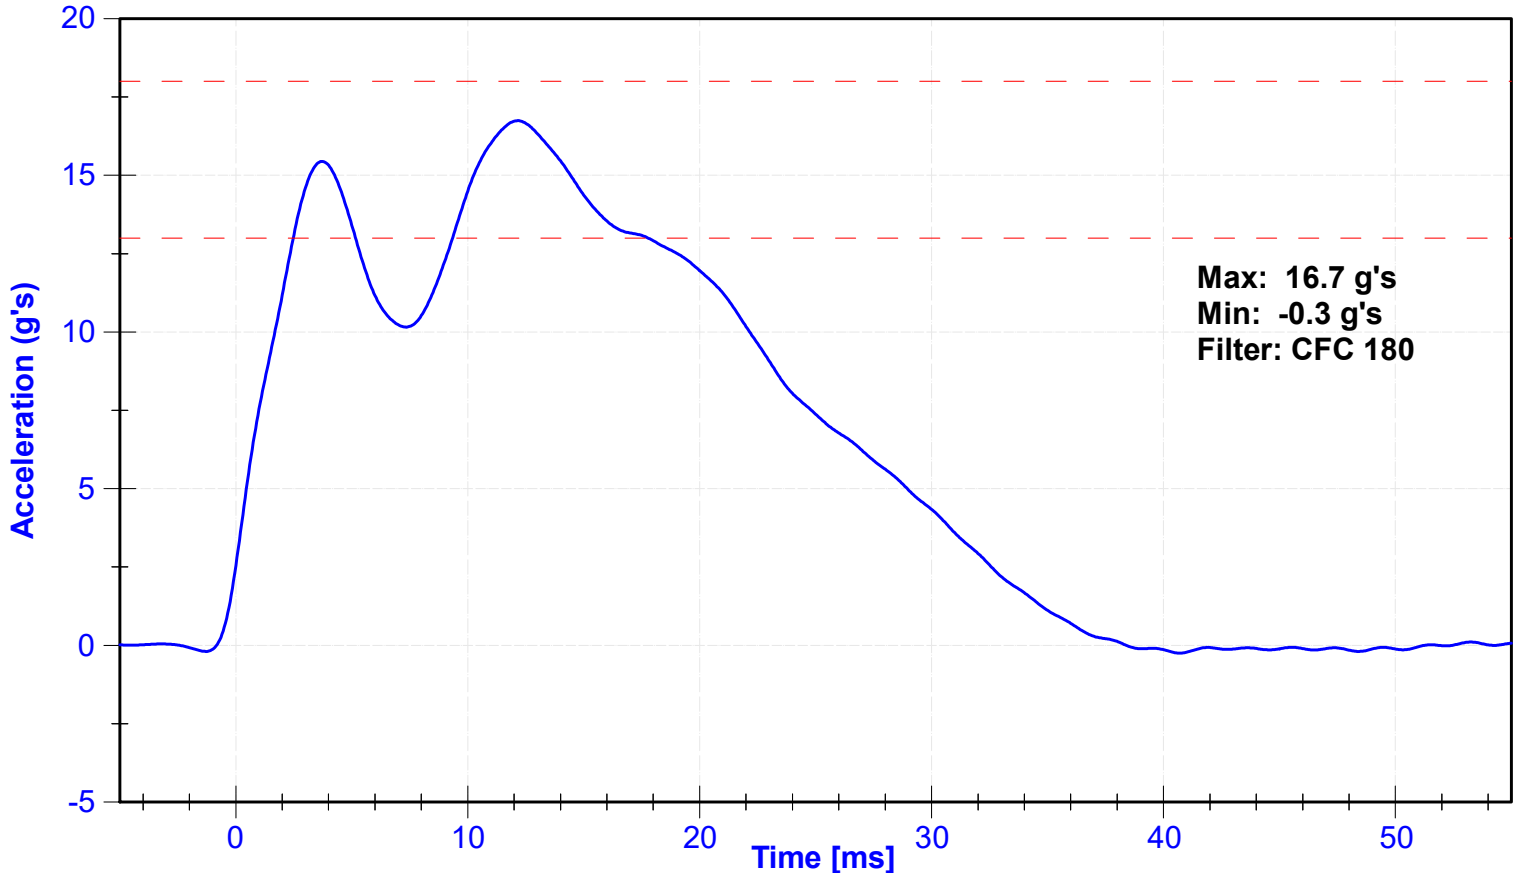
Test Parameter	Minimum Specification	Maximum Specification	Unit	Result	Pass/Fail
Temperature	20.6	22.2	°C	21.1	Pass
Humidity	10	70	%	40	Pass
Velocity	4.2	4.4	m/s	4.32	Pass
Probe Acceleration	13	18	g's	16.7	Pass
Shoulder Deflection	28	37	mm	28.0	Pass
Lateral Upper Spine Acceleration	17	22	g's	21.5	Pass

Probe Acceleration

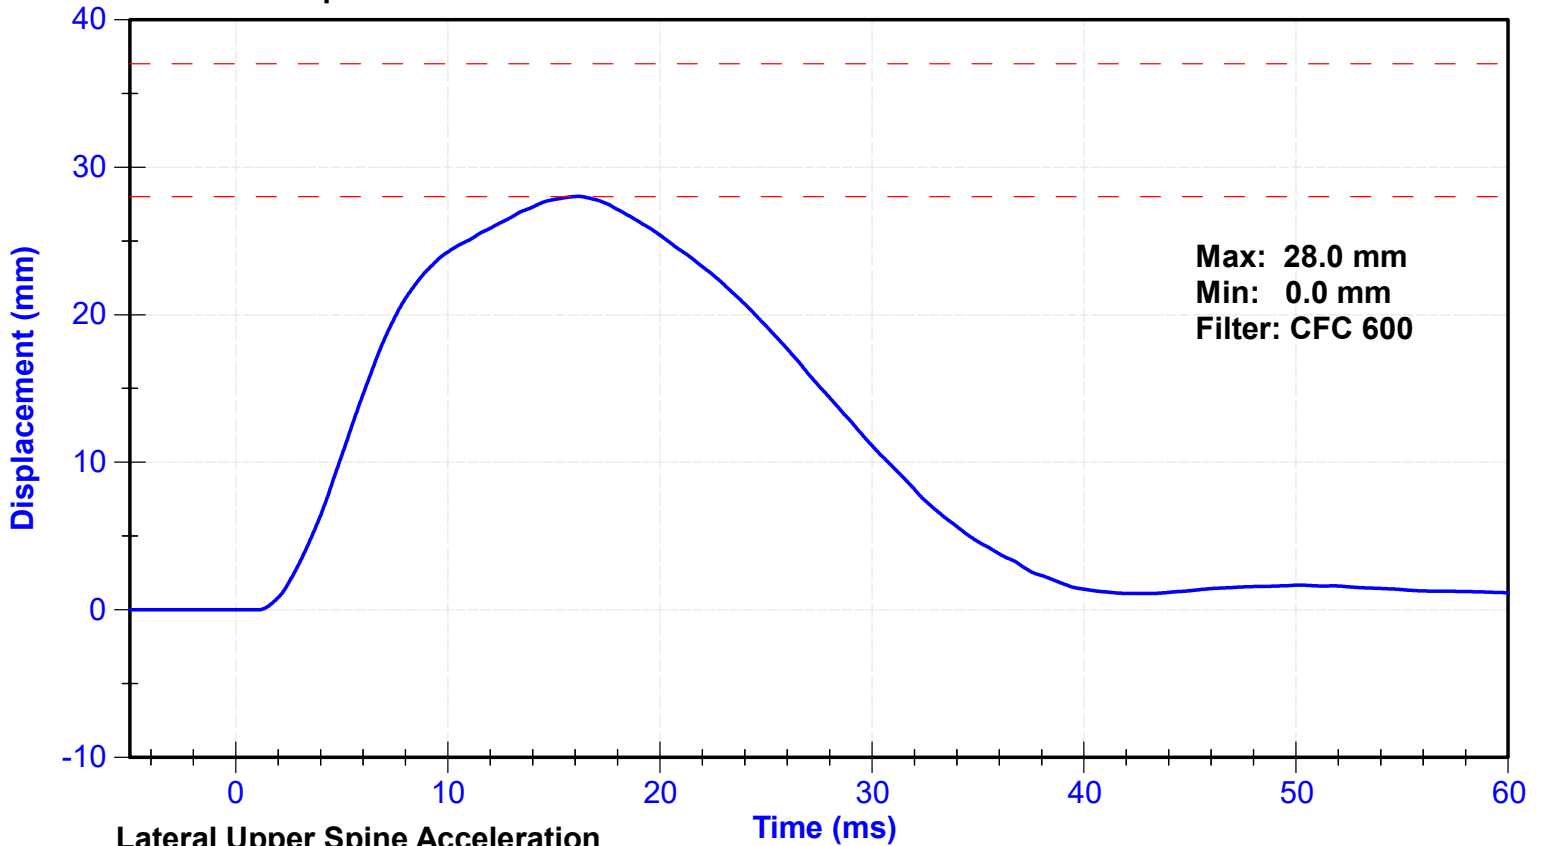
Shoulder Displacement

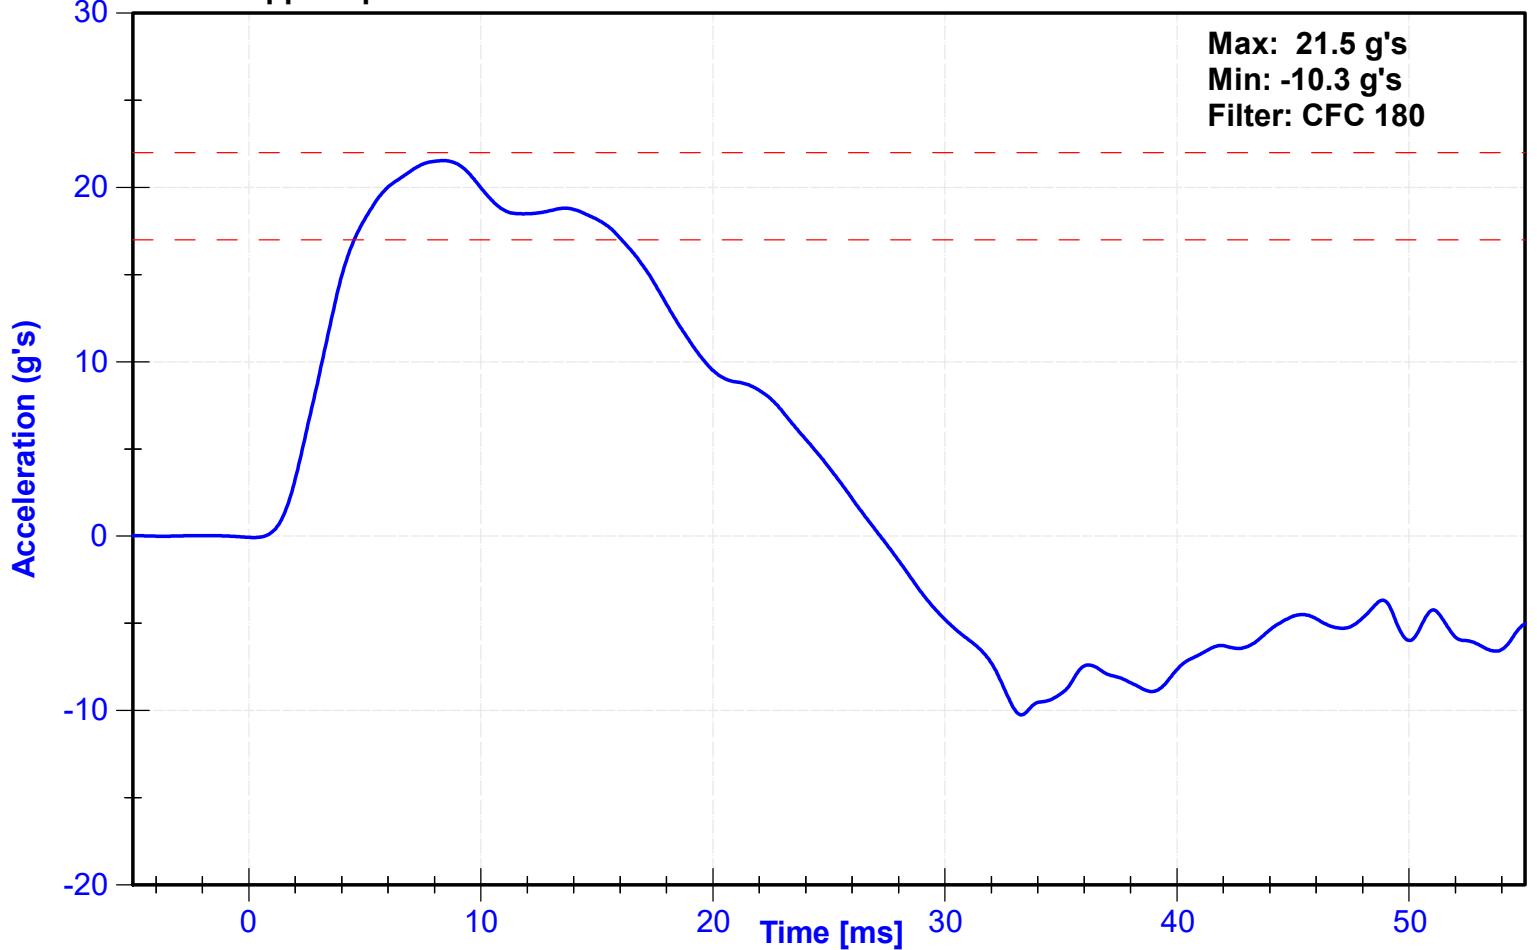
Lateral Upper Spine Acceleration

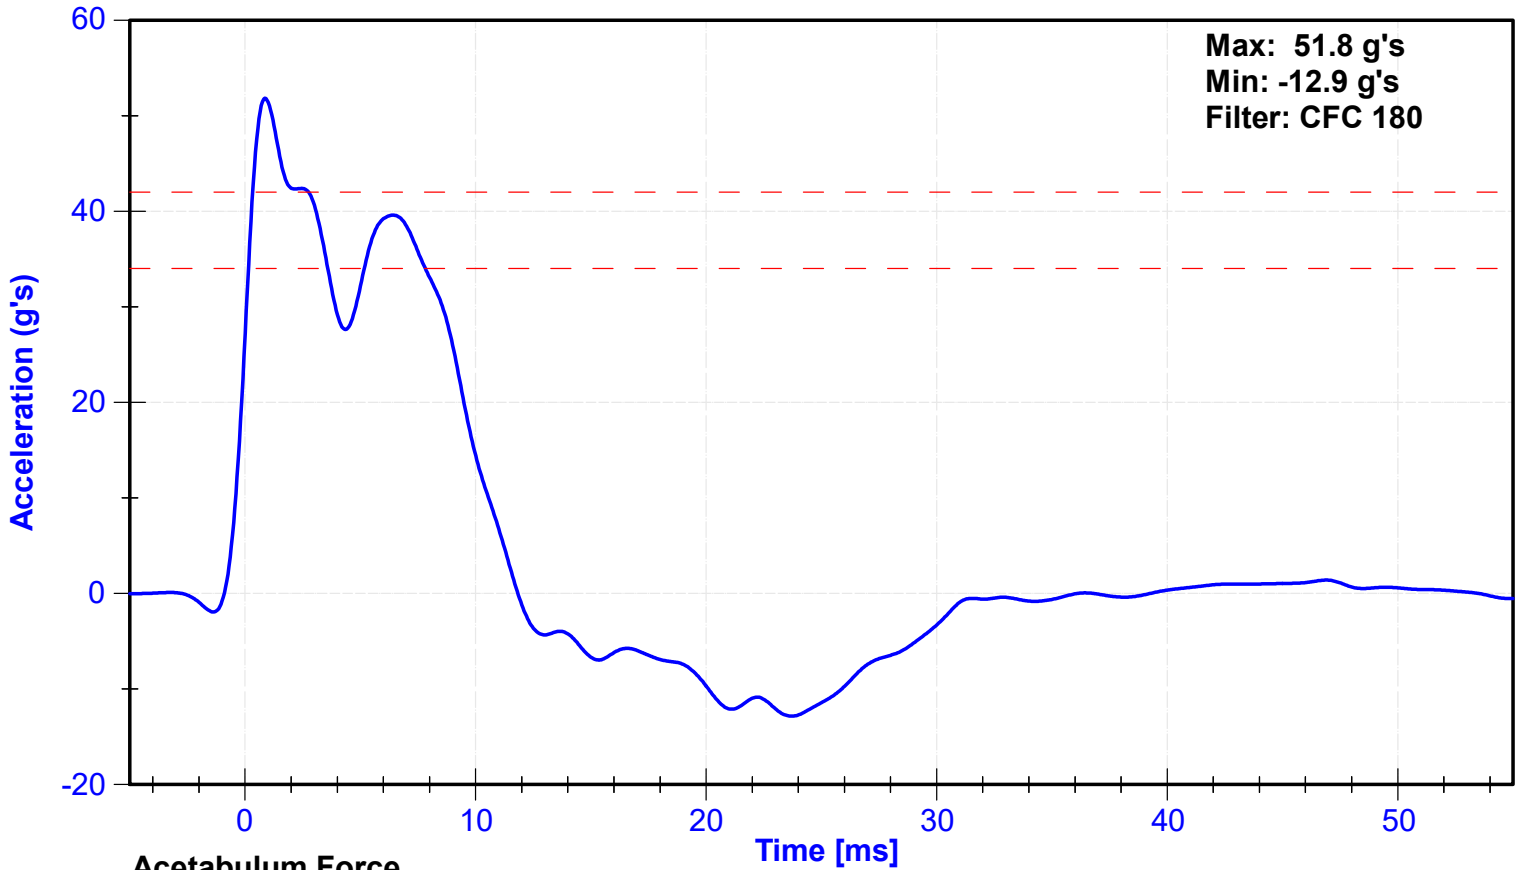
Test Parameter	Minimum Specification	Maximum Specification	Unit	Result	Pass/Fail
Temperature	20.6	22.2	°C	21.1	Pass
Humidity	10	70	%	40	Pass
Velocity	6.6	6.8	m/s	6.63	Pass
Probe Acceleration	38	47	g's	45.9	Pass
Lateral Pelvis Acceleration after 6ms	34	42	g's	39.6	Pass
Acetabulum Force	3600	4300	N	4159.1	Pass

Lateral Pelvis Acceleration

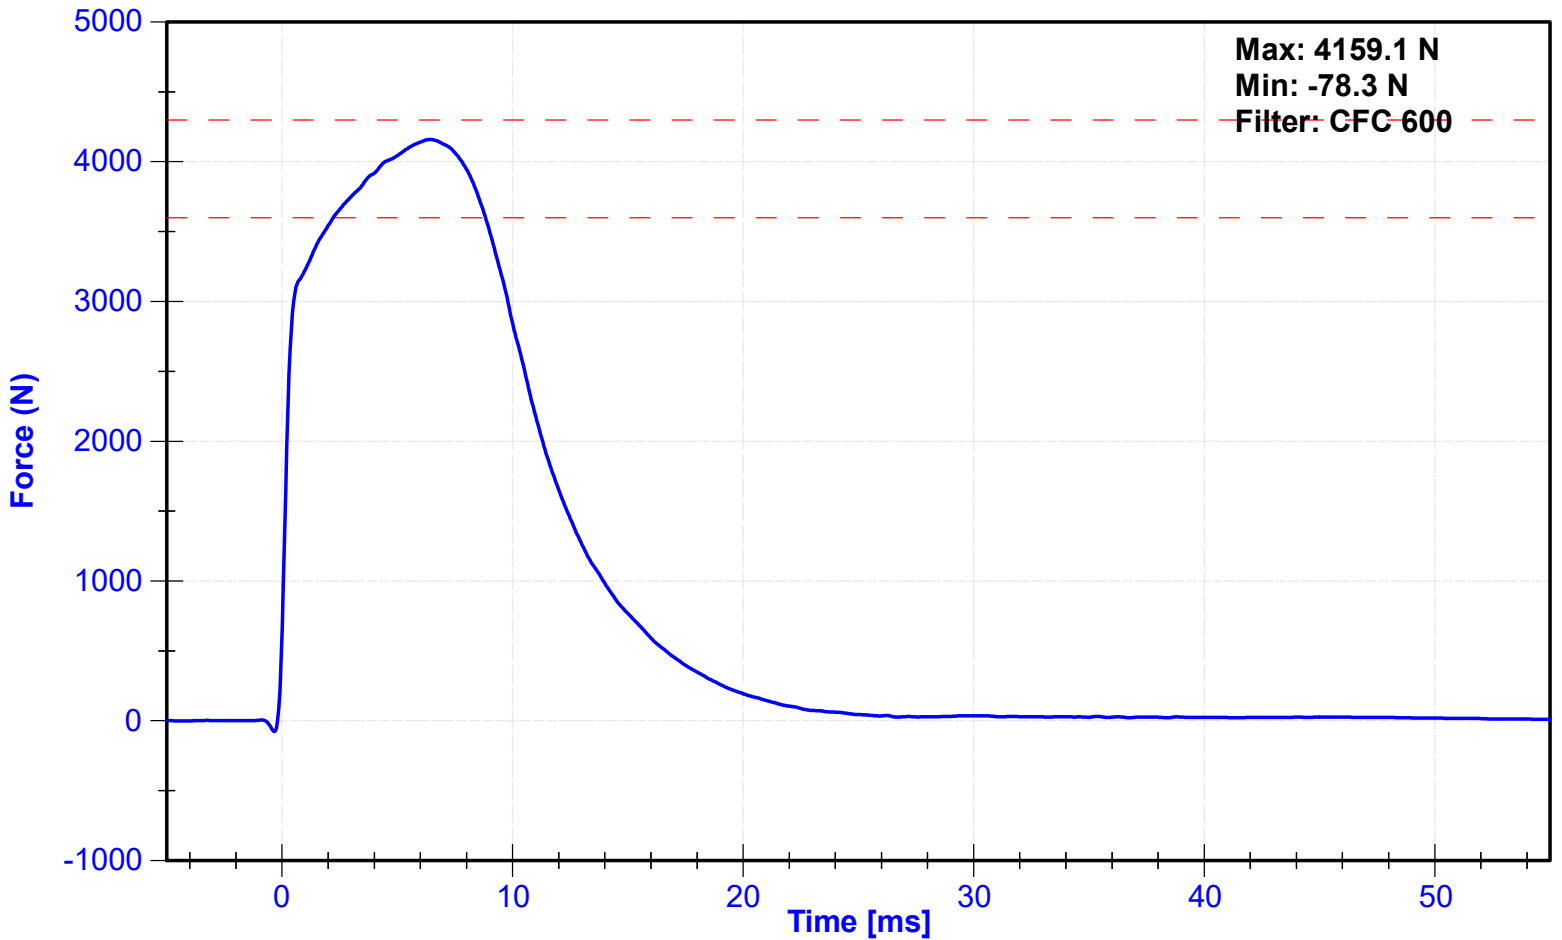
Acetabulum Force

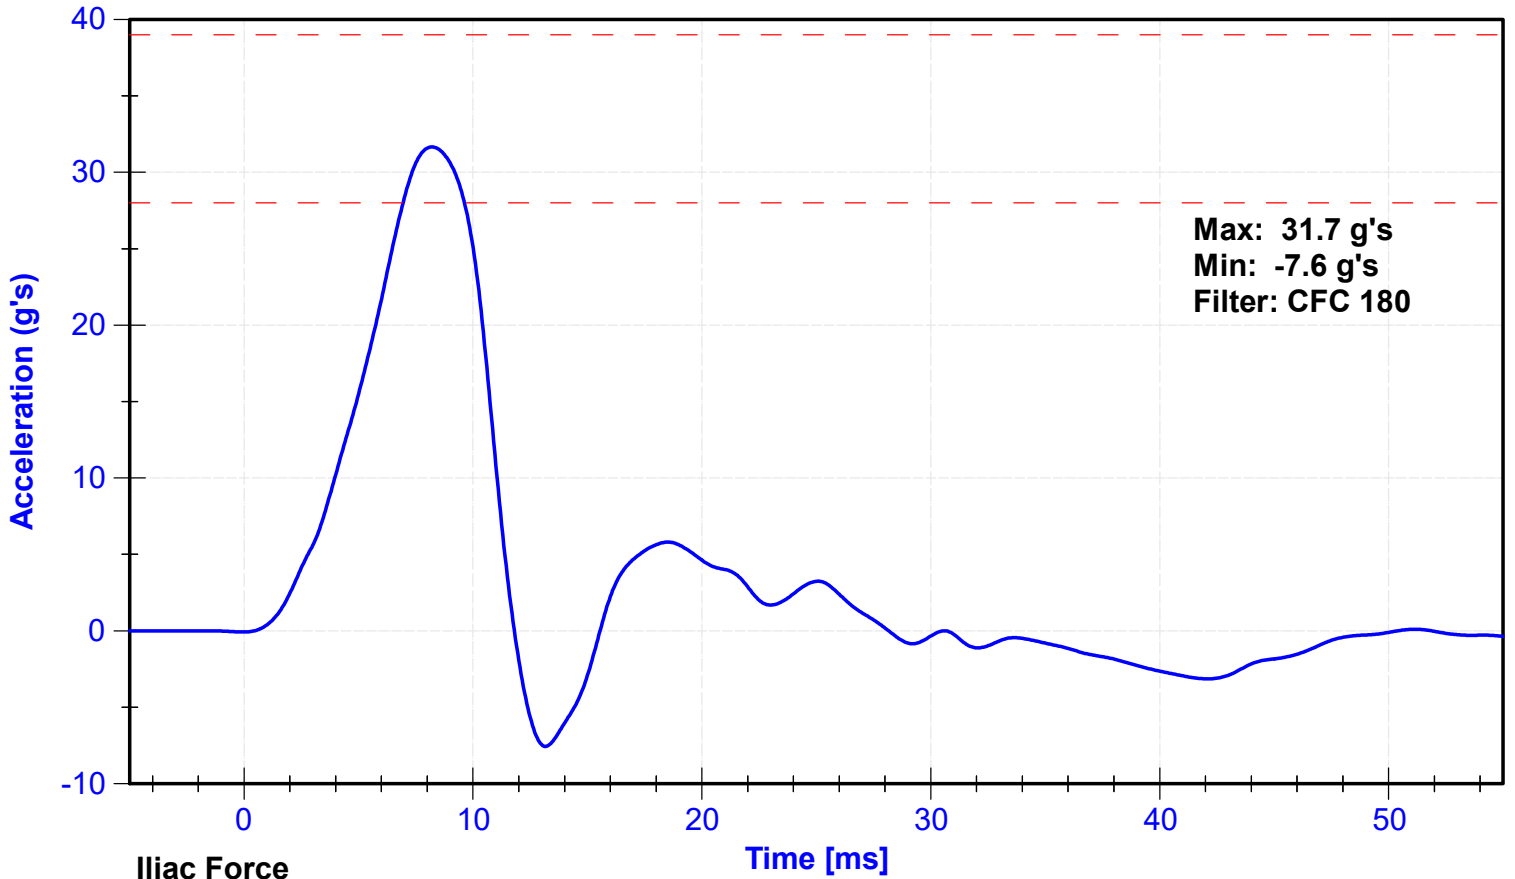
Test Parameter	Minimum Specification	Maximum Specification	Unit	Result	Pass/Fail
Temperature	20.6	22.2	°C	21.1	Pass
Humidity	10	70	%	40	Pass
Velocity	4.2	4.4	m/s	4.23	Pass
Probe Acceleration	36	45	g's	44.8	Pass
Lateral Pelvis Acceleration	28	39	g's	31.7	Pass
Iliac Force	4100	5100	N	4735.7	Pass

Lateral Pelvis Acceleration

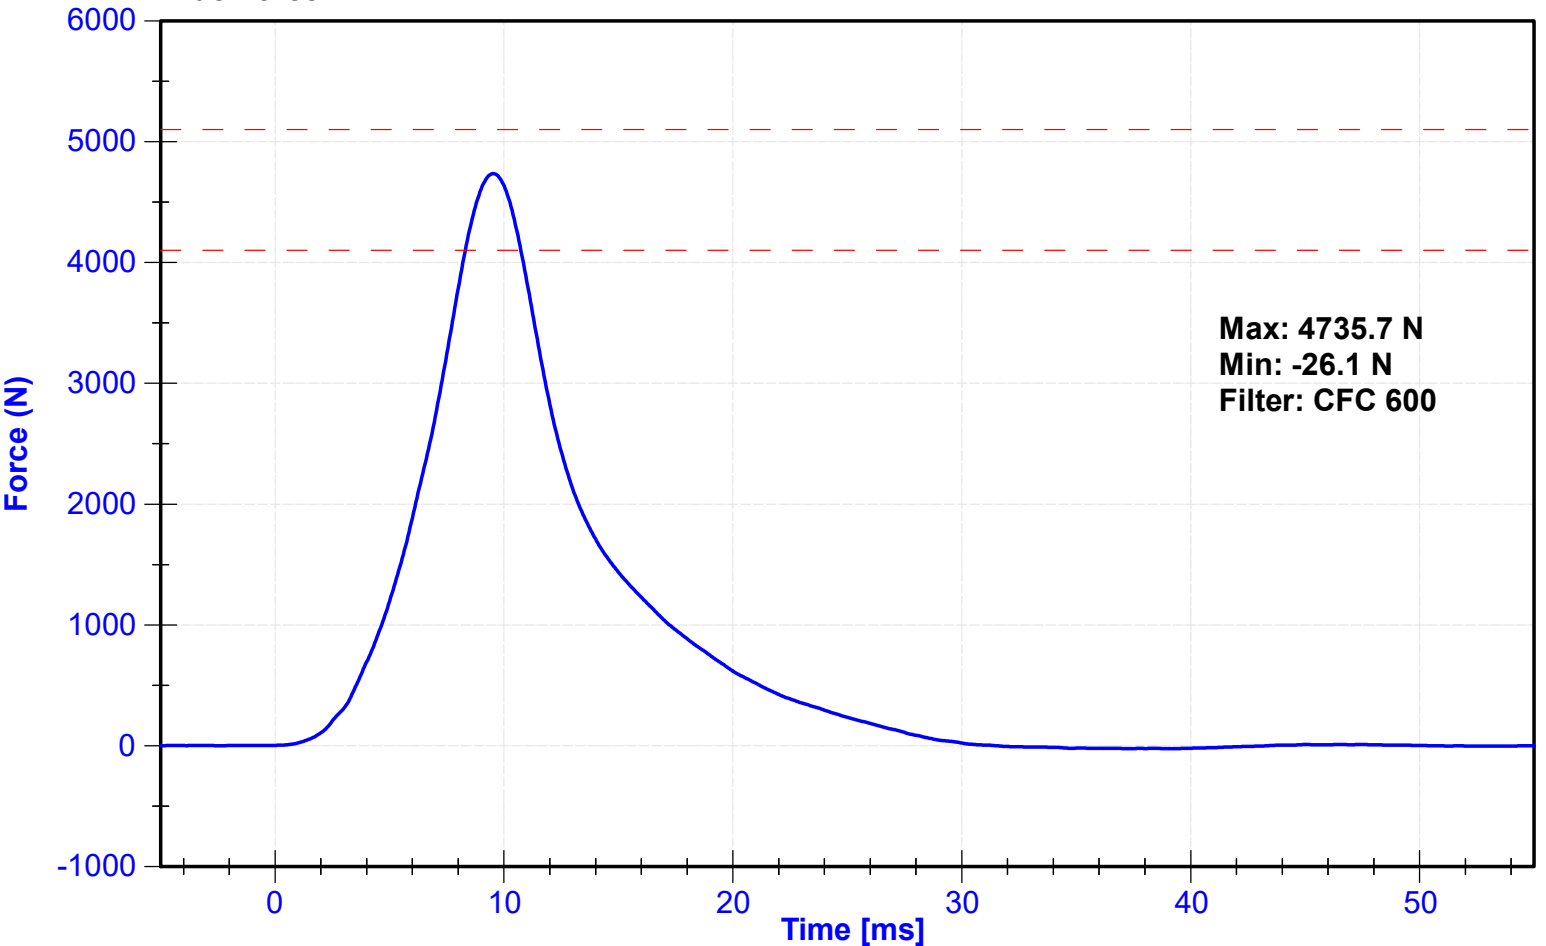
Iliac Force

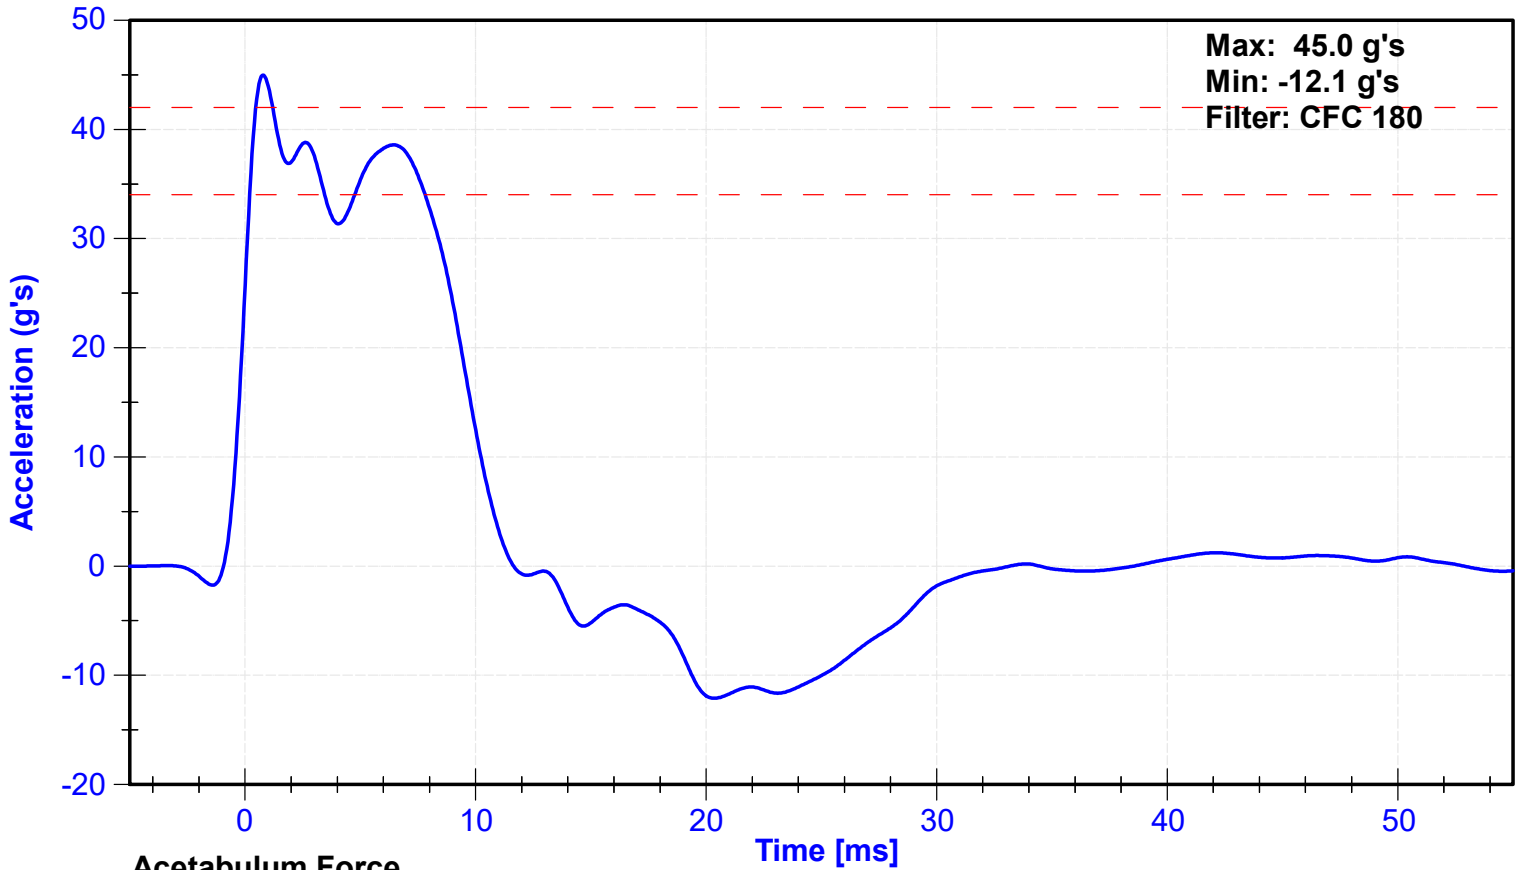
Test Parameter	Minimum Specification	Maximum Specification	Unit	Result	Pass/Fail
Temperature	20.6	22.2	°C	20.9	Pass
Humidity	10	70	%	28	Pass
Velocity	6.6	6.8	m/s	6.67	Pass
Probe Acceleration	38	47	g's	46.4	Pass
Lateral Pelvis Acceleration after 6ms	34	42	g's	38.6	Pass
Acetabulum Force	3600	4300	N	4011.1	Pass

Lateral Pelvis Acceleration
