REPORT NUMBER: 214D-CAL-24-002

**NEW CAR ASSESSMENT PROGRAM (NCAP)
SIDE IMPACT POLE TEST**

**Hyundai Motor Company
2024 Genesis GV60
5 Door SUV**

NHTSA No: O20244209

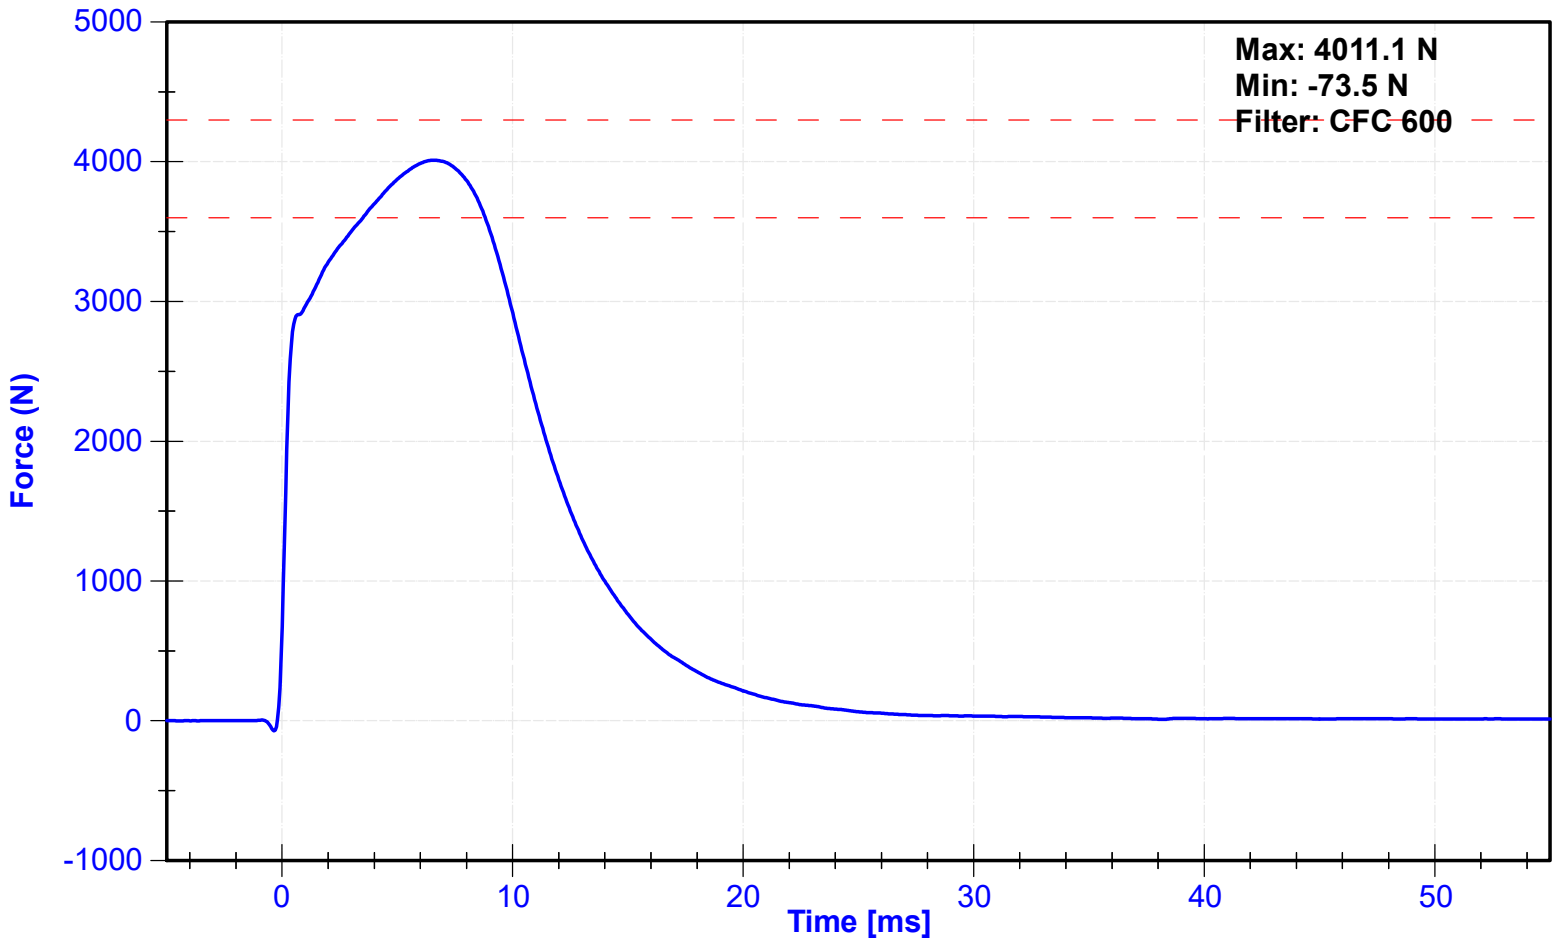
Test Parameter	Minimum Specification	Maximum Specification	Unit	Result	Pass/Fail
Temperature	20.6	22.2	°C	20.9	Pass
Humidity	10	70	%	28	Pass
Velocity	6.6	6.8	m/s	6.67	Pass
Probe Acceleration	38	47	g's	46.4	Pass
Lateral Pelvis Acceleration after 6ms	34	42	g's	38.6	Pass
Acetabulum Force	3600	4300	N	4011.1	Pass

Acetabulum Force

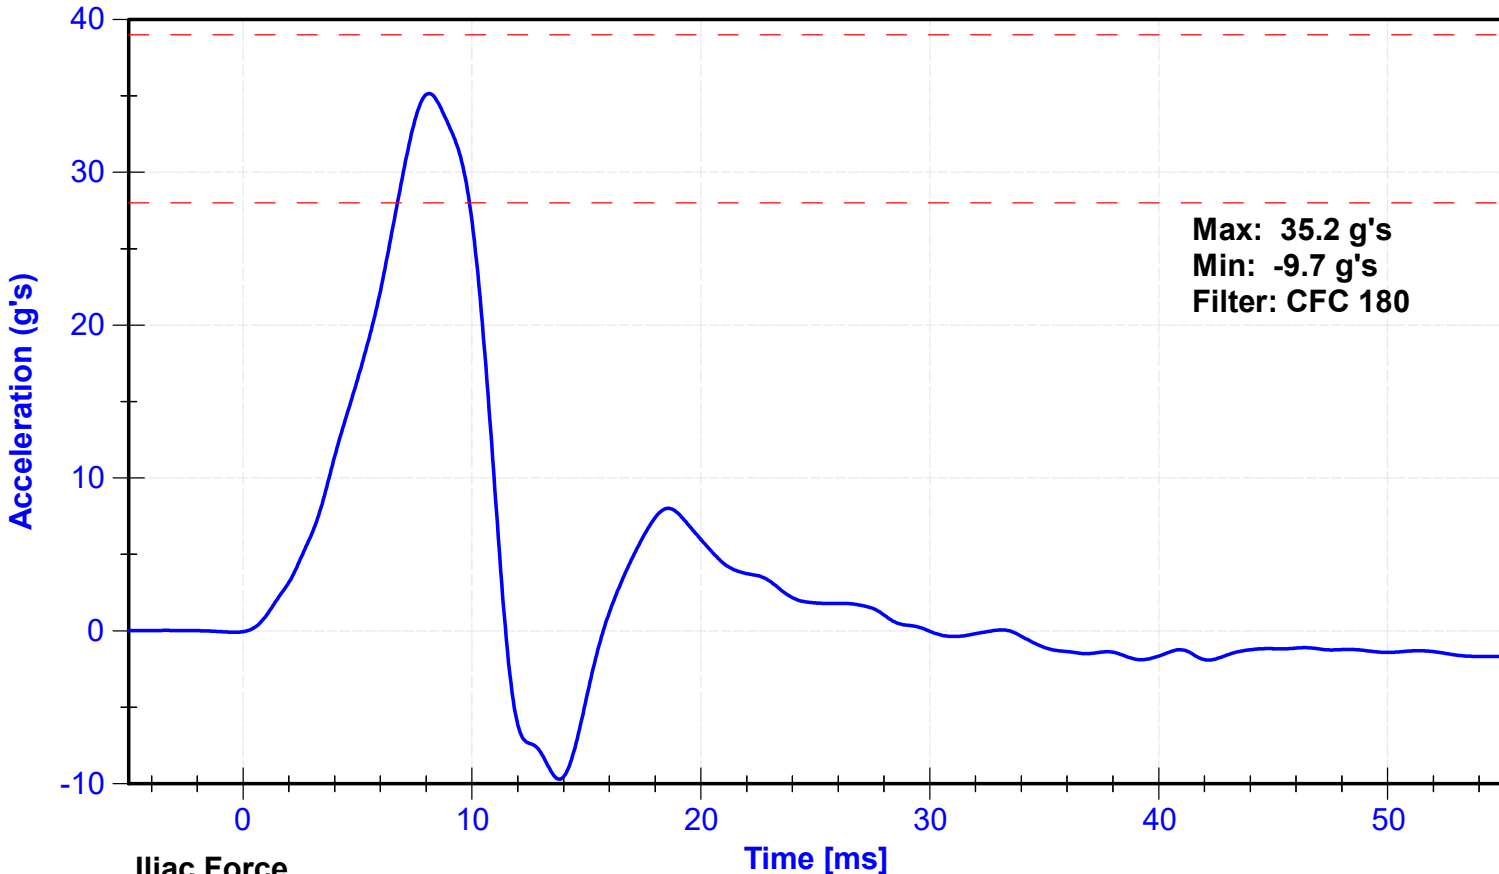
Test Parameter	Minimum Specification	Maximum Specification	Unit	Result	Pass/Fail
Temperature	20.6	22.2	°C	20.9	Pass
Humidity	10	70	%	28	Pass
Velocity	4.2	4.4	m/s	4.28	Pass
Probe Acceleration	36	45	g's	44.9	Pass
Lateral Pelvis Acceleration	28	39	g's	35.2	Pass
Iliac Force	4100	5100	N	4943.3	Pass

Lateral Pelvis Acceleration

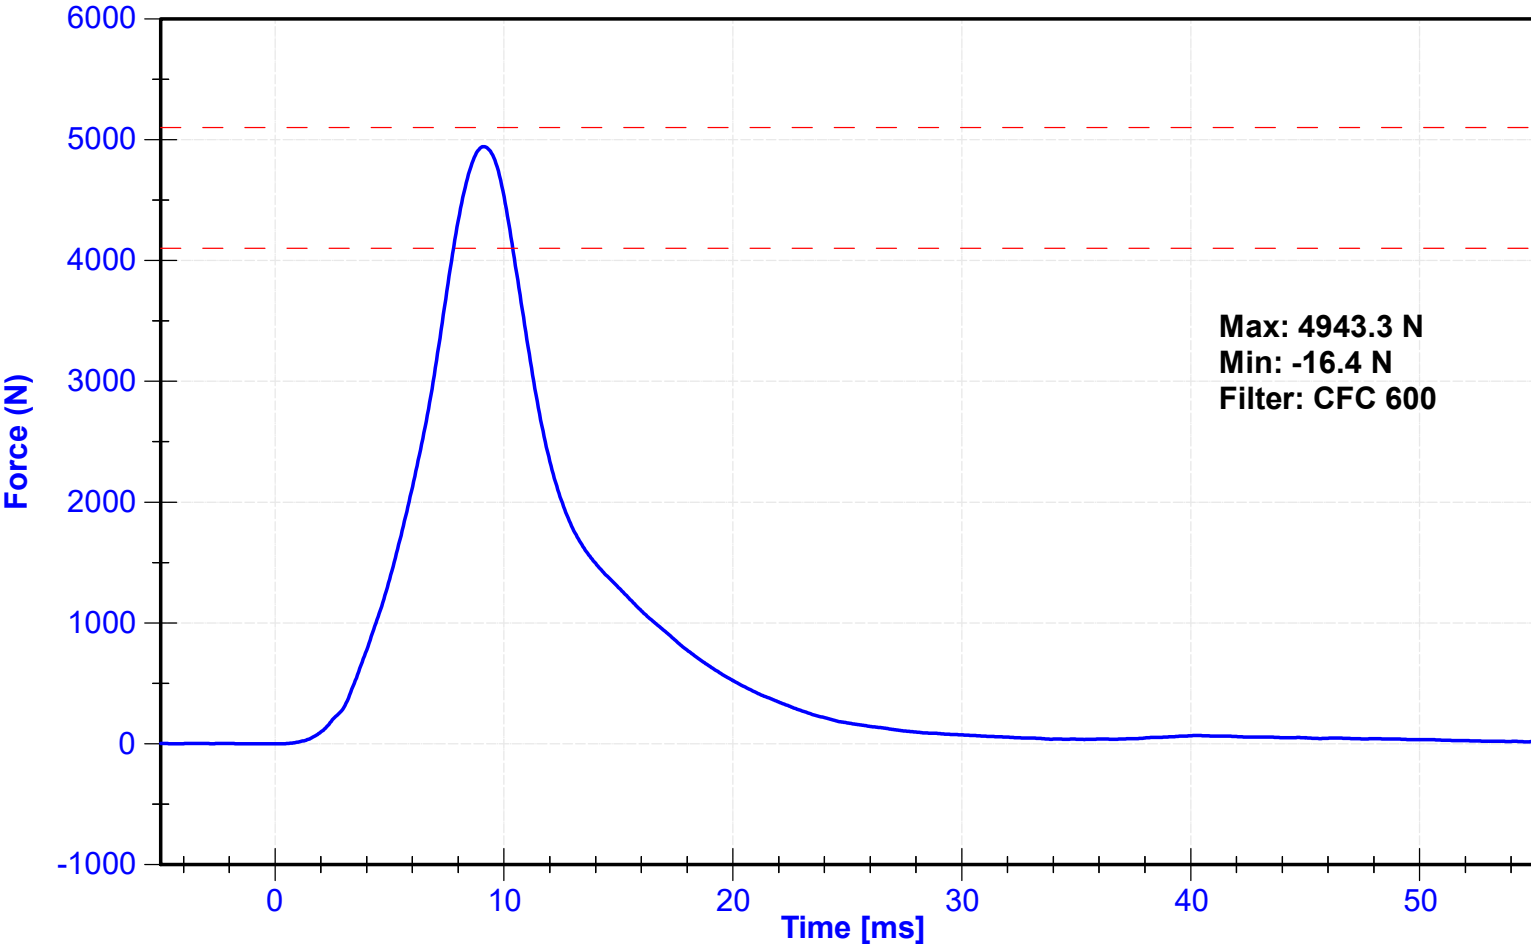
Iliac Force
