**REPORT NUMBER: SideNCAPMDB-MGA-23-028**

**NEW CAR ASSESSMENT PROGRAM (NCAP)  
Moving Deformable Barrier Side Impact Test**

**HONDA DEVELOPMENT & MANUFACTURING OF AMERICA, LLC  
2023 Honda Pilot EX-L 5-Door SUV  
NHTSA No.: O20235314**

**MGA RESEARCH CORPORATION  
5000 Warren Road  
Burlington, WI 53105**

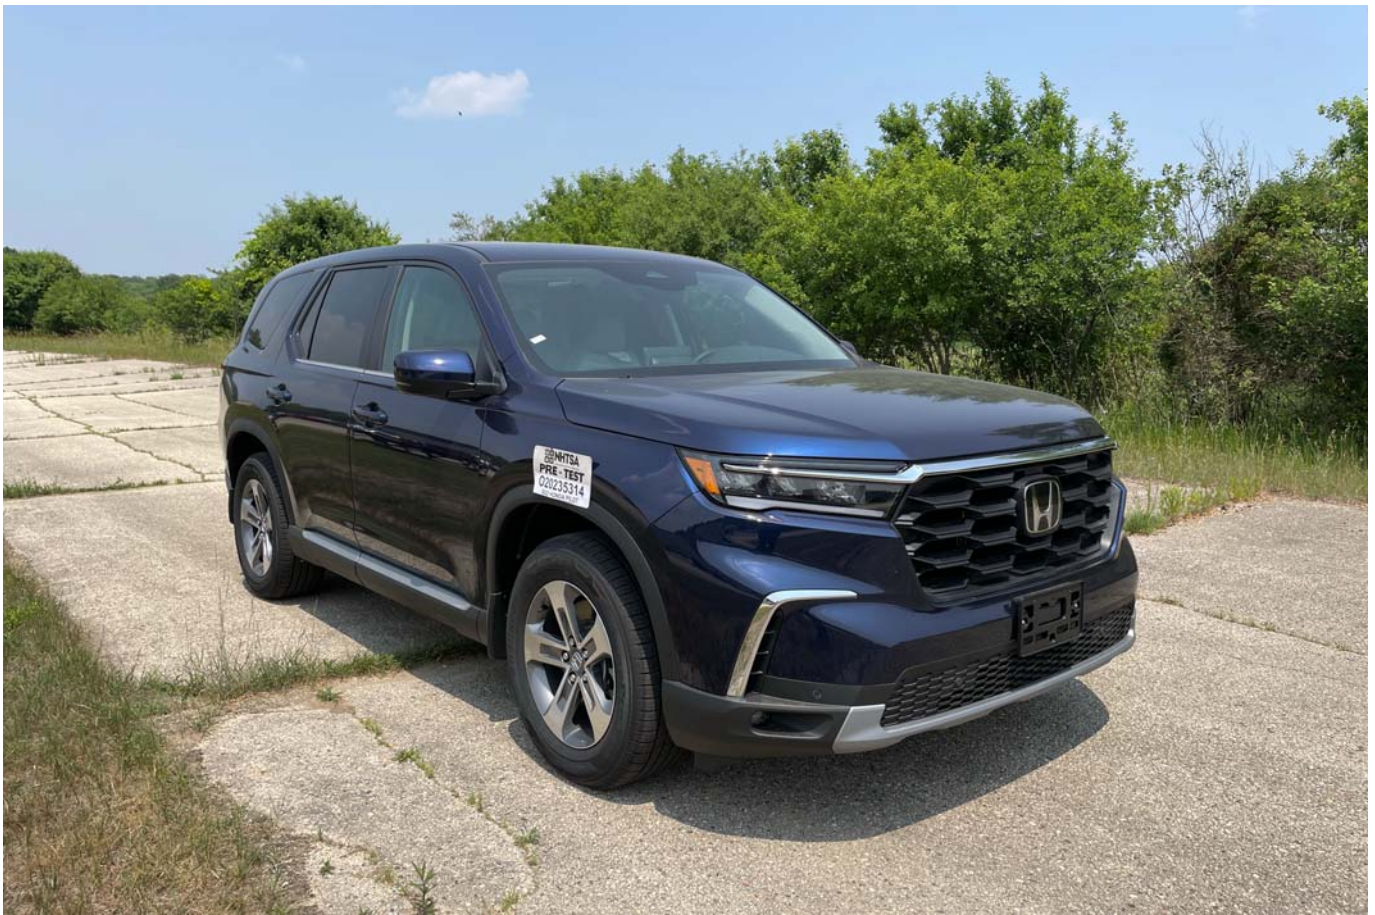
Photo No. 001 - As Delivered Right Front Three-Quarter View of Test Vehicle

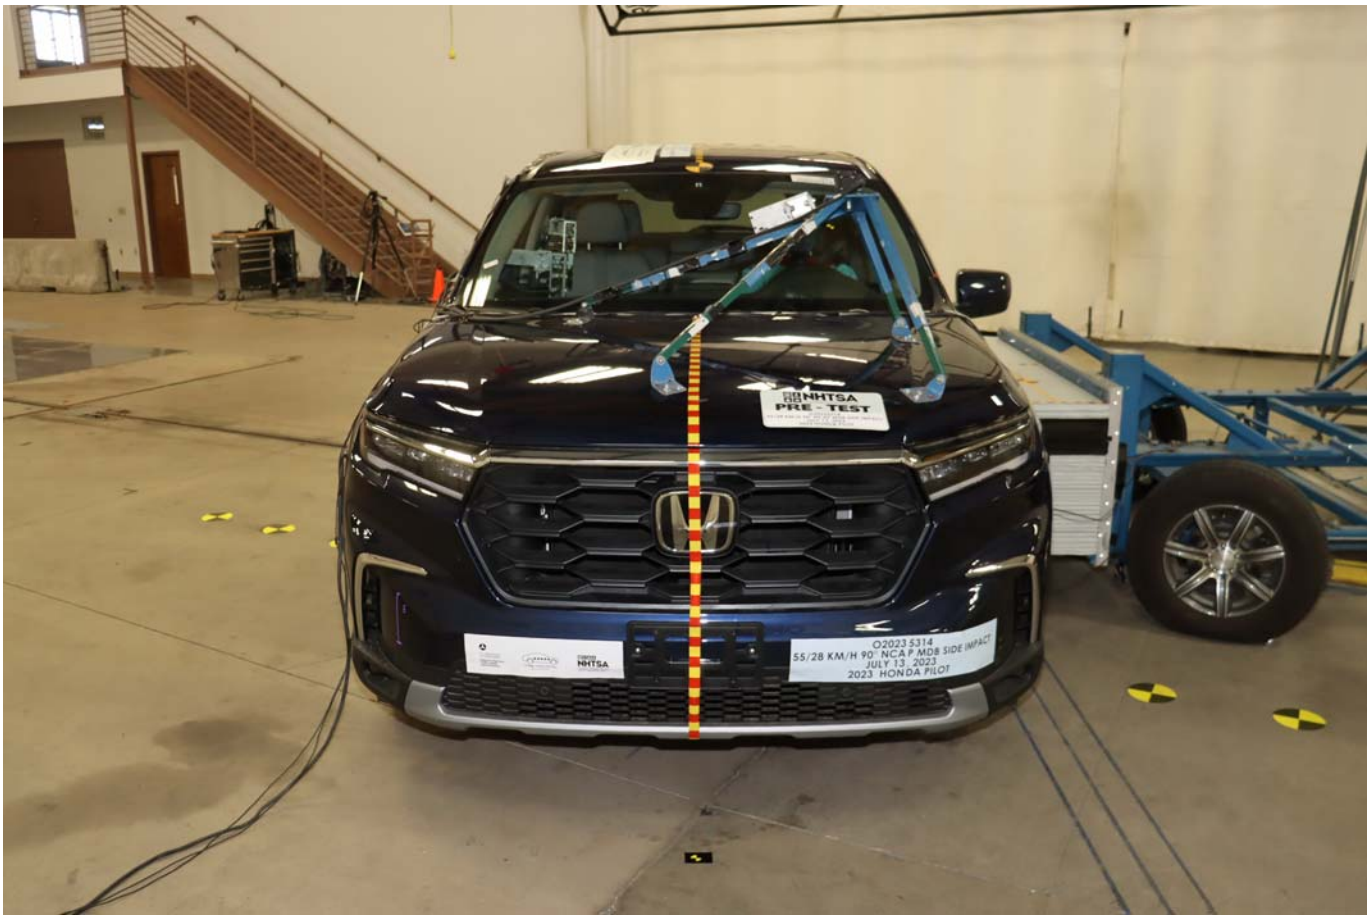
Photo No. 003 - Pre-Test Frontal View of Test Vehicle

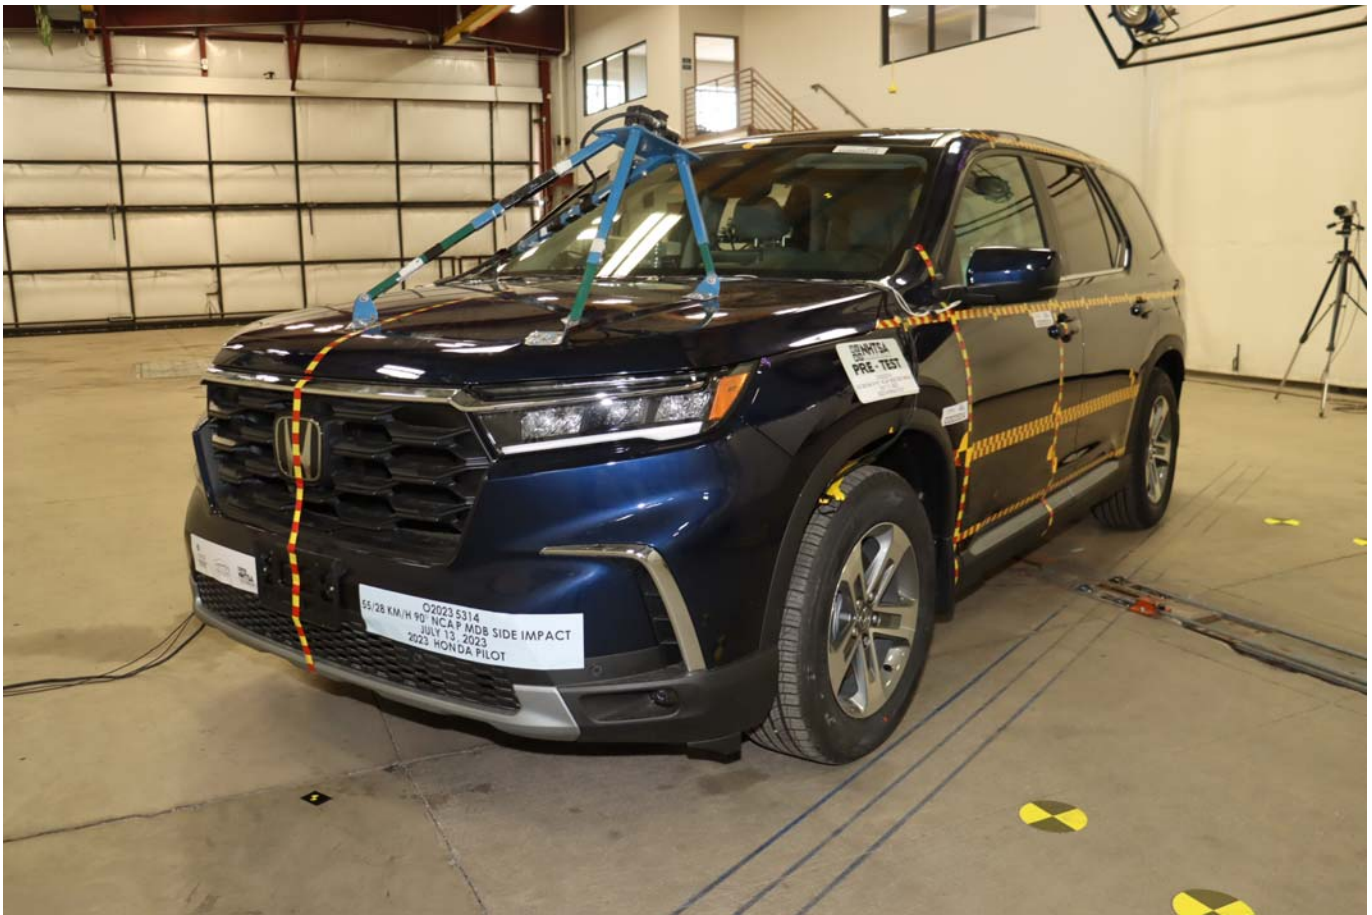
Photo No. 005 - Pre-Test Left Front Three-Quarter View of Test Vehicle

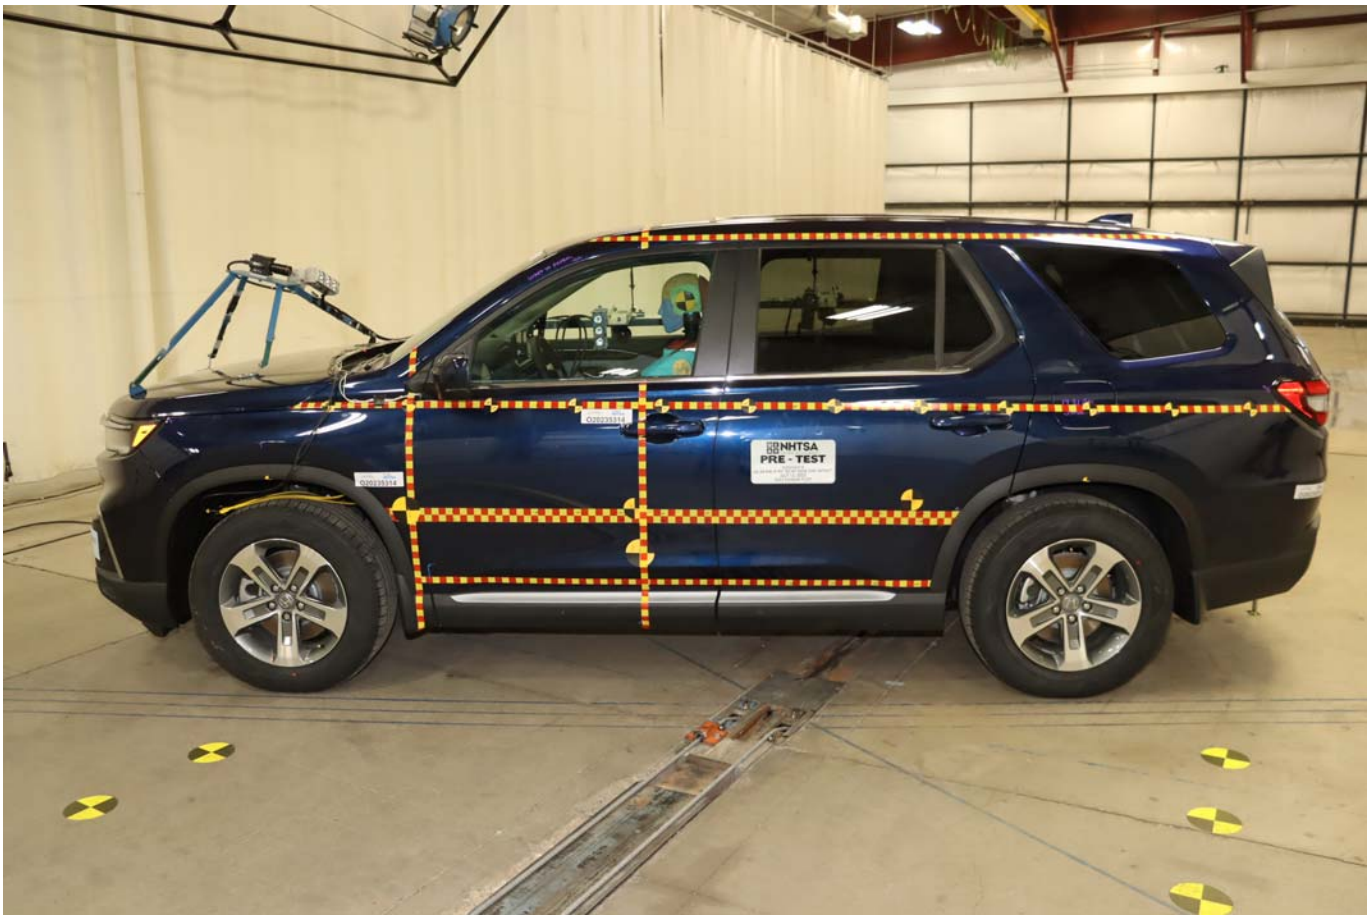
Photo No. 007 - Pre-Test Left Side View of Test Vehicle

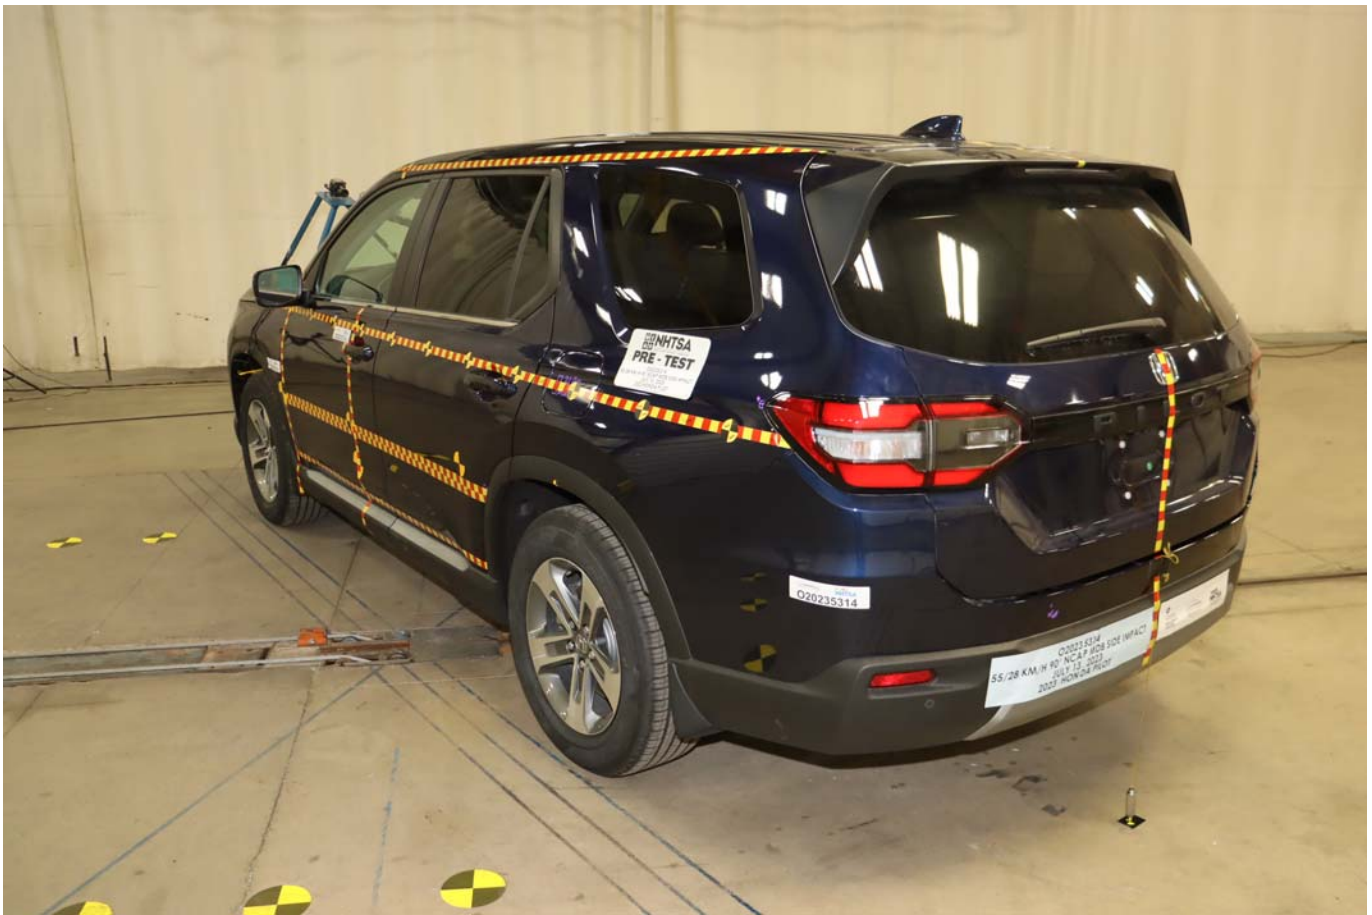
Photo No. 009 - Pre-Test Left Three-Quarter Rear View of Test Vehicle

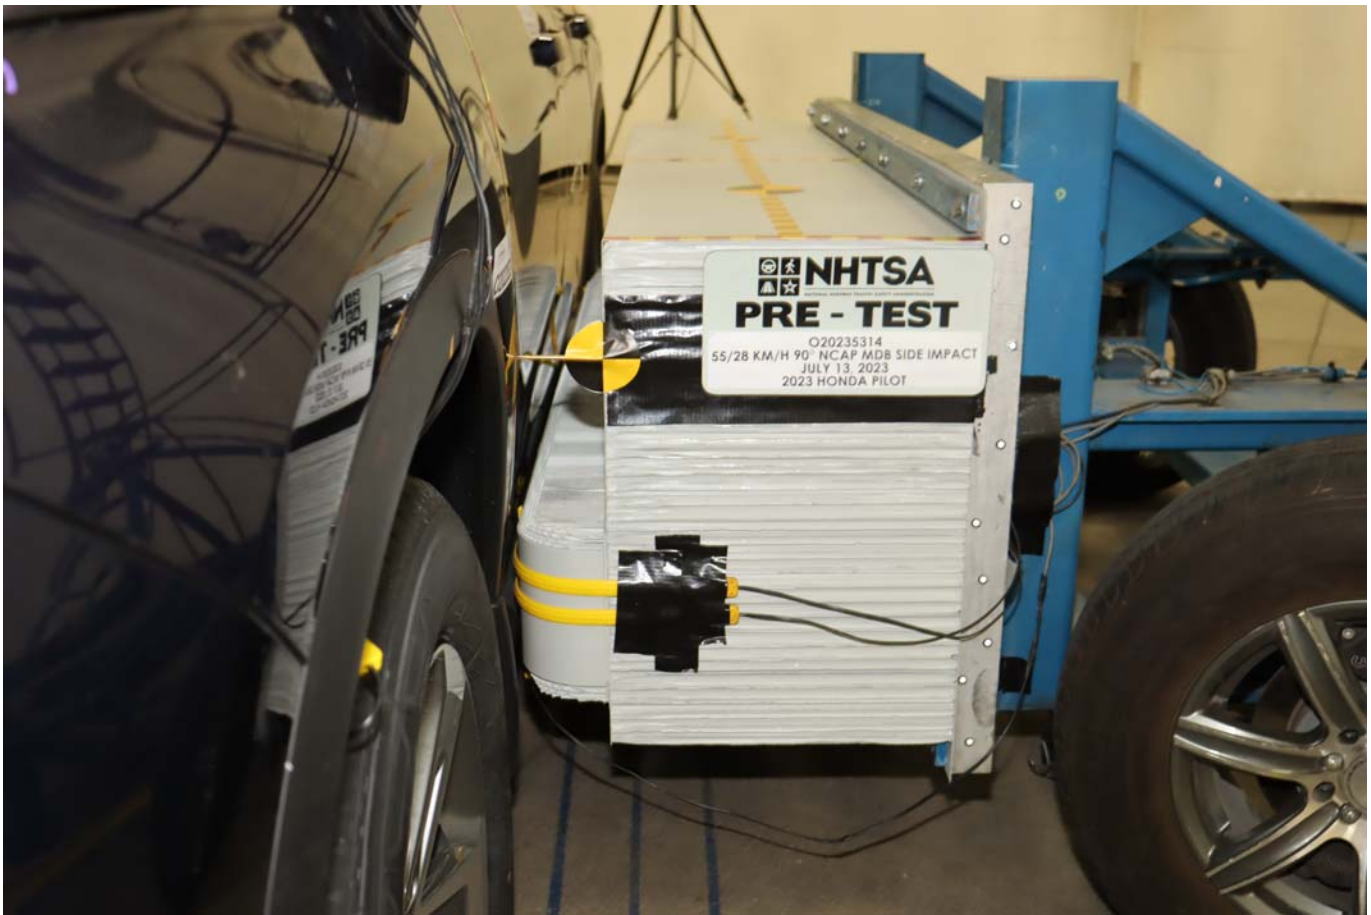
Photo No. 017 - Pre-Test Left Side View of MDB Positioned Against Side of Test Vehicle

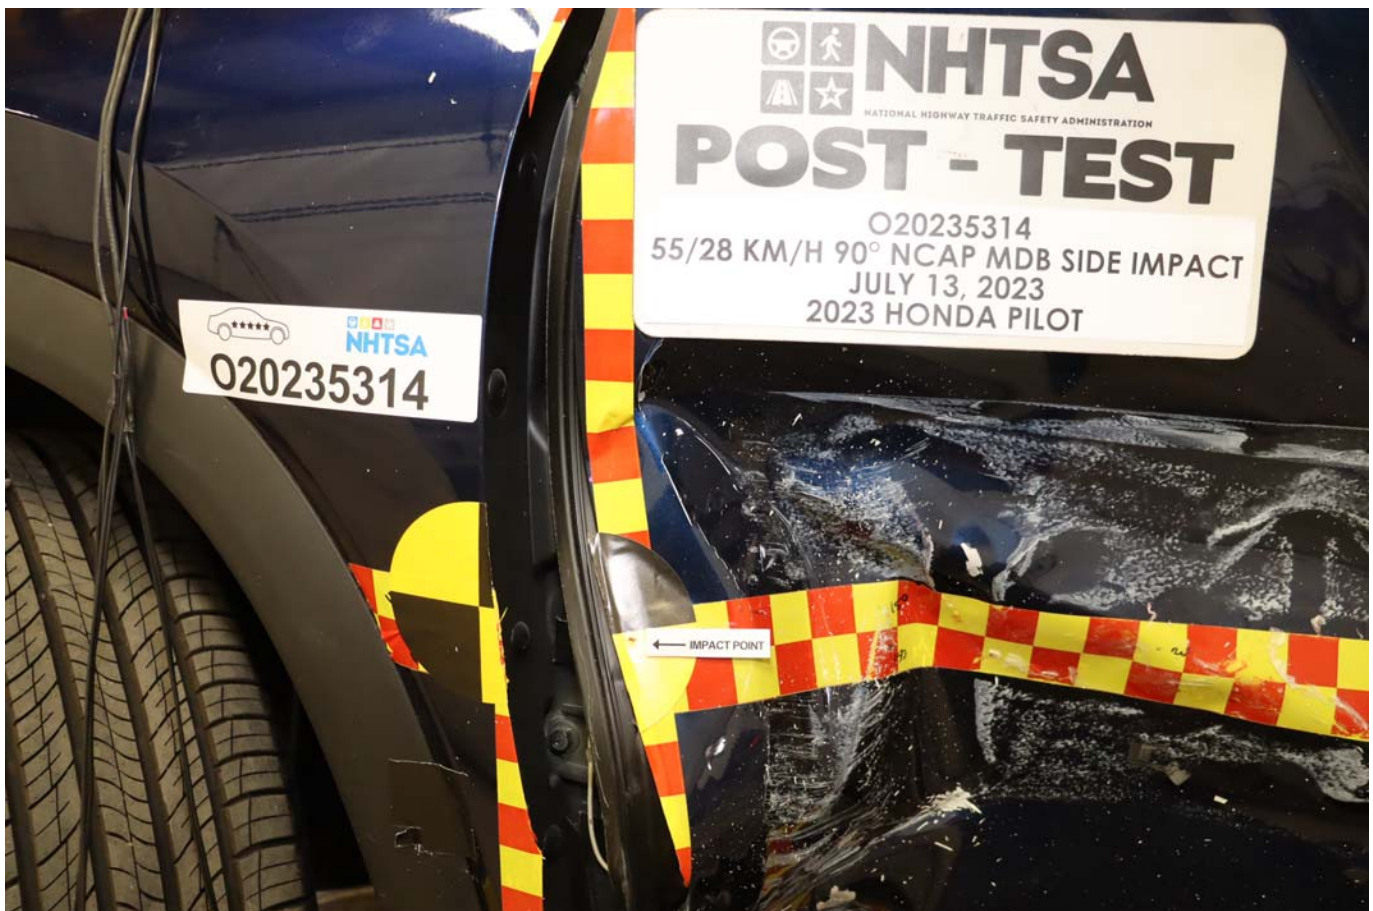
Photo No. 020 - Post-Test Close-Up View of Impact Point Target

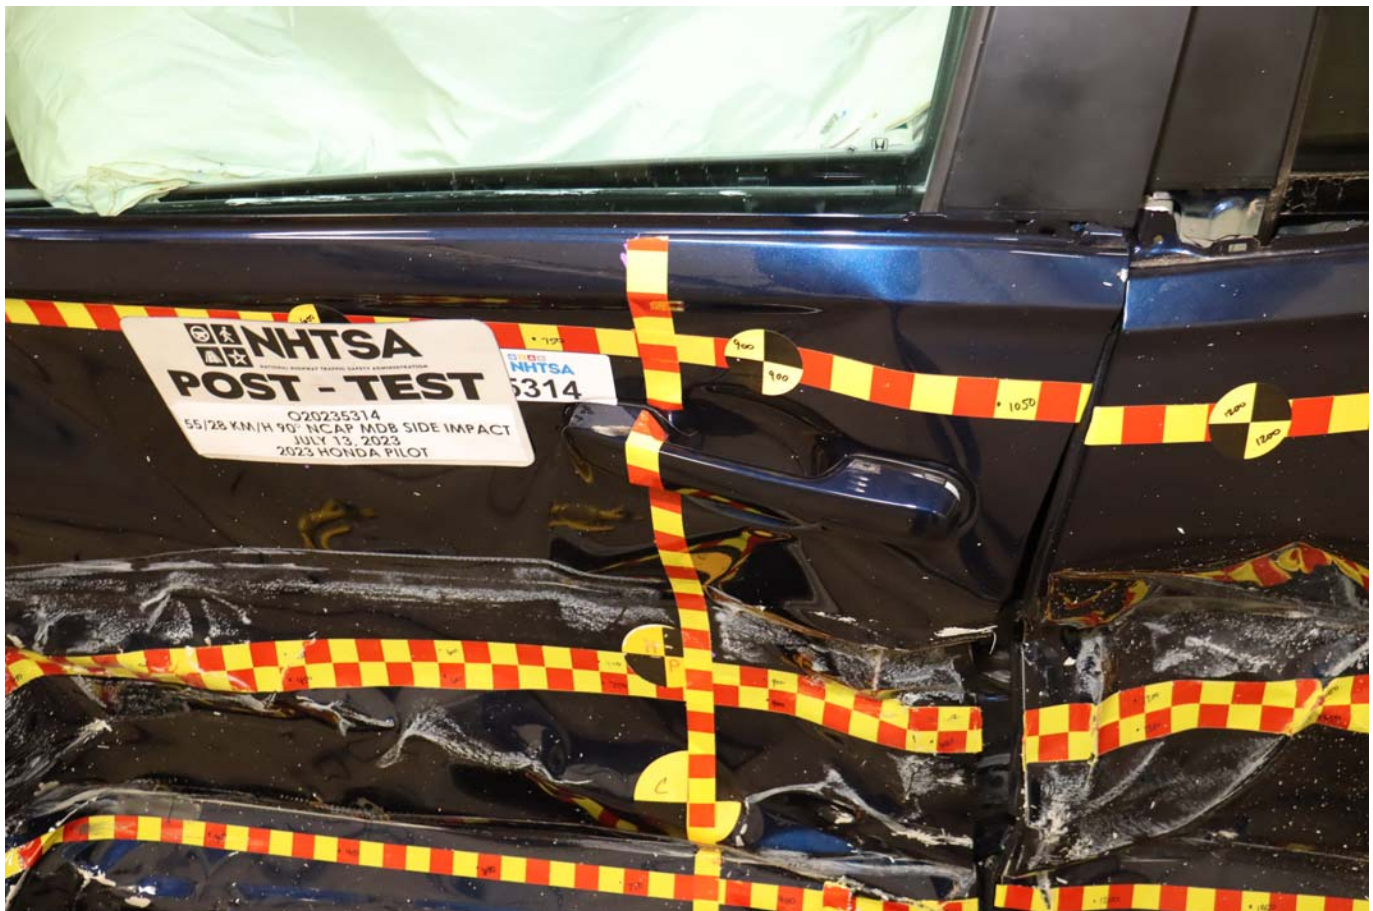
Photo No. 022 - Post-Test Left Front Door Latch Close-Up

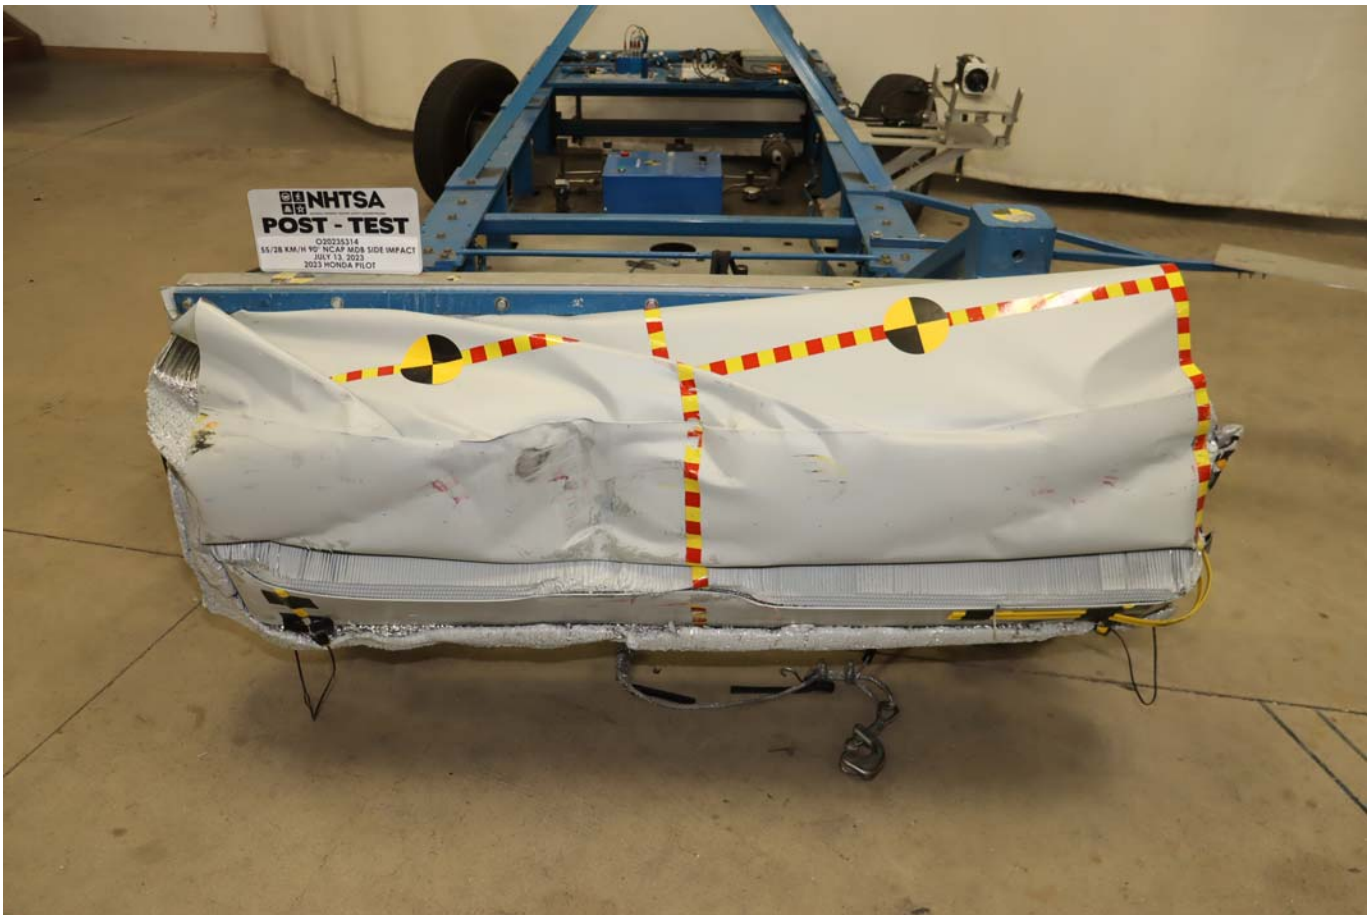
Photo No. 085 - Post-Test Front View of MDB Impactor Face

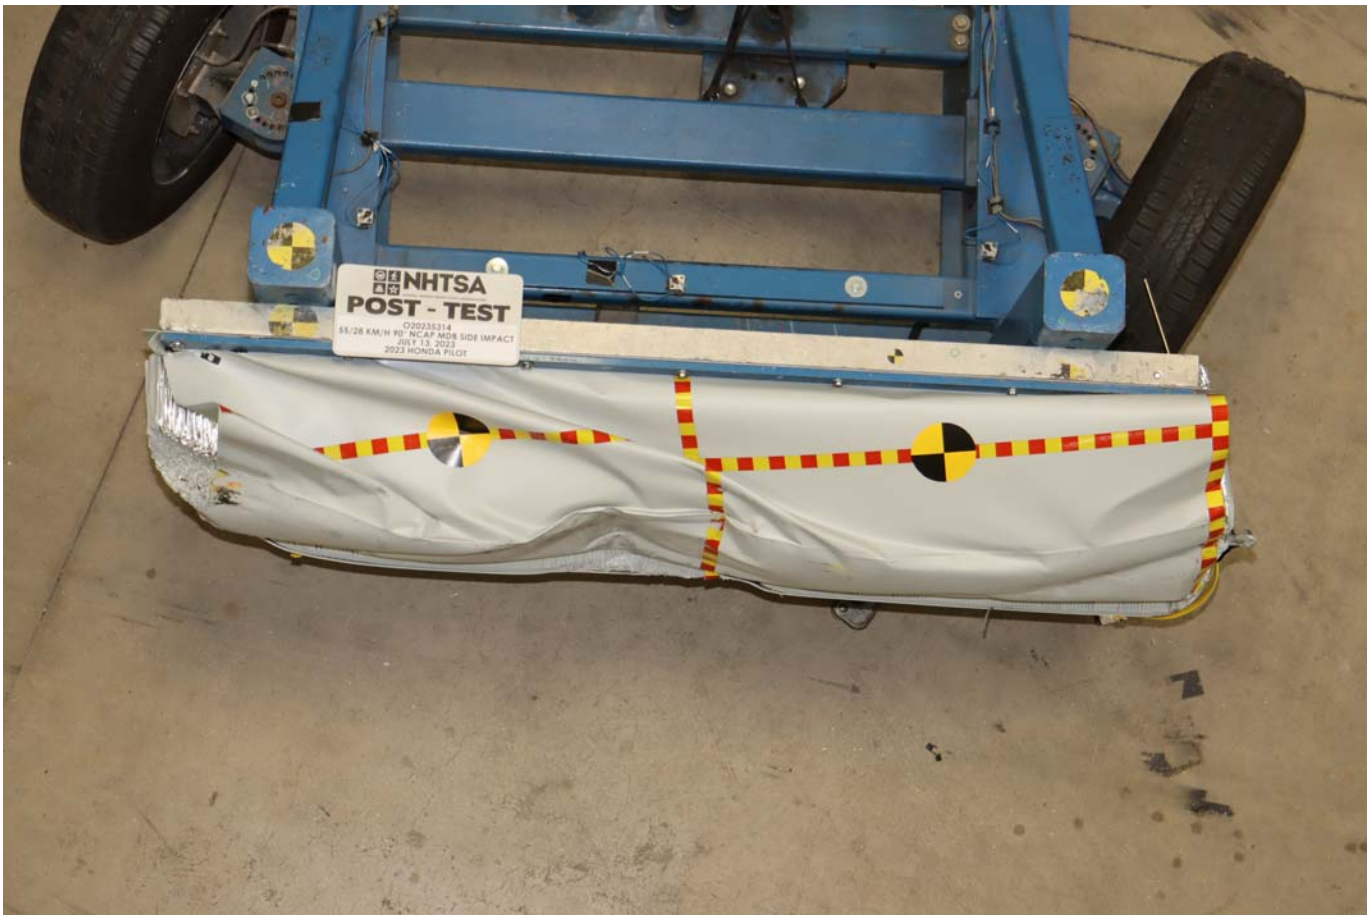
Photo No. 087 - Post-Test Top View of MDB Impactor Face

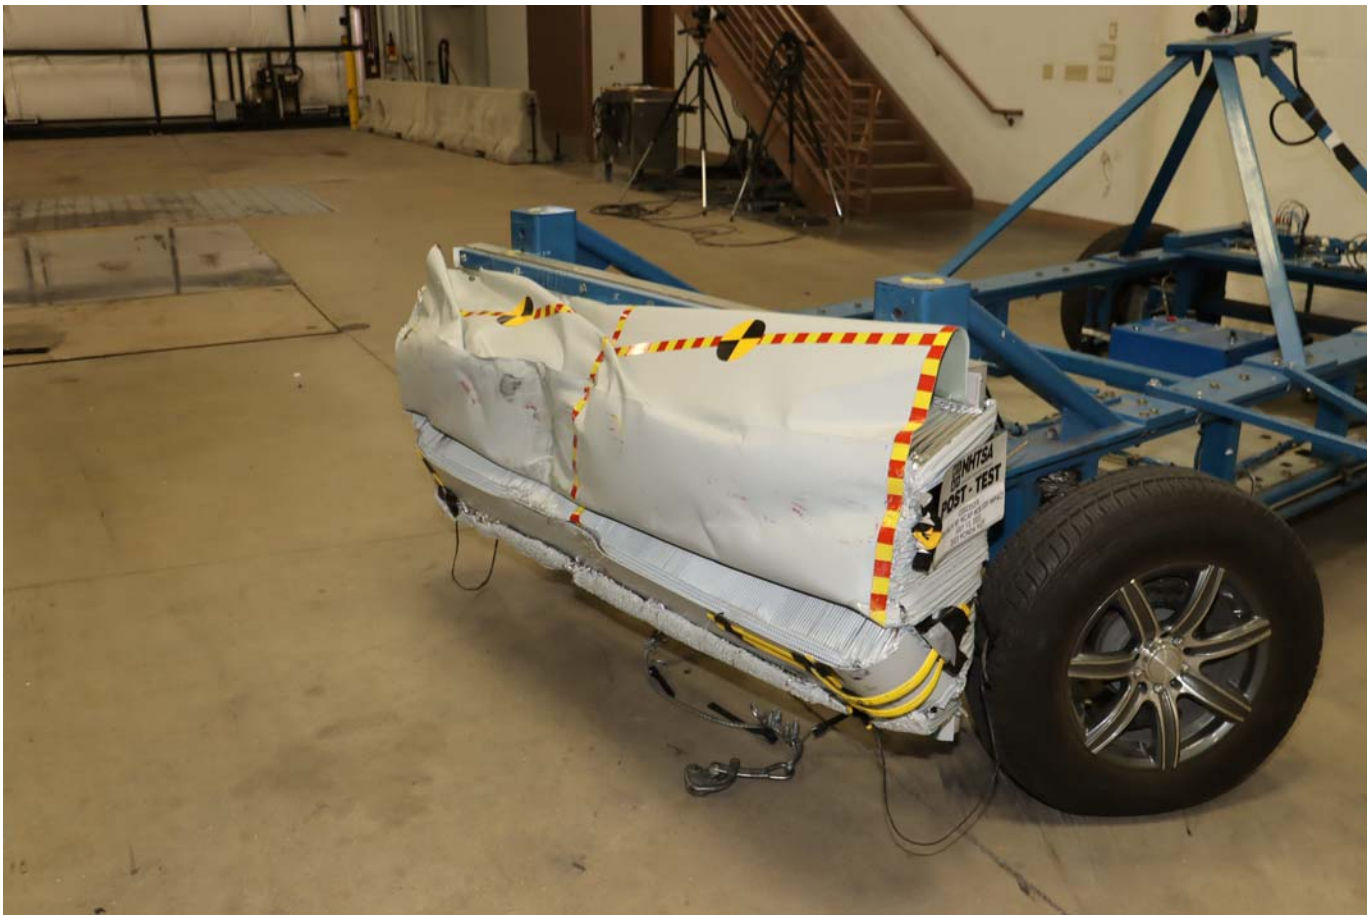
Photo No. 089 - Post-Test Left Side View of MDB Impactor Face

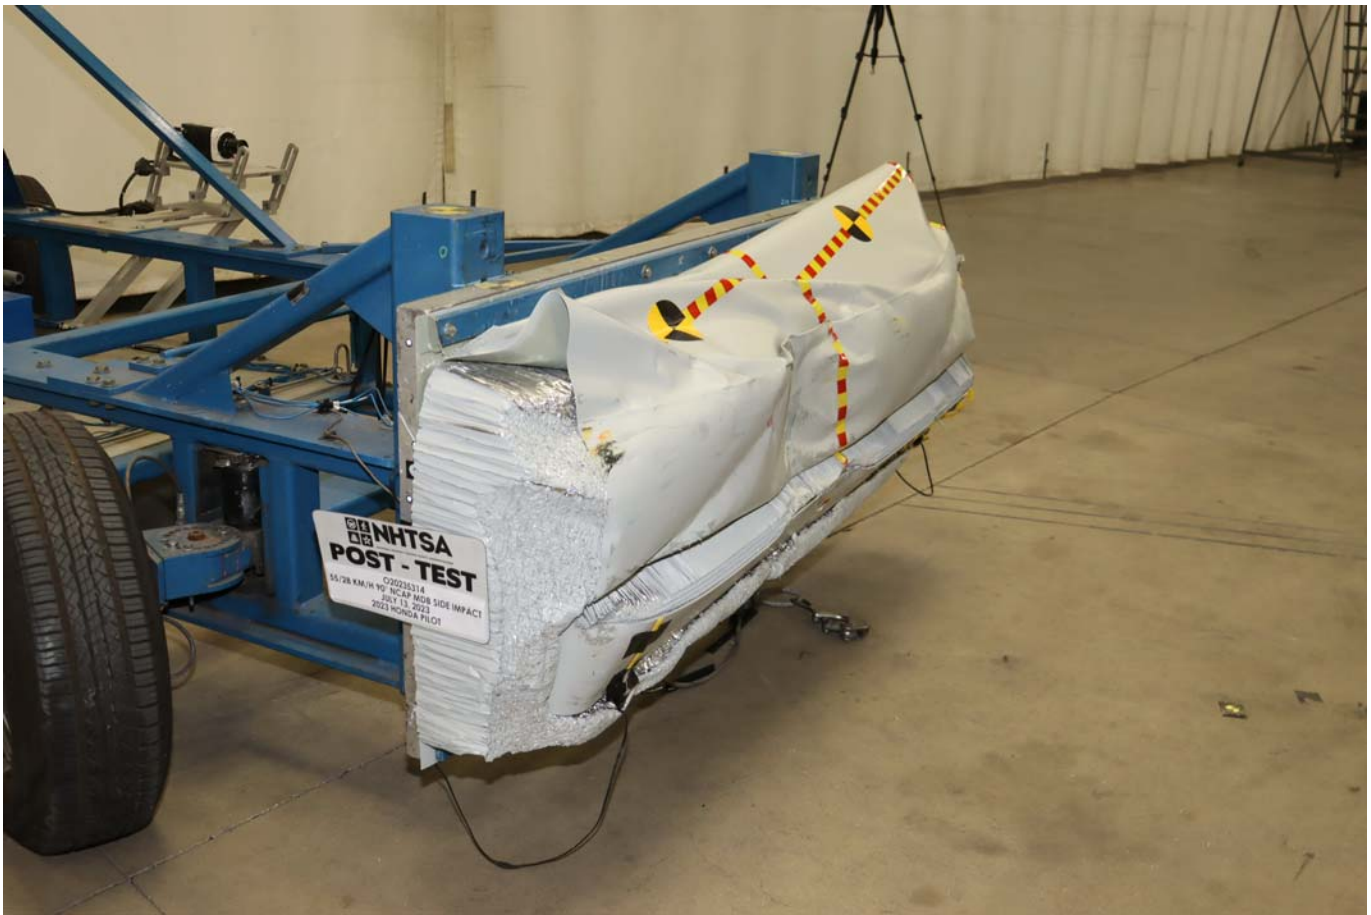
Photo No. 091 - Post-Test Right Side View of MDB Impactor Face

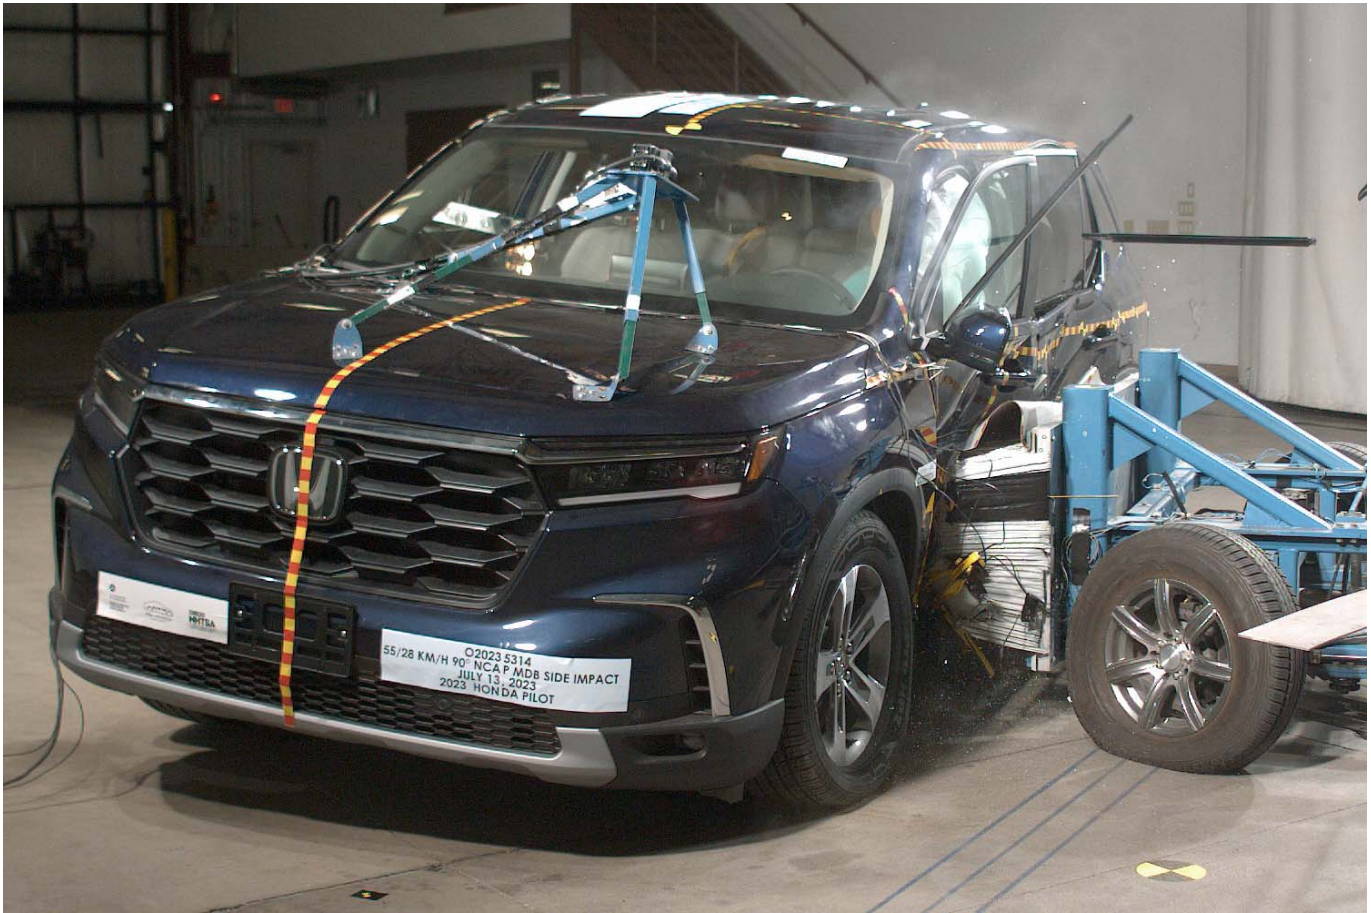
Photo No. 101 - Impact Event
