**REPORT NUMBER: SideNCAPPole-MGA-23-029**

**NEW CAR ASSESSMENT PROGRAM (NCAP)  
Side Impact Pole Test**

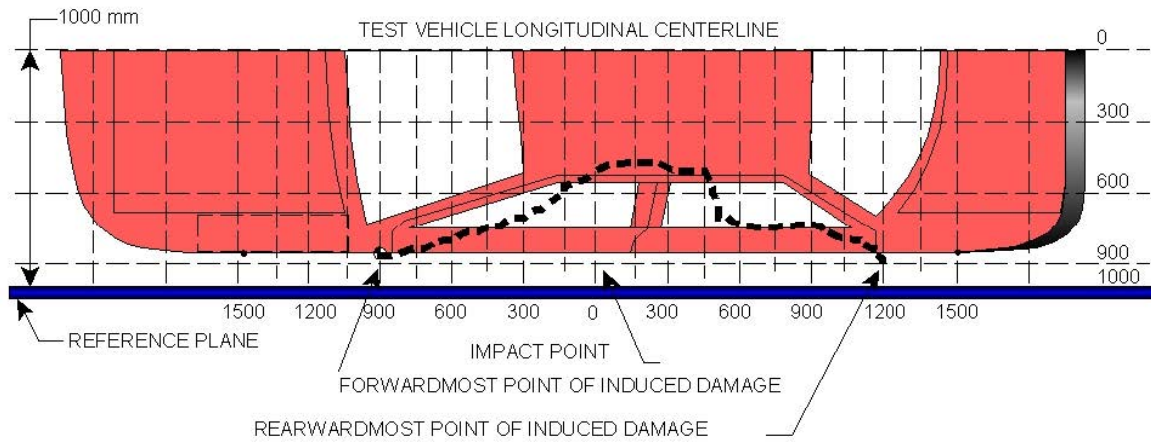
**VEHICLE DAMAGE PROFILE DISTANCES**
