**REPORT NUMBER: SideNCAPPole-MGA-23-032**

**NEW CAR ASSESSMENT PROGRAM (NCAP)  
Side Impact Pole Test**

**HONDA DEVELOPMENT & MANUFACTURING OF AMERICA, LLC  
2023 Honda Accord LX 4-Door Sedan  
NHTSA No.: O20235310**

**FINAL REPORT**

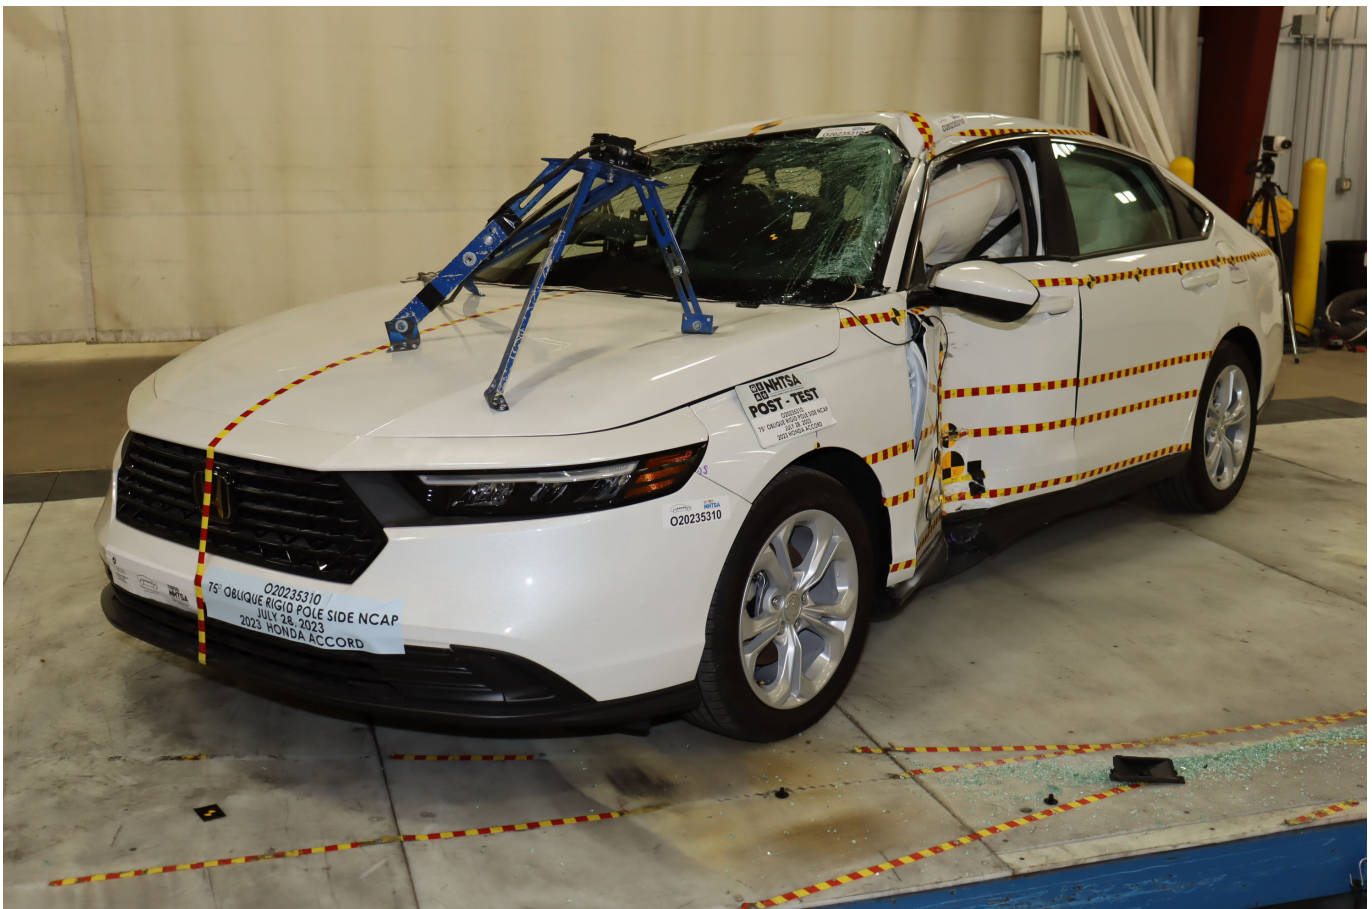
Photo No. 006 - Post-Test Left Front Three-Quarter View of Test Vehicle

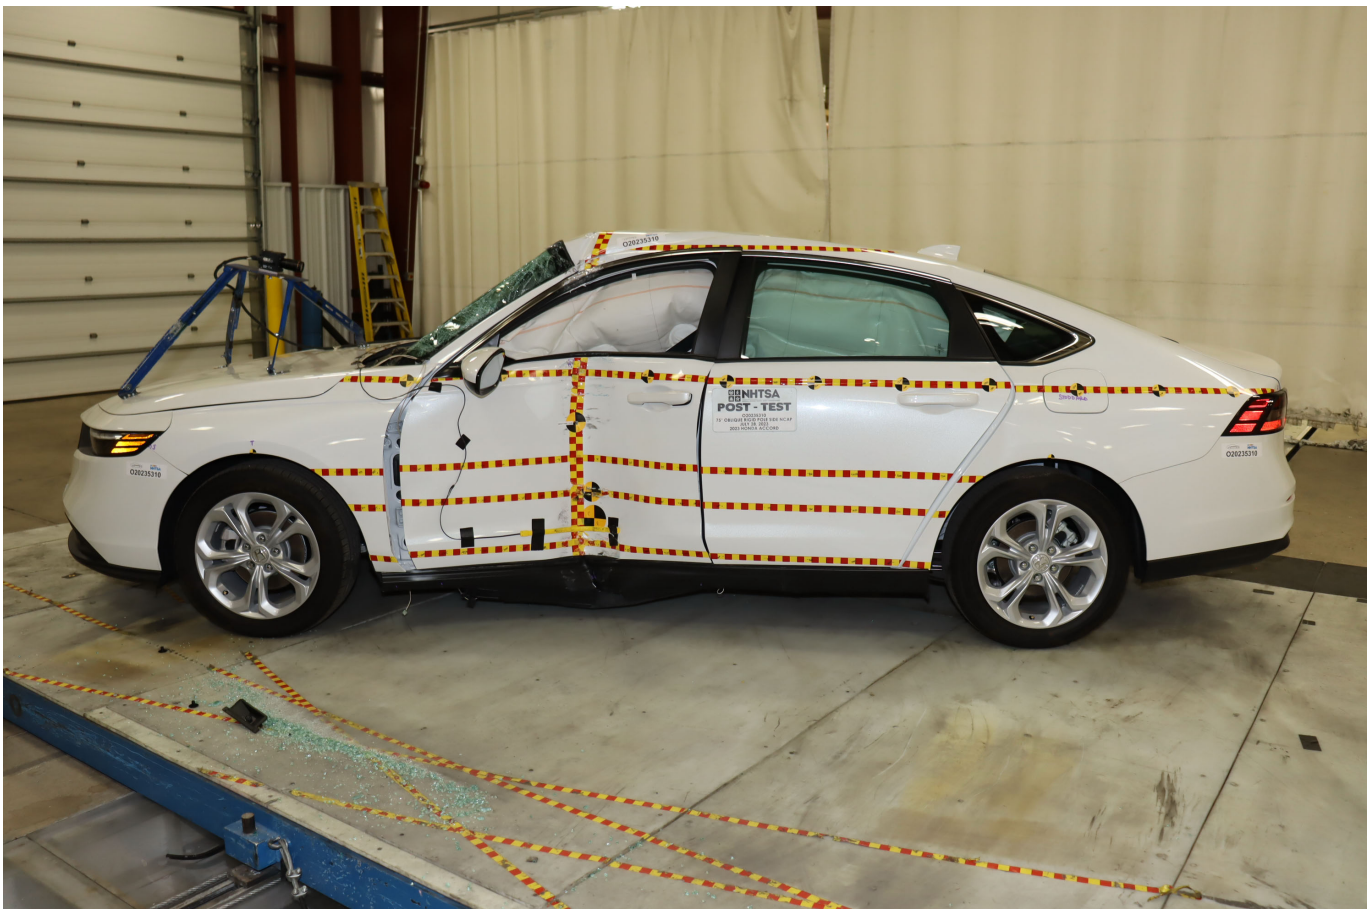
Photo No. 008 - Post-Test Left Side View of Test Vehicle

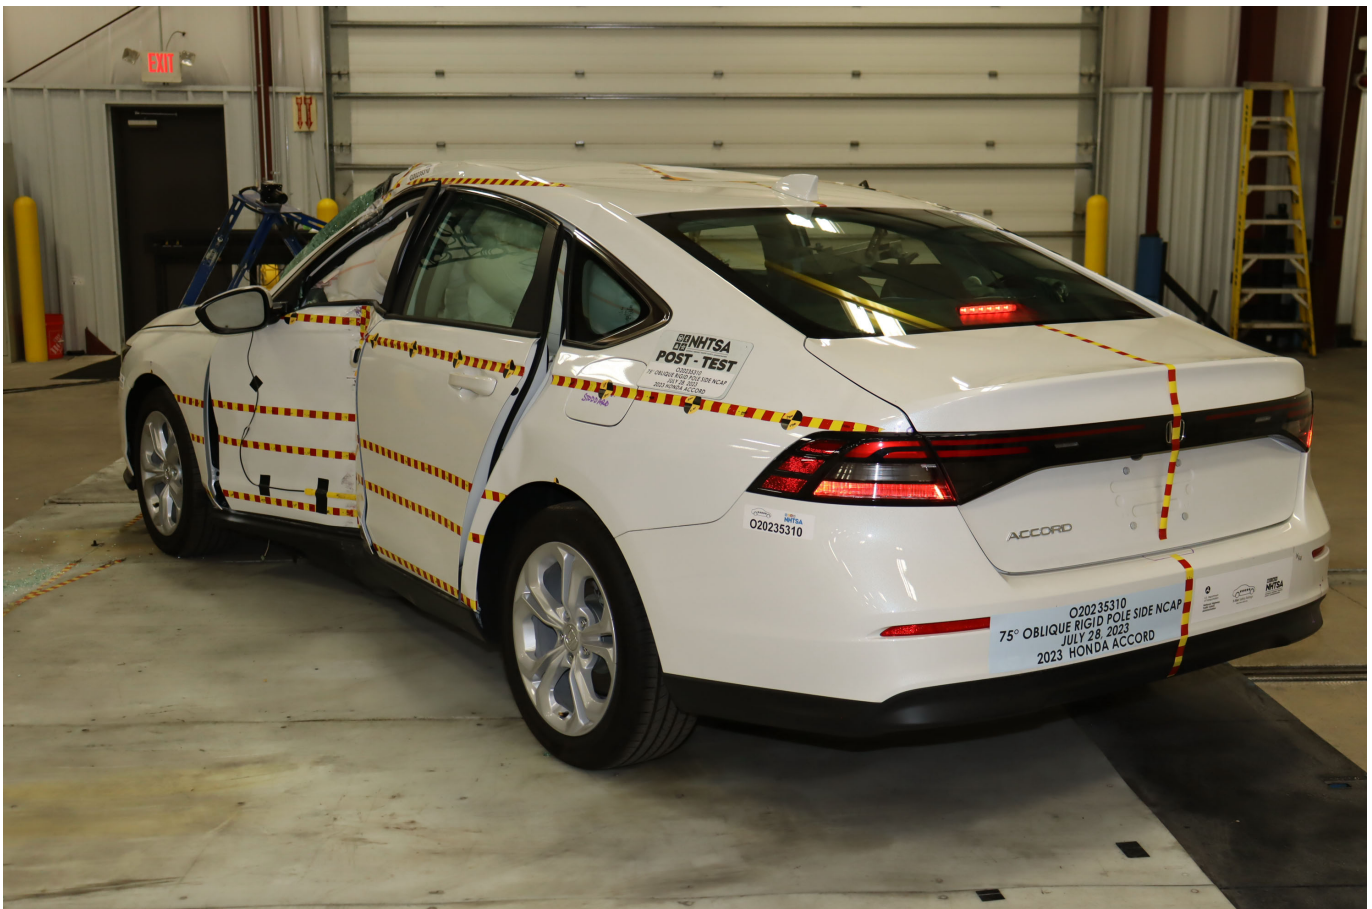
Photo No. 010 - Post-Test Left Rear Three-Quarter View of Test Vehicle

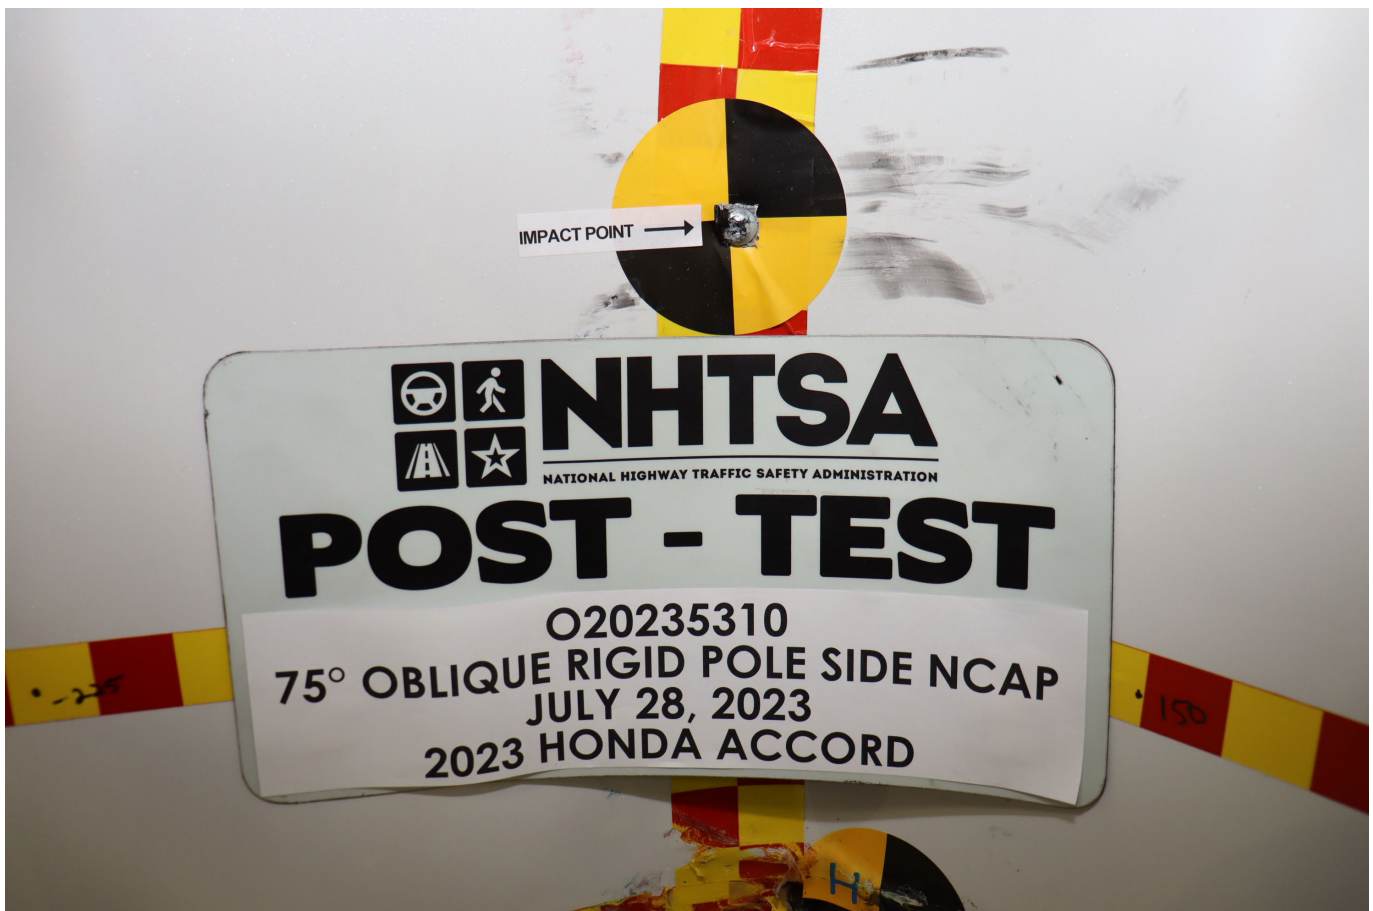
Photo No. 020 - Post-Test Close-Up View of Impact Point Target Showing Impact Location

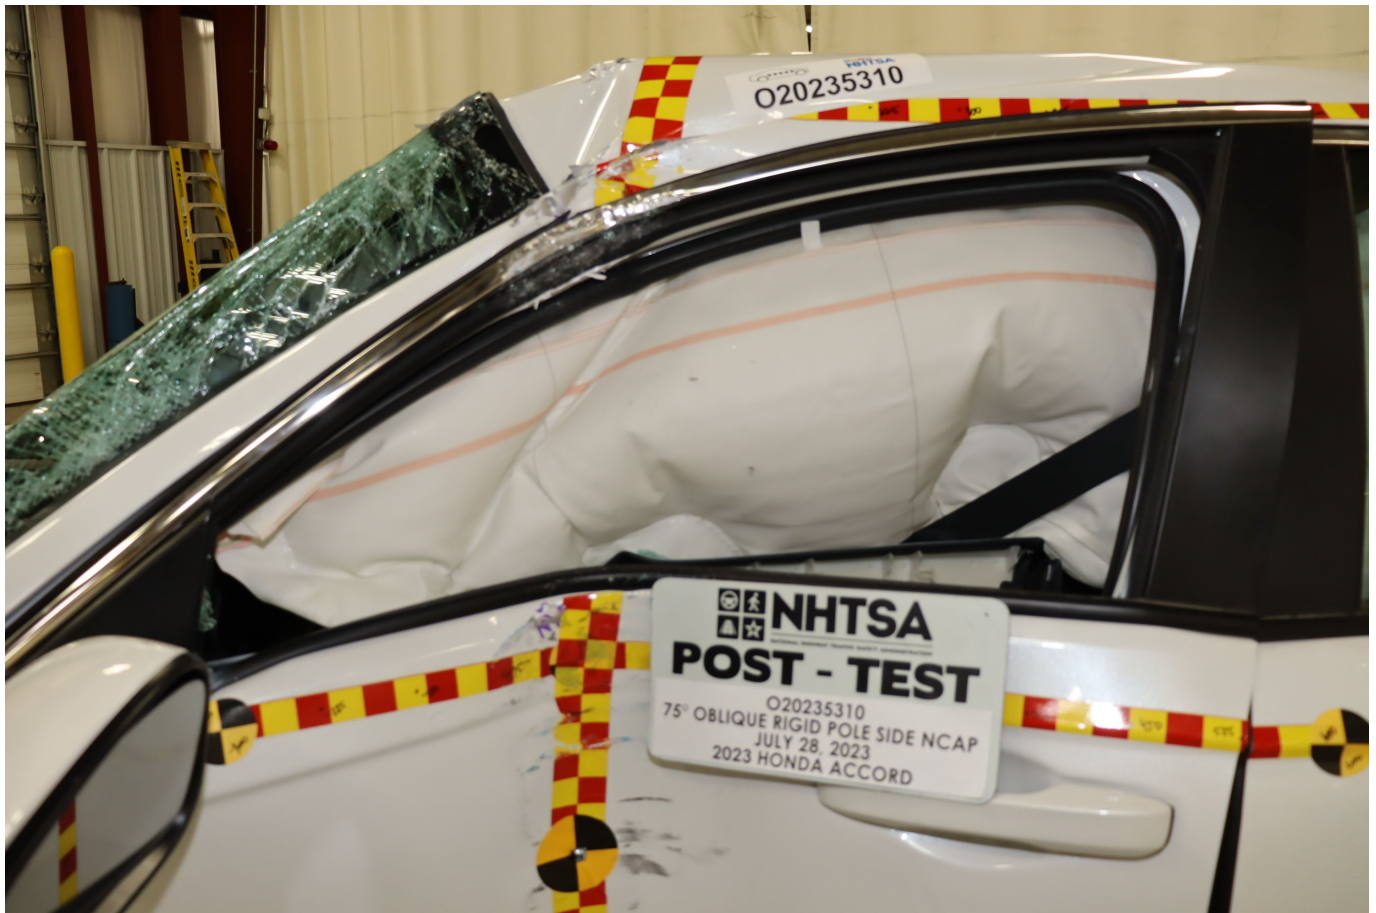
Photo No. 025 - Post-Test Left Side View of Dummy Shoulder and Door Top View

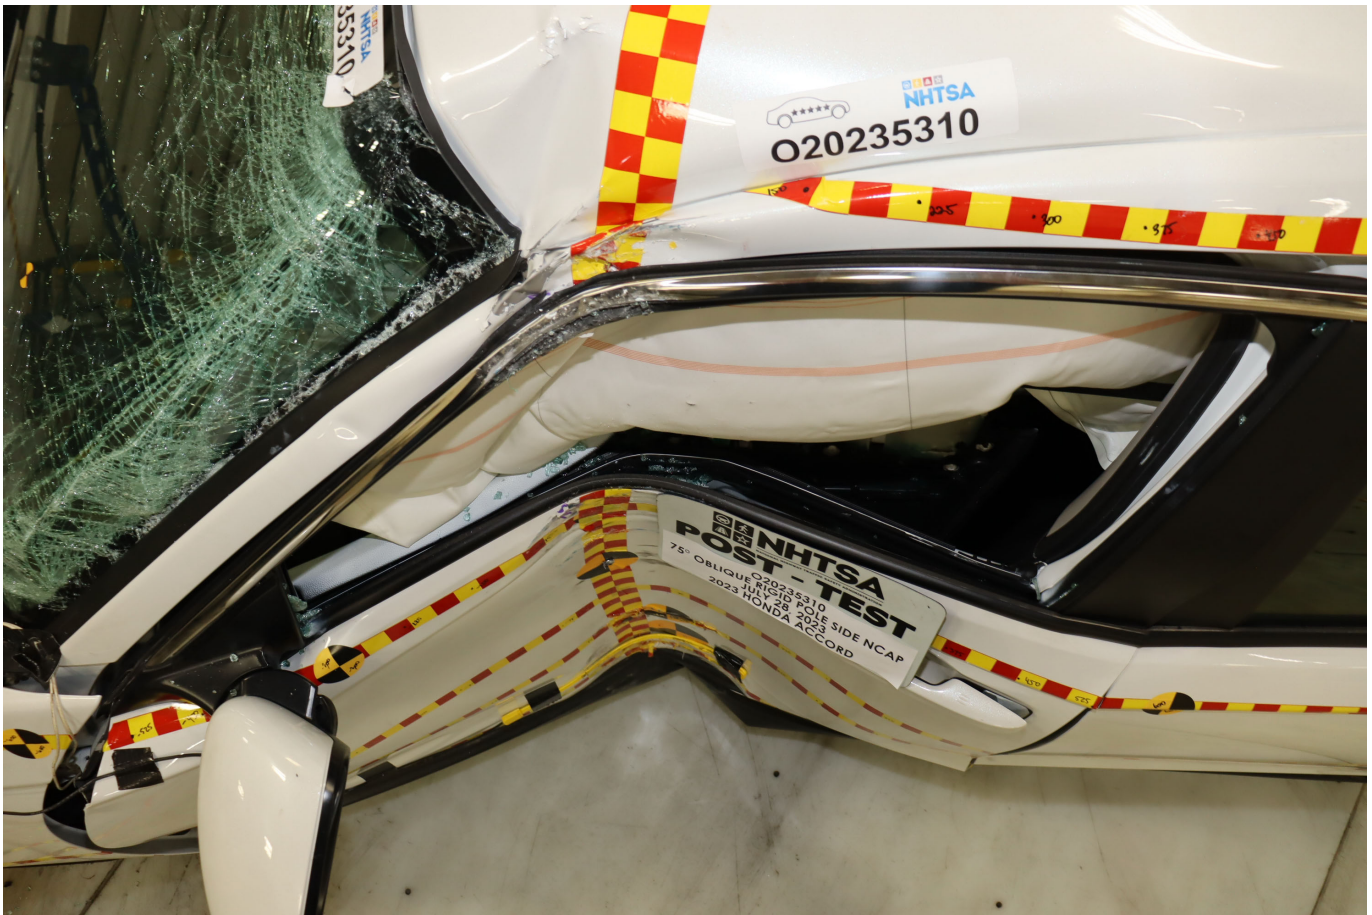
Photo No. 041 - Post-Test Dummy and Door Clearance View

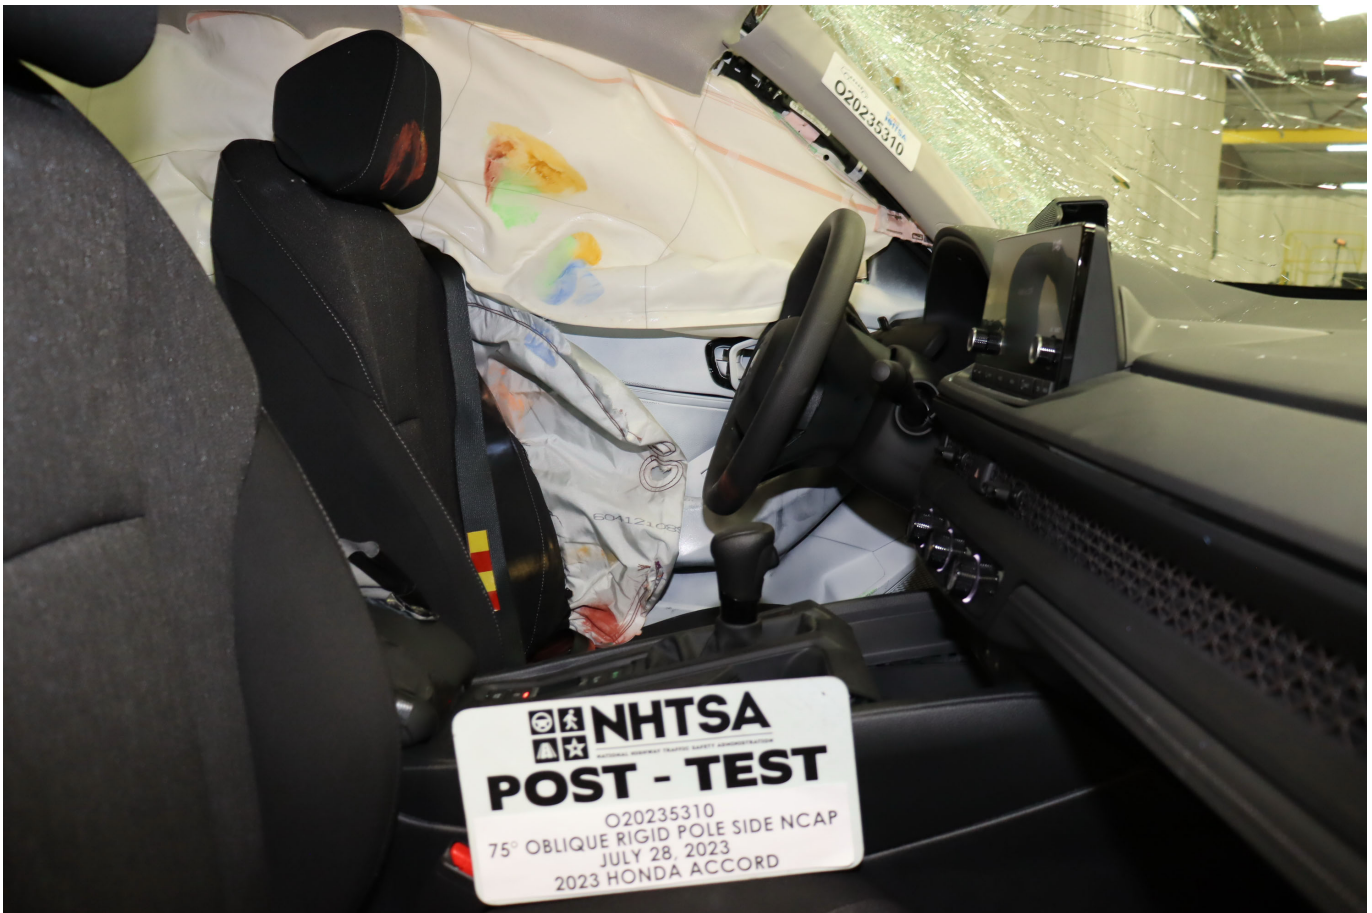
Photo No. 045 - Post-Test Inner Door Panel View Showing Dummy Contact Location

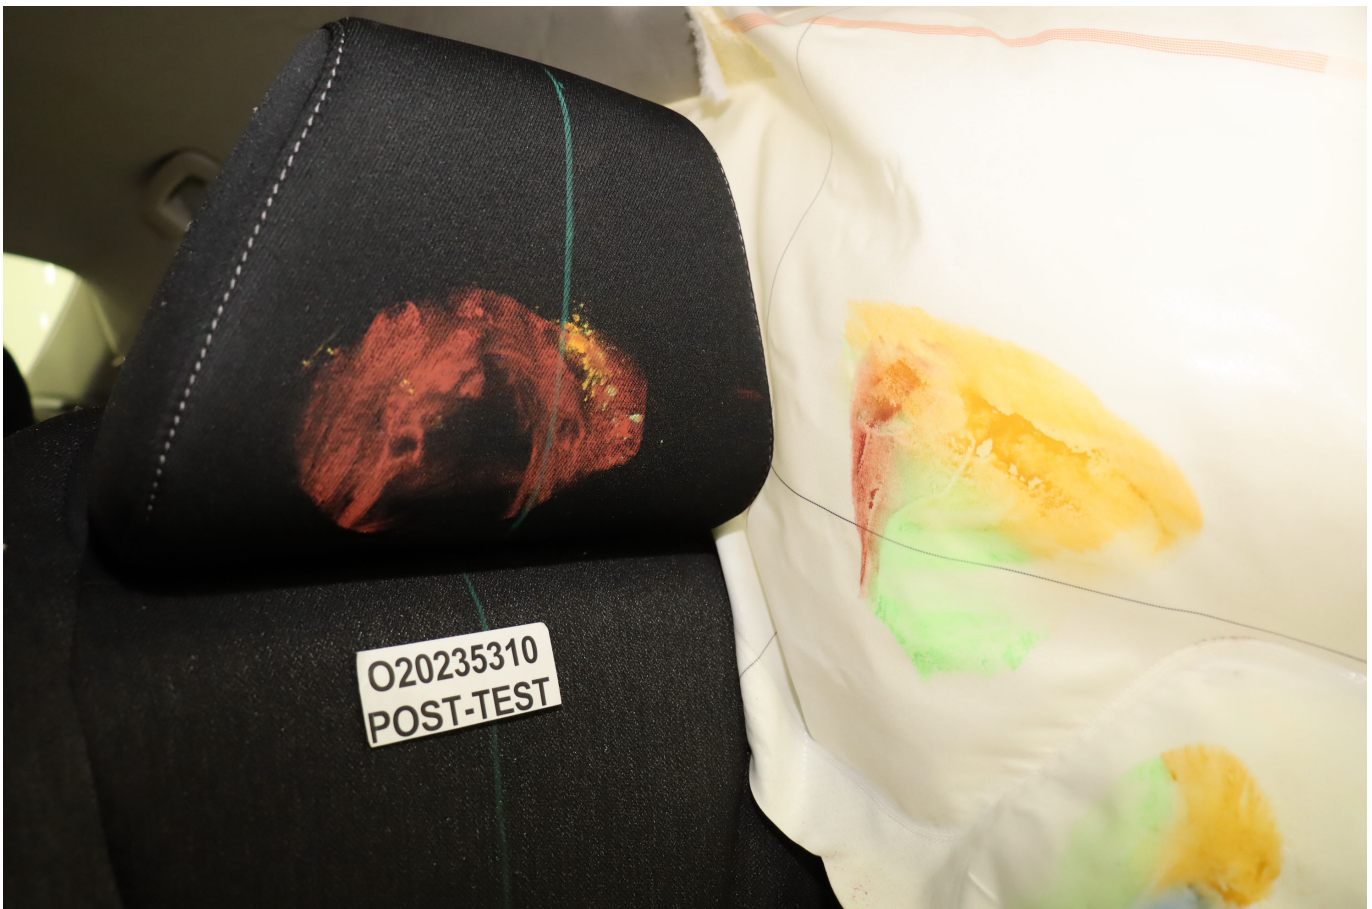
Photo No. 046 - Post-Test Dummy Close-Up Head Contact with Vehicle Interior View

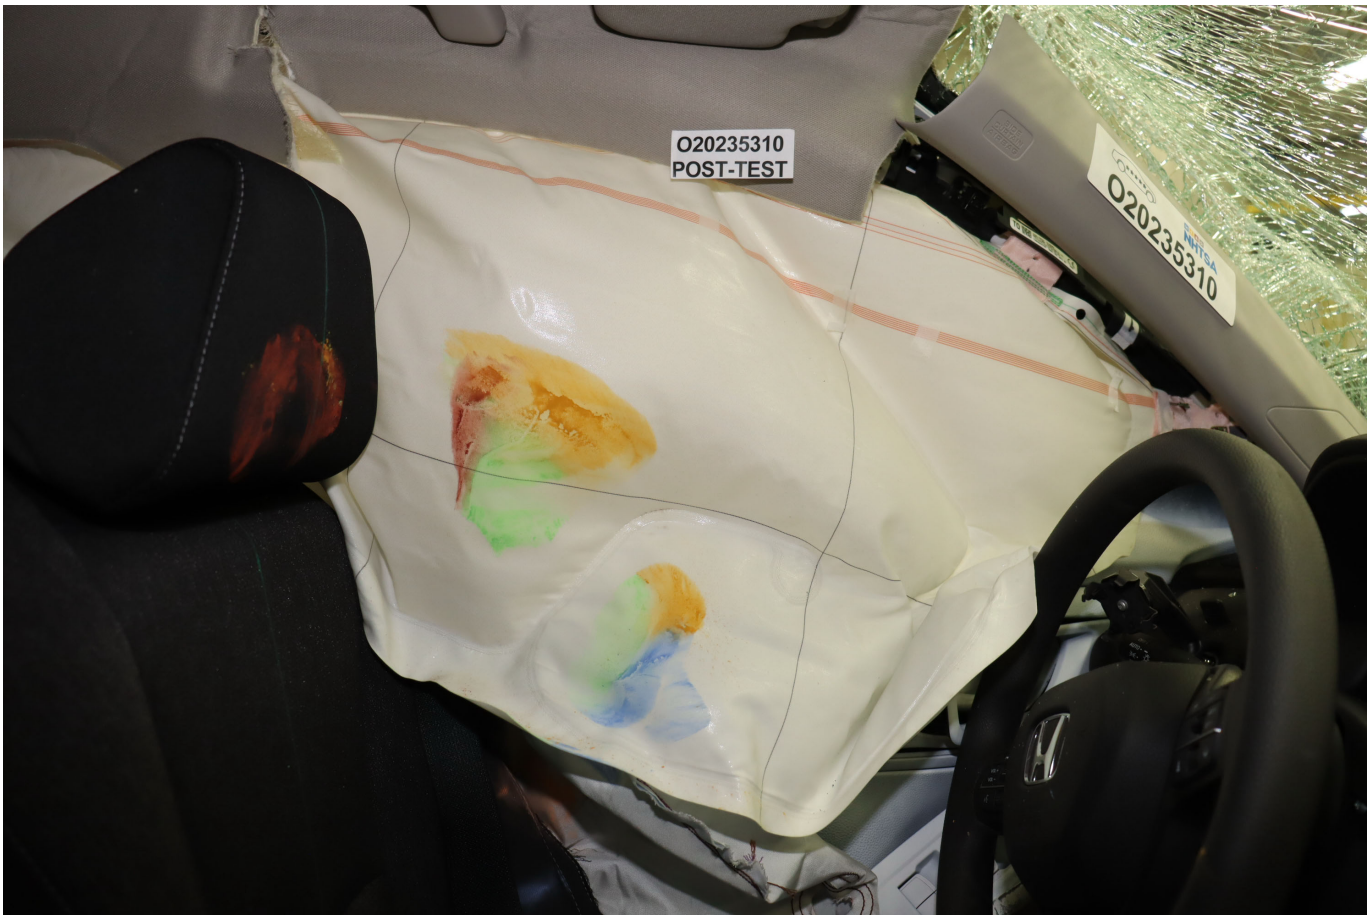
Photo No. 047 - Post-Test Dummy Close-Up Head Contact with Side Air Bag View

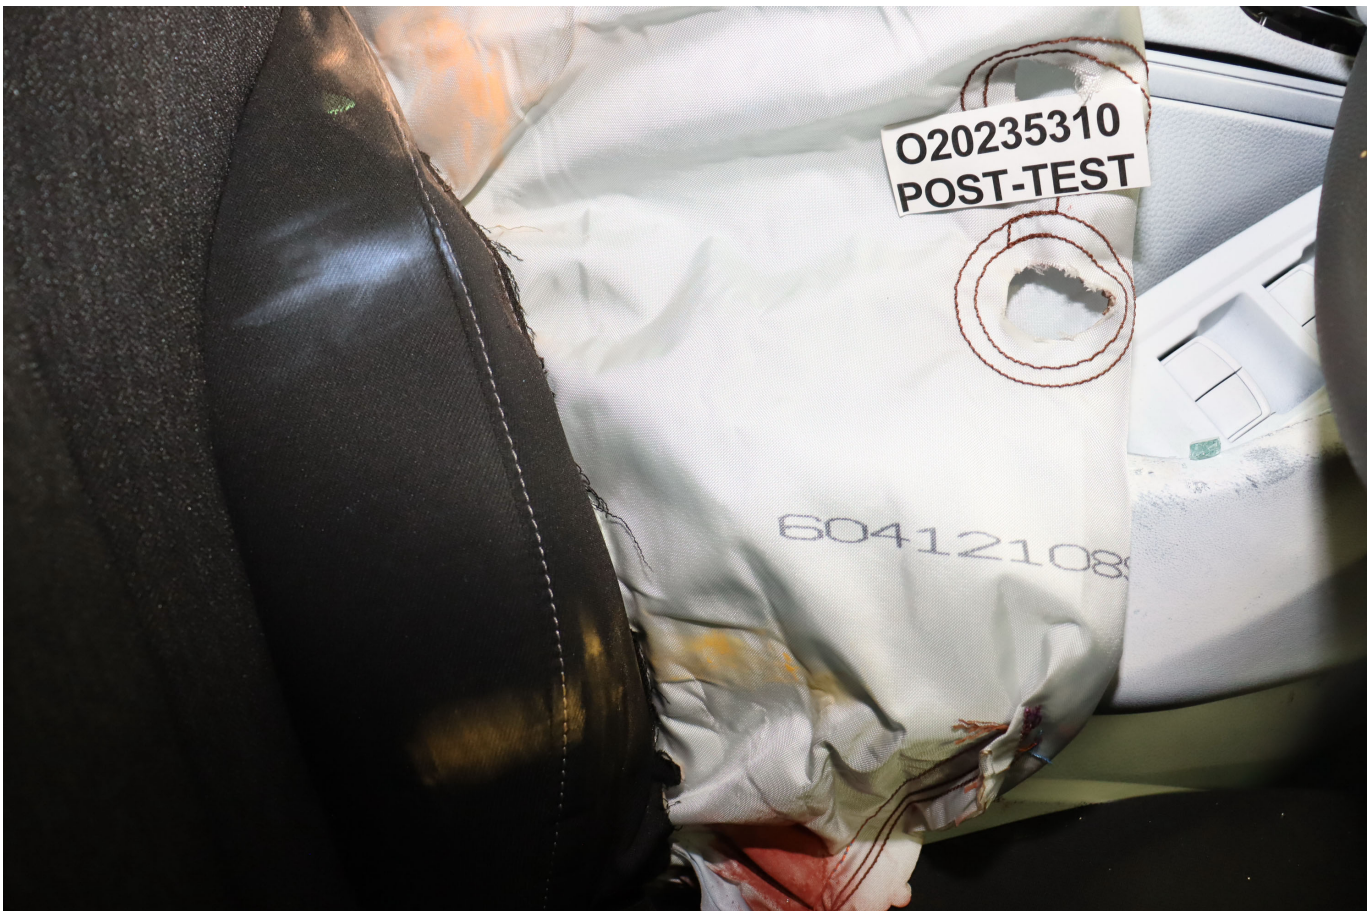
Photo No. 048 - Post-Test Dummy Close-Up Torso Contact with Vehicle Interior View

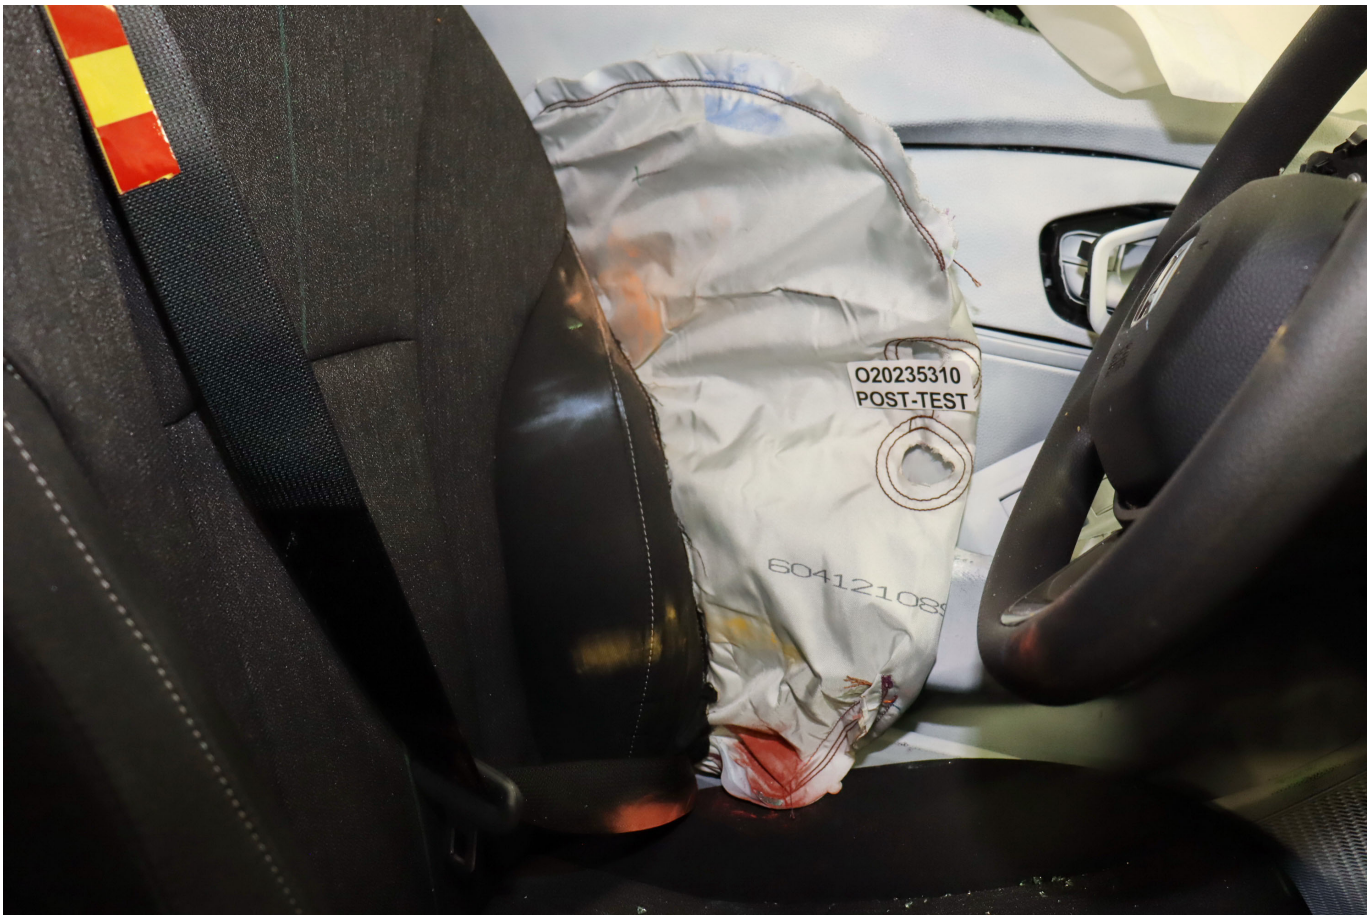
Photo No. 049 - Post-Test Dummy Close-Up Torso Contact with Side Air Bag View

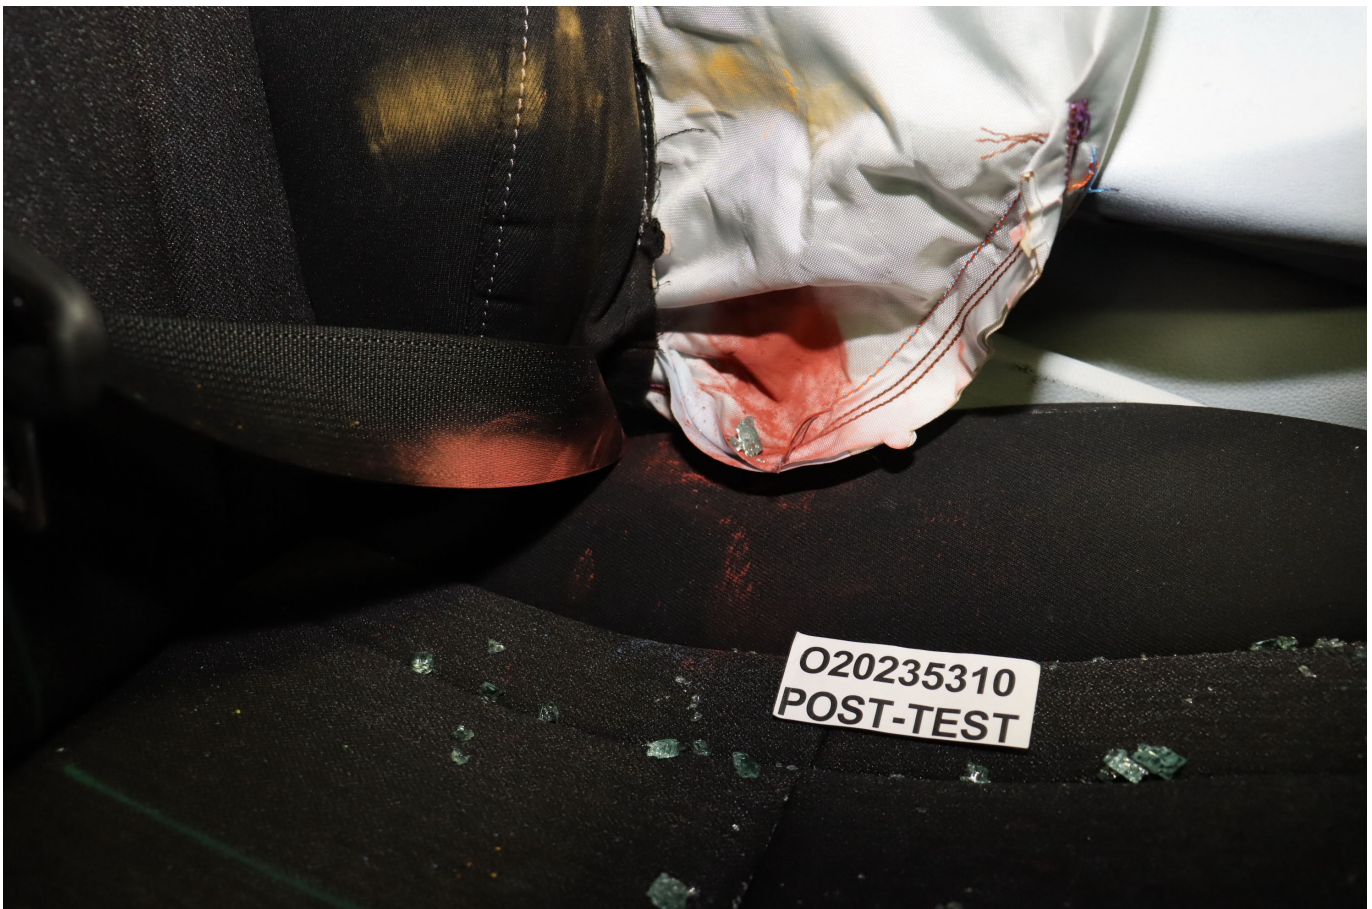
Photo No. 050 - Post-Test Dummy Close-Up Pelvis Contact with Vehicle Interior View

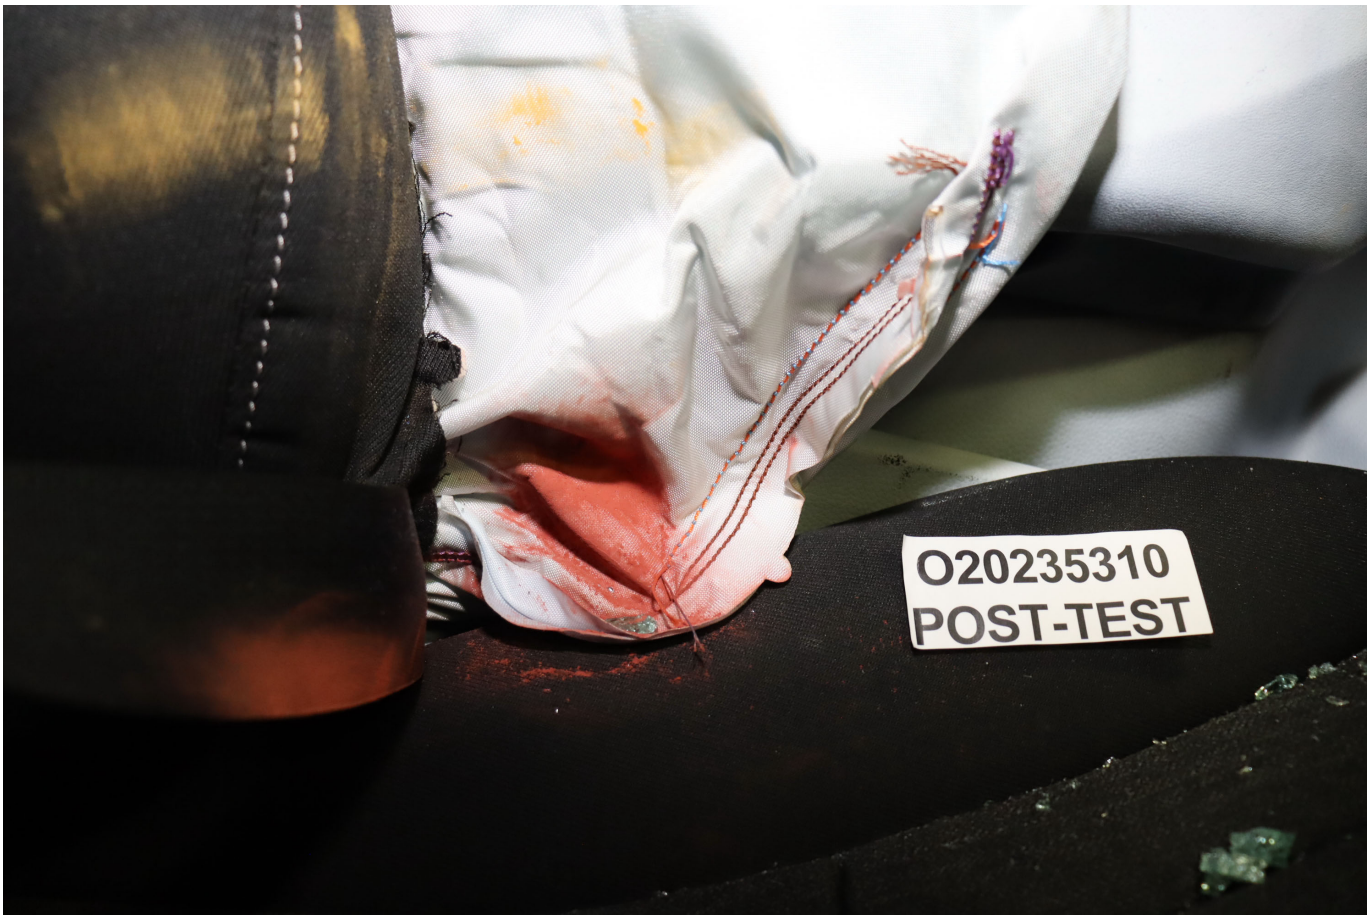
Photo No. 051 - Post-Test Dummy Close-Up Pelvis Contact with Side Air Bag View

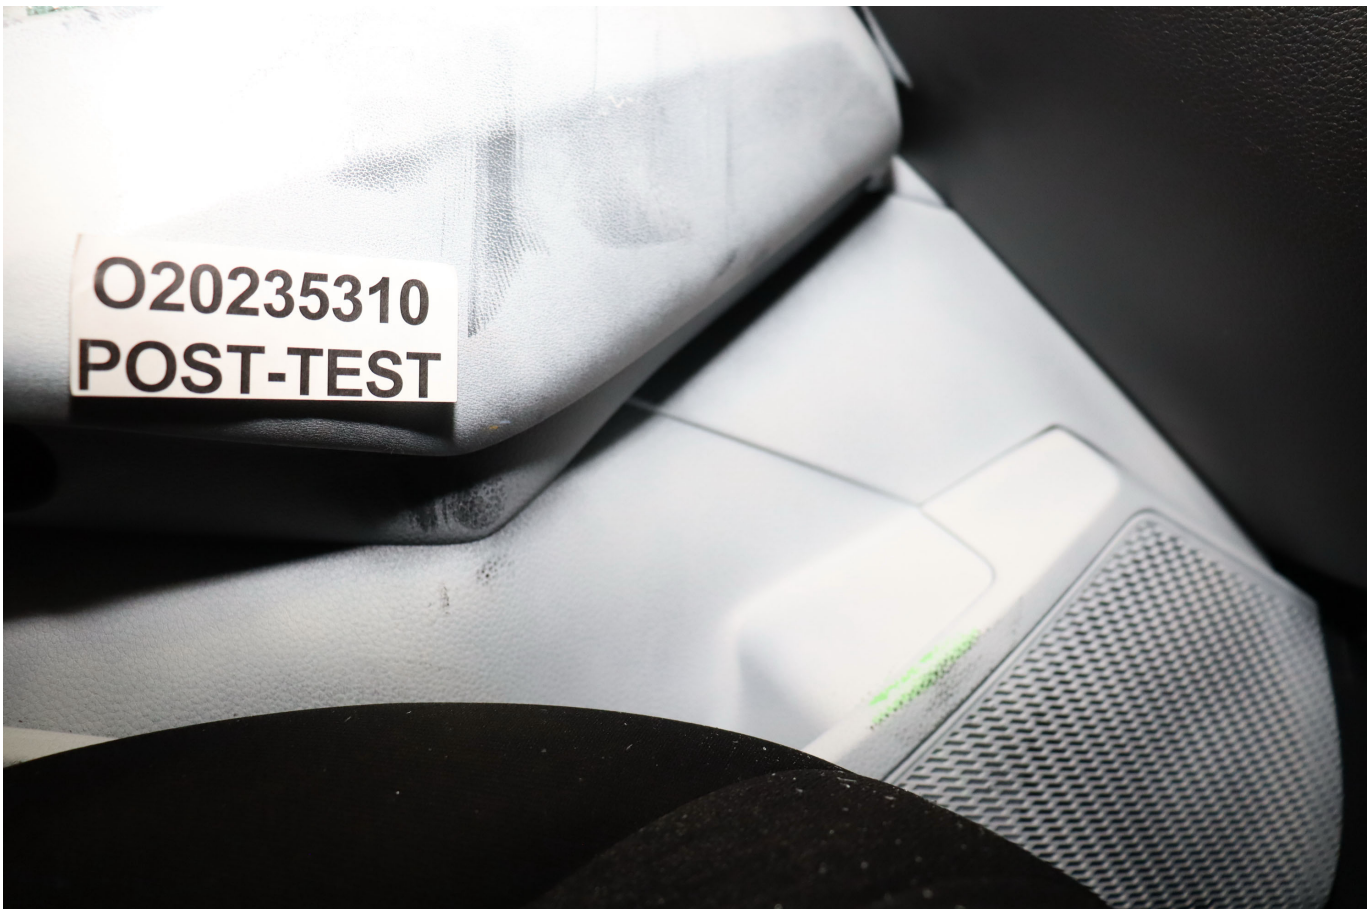
Photo No. 052 - Post-Test Dummy Close-Up Knee Contact with Vehicle Interior View

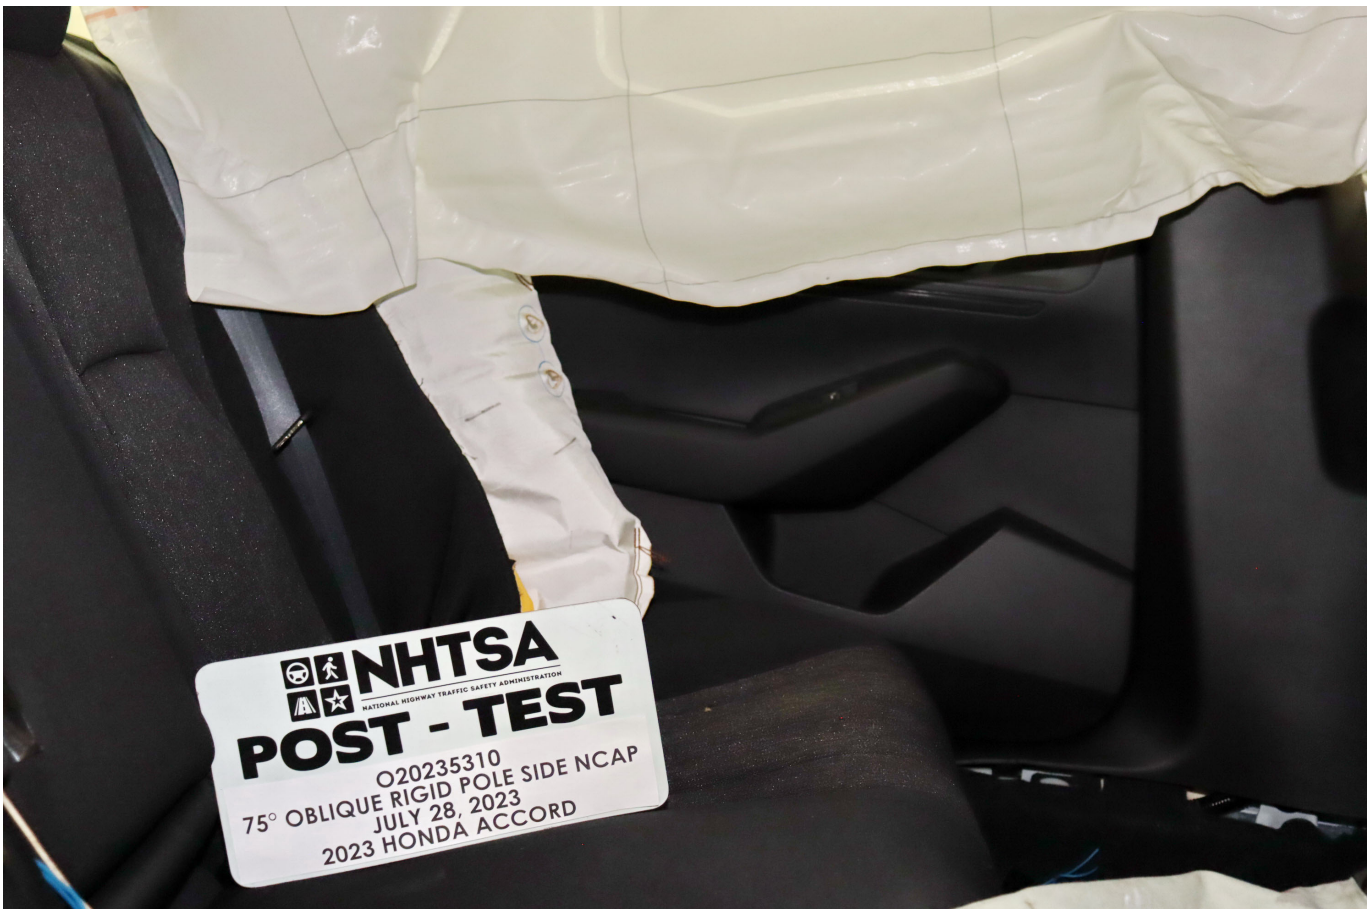
Photo No. 054 - Post-Test Inner Rear Passenger Torso Air Bag Deployment View

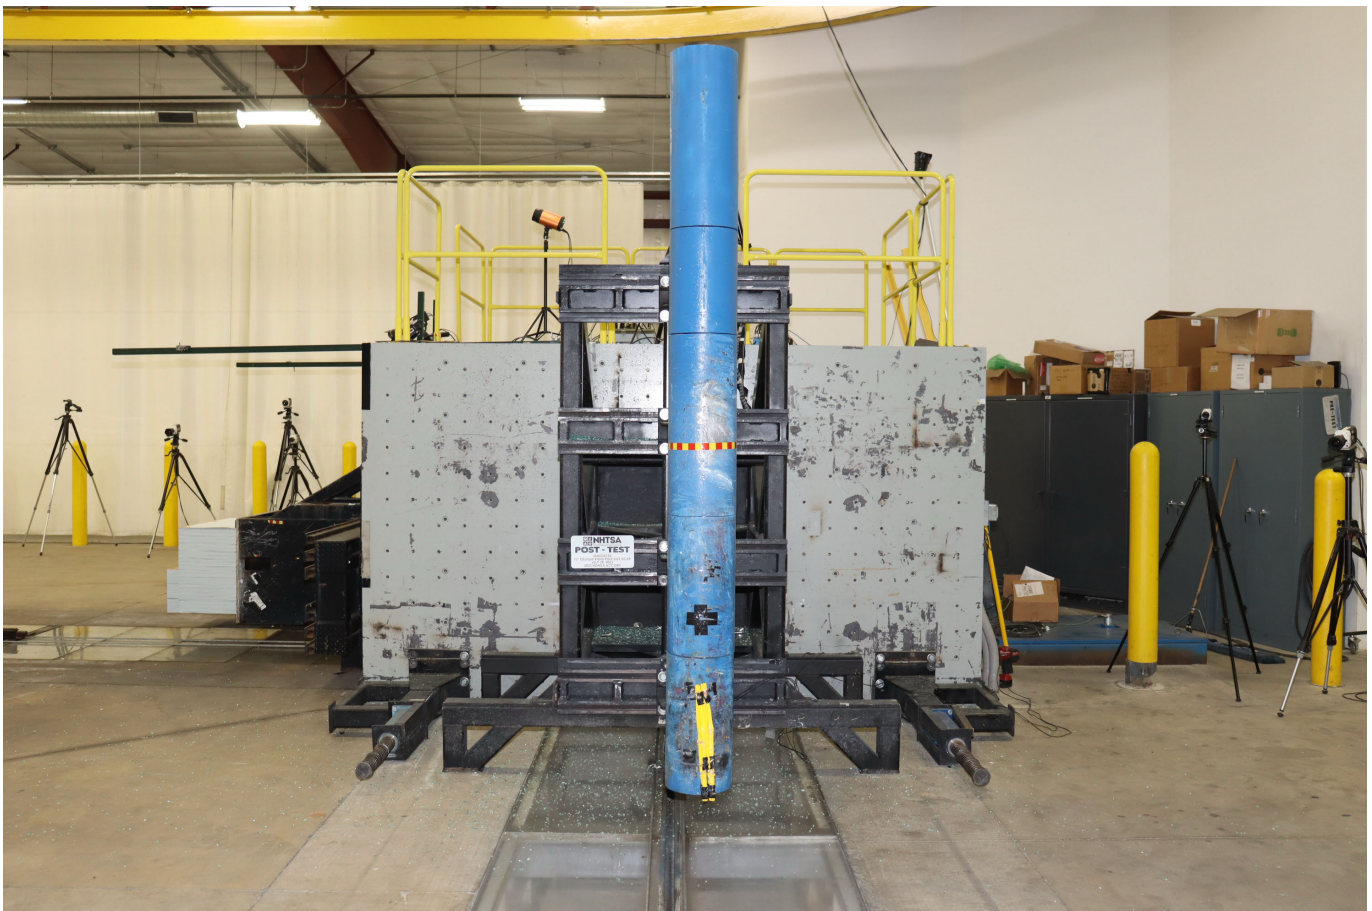
Photo No. 060 - Post-Test Pole Barrier Front View

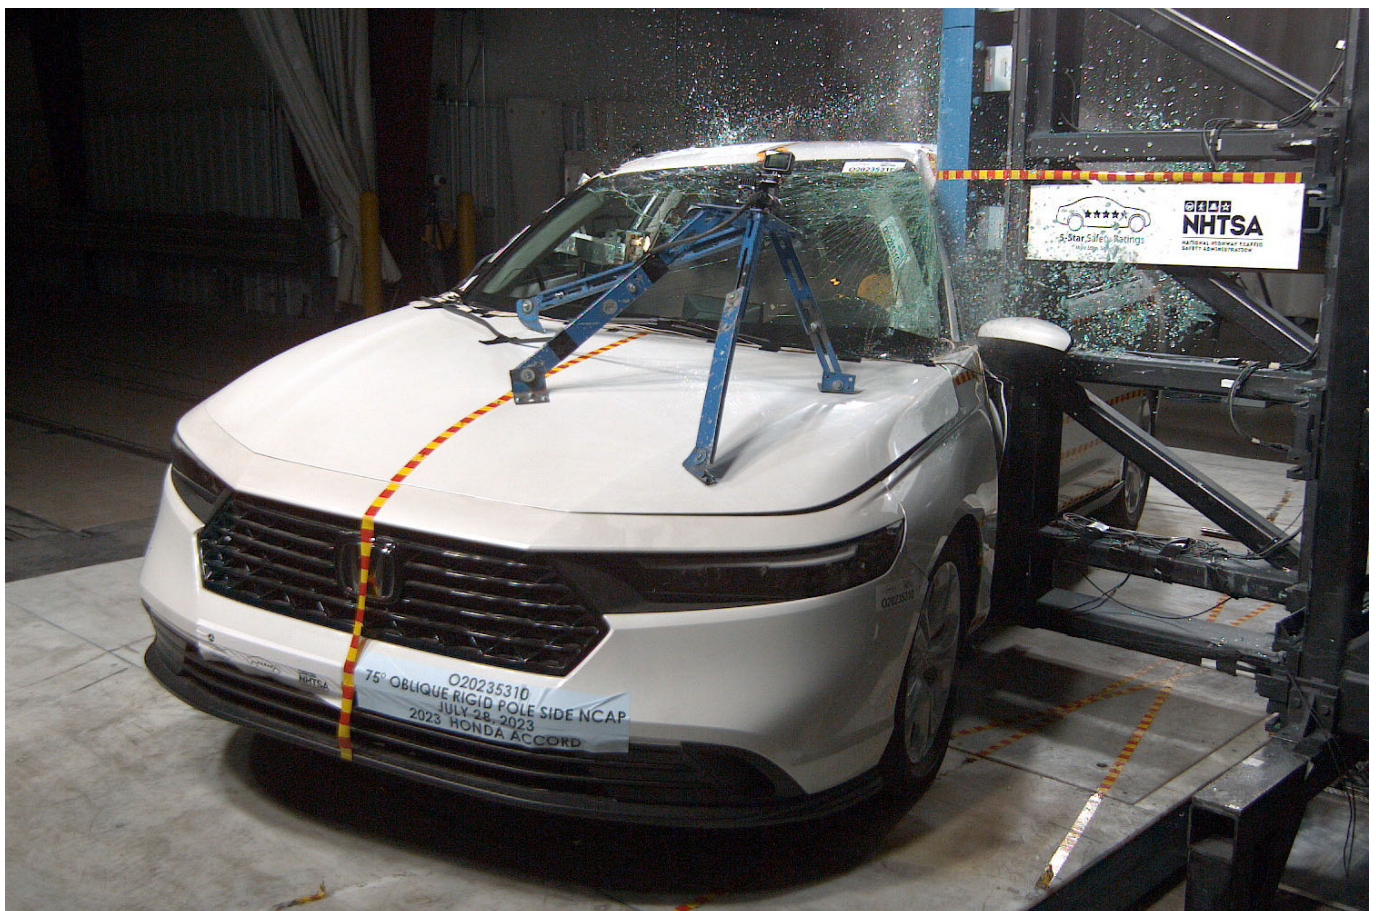
Photo No. 070 - Impact Event

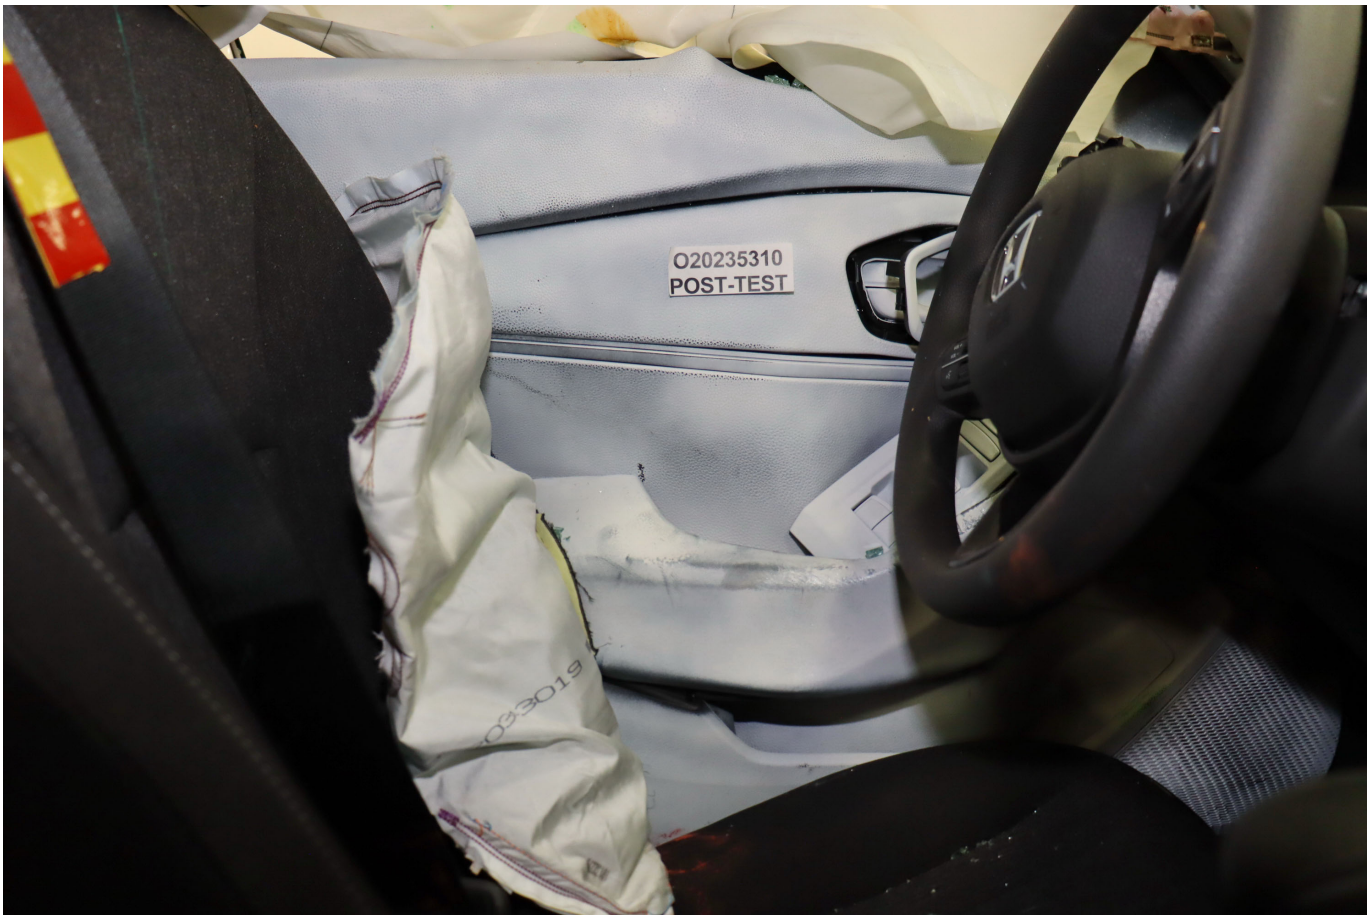
Photo No. 073 - Post-Test View of Shattered Vehicle Inner Door Panel
