**REPORT NUMBER: SideNCAPPole-MGA-23-043**

**NEW CAR ASSESSMENT PROGRAM (NCAP)  
Side Impact Pole Test**

**TOYOTA MOTOR CORPORATION  
2023 Toyota Prius LE HEV 5-Door Hatchback  
NHTSA No.: O20235109**

**FINAL REPORT**

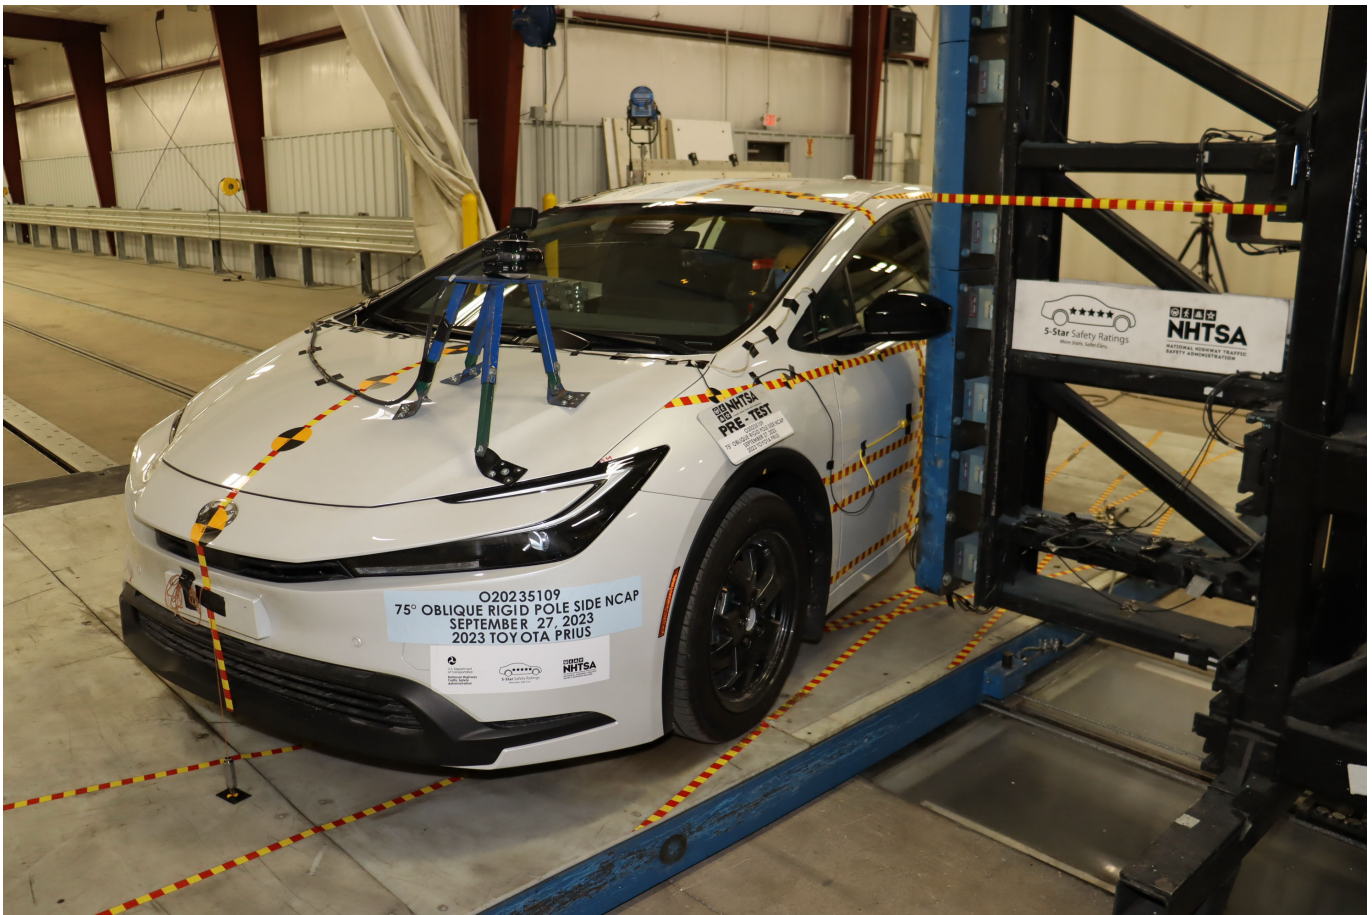
Photo No. 017 - Pre-Test Left Side View of Pole Positioned Against Side of Vehicle

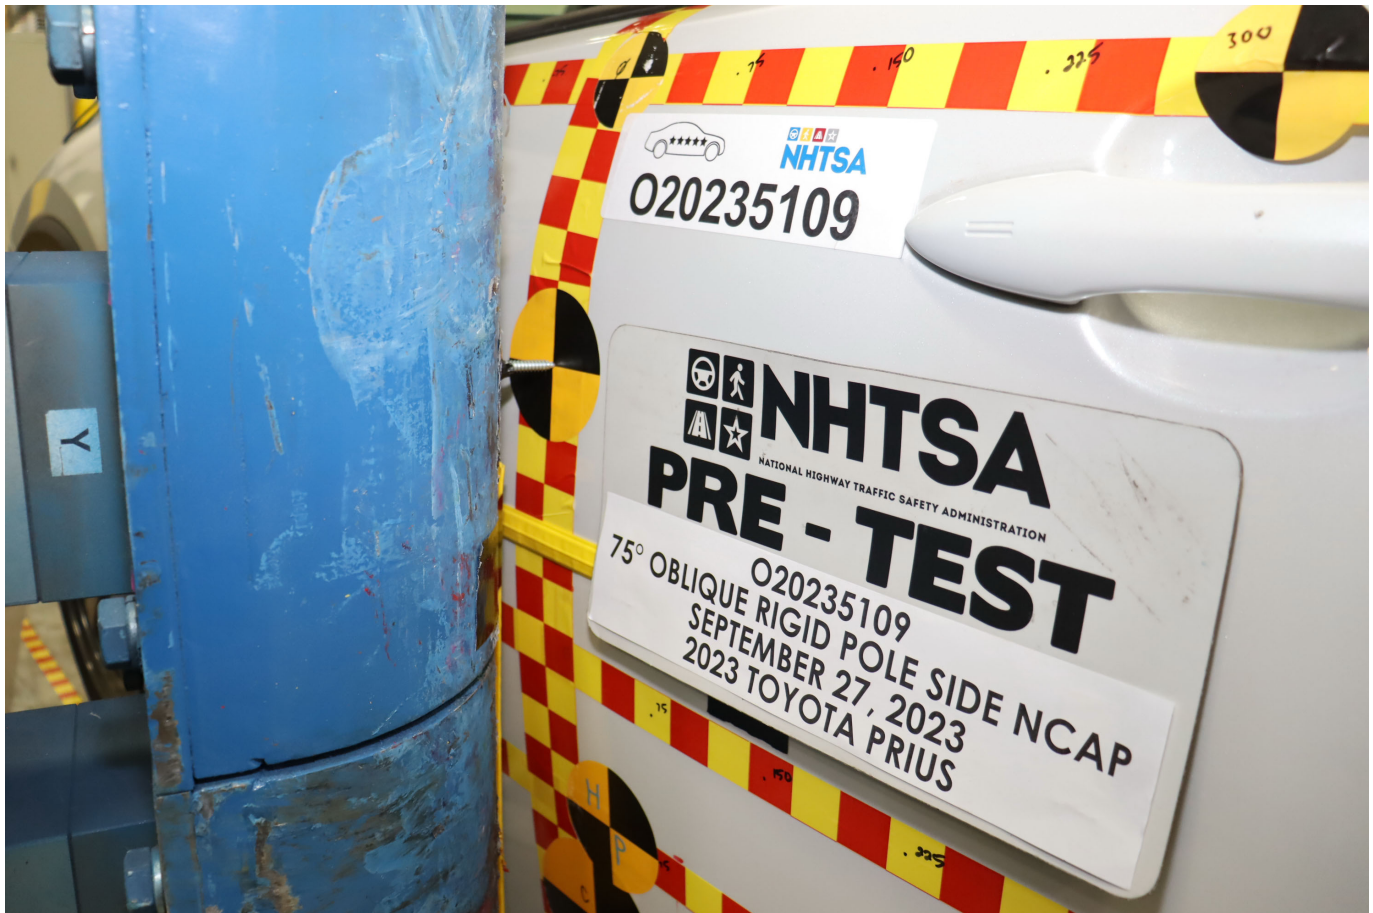
Photo No. 019 - Pre-Test Close-Up View of Impact Point Target

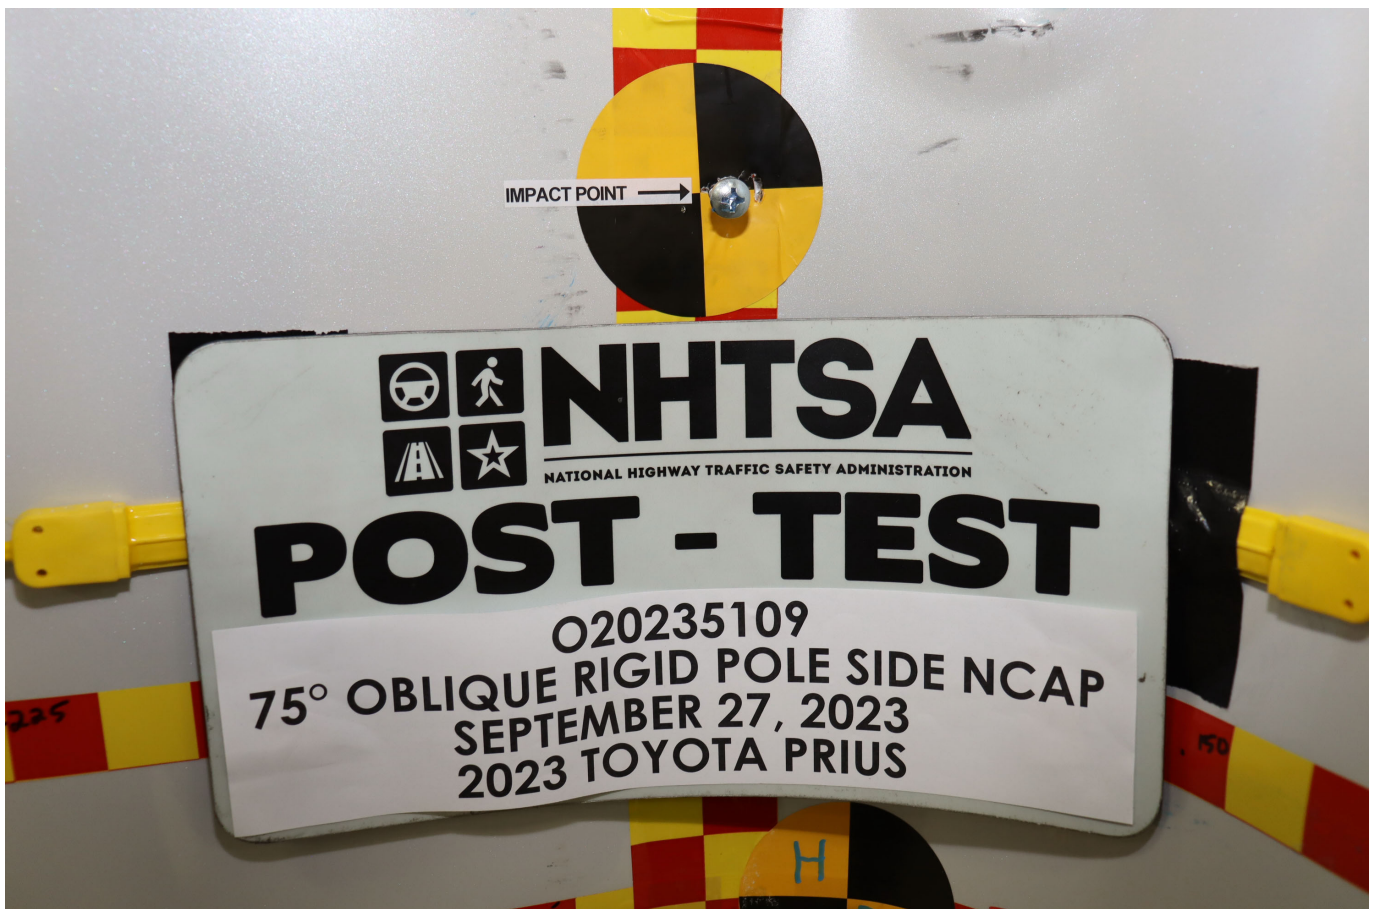
Photo No. 020 - Post-Test Close-Up View of Impact Point Target Showing Impact Location

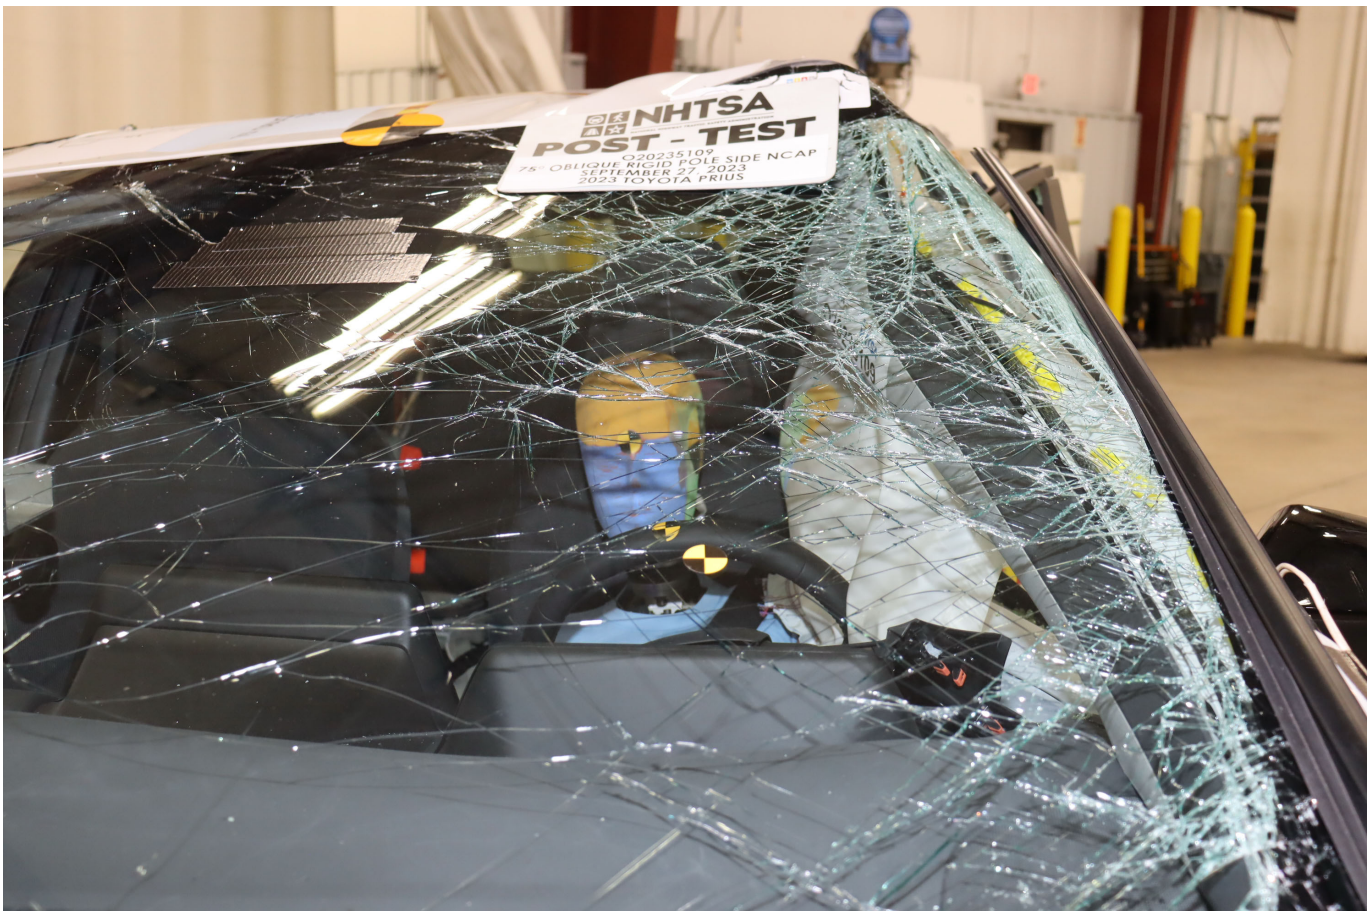
Photo No. 022 - Post-Test Front Close-Up View of Dummy

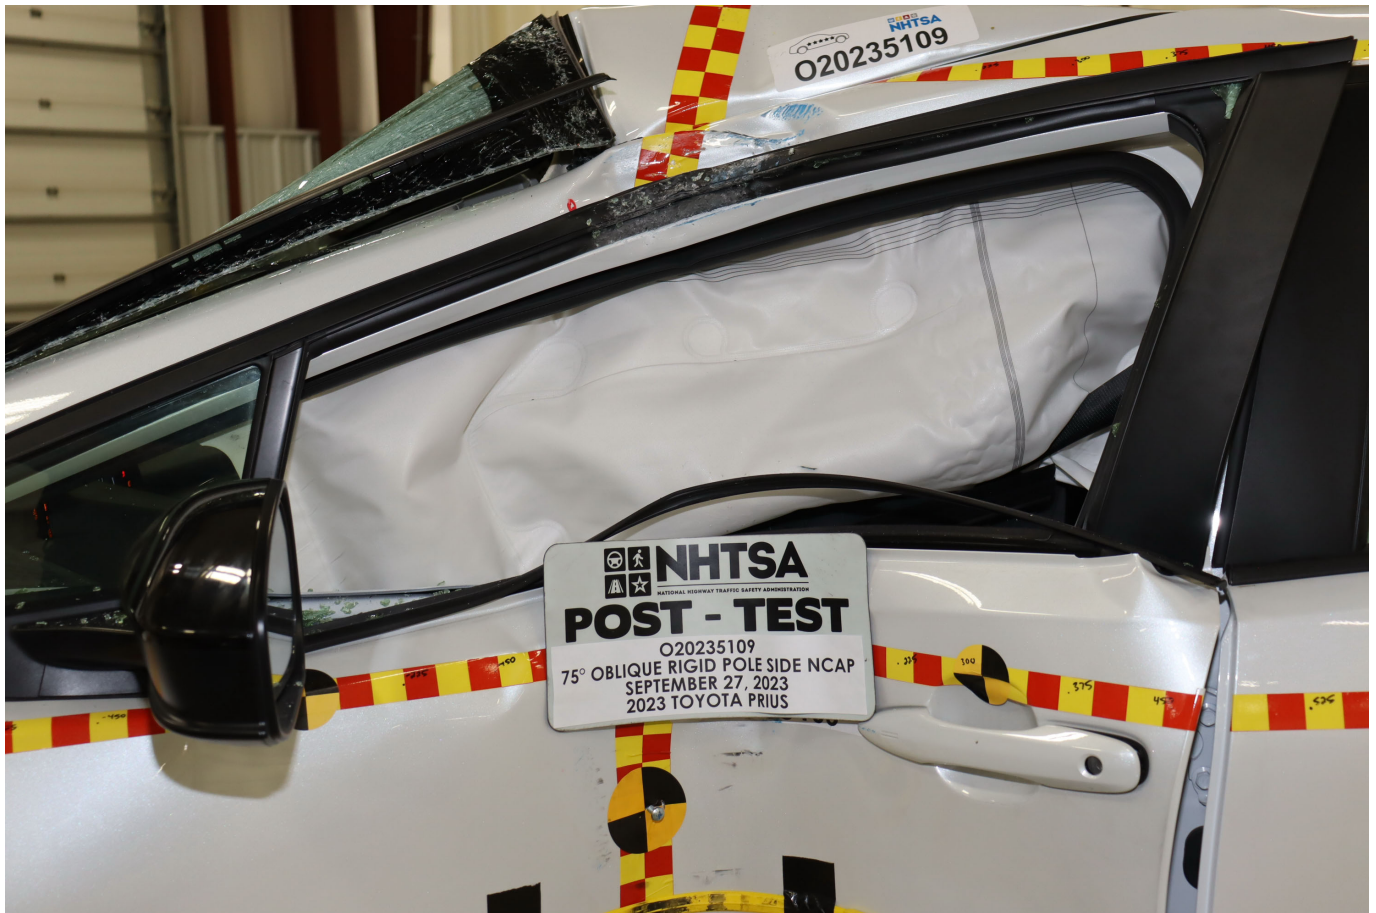
Photo No. 025 - Post-Test Left Side View of Dummy Shoulder and Door Top View

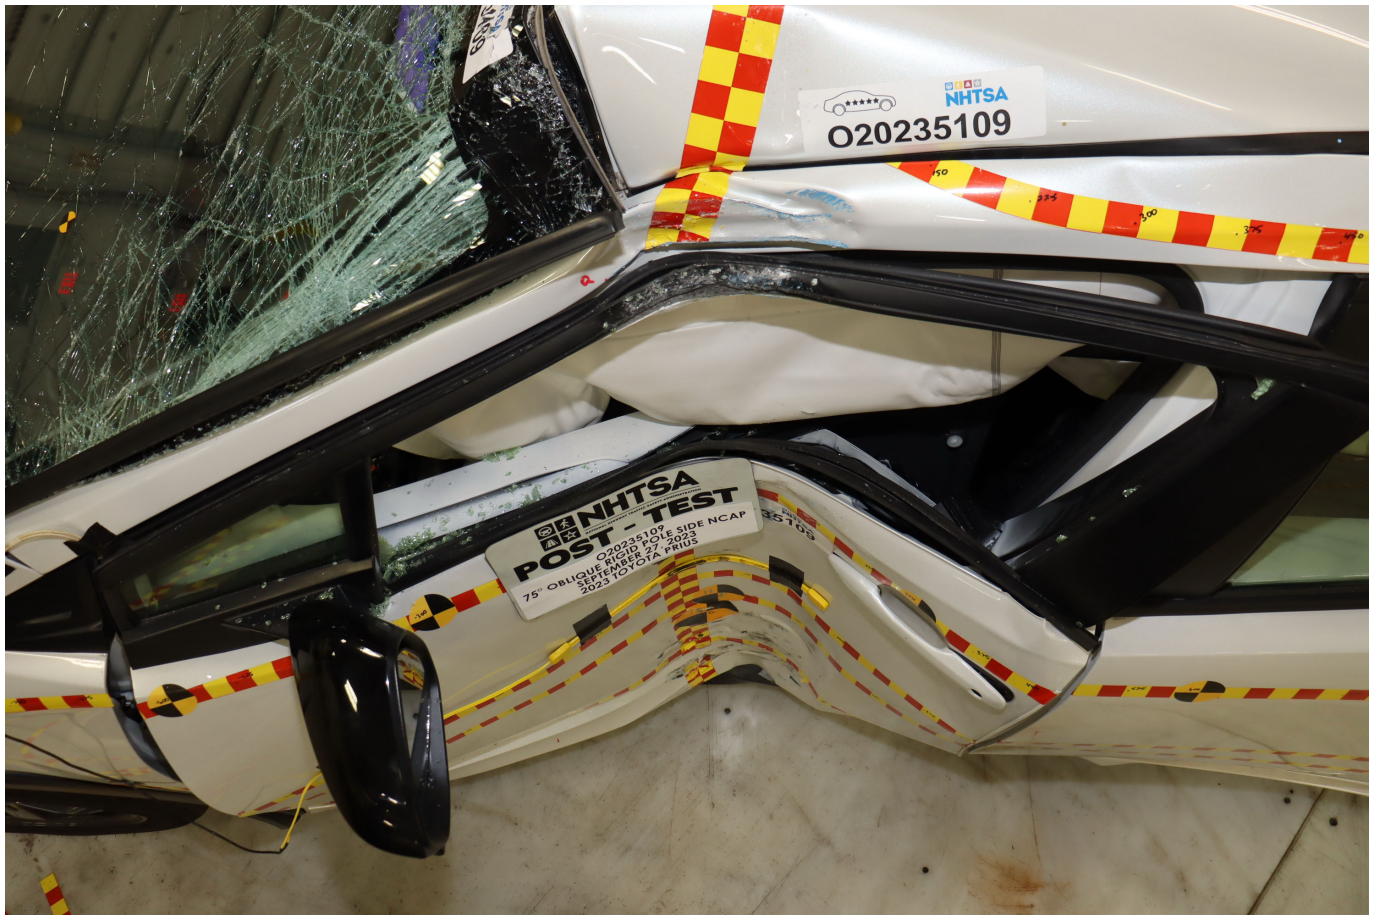
Photo No. 041 - Post-Test Dummy and Door Clearance View

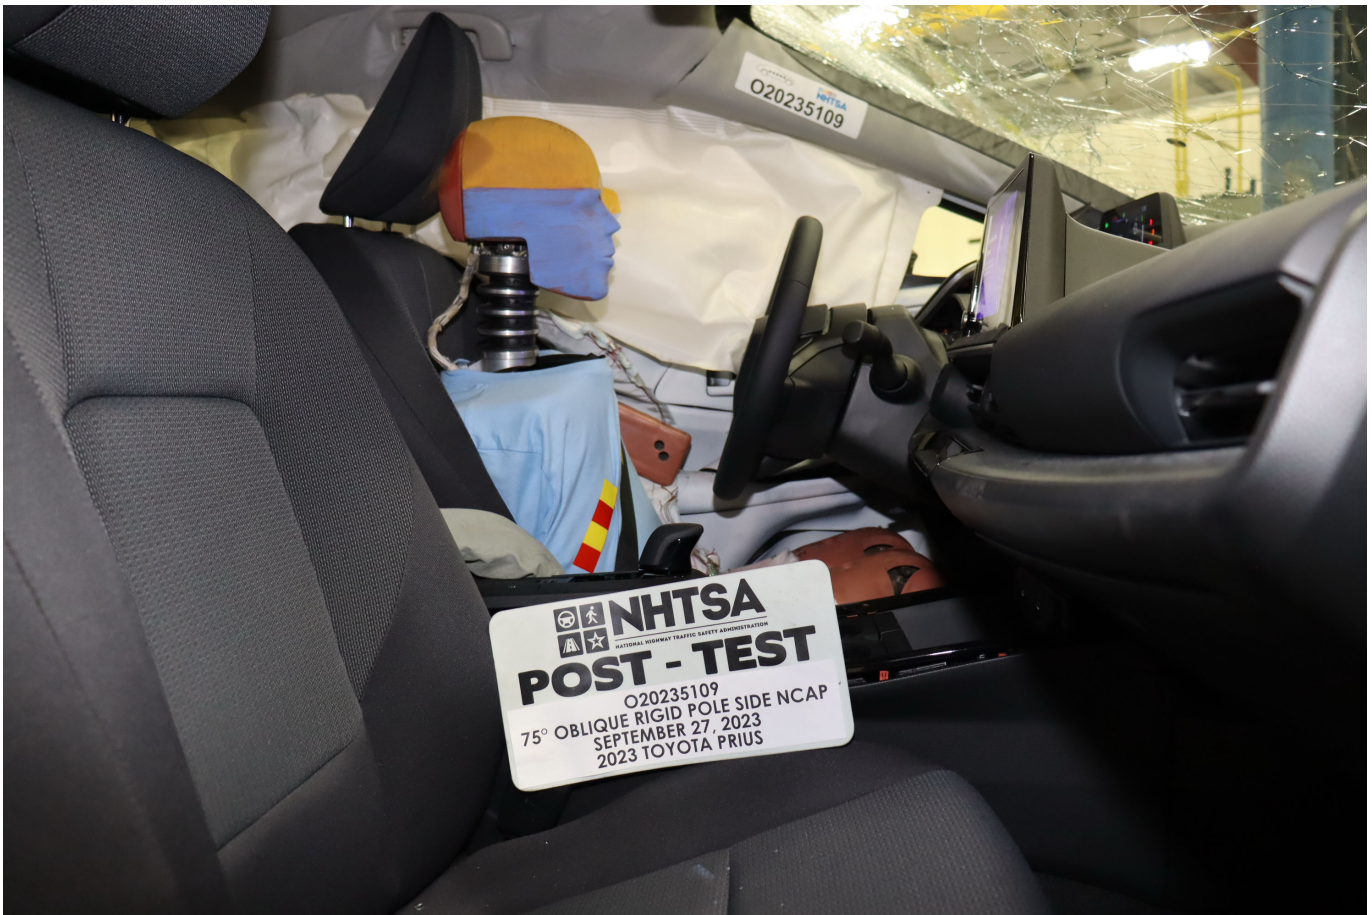
Photo No. 043 - Post-Test Right Side View of Dummy and Front Seat of Occupant Compartment

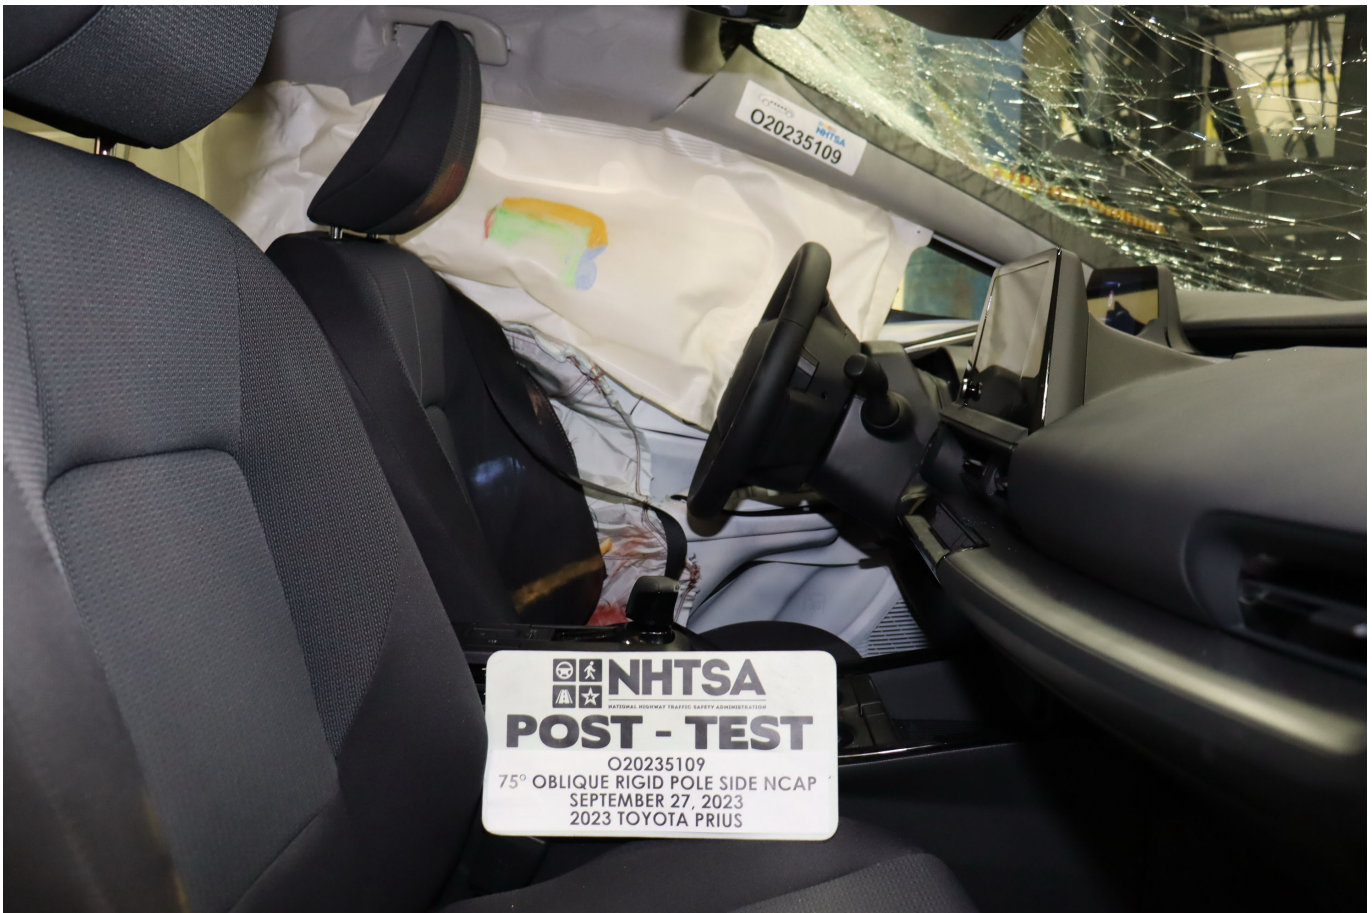
Photo No. 045 - Post-Test Inner Door Panel View Showing Dummy Contact Location

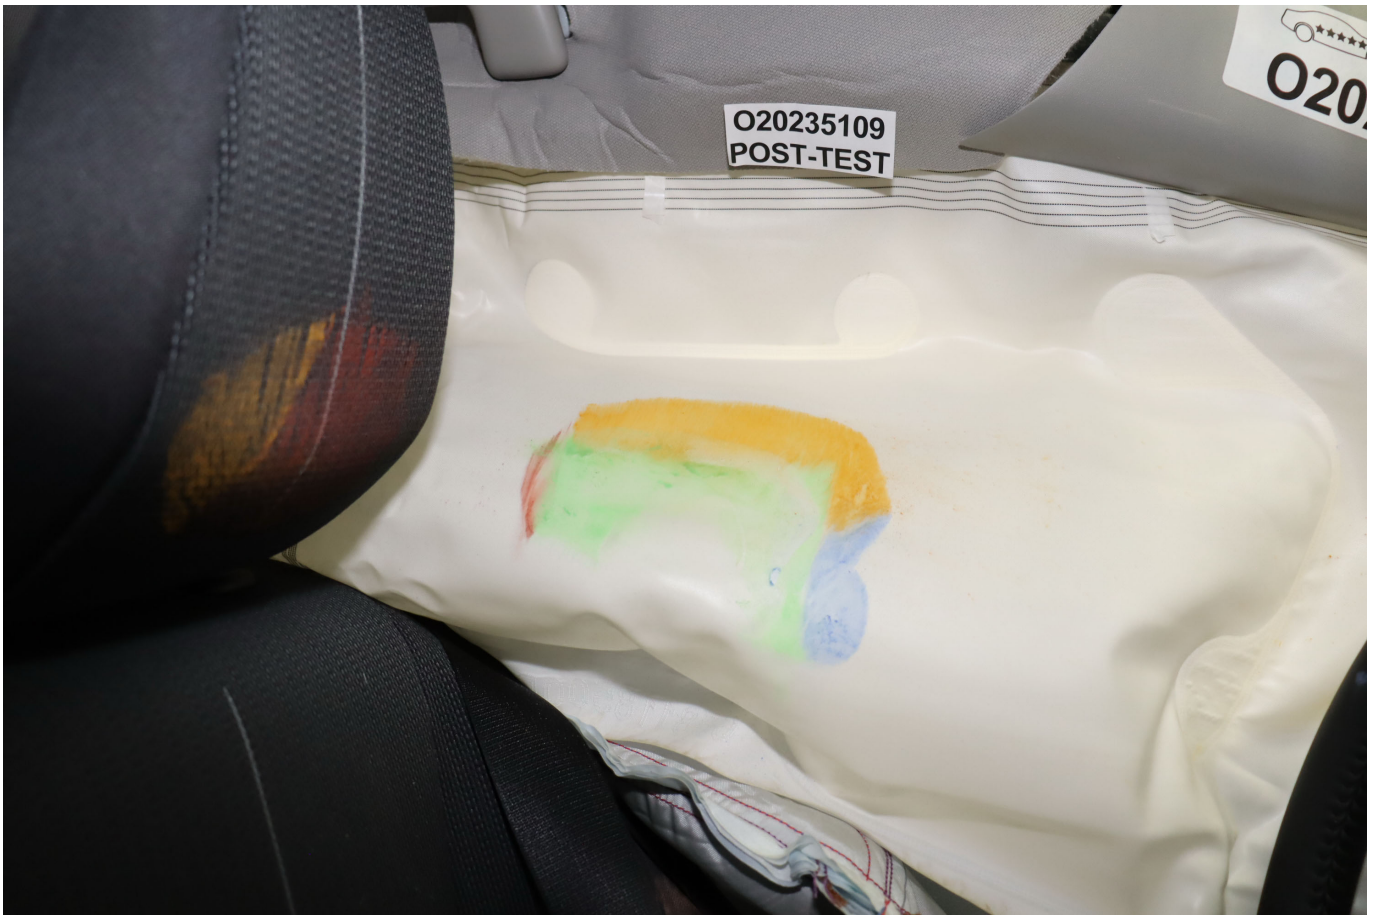
Photo No. 047 - Post-Test Dummy Close-Up Head Contact with Side Air Bag View

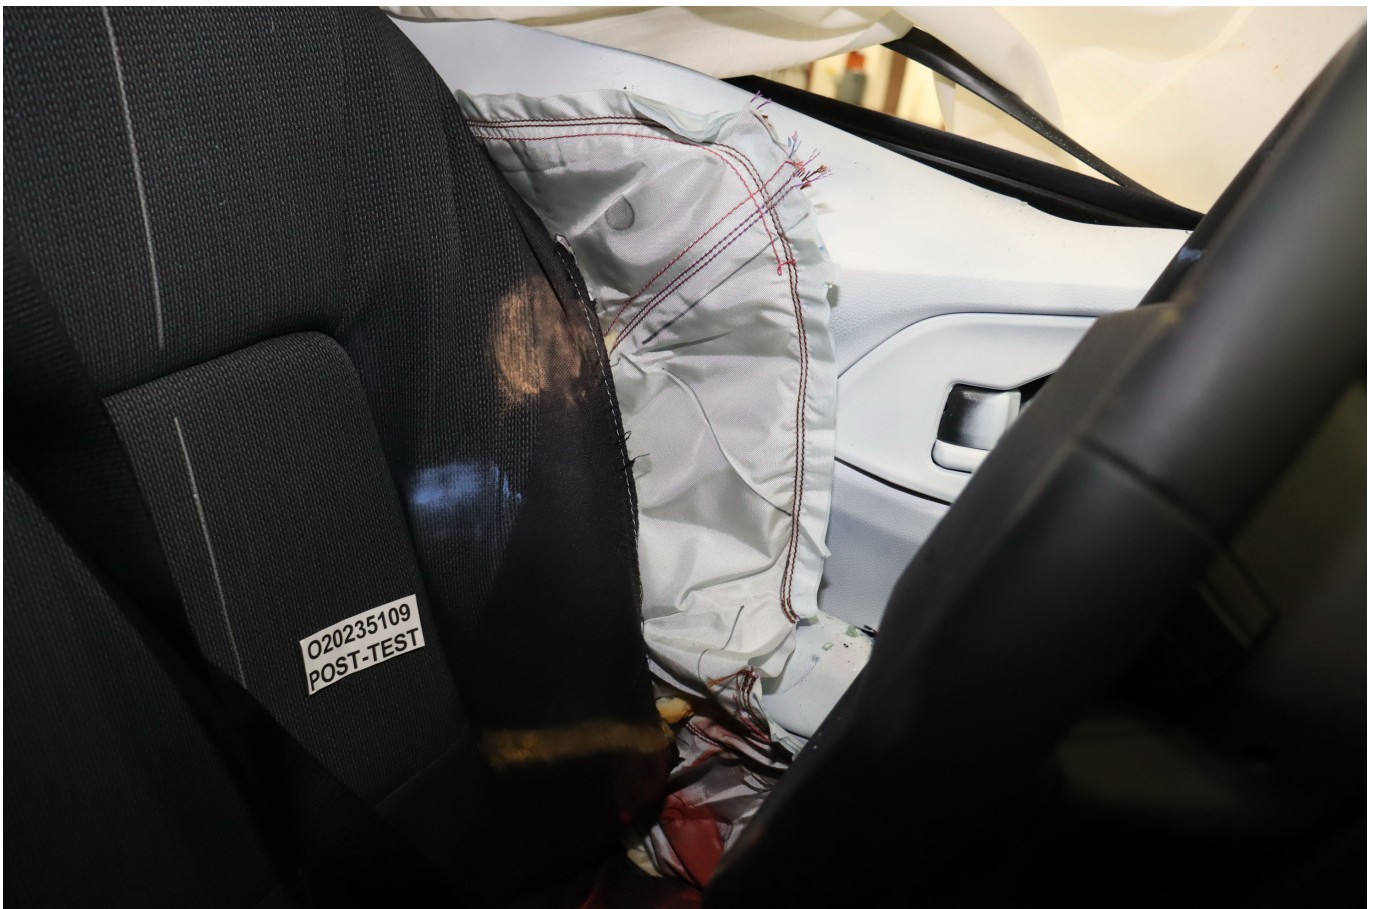
Photo No. 048 - Post-Test Dummy Close-Up Torso Contact with Vehicle Interior View

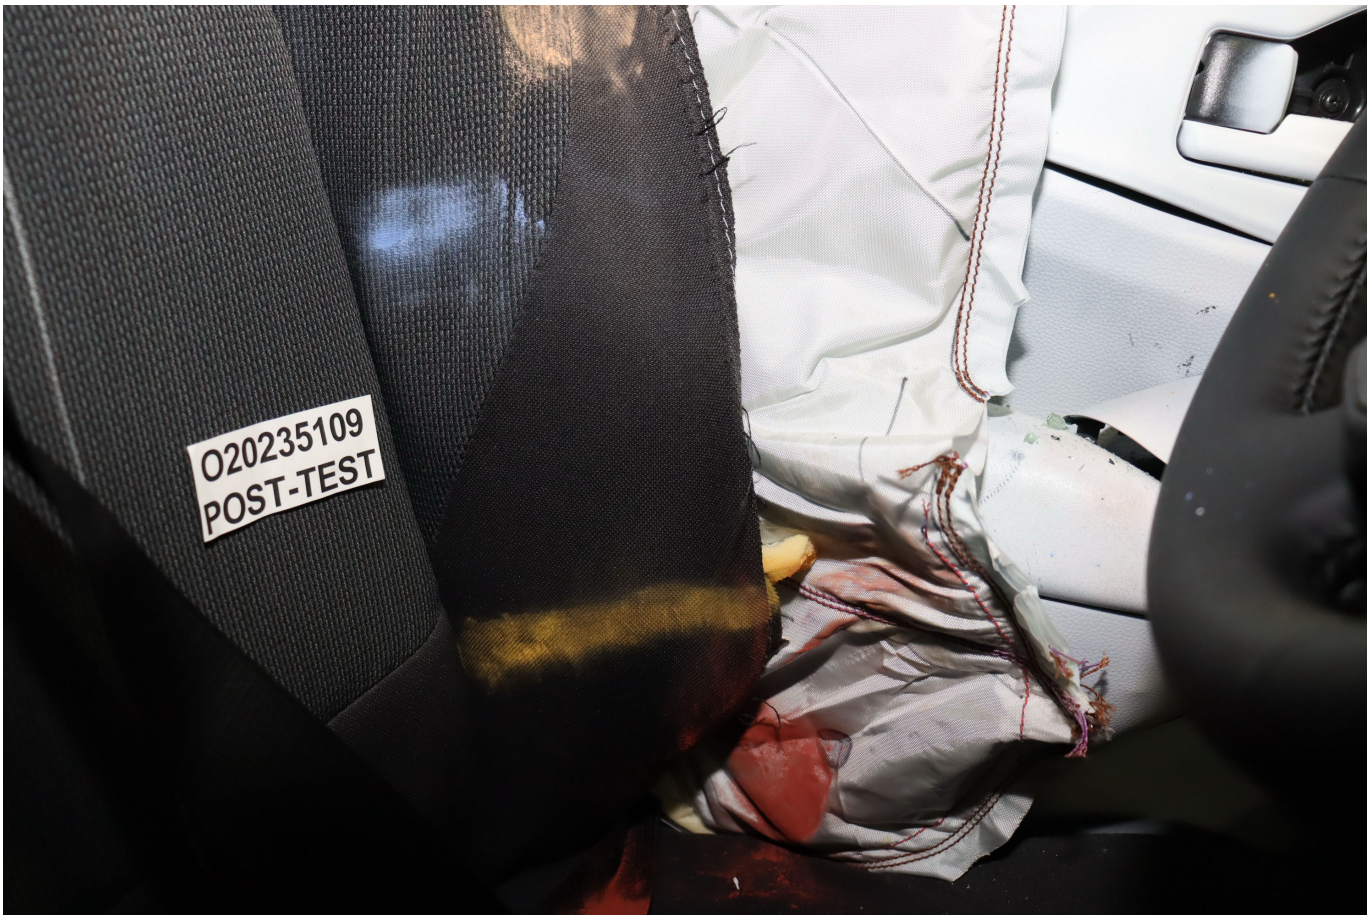
Photo No. 049 - Post-Test Dummy Close-Up Torso Contact with Side Air Bag View

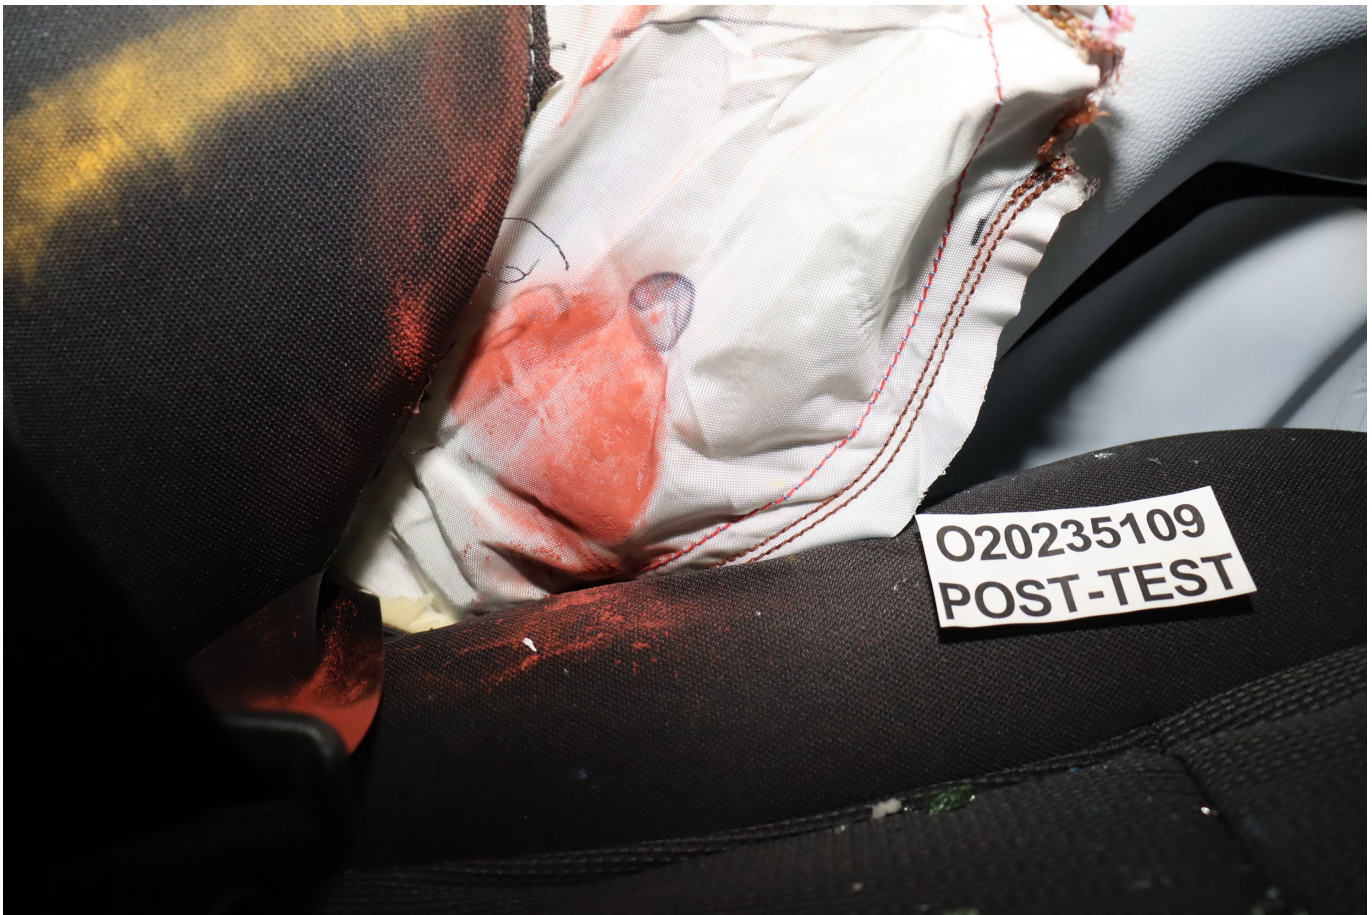
Photo No. 051 - Post-Test Dummy Close-Up Pelvis Contact with Side Air Bag View

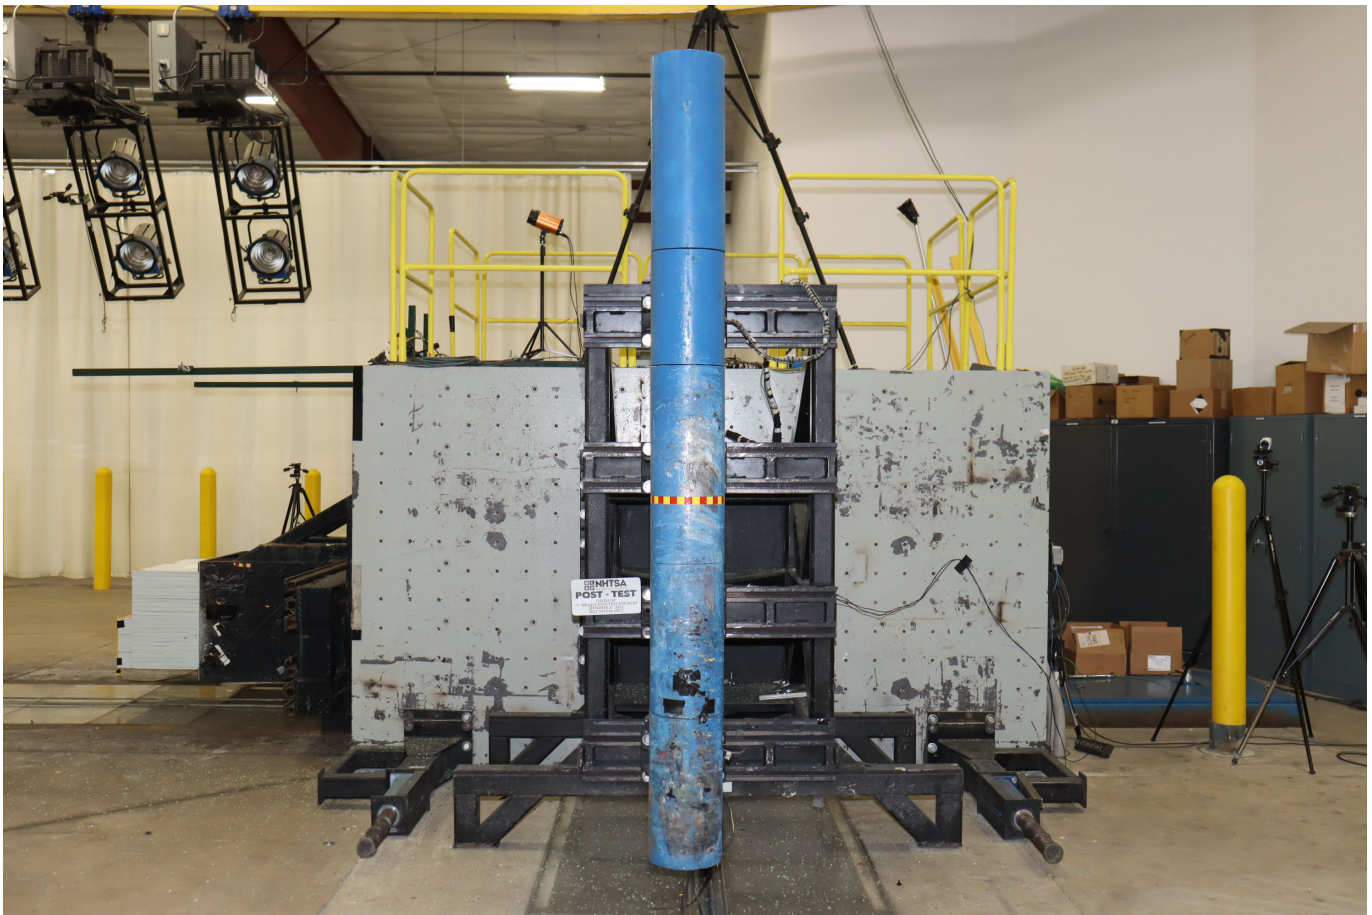
Photo No. 060 - Post-Test Pole Barrier Front View

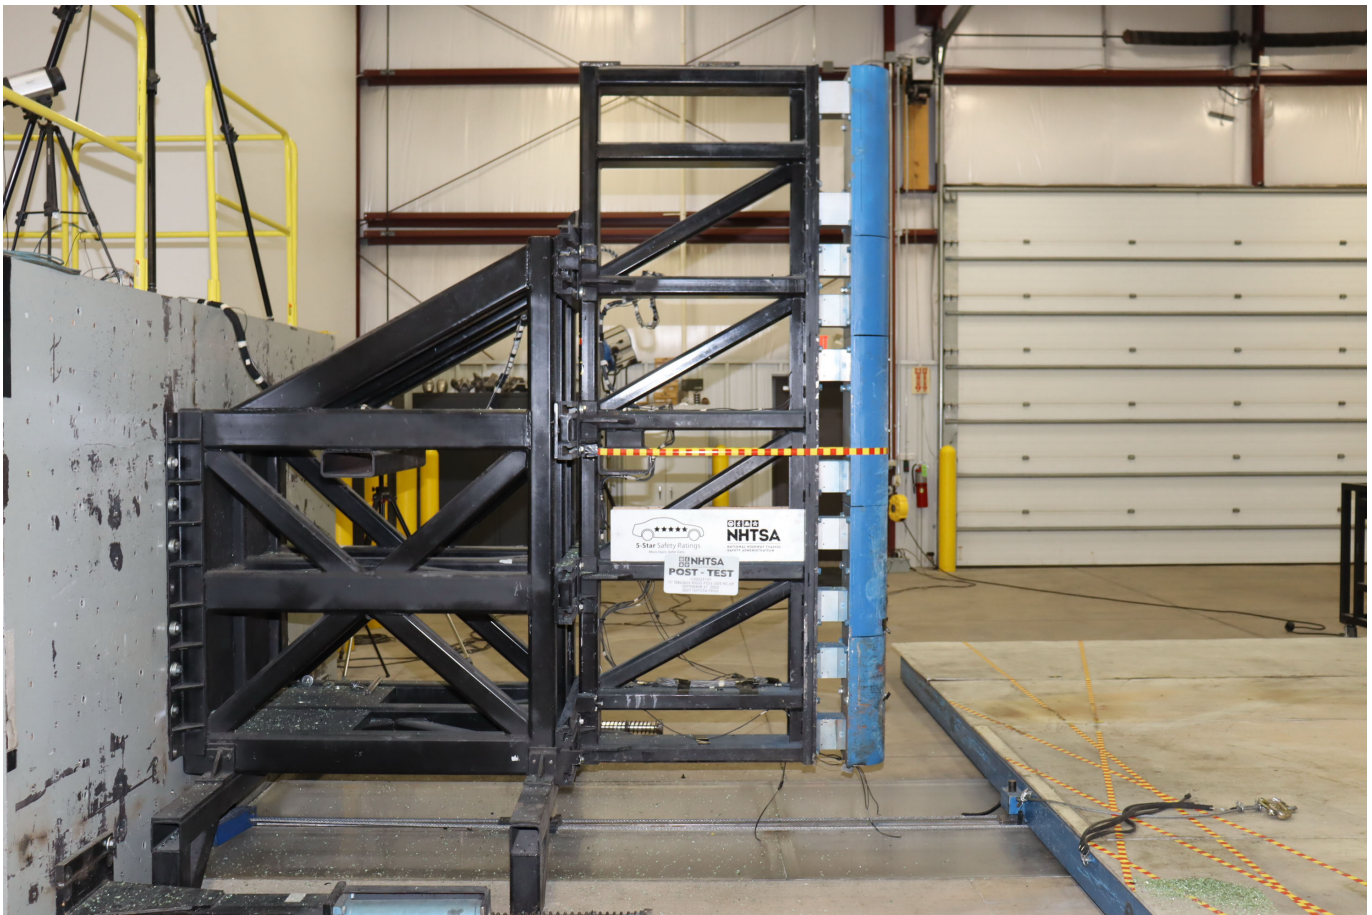
Photo No. 062 - Post-Test Pole Barrier Side View

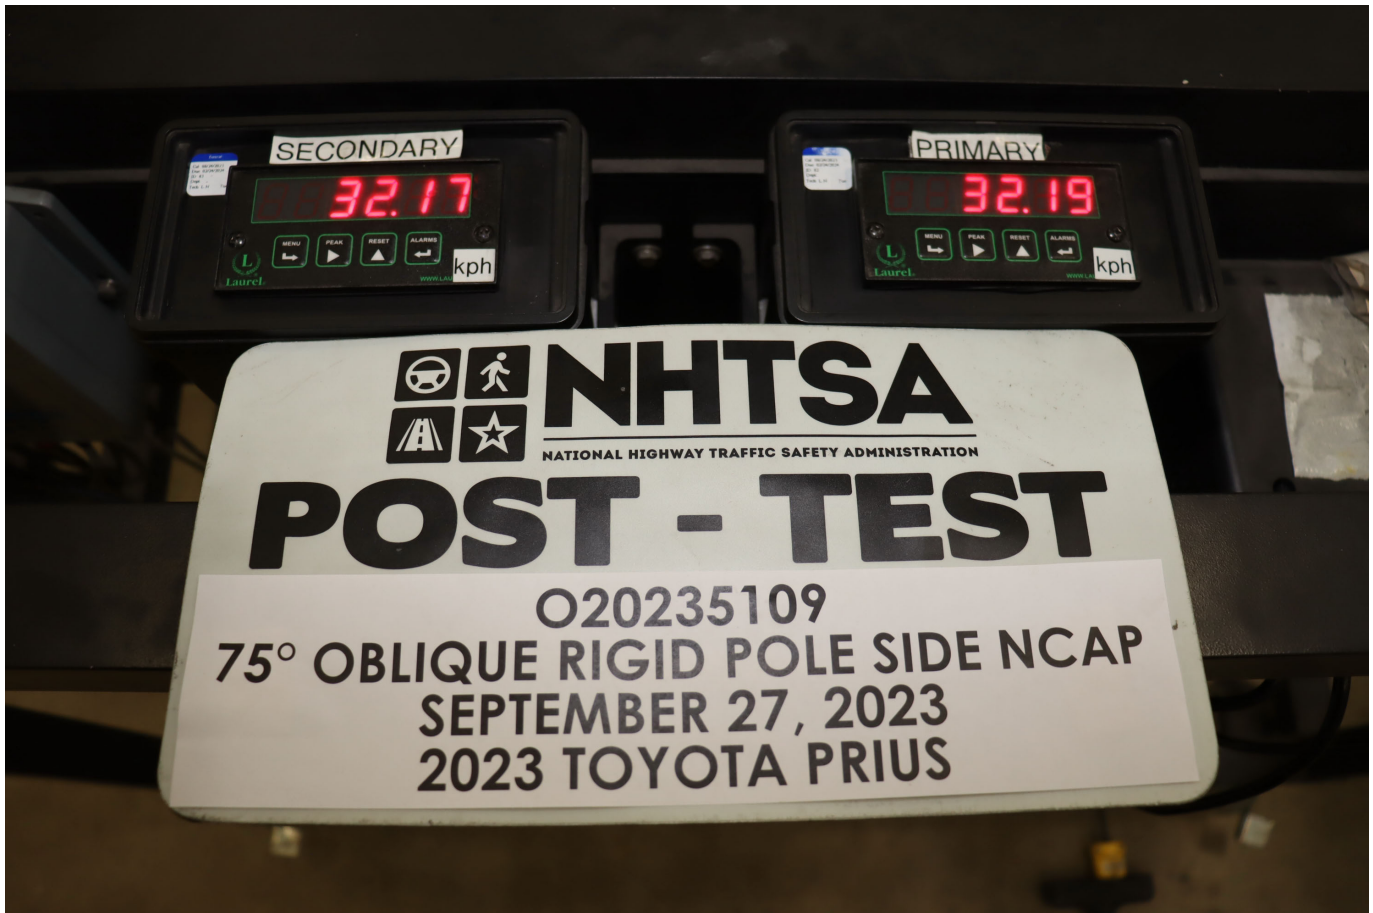
Photo No. 064 - Post-Test Primary and Redundant Speed Trap Read-Out

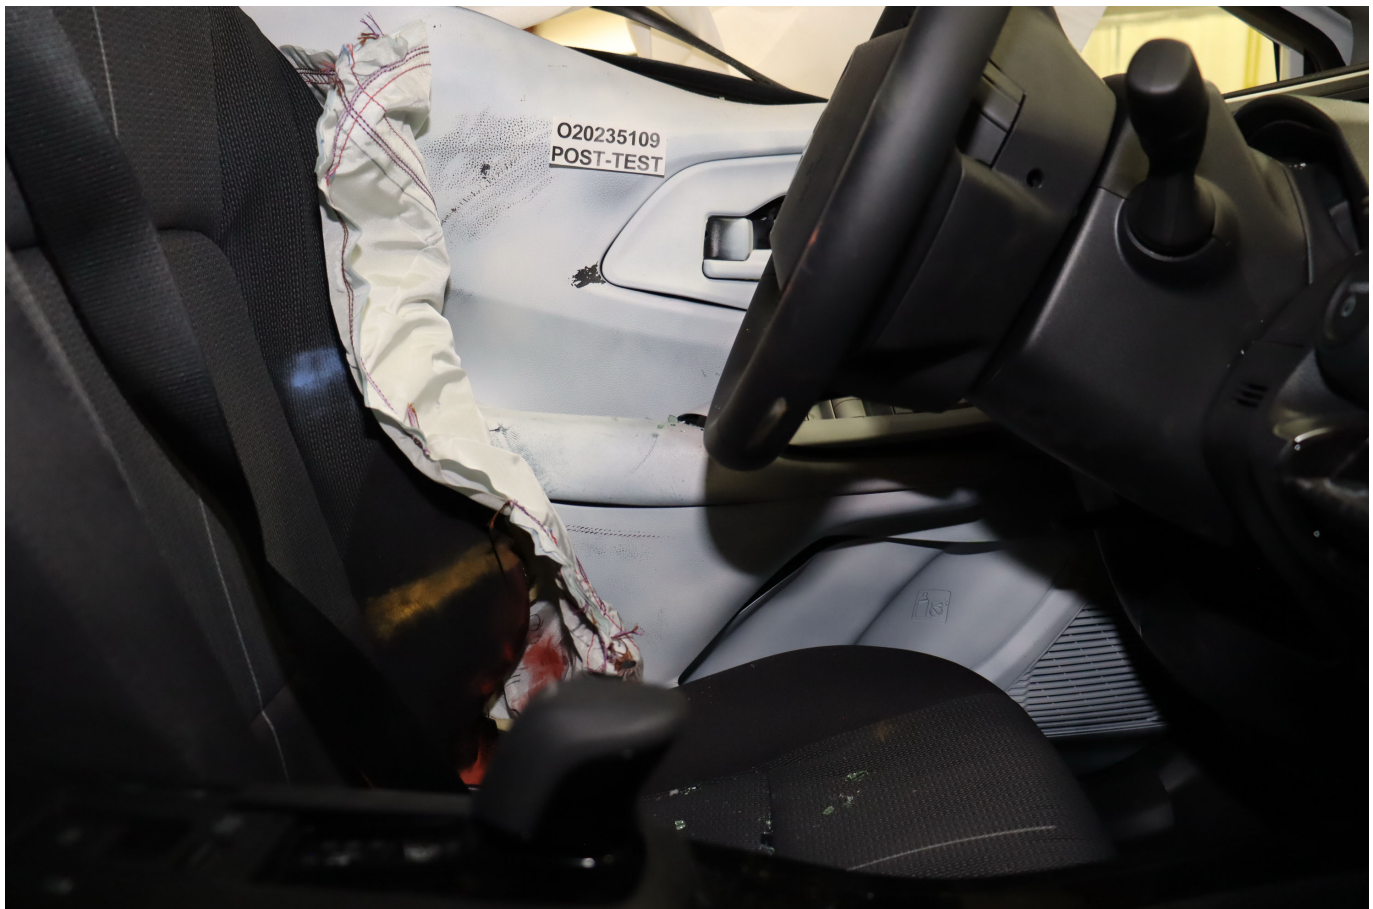
Photo No. 073 - Post-Test View of Shattered Vehicle Inner Door Panel
