**REPORT NUMBER: SideNCAPMDB-MGA-23-044**

**NEW CAR ASSESSMENT PROGRAM (NCAP)  
Moving Deformable Barrier Side Impact Test**

**TOYOTA MOTOR CORPORATION  
2023 Toyota Crown XLE HEV 4-Door Sedan  
NHTSA No.: O20235116**

**MGA RESEARCH CORPORATION  
5000 Warren Road  
Burlington, WI 53105**

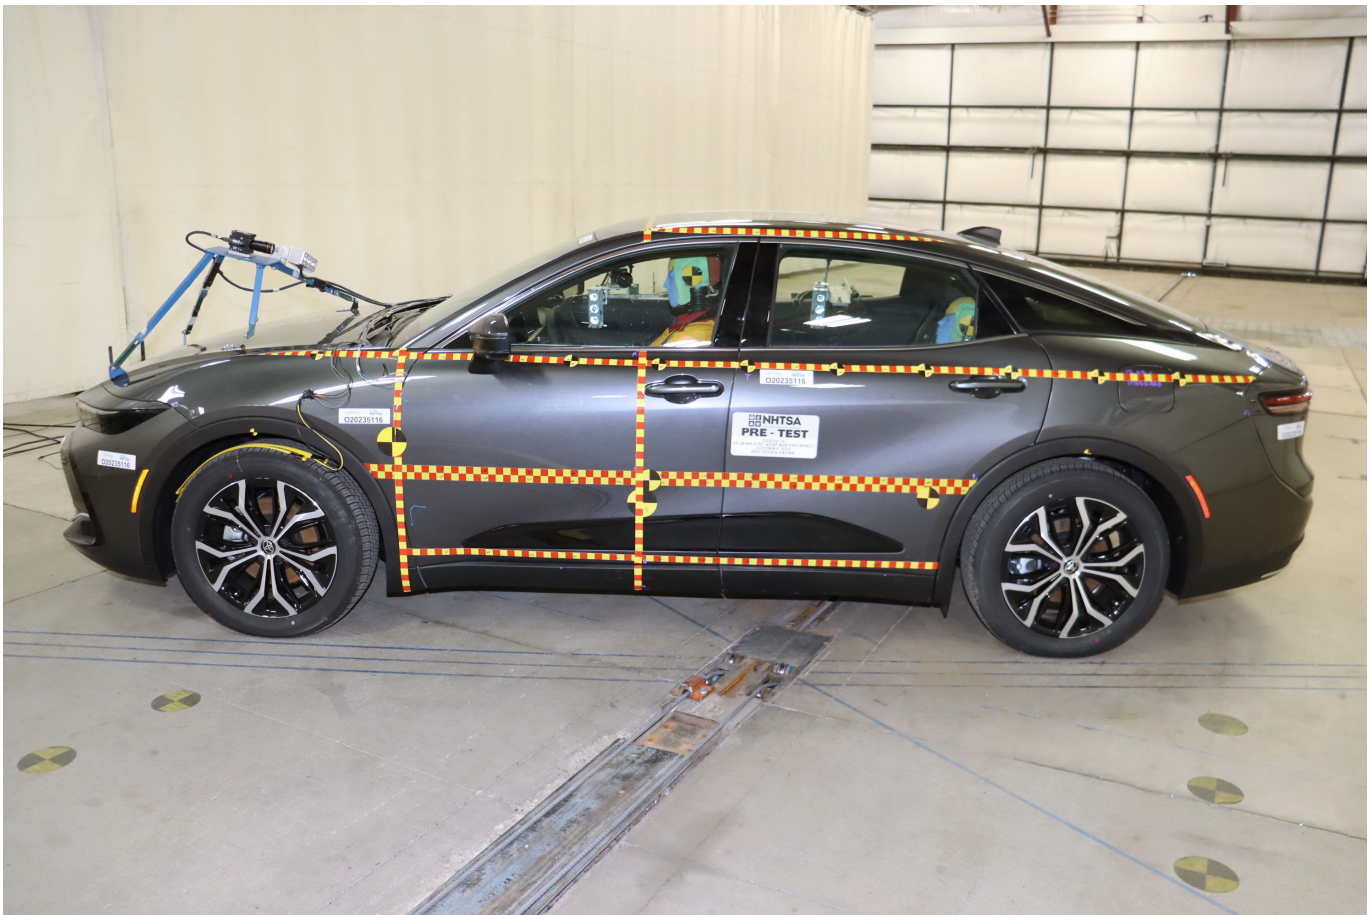
Photo No. 007 - Pre-Test Left Side View of Test Vehicle

Photo No. 008 - Post-Test Left Side View of Test Vehicle

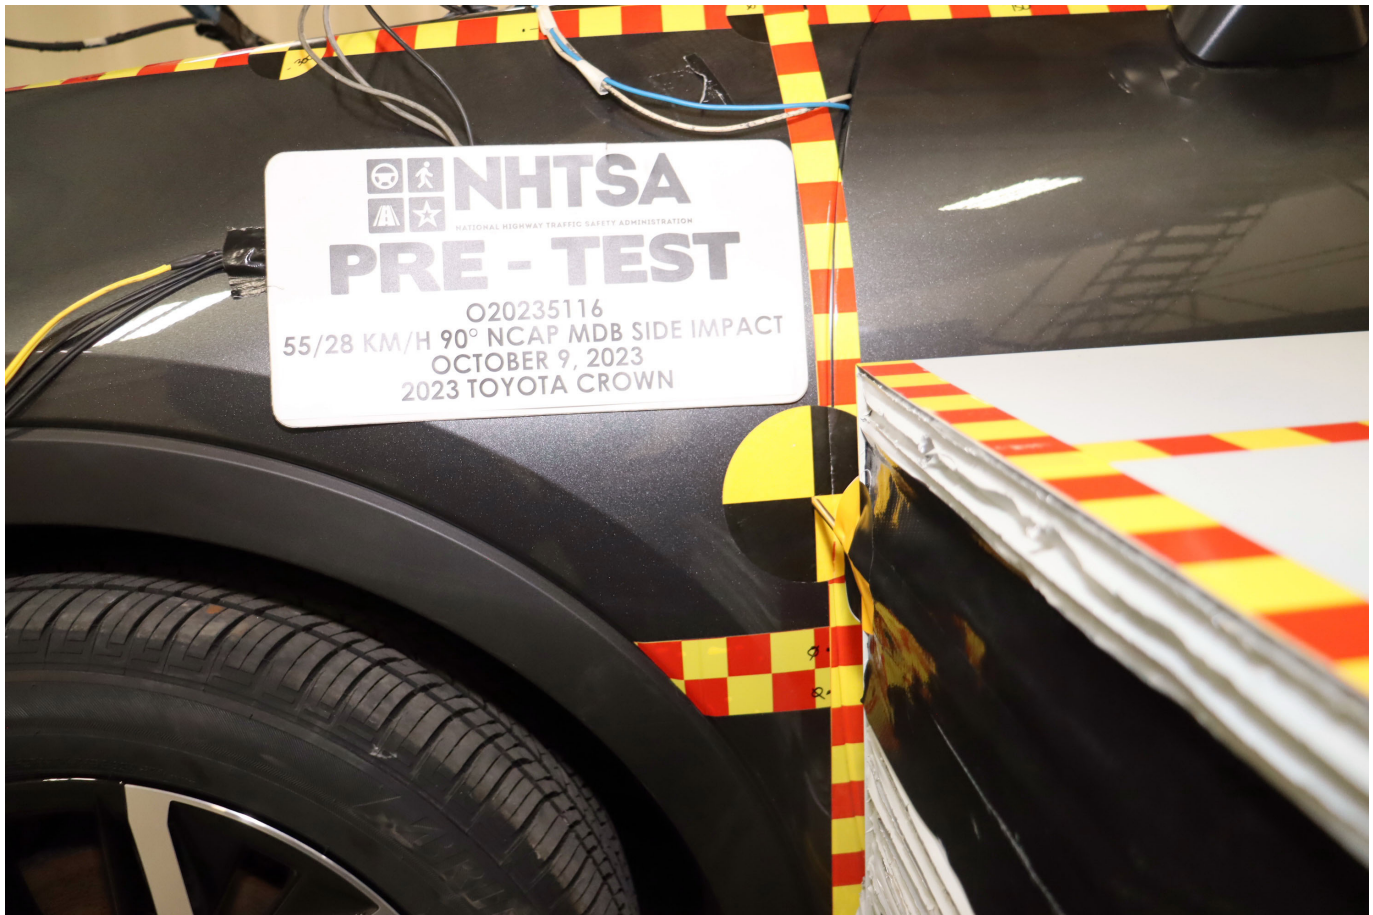
Photo No. 019 - Pre-Test Close-Up View of Impact Point Target

Photo No. 020 - Post-Test Close-Up View of Impact Point Target

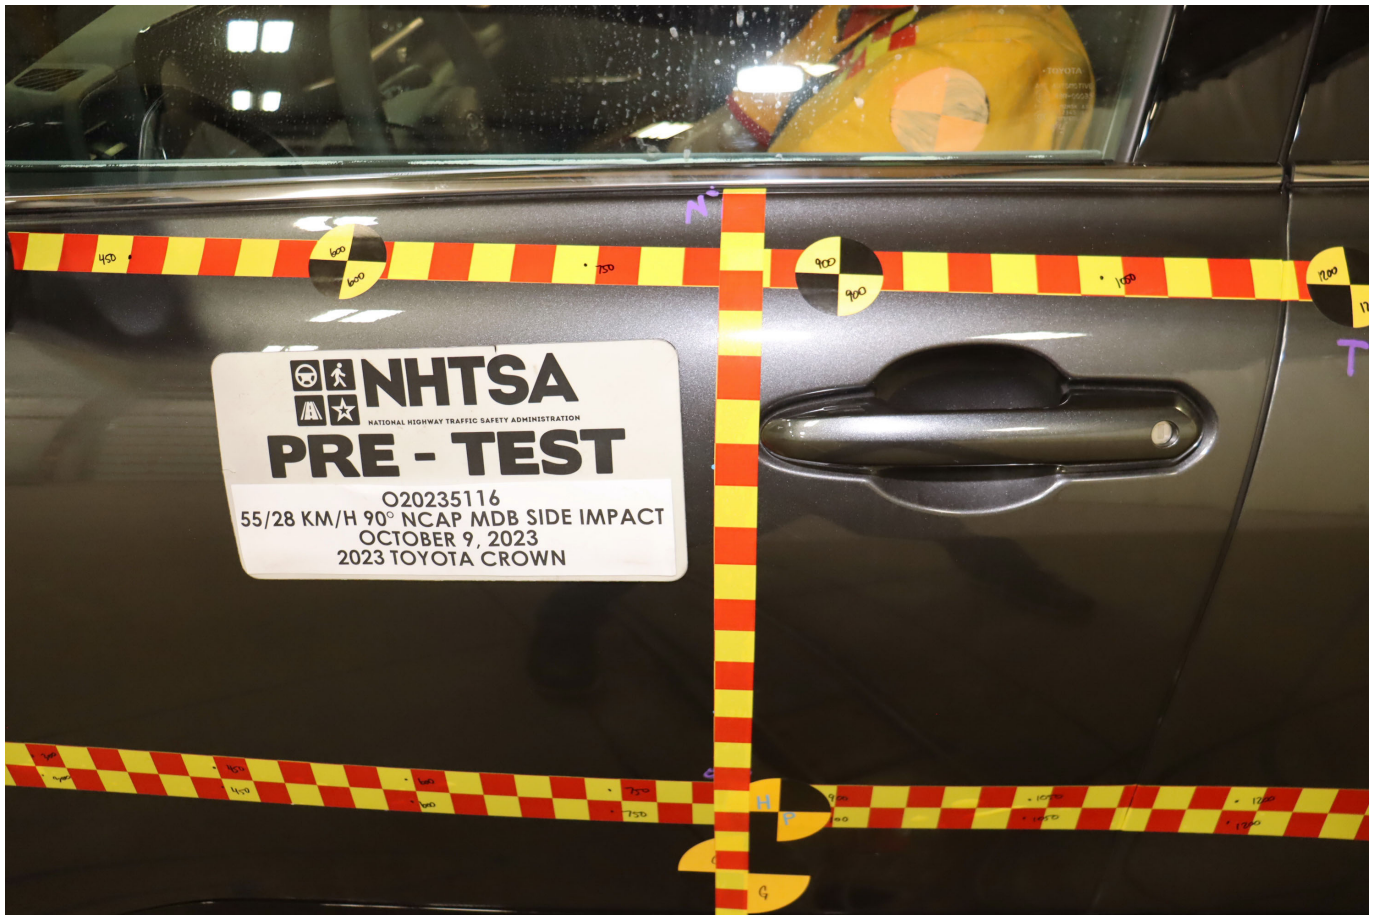
Photo No. 021 - Pre-Test Left Front Door Latch Close-Up

Photo No. 022 - Post-Test Left Front Door Latch Close-Up

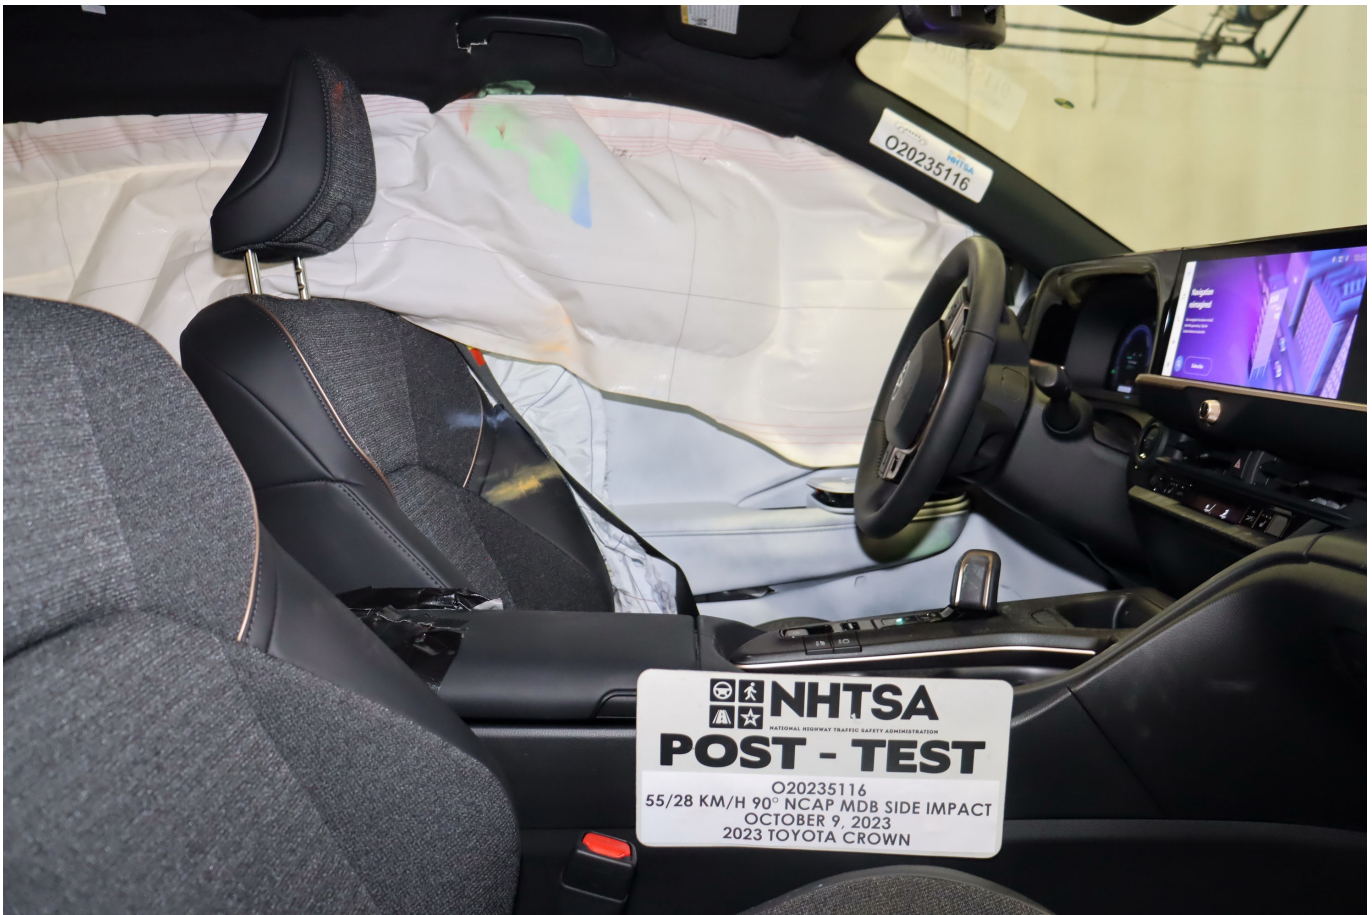
Photo No. 047 - Post-Test Driver Inner Door Panel View

Photo No. 048 - Post-Test Driver Dummy Close-Up Head Contact with Vehicle Interior View

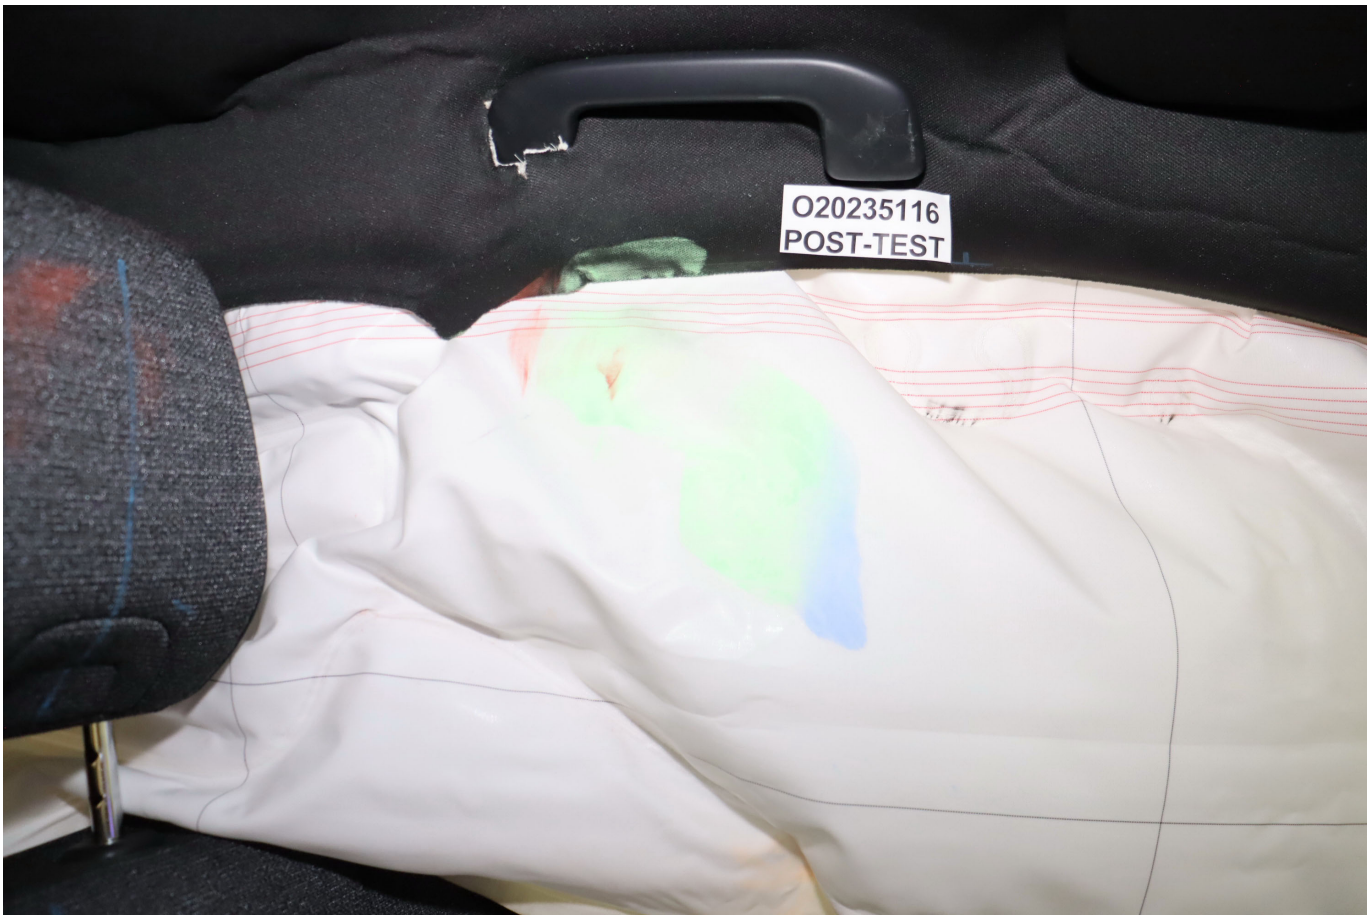
Photo No. 049 - Post-Test Driver Dummy Close-Up Head Contact with Side Airbag View

Photo No. 050 - Post-Test Driver Dummy Close-Up Torso Contact with Vehicle Interior View

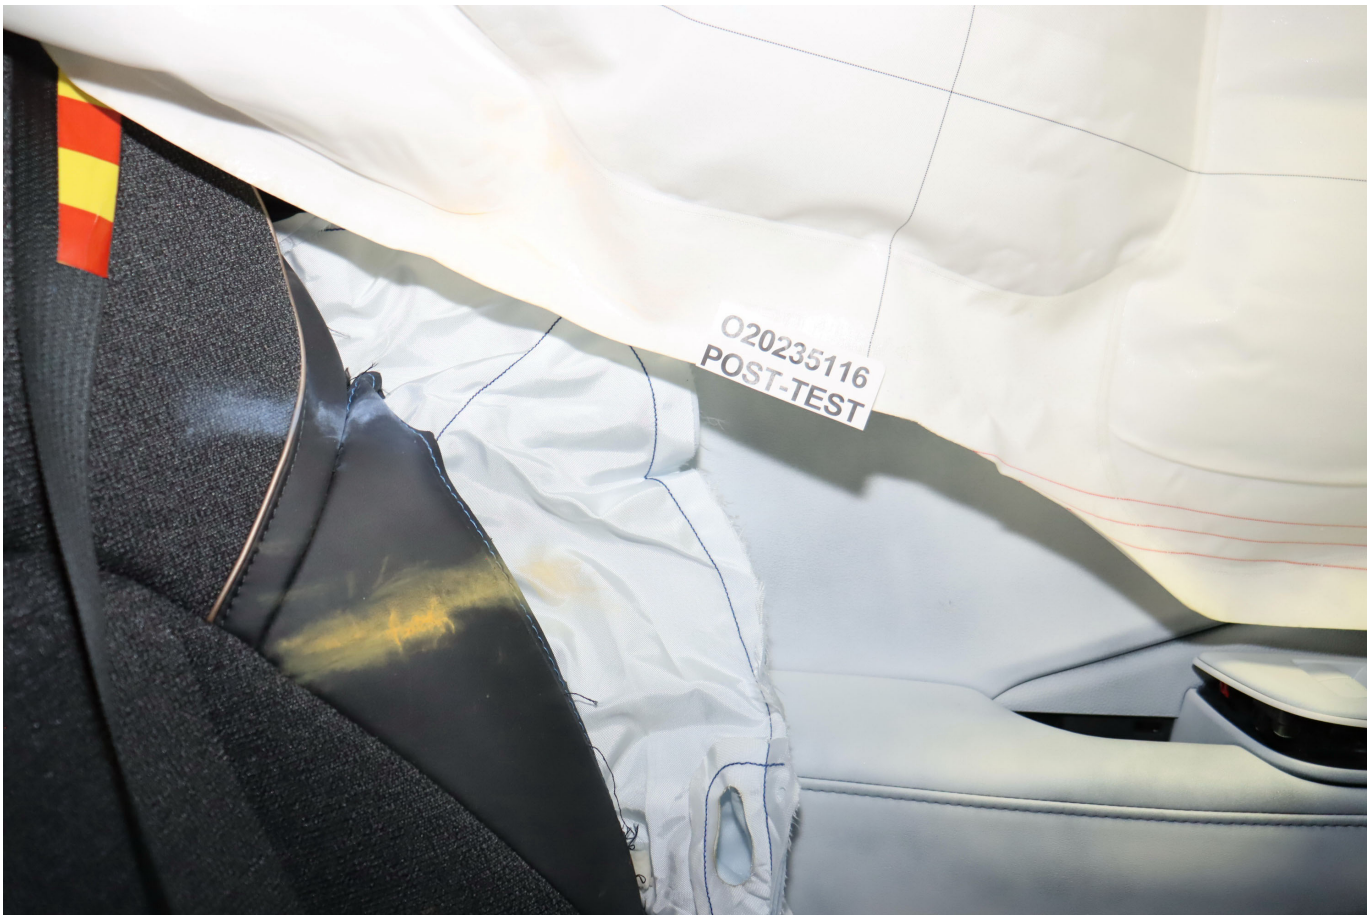
Photo No. 051 - Post-Test Driver Dummy Close-Up Torso Contact with Side Airbag View

Photo No. 052 - Post-Test Driver Dummy Close-Up Pelvis Contact with Vehicle Interior View

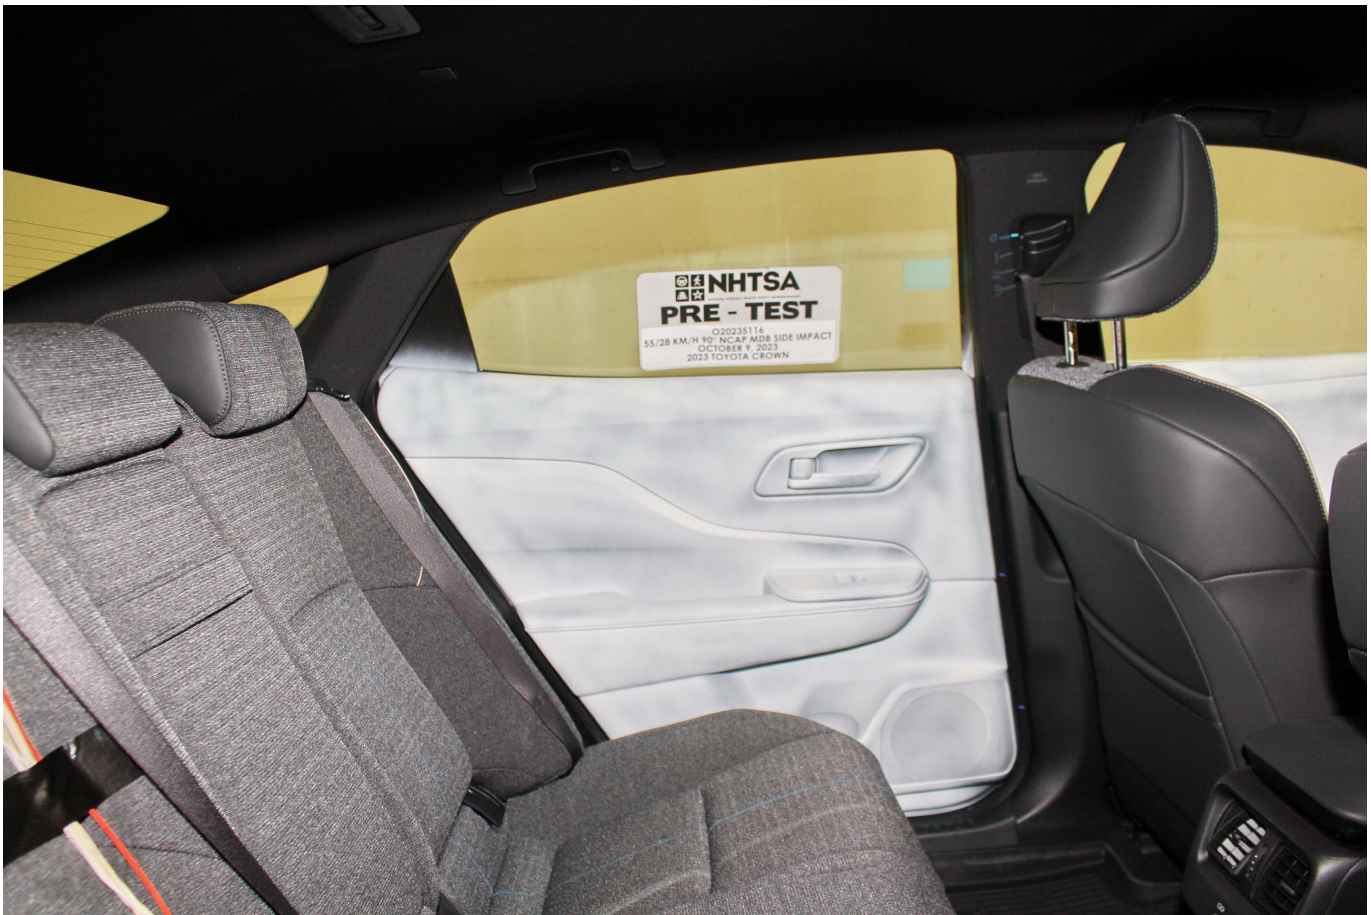
Photo No. 073 - Pre-Test Rear Passenger Inner Door Panel View

Photo No. 074 - Post-Test Rear Passenger Inner Door Panel View

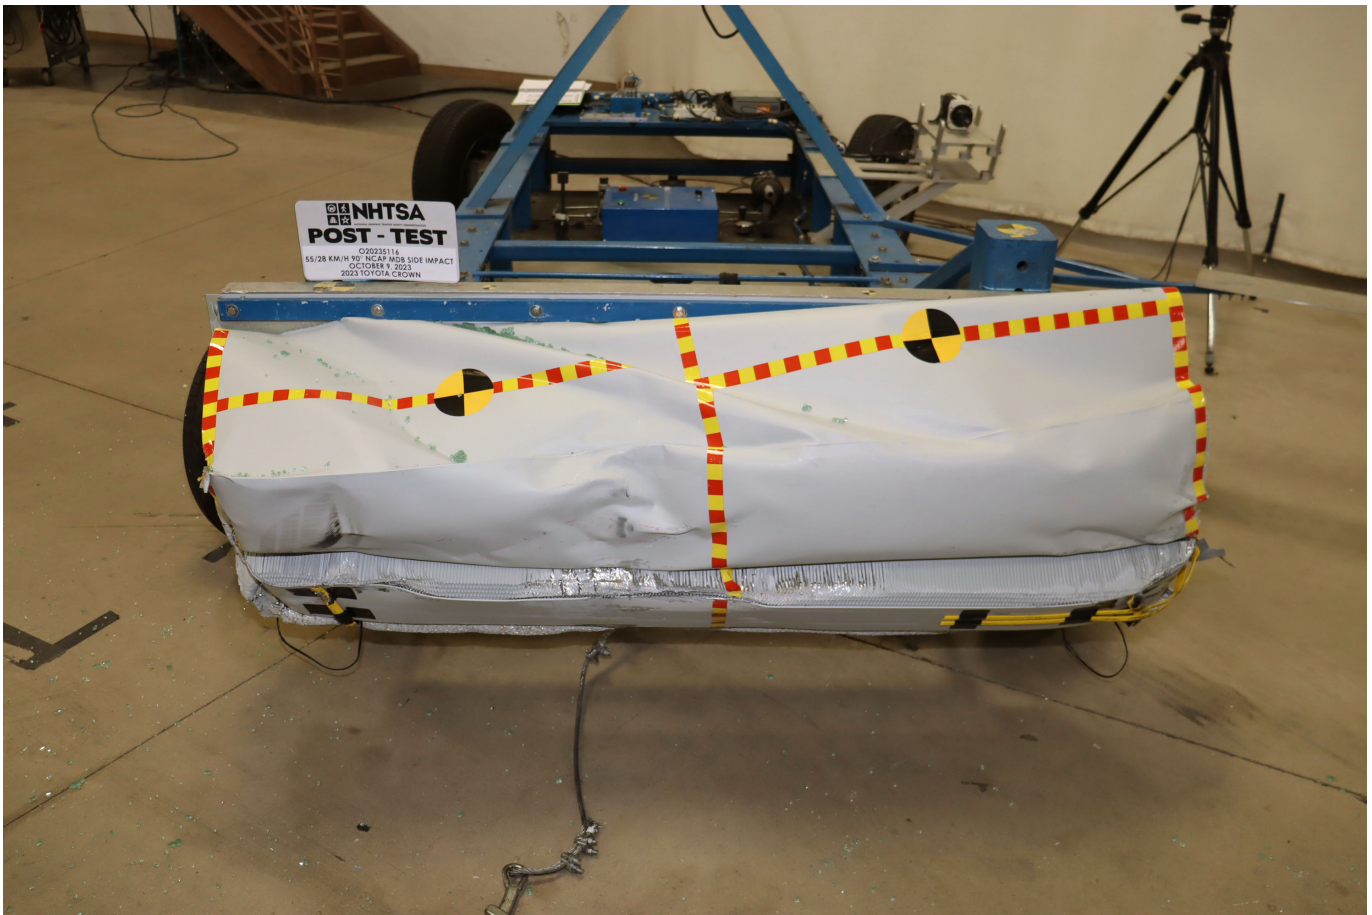
Photo No. 085 - Post-Test Front View of MDB Impactor Face

Photo No. 086 - Pre-Test Top View of MDB Impactor Face

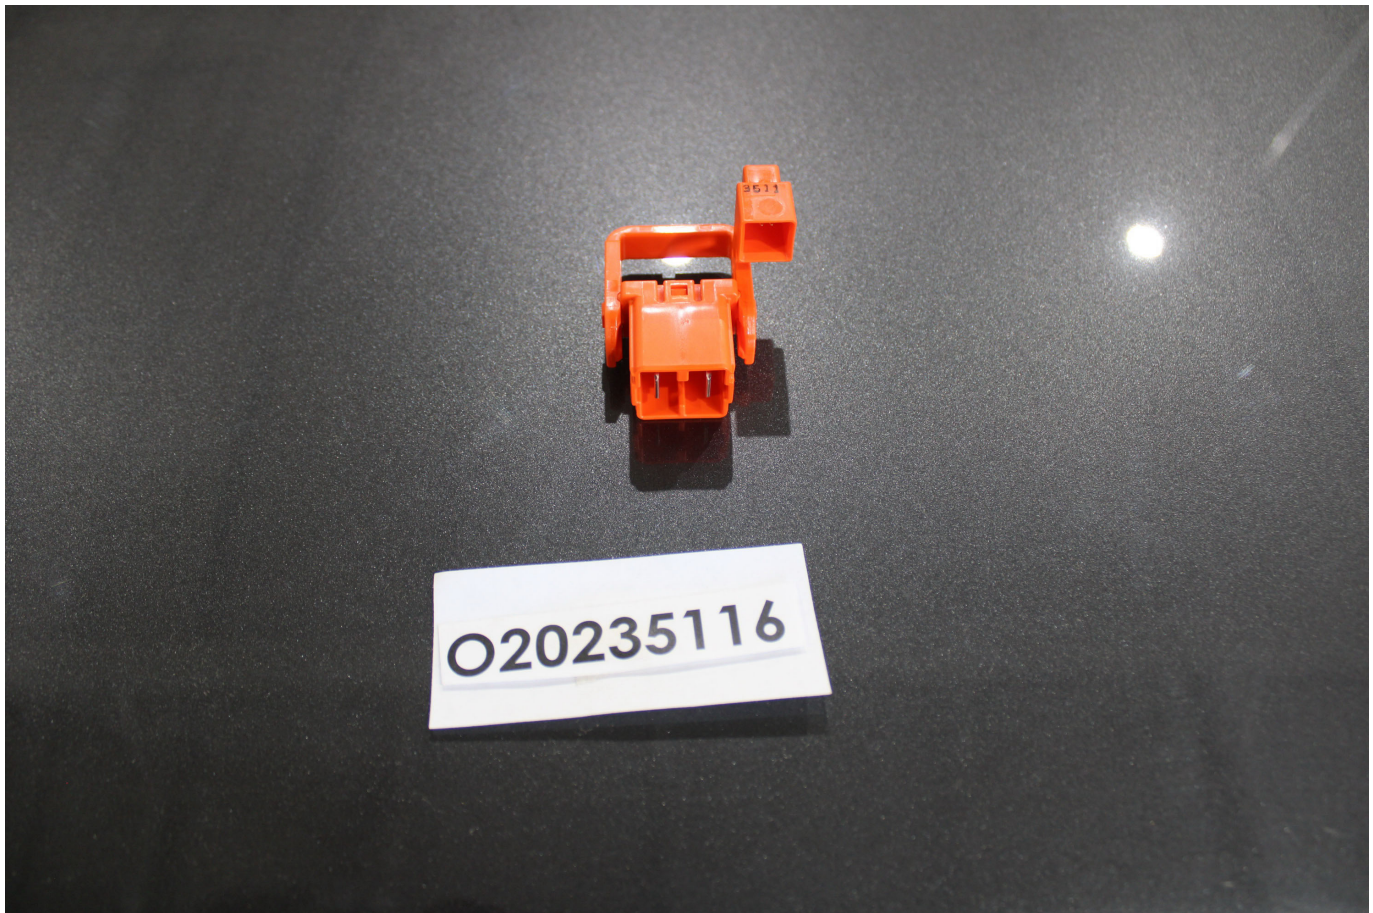
Photo No. 305-08 - Manual High Voltage Service Disconnect Removed

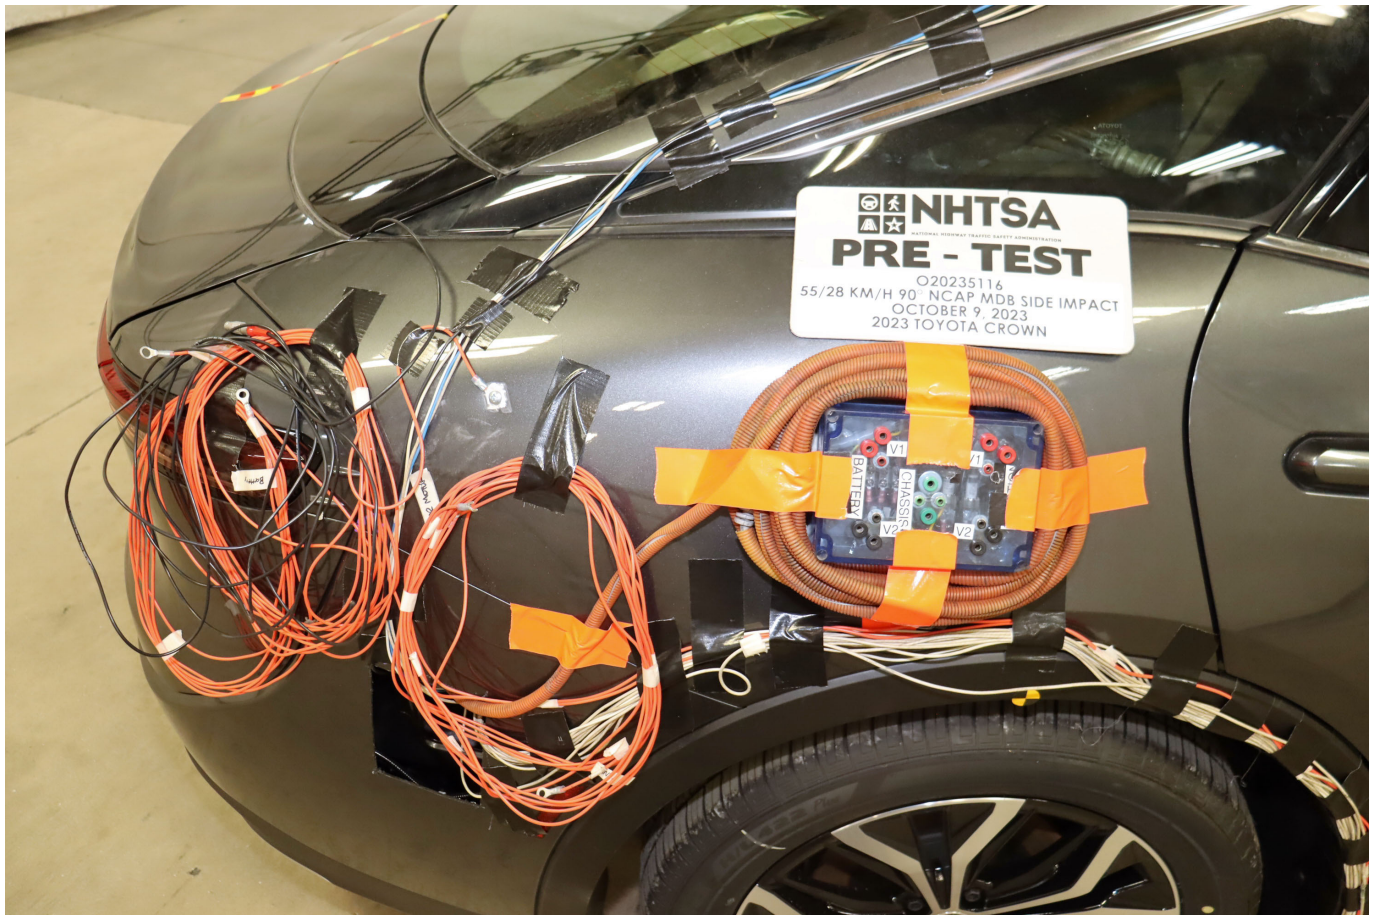
Photo No. 305-24 - Pre-Impact View of Installed Test Interface Port

Photo No. 305-25 - Post-Impact View of Installed Test Interface Port
