**REPORT NUMBER: SPNCAP-CAL-24-004**

**NEW CAR ASSESSMENT PROGRAM (NCAP)  
SIDE IMPACT POLE TEST**

**Hyundai Motor Company  
2024 Hyundai Ioniq 5  
5 Door SUV**

**FINAL REPORT**

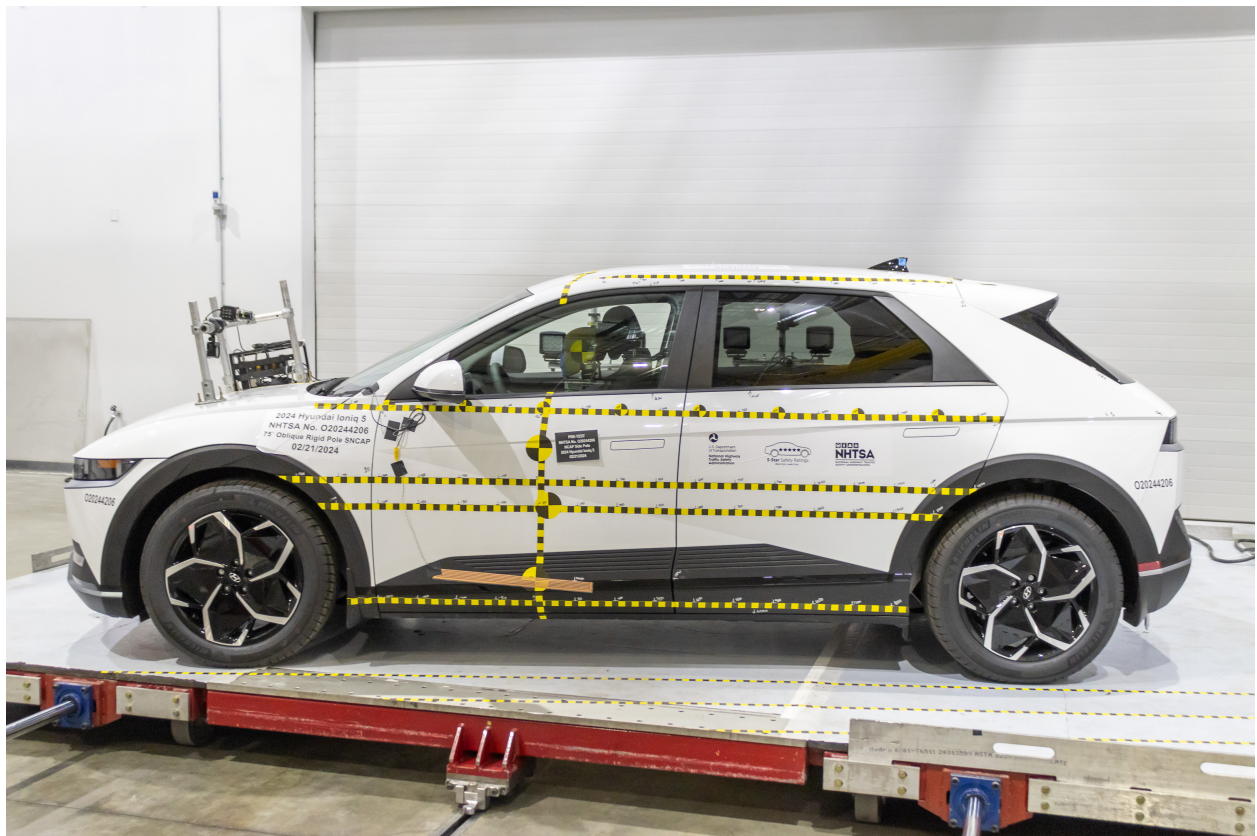
**Figure A-7: Pre-Test Left Side View of Test Vehicle**

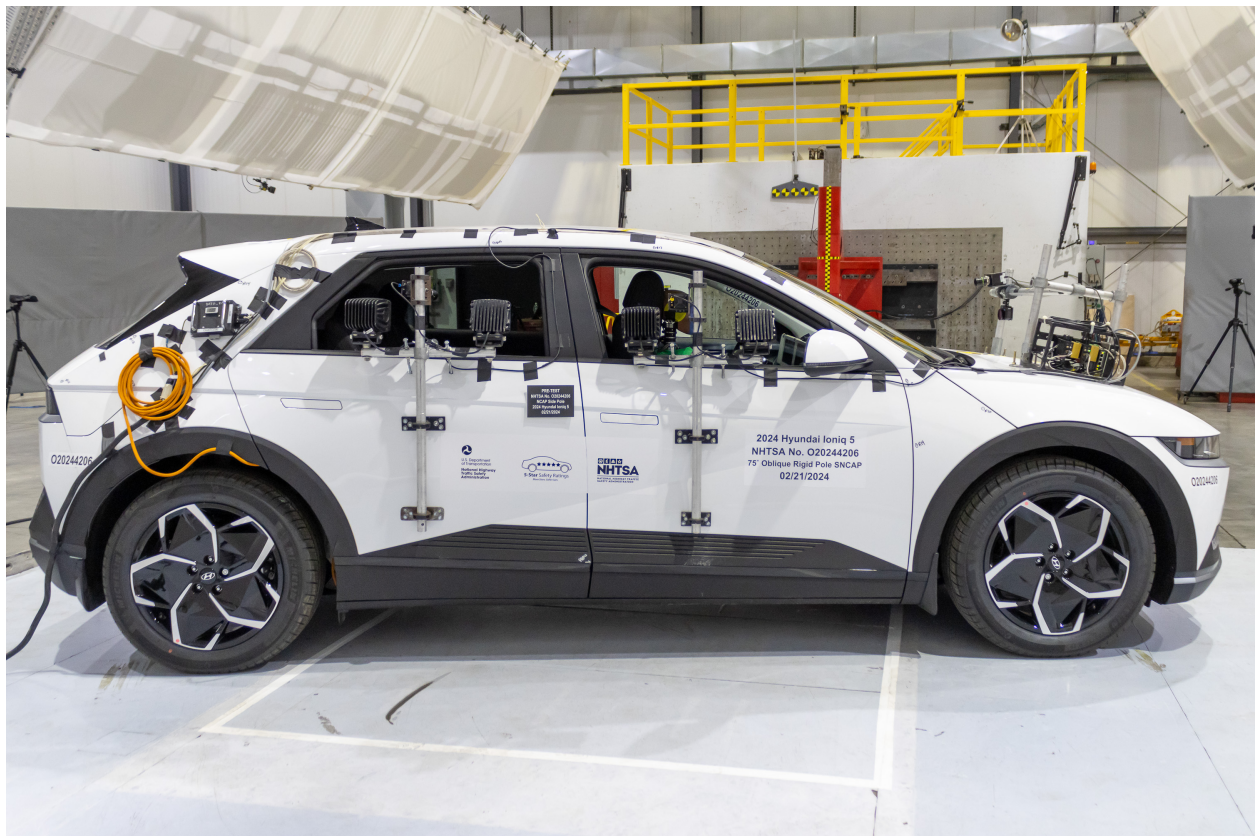
**Figure A-13: Pre-Test Right Side View of Test Vehicle**

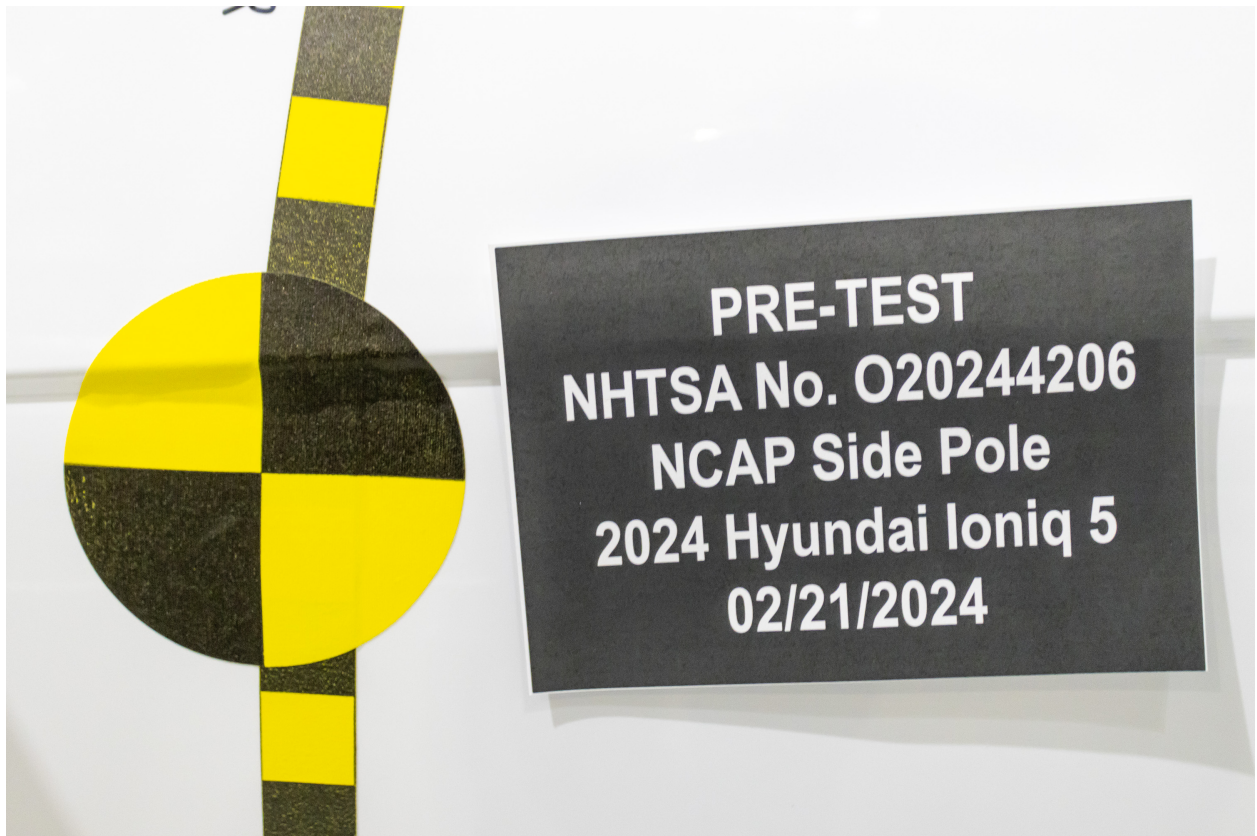
Figure A-19: Pre-Test Close-Up View of Impact Point Target

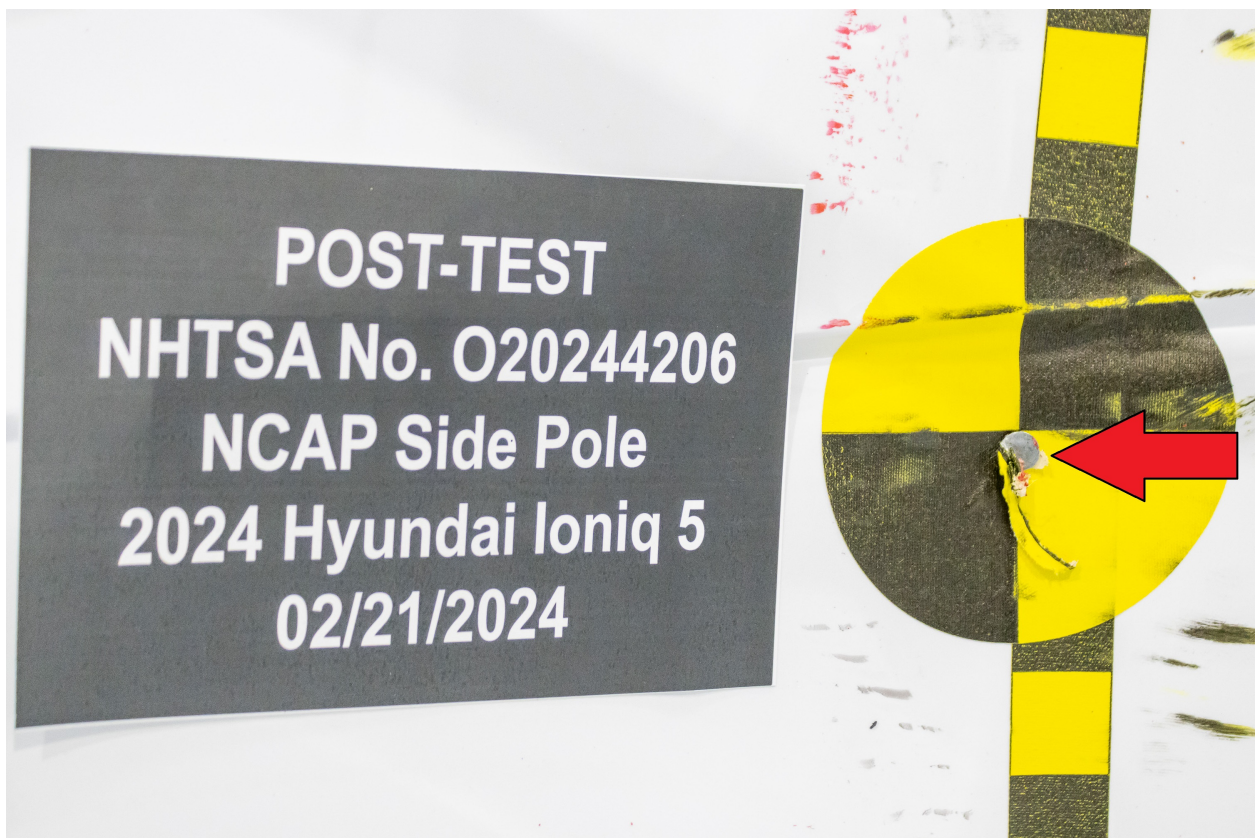
Figure A-20: Post-Test Close-Up View of Impact Point Target Showing Impact Location

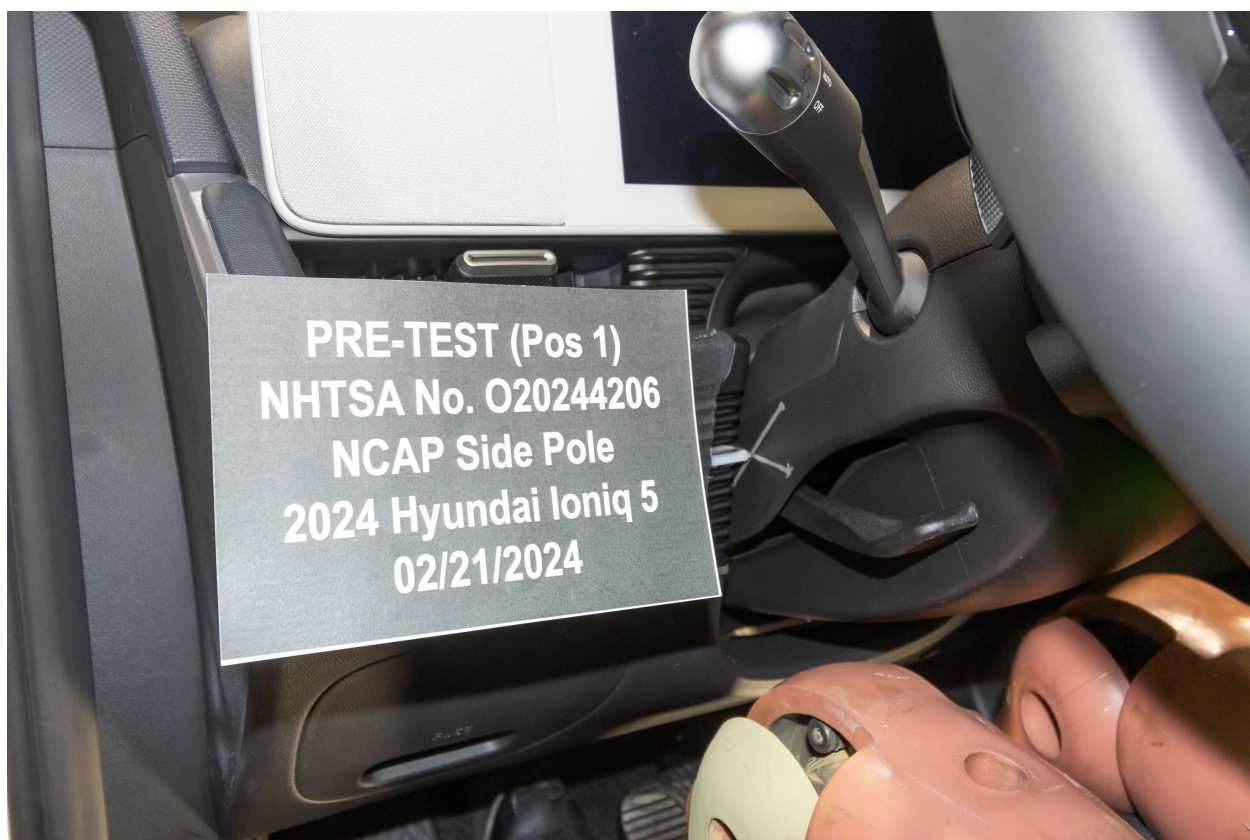
**Figure A-34: Pre-Test Left Side View of Steering Wheel**

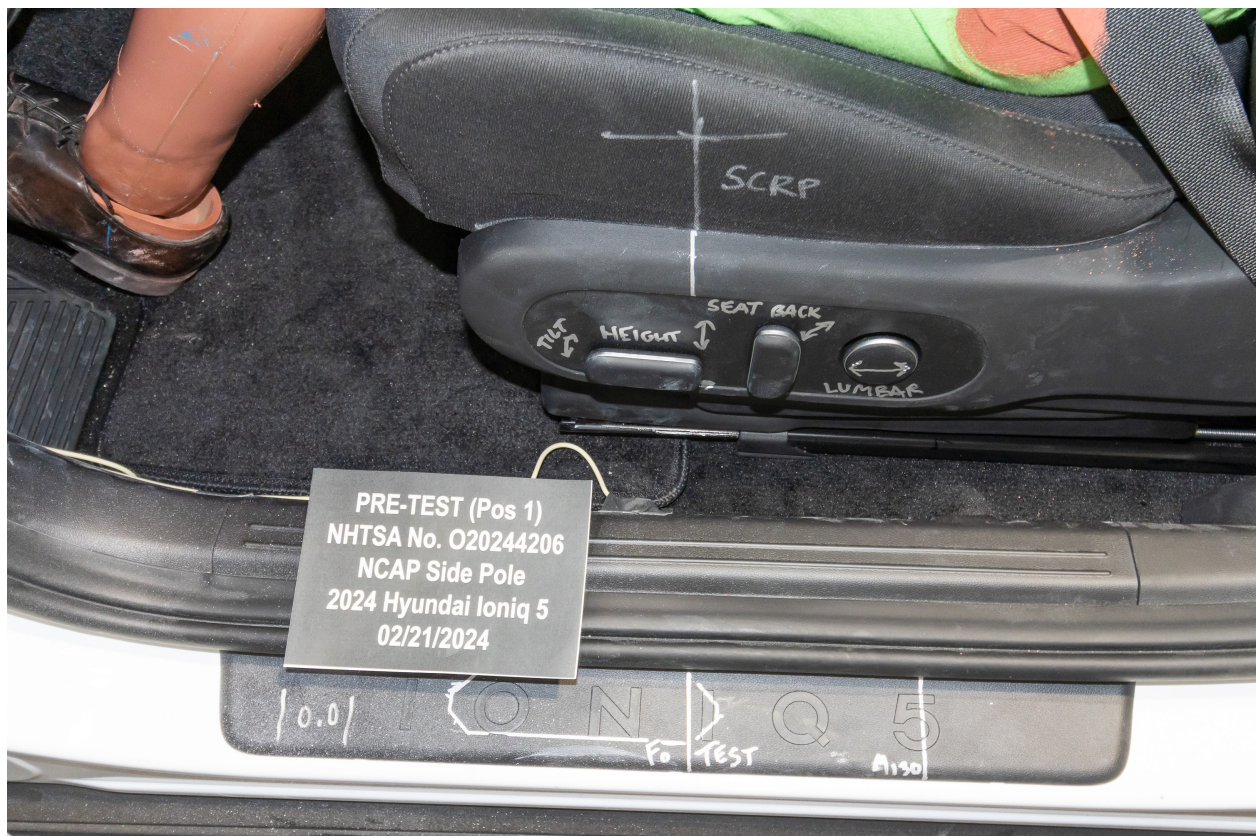
**Figure A-37: Pre-Test Close-Up Left Side View of Driver Seat Track**

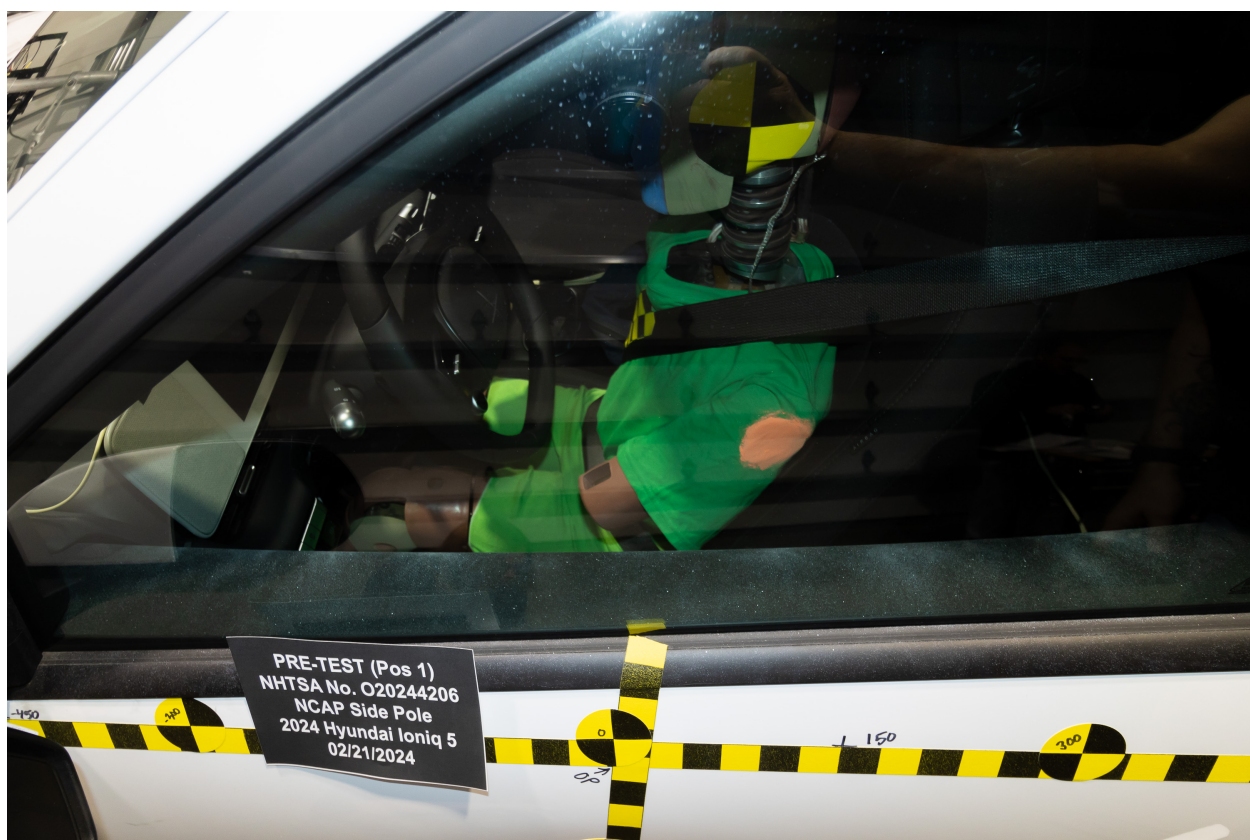
**Figure A-40: Pre-Test Dummy and Door Clearance View**

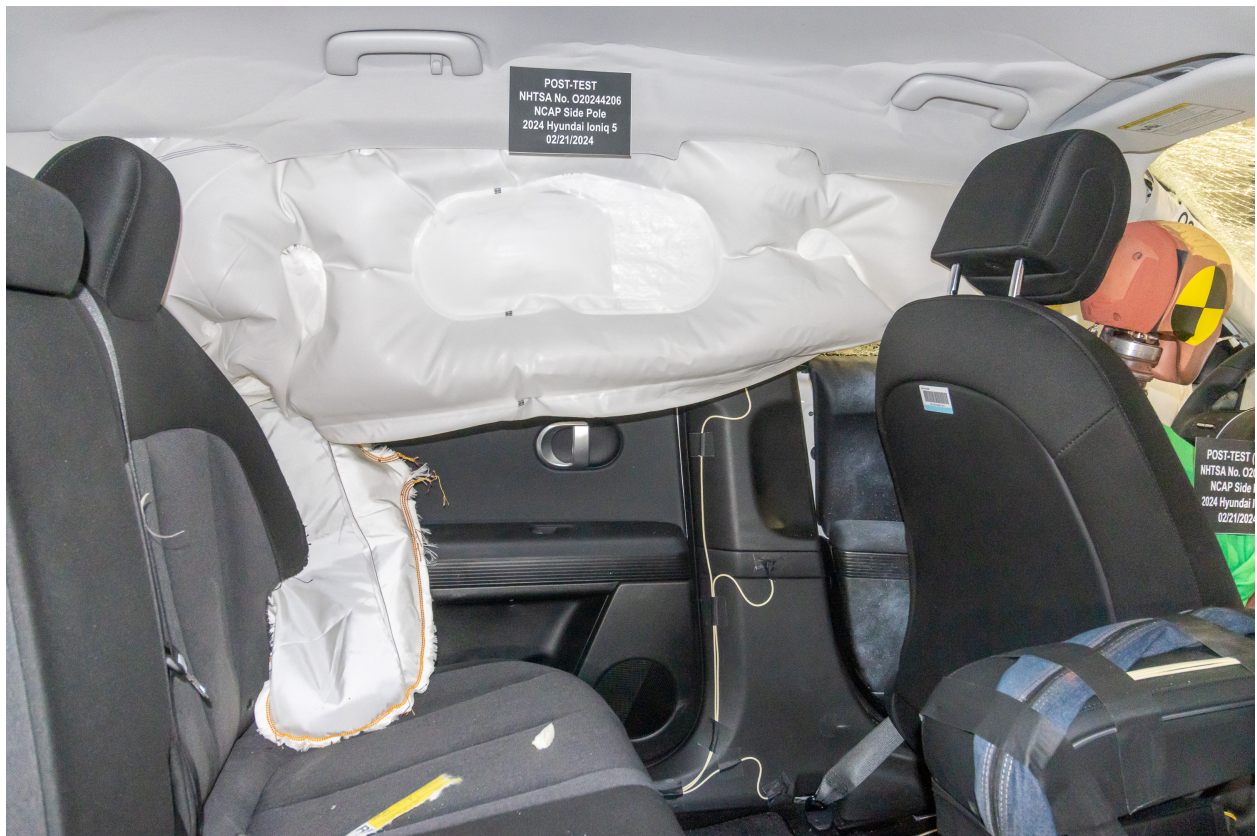
**Figure A-54: Post-Test Inner Rear Passenger Torso Air Bag Deployment View**

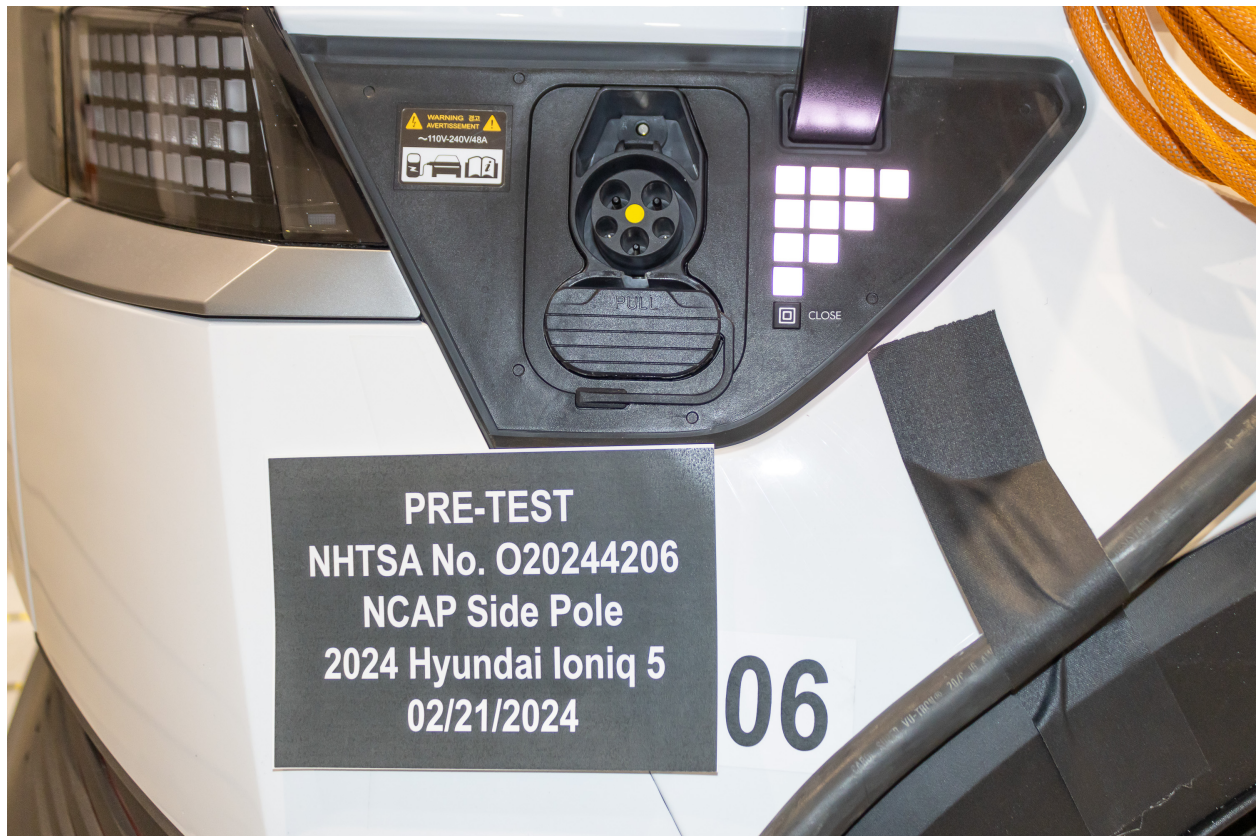
**Figure A-55: Pre-Test Charging Port**

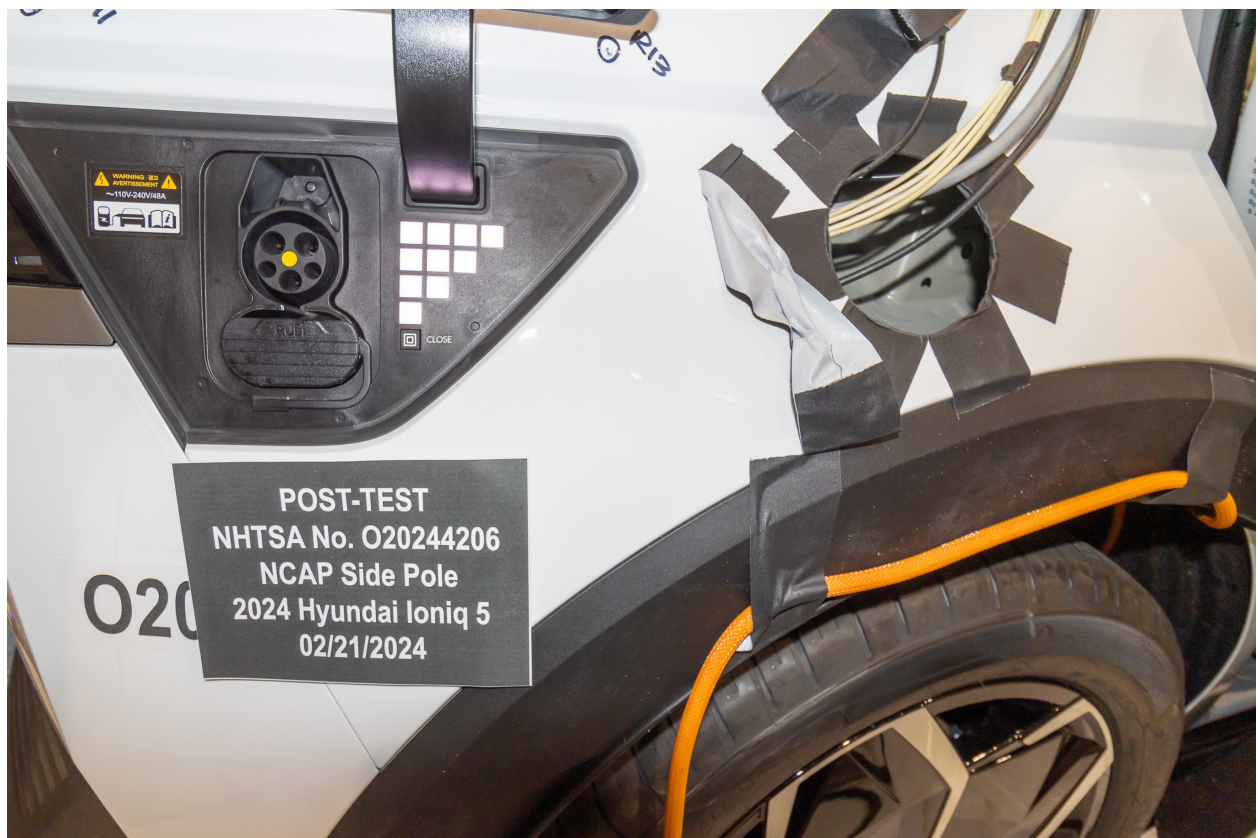
**Figure A-56: Post-Test Charging Port**

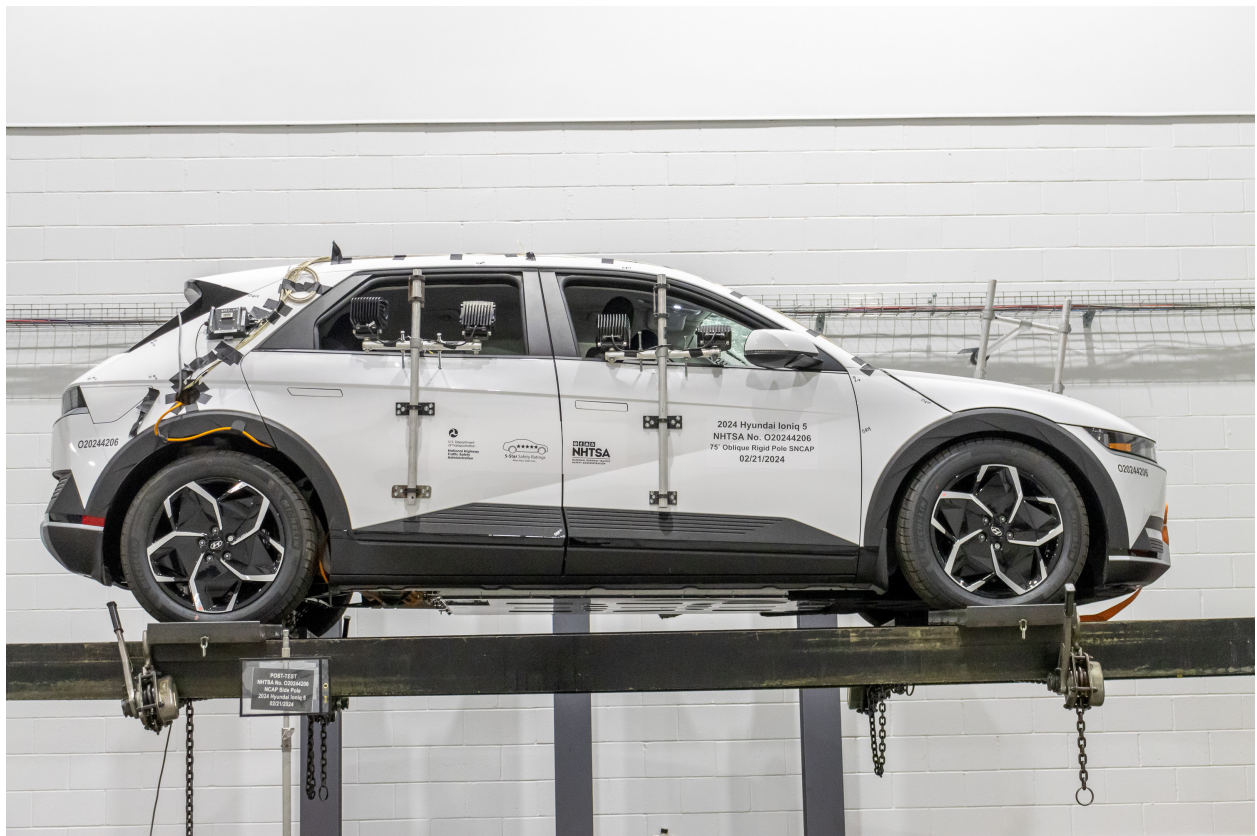
**Figure A-69: FMVSS No. 301 Static Rollover 360 Degrees**

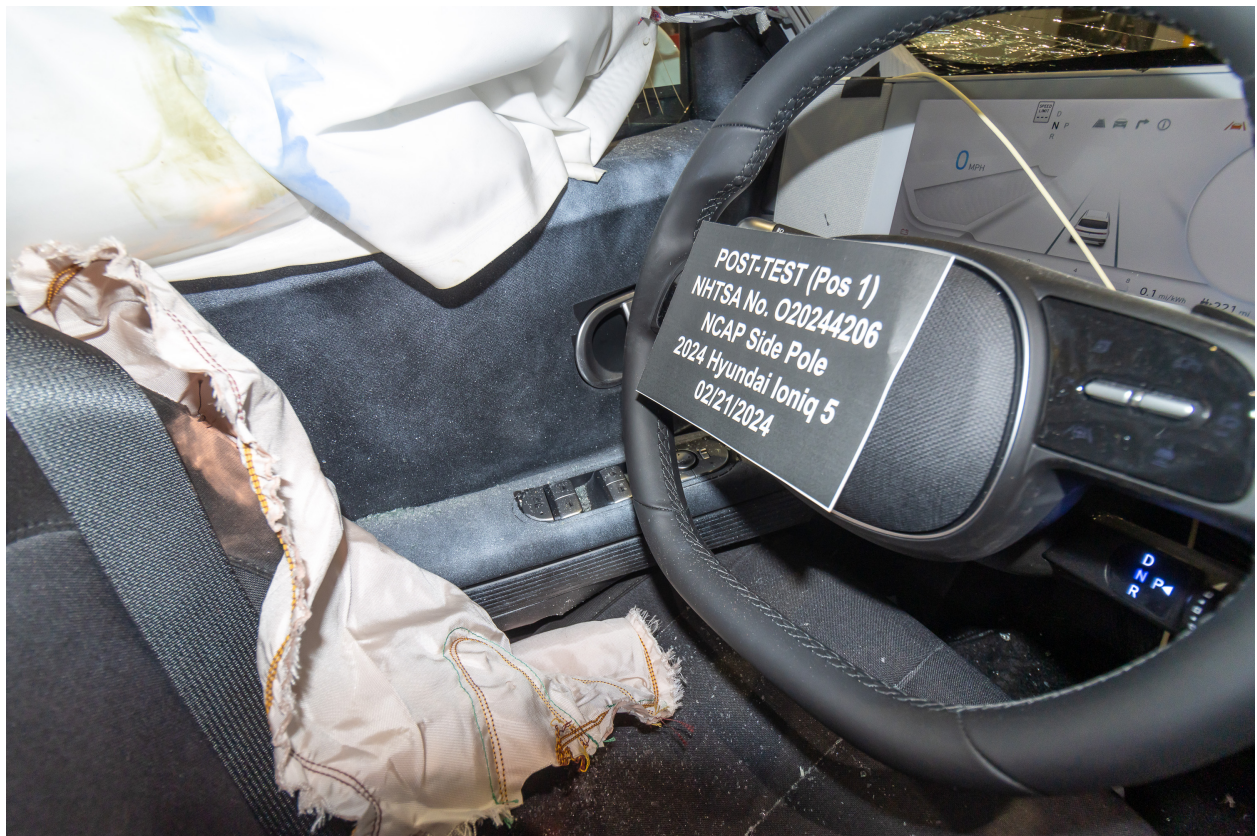
**Figure A-73: Post-Test View of Shattered Vehicle Inner Door Panel**
