REPORT NUMBER: NCAP-MGA-23-048

**NEW CAR ASSESSMENT PROGRAM (NCAP)
Frontal Barrier Impact Test**

**TOYOTA MOTOR CORPORATION
2023 Lexus RZ 450e Premium AWD 5-Door SUV
NHTSA No.: O20235111**

**MGA RESEARCH CORPORATION
5000 Warren Road
Burlington, WI 53105**

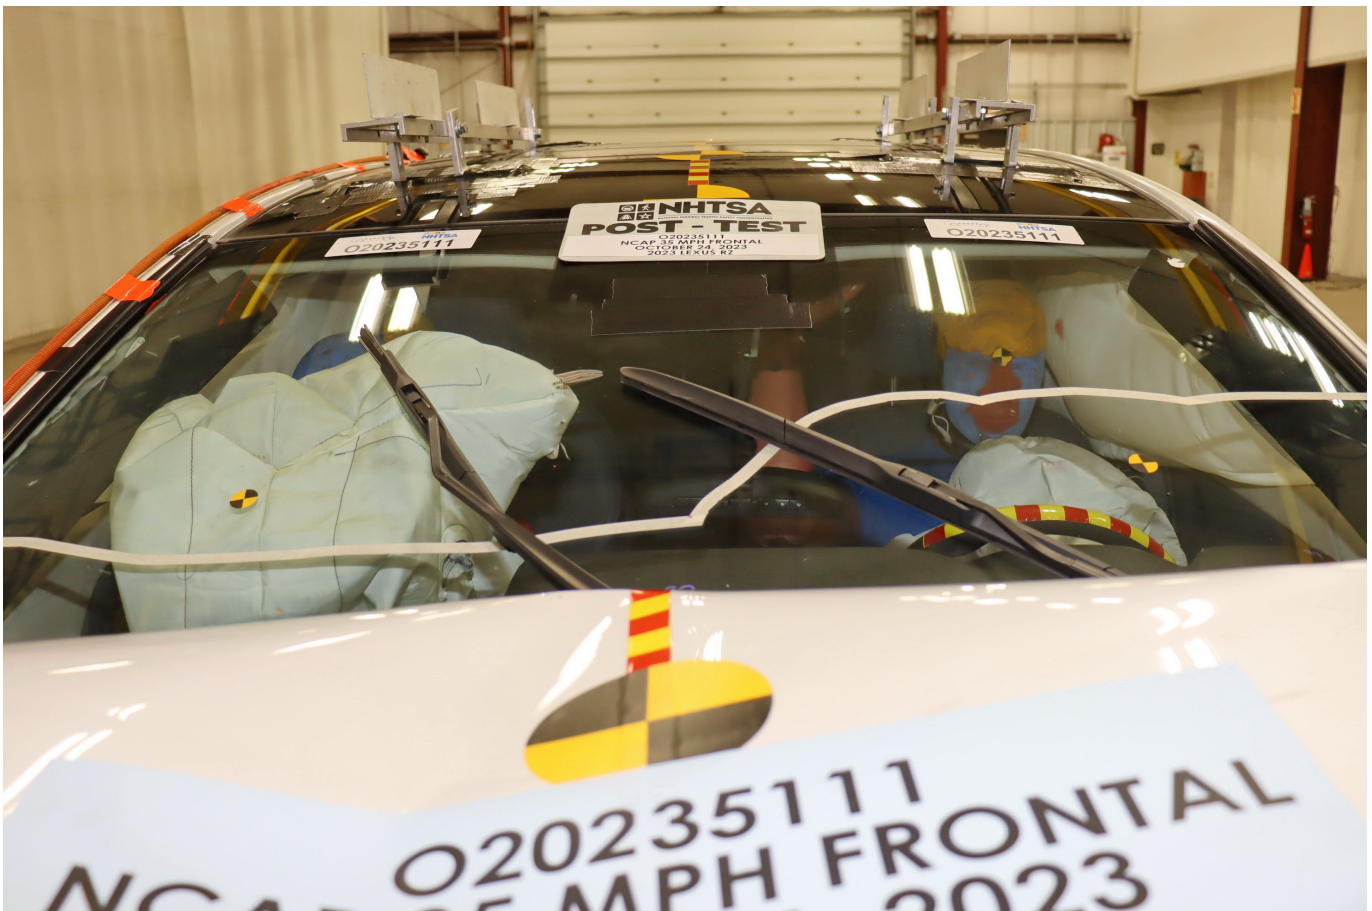
Photo No. 019 - Post-Test Windshield View

Critical Areas of Performance	Observations and Conclusions
Windshield Damage	Cracked on driver side by hood
Window Damage	None
Other Notable Effects	None
