**REPORT NUMBER: SPNCAP-CAL-24-005**

**NEW CAR ASSESSMENT PROGRAM (NCAP)  
SIDE IMPACT POLE TEST**

**KIA Georgia. INC.  
2024 KIA Sportage  
5 Door SUV**

**FINAL REPORT**

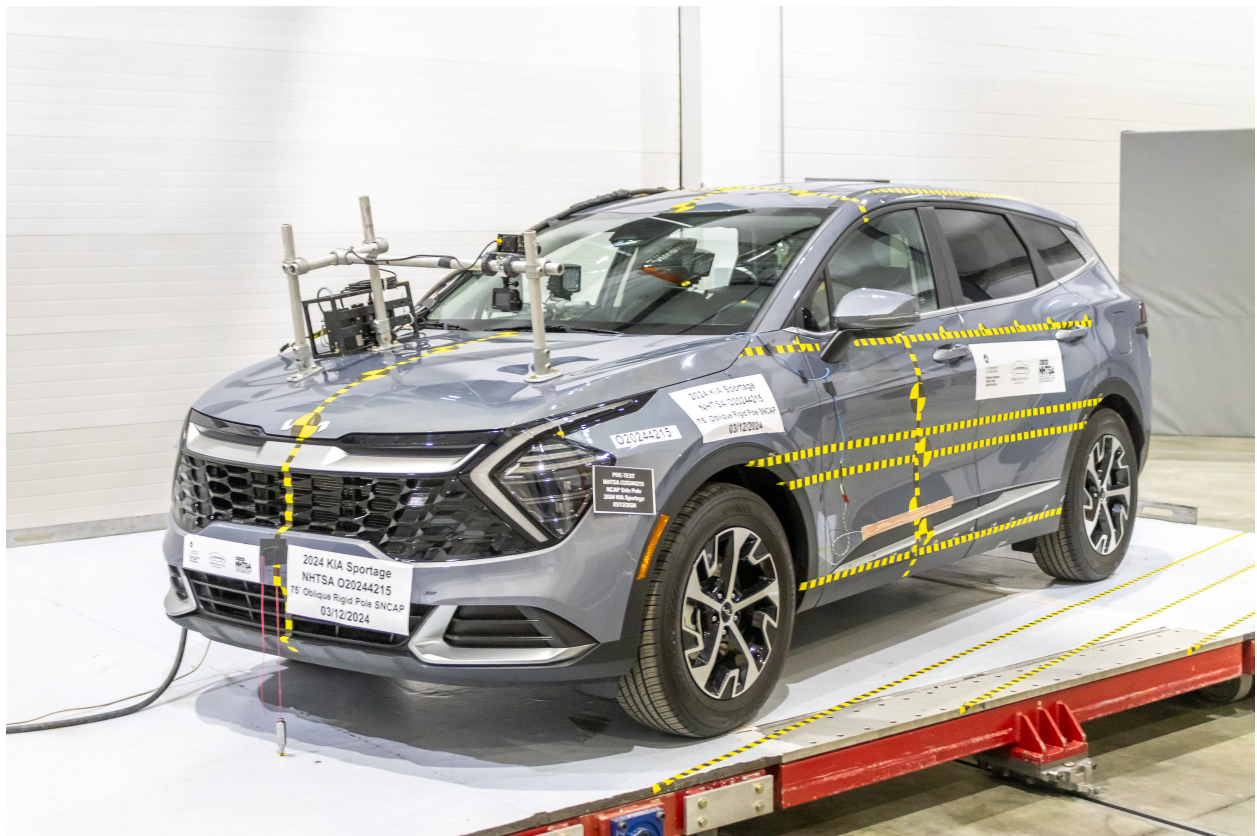
**Figure A-5: Pre-Test Left Front  $\frac{3}{4}$  View of Test Vehicle**

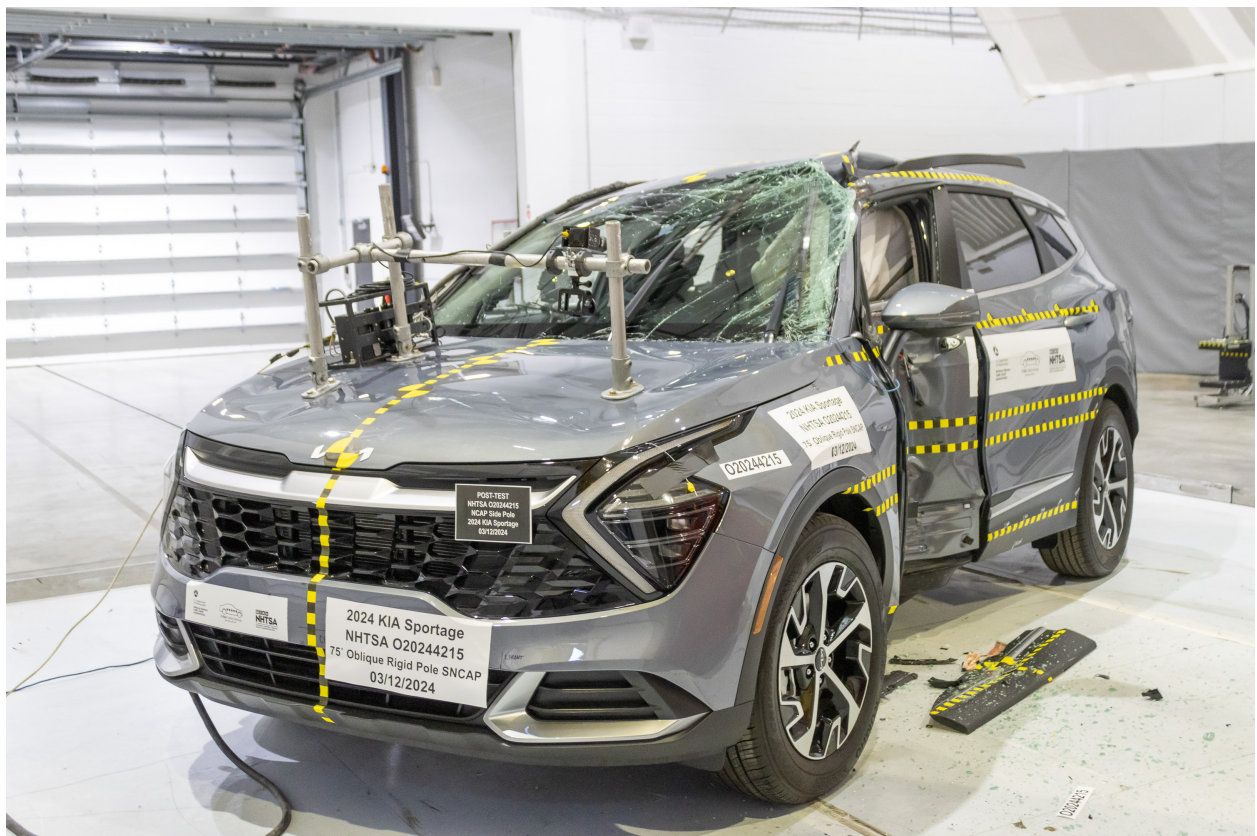
**Figure A-6: Post-Test Left Front  $\frac{3}{4}$  View of Test Vehicle**

| Critical Areas of Performance | Observations and Conclusions |
|---|---|
| Windshield Damage | Cracked throughout, separated along A-pillar |
| Side Window Damage | Driver window shattered and fell out |

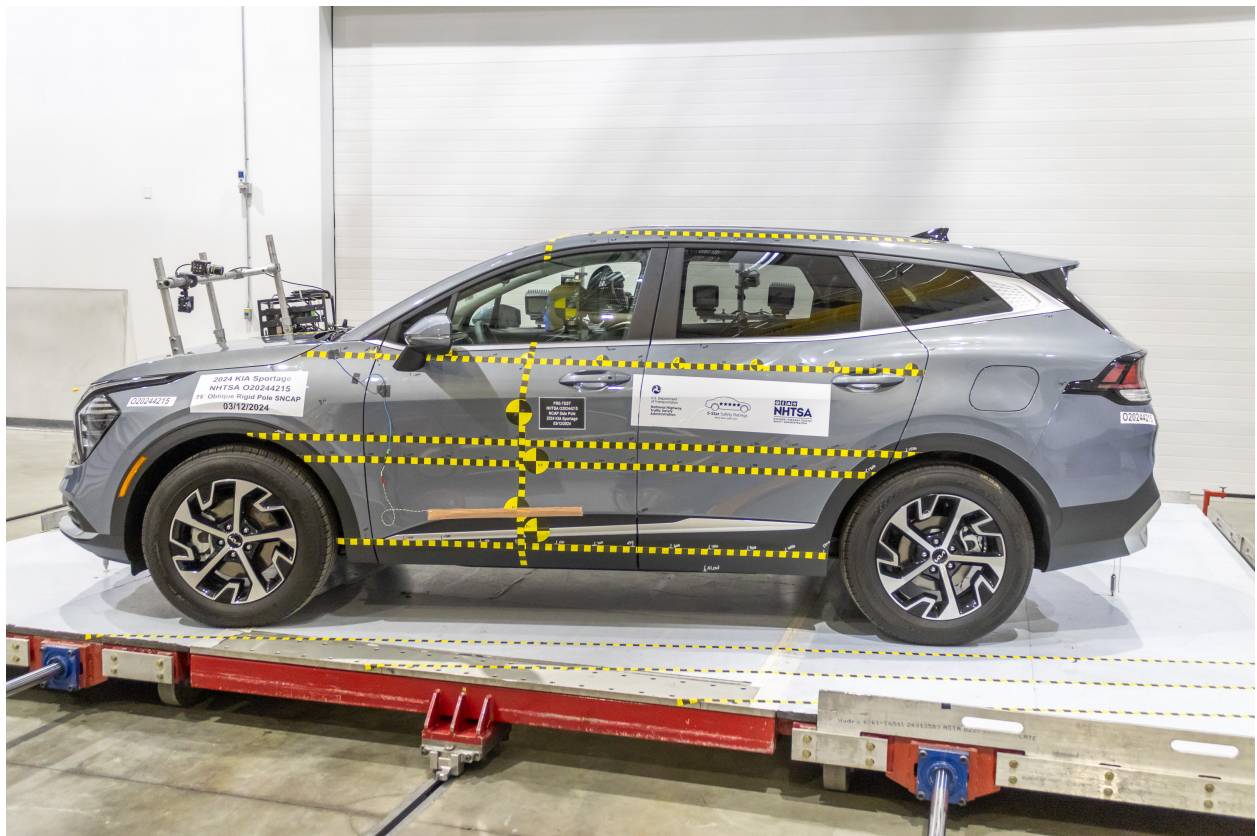
**Figure A-7: Pre-Test Left Side View of Test Vehicle**

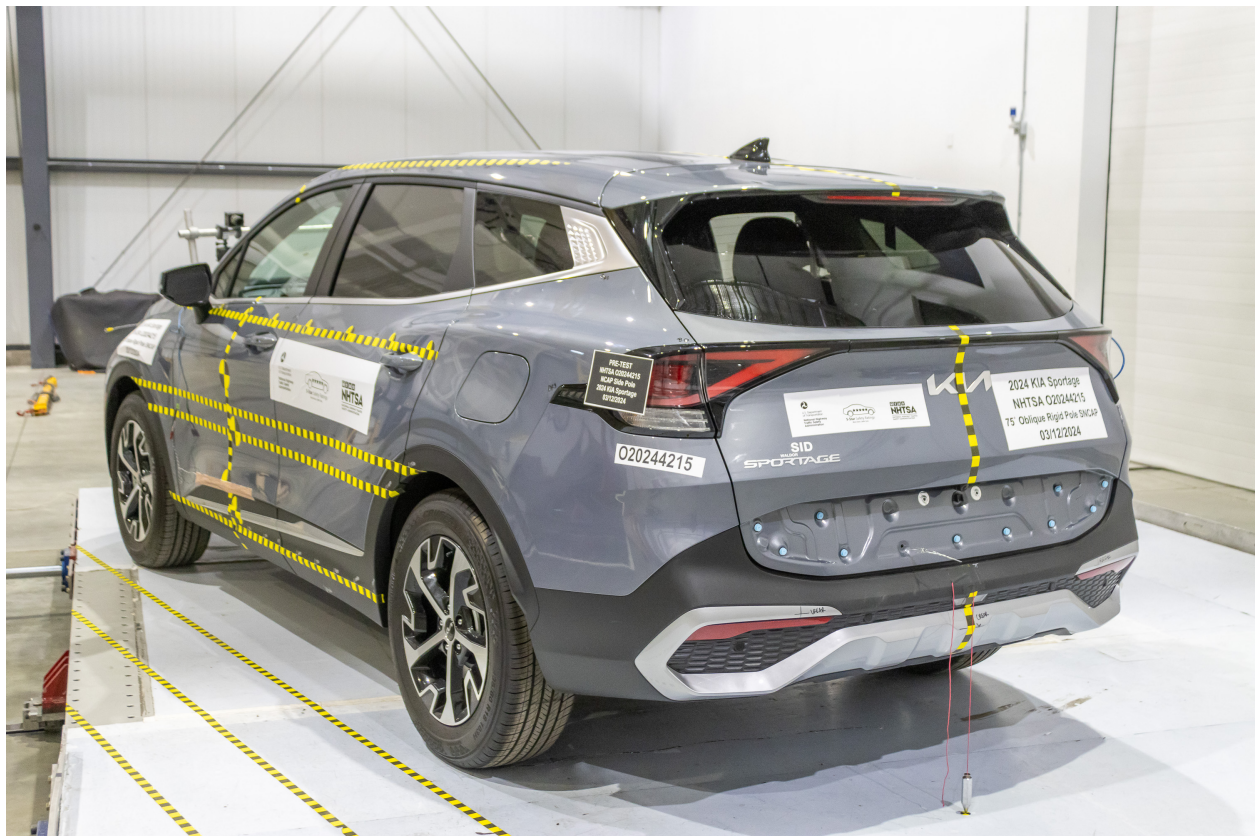
**Figure A-9: Pre-Test Left Rear  $\frac{3}{4}$  View of Test Vehicle**

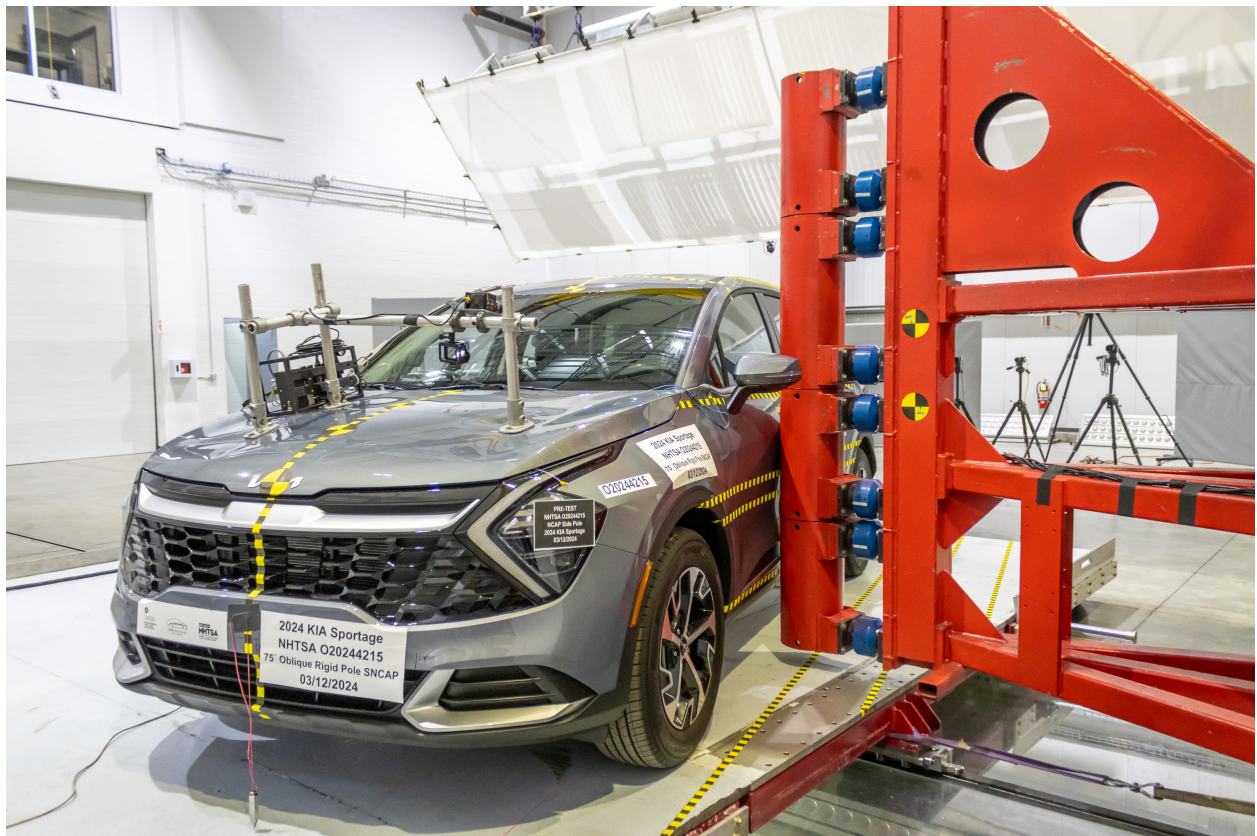
**Figure A-17: Pre-Test Left Side View of Pole Positioned Against Side of Vehicle**

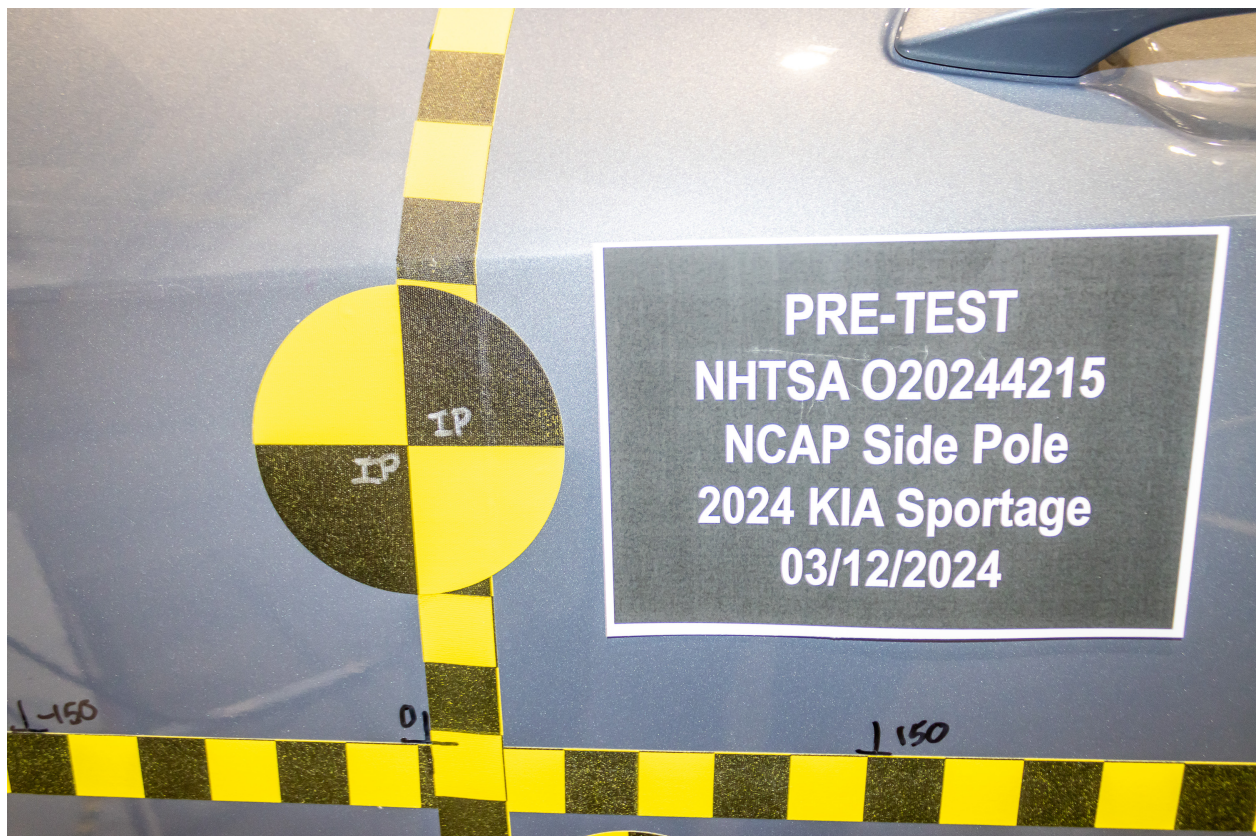
Figure A-19: Pre-Test Close-Up View of Impact Point Target

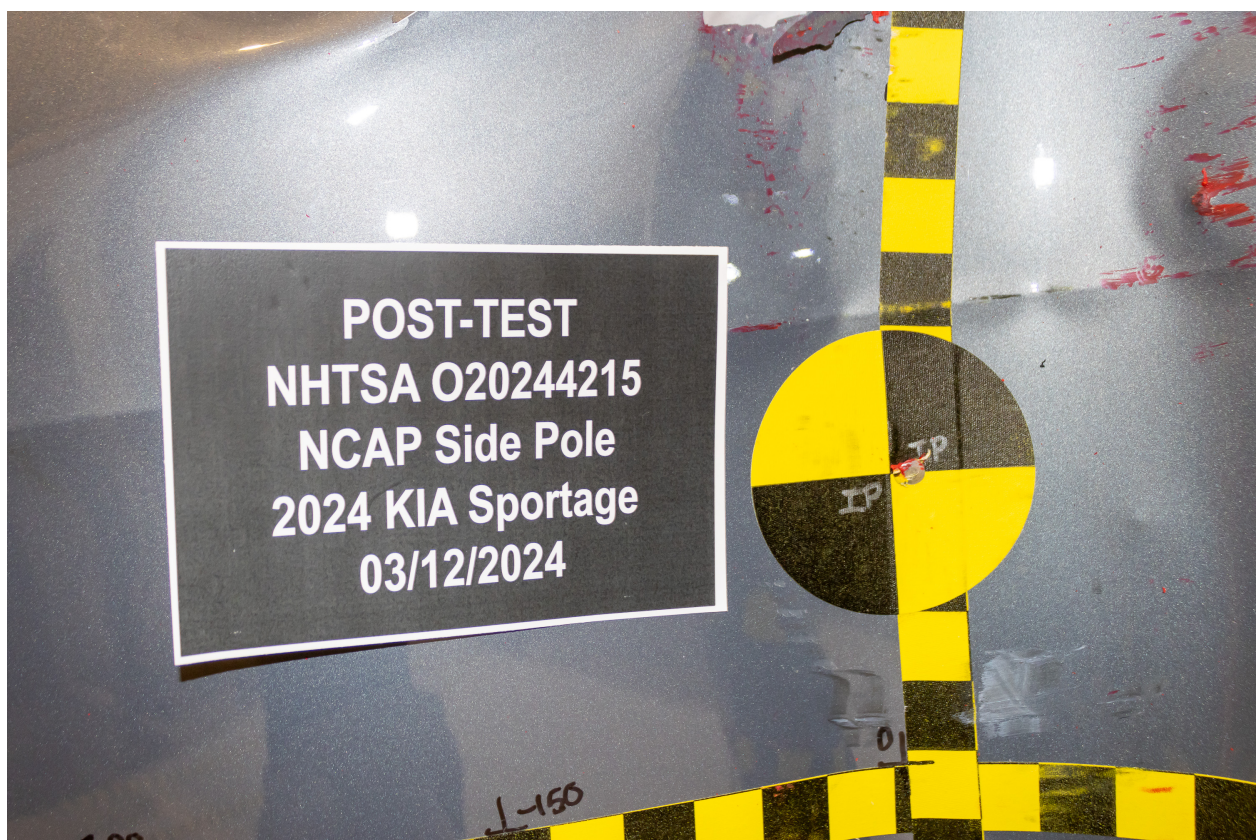
Figure A-20: Post-Test Close-Up View of Impact Point Target Showing Impact Location

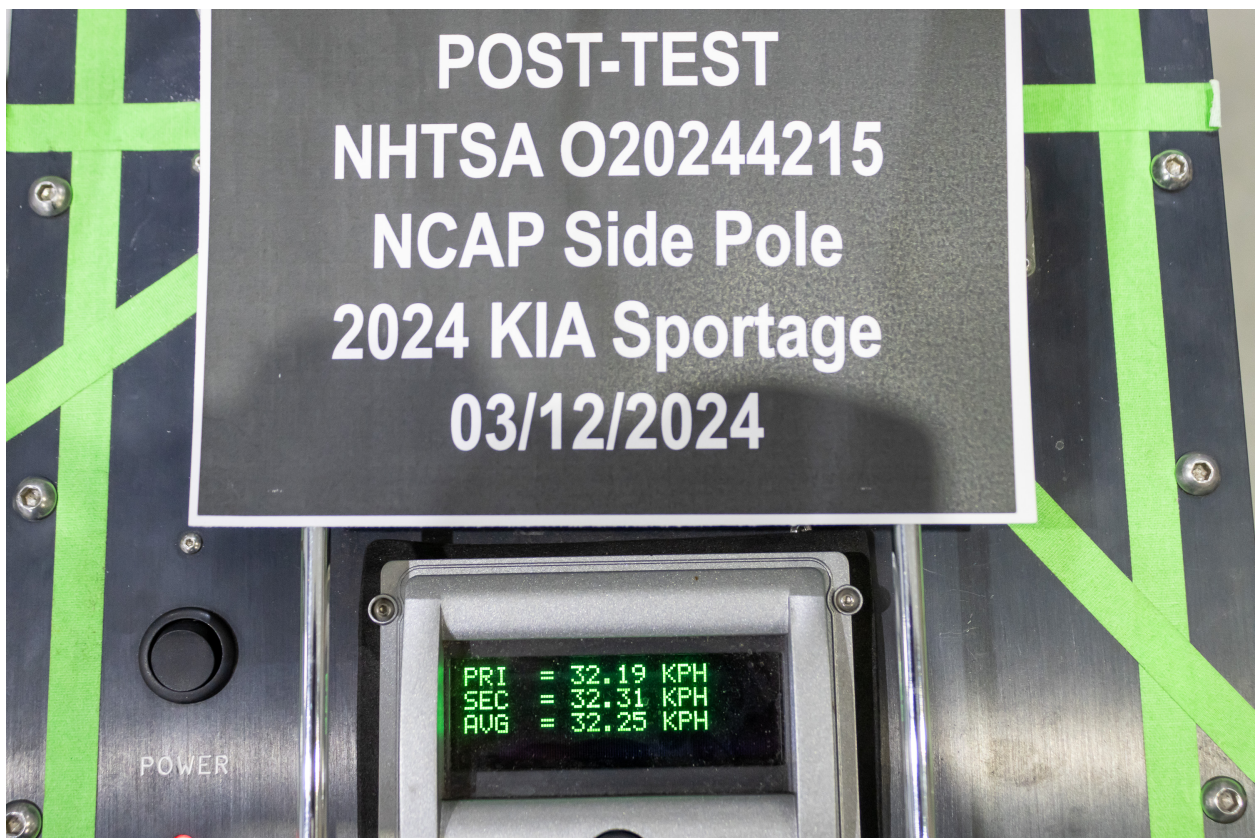
**Figure A-64: Post-Test Primary and Redundant Speed Trap Read-Out**
