**REPORT NUMBER: SideNCAPPole-MGA-23-052**

**NEW CAR ASSESSMENT PROGRAM (NCAP)  
Side Impact Pole Test**

**HYUNDAI MOTOR COMPANY  
2023 Hyundai IONIQ 6 SEL 4-Door Sedan  
NHTSA No.: O20234201**

**FINAL REPORT**

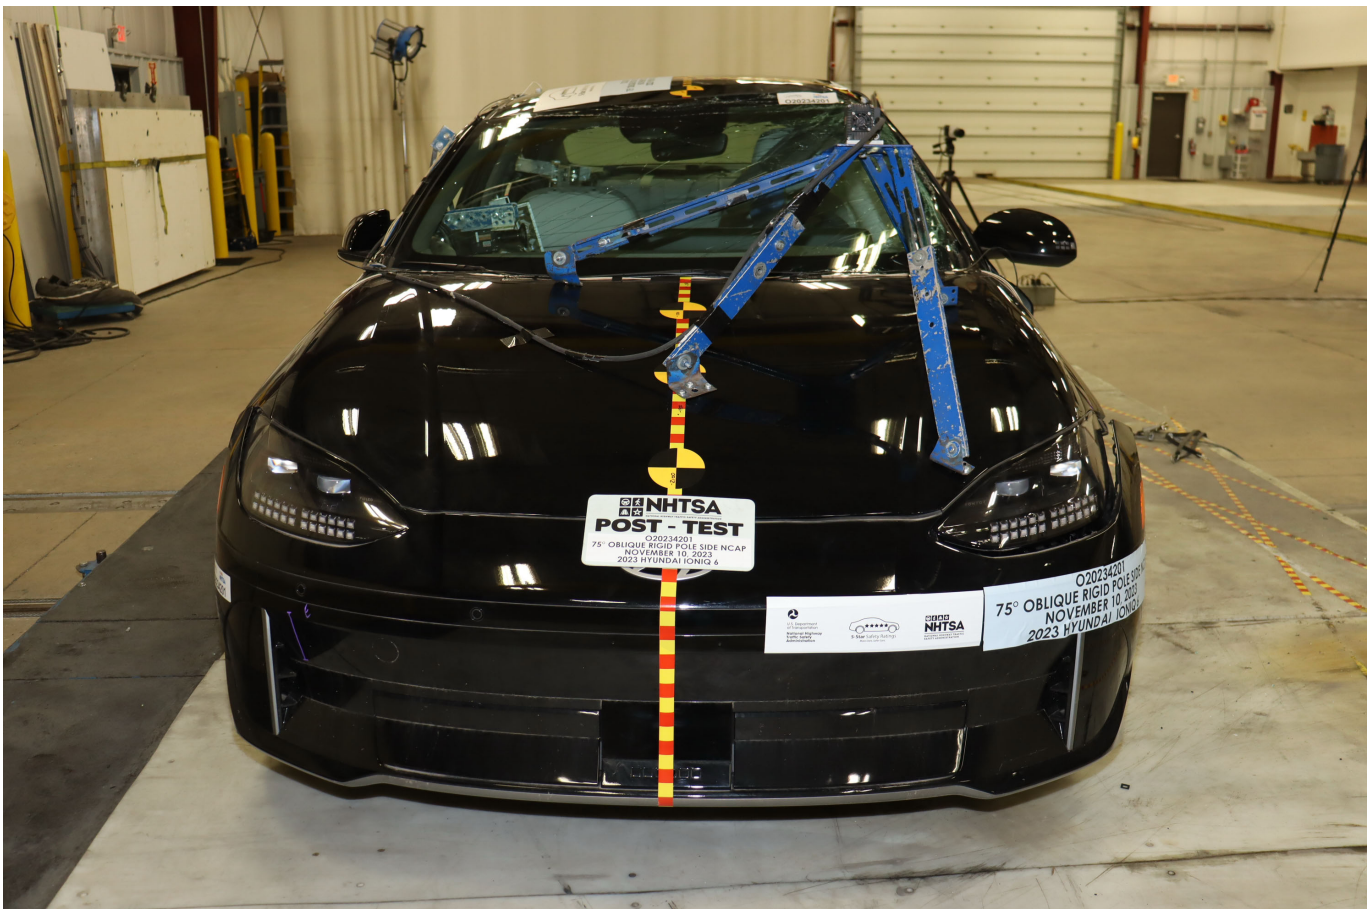
Photo No. 004 - Post-Test Frontal View of Test Vehicle

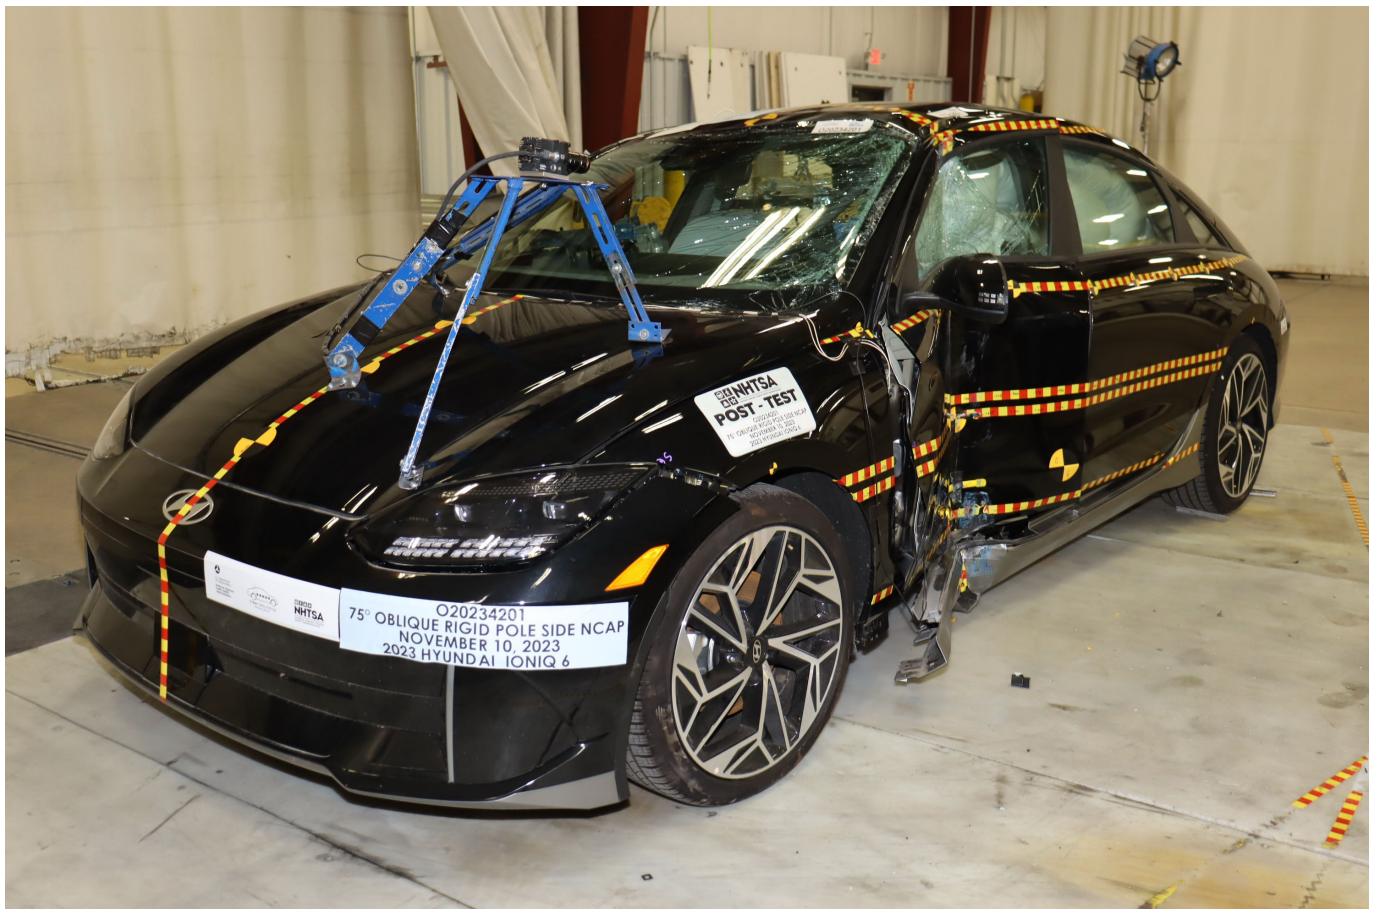
Photo No. 006 - Post-Test Left Front Three-Quarter View of Test Vehicle

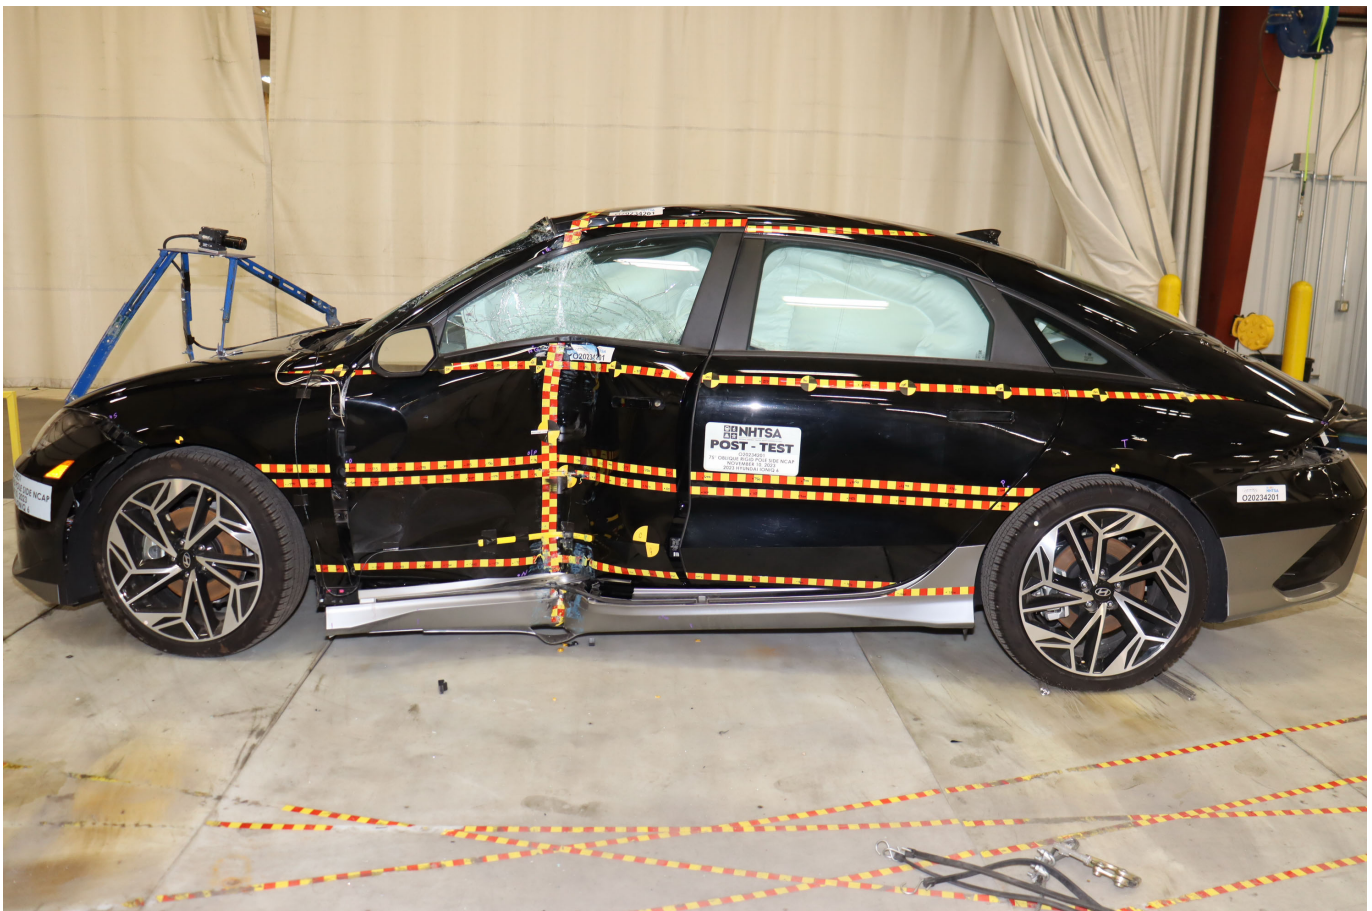
Photo No. 008 - Post-Test Left Side View of Test Vehicle

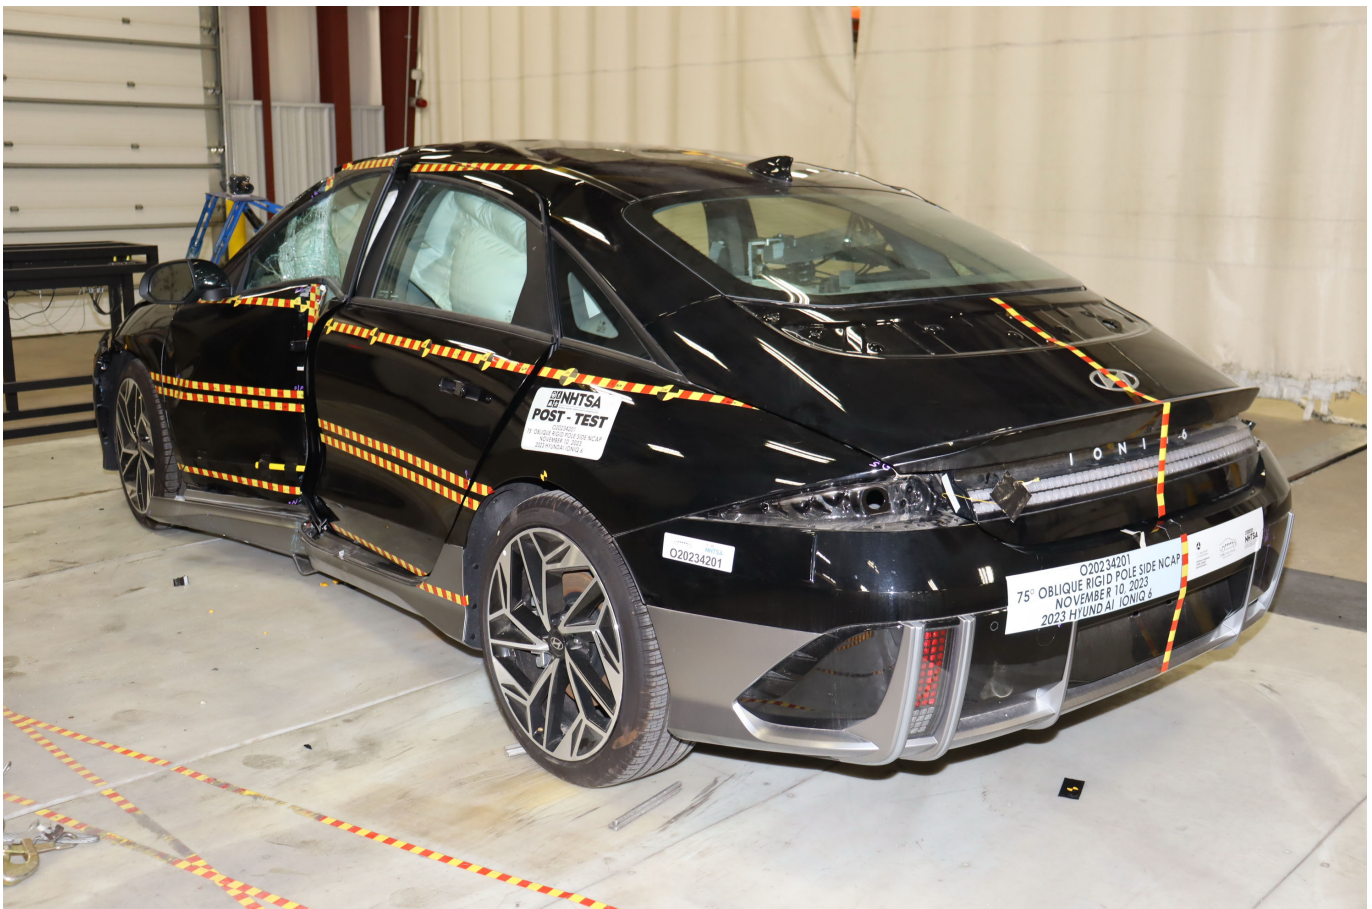
Photo No. 010 - Post-Test Left Rear Three-Quarter View of Test Vehicle

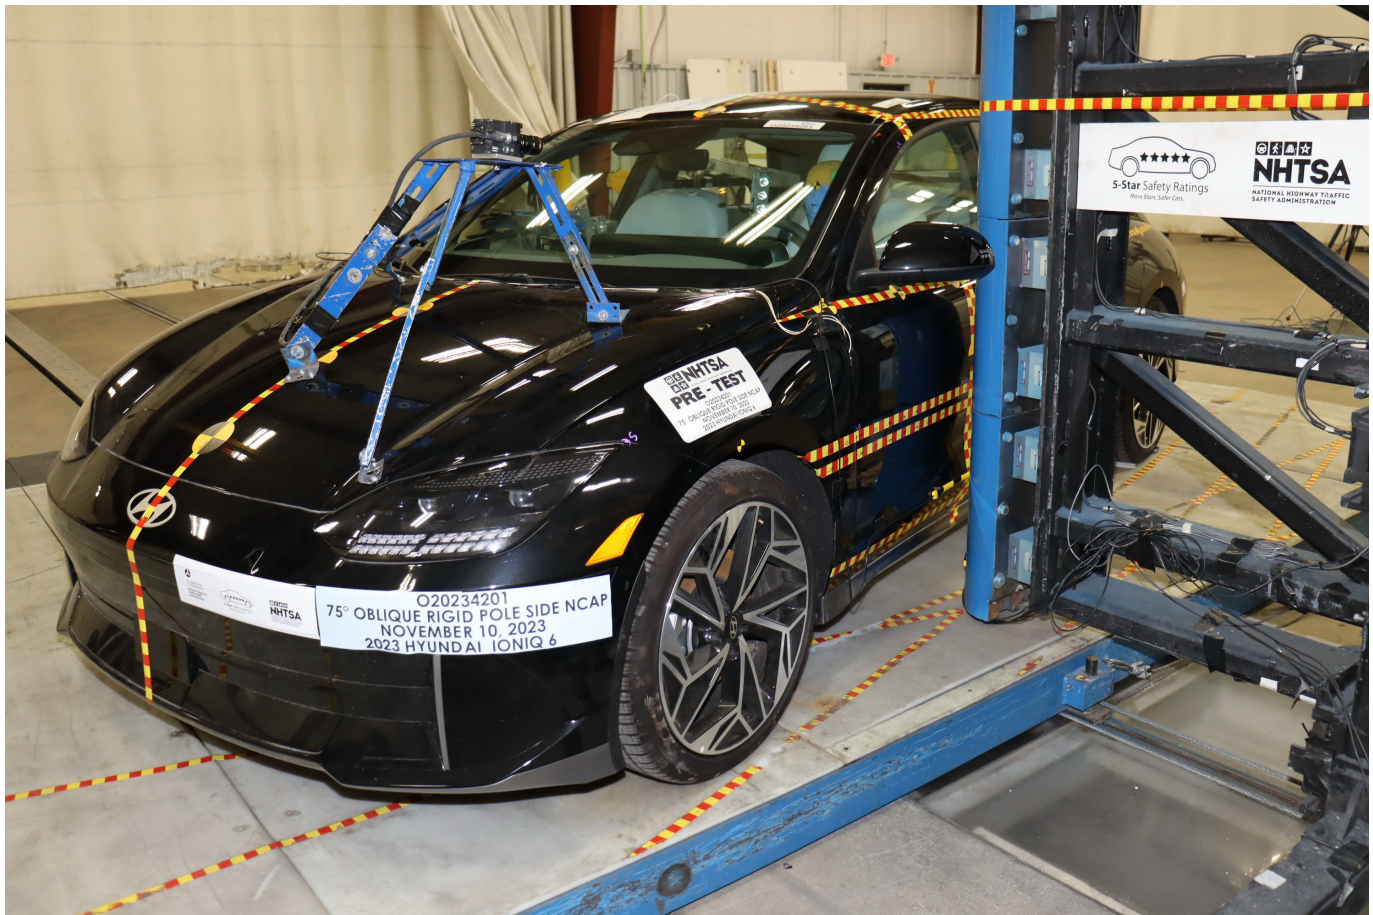
Photo No. 017 - Pre-Test Left Side View of Pole Positioned Against Side of Vehicle

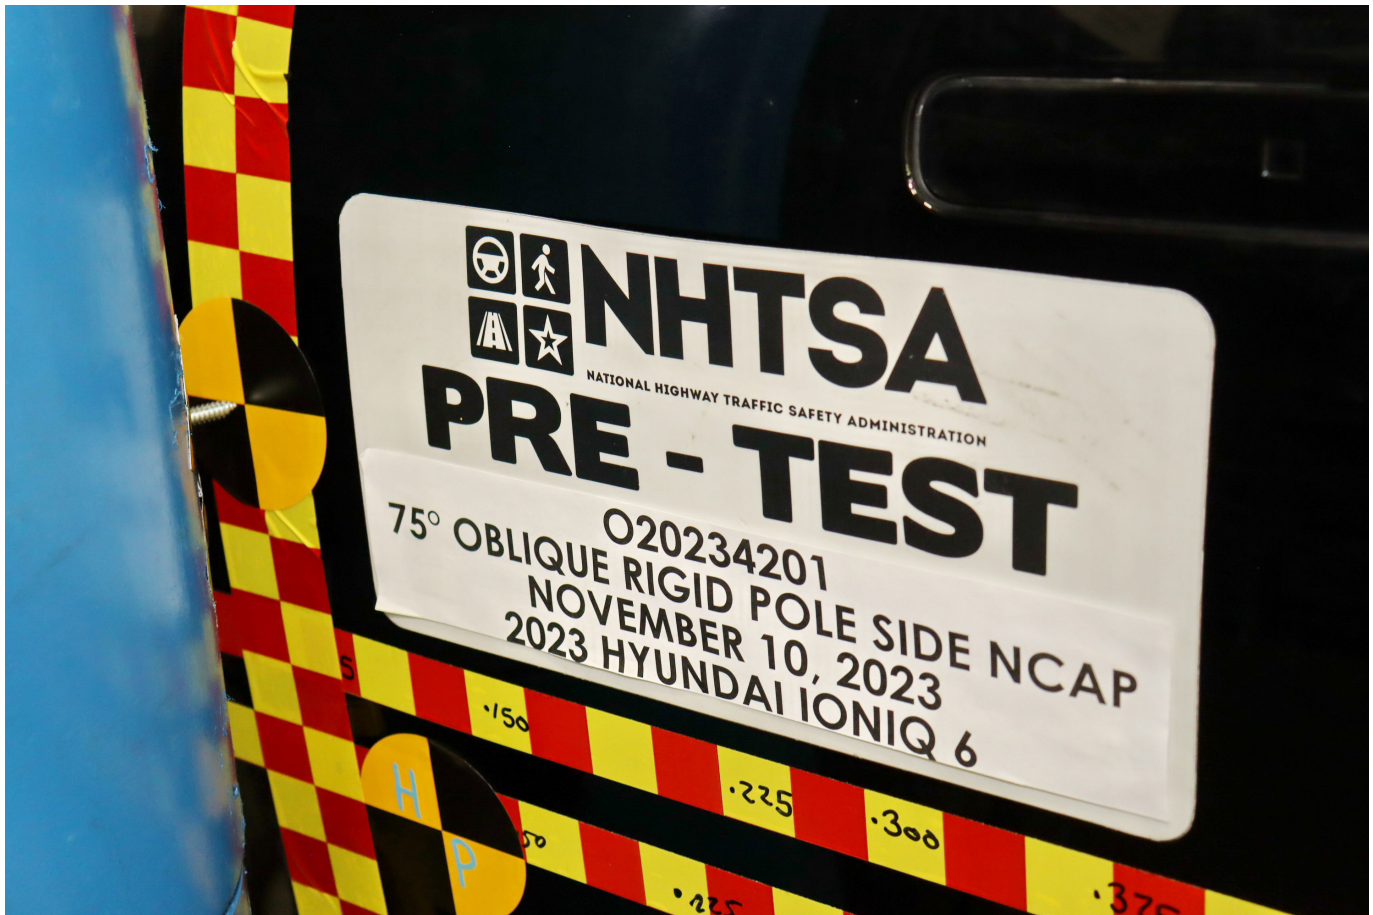
Photo No. 019 - Pre-Test Close-Up View of Impact Point Target

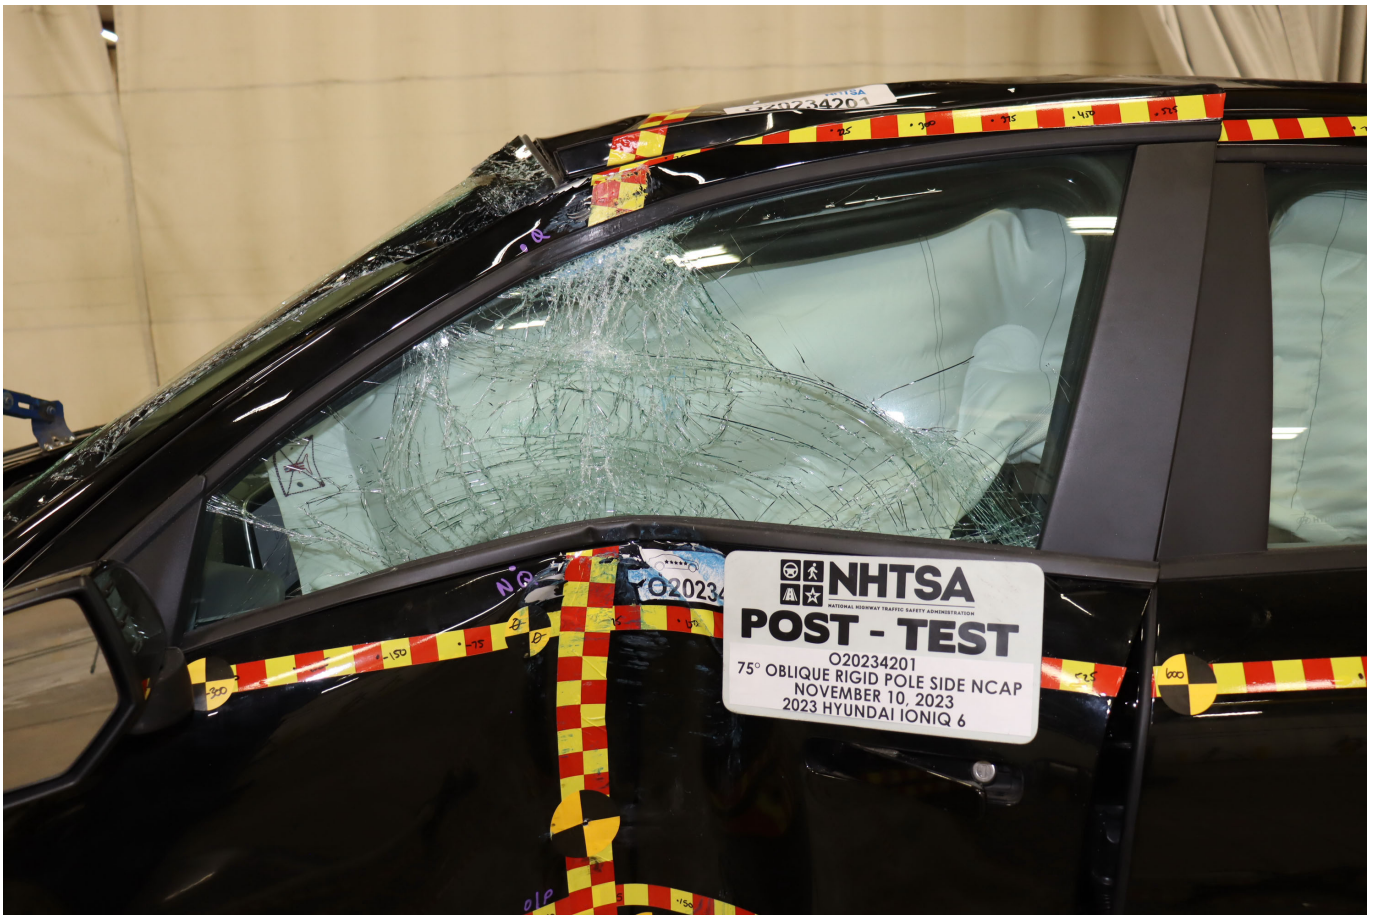
Photo No. 025 - Post-Test Left Side View of Dummy Shoulder and Door Top View

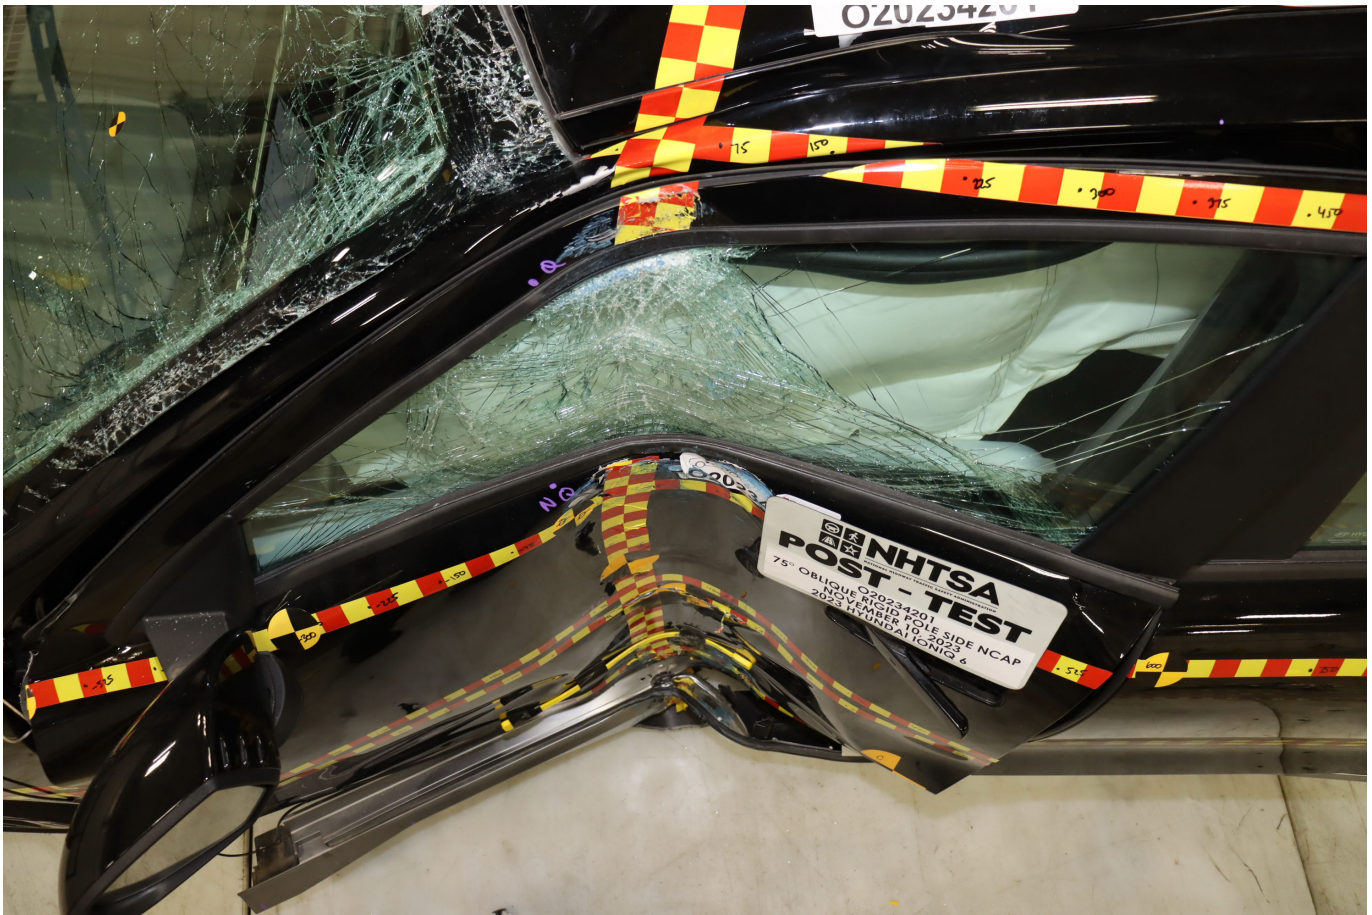
Photo No. 041 - Post-Test Dummy and Door Clearance View

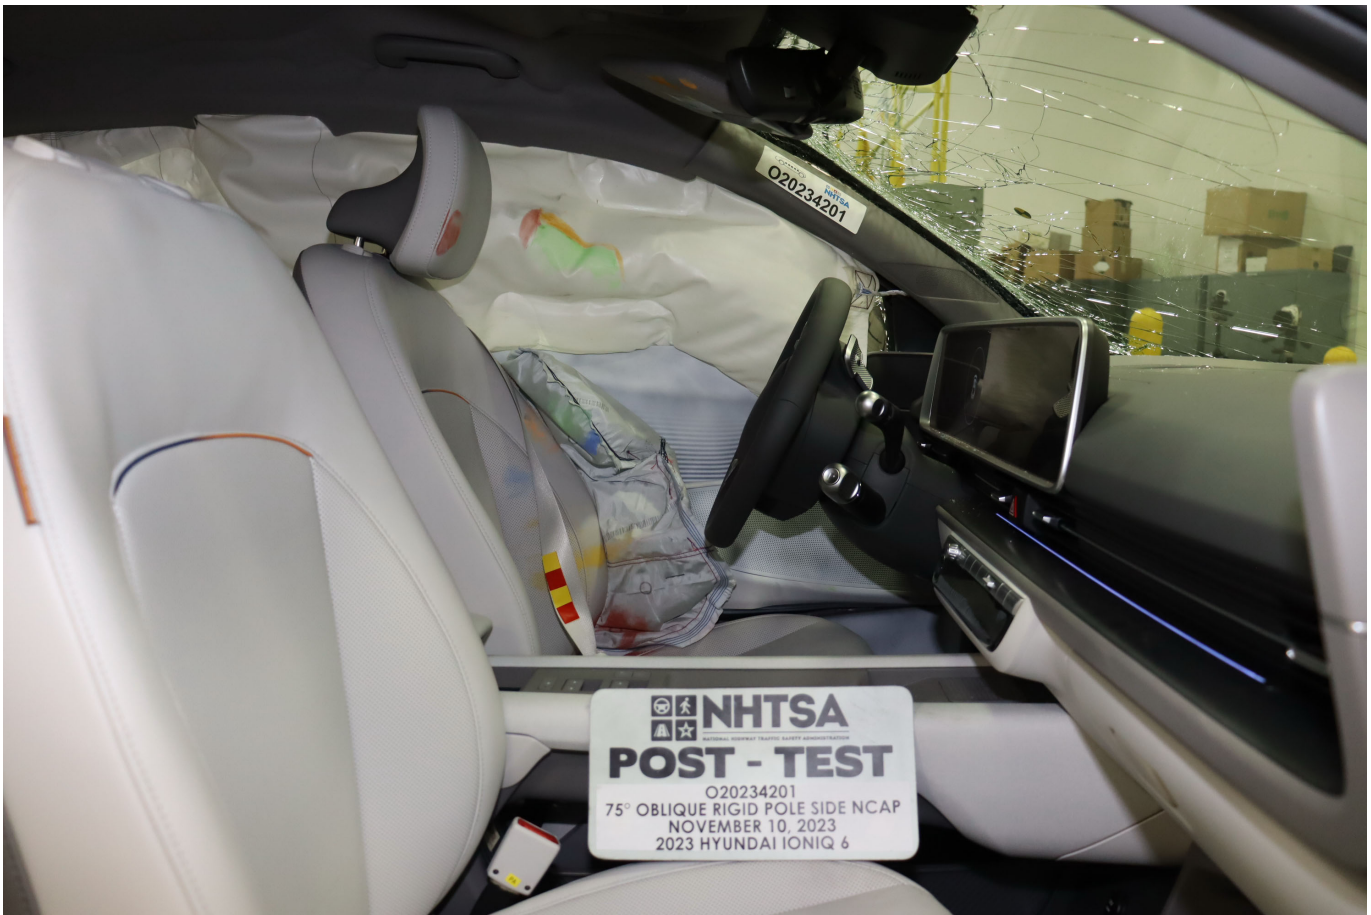
Photo No. 045 - Post-Test Inner Door Panel View Showing Dummy Contact Location

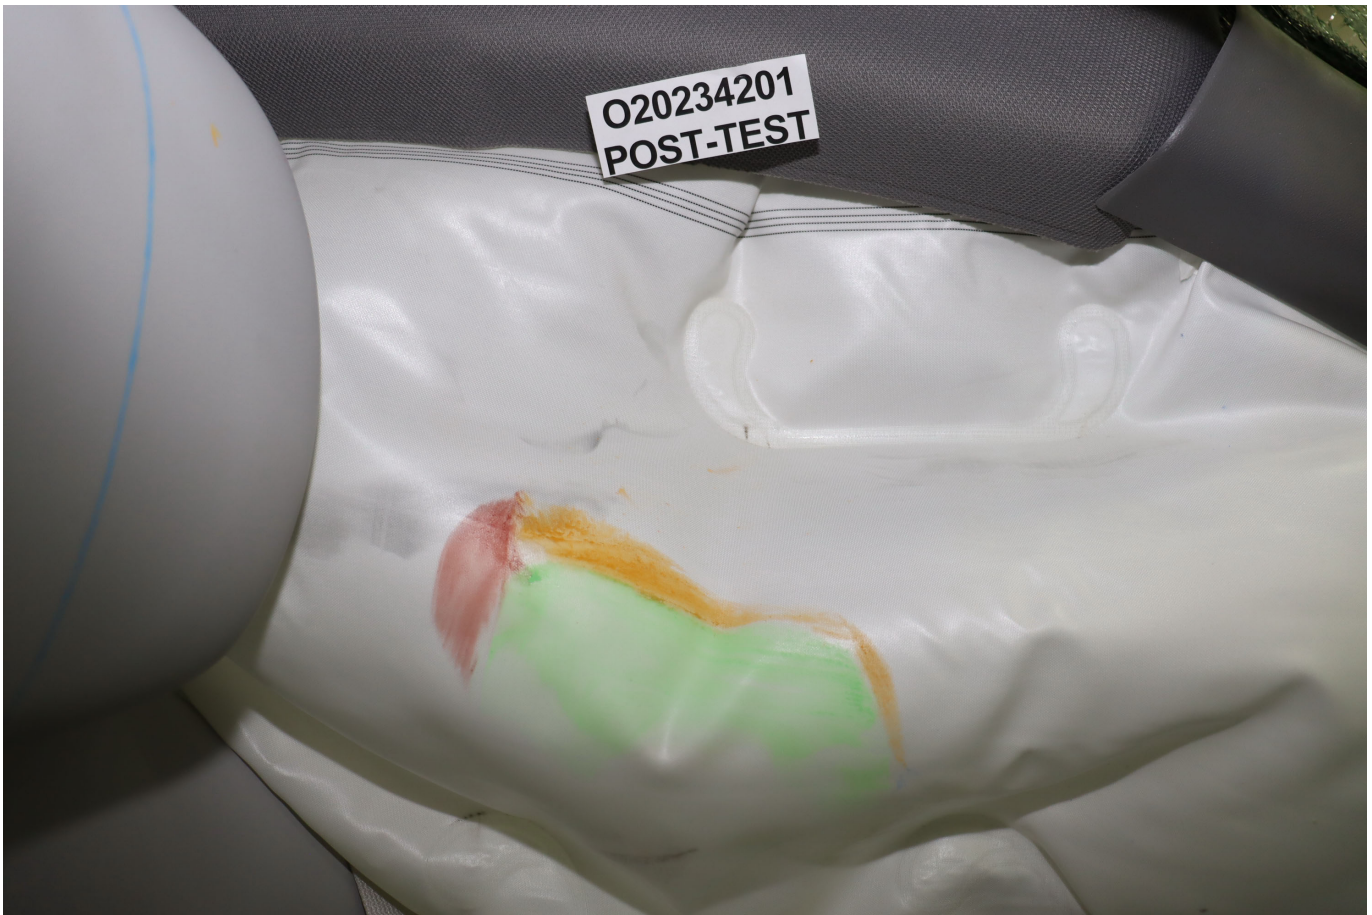
Photo No. 047 - Post-Test Dummy Close-Up Head Contact with Side Air Bag View

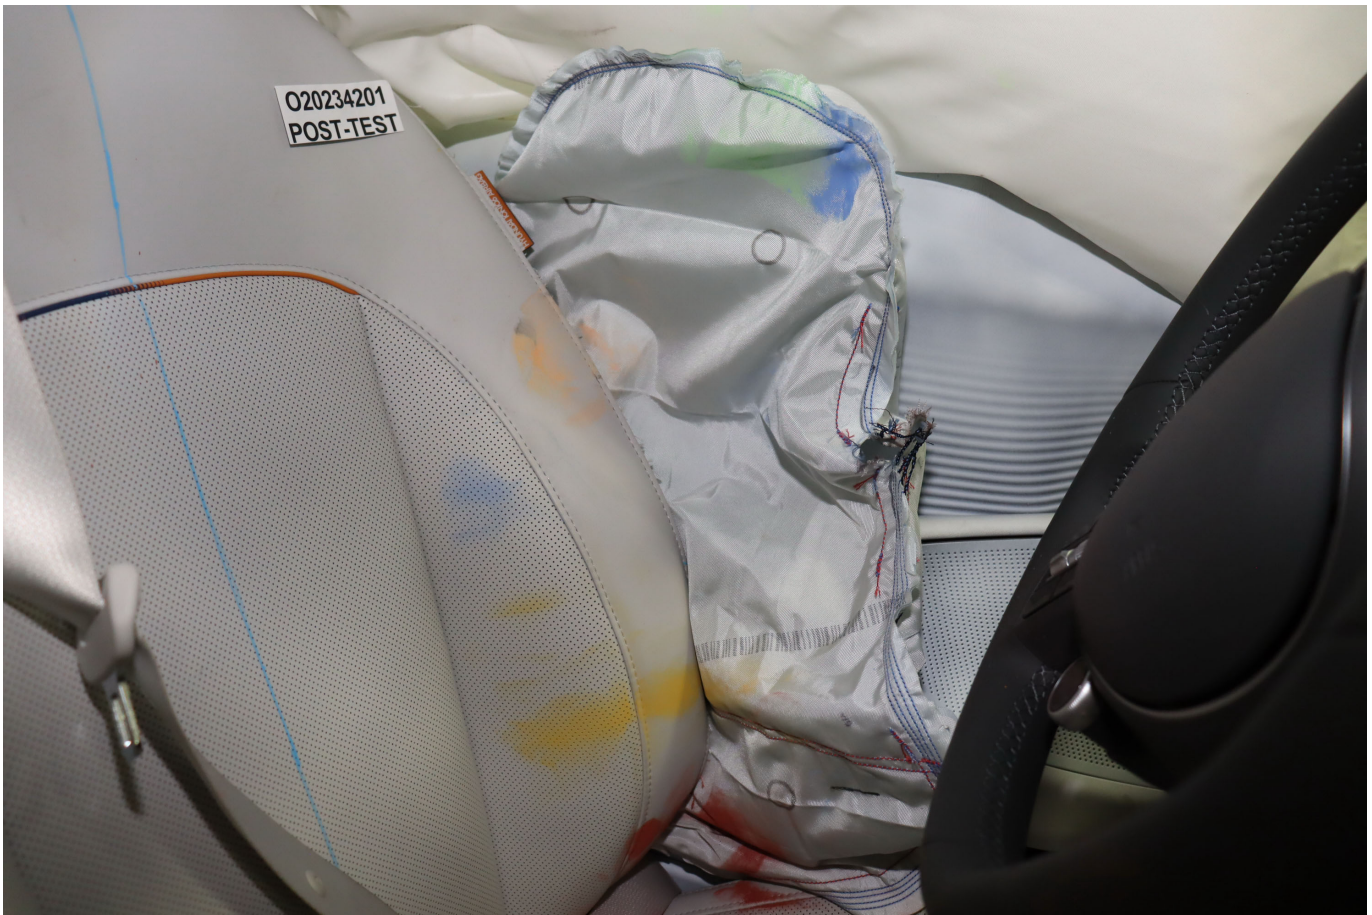
Photo No. 049 - Post-Test Dummy Close-Up Torso Contact with Side Air Bag View

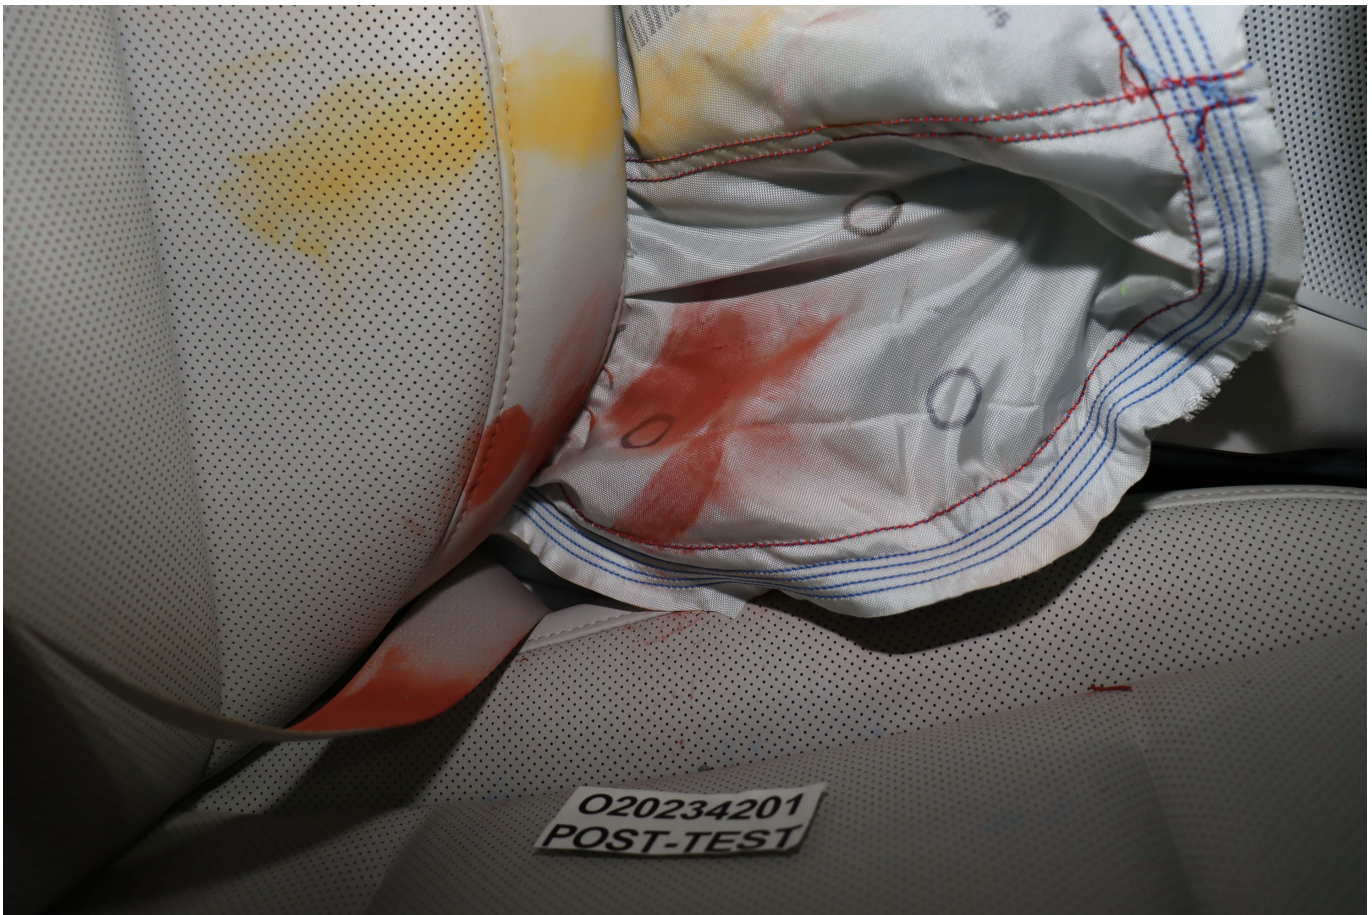
Photo No. 051 - Post-Test Dummy Close-Up Pelvis Contact with Side Air Bag View

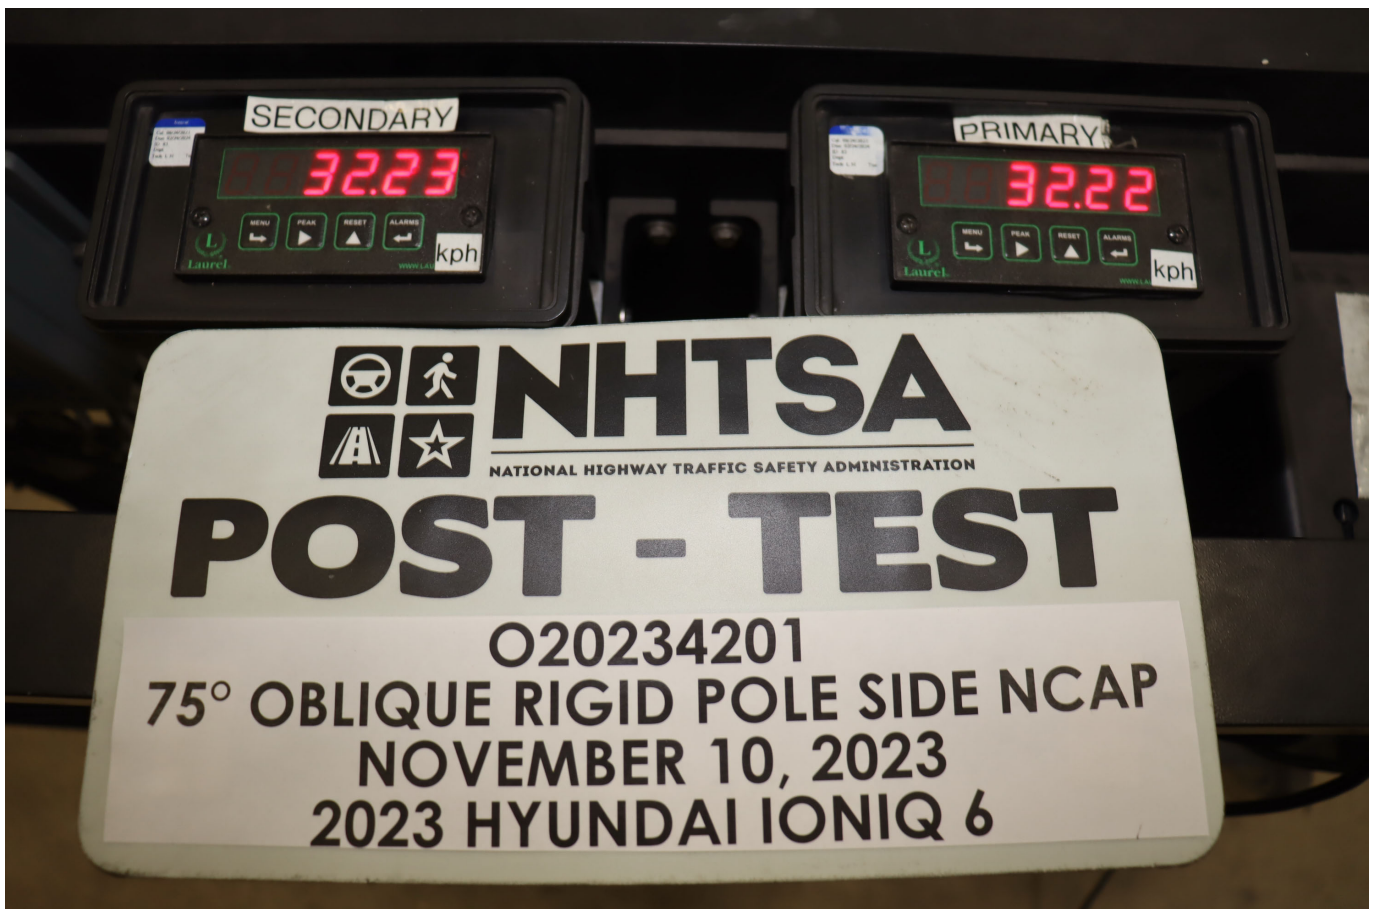
Photo No. 064 - Post-Test Primary and Redundant Speed Trap Read-Out
