REPORT NUMBER: NCAP-KAR-24-001

**NEW CAR ASSESSMENT PROGRAM (NCAP)
FRONTAL BARRIER IMPACT TEST**

**FCA US LLC
2024 JEEP COMPASS 4X4 5-DOOR SUV**

NHTSA NUMBER: M20240300

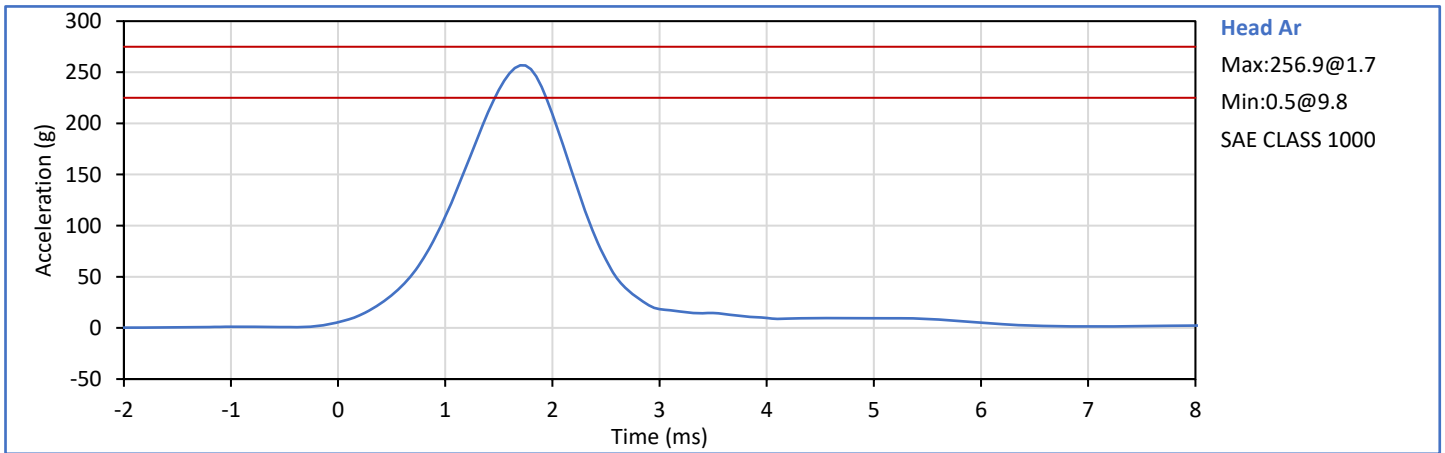
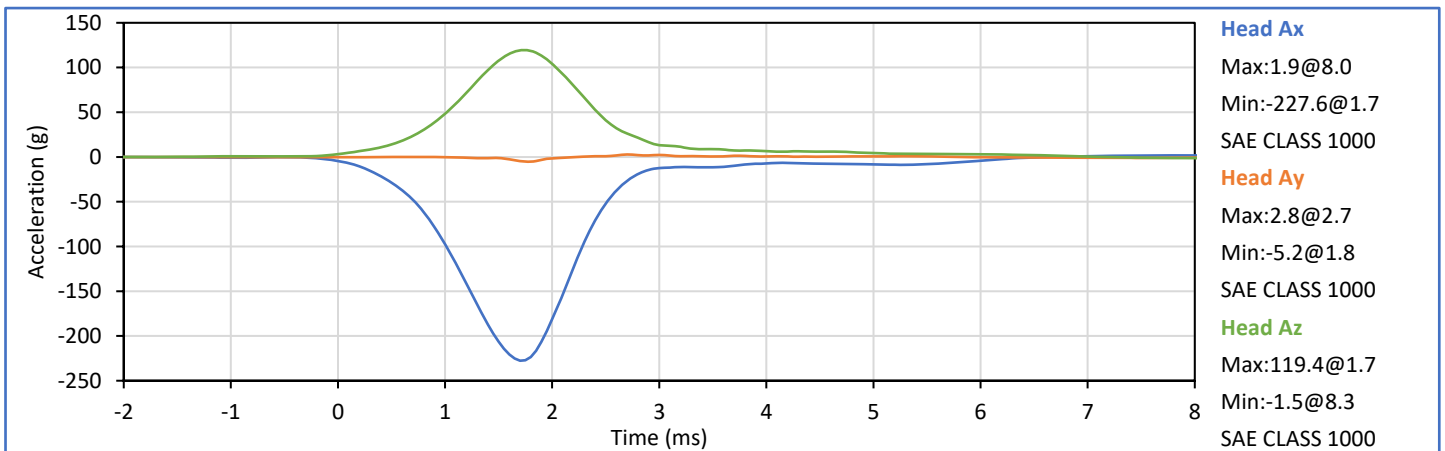
Tested Parameter	Units	Spec. Low	Spec. High	Result	Pass/Fail
Laboratory Temperature	°C	18.9	25.6	21.7	Pass
Laboratory Relative Humidity	%	10	70	41	Pass
Peak Resultant Acceleration	g	225.0	275.0	256.9	Pass
Peak Lateral Acceleration	g	-15.0	15.0	-5.2	Pass
Oscillations After Main Pulse	%	0.0	10.0	0.0	Pass
Is Acceleration Unimodal?	Yes/No	Yes		Yes	Pass
Overall Test Results					Pass

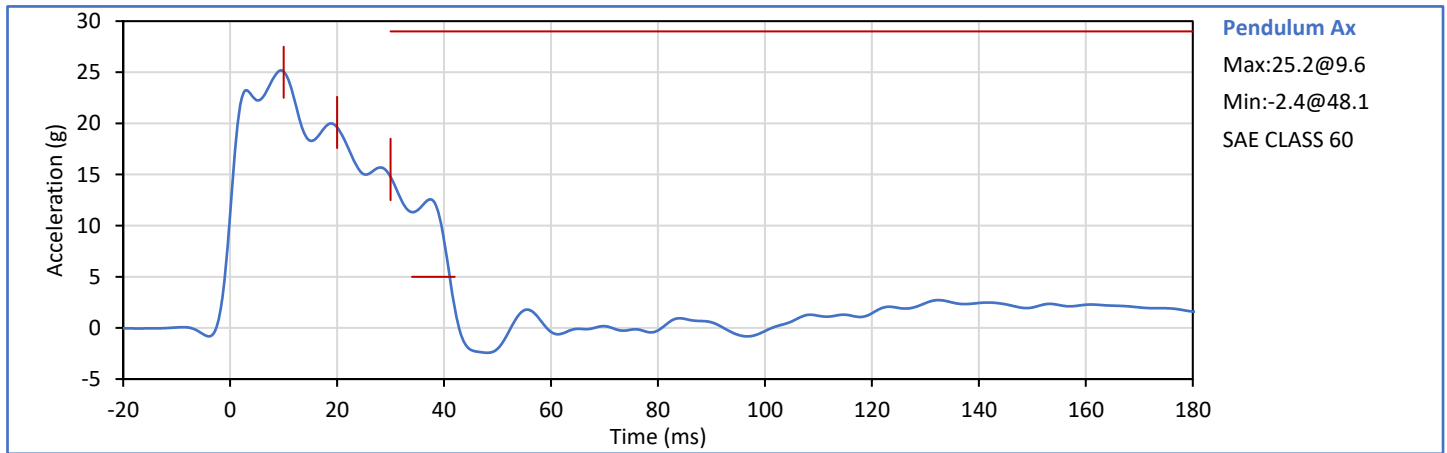
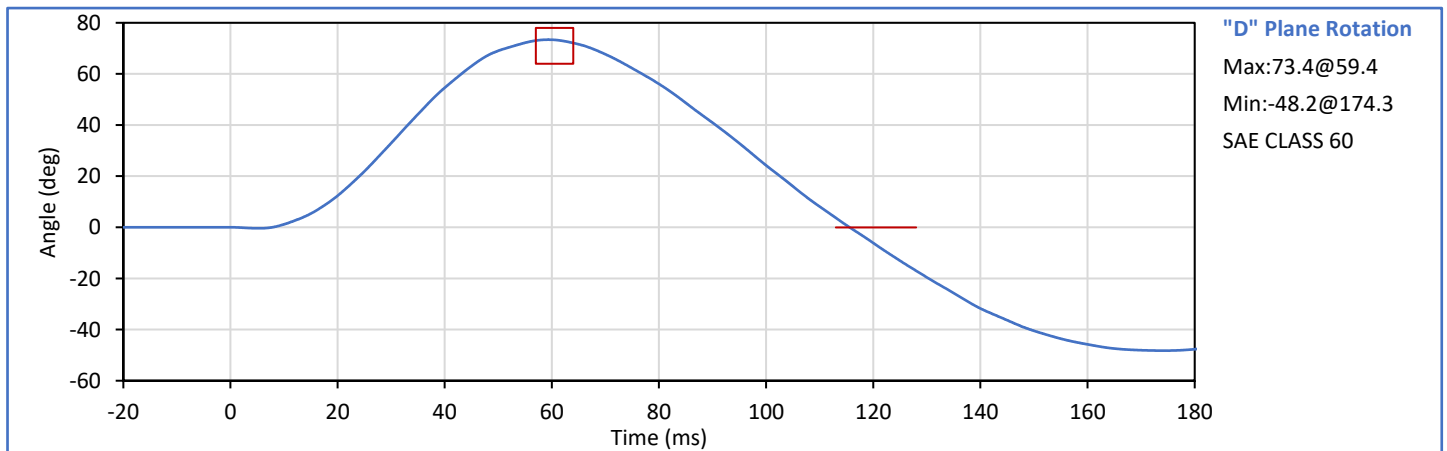
Tested Parameter	Units	Spec. Low	Spec. High	Result	Pass/Fail
Laboratory Temperature	°C	20.6	22.2	21.1	Pass
Laboratory Relative Humidity	%	10	70	36	Pass
Pendulum Velocity	m/s	6.89	7.13	7.02	Pass
Pendulum Deceleration at 10 ms	g	22.5	27.5	25.1	Pass
Pendulum Deceleration at 20 ms	g	17.6	22.6	19.6	Pass
Pendulum Deceleration at 30 ms	g	12.5	18.5	14.8	Pass
Peak Pendulum Decel After 30 ms	g	0.0	29.0	14.8	Pass
Deceleration Decay to Cross 5g	ms	34.0	42.0	41.1	Pass
"D" Plane Rotation peak	deg	64.0	78.0	73.4	Pass
	ms	57.0	64.0	59.4	Pass
"D" Plane Rotation Decay to Zero	ms	113.0	128.0	115.6	Pass
Moment About Occipital Condyle	Nm	88.1	108.5	92.6	Pass
	ms	47.0	58.0	53.8	Pass
Moment Decay, Peak to Zero	ms	97.0	107.0	97.9	Pass
Overall Test Results					Pass

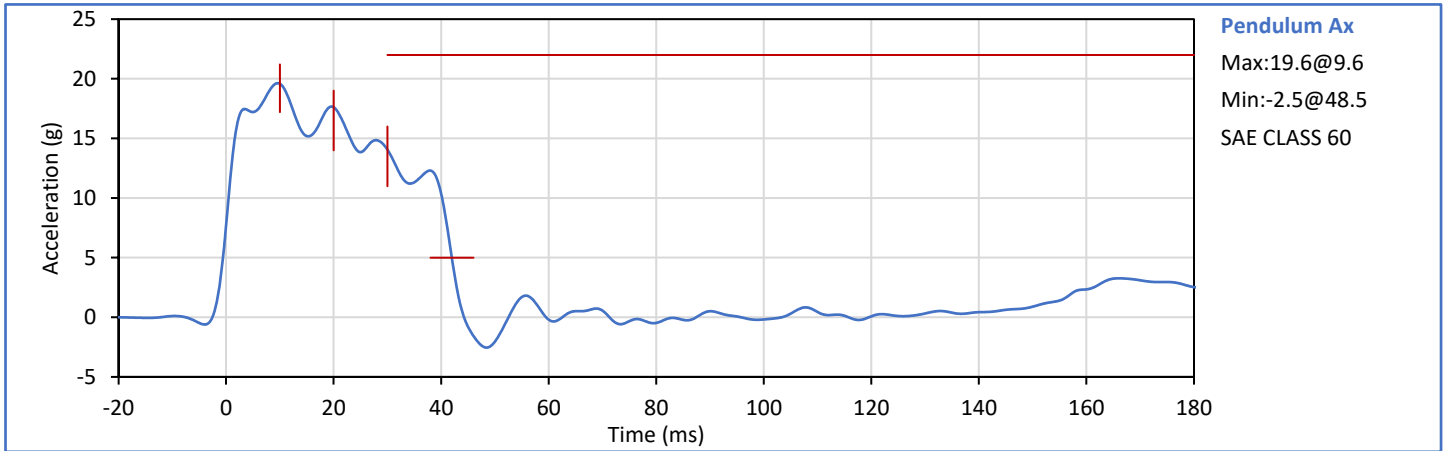
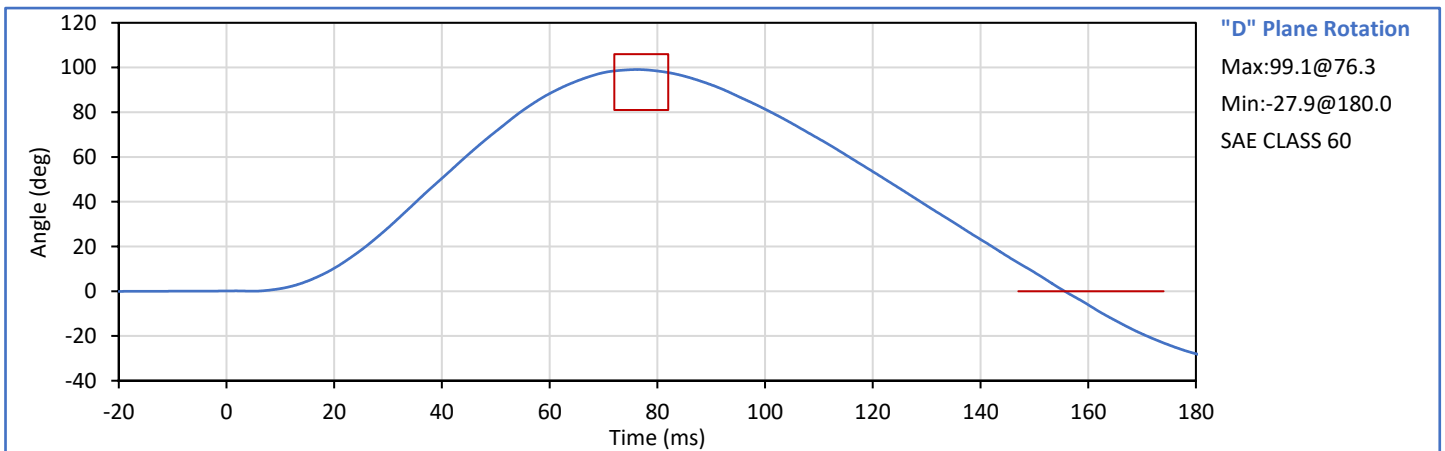
Tested Parameter	Units	Spec. Low	Spec. High	Result	Pass/Fail
Laboratory Temperature	°C	20.6	22.2	21.7	Pass
Laboratory Relative Humidity	%	10	70	36	Pass
Pendulum Velocity	m/s	5.94	6.19	6.09	Pass
Pendulum Deceleration at 10 ms	g	17.2	21.2	19.6	Pass
Pendulum Deceleration at 20 ms	g	14.0	19.0	17.6	Pass
Pendulum Deceleration at 30 ms	g	11.0	16.0	14.1	Pass
Peak Pendulum Decel After 30 ms	g	0.0	22.0	14.1	Pass
Deceleration Decay to Cross 5g	ms	38.0	46.0	42.0	Pass
"D" Plane Rotation peak	deg	81.0	106.0	99.1	Pass
	ms	72.0	82.0	76.3	Pass
"D" Plane Rotation Decay to Zero	ms	147.0	174.0	155.7	Pass
Moment About Occipital Condyle	Nm	-79.9	-52.9	-64.4	Pass
	ms	65.0	79.0	71.2	Pass
Moment Decay, Peak to Zero	ms	120.0	148.0	135.5	Pass
Overall Test Results					Pass

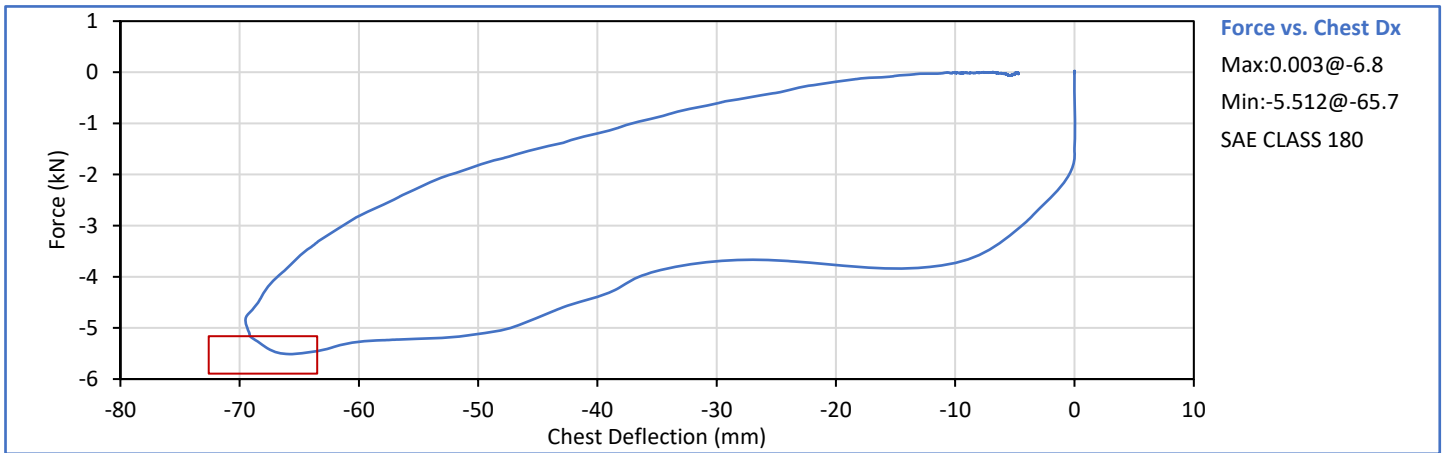
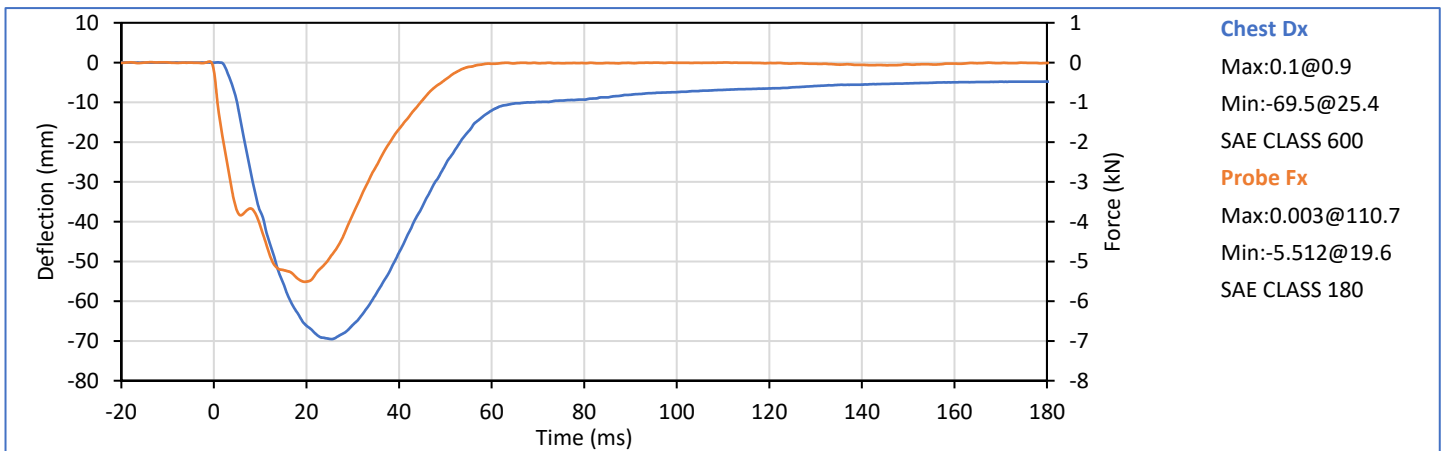
Tested Parameter	Units	Spec. Low	Spec. High	Result	Pass/Fail
Laboratory Temperature	°C	20.6	22.2	21.4	Pass
Laboratory Relative Humidity	%	10	70	35	Pass
Probe Velocity	m/s	6.58	6.82	6.75	Pass
Peak Chest Deflection	mm	-72.6	-63.5	-69.5	Pass
Peak Probe Force	kN	-5.893	-5.159	-5.512	Pass
Internal Hysteresis	%	69.0	85.0	70.9	Pass
Overall Test Results					Pass

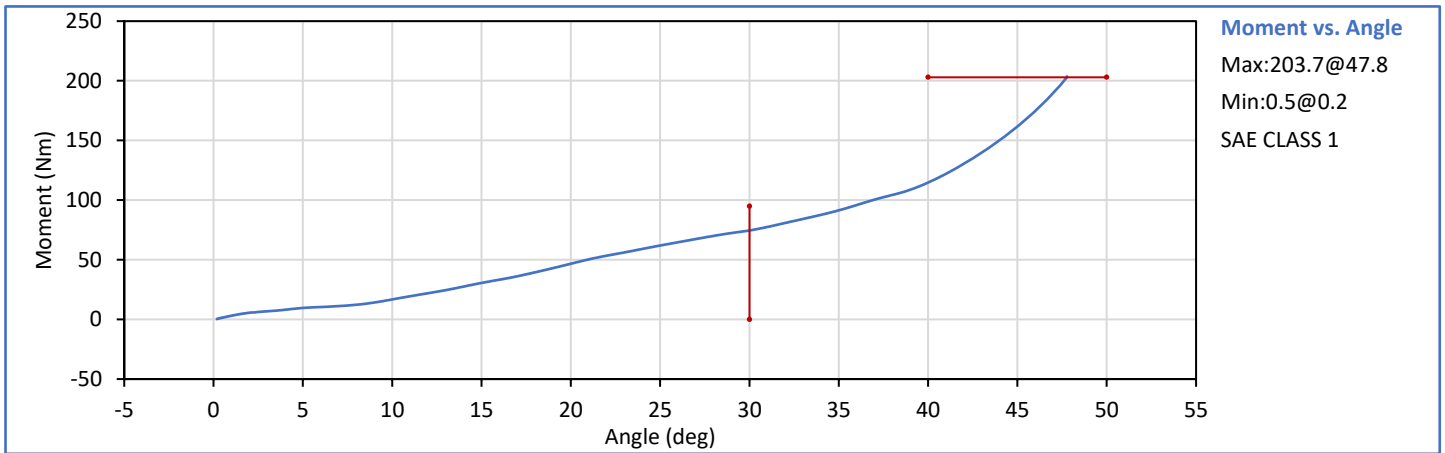
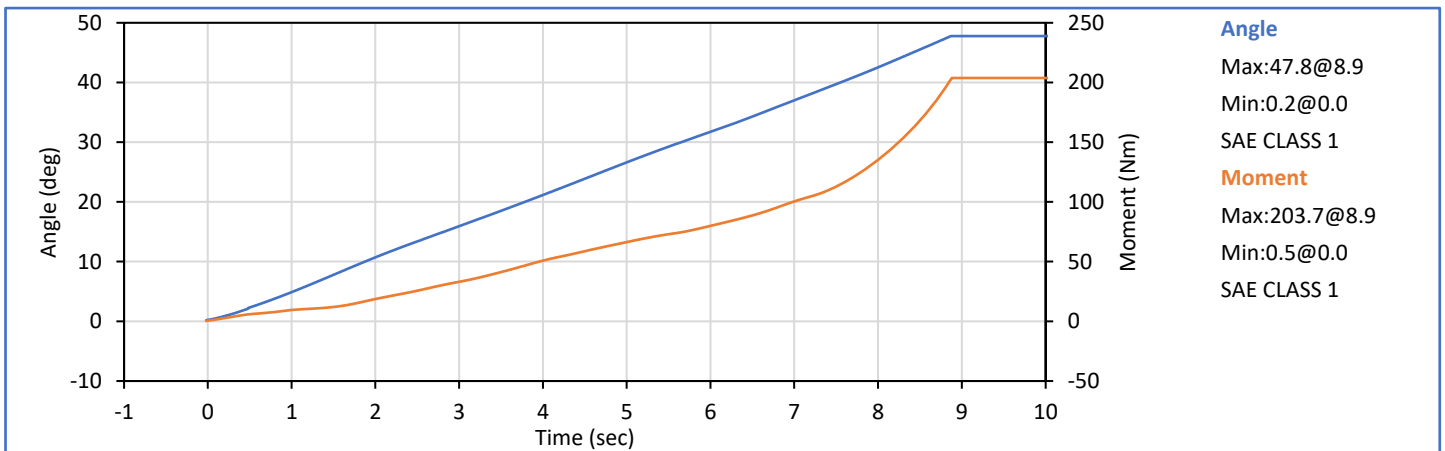
Tested Parameter	Units	Spec. Low	Spec. High	Result	Pass/Fail
Laboratory Temperature	°C	18.9	25.6	20.9	Pass
Laboratory Relative Humidity	%	10	70	35	Pass
Left Hip Rotation Rate	deg/s	5.0	10.0	5.3	Pass
Left Femur Torque at 30°	Nm	0.0	95.0	74.5	Pass
Left Hip Rotation at 203 Nm	deg	40.0	50.0	47.8	Pass
Overall Test Results					Pass

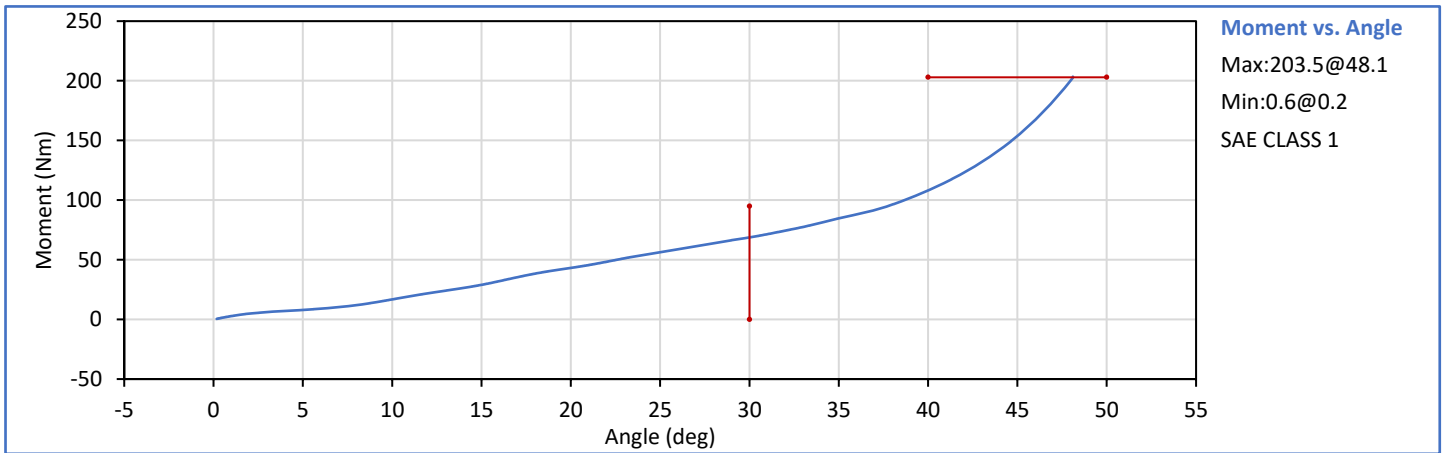
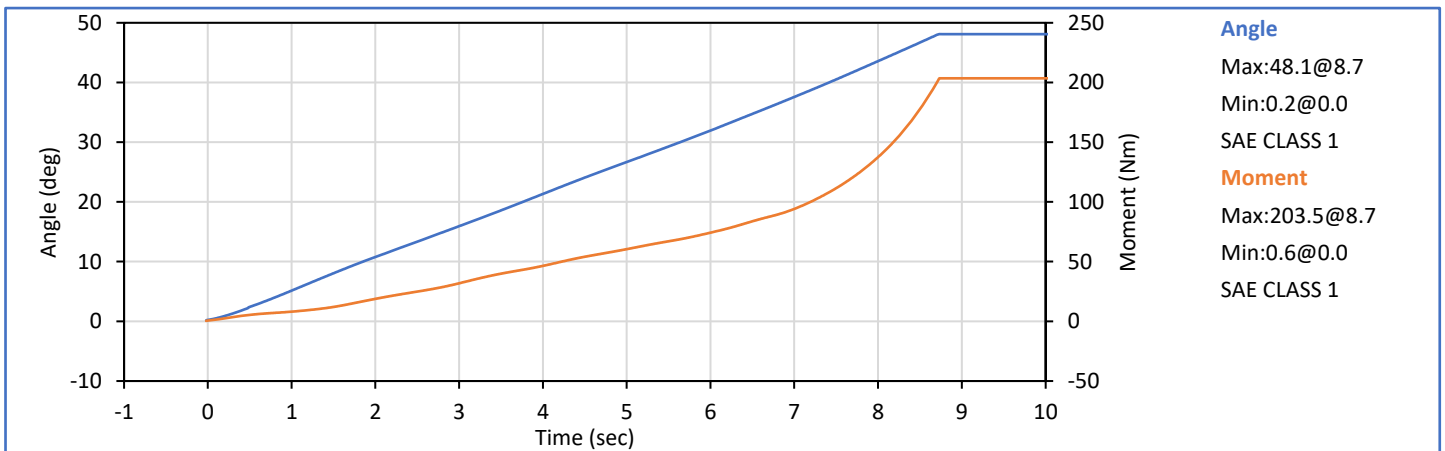
Tested Parameter	Units	Spec. Low	Spec. High	Result	Pass/Fail
Laboratory Temperature	°C	18.9	25.6	20.9	Pass
Laboratory Relative Humidity	%	10	70	35	Pass
Right Hip Rotation Rate	deg/s	5.0	10.0	5.4	Pass
Right Femur Torque at 30°	Nm	0.0	95.0	68.7	Pass
Right Hip Rotation at 203 Nm	deg	40.0	50.0	48.1	Pass
Overall Test Results					Pass

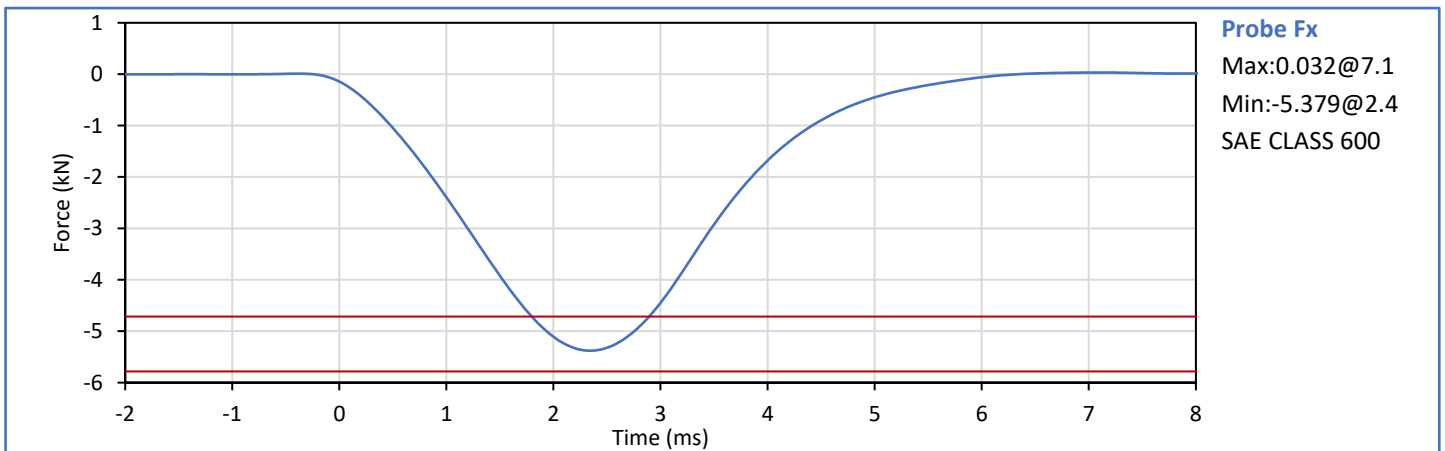
Tested Parameter	Units	Spec. Low	Spec. High	Result	Pass/Fail
Laboratory Temperature	°C	18.9	25.6	21.7	Pass
Laboratory Relative Humidity	%	10	70	39	Pass
Probe Velocity	m/s	2.070	2.130	2.086	Pass
Peak Resistive Force	kN	-5.782	-4.715	-5.379	Pass
Overall Test Results					Pass

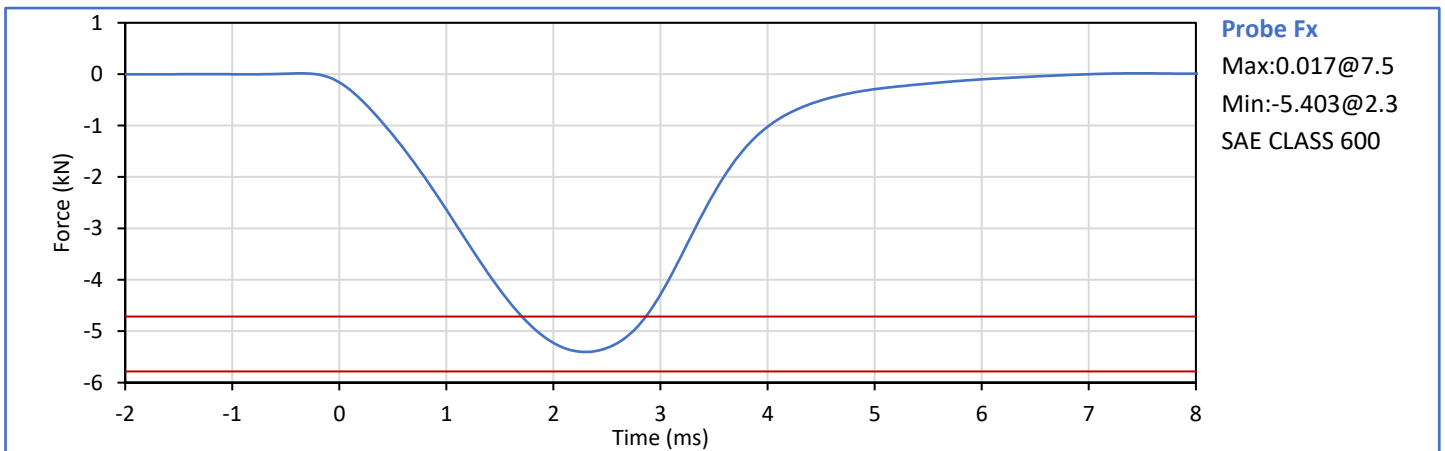
Tested Parameter	Units	Spec. Low	Spec. High	Result	Pass/Fail
Laboratory Temperature	°C	18.9	25.6	21.7	Pass
Laboratory Relative Humidity	%	10	70	41	Pass
Probe Velocity	m/s	2.070	2.130	2.095	Pass
Peak Resistive Force	kN	-5.782	-4.715	-5.403	Pass
Overall Test Results					Pass

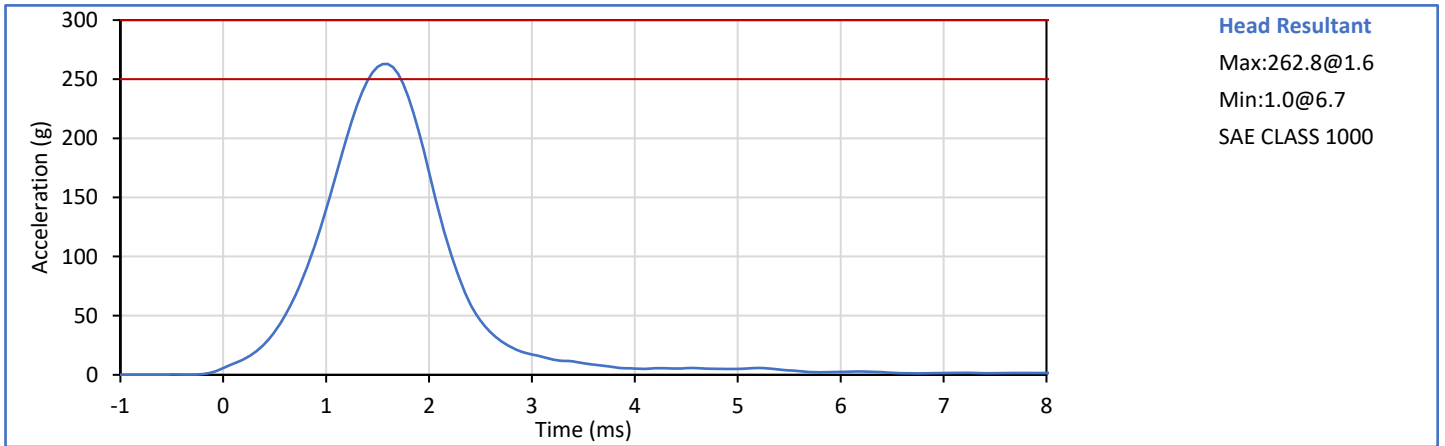
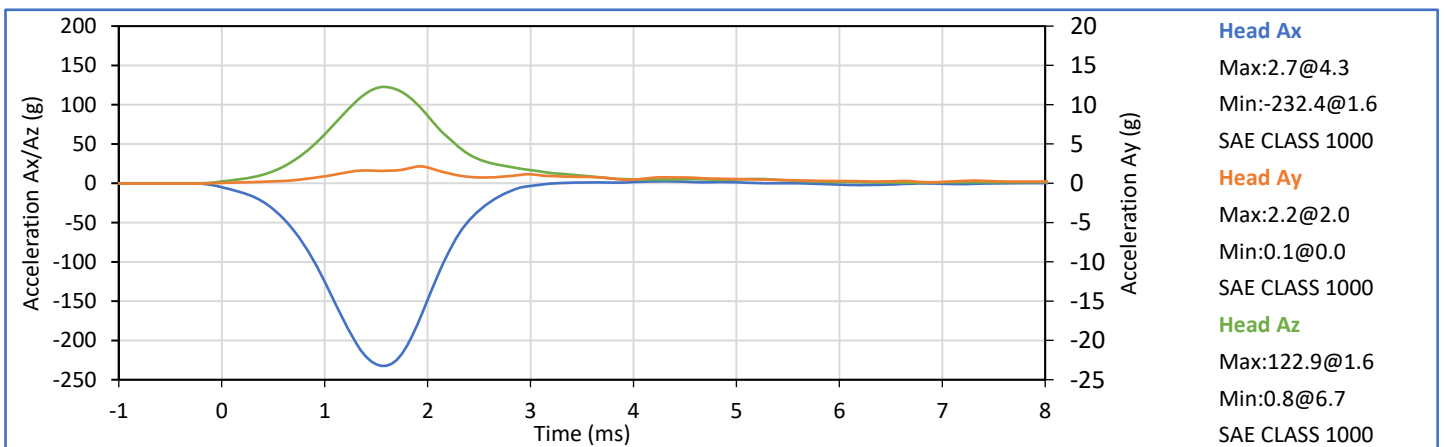
Tested Parameter	Units	Spec. Low	Spec. High	Result	Pass/Fail
Laboratory Temperature	°C	18.9	25.6	21.1	Pass
Laboratory Humidity	%	10	70	35	Pass
Peak Resultant Acceleration	g	250.0	300.0	262.8	Pass
Peak Lateral Acceleration	g	-15.0	15.0	2.2	Pass
Oscillations After Main Pulse	%	0.0	10.0	1.3	Pass
Is Acceleration Unimodal?	Yes/No	Yes		Yes	Pass
Overall Test Results					Pass

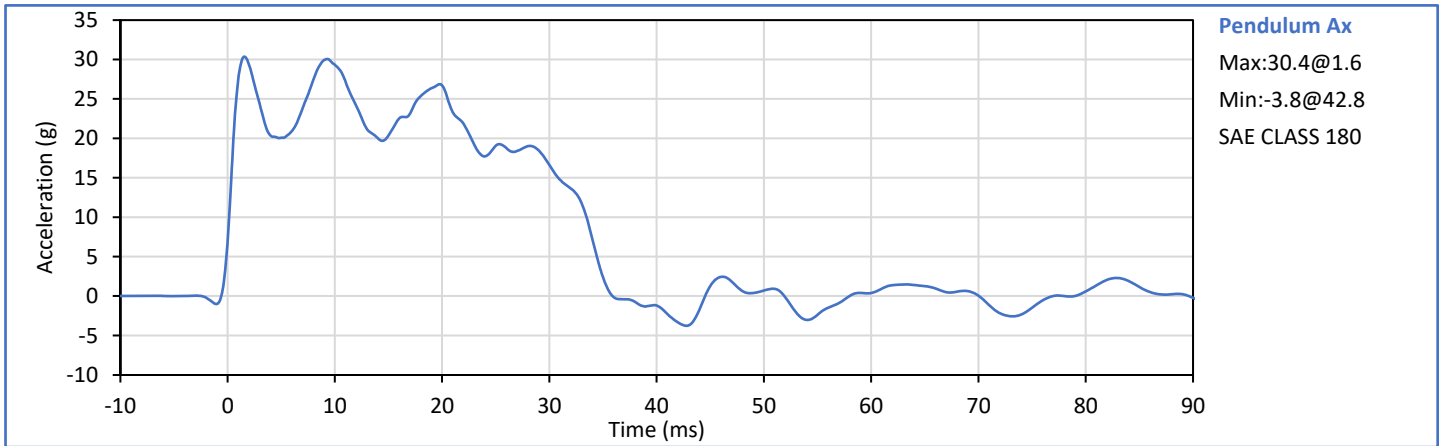
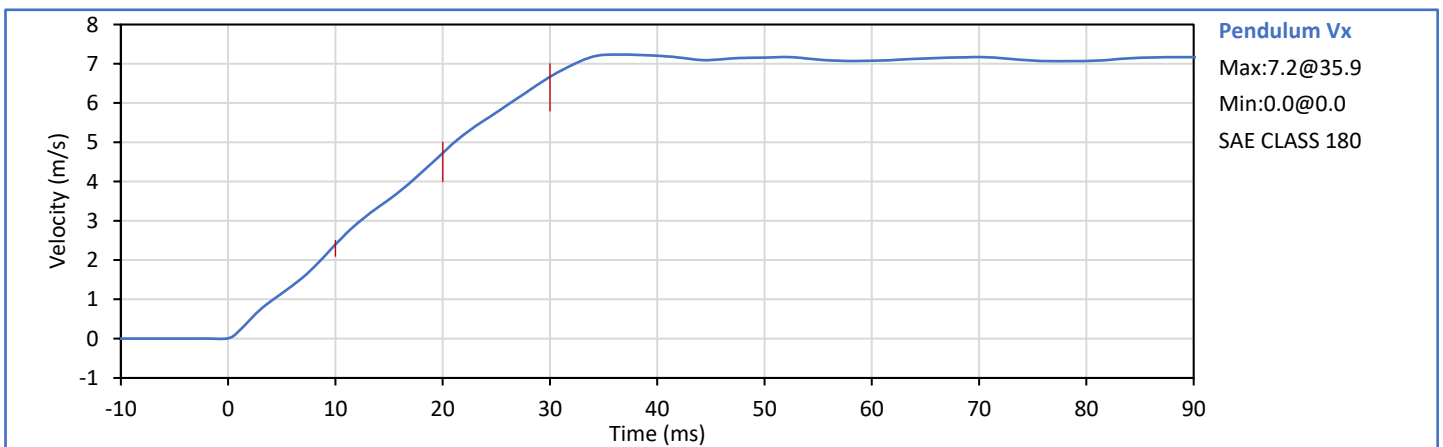
Tested Parameter	Units	Spec. Low	Spec. High	Result	Pass/Fail
Laboratory Temperature	°C	20.6	22.2	21.0	Pass
Laboratory Humidity	%	10	70	35	Pass
Pendulum Velocity	m/s	6.89	7.13	7.00	Pass
Pendulum Velocity at 10 ms	m/s	2.10	2.50	2.39	Pass
Pendulum Velocity at 20 ms	m/s	4.00	5.00	4.73	Pass
Pendulum Velocity at 30 ms	m/s	5.80	7.00	6.67	Pass
Peak "D" Plane Rotation	deg	77.0	91.0	82.0	Pass
Peak Moment in Rotation	Nm	69.0	83.0	80.1	Pass
Positive Moment Decay to 10 Nm	ms	80.0	100.0	82.4	Pass
Overall Test Results					Pass

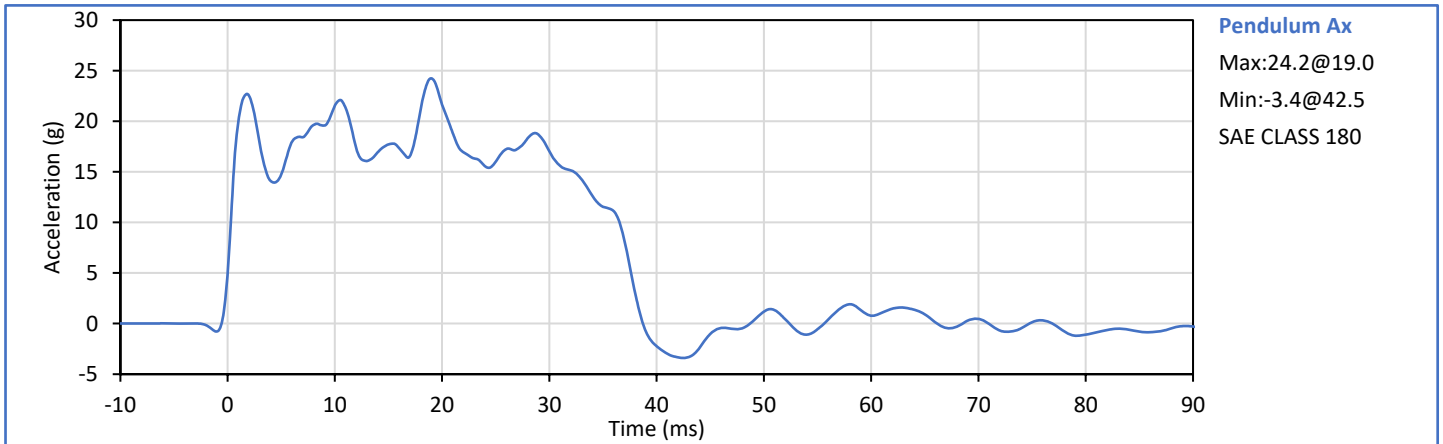
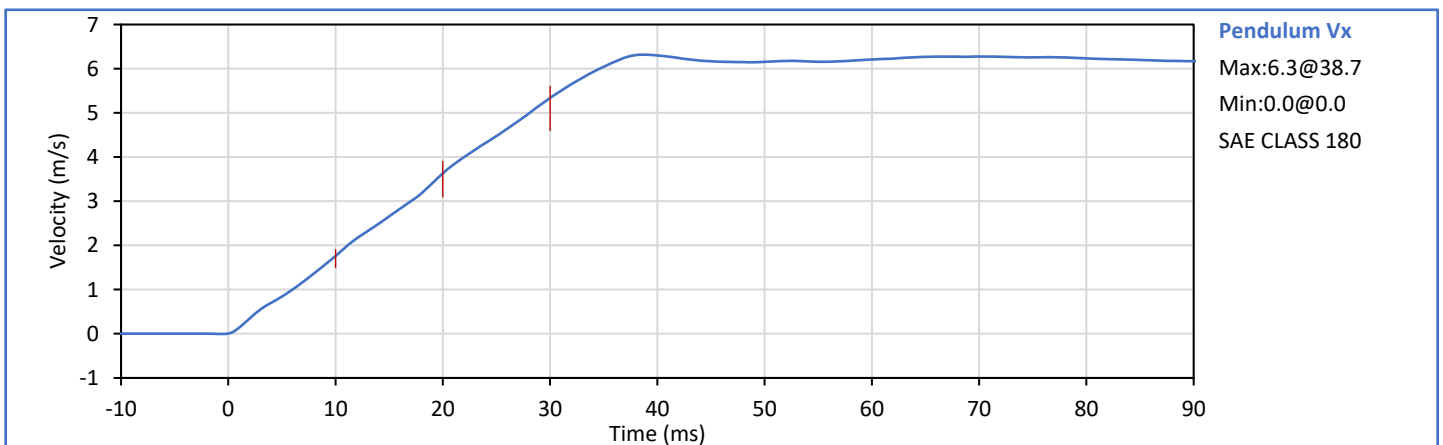
Tested Parameter	Units	Spec. Low	Spec. High	Result	Pass/Fail
Laboratory Temperature	°C	20.6	22.2	21.0	Pass
Laboratory Relative Humidity	%	10	70	35	Pass
Pendulum Velocity	m/s	5.95	6.19	6.09	Pass
Pendulum Velocity at 10 ms	m/s	1.50	1.90	1.76	Pass
Pendulum Velocity at 20 ms	m/s	3.10	3.90	3.63	Pass
Pendulum Velocity at 30 ms	m/s	4.60	5.60	5.34	Pass
Peak "D" Plane Rotation	deg	99.0	114.0	108.4	Pass
Peak Moment in Rotation	Nm	-65.0	-53.0	-62.4	Pass
Negative Moment Decay to -10 Nm	ms	94.0	114.0	100.5	Pass
Overall Test Results					Pass

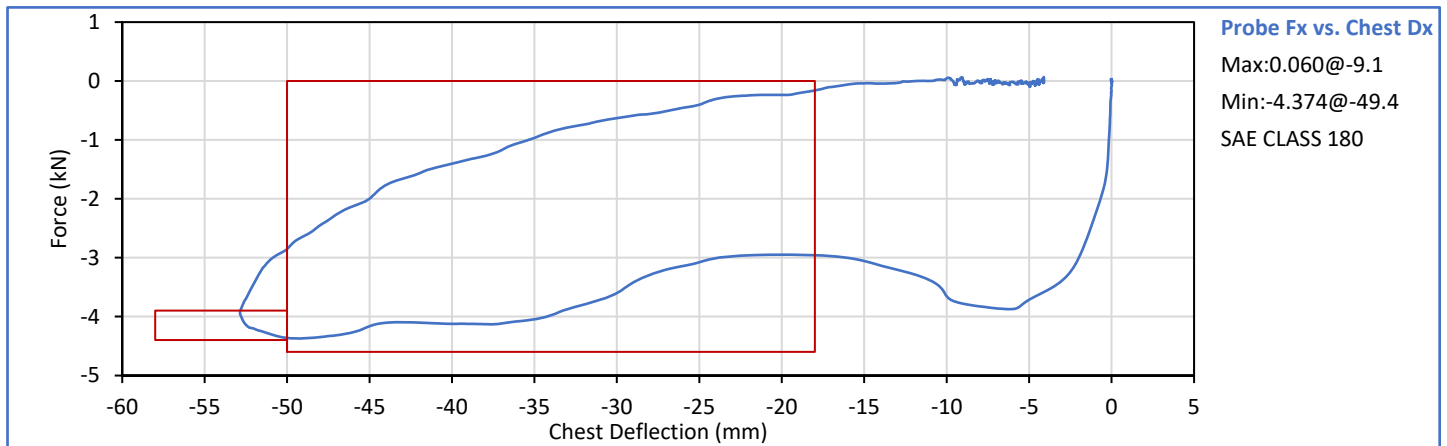
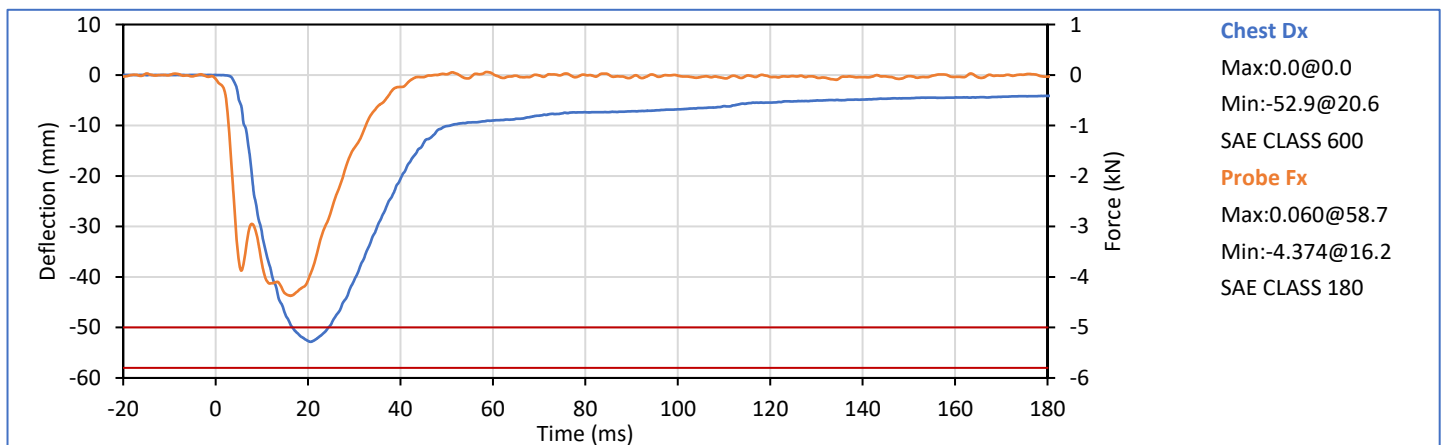
Tested Parameter	Units	Spec. Low	Spec. High	Result	Pass/Fail
Laboratory Temperature	°C	20.6	22.2	21.1	Pass
Laboratory RelativeHumidity	%	10	70	40	Pass
Probe Velocity	m/s	6.59	6.83	6.76	Pass
Peak Chest Deflection	mm	-58.0	-50.0	-52.9	Pass
Peak Probe Force, 50 and 58 mm	kN	-4.400	-3.900	-4.363	Pass
Peak Probe Force, 18 and 50 mm	kN	-4.600	0.000	-4.374	Pass
Internal Hysteresis	%	69.0	85.0	76.8	Pass
Overall Test Results					Pass

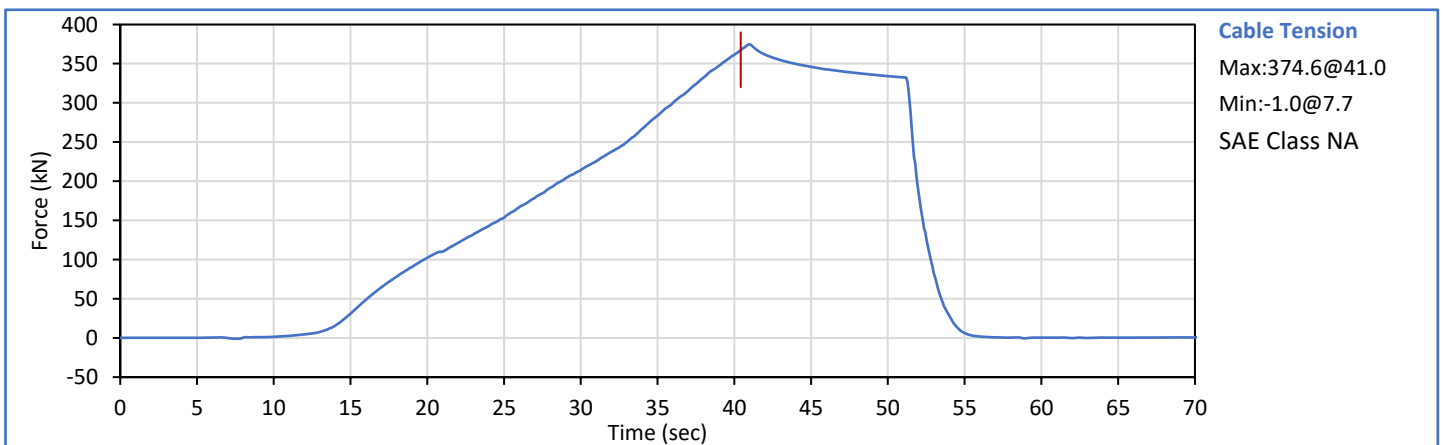
Tested Parameter	Units	Spec. Low	Spec. High	Result	Pass/Fail
Laboratory Temperature	°C	18.9	25.6	21.1	Pass
Laboratory Humidity	%	10	70	40	Pass
Orientation Angle	deg	0.0	20.0	15.9	Pass
Test Initial Angle	deg	11.0	19.0	15.9	Pass
Peak Force at 45° (+/-0.5°)	N	320.0	390.0	367.0	Pass
Torso Flexion Rate	deg/s	0.50	1.50	1.06	Pass
Final Reference Plane Angle	deg	-8.0	8.0	4.3	Pass
Overall Test Results					Pass

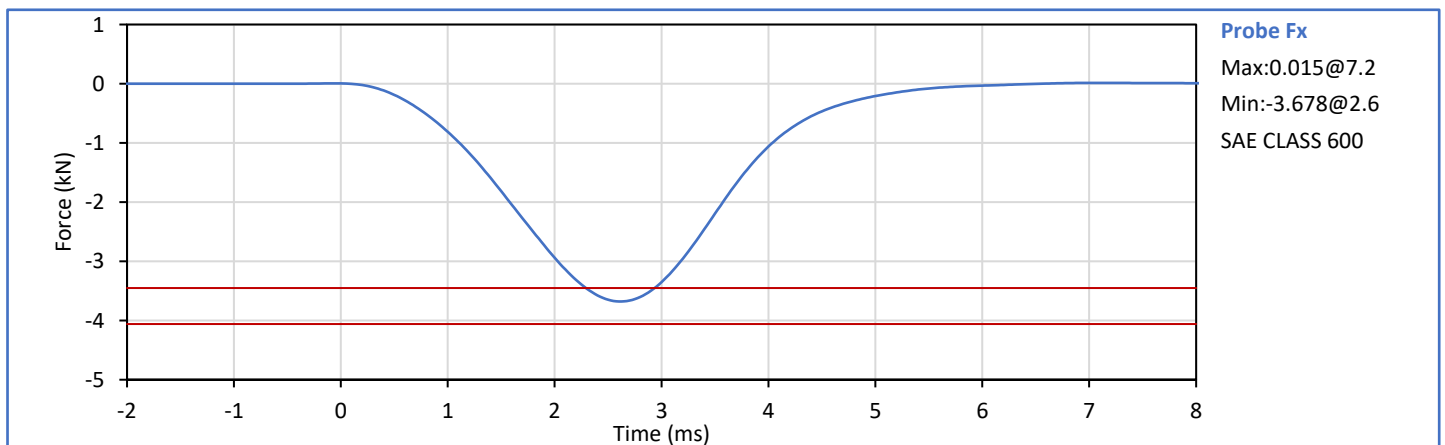
Tested Parameter	Units	Spec. Low	Spec. High	Result	Pass/Fail
Laboratory Temperature	°C	18.9	25.6	21.1	Pass
Laboratory Relative Humidity	%	10	70	35	Pass
Probe Velocity	m/s	2.070	2.130	2.109	Pass
Peak Resistive Force	kN	-4.060	-3.450	-3.678	Pass
Overall Test Results					Pass

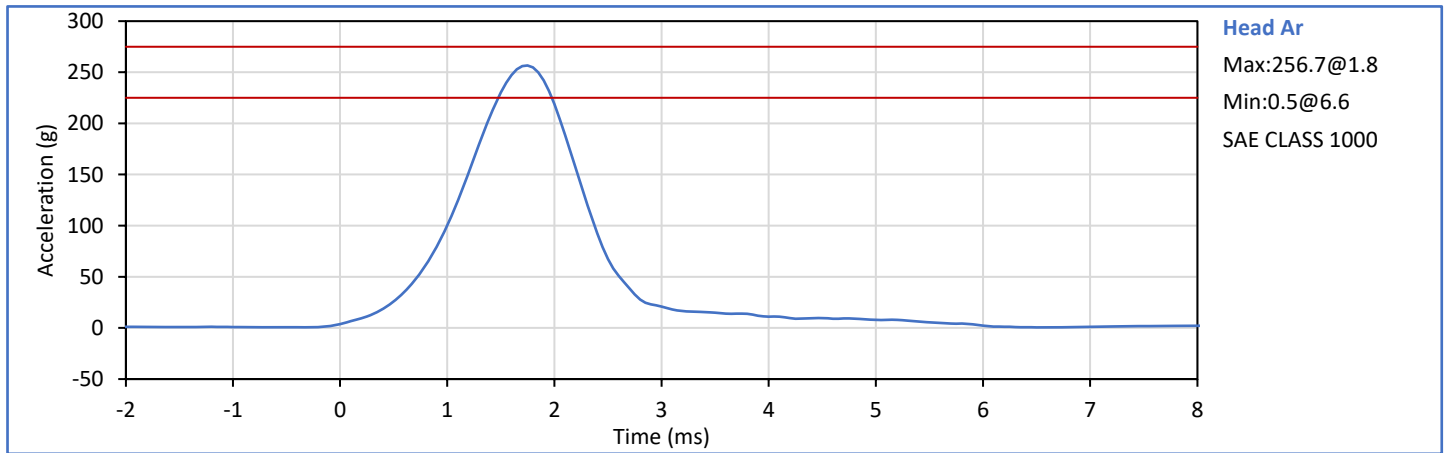
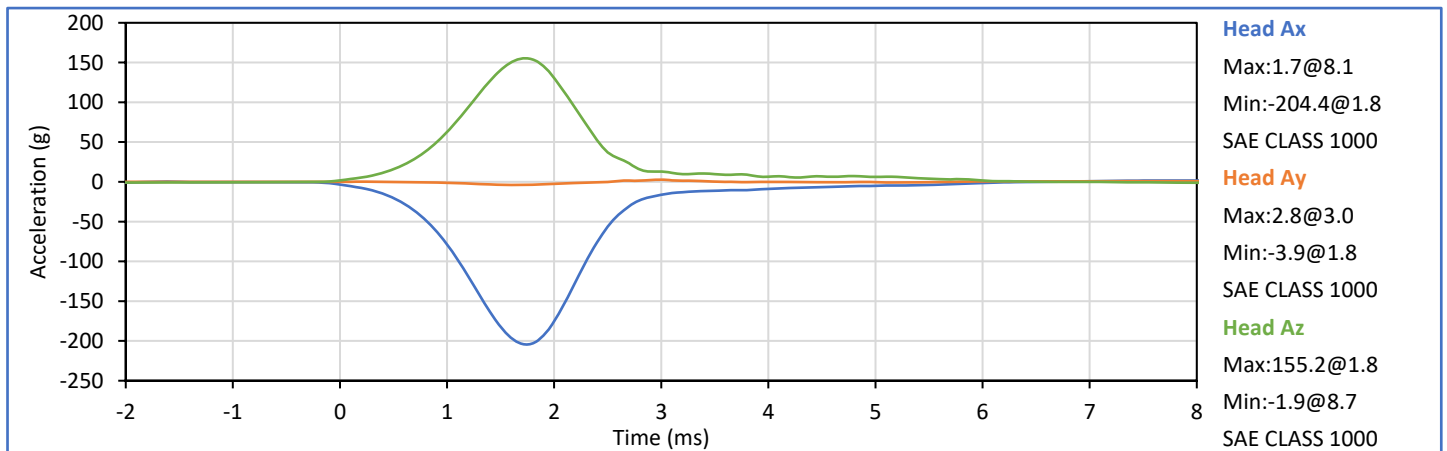
Tested Parameter	Units	Spec. Low	Spec. High	Result	Pass/Fail
Laboratory Temperature	°C	18.9	25.6	21.7	Pass
Laboratory Relative Humidity	%	10	70	41	Pass
Peak Resultant Acceleration	g	225.0	275.0	256.7	Pass
Peak Lateral Acceleration	g	-15.0	15.0	-3.9	Pass
Oscillations After Main Pulse	%	0.0	10.0	0.0	Pass
Is Acceleration Unimodal?	Yes/No	Yes		Yes	Pass
Overall Test Results					Pass

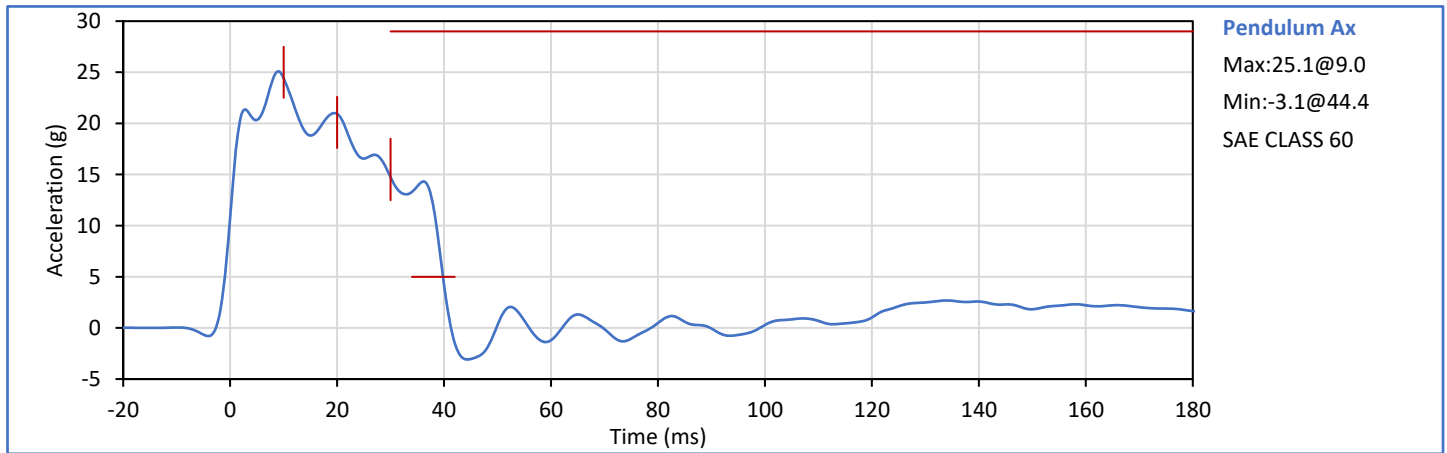
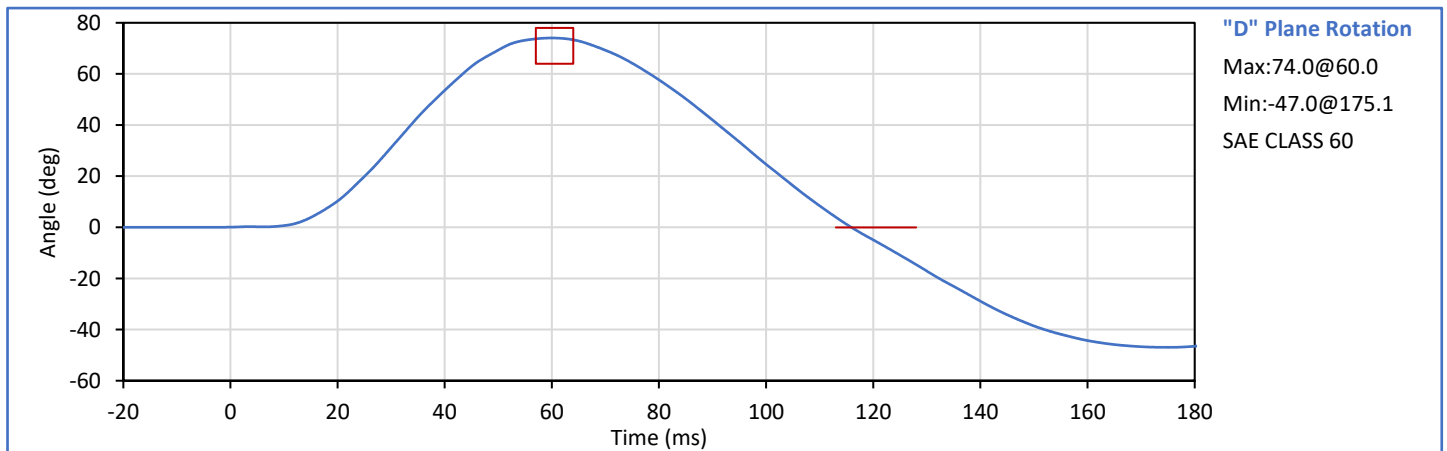
Tested Parameter	Units	Spec. Low	Spec. High	Result	Pass/Fail
Laboratory Temperature	°C	20.6	22.2	21.1	Pass
Laboratory Relative Humidity	%	10	70	35	Pass
Pendulum Velocity	m/s	6.89	7.13	6.92	Pass
Pendulum Deceleration at 10 ms	g	22.5	27.5	24.4	Pass
Pendulum Deceleration at 20 ms	g	17.6	22.6	20.9	Pass
Pendulum Deceleration at 30 ms	g	12.5	18.5	14.7	Pass
Peak Pendulum Decel After 30 ms	g	0.0	29.0	14.7	Pass
Deceleration Decay to Cross 5g	ms	34.0	42.0	39.8	Pass
"D" Plane Rotation peak	deg	64.0	78.0	74.0	Pass
	ms	57.0	64.0	60.0	Pass
"D" Plane Rotation Decay to Zero	ms	113.0	128.0	116.0	Pass
Moment About Occipital Condyle	Nm	88.1	108.5	96.5	Pass
	ms	47.0	58.0	52.6	Pass
Moment Decay, Peak to Zero	ms	97.0	107.0	98.0	Pass
Overall Test Results					Pass

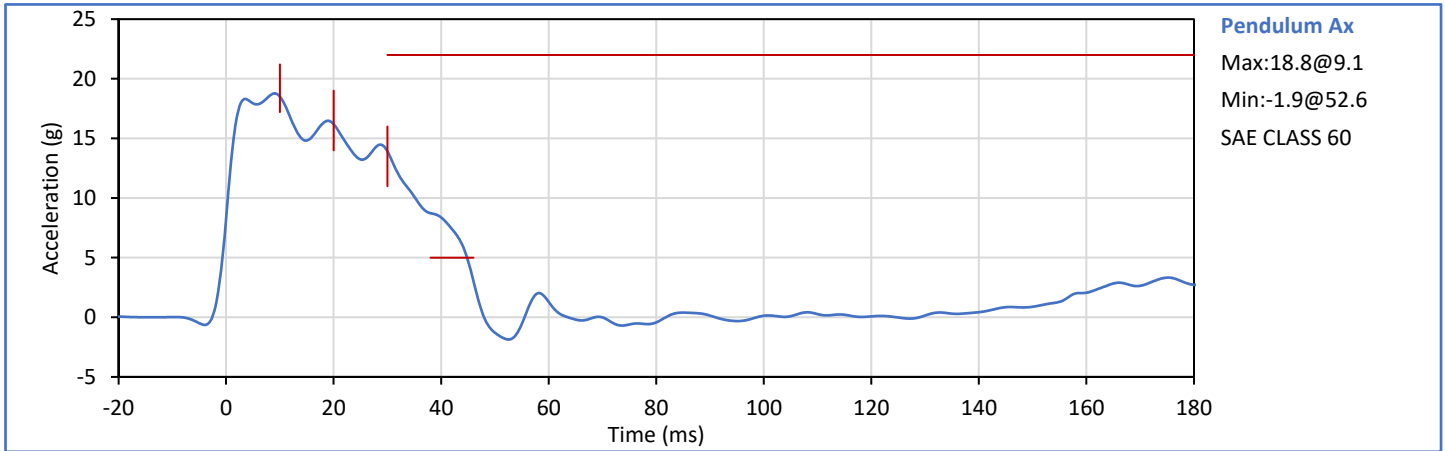
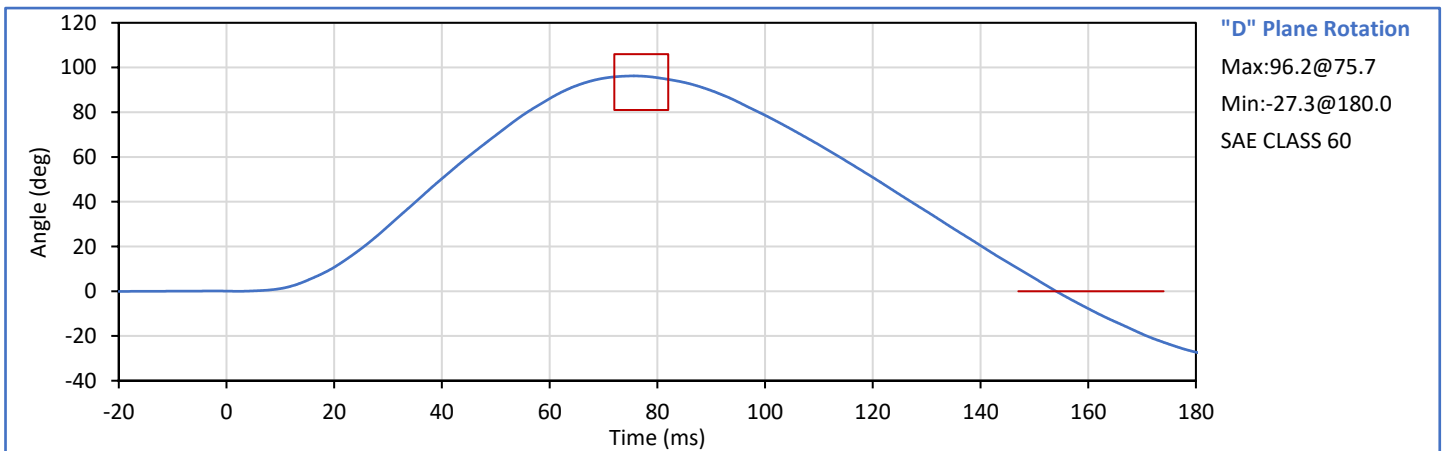
Tested Parameter	Units	Spec. Low	Spec. High	Result	Pass/Fail
Laboratory Temperature	°C	20.6	22.2	21.7	Pass
Laboratory Relative Humidity	%	10	70	35	Pass
Pendulum Velocity	m/s	5.94	6.19	6.00	Pass
Pendulum Deceleration at 10 ms	g	17.2	21.2	18.5	Pass
Pendulum Deceleration at 20 ms	g	14.0	19.0	16.2	Pass
Pendulum Deceleration at 30 ms	g	11.0	16.0	13.9	Pass
Peak Pendulum Decel After 30 ms	g	0.0	22.0	13.9	Pass
Deceleration Decay to Cross 5g	ms	38.0	46.0	44.8	Pass
"D" Plane Rotation peak	deg	81.0	106.0	96.2	Pass
	ms	72.0	82.0	75.7	Pass
"D" Plane Rotation Decay to Zero	ms	147.0	174.0	154.1	Pass
Moment About Occipital Condyle	Nm	-79.9	-52.9	-65.2	Pass
	ms	65.0	79.0	71.8	Pass
Moment Decay, Peak to Zero	ms	120.0	148.0	135.6	Pass
Overall Test Results					Pass

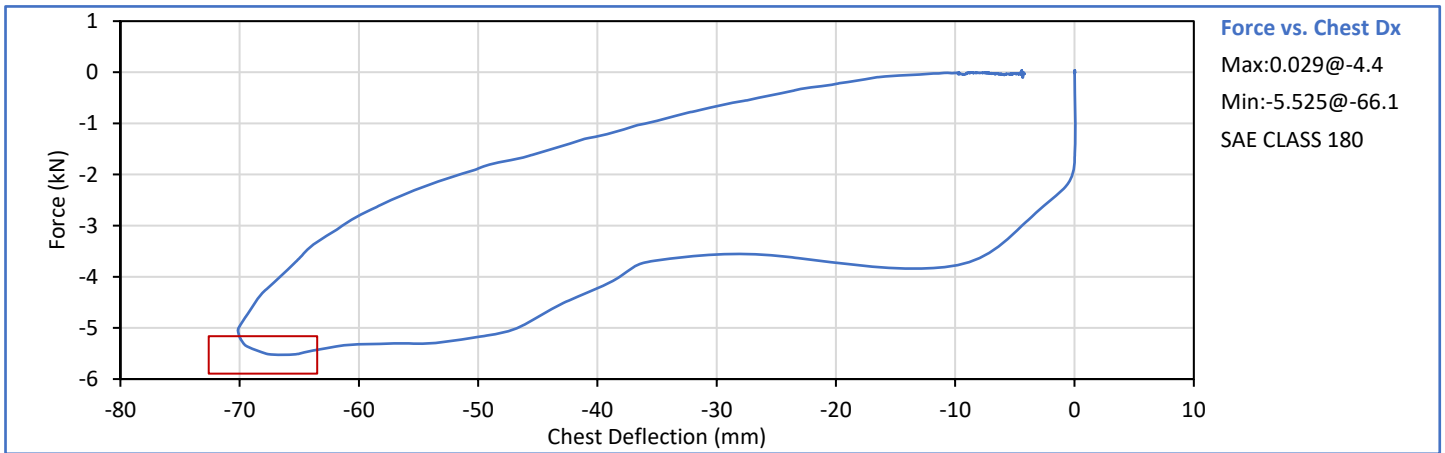
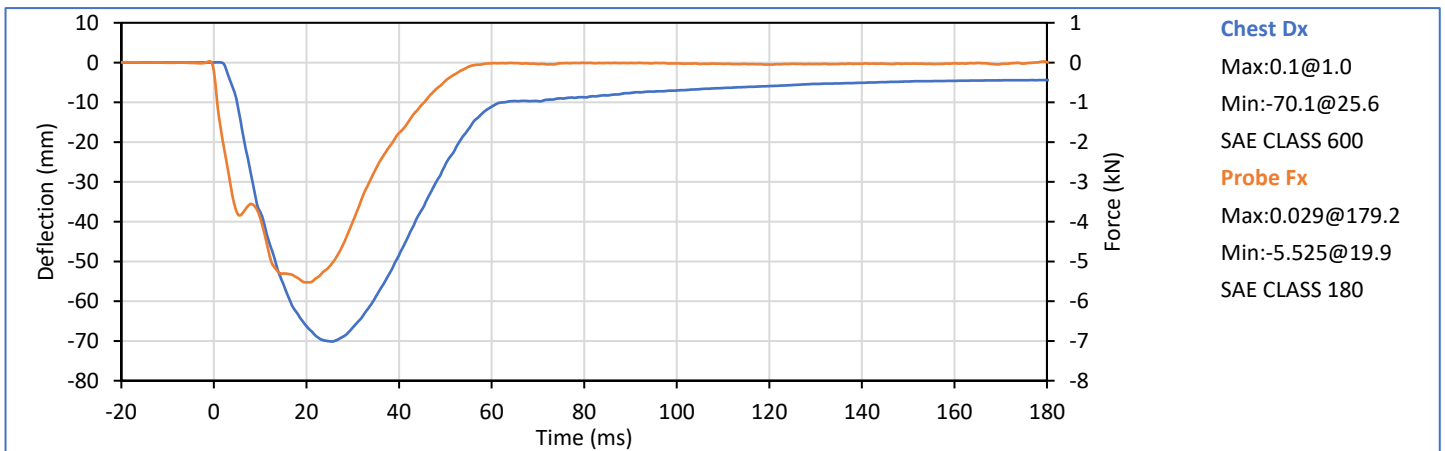
Tested Parameter	Units	Spec. Low	Spec. High	Result	Pass/Fail
Laboratory Temperature	°C	20.6	22.2	21.7	Pass
Laboratory Relative Humidity	%	10	70	37	Pass
Probe Velocity	m/s	6.58	6.82	6.72	Pass
Peak Chest Deflection	mm	-72.6	-63.5	-70.1	Pass
Peak Probe Force	kN	-5.893	-5.159	-5.525	Pass
Internal Hysteresis	%	69.0	85.0	69.3	Pass
Overall Test Results					Pass
