REPORT NUMBER: NCAP-KAR-24-001

**NEW CAR ASSESSMENT PROGRAM (NCAP)
FRONTAL BARRIER IMPACT TEST**

**FCA US LLC
2024 JEEP COMPASS 4X4 5-DOOR SUV**

NHTSA NUMBER: M20240300

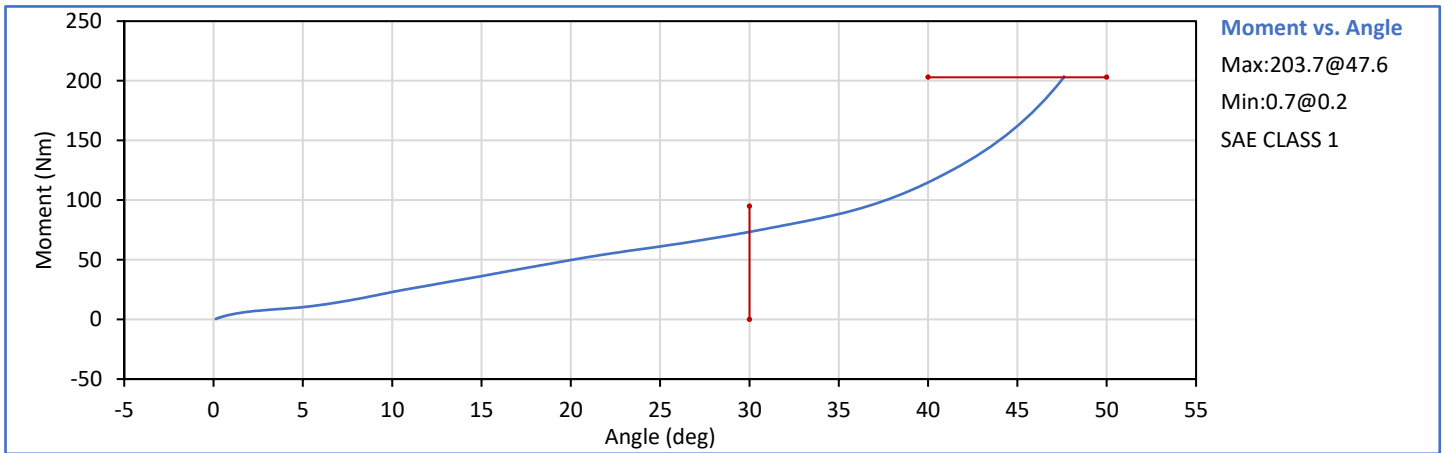
Tested Parameter	Units	Spec. Low	Spec. High	Result	Pass/Fail
Laboratory Temperature	°C	18.9	25.6	21.7	Pass
Laboratory Relative Humidity	%	10	70	36	Pass
Left Hip Rotation Rate	deg/s	5.0	10.0	5.9	Pass
Left Femur Torque at 30°	Nm	0.0	95.0	73.3	Pass
Left Hip Rotation at 203 Nm	deg	40.0	50.0	47.6	Pass
Overall Test Results					Pass

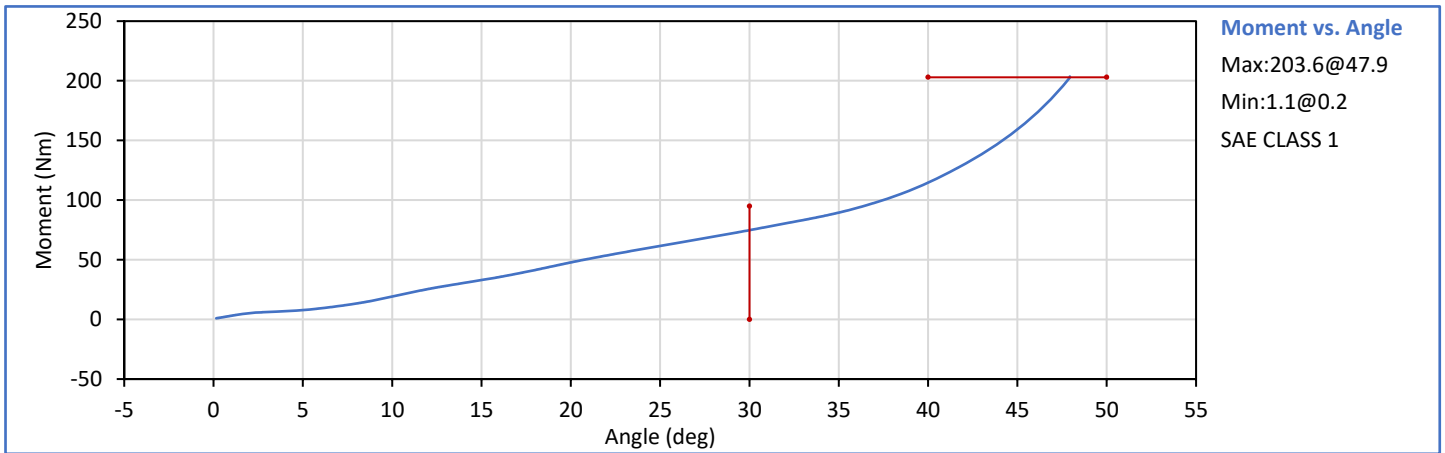
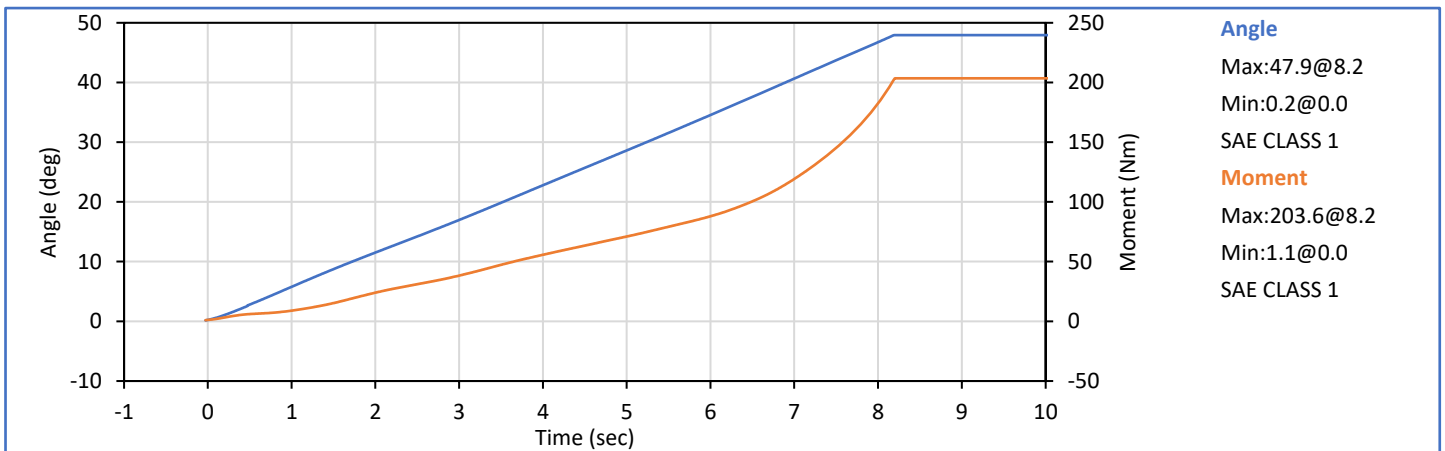
Tested Parameter	Units	Spec. Low	Spec. High	Result	Pass/Fail
Laboratory Temperature	°C	18.9	25.6	21.4	Pass
Laboratory Relative Humidity	%	10	70	36	Pass
Right Hip Rotation Rate	deg/s	5.0	10.0	5.8	Pass
Right Femur Torque at 30°	Nm	0.0	95.0	74.8	Pass
Right Hip Rotation at 203 Nm	deg	40.0	50.0	47.9	Pass
Overall Test Results					Pass

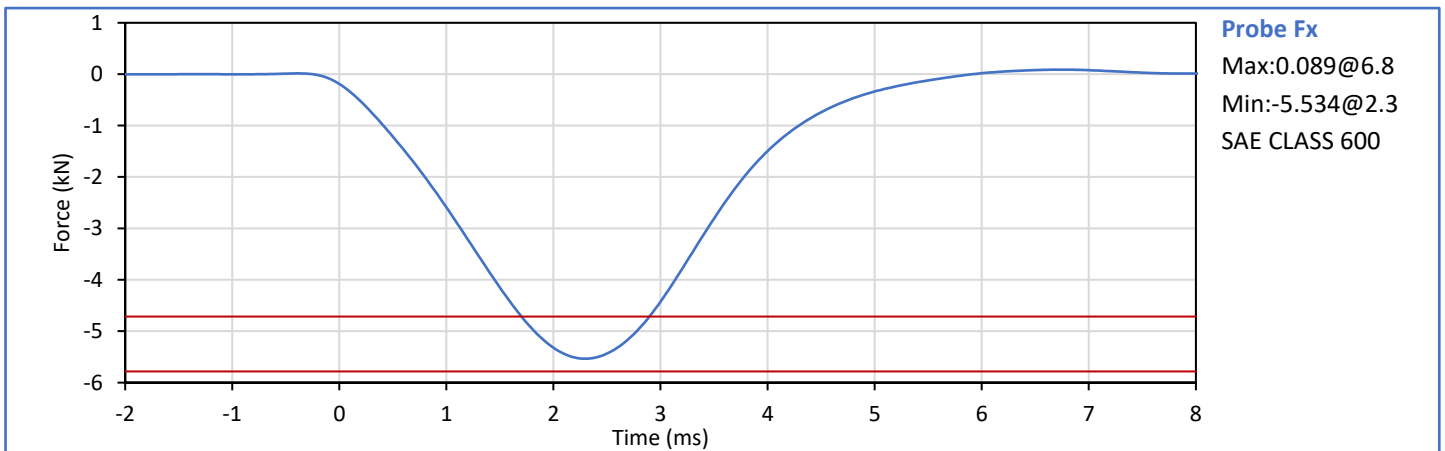
Tested Parameter	Units	Spec. Low	Spec. High	Result	Pass/Fail
Laboratory Temperature	°C	18.9	25.6	21.7	Pass
Laboratory Relative Humidity	%	10	70	35	Pass
Probe Velocity	m/s	2.070	2.130	2.092	Pass
Peak Resistive Force	kN	-5.782	-4.715	-5.534	Pass
Overall Test Results					Pass

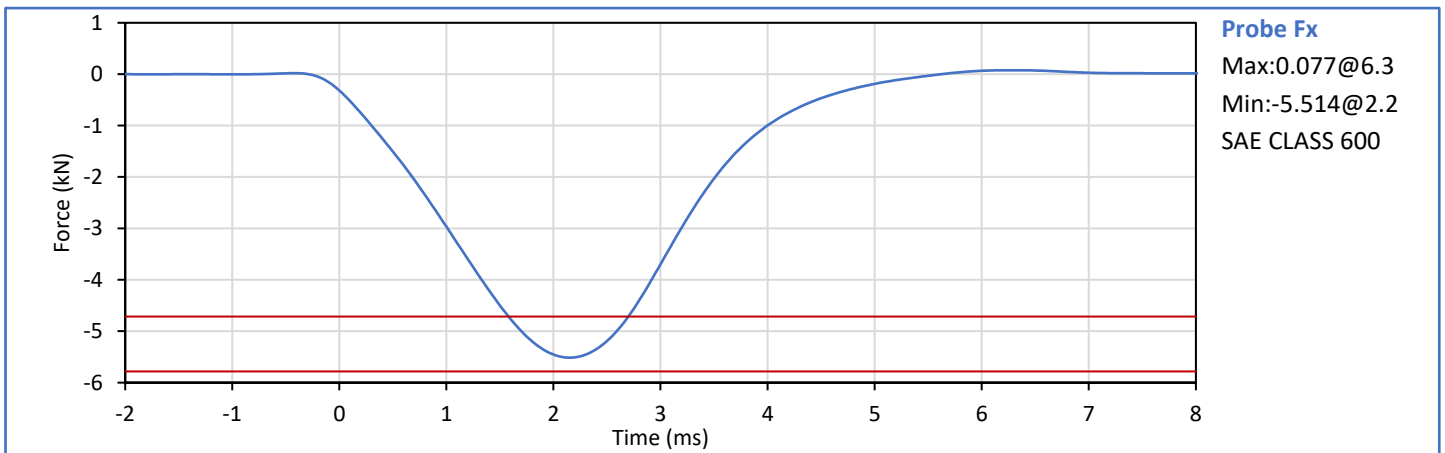
Tested Parameter	Units	Spec. Low	Spec. High	Result	Pass/Fail
Laboratory Temperature	°C	18.9	25.6	21.7	Pass
Laboratory Relative Humidity	%	10	70	35	Pass
Probe Velocity	m/s	2.070	2.130	2.084	Pass
Peak Resistive Force	kN	-5.782	-4.715	-5.514	Pass
Overall Test Results					Pass

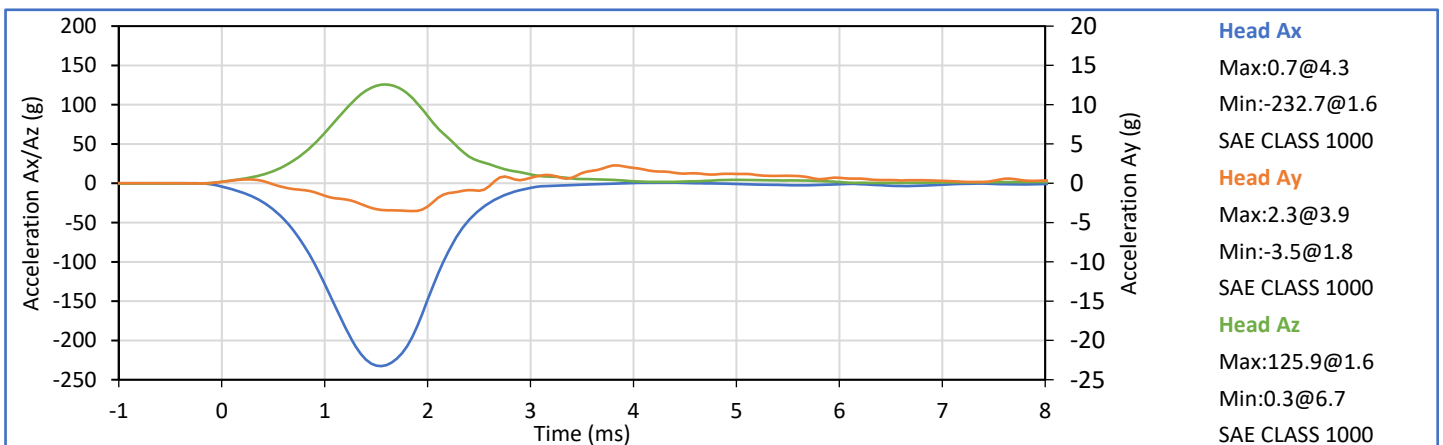
Tested Parameter	Units	Spec. Low	Spec. High	Result	Pass/Fail
Laboratory Temperature	°C	18.9	25.6	21.1	Pass
Laboratory Humidity	%	10	70	37	Pass
Peak Resultant Acceleration	g	250.0	300.0	264.5	Pass
Peak Lateral Acceleration	g	-15.0	15.0	-3.5	Pass
Oscillations After Main Pulse	%	0.0	10.0	1.7	Pass
Is Acceleration Unimodal?	Yes/No	Yes		Yes	Pass
Overall Test Results					Pass

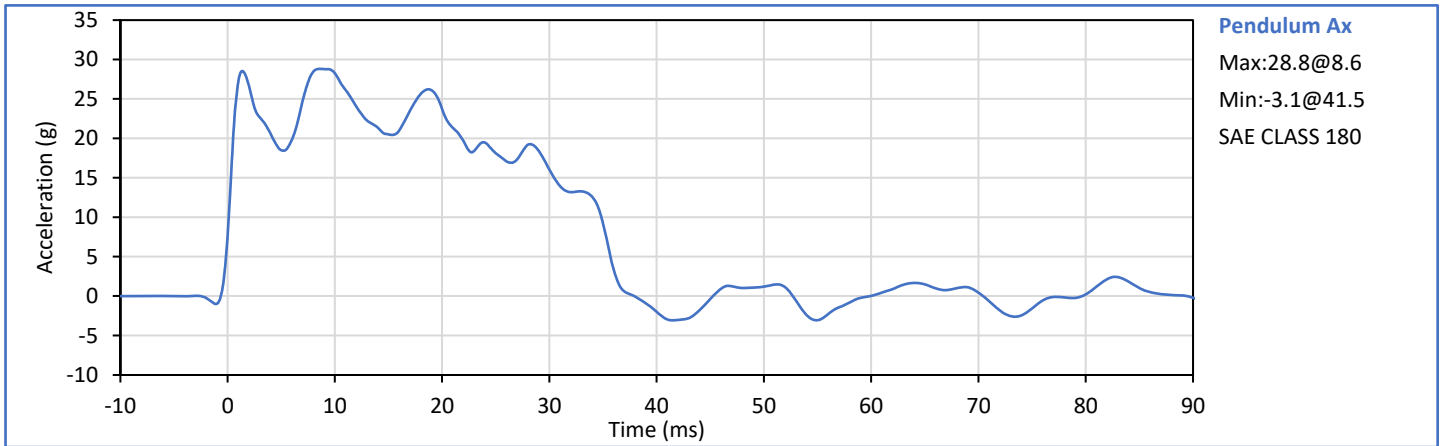
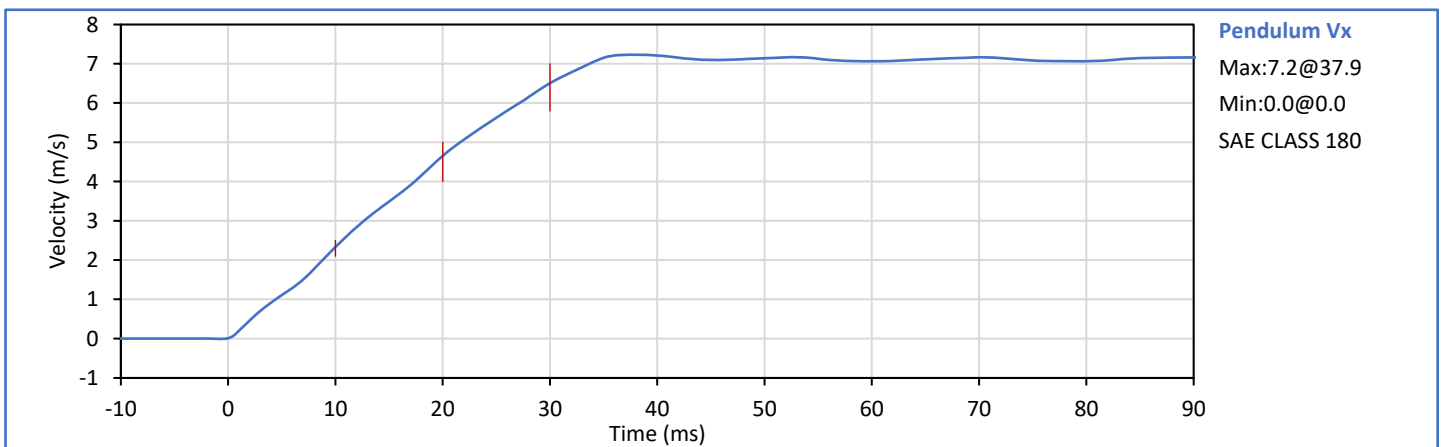
Tested Parameter	Units	Spec. Low	Spec. High	Result	Pass/Fail
Laboratory Temperature	°C	20.6	22.2	21.1	Pass
Laboratory Humidity	%	10	70	36	Pass
Pendulum Velocity	m/s	6.89	7.13	7.00	Pass
Pendulum Velocity at 10 ms	m/s	2.10	2.50	2.33	Pass
Pendulum Velocity at 20 ms	m/s	4.00	5.00	4.65	Pass
Pendulum Velocity at 30 ms	m/s	5.80	7.00	6.50	Pass
Peak "D" Plane Rotation	deg	77.0	91.0	82.0	Pass
Peak Moment in Rotation	Nm	69.0	83.0	79.8	Pass
Positive Moment Decay to 10 Nm	ms	80.0	100.0	83.0	Pass
Overall Test Results					Pass

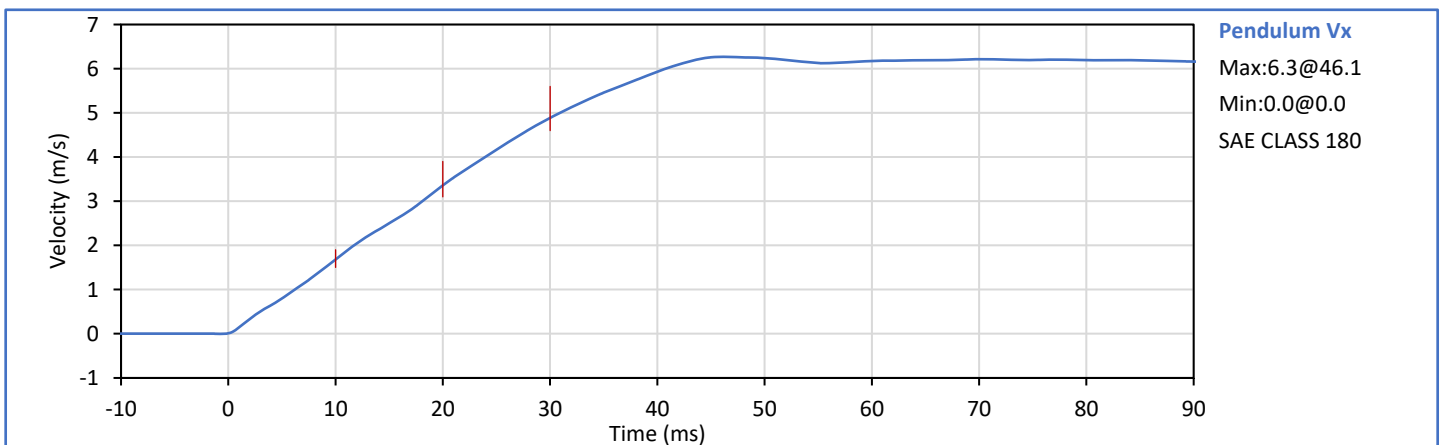
Tested Parameter	Units	Spec. Low	Spec. High	Result	Pass/Fail
Laboratory Temperature	°C	20.6	22.2	21.1	Pass
Laboratory Relative Humidity	%	10	70	36	Pass
Pendulum Velocity	m/s	5.95	6.19	6.14	Pass
Pendulum Velocity at 10 ms	m/s	1.50	1.90	1.68	Pass
Pendulum Velocity at 20 ms	m/s	3.10	3.90	3.36	Pass
Pendulum Velocity at 30 ms	m/s	4.60	5.60	4.88	Pass
Peak "D" Plane Rotation	deg	99.0	114.0	106.4	Pass
Peak Moment in Rotation	Nm	-65.0	-53.0	-56.7	Pass
Negative Moment Decay to -10 Nm	ms	94.0	114.0	103.8	Pass
Overall Test Results					Pass

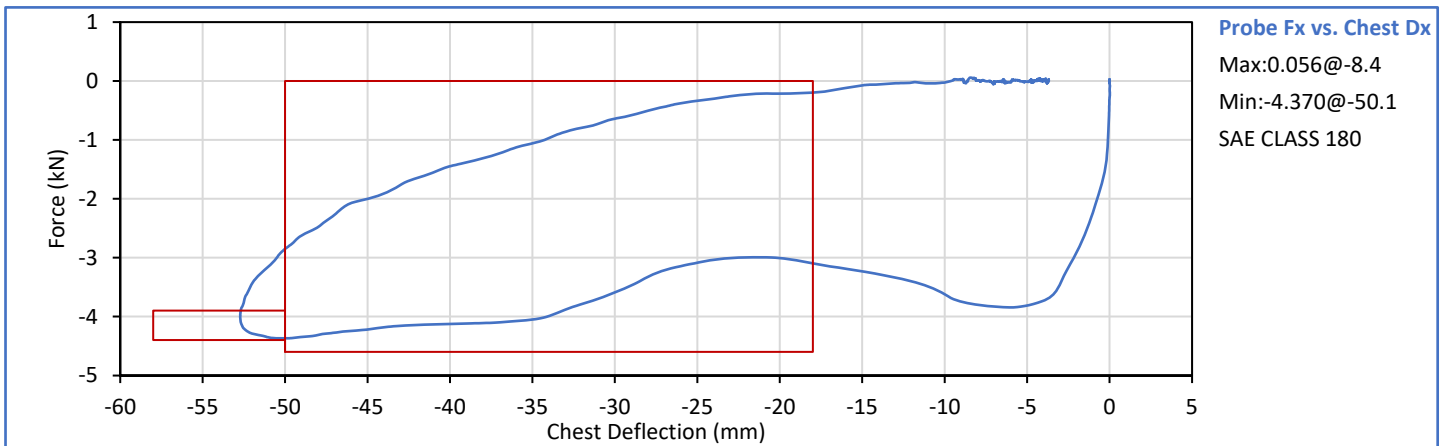
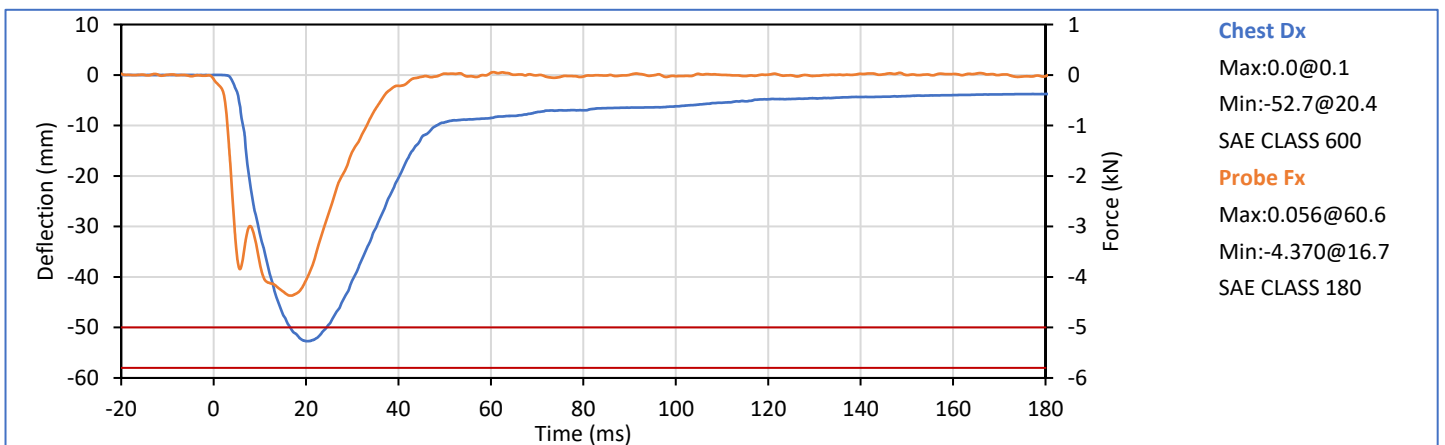
Tested Parameter	Units	Spec. Low	Spec. High	Result	Pass/Fail
Laboratory Temperature	°C	20.6	22.2	21.4	Pass
Laboratory RelativeHumidity	%	10	70	39	Pass
Probe Velocity	m/s	6.59	6.83	6.76	Pass
Peak Chest Deflection	mm	-58.0	-50.0	-52.7	Pass
Peak Probe Force, 50 and 58 mm	kN	-4.400	-3.900	-4.370	Pass
Peak Probe Force, 18 and 50 mm	kN	-4.600	0.000	-4.370	Pass
Internal Hysteresis	%	69.0	85.0	76.7	Pass
Overall Test Results					Pass

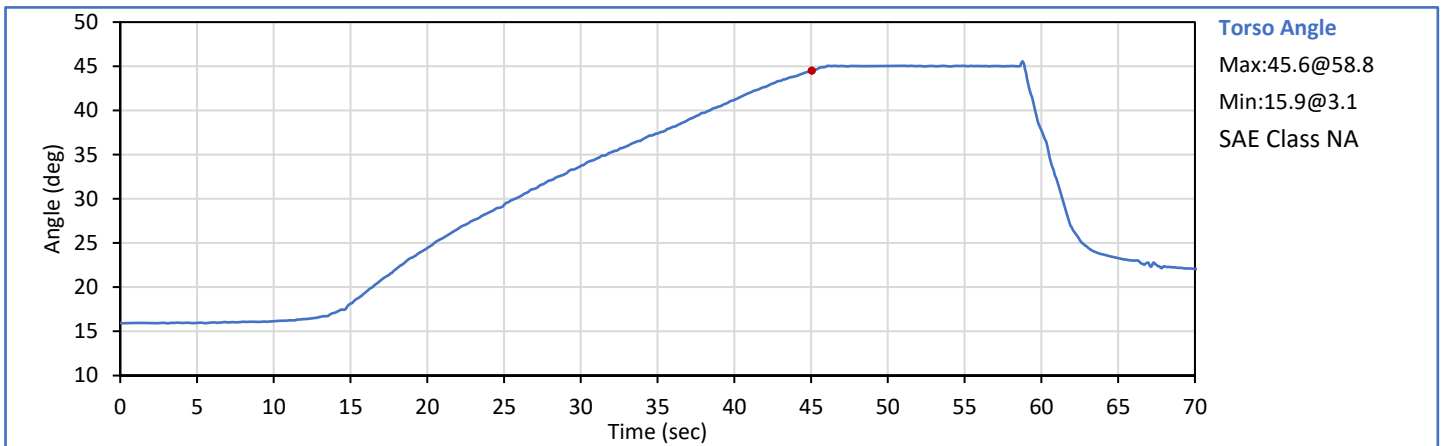
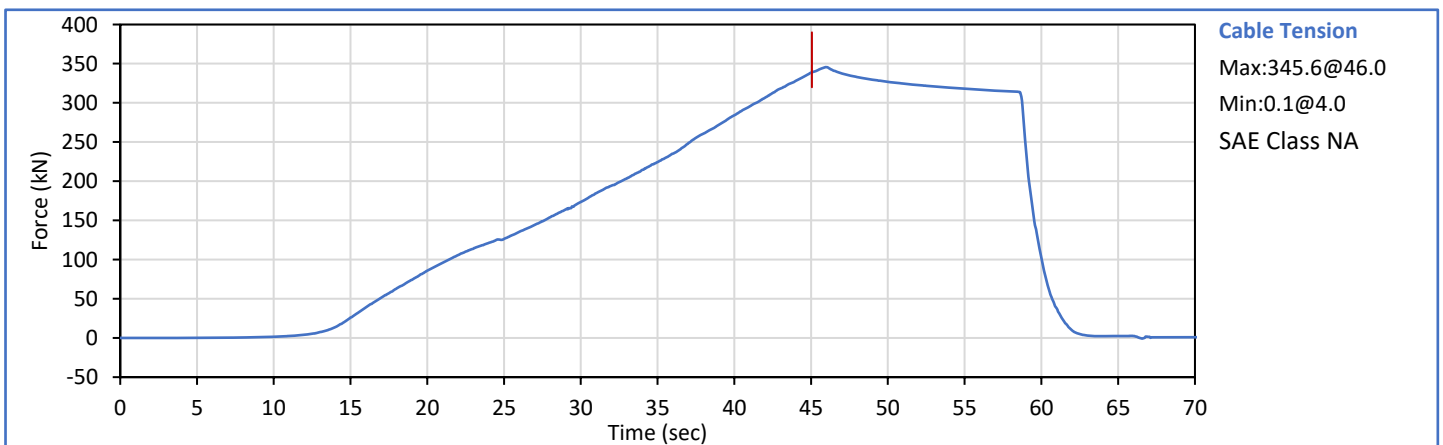
Tested Parameter	Units	Spec. Low	Spec. High	Result	Pass/Fail
Laboratory Temperature	°C	18.9	25.6	21.4	Pass
Laboratory Humidity	%	10	70	39	Pass
Orientation Angle	deg	0.0	20.0	15.1	Pass
Test Initial Angle	deg	11.0	19.0	15.9	Pass
Peak Force at 45° (+/-0.5°)	N	320.0	390.0	338.8	Pass
Torso Flexion Rate	deg/s	0.50	1.50	0.90	Pass
Final Reference Plane Angle	deg	-8.0	8.0	4.4	Pass
Overall Test Results					Pass
