**FINAL REPORT NUMBER: SPNCAP-TRC-24-002**

**NEW CAR ASSESSMENT PROGRAM (NCAP)  
SIDE IMPACT POLE TEST**

**KIA CORPORATION  
2024 Kia Seltos SUV  
NHTSA NUMBER: M20244211**

**PREPARED BY:  
Transportation Research Center Inc.  
10820 State Route 347  
P. O. Box B-67  
East Liberty, OH 43319**

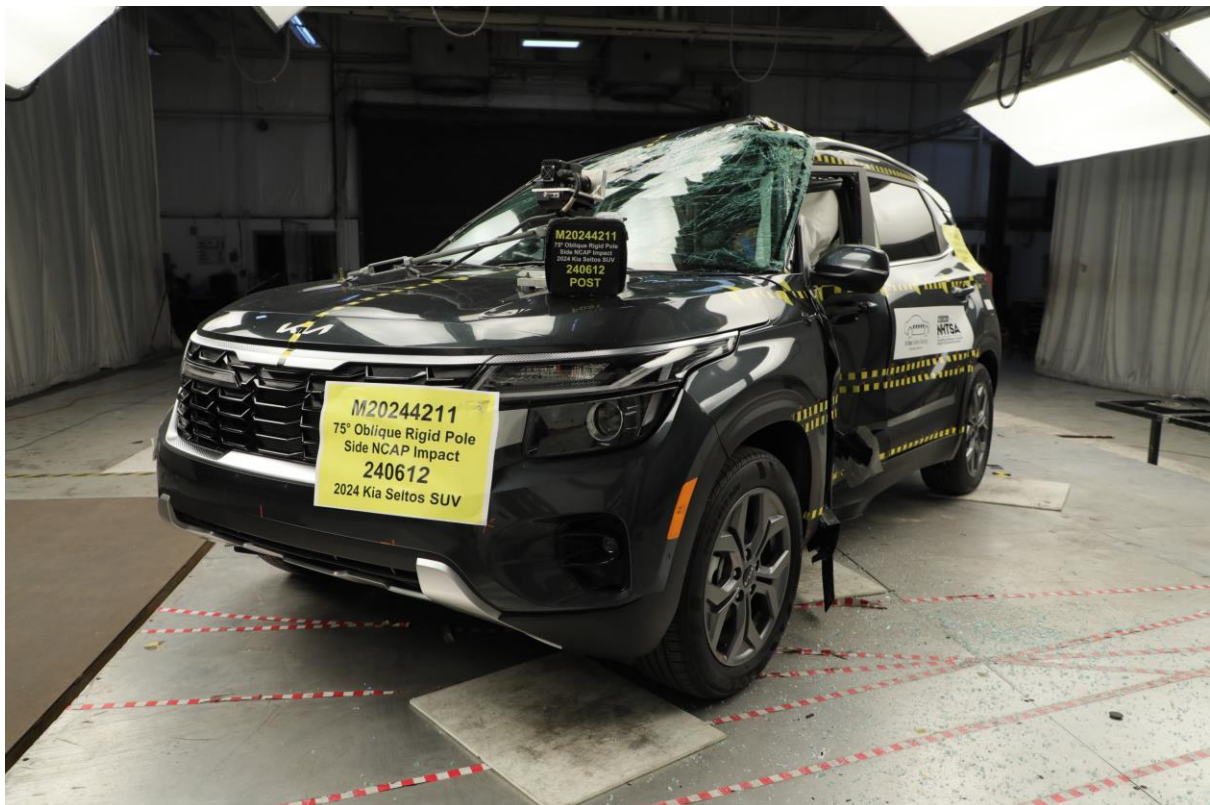
**No. 006 Post-Test Left Front  $\frac{3}{4}$  View of Test Vehicle**

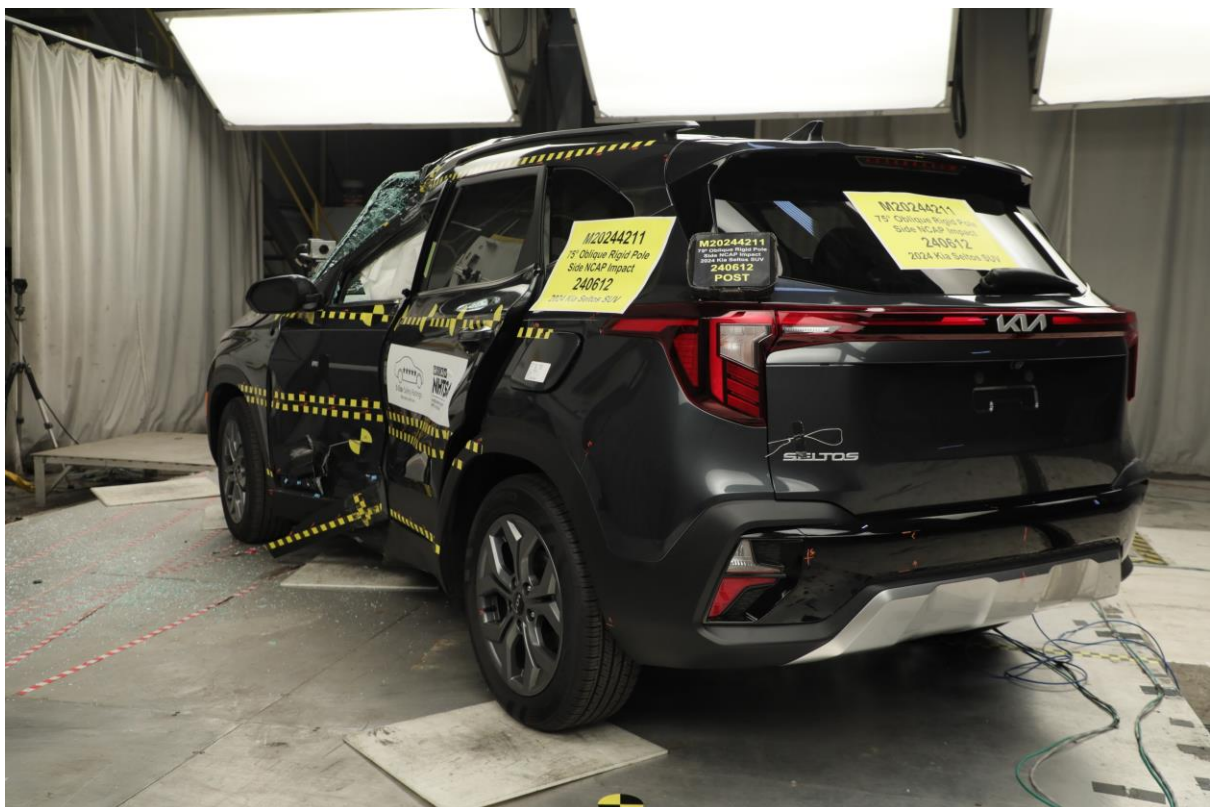
**No. 010 Post-Test Left Rear  $\frac{3}{4}$  View of Test Vehicle**

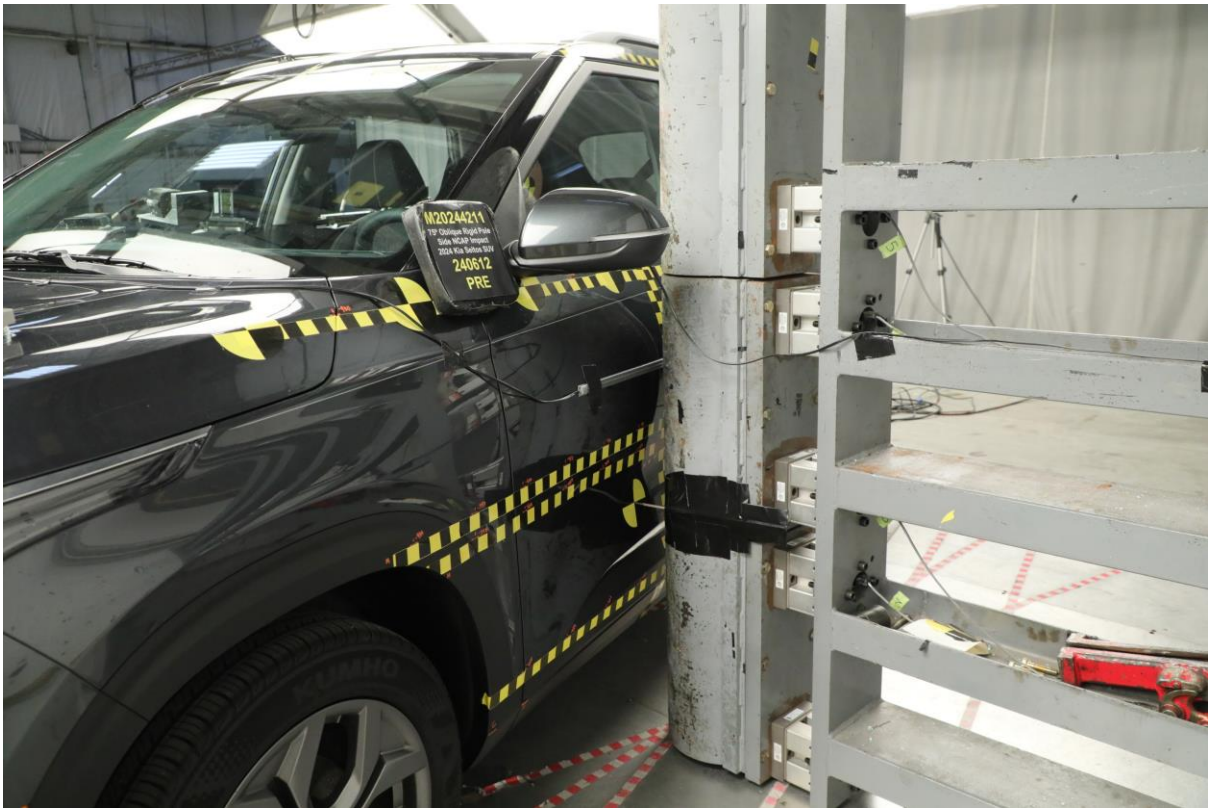
**No. 017 Pre-Test Left Side View of Pole Positioned Against Side of Vehicle**

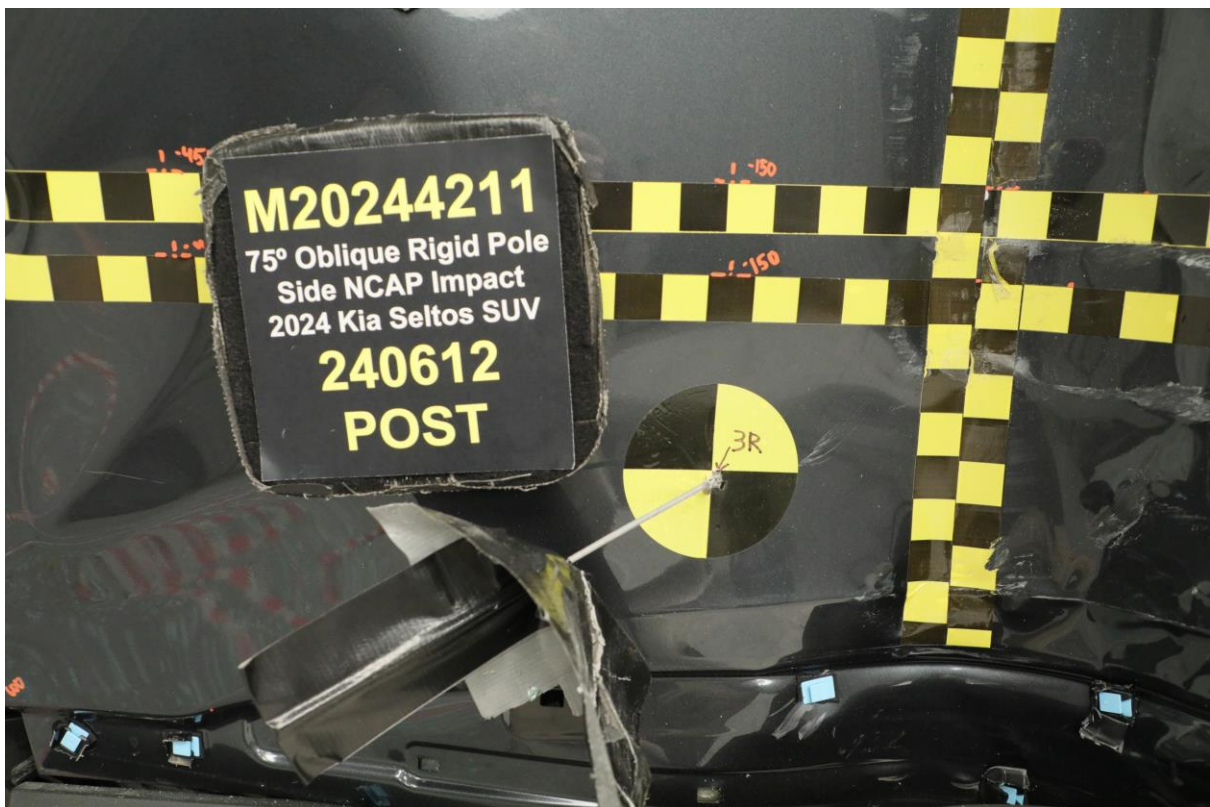
No. 020 Post-Test Close-Up View of Impact Point Target Showing Impact Location

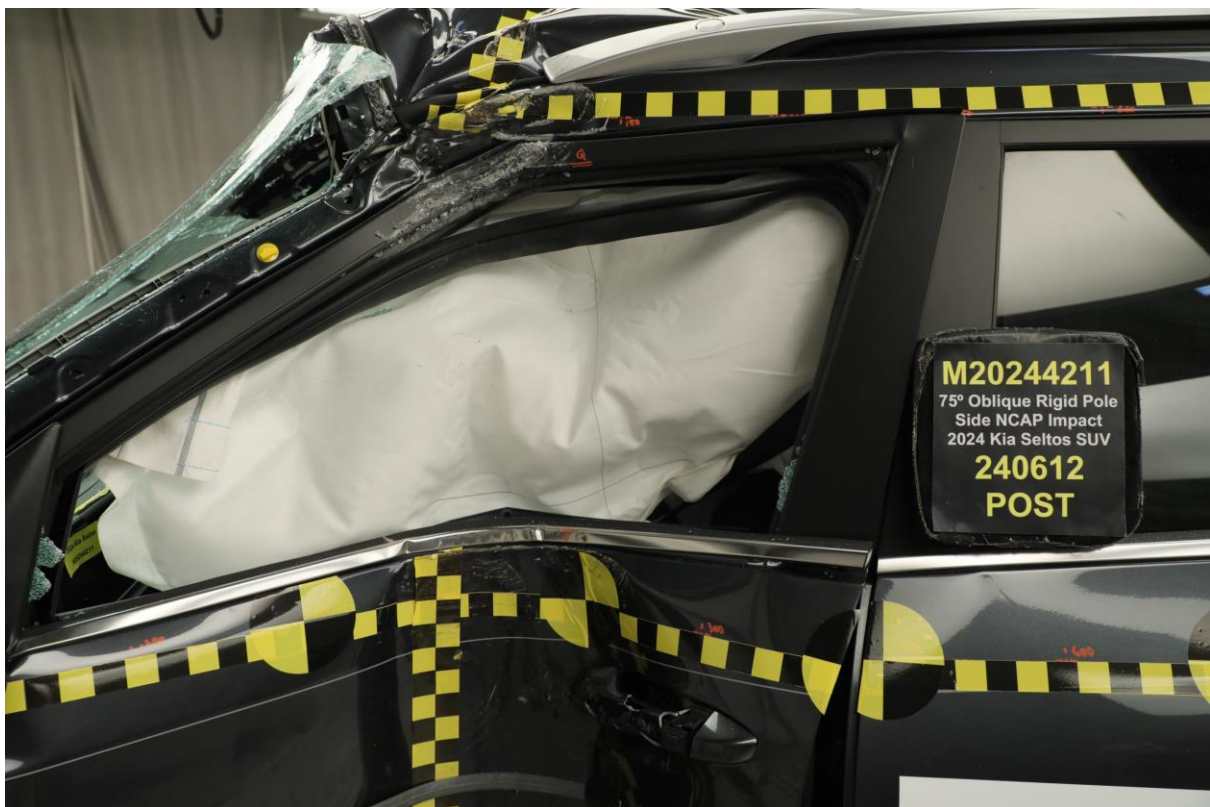
No. 025 Post-Test Left Side View of Dummy Shoulder and Door Top View

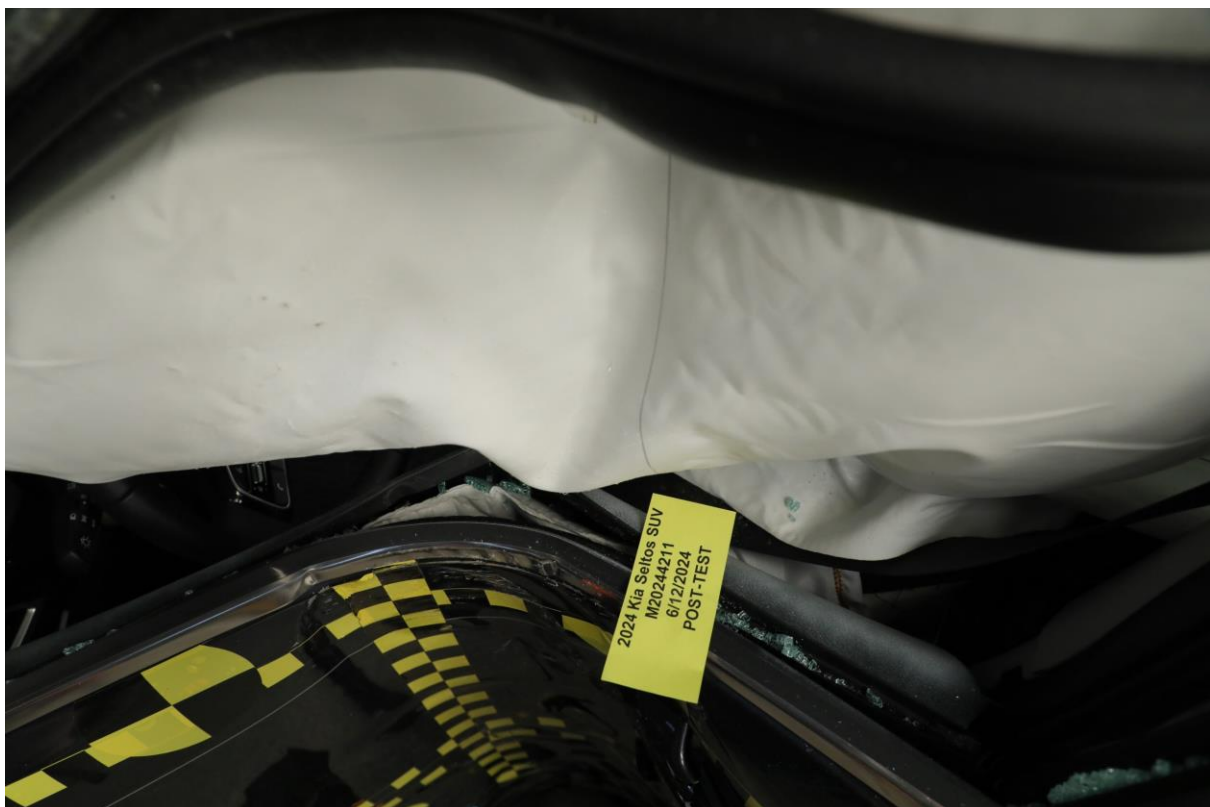
**No. 041 Post-Test Dummy and Door Clearance View**

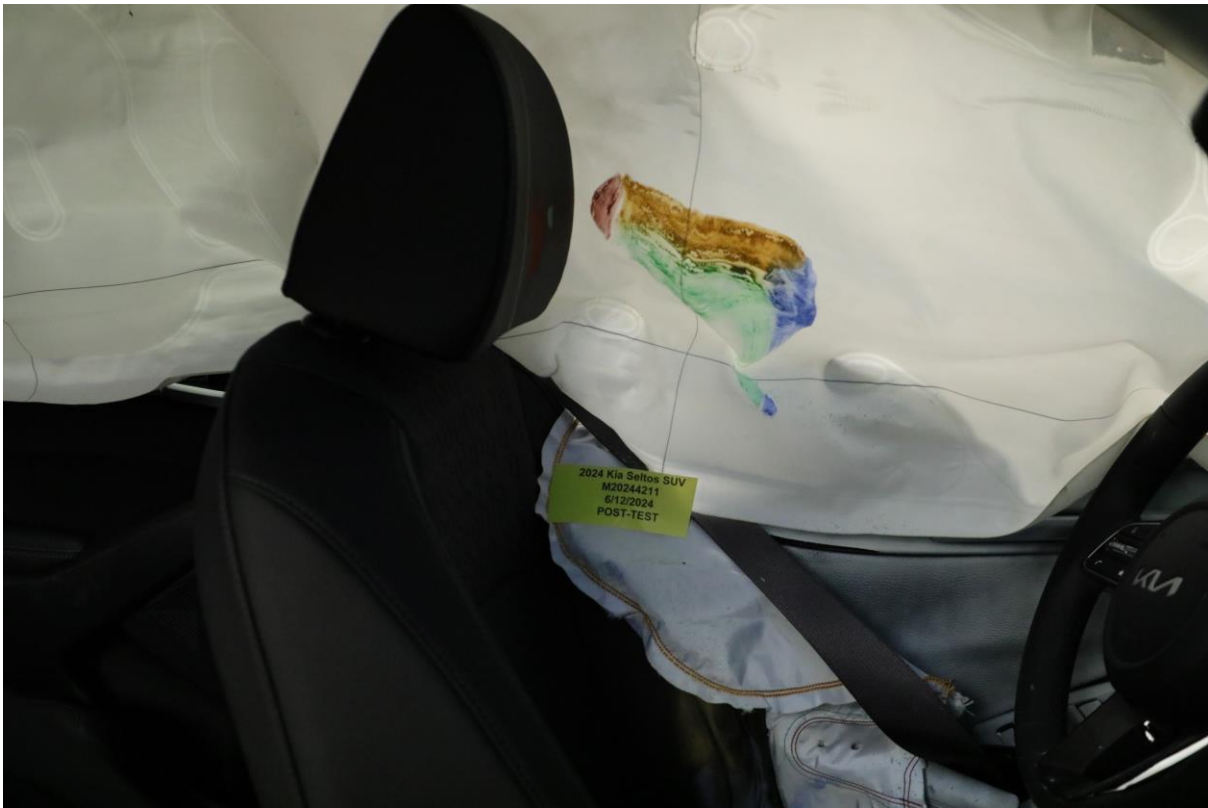
**No. 047 Post-Test Dummy Close-Up Head Contact with Side Airbag View**

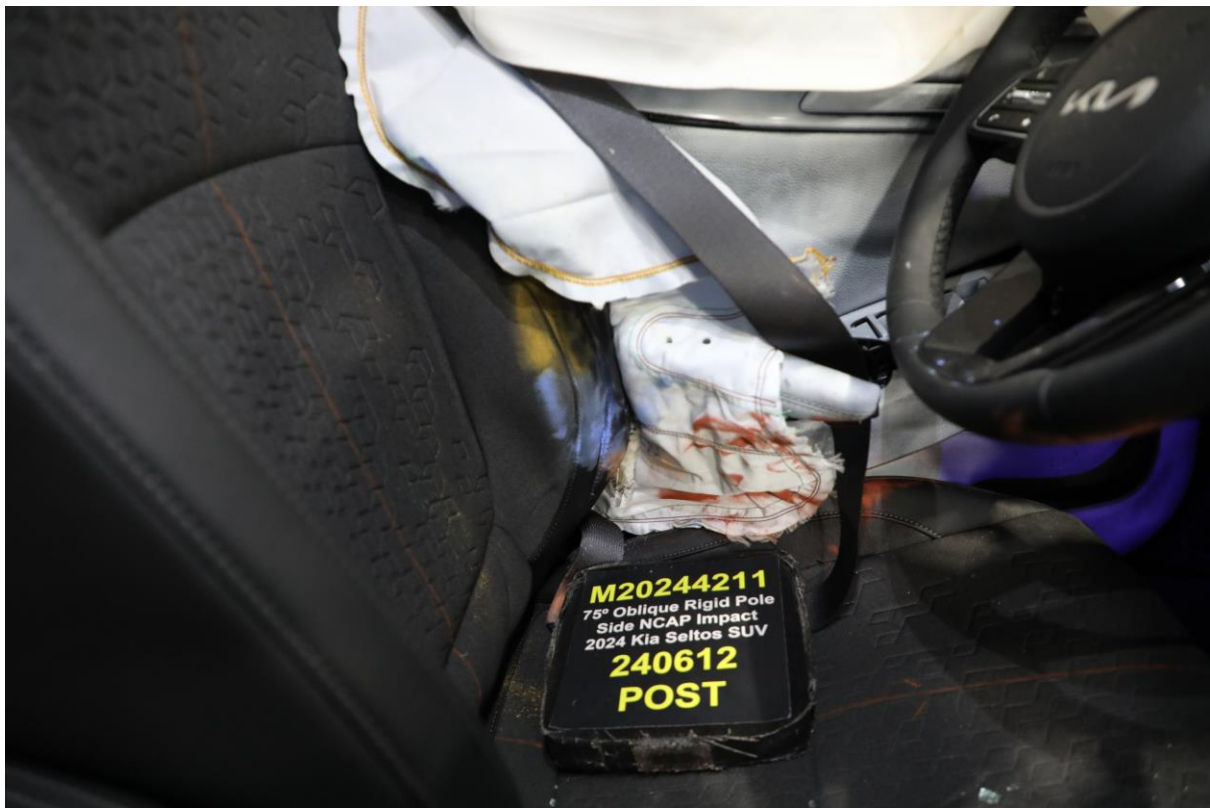
No. 049 Post-Test Dummy Close-Up Torso Contact with Side Airbag View

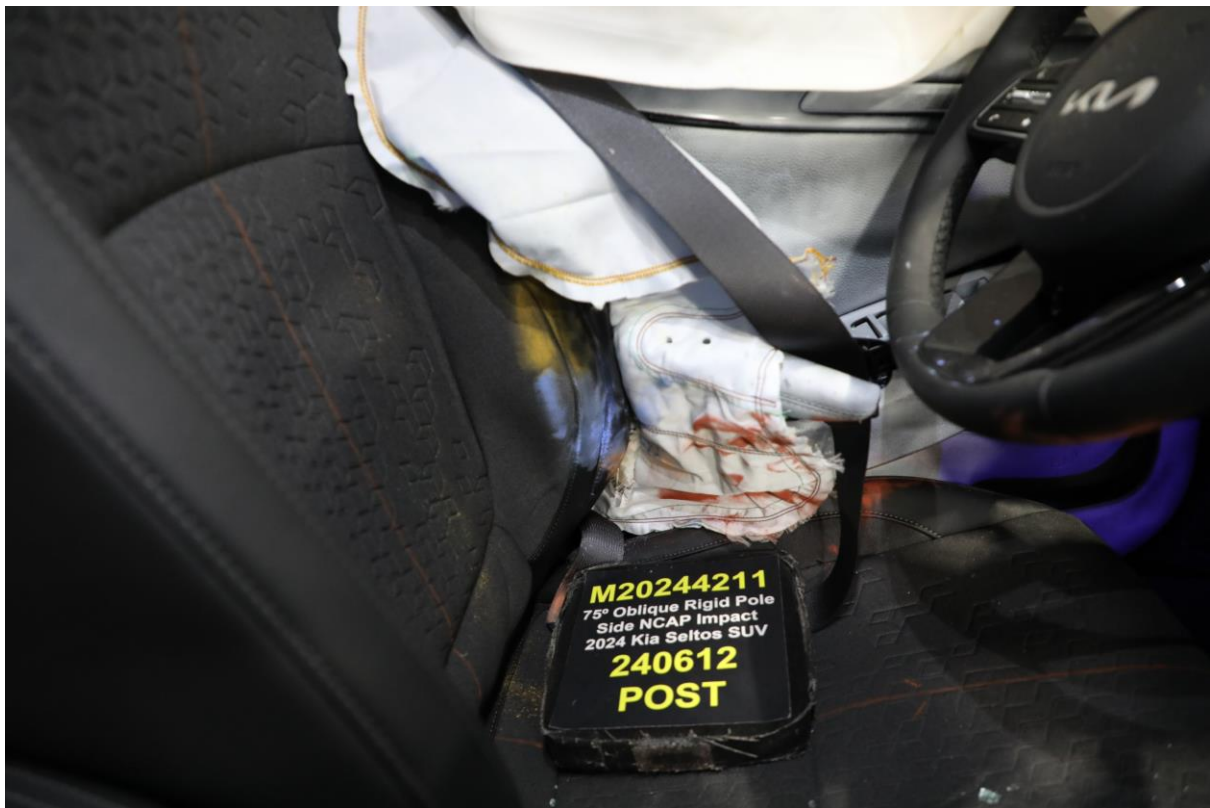
**No. 051 Post-Test Dummy Close-Up Pelvis Contact with Side Airbag View**

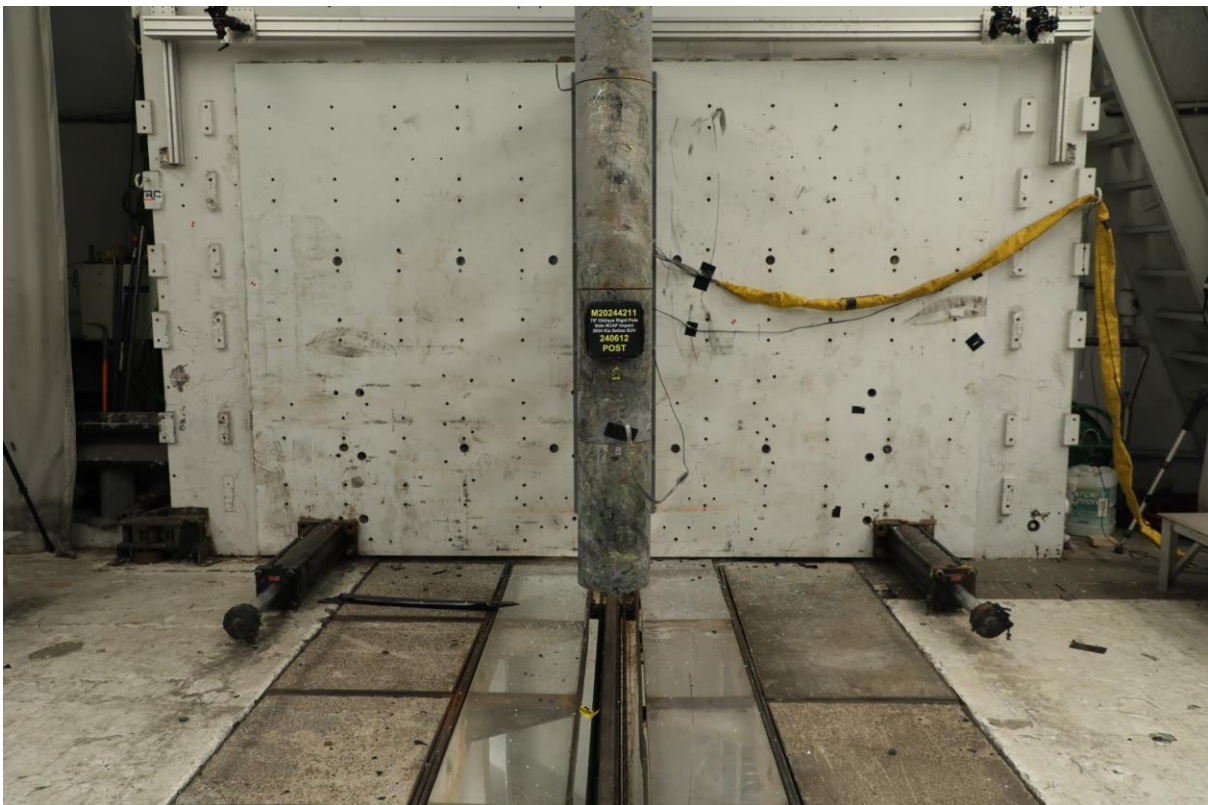
**No. 060 Post-Test Pole Barrier Front View**

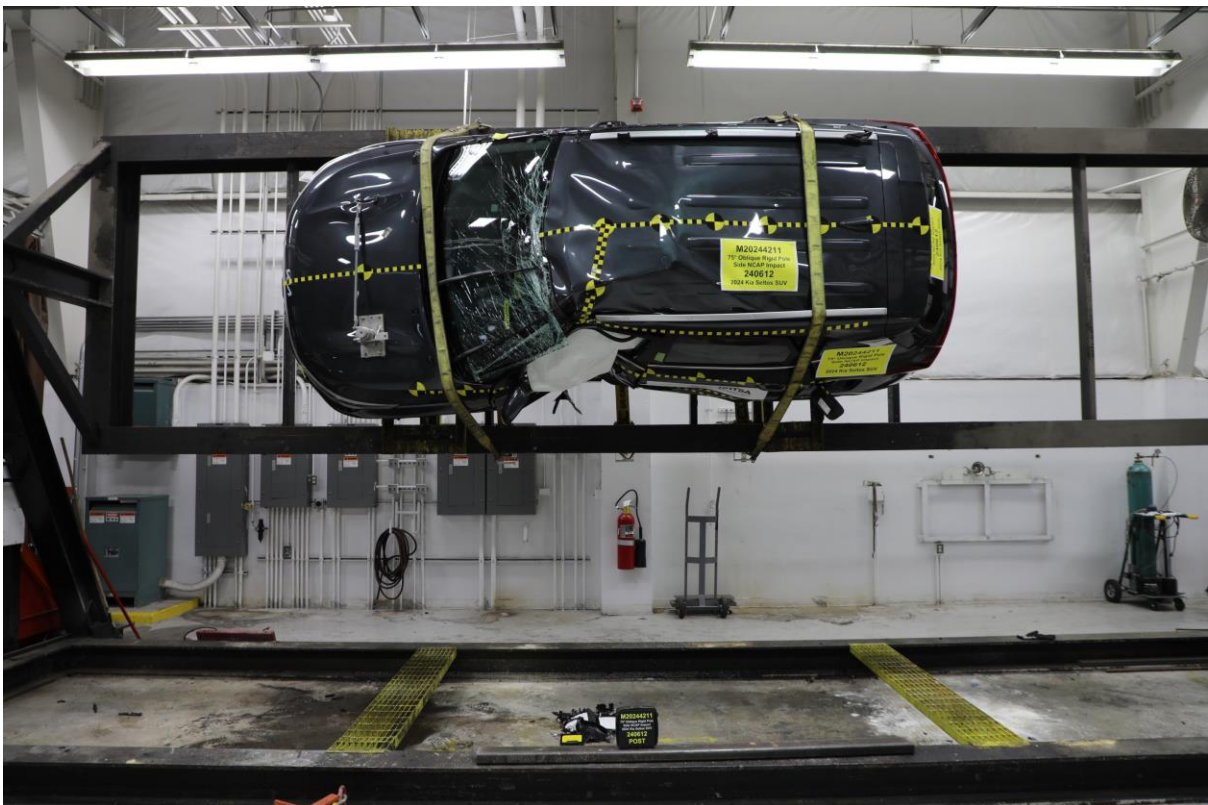
**No. 066 FMVSS No. 301 Static Rollover 90 Degrees**

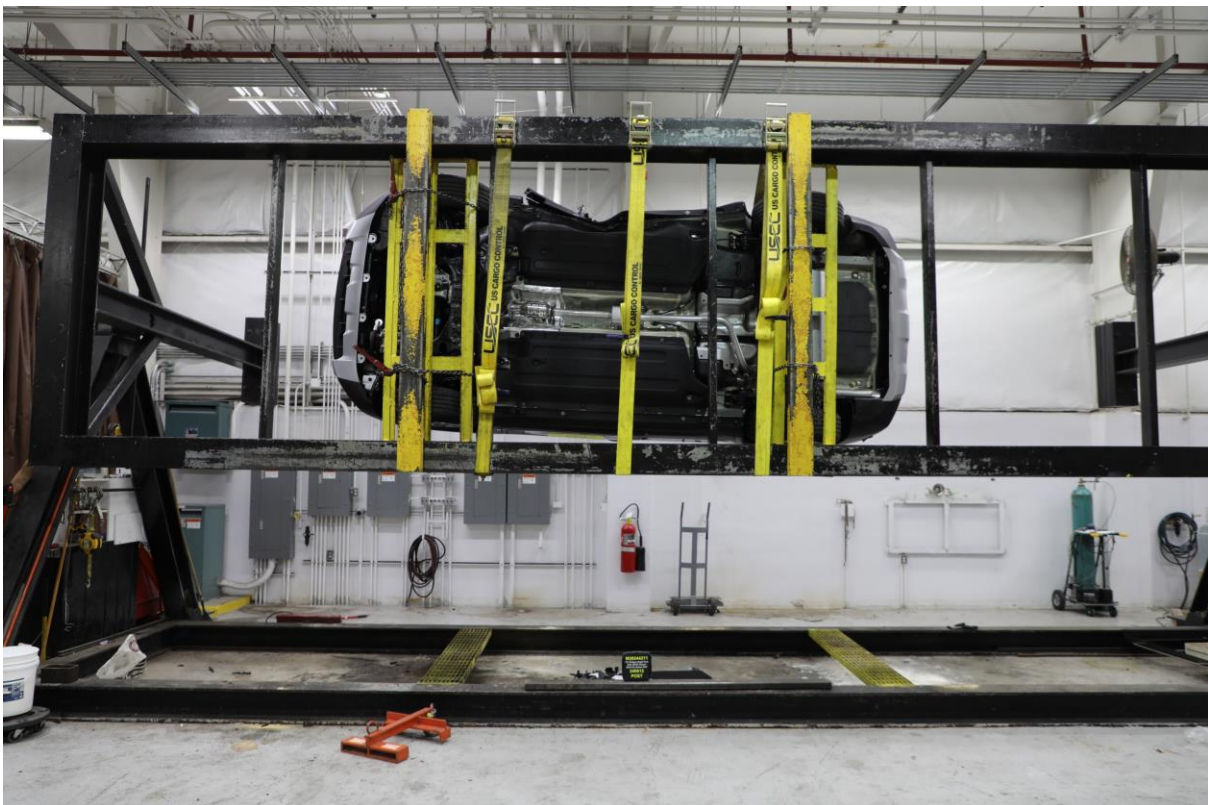
**No. 068 FMVSS No. 301 Static Rollover 270 Degrees**

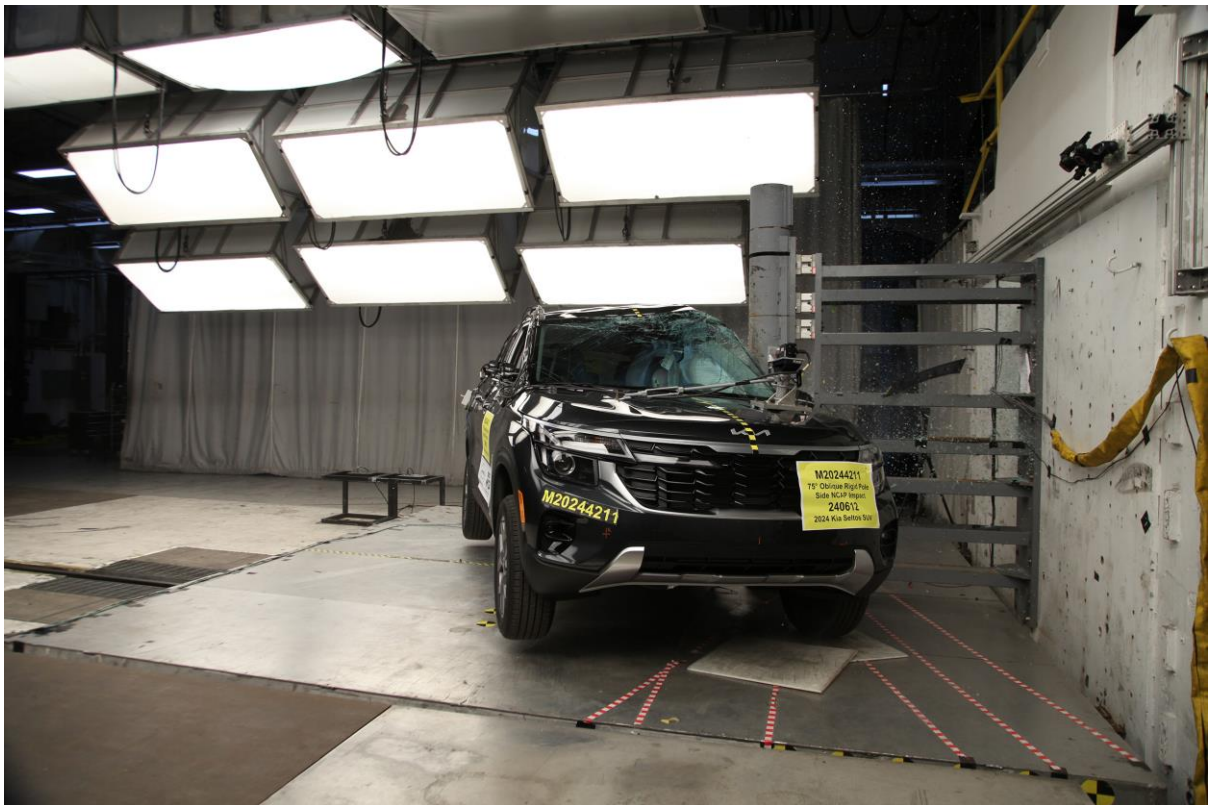
**No. 070 Impact Event**
