**REPORT NUMBER: NCAP-MGA-24-015**

**NEW CAR ASSESSMENT PROGRAM (NCAP)  
Frontal Barrier Impact Test**

**VOLVO CAR CORPORATION  
2024 Volvo XC60 Recharge AWD Ultimate 5-Door SUV  
NHTSA No.: O20245900**

**MGA RESEARCH CORPORATION  
5000 Warren Road  
Burlington, WI 53105**

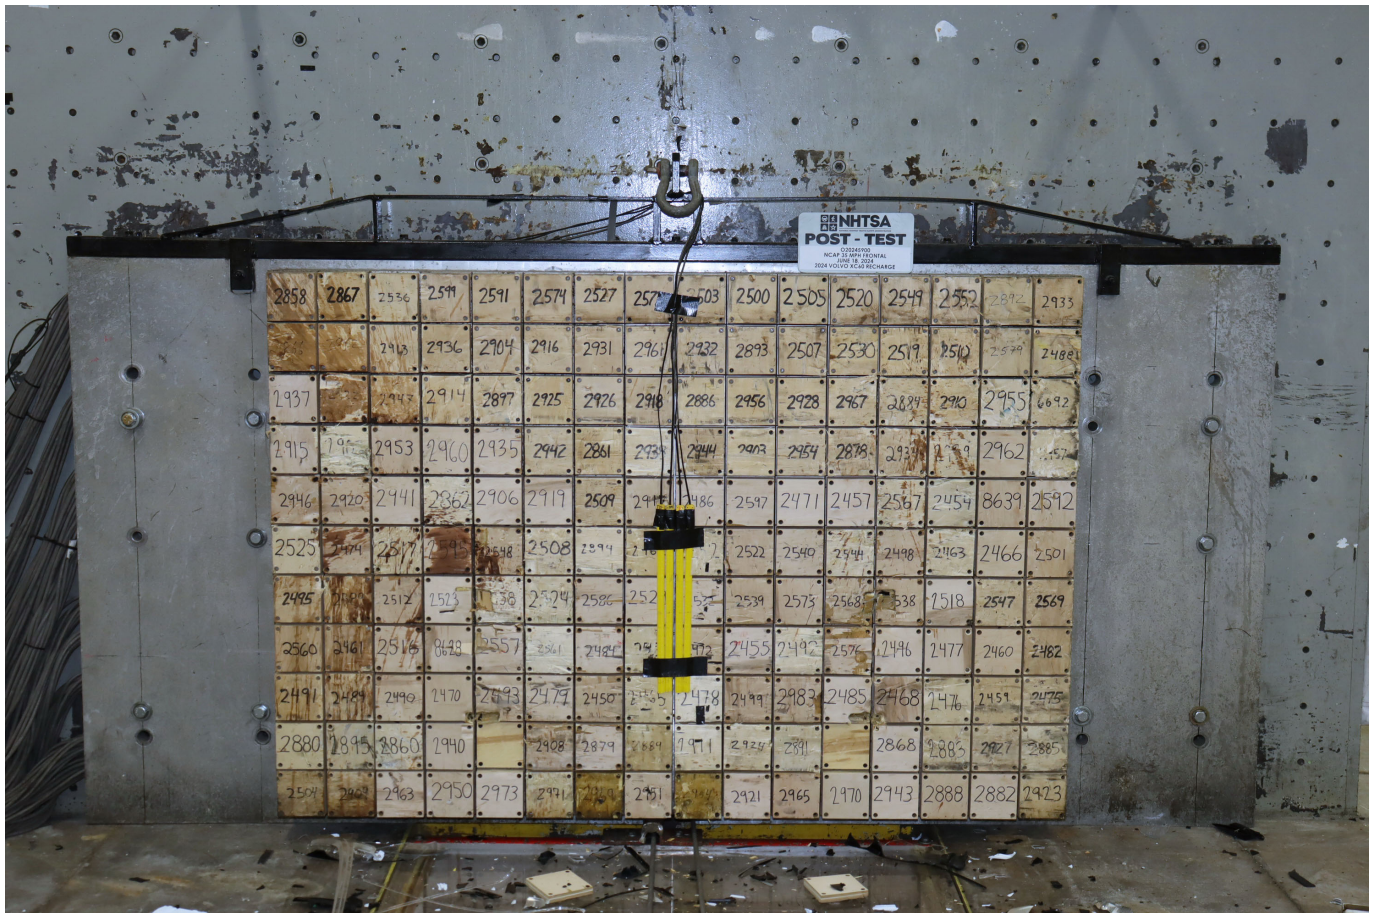
Photo No. 003 - Post-Test Load Cell Wall

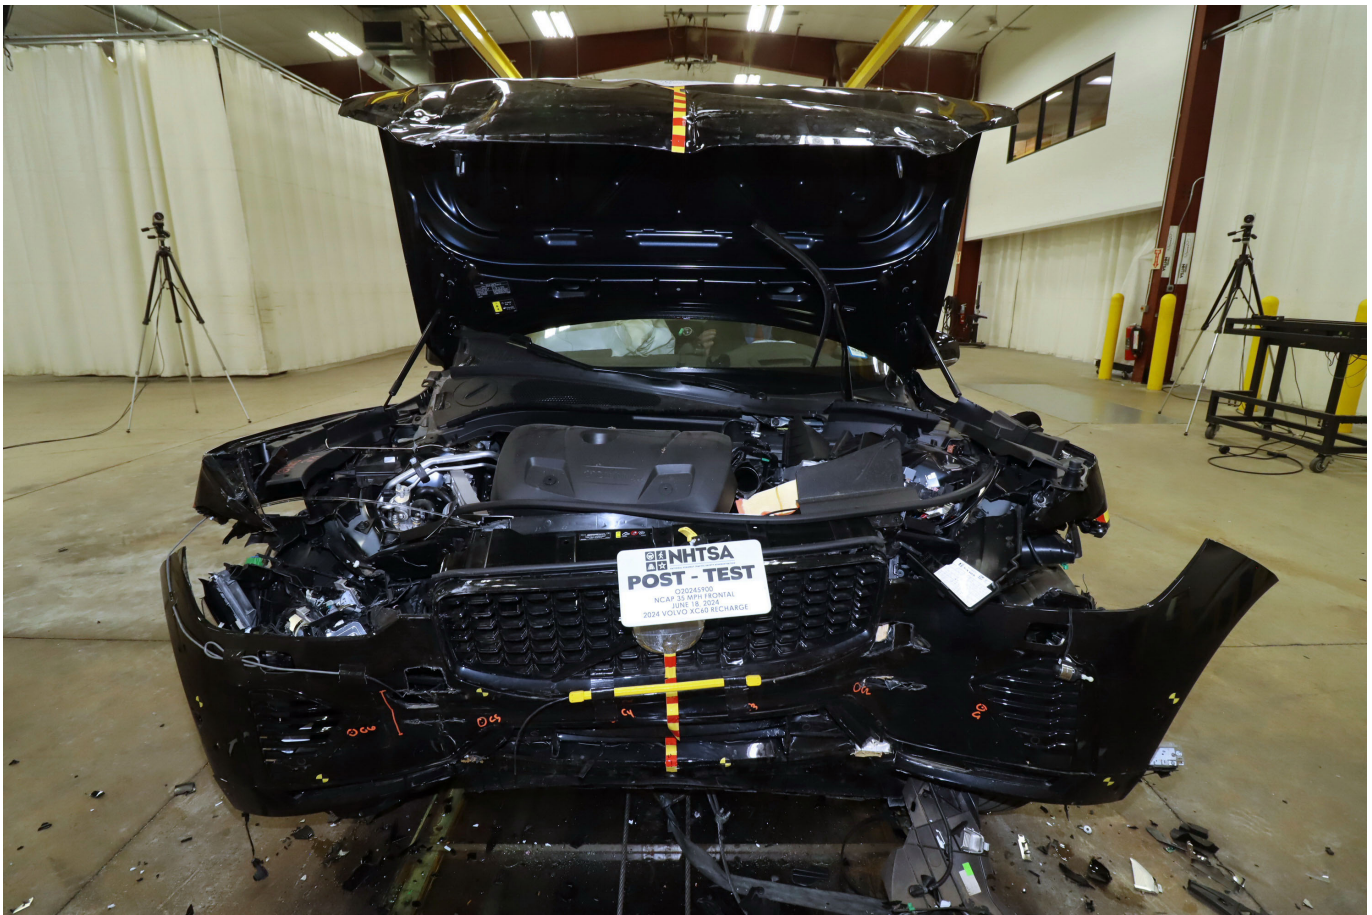
Photo No. 009 - Post-Test Front View of Test Vehicle

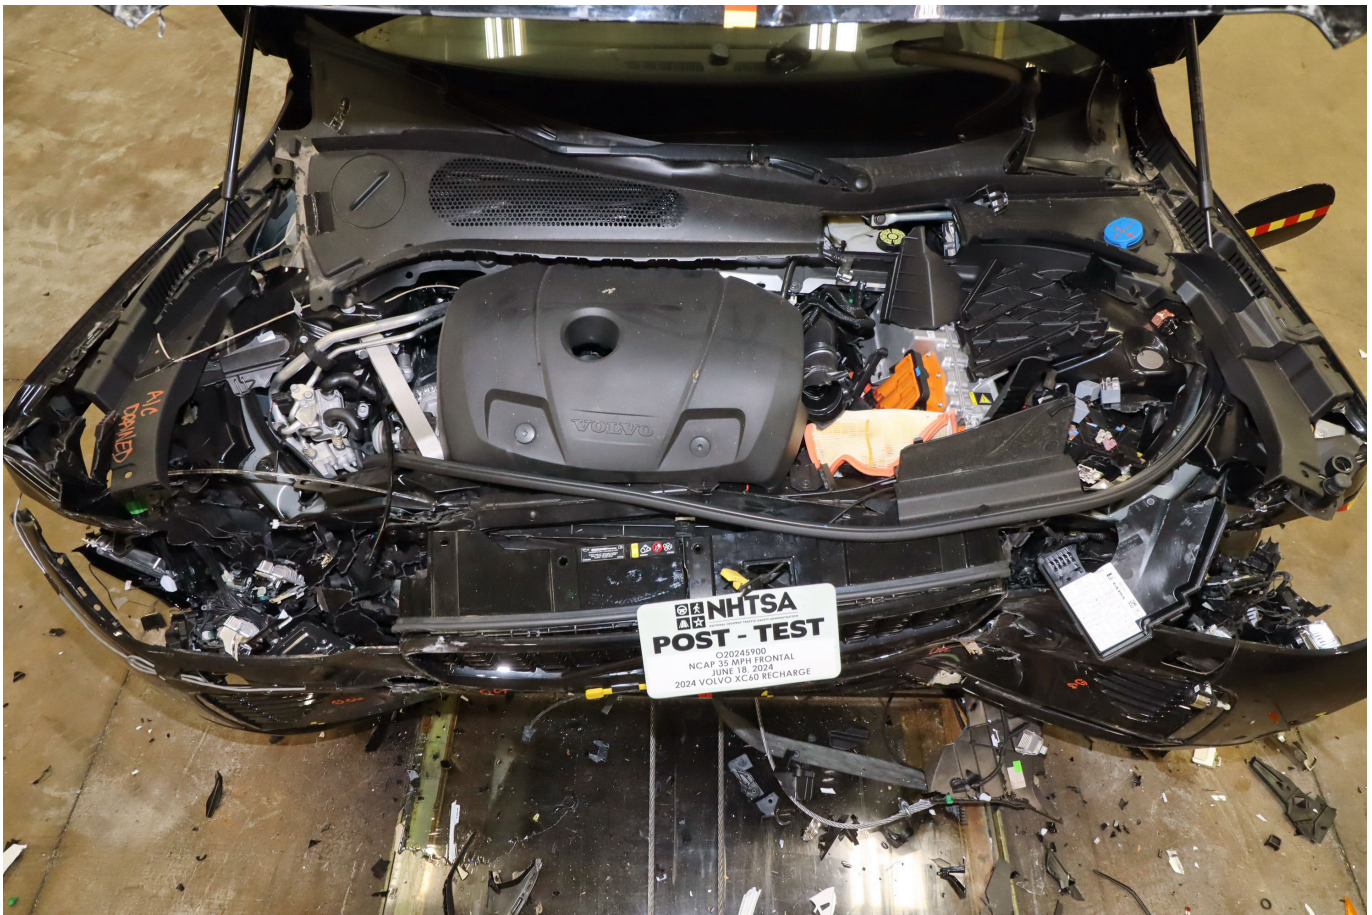
Photo No. 021 - Post-Test Engine Compartment View

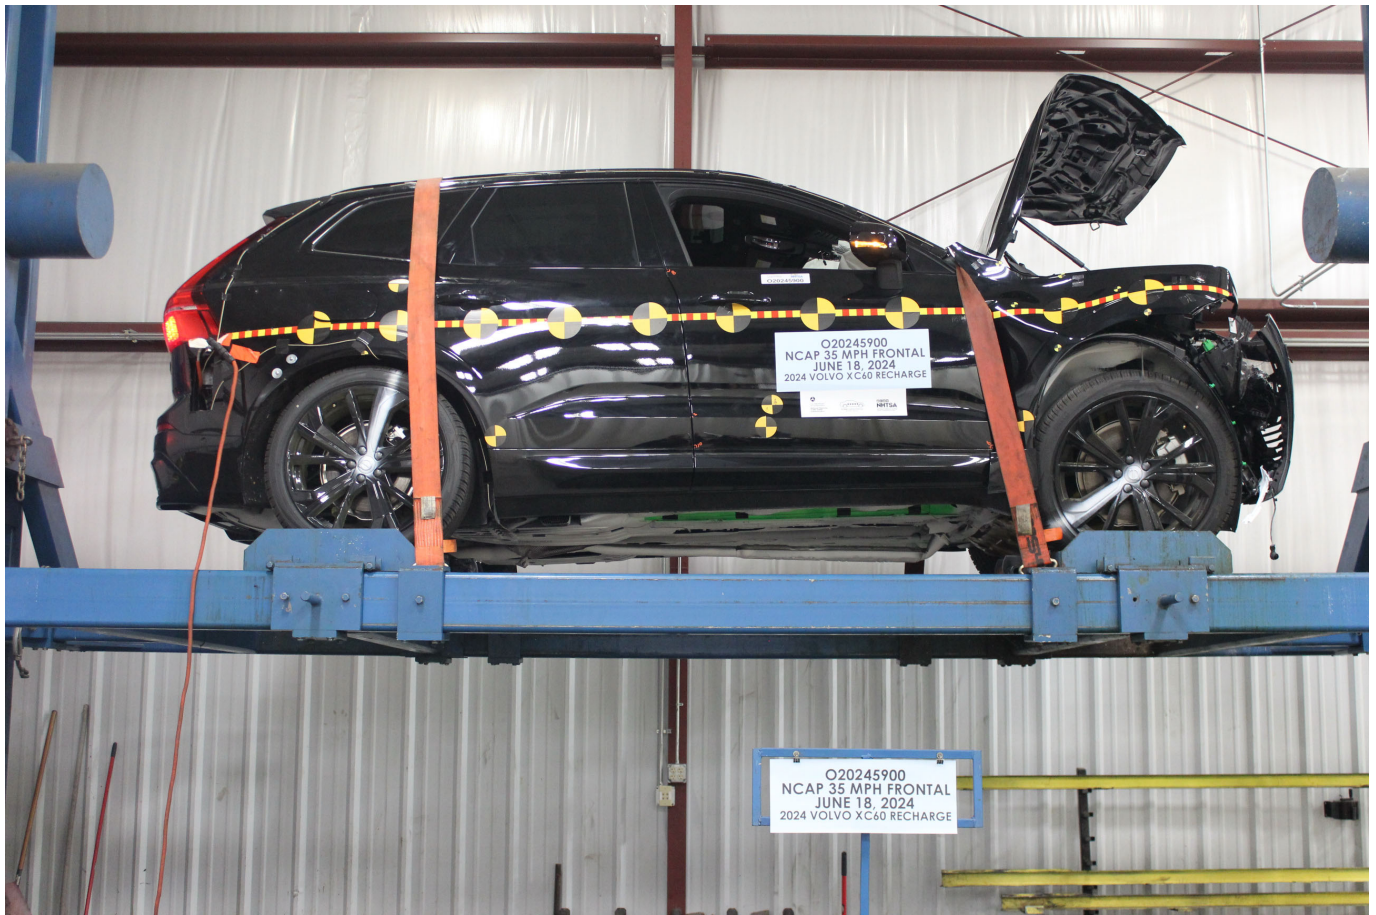
Photo No. 077 - Vehicle at 0 Degrees on Static Rollover Device
