REPORT NUMBER: SideNCAPMDB-KAR-24-004

**NEW CAR ASSESSMENT PROGRAM (NCAP)
MOVING DEFORMABLE BARRIER SIDE IMPACT TEST**

**MAZDA MOTOR CORPORATION
2024 MAZDA CX-50 5-DOOR SUV**

NHTSA No: M20245401

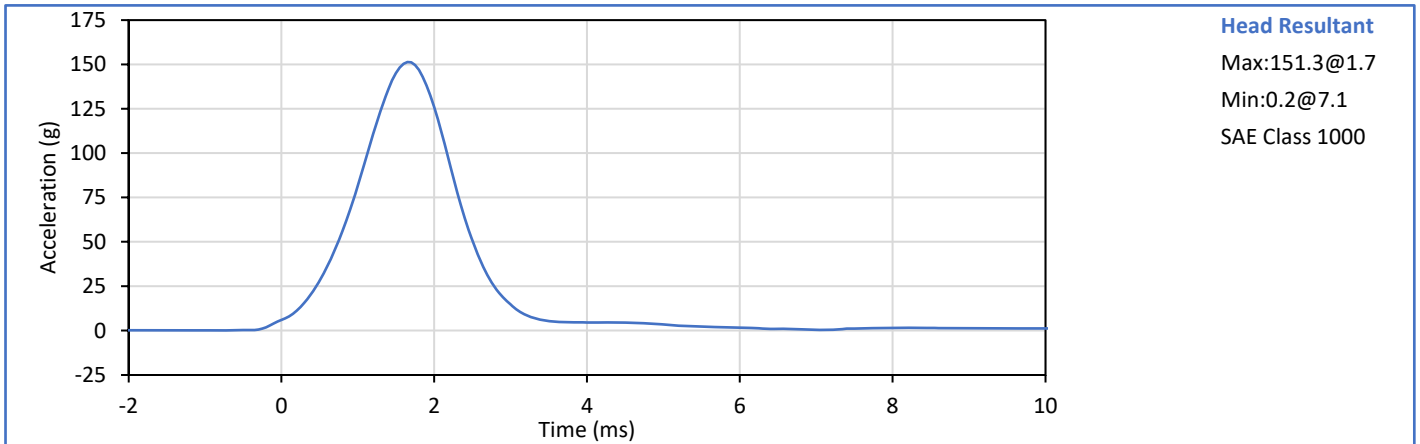
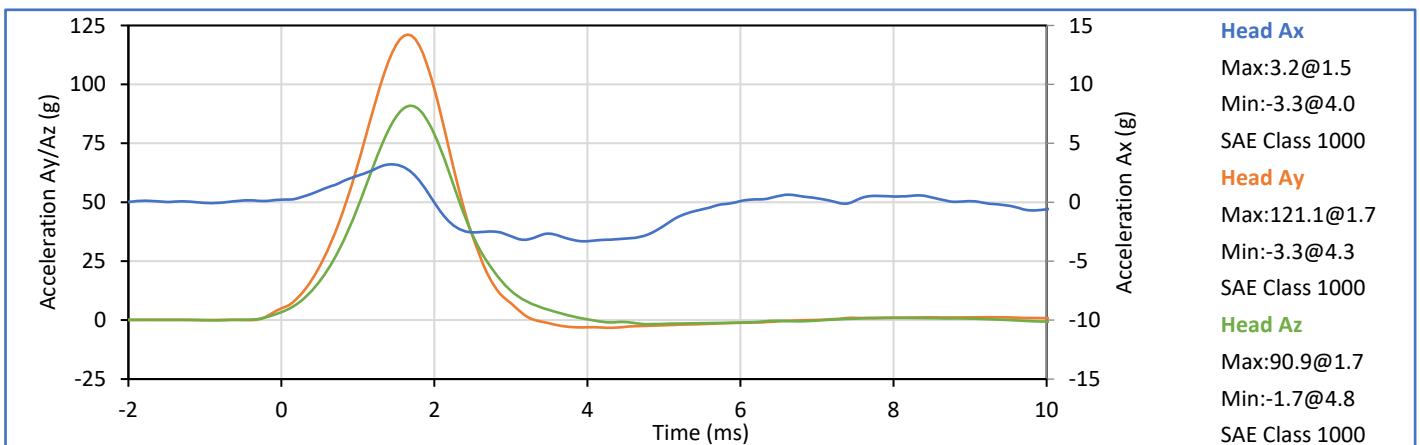
Tested Parameter	Units	Spec. Low	Spec. High	Result	Pass/Fail
Laboratory Temperature	°C	18.9	25.6	21.3	Pass
Laboratory Relative Humidity	%	10	70	40	Pass
Peak Resultant Acceleration	g	125.0	155.0	151.3	Pass
Peak Head Ax	g	-15.0	15.0	3.2	Pass
Oscillations After Main Pulse	%	0.0	15.0	1.3	Pass
Is Acceleration Unimodal?	Yes/No	Yes		Yes	Pass
Overall Test Results					Pass

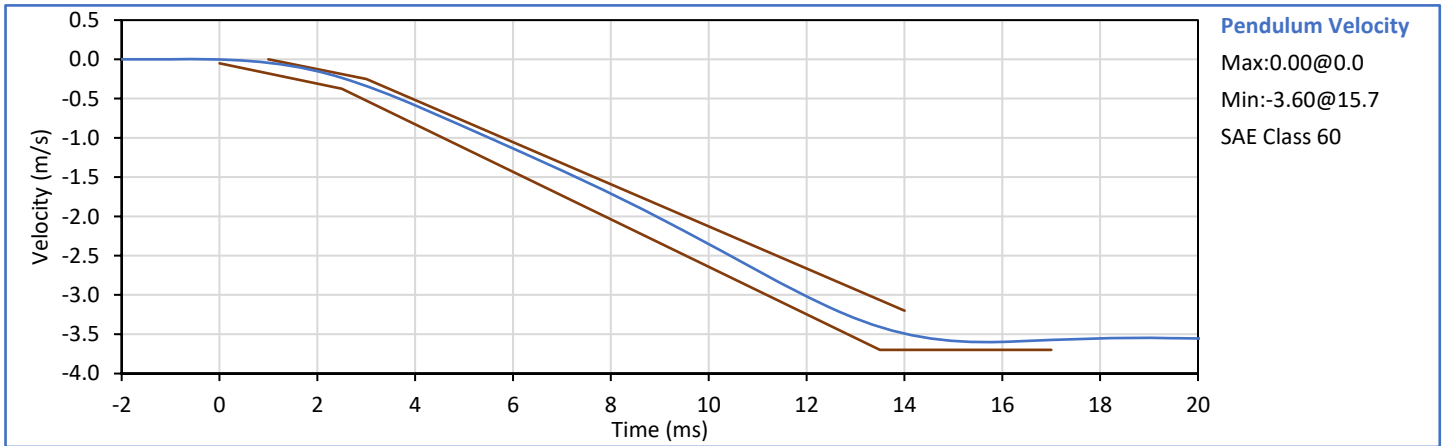
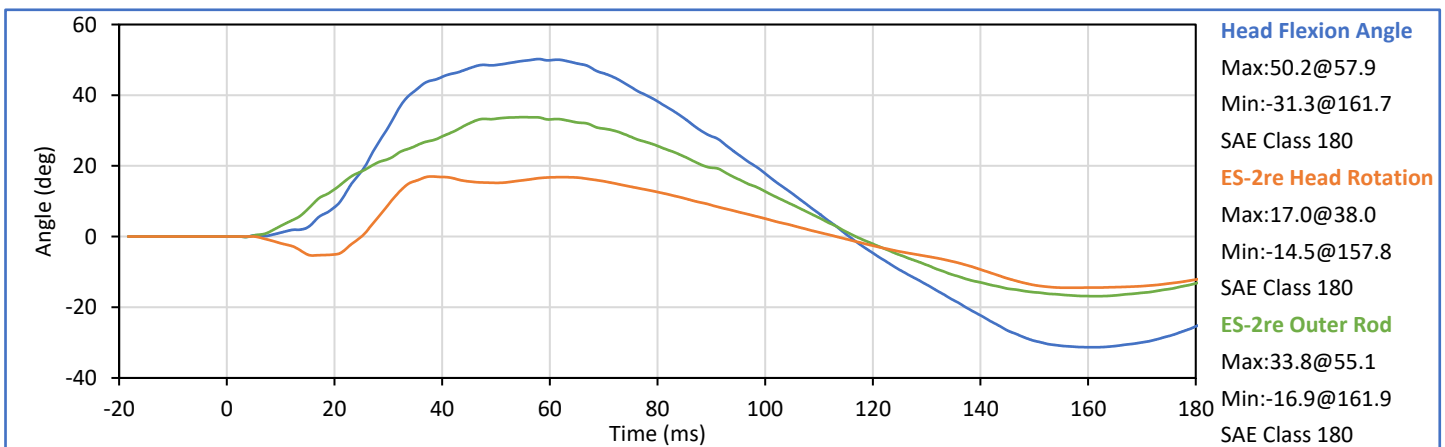
Tested Parameter	Units	Spec. Low	Spec. High	Result	Pass/Fail
Laboratory Temperature	°C	20.6	22.2	21.6	Pass
Laboratory Relative Humidity	%	10	70	40	Pass
Pendulum Velocity	m/s	3.30	3.50	3.40	Pass
Peak Headform Flexion	deg	49.0	59.0	50.2	Pass
Time of Peak Headform Flexion	ms	54.0	66.0	57.9	Pass
Flexion Decay (Peak to zero)	ms	53.0	88.0	57.7	Pass
Overall Test Results					Pass

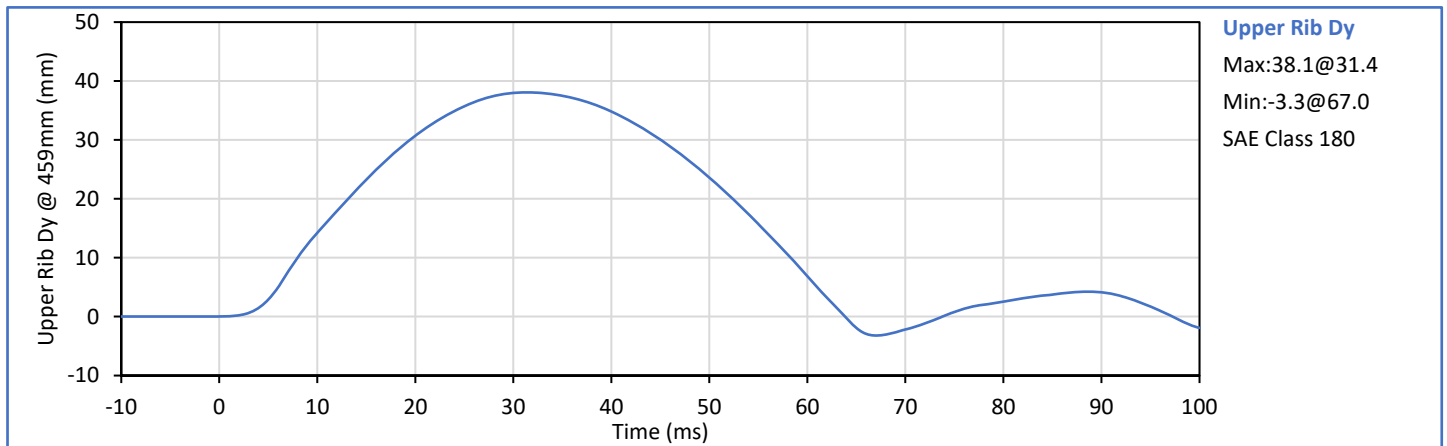
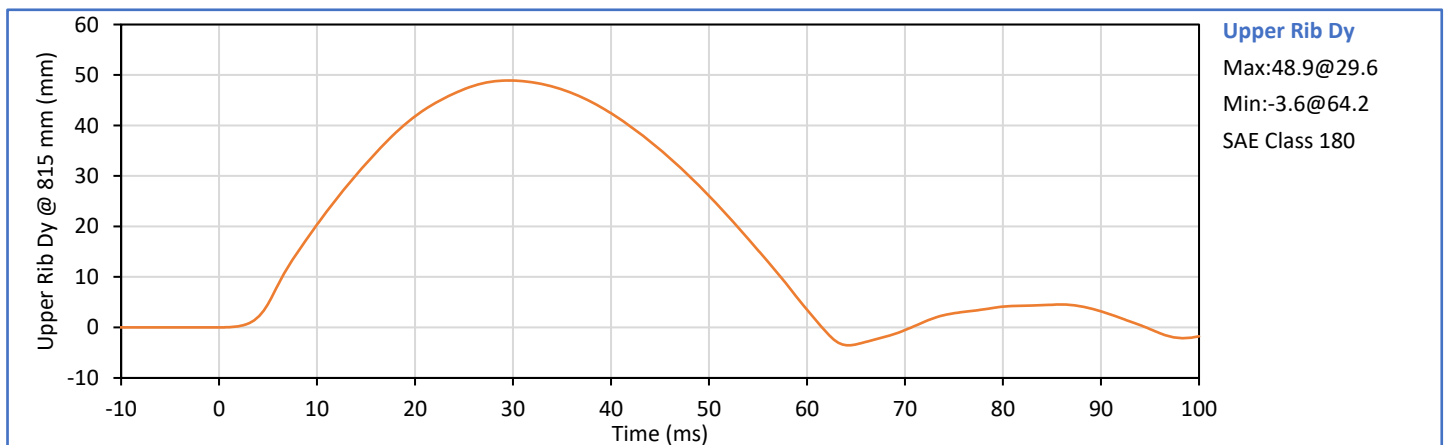
Tested Parameter	Units	Spec. Low	Spec. High	Result	Pass/Fail
Laboratory Temperature	°C	20.6	22.2	21.3	Pass
Laboratory Relative Humidity	%	10	70	40	Pass
Upper Rib Dy @ 459mm	mm	36.0	40.0	38.1	Pass
Upper Rib Dy @ 815mm	mm	46.0	51.0	48.9	Pass
Overall Test Results					Pass

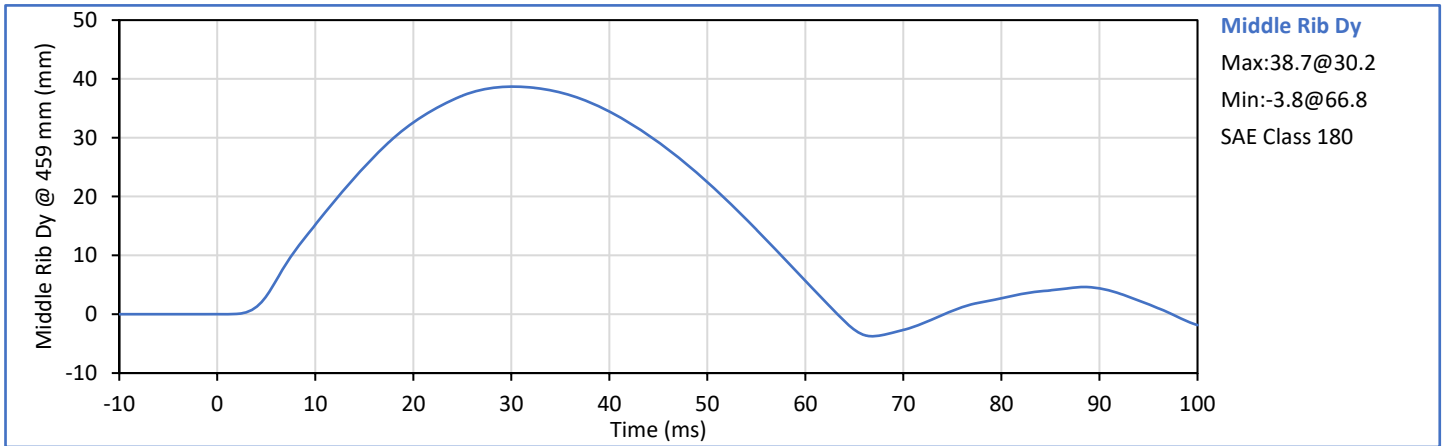
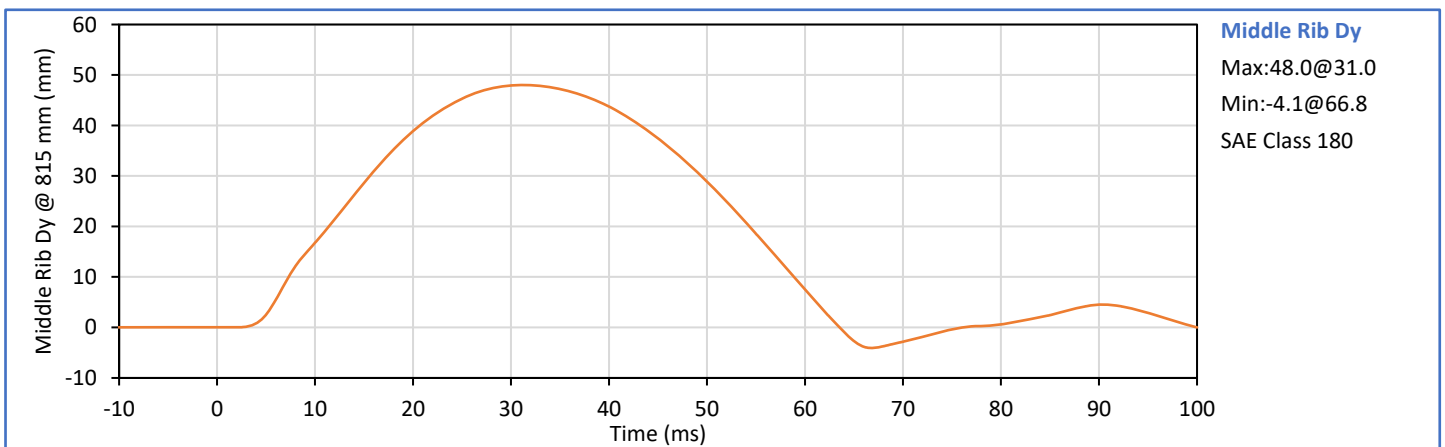
Tested Parameter	Units	Spec. Low	Spec. High	Result	Pass/Fail
Laboratory Temperature	°C	20.6	22.2	21.3	Pass
Laboratory Relative Humidity	%	10	70	40	Pass
Middle Rib Dy @ 459mm	mm	36.0	40.0	38.7	Pass
Middle Rib Dy @ 815mm	mm	46.0	51.0	48.0	Pass
Overall Test Results					Pass

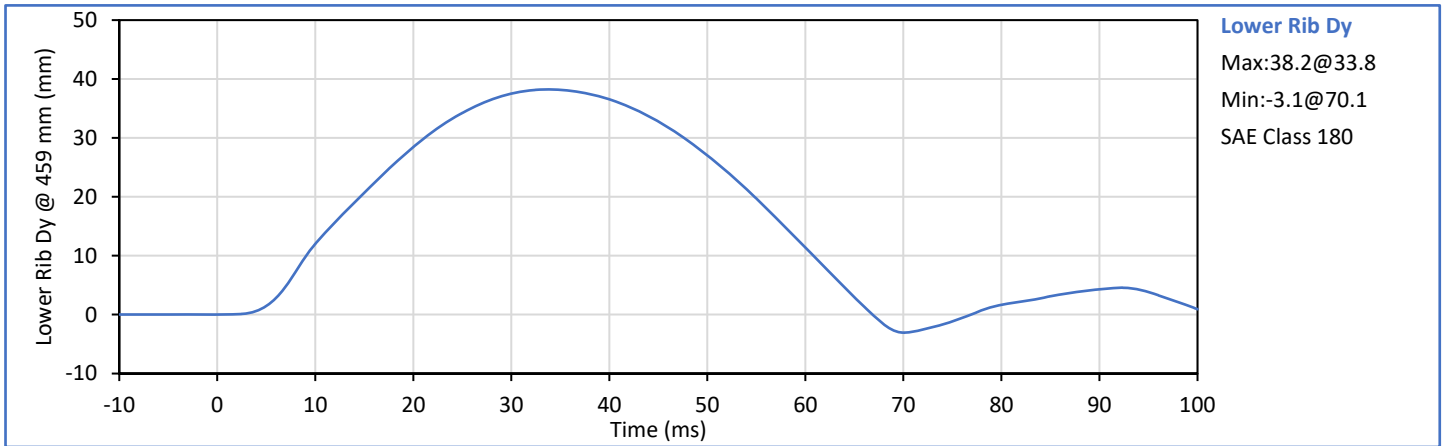
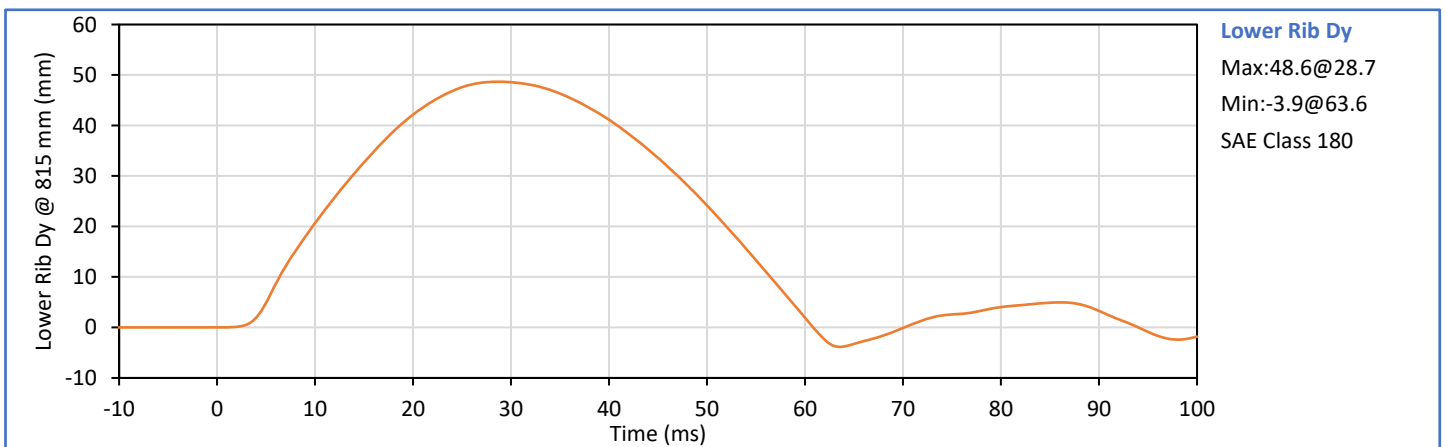
Tested Parameter	Units	Spec. Low	Spec. High	Result	Pass/Fail
Laboratory Temperature	°C	20.6	22.2	21.3	Pass
Laboratory Relative Humidity	%	10	70	40	Pass
Lower Rib Dy @ 459mm	mm	36.0	40.0	38.2	Pass
Lower Rib Dy @ 815mm	mm	46.0	51.0	48.6	Pass
Overall Test Results					Pass

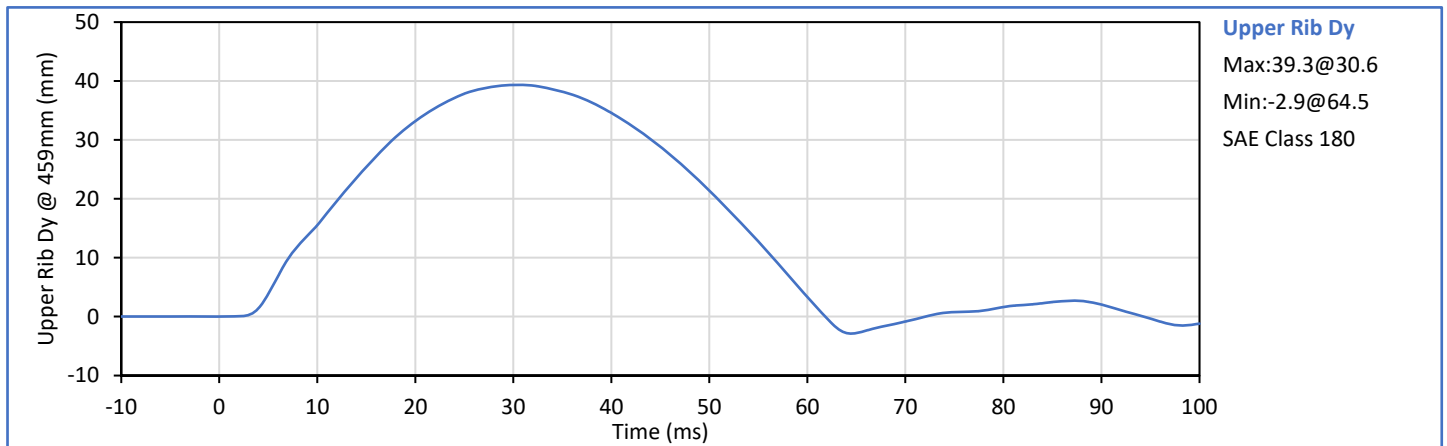
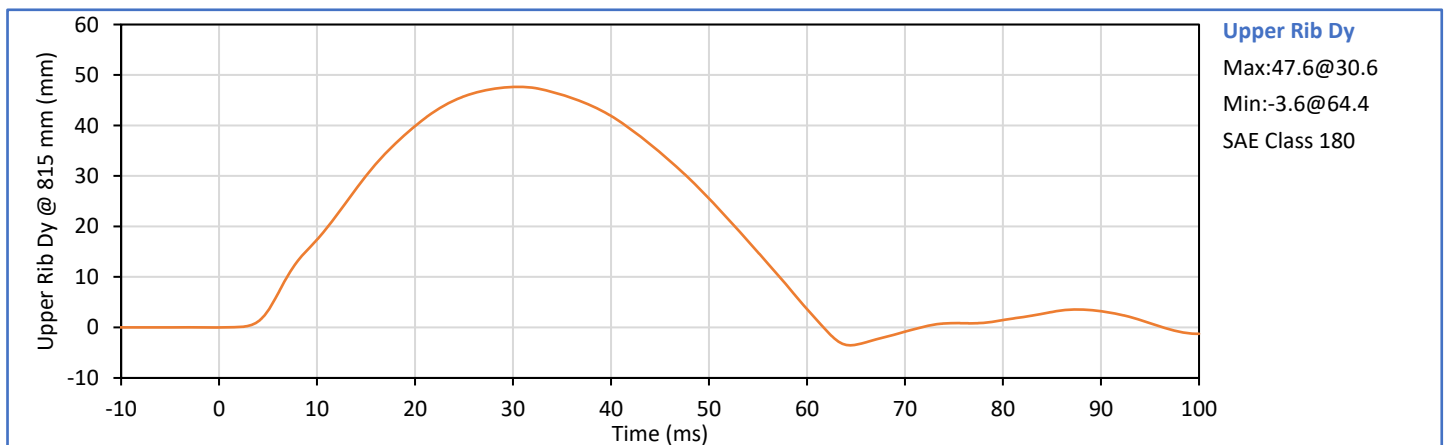
Tested Parameter	Units	Spec. Low	Spec. High	Result	Pass/Fail
Laboratory Temperature	°C	20.6	22.2	21.3	Pass
Laboratory Relative Humidity	%	10	70	41	Pass
Upper Rib Dy @ 459mm	mm	36.0	40.0	39.3	Pass
Upper Rib Dy @ 815mm	mm	46.0	51.0	47.6	Pass
Overall Test Results					Pass

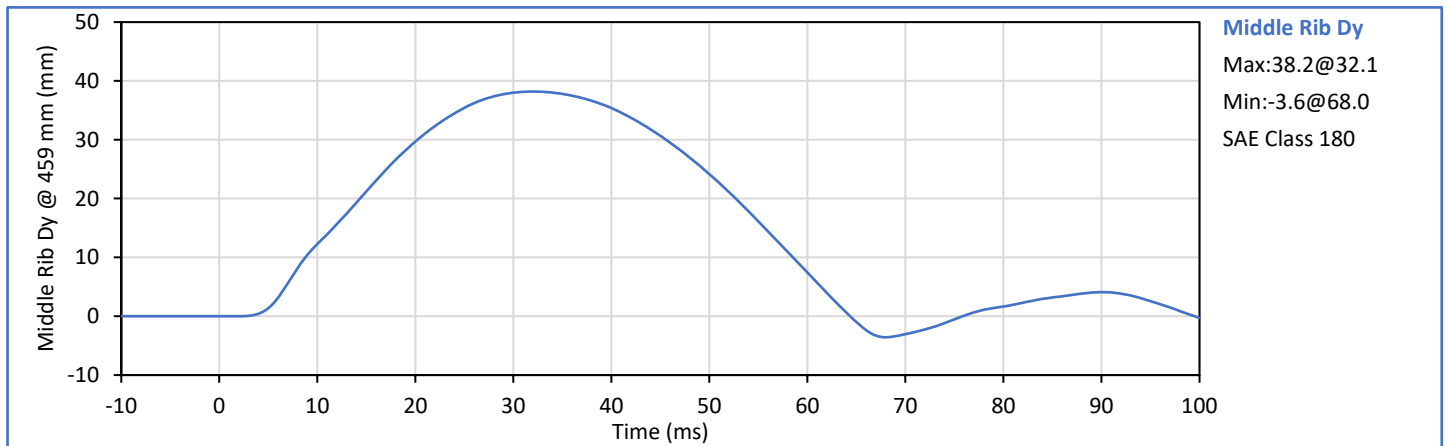
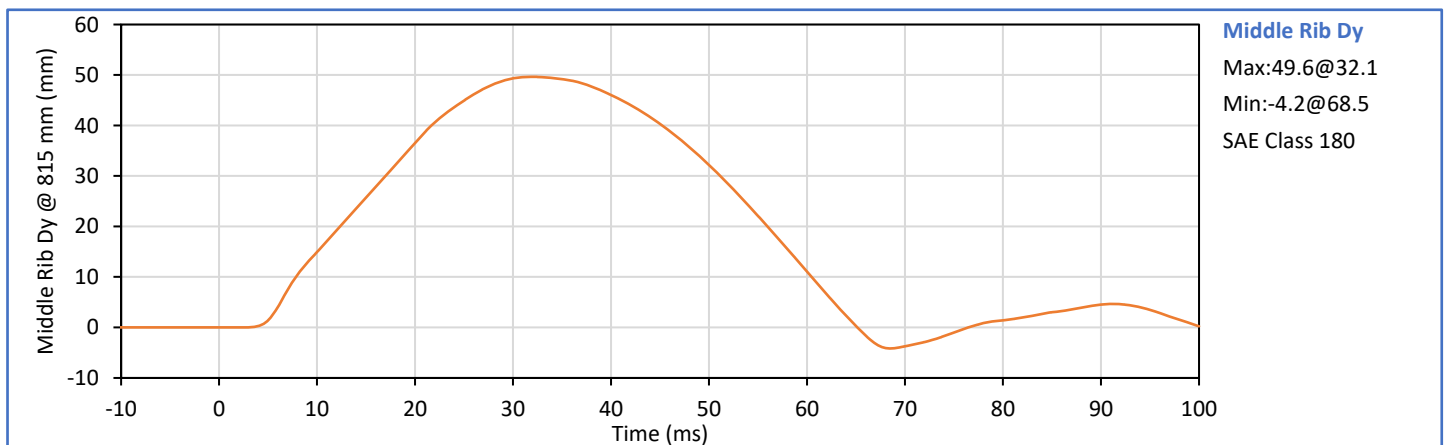
Tested Parameter	Units	Spec. Low	Spec. High	Result	Pass/Fail
Laboratory Temperature	°C	20.6	22.2	21.6	Pass
Laboratory Relative Humidity	%	10	70	41	Pass
Middle Rib Dy @ 459mm	mm	36.0	40.0	38.2	Pass
Middle Rib Dy @ 815mm	mm	46.0	51.0	49.6	Pass
Overall Test Results					Pass

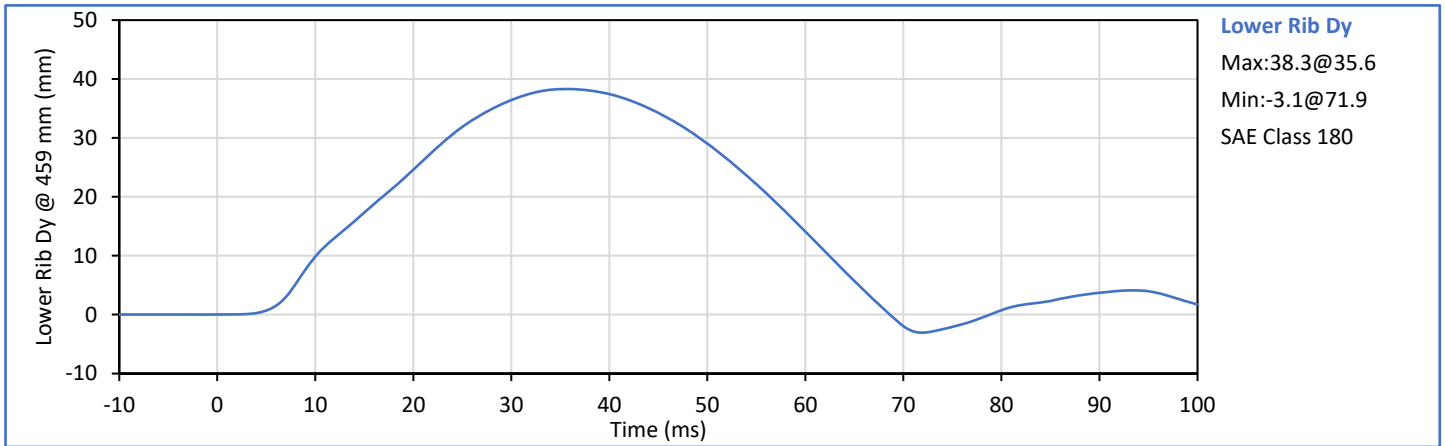
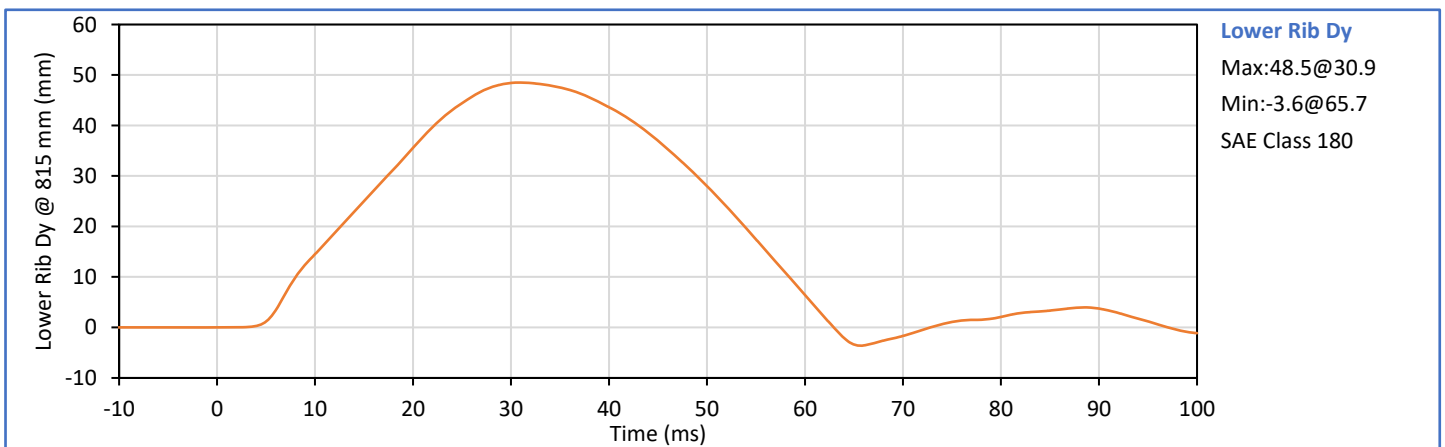
Tested Parameter	Units	Spec. Low	Spec. High	Result	Pass/Fail
Laboratory Temperature	°C	20.6	22.2	21.6	Pass
Laboratory Relative Humidity	%	10	70	41	Pass
Lower Rib Dy @ 459mm	mm	36.0	40.0	38.3	Pass
Lower Rib Dy @ 815mm	mm	46.0	51.0	48.5	Pass
Overall Test Results					Pass
