**REPORT NUMBER: SideNCAPMDB-KAR-24-005**

**NEW CAR ASSESSMENT PROGRAM (NCAP)  
MOVING DEFORMABLE BARRIER SIDE IMPACT TEST**

**MITSUBISHI MOTORS  
2024 MITSUBISHI OUTLANDER 5-DOOR SUV**

**NHTSA No: M20245601**

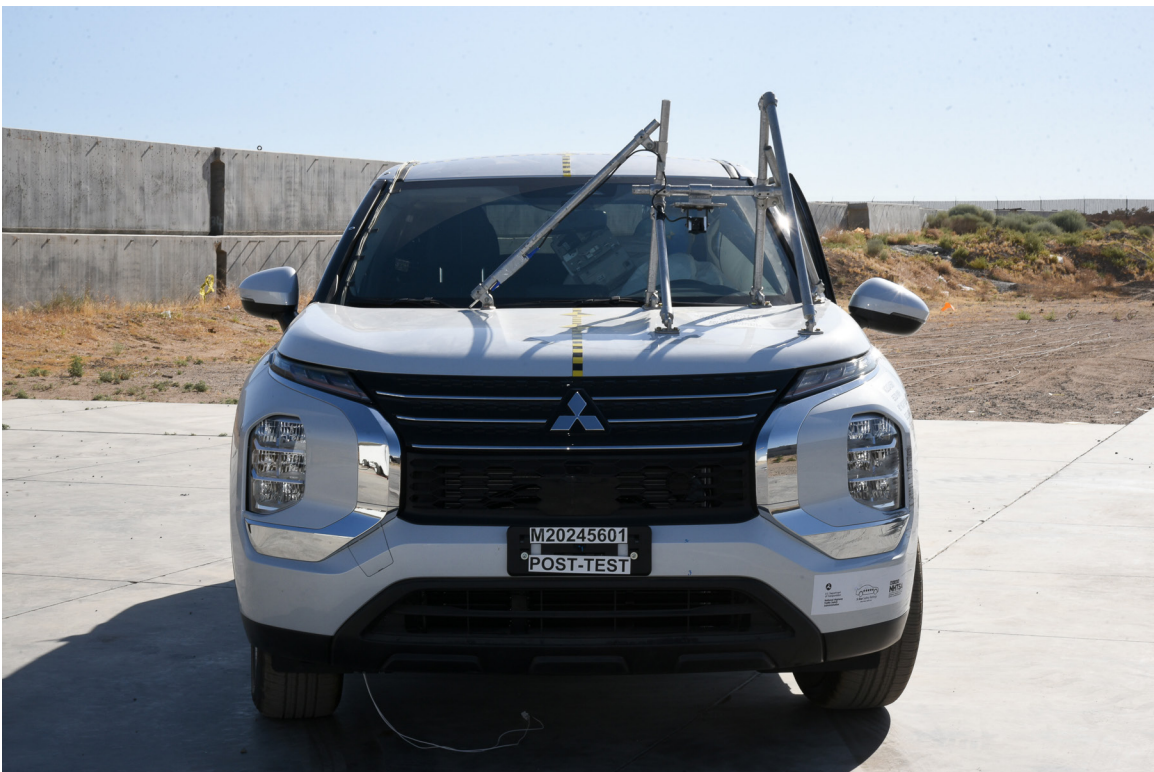
FIGURE 4. Post-Test Frontal View of Test Vehicle

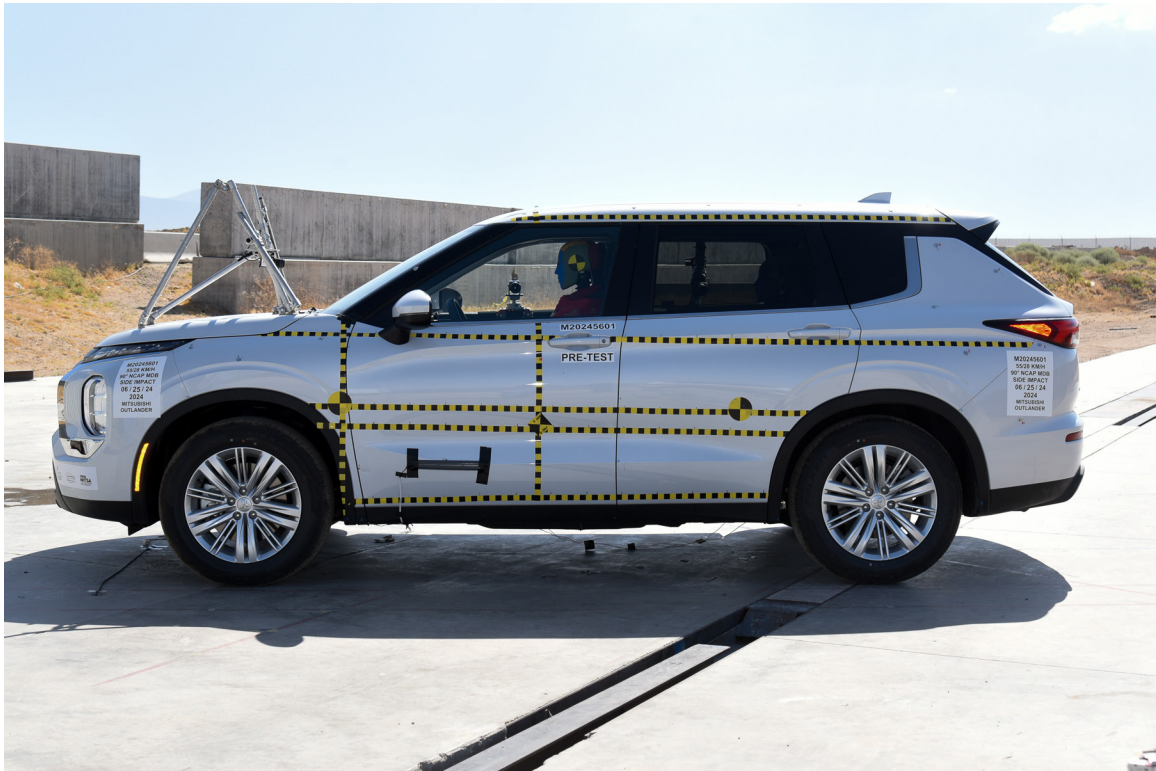
FIGURE 7. Pre-Test Left Side View of Test Vehicle

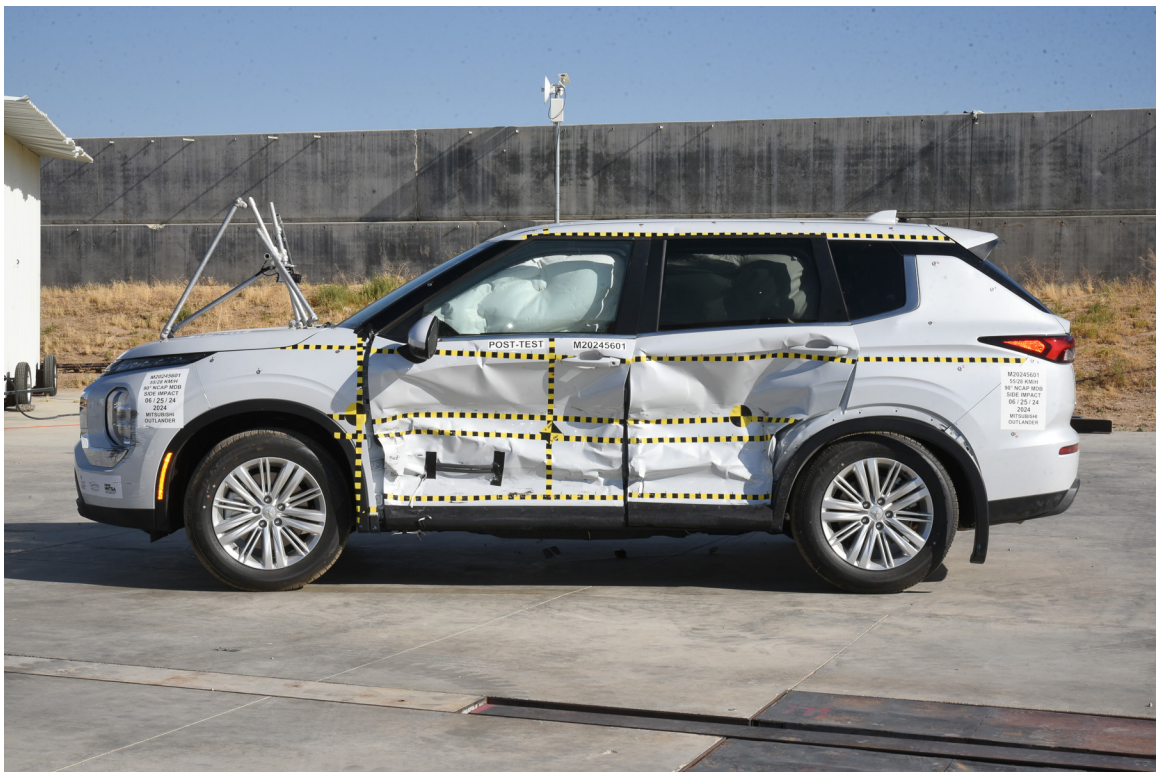
FIGURE 8. Post-Test Left Side View of Test Vehicle

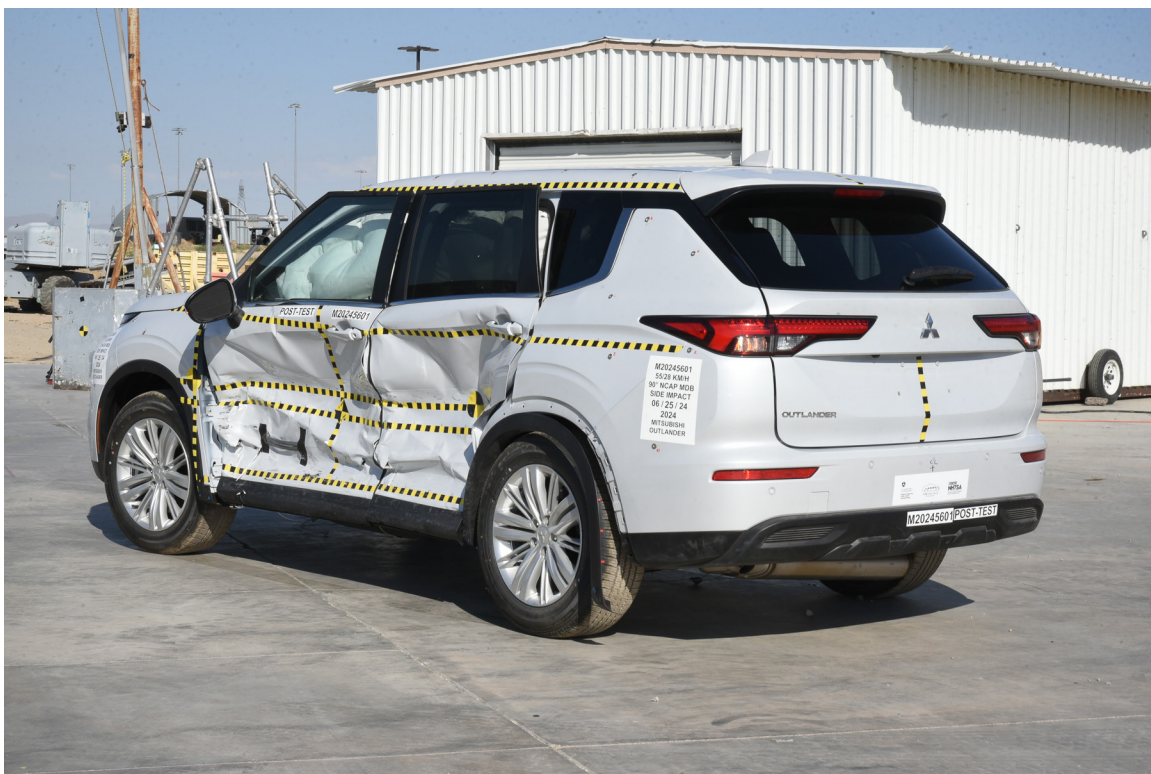
FIGURE 10. Post-Test Left Rear 3/4 View of Test Vehicle

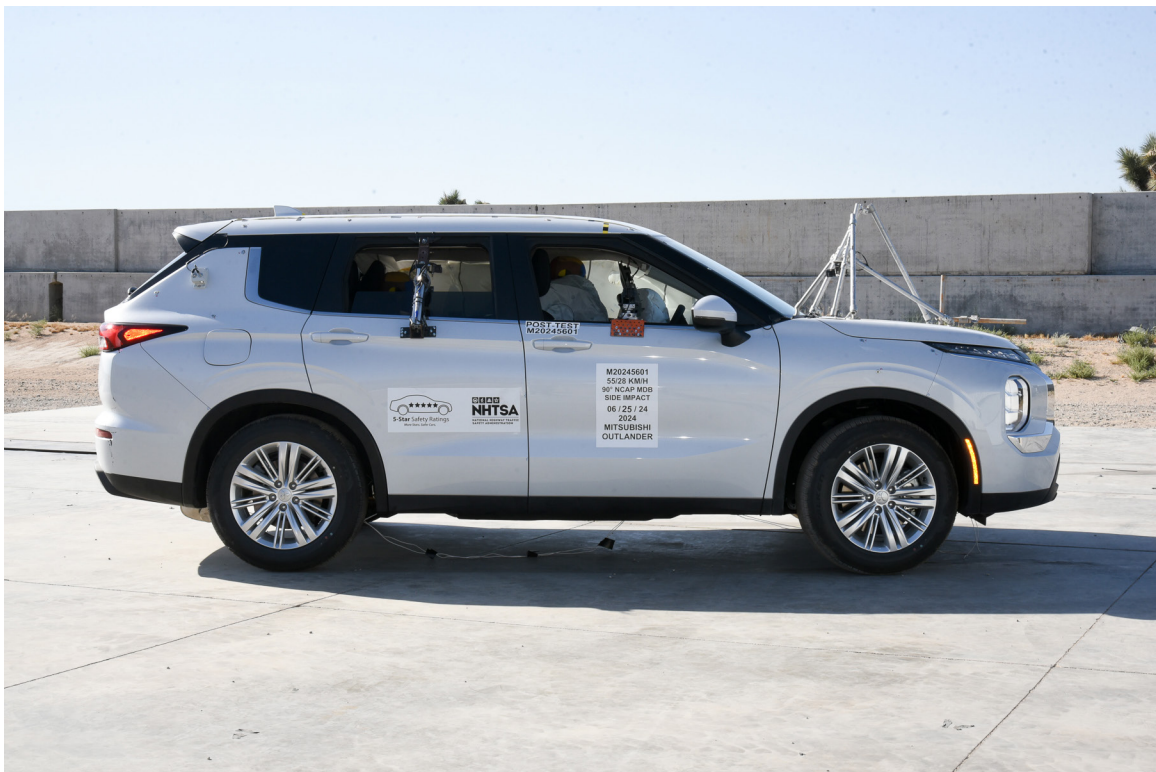
FIGURE 14. Post-Test Right Side View of Test Vehicle

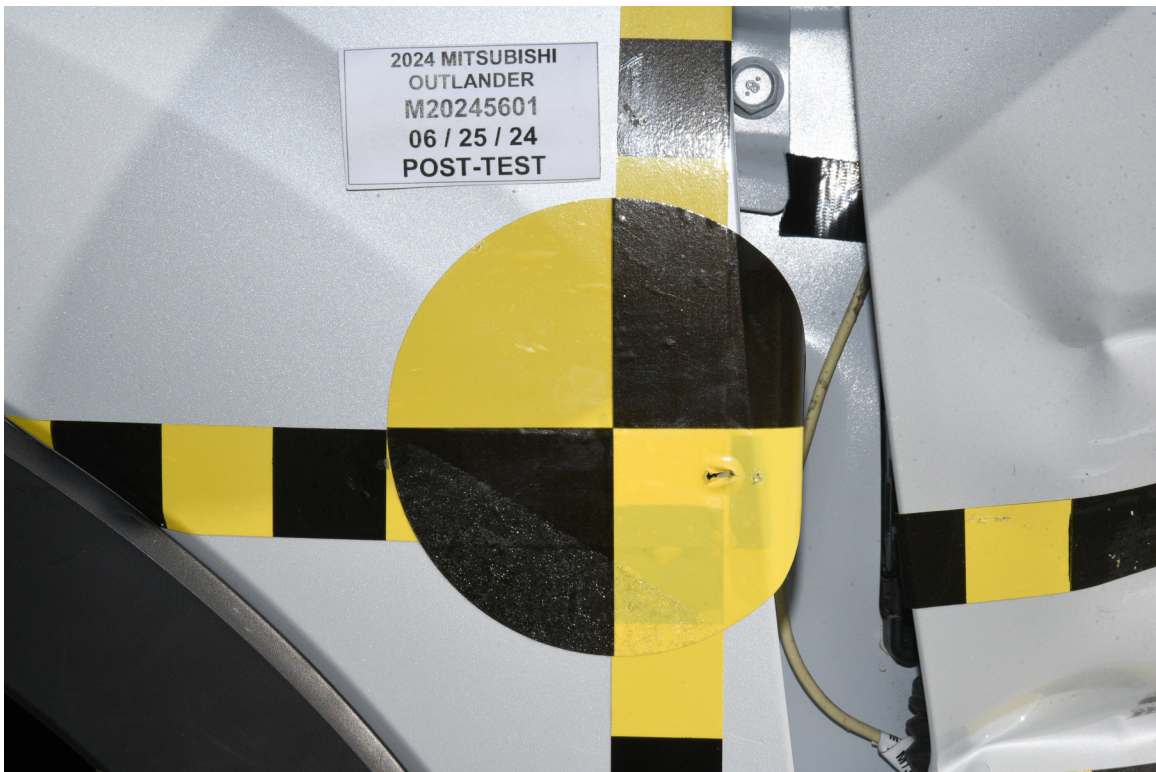
FIGURE 20. Post-Test Close-Up View of Impact Point Target

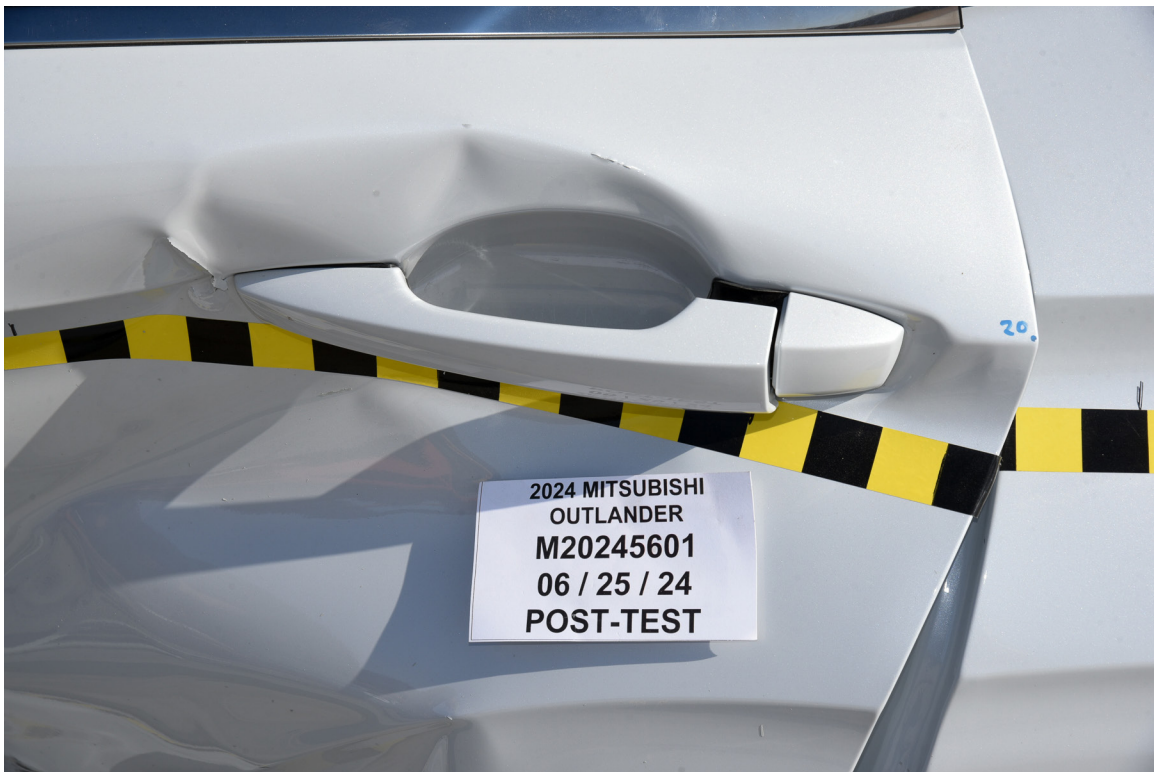
FIGURE 24. Post-Test Left Rear Door Latch Close-Up

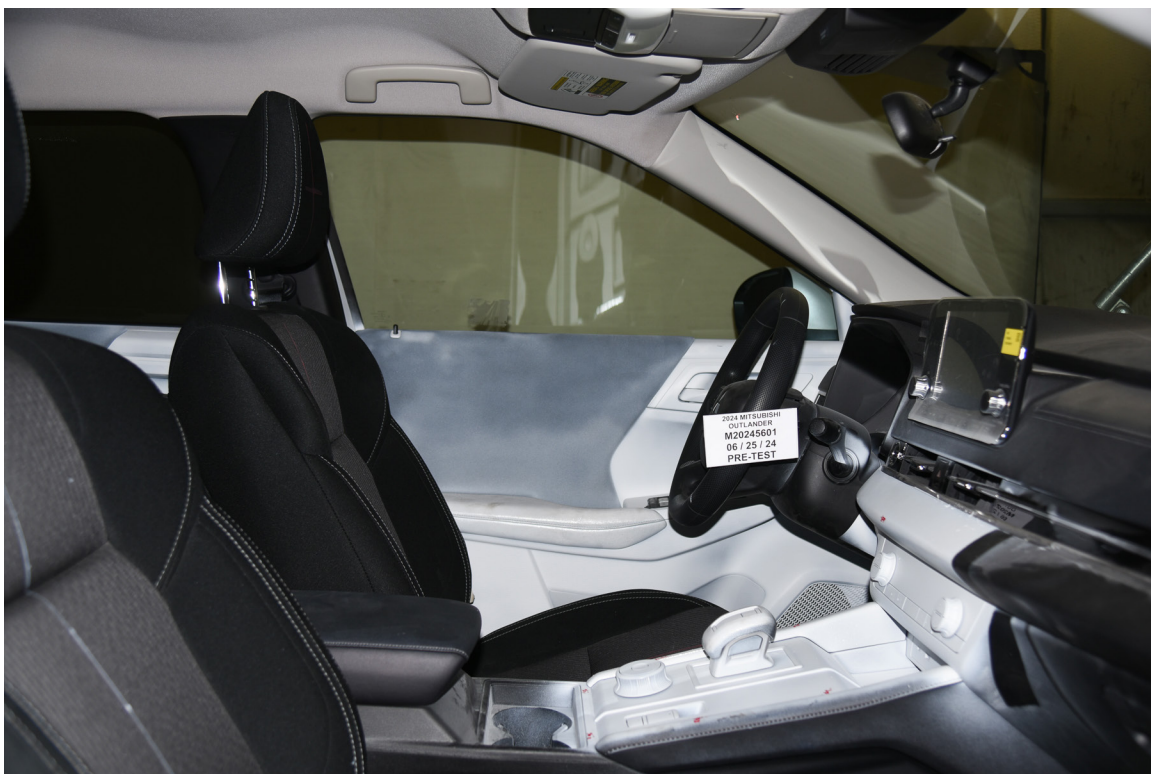
FIGURE 46. Pre-Test Driver Inner Door Panel View

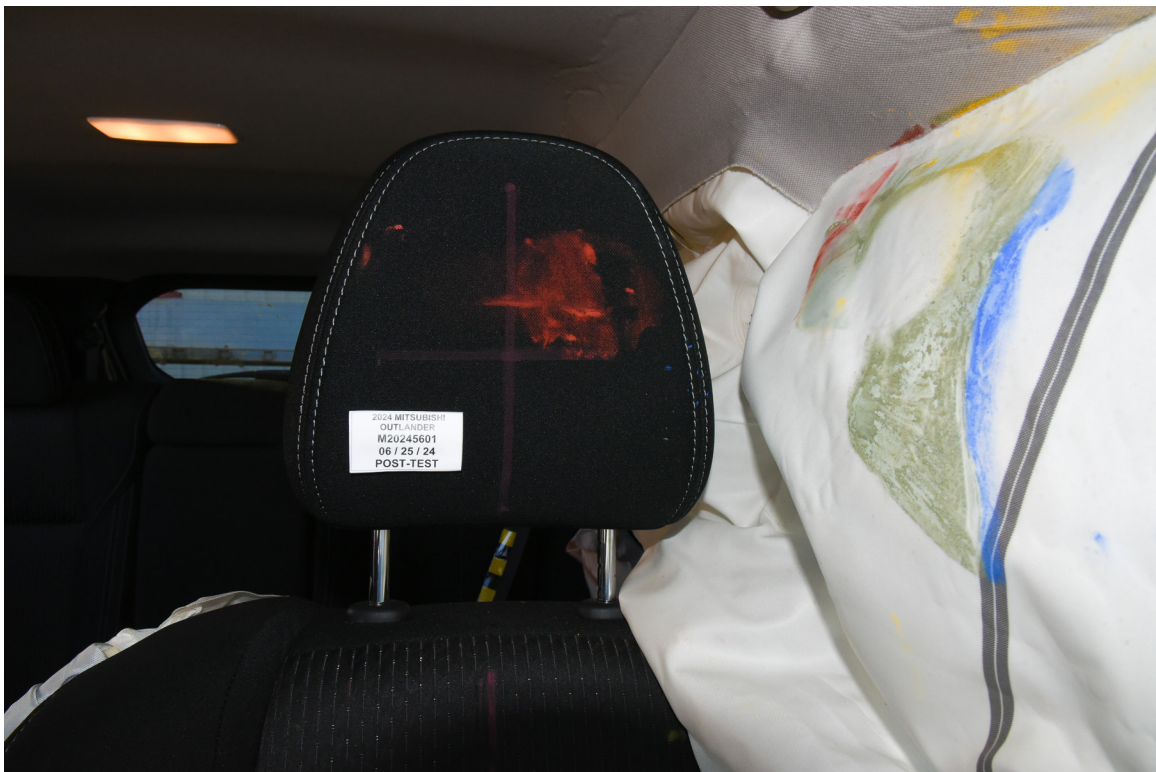
FIGURE 48. Post-Test Driver Dummy Close-Up Head Contact with Vehicle Interior View

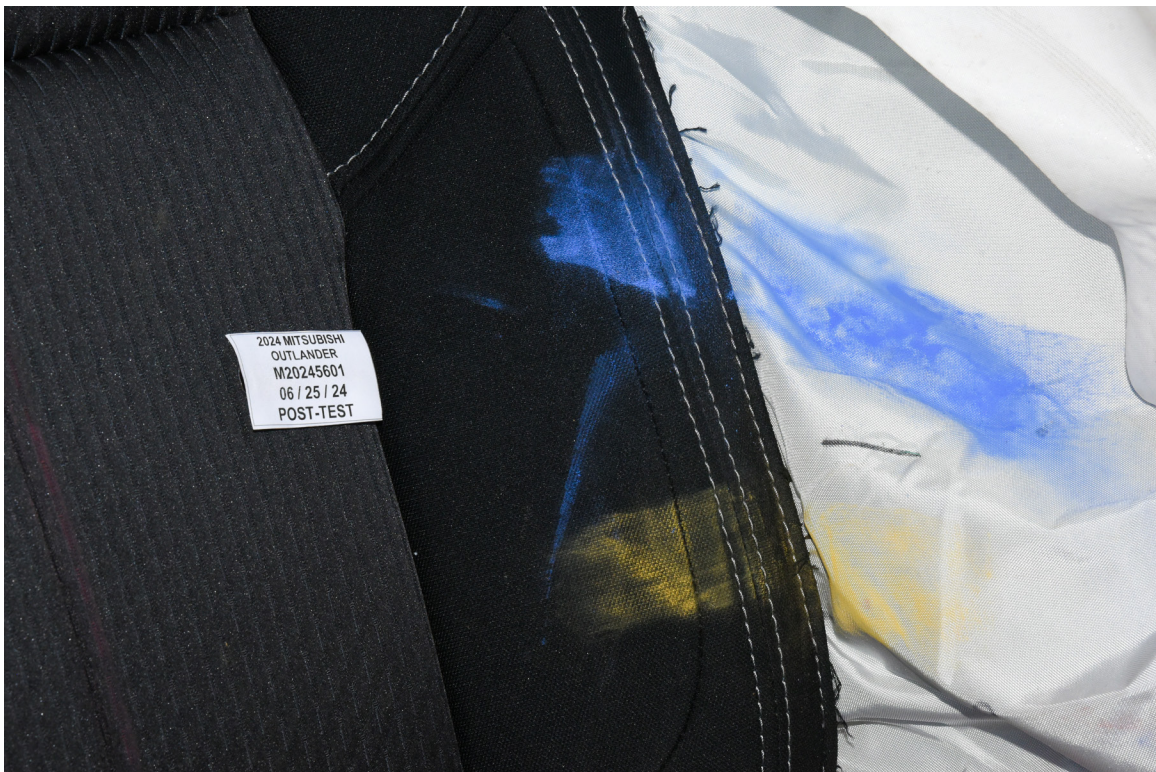
FIGURE 50. Post-Test Driver Dummy Close-Up Torso Contact With Vehicle Interior View

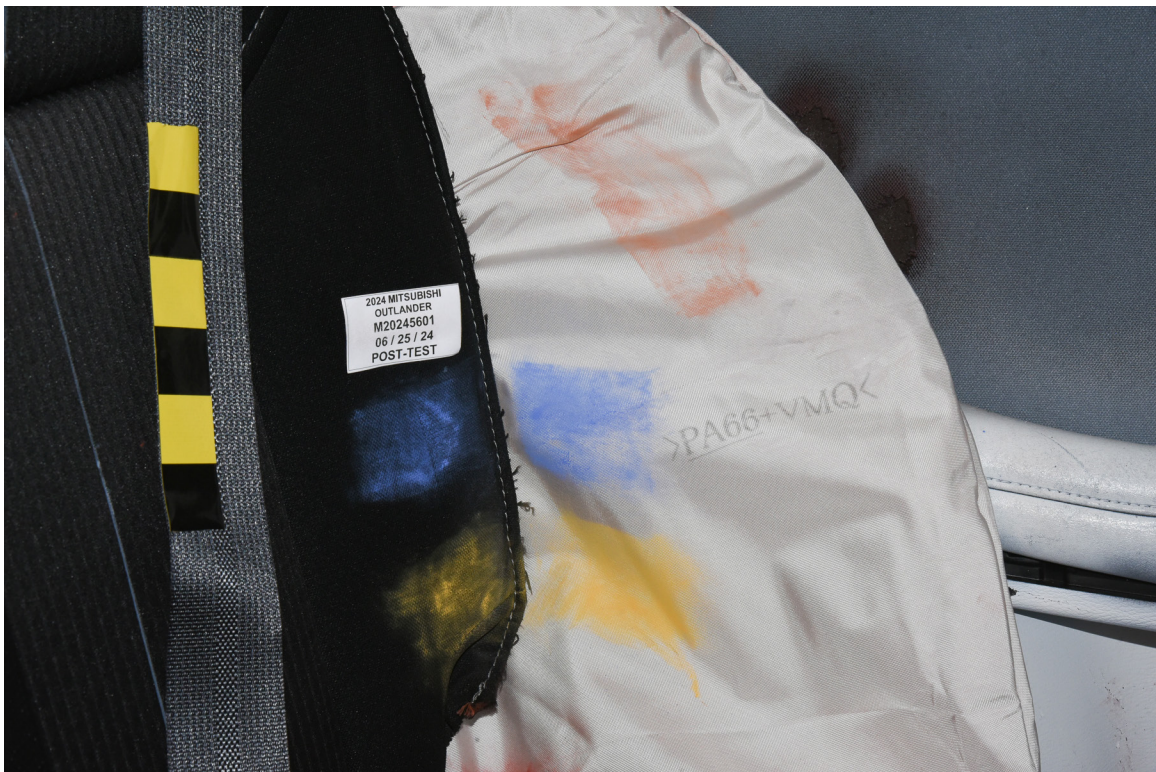
FIGURE 78. Post-Test Rear Passenger Dummy Close-Up Torso Contact with Vehicle Side Airbag View

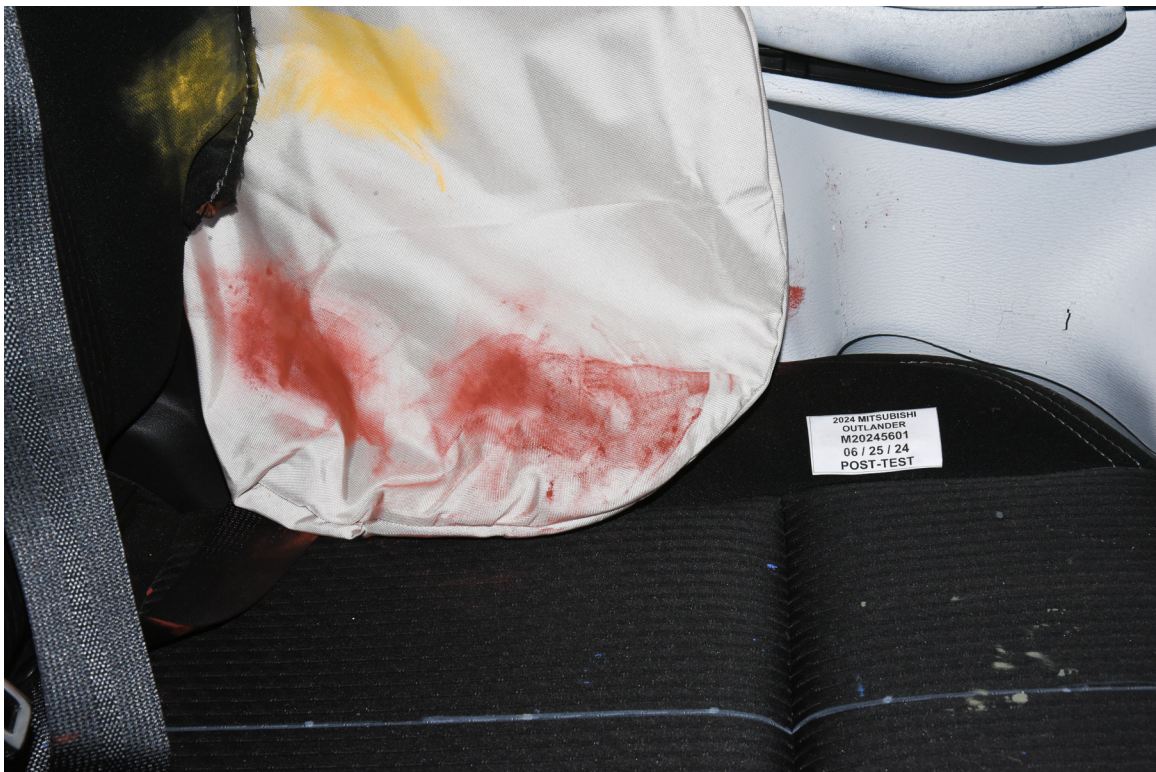
FIGURE 80. Post-Test Rear Passenger Dummy Close-Up Pelvis Contact with Side Airbag View

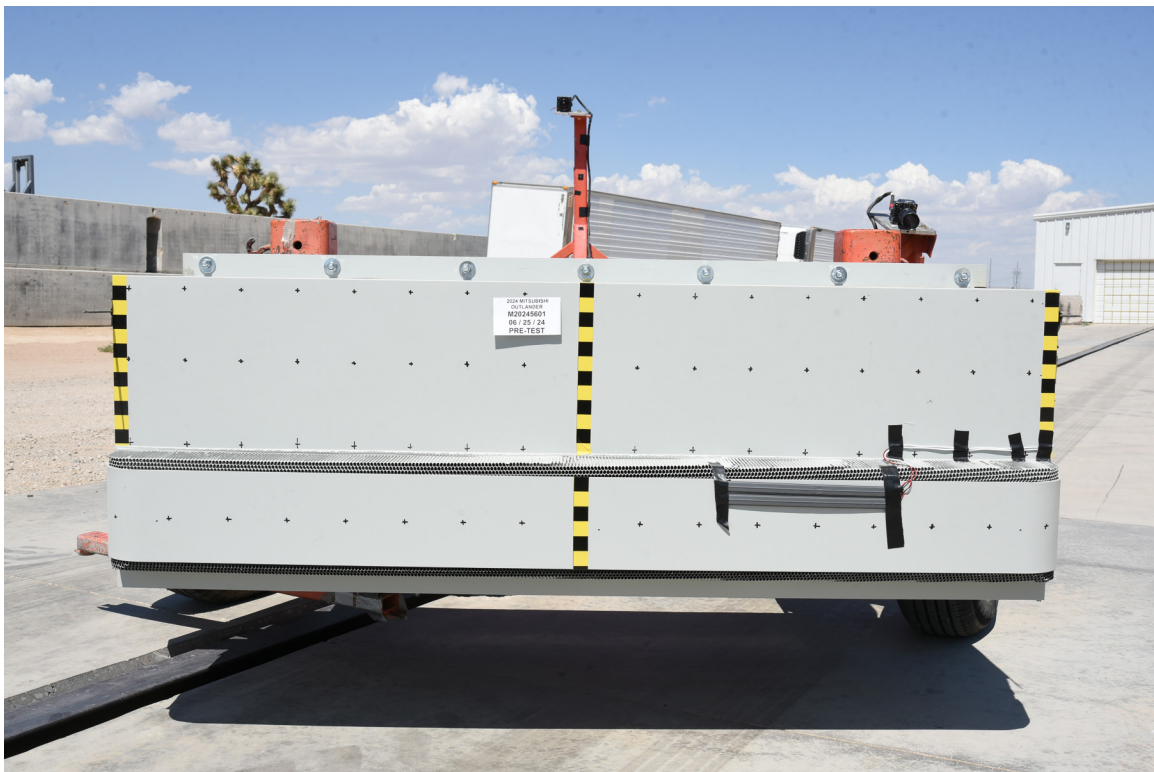
FIGURE 84. Pre-Test Front View of MDB Impactor Face

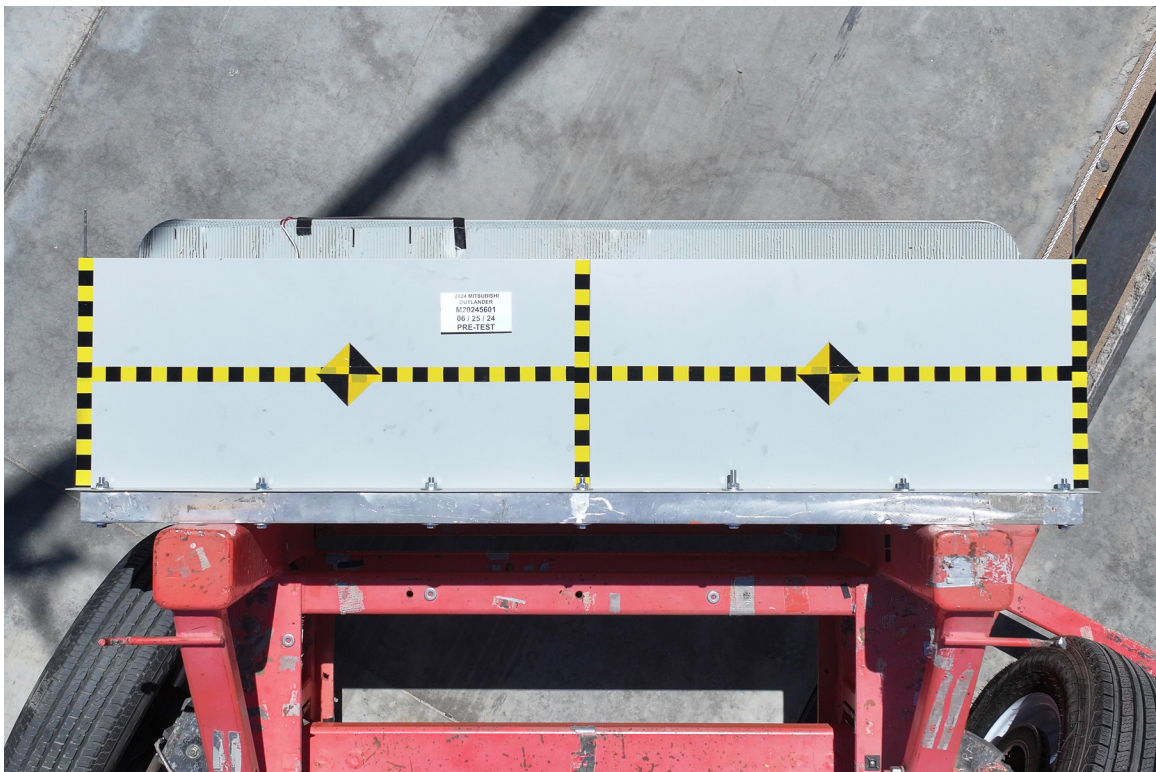
FIGURE 86. Pre-Test Top View of MDB Impactor Face

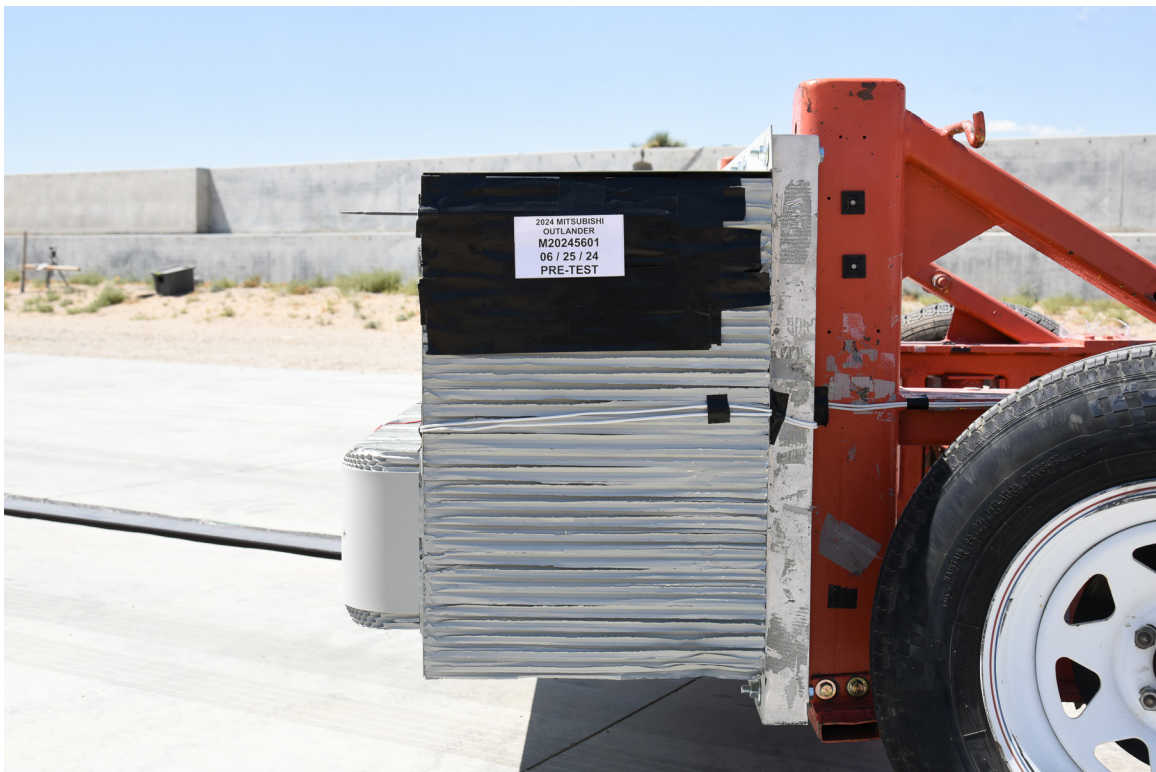
FIGURE 88. Pre-Test Left View of MDB Impactor Face

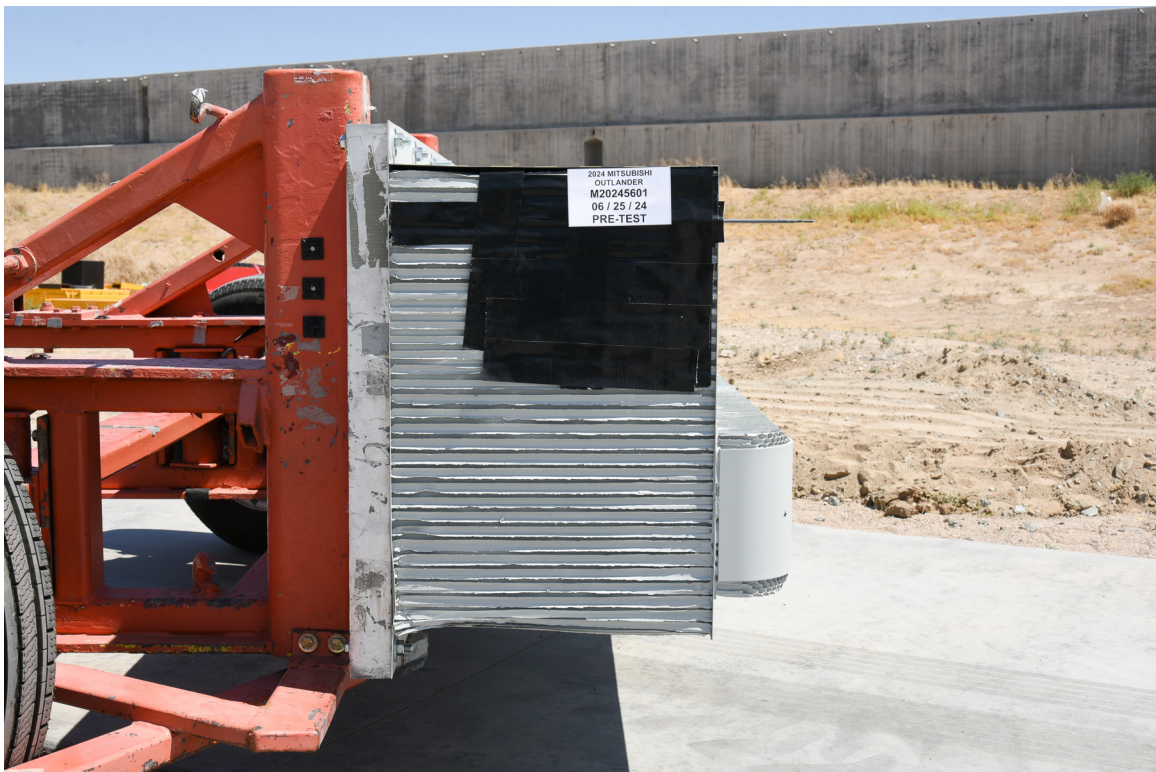
FIGURE 90. Pre-Test Right View of MDB Impactor Face
