**REPORT NUMBER: SideNCAPPole-KAR-24-006**  
**NEW CAR ASSESSMENT PROGRAM (NCAP)**  
**SIDE IMPACT POLE TEST**

**MITSUBISHI MOTORS CORPORATION**  
**2024 MITSUBISHI OUTLANDER 5-DOOR SUV**

**NHTSA No: M20245600**

**FINAL REPORT**

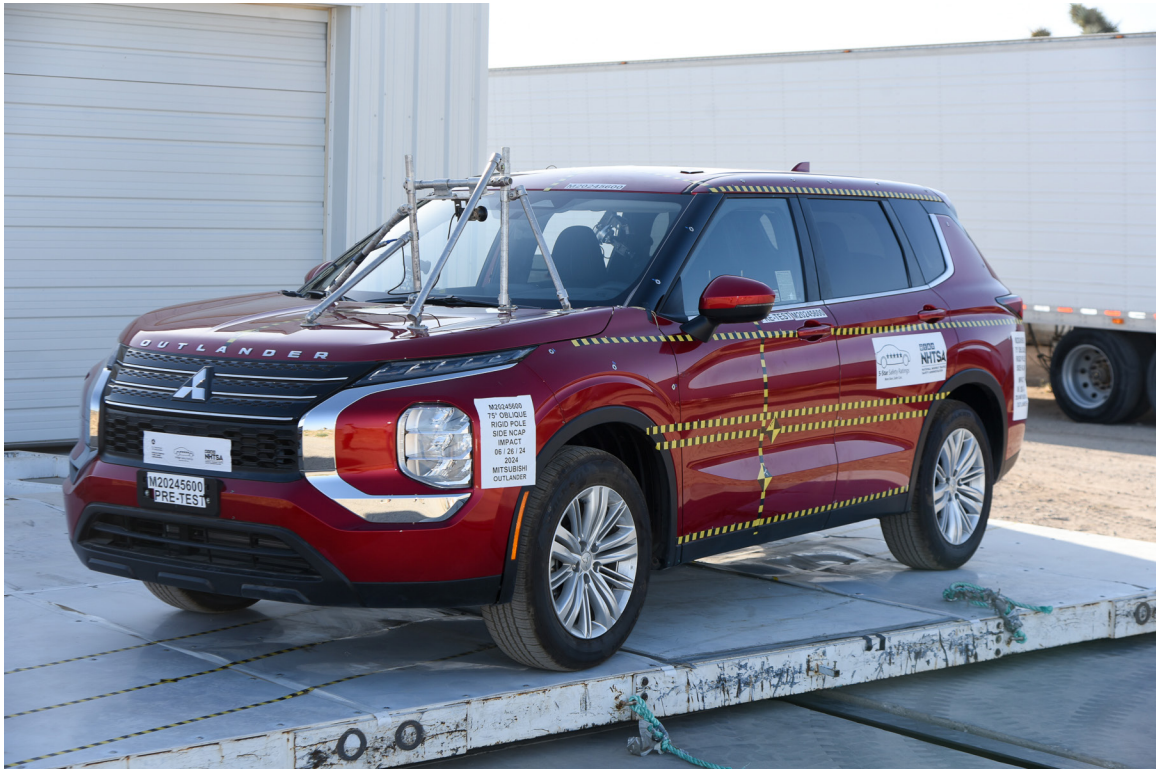
FIGURE 4. Post-Test Frontal View of Test Vehicle

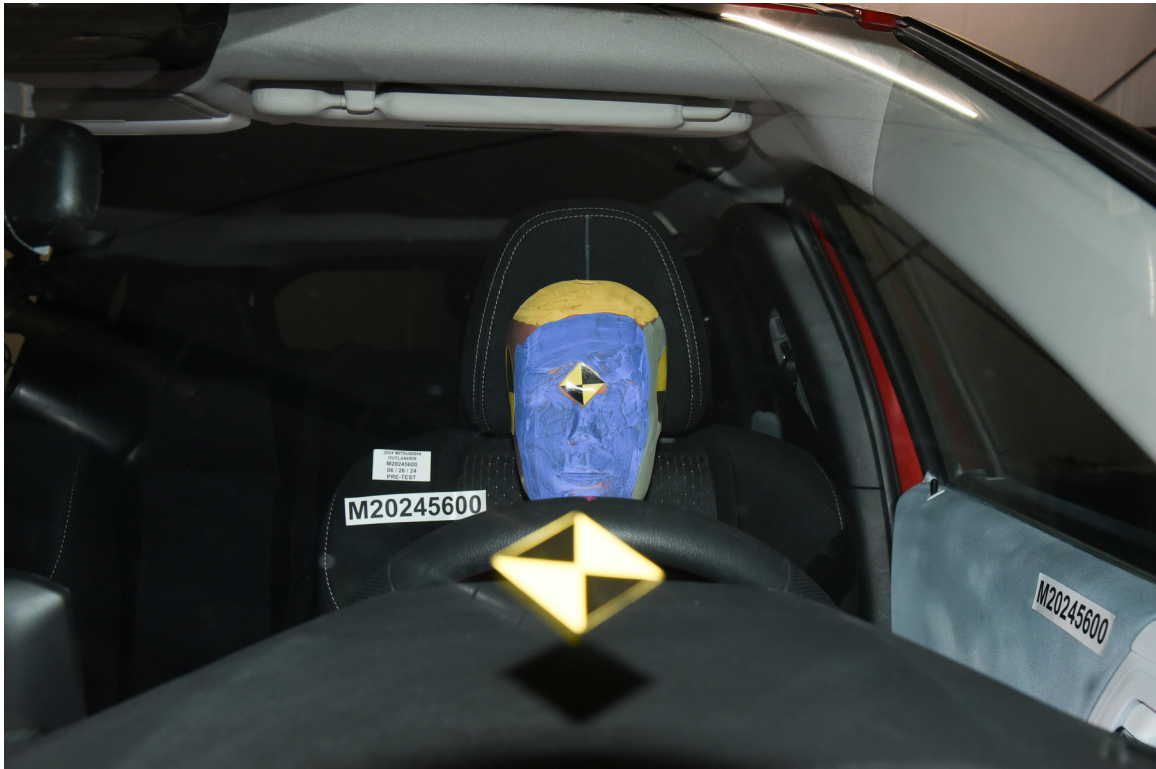
FIGURE 20. Post-Test Close-Up View of Impact Point Target Showing Impact Location

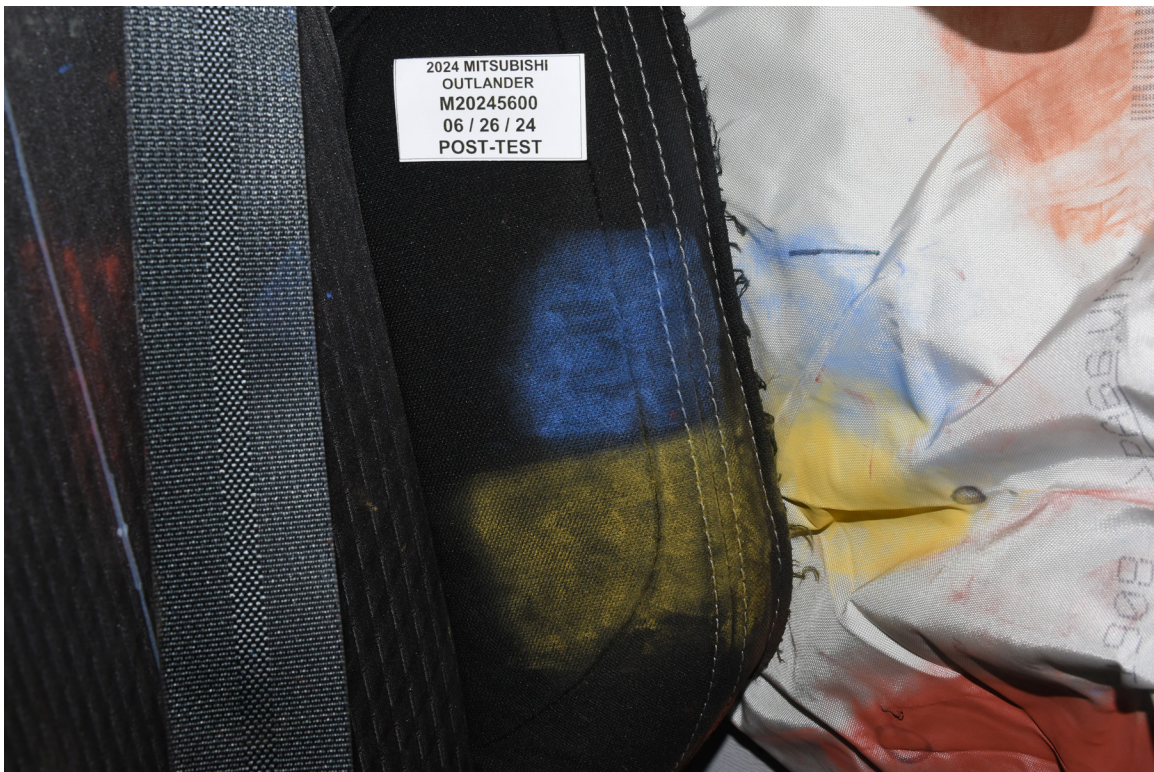
FIGURE 47. Post-Test Dummy Close-Up Head Contact With Side Airbag View

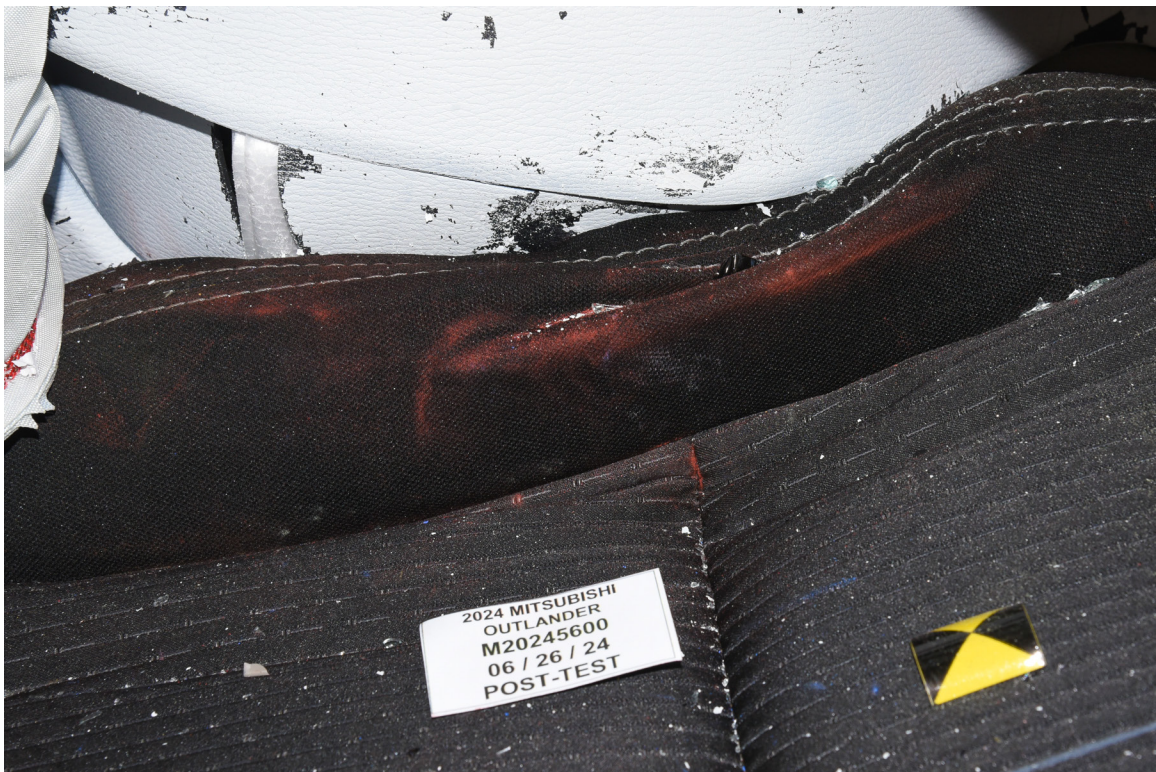
FIGURE 49. Post-Test Dummy Close-Up Torso Contact With Side Airbag View

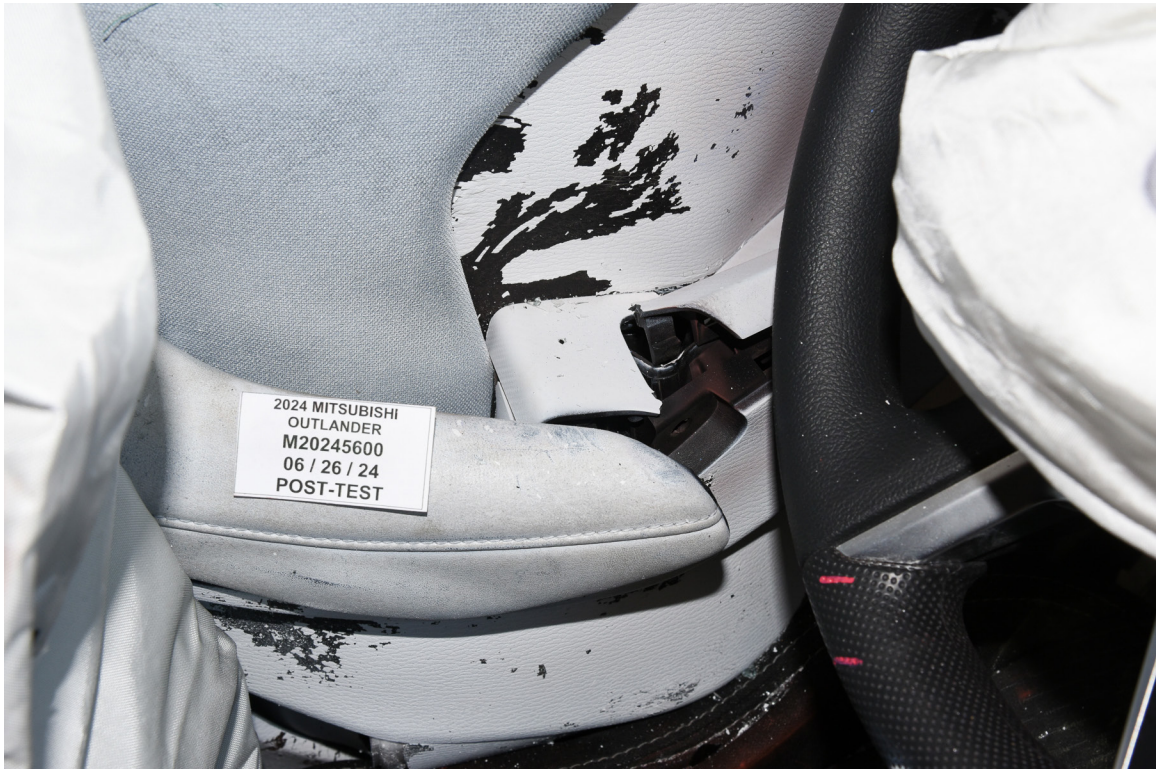
FIGURE 72. Head Restraint Use and Adjustment Information from Vehicle Owner's Manual

1. Pull the head restraint up to the highest position.
2. Push and hold the lock knob.
3. Remove the head restraint from the seat.
4. Store the head restraint properly in a secure place so it is not loose in the vehicle.
5. Reinstall and properly adjust the head restraint before an occupant uses the seating position.
