**REPORT NUMBER: SideNCAPMDB-KAR-24-007**

**NEW CAR ASSESSMENT PROGRAM (NCAP)  
MOVING DEFORMABLE BARRIER SIDE IMPACT TEST**

**FORD MOTOR CO.  
2024 FORD RANGER 4-DOOR CREW CAB**

**NHTSA No: M20240204**

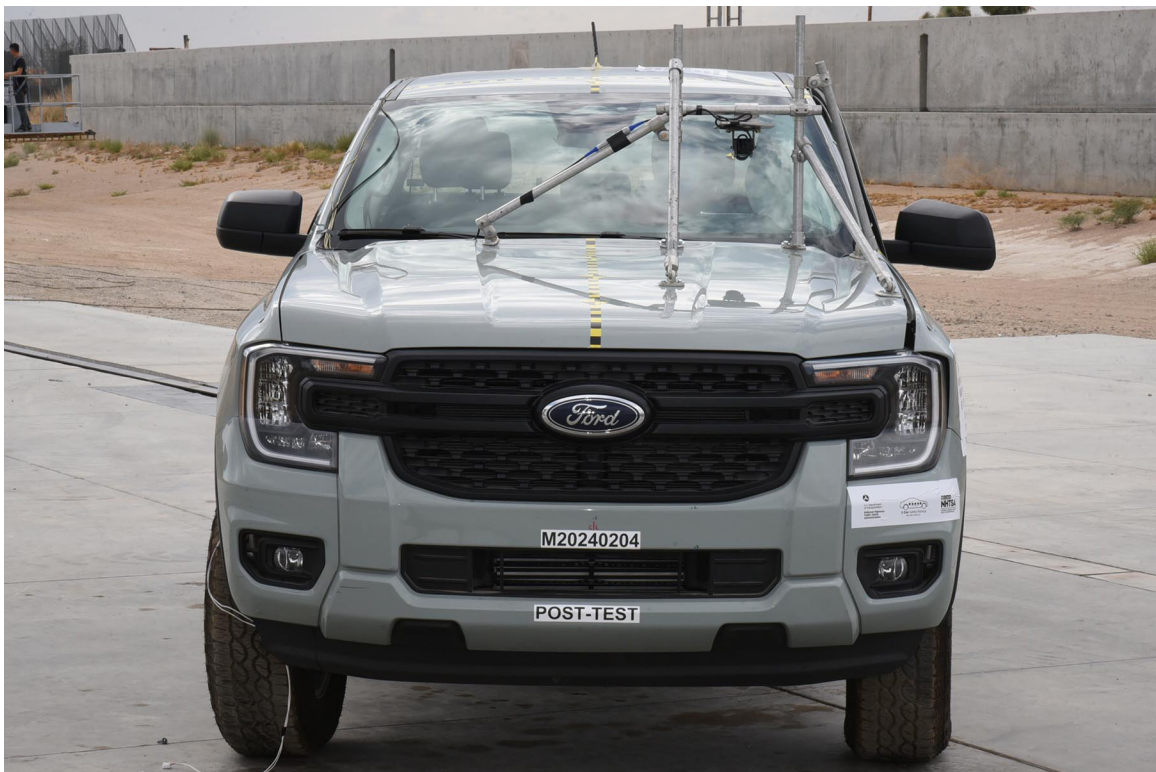
FIGURE 4. Post-Test Frontal View of Test Vehicle

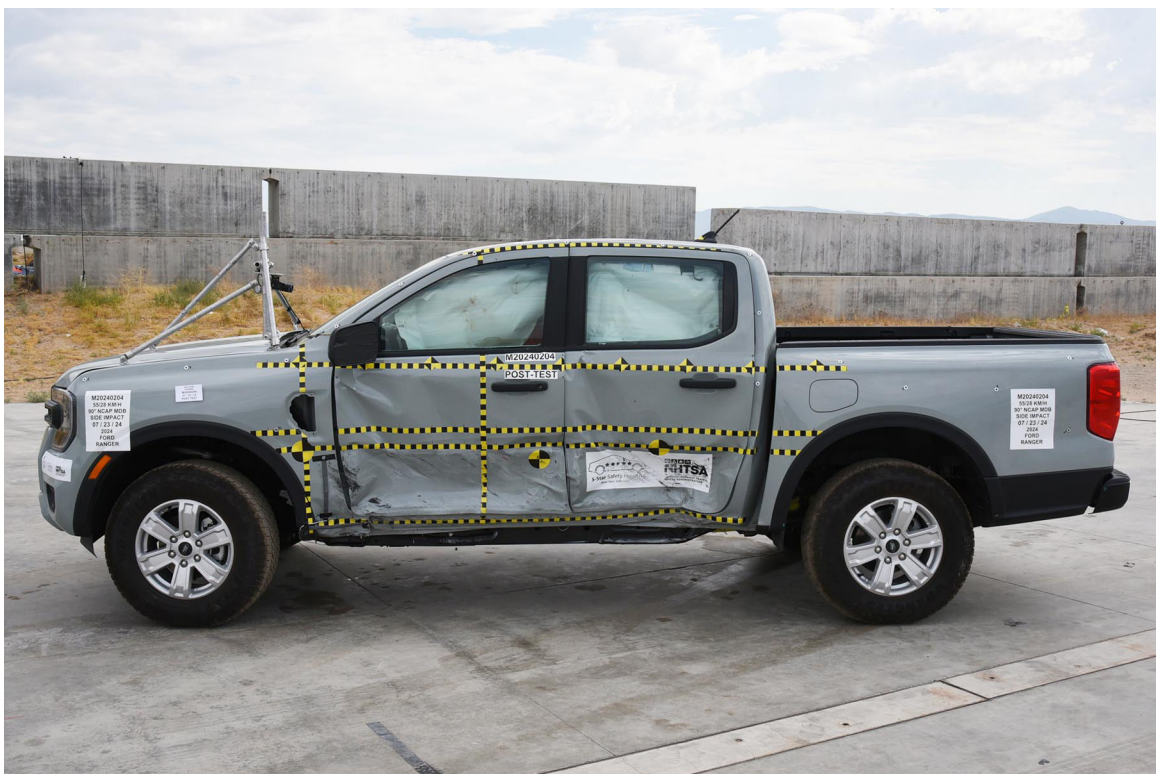
FIGURE 8. Post-Test Left Side View of Test Vehicle

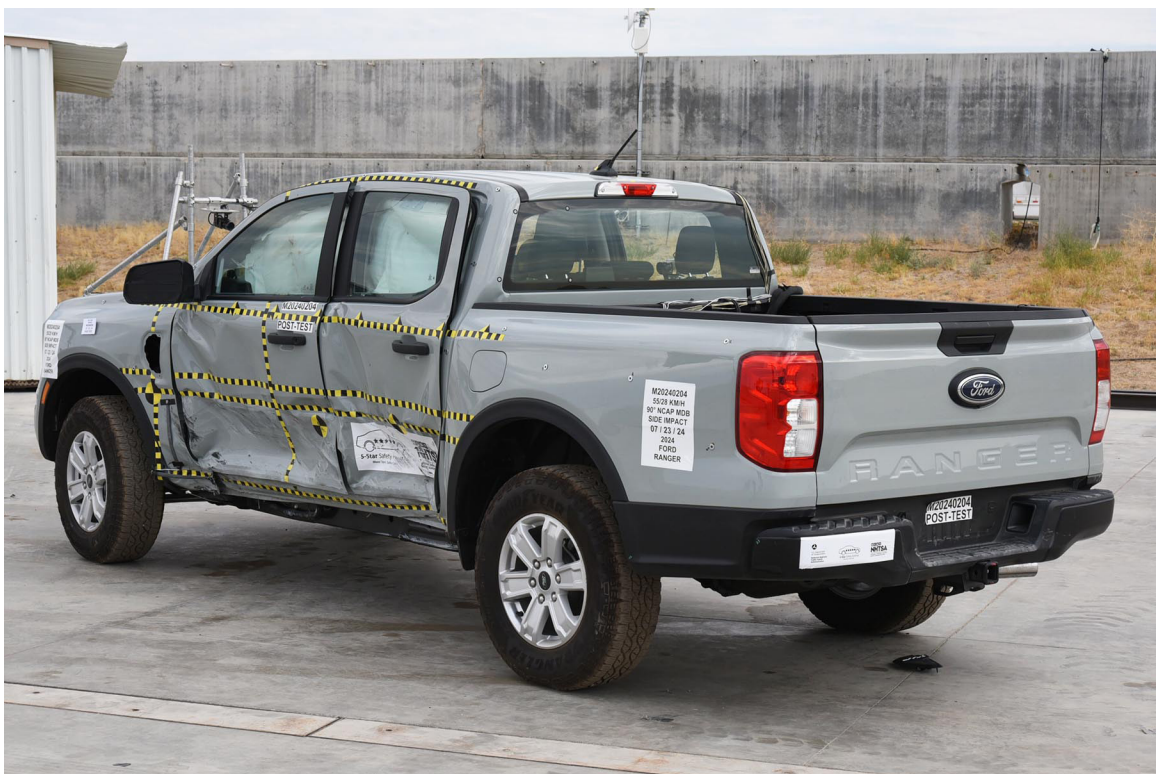
FIGURE 10. Post-Test Left Rear 3/4 View of Test Vehicle

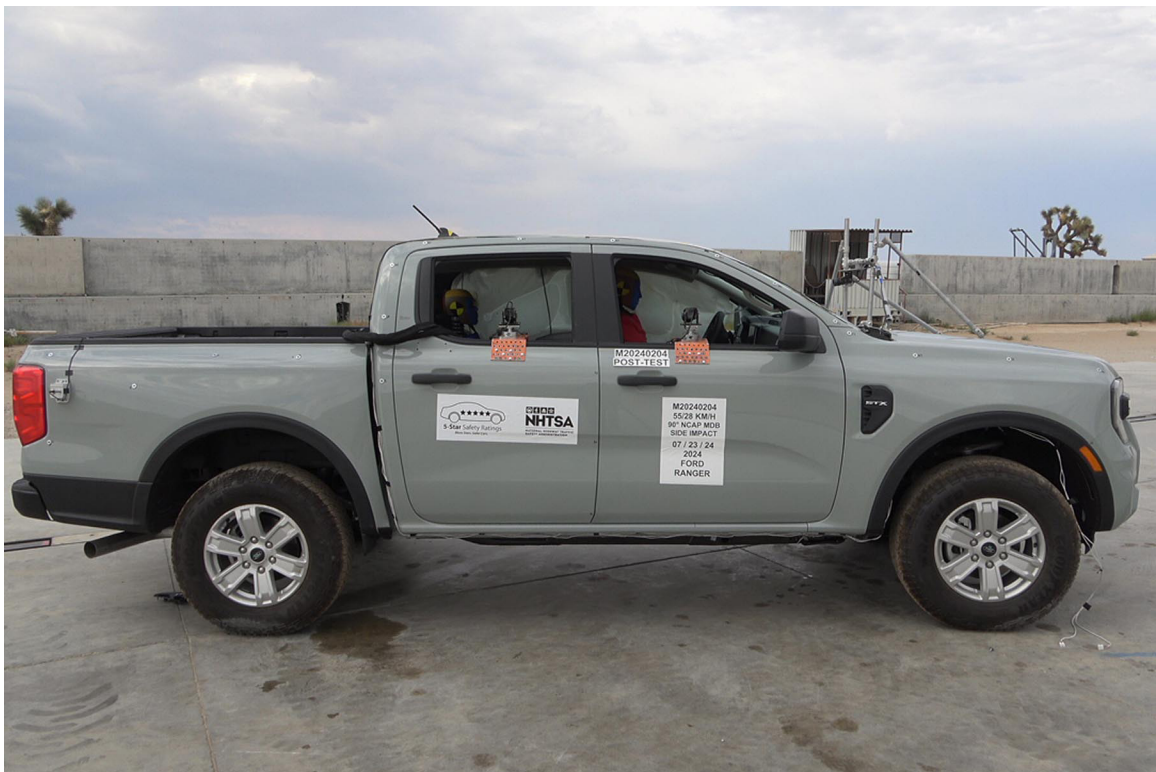
FIGURE 14. Post-Test Right Side View of Test Vehicle

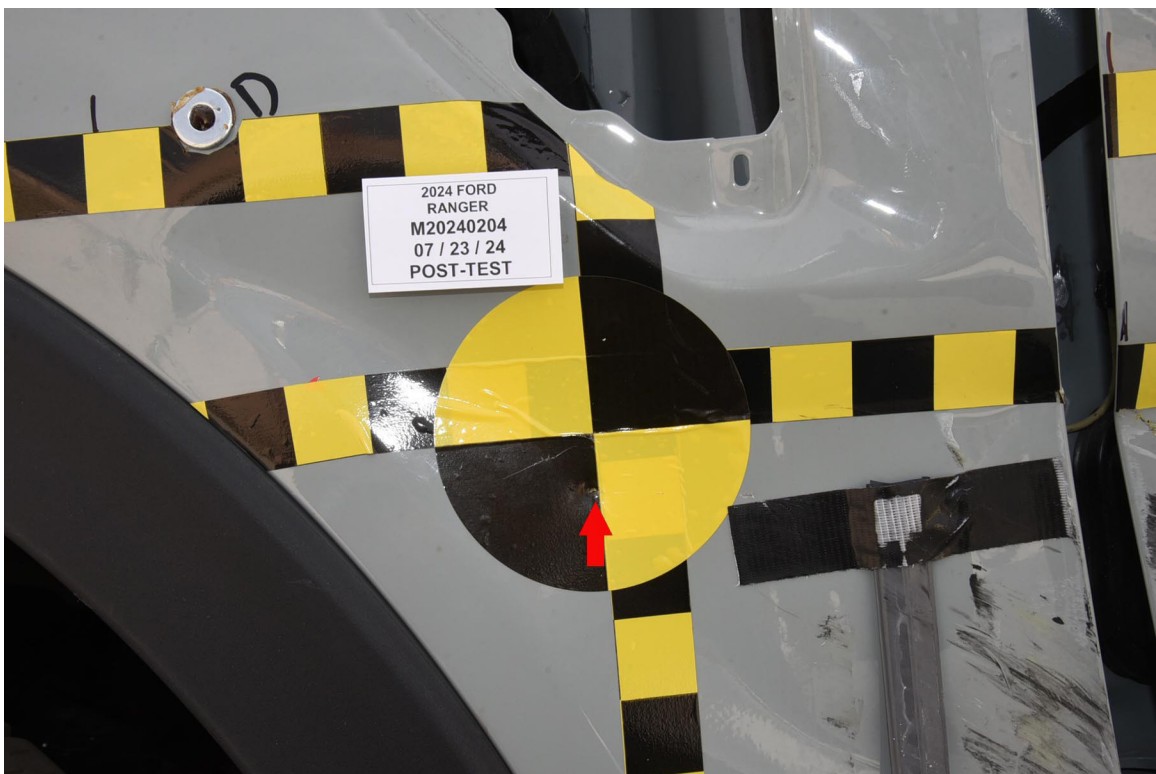
FIGURE 20. Post-Test Close-Up View of Impact Point Target

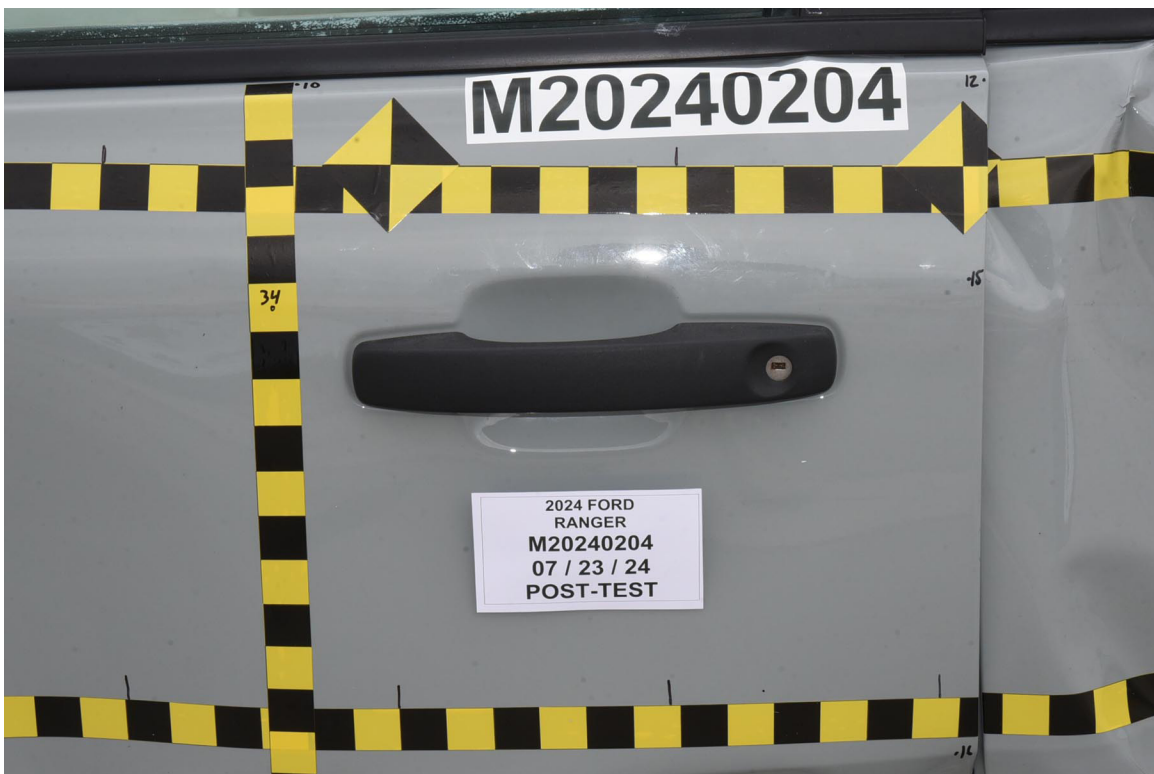
FIGURE 22. Post-Test Left Front Door Latch Close-Up

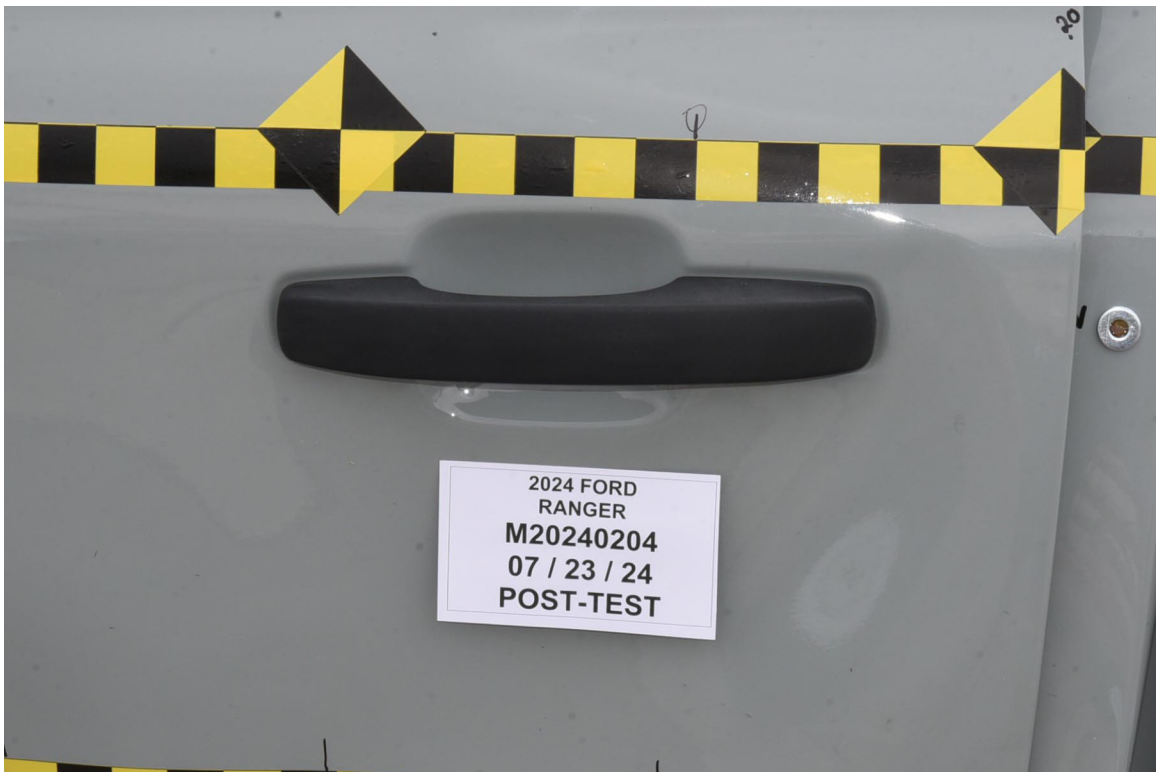
FIGURE 24. Post-Test Left Rear Door Latch Close-Up

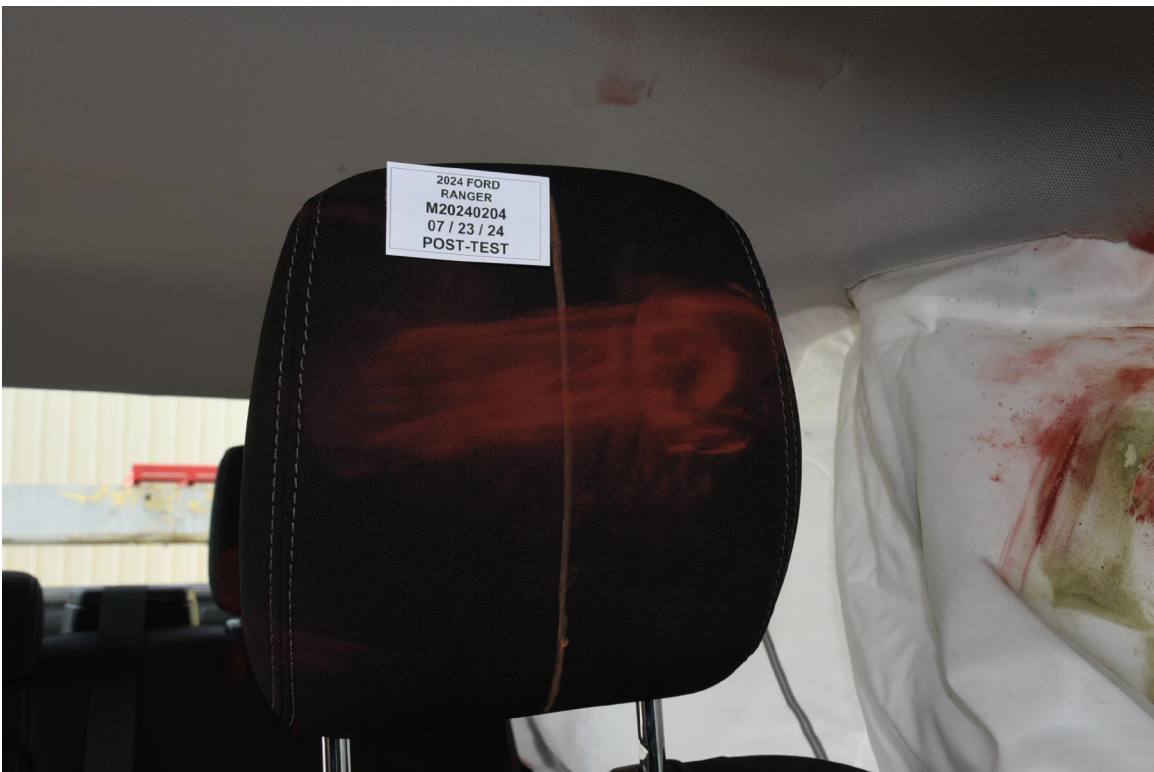
FIGURE 48. Post-Test Driver Dummy Close-Up Head Contact with Vehicle Interior View

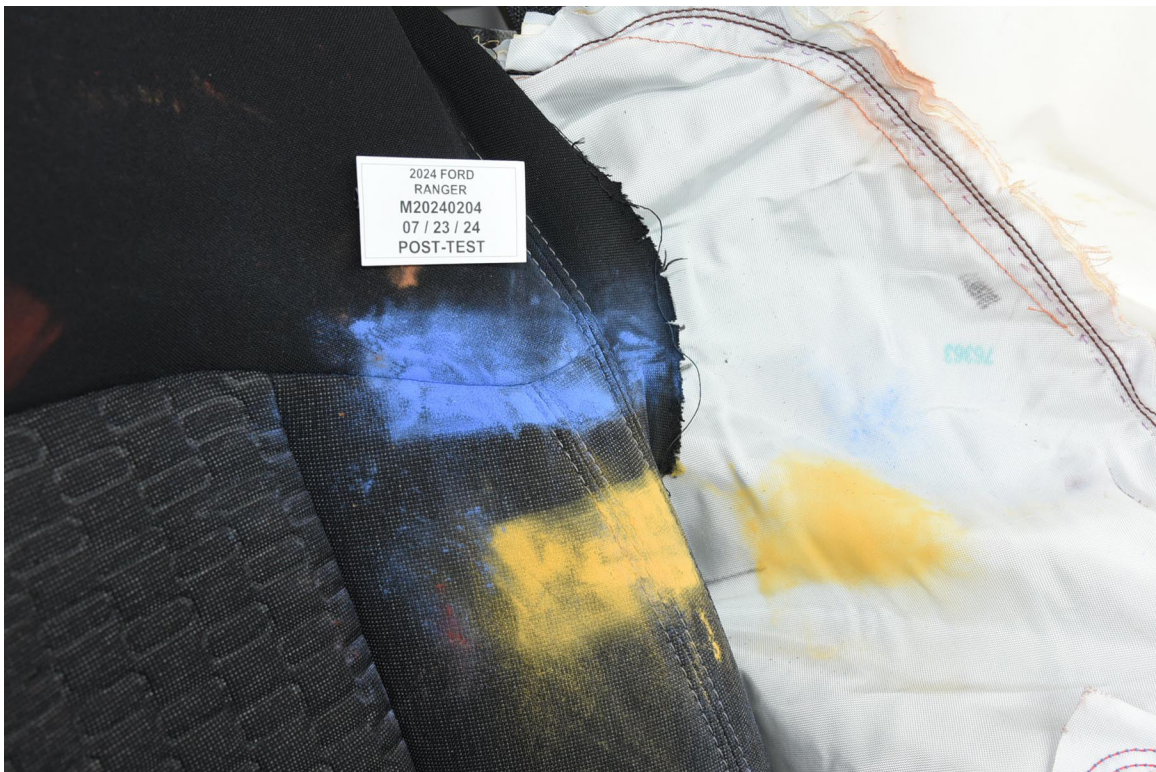
FIGURE 50. Post-Test Driver Dummy Close-Up Torso Contact With Vehicle Interior View

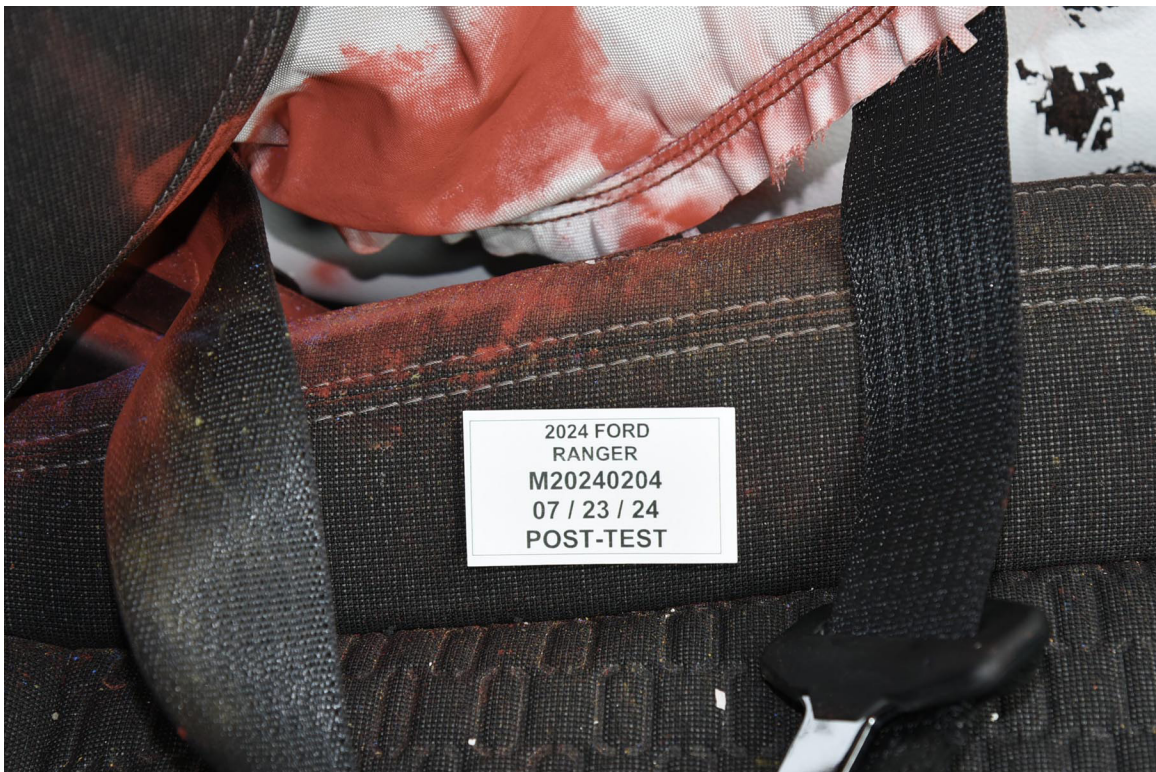
FIGURE 52. Post-Test Driver Dummy Close-Up Pelvis Contact With Vehicle Interior View

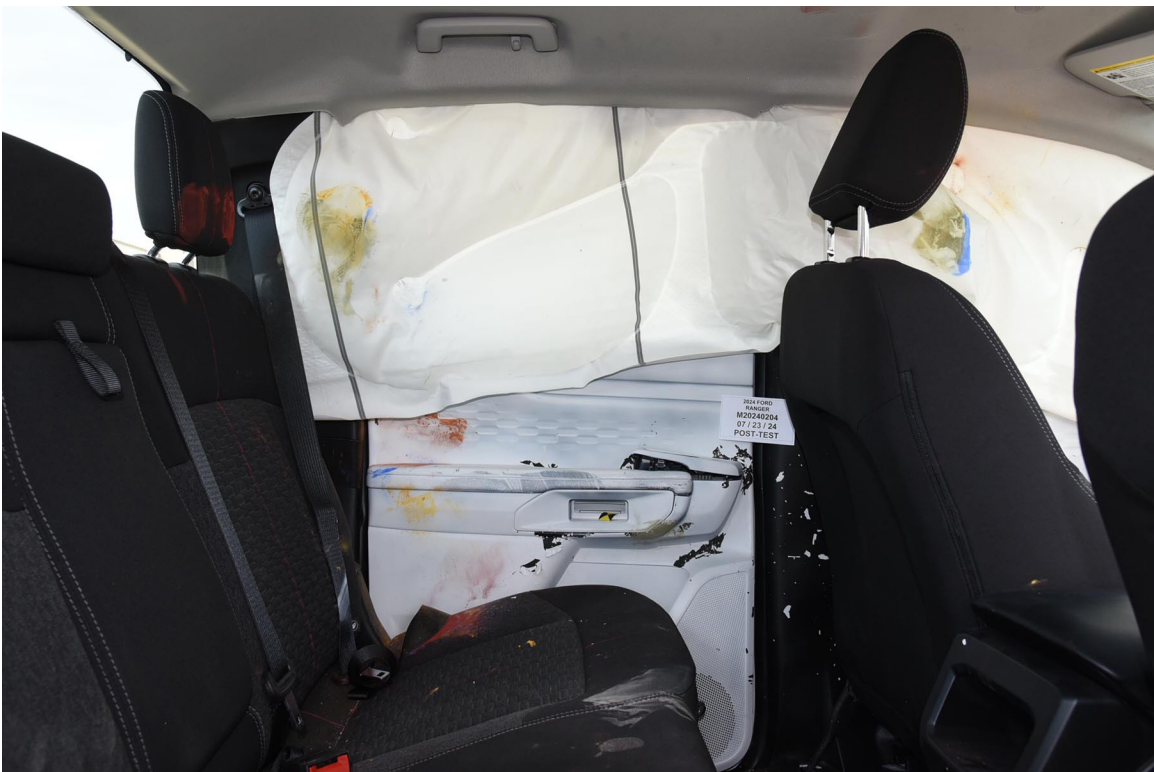
FIGURE 74. Post-Test Rear Passenger Inner Door Panel View

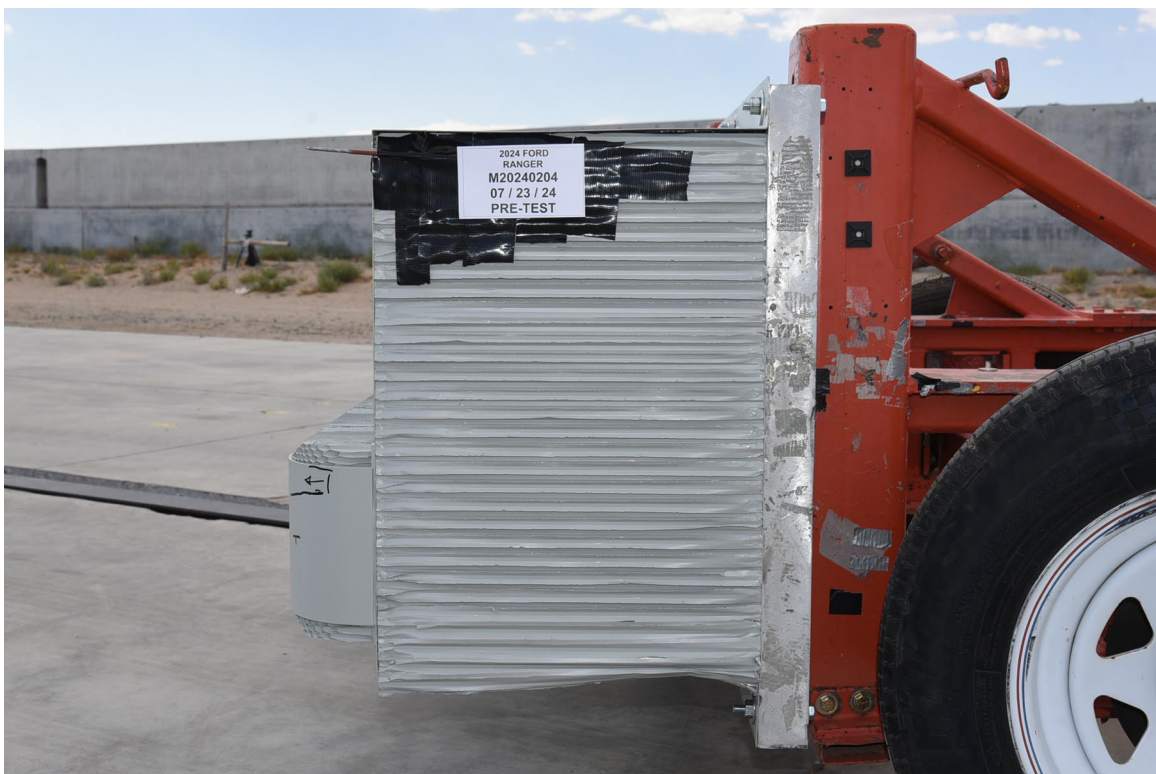
FIGURE 88. Pre-Test Left View of MDB Impactor Face

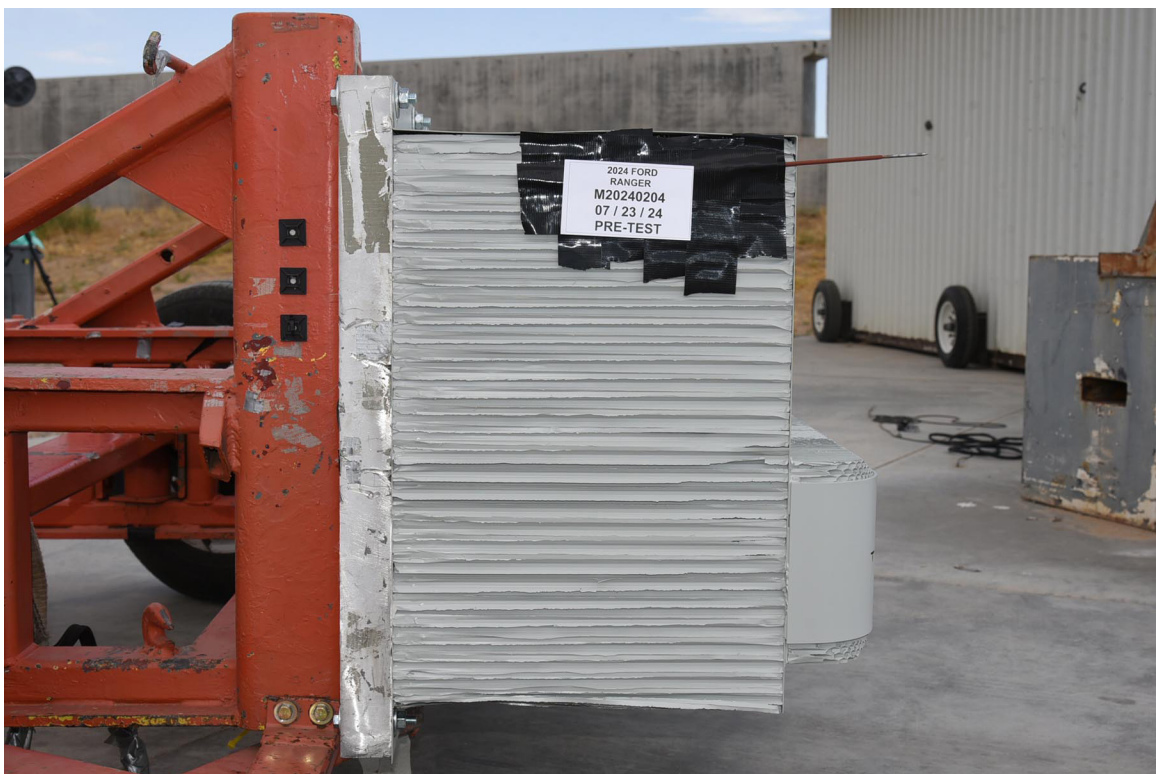
FIGURE 90. Pre-Test Right View of MDB Impactor Face

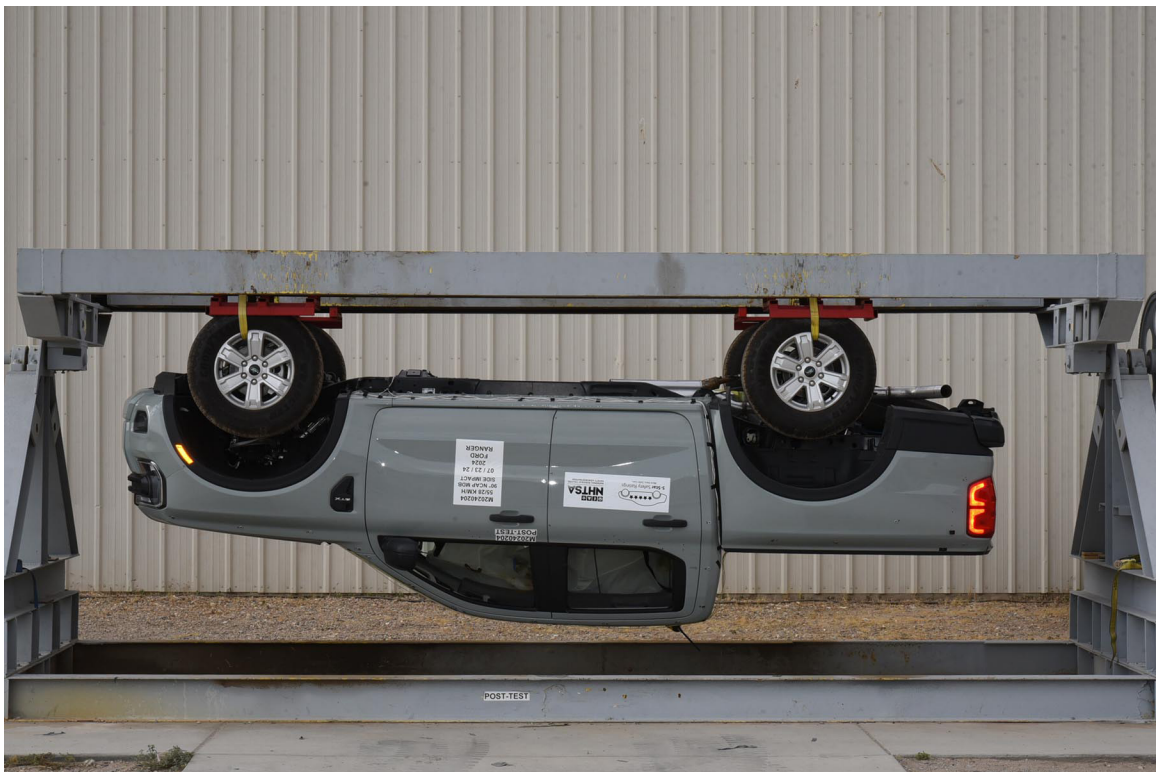
FIGURE 98. FMVSS No. 301 Static Rollover 180 Degrees
