**REPORT NUMBER: SideNCAPMDB-KAR-24-006**

**NEW CAR ASSESSMENT PROGRAM (NCAP)  
MOVING DEFORMABLE BARRIER SIDE IMPACT TEST**

**VINFAST TRADING AND PRODUCTION JSC.  
2024 VINFAST VF8 ECO 5-DOOR SUV**

**NHTSA No: M20244702**

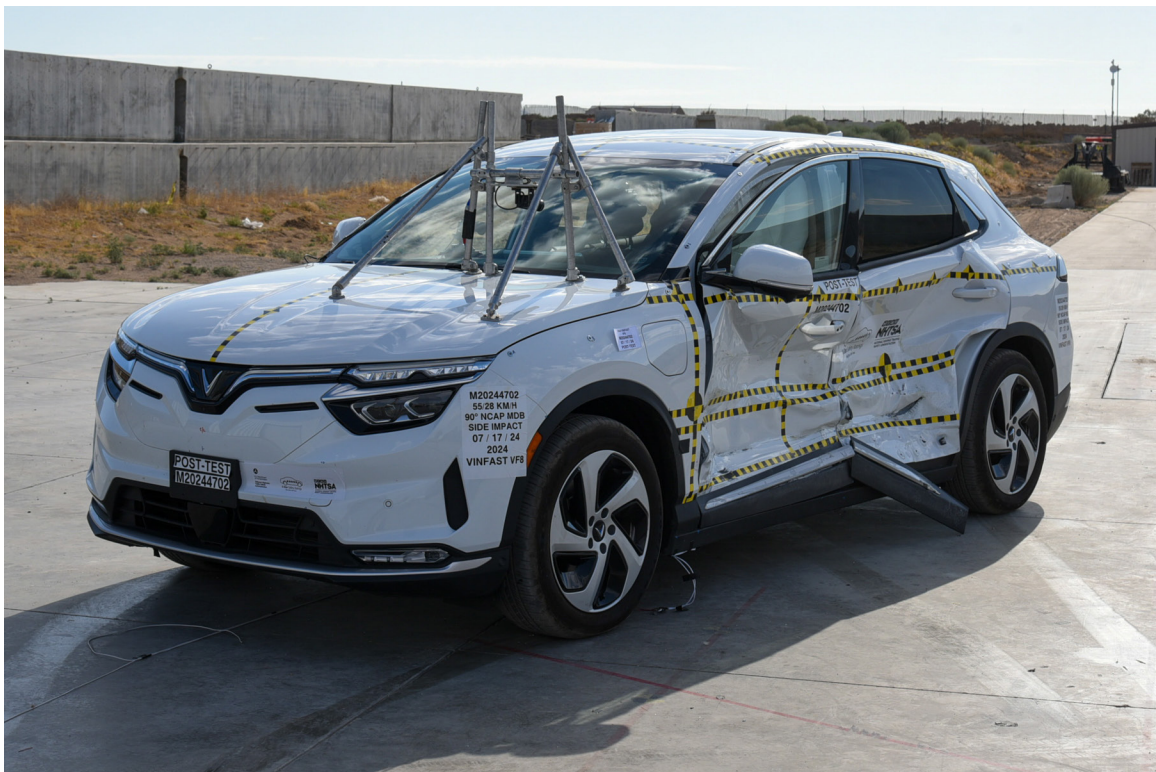
FIGURE 6. Post-Test Left Front 3/4 View of Test Vehicle

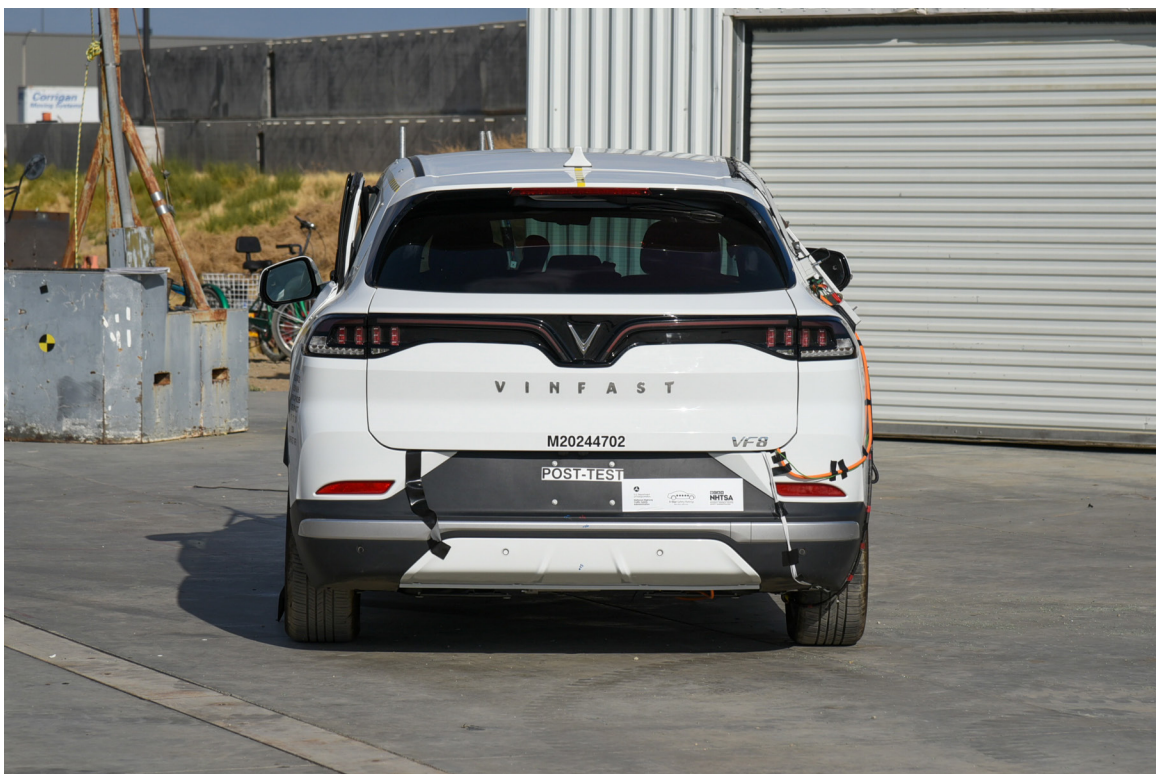
FIGURE 12. Post-Test Rear View of Test Vehicle

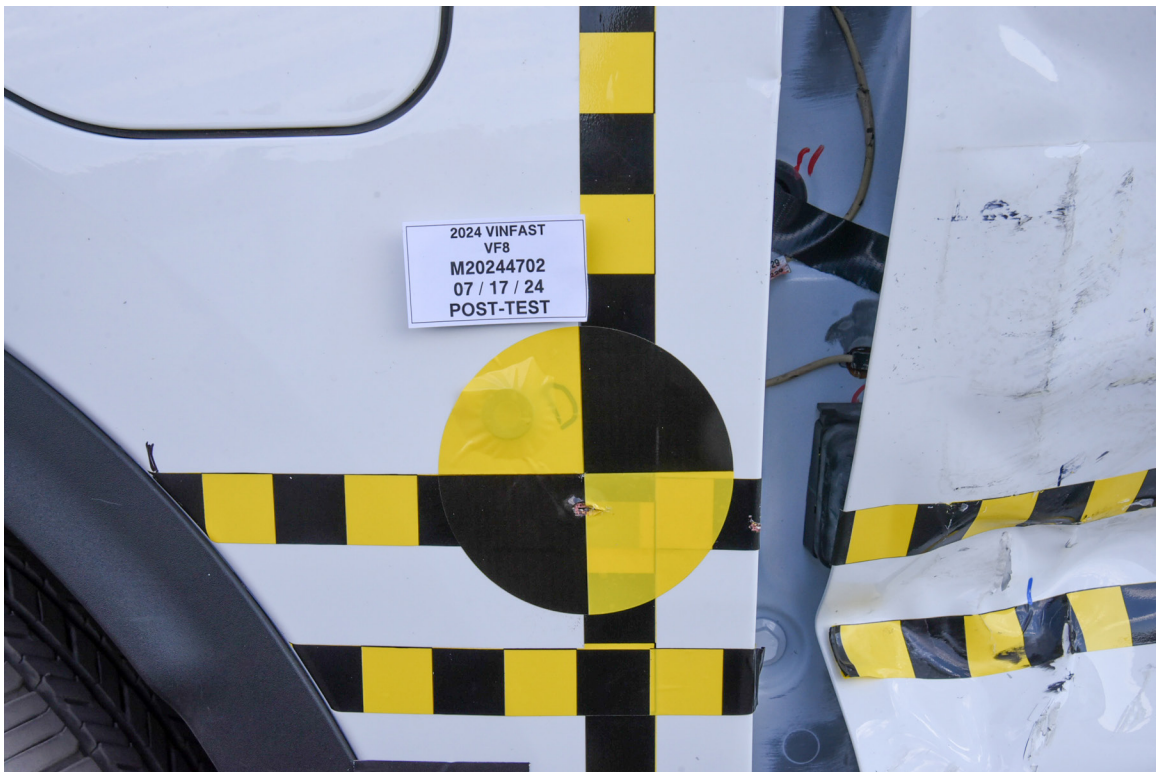
FIGURE 20. Post-Test Close-Up View of Impact Point Target

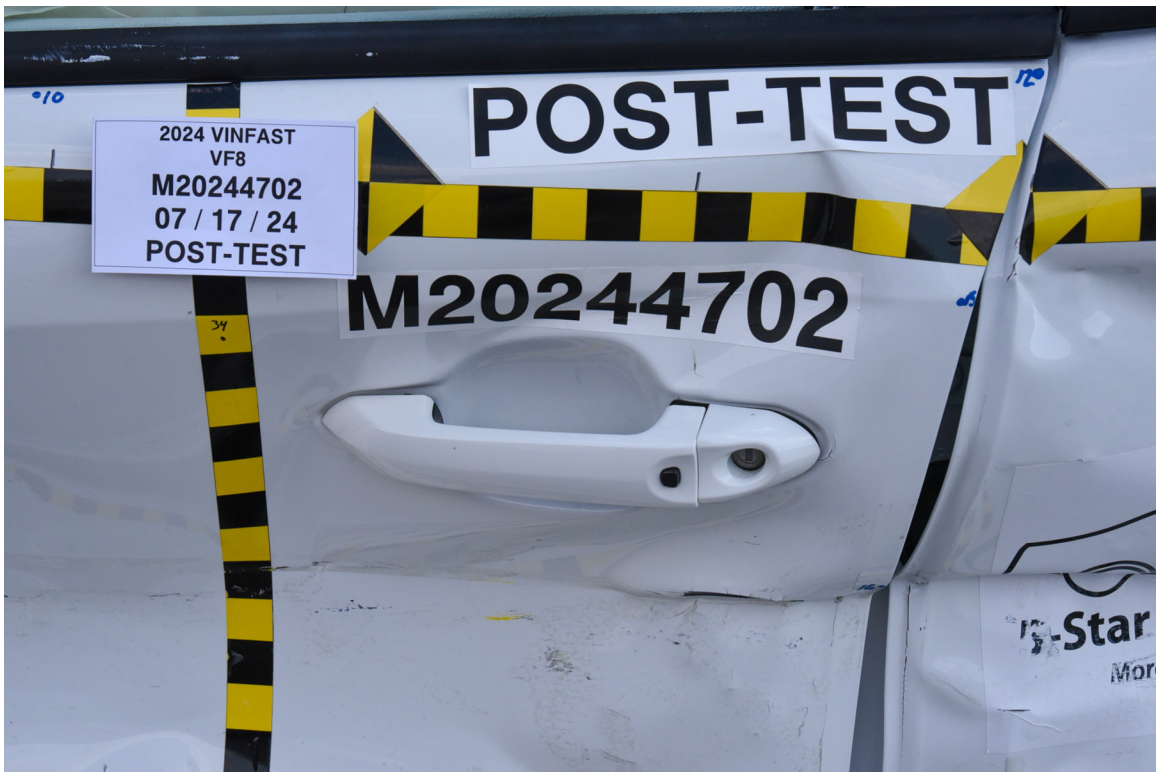
FIGURE 22. Post-Test Left Front Door Latch Close-Up

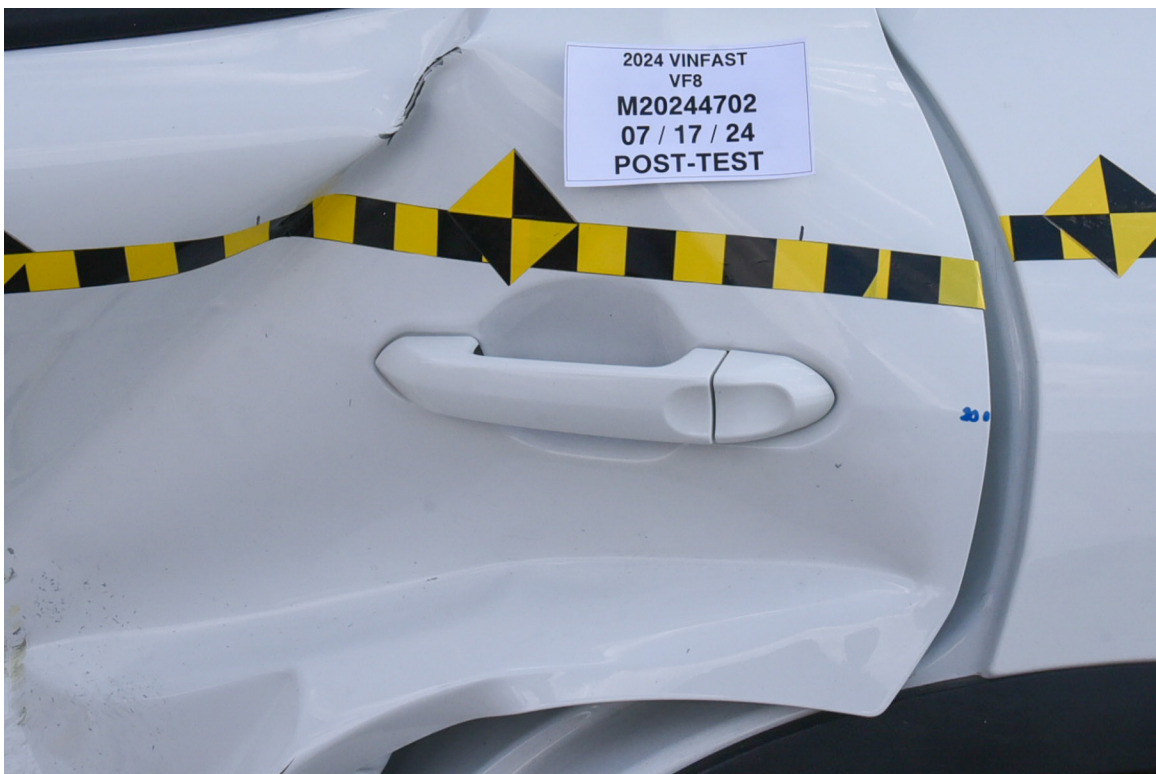
FIGURE 24. Post-Test Left Rear Door Latch Close-Up

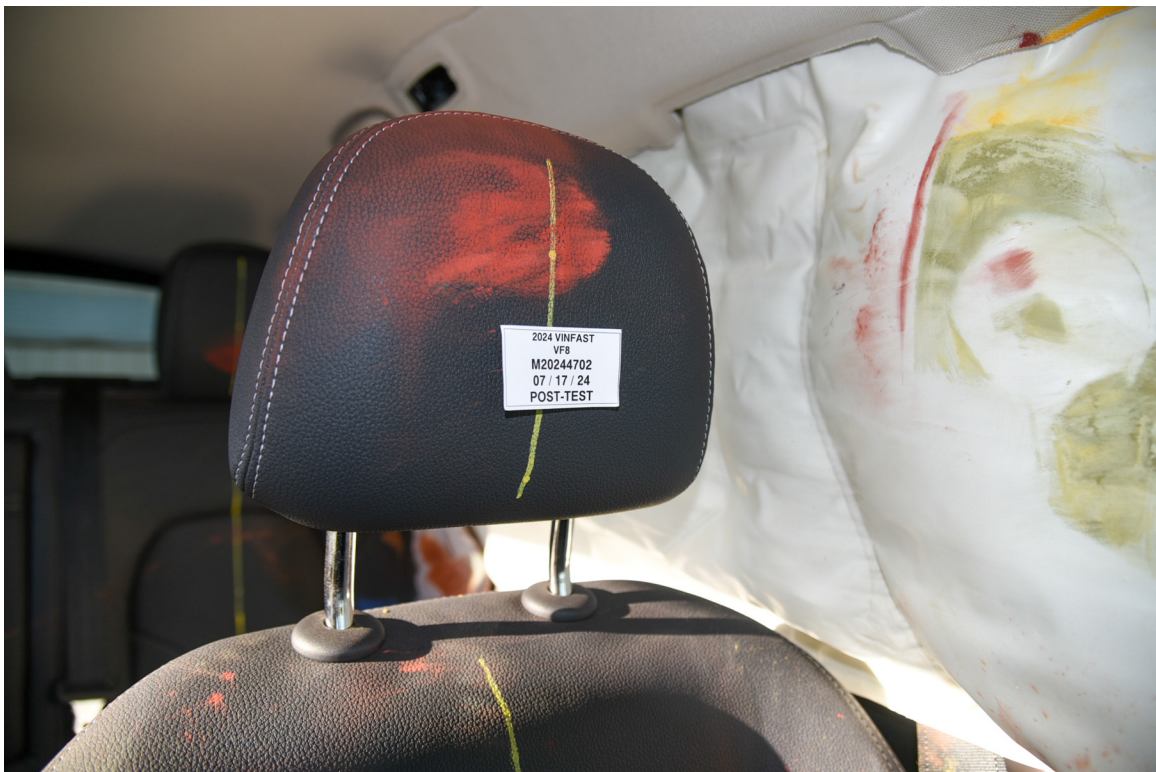
FIGURE 48. Post-Test Driver Dummy Close-Up Head Contact with Vehicle Interior View

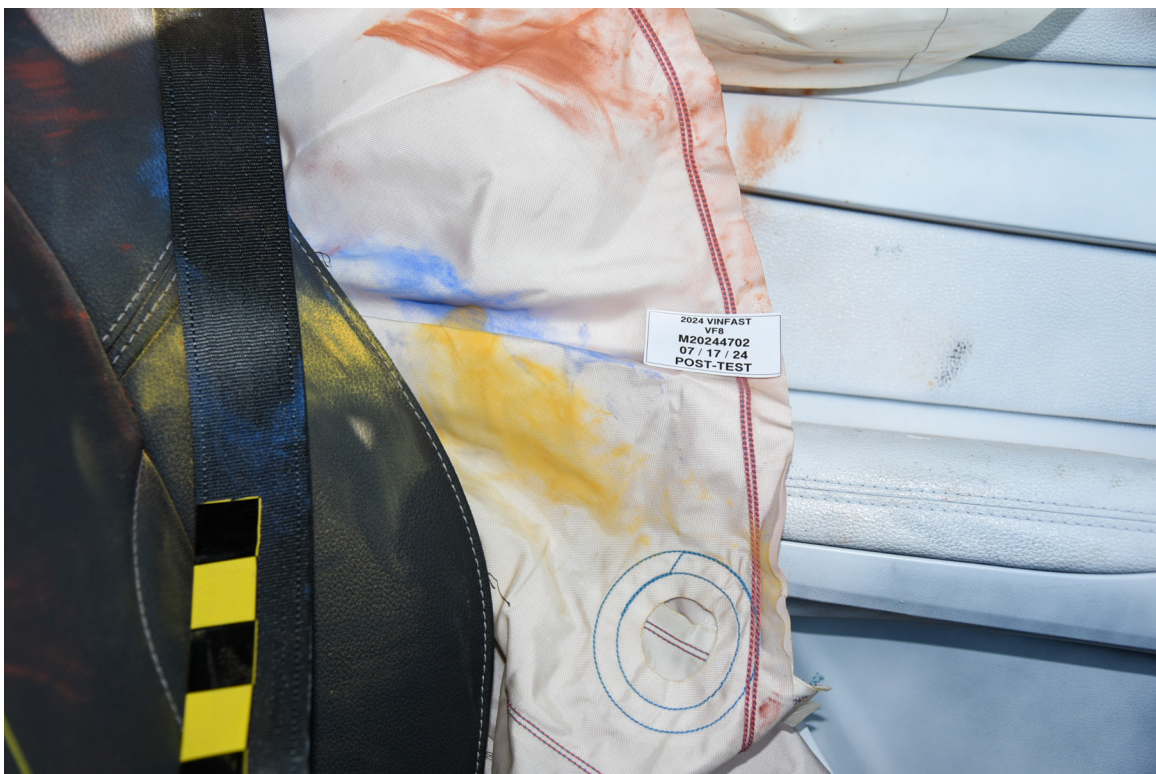
FIGURE 50. Post-Test Driver Dummy Close-Up Torso Contact With Vehicle Interior View

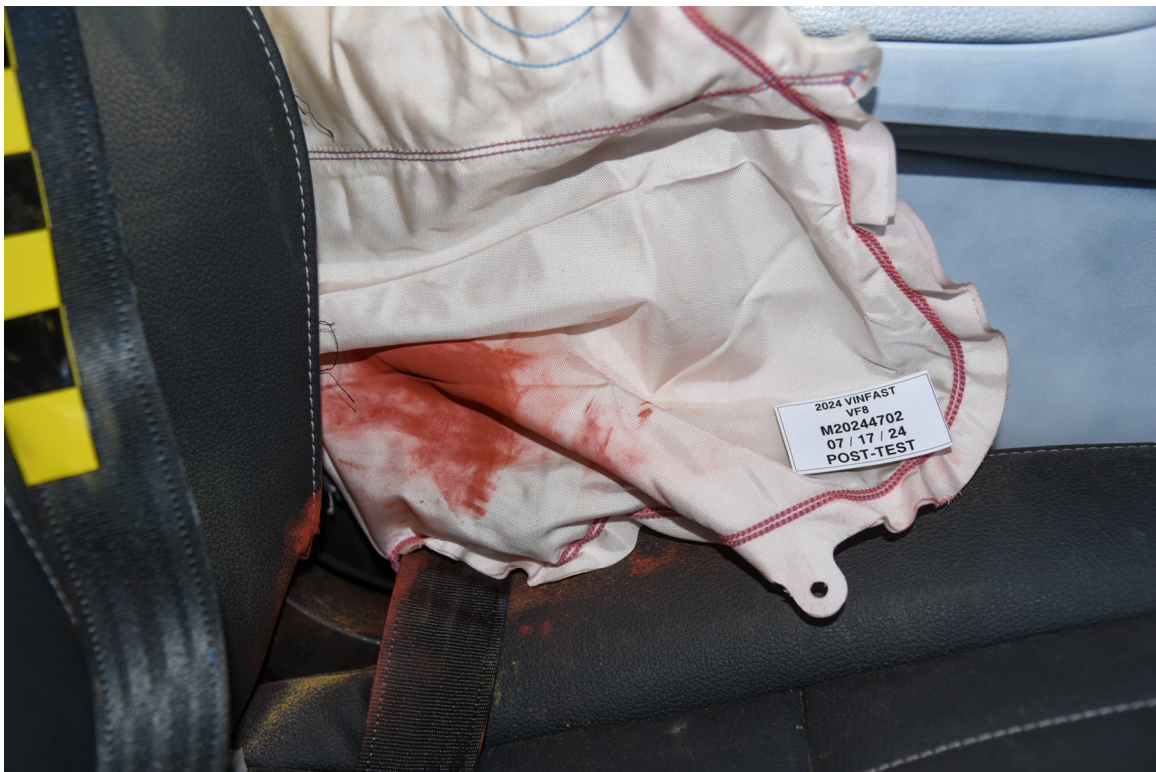
FIGURE 52. Post-Test Driver Dummy Close-Up Pelvis Contact With Vehicle Interior View

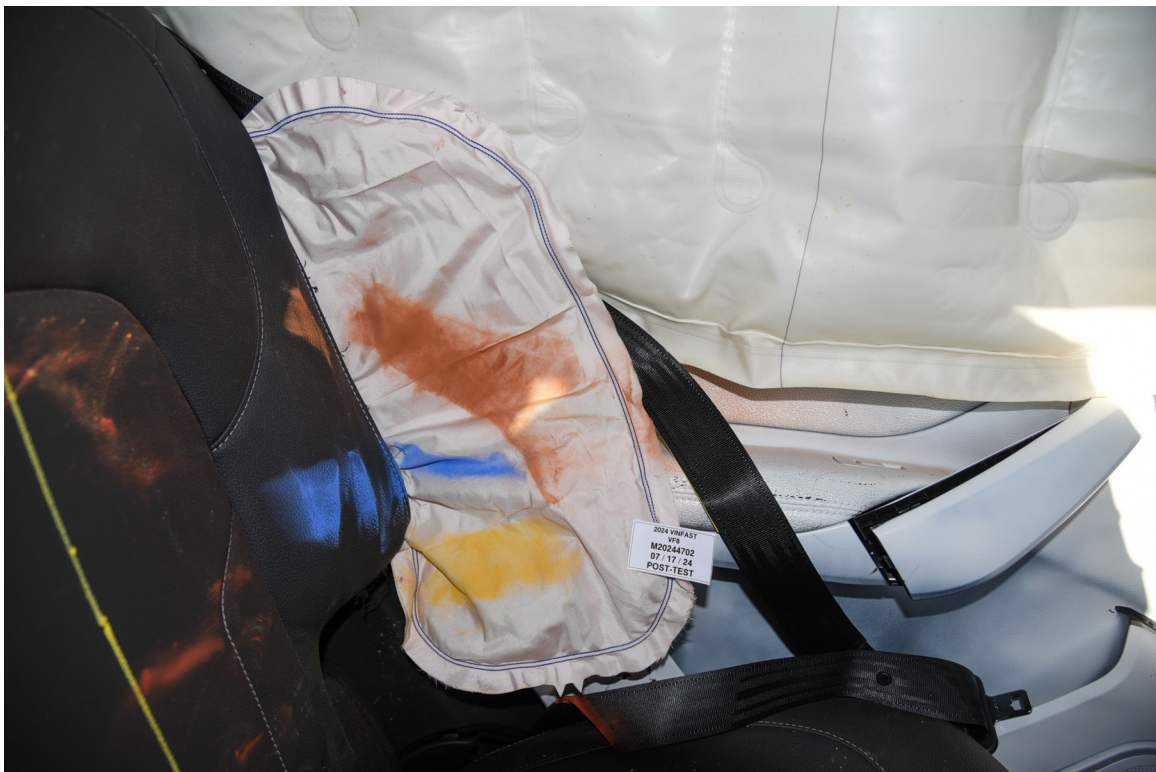
FIGURE 78. Post-Test Rear Passenger Dummy Close-Up Torso Contact with Vehicle Side Air Bag View

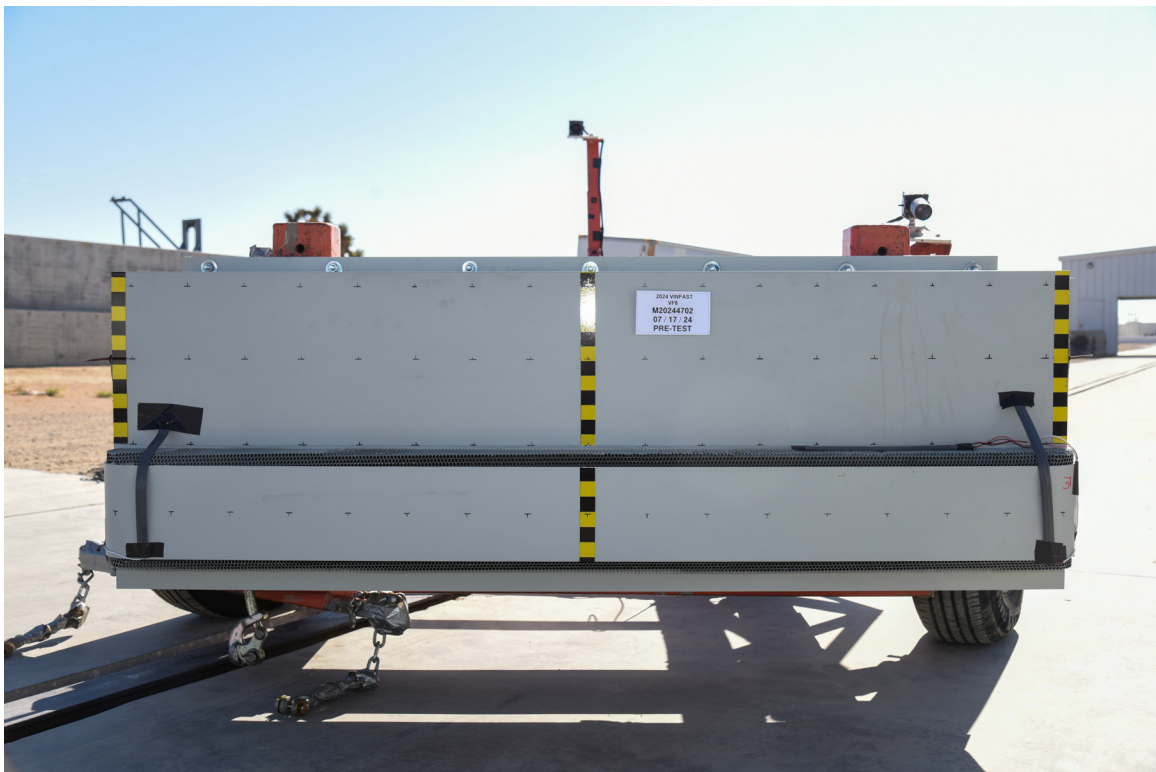
FIGURE 84. Pre-Test Front View of MDB Impactor Face

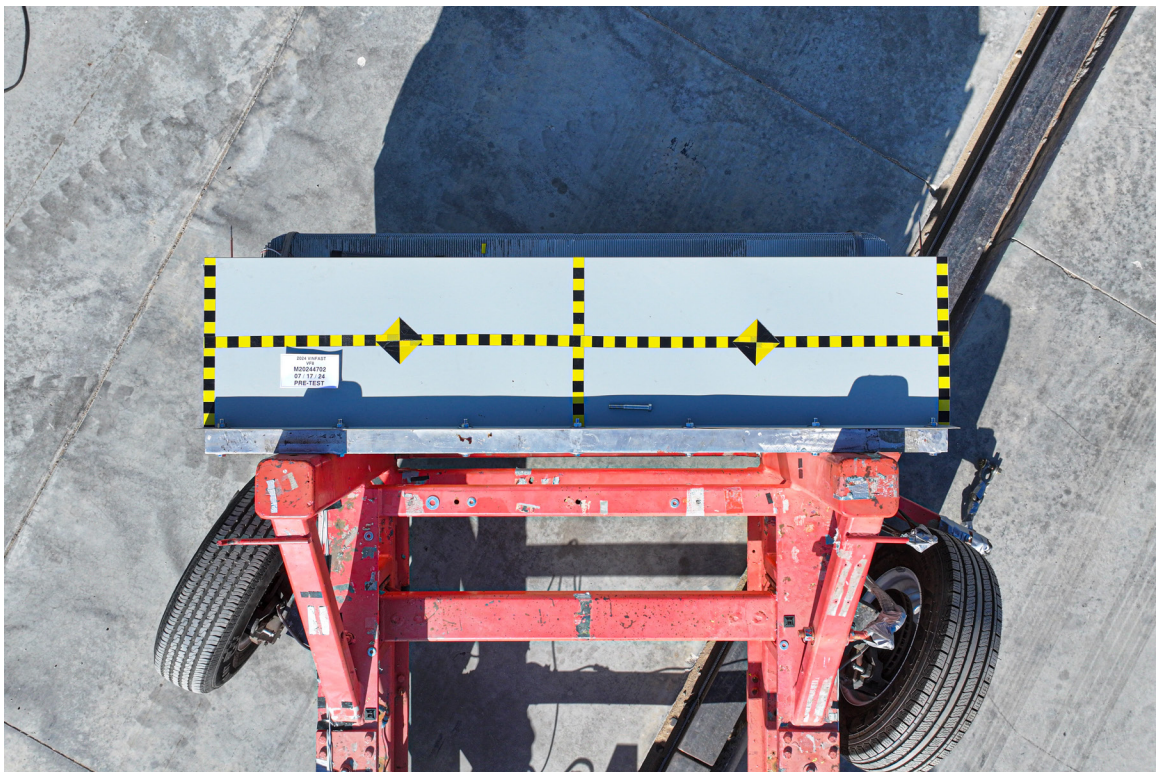
FIGURE 86. Pre-Test Top View of MDB Impactor Face

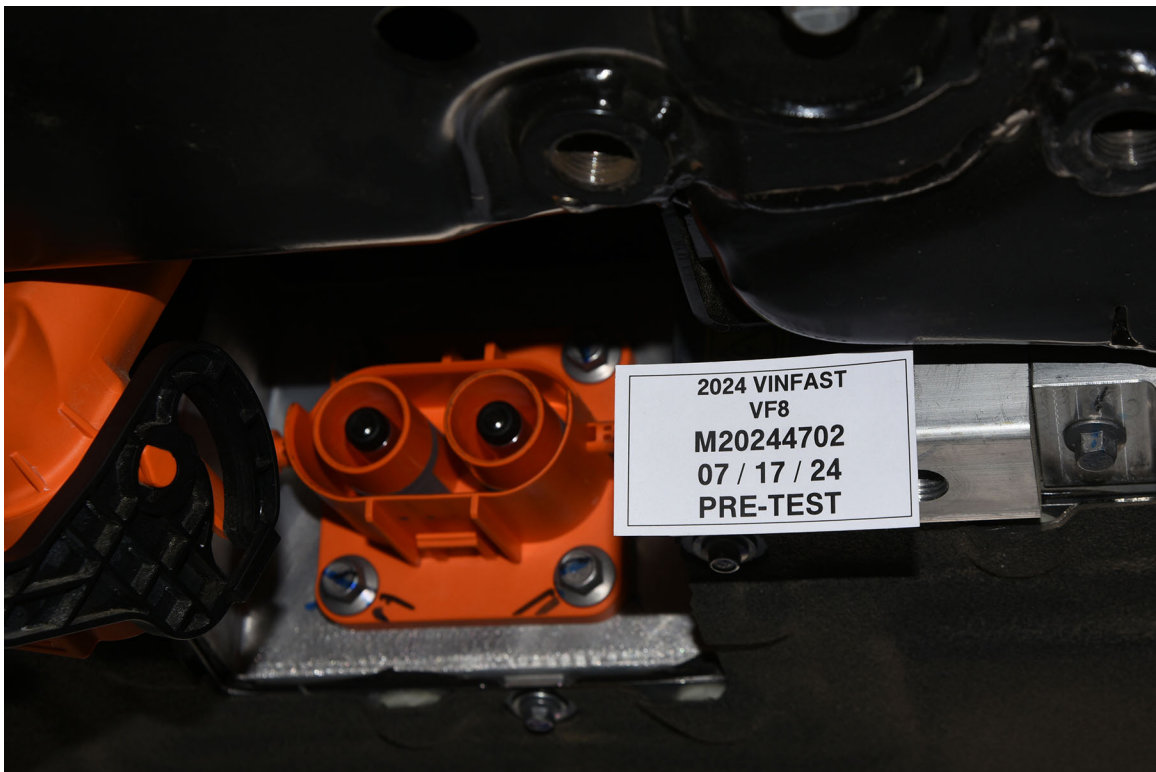
FIGURE 305-08 Manual High Voltage Service Disconnect Removed

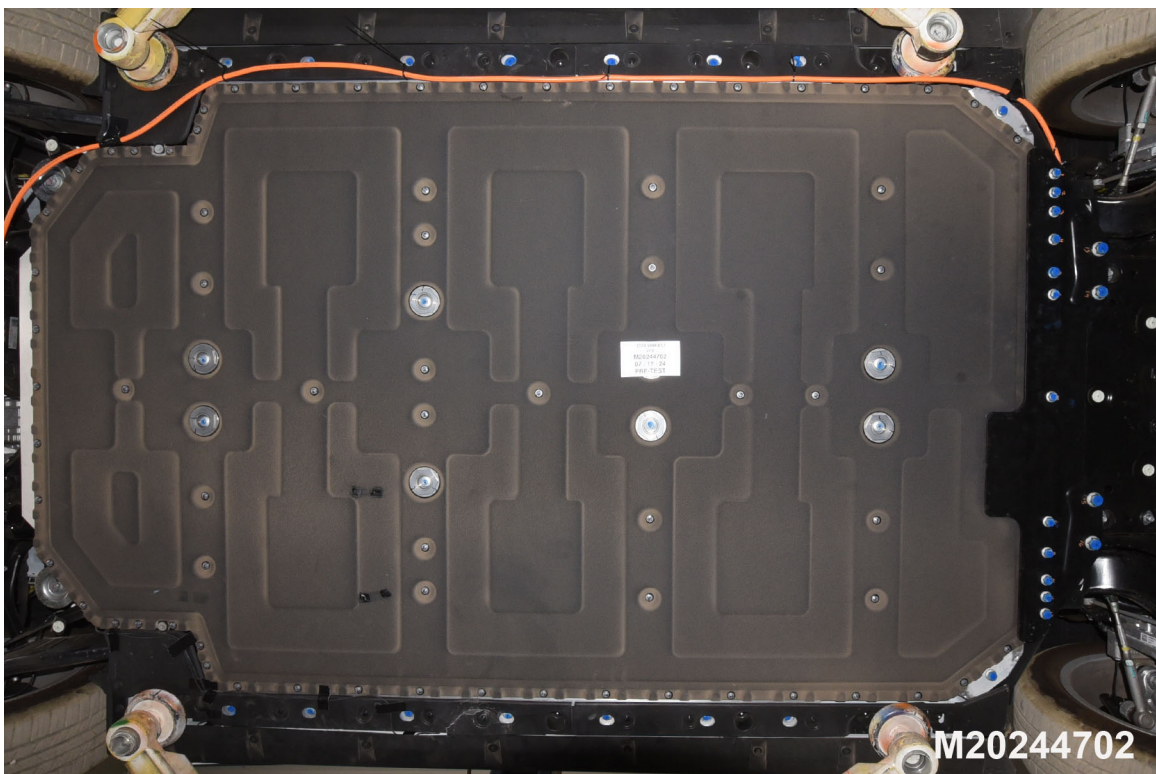
FIGURE 305-012 Pre-Impact View of Battery Box(s) or Container(s) Which Holds Individual Battery Modules
