**REPORT NUMBER: SideNCAPMDB-MGA-24-022**

**NEW CAR ASSESSMENT PROGRAM (NCAP)  
Moving Deformable Barrier Side Impact Test**

**GENERAL MOTORS DE MEXICO, S. DE R.L. DE C.V.  
2024 Chevrolet Equinox EV 2LT 5-Door SUV  
NHTSA No.: M20240112**

**FINAL REPORT**

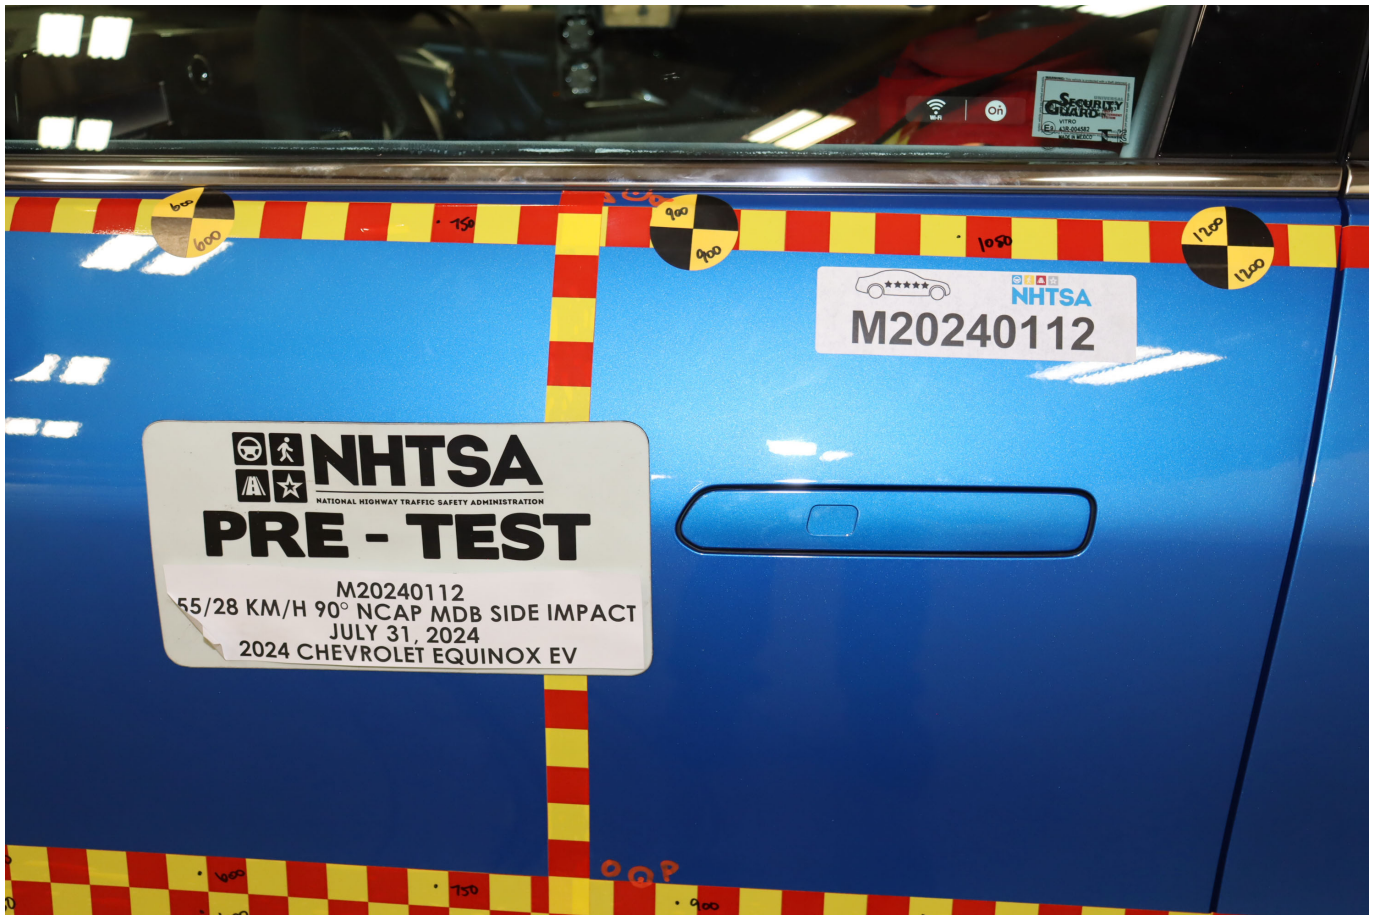
Photo No. 022 - Post-Test Left Front Door Latch Close-Up

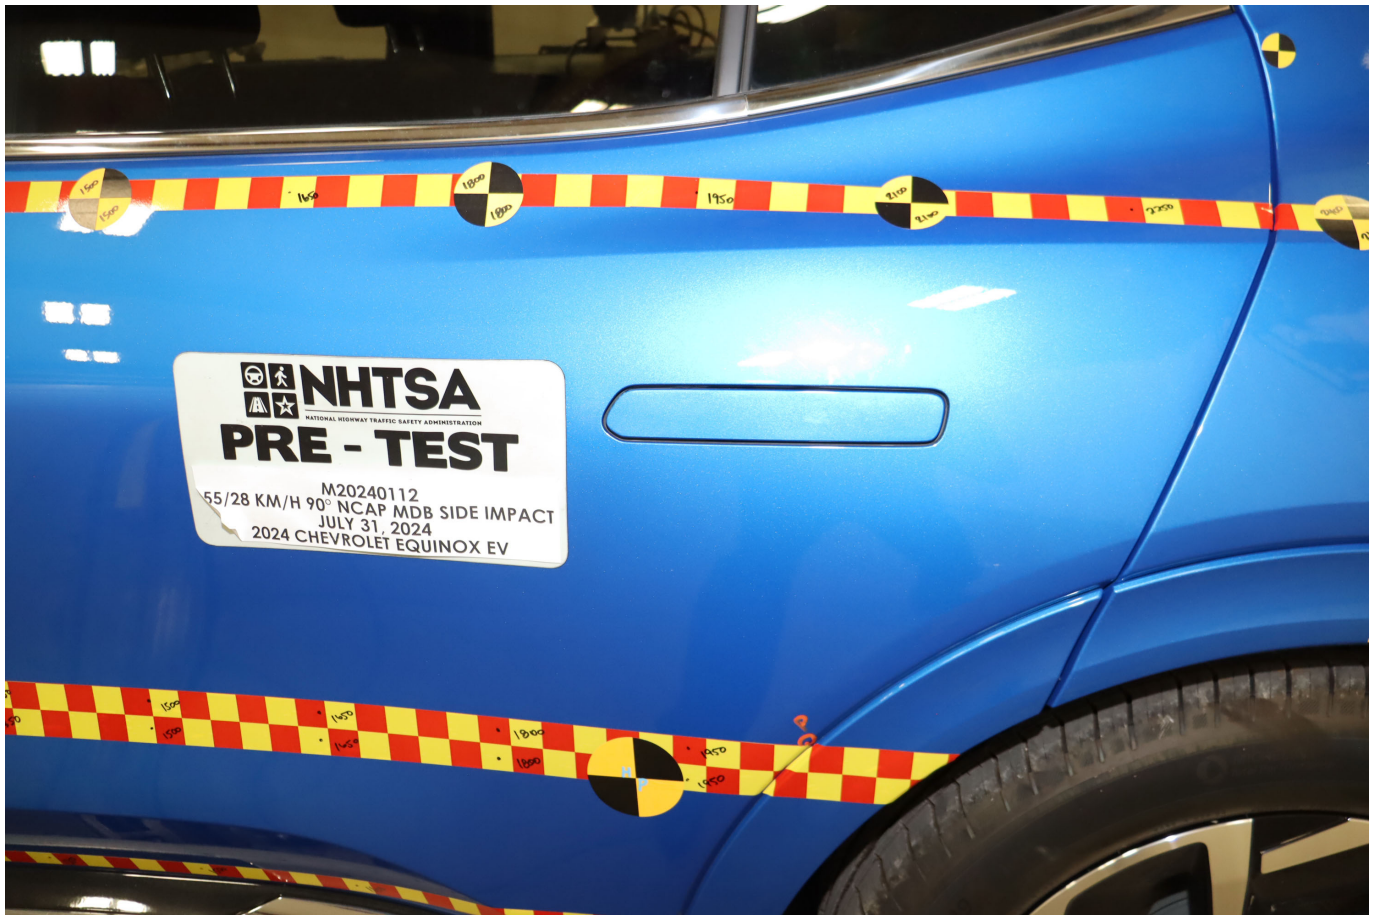
Photo No. 024 - Post-Test Left Rear Door Latch Close-Up

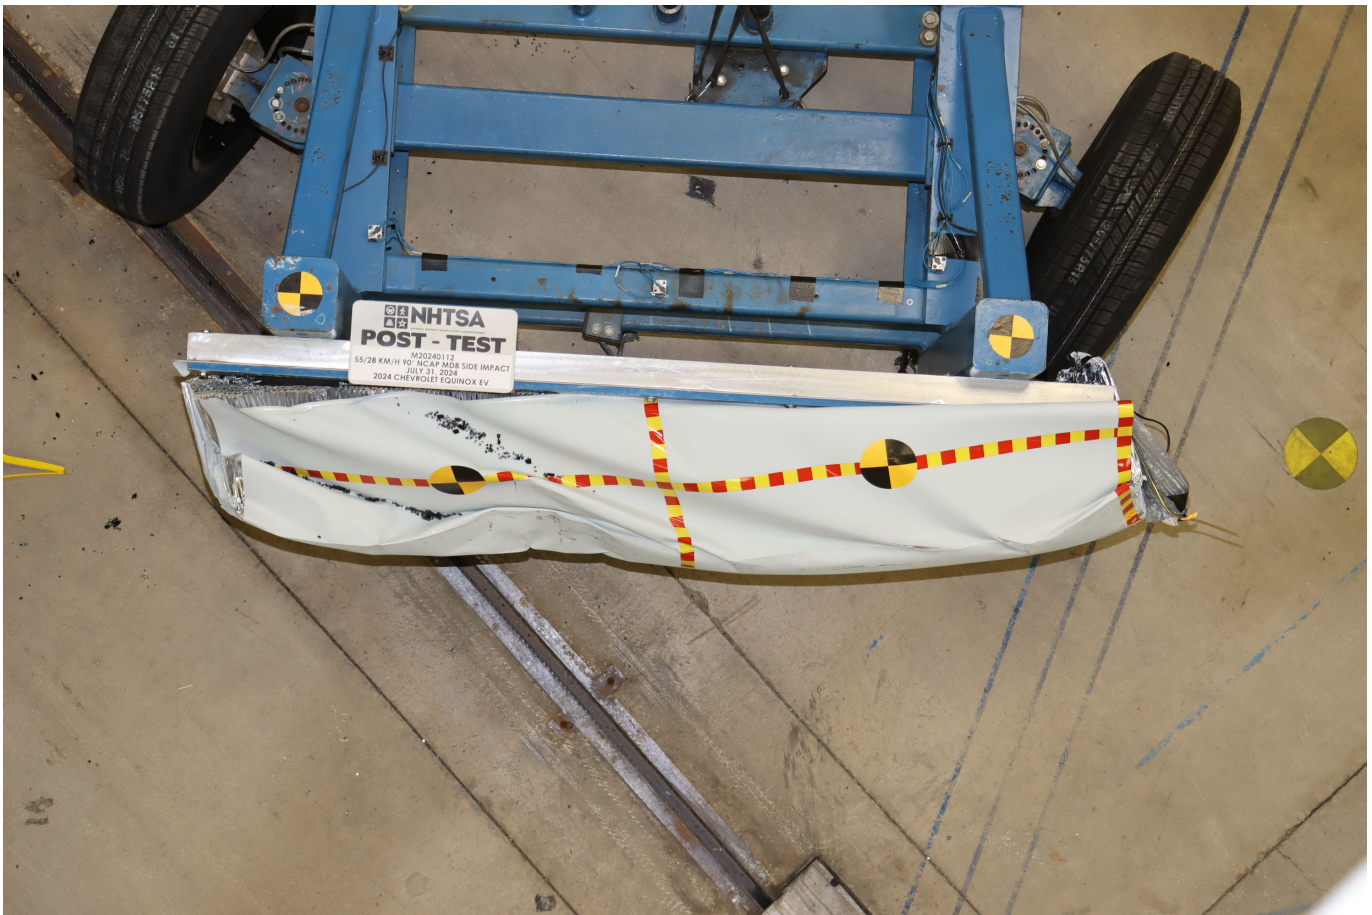
Photo No. 087 - Post-Test Top View of MDB Impactor Face

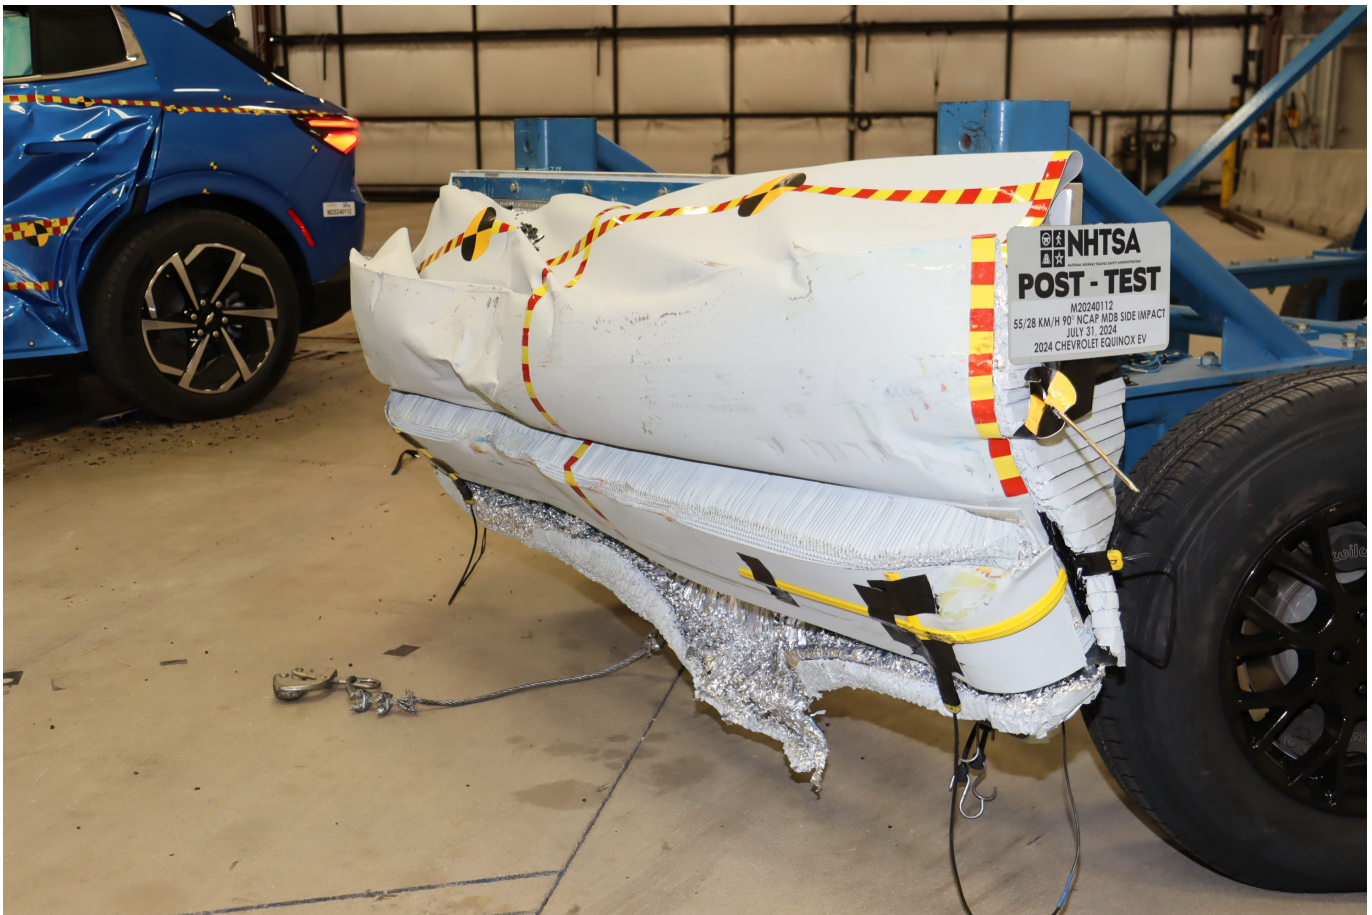
Photo No. 089 - Post-Test Left Side View of MDB Impactor Face

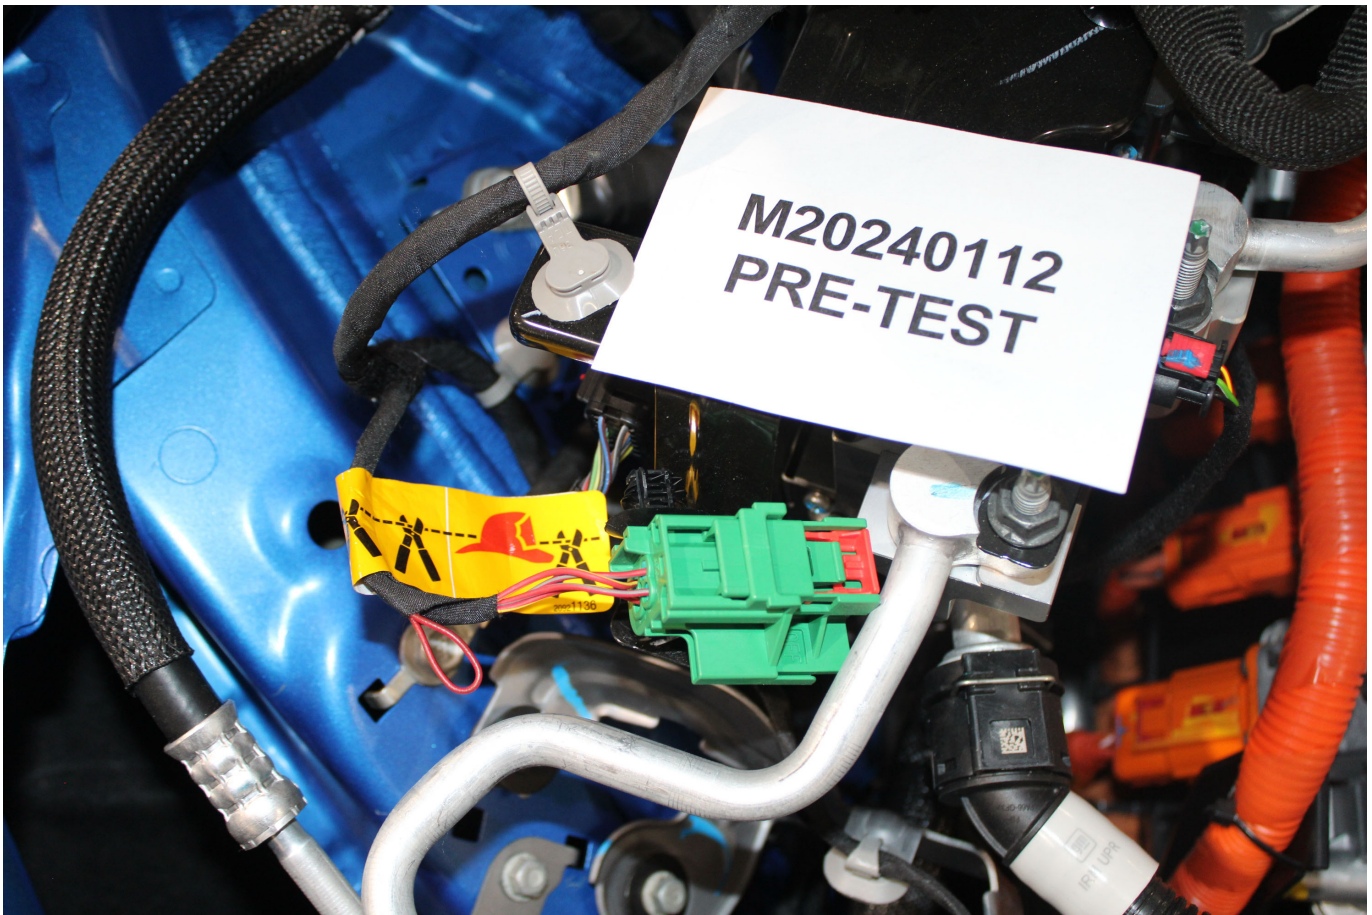
Photo No. 305-07 - Manual High Voltage Service Disconnect Removed

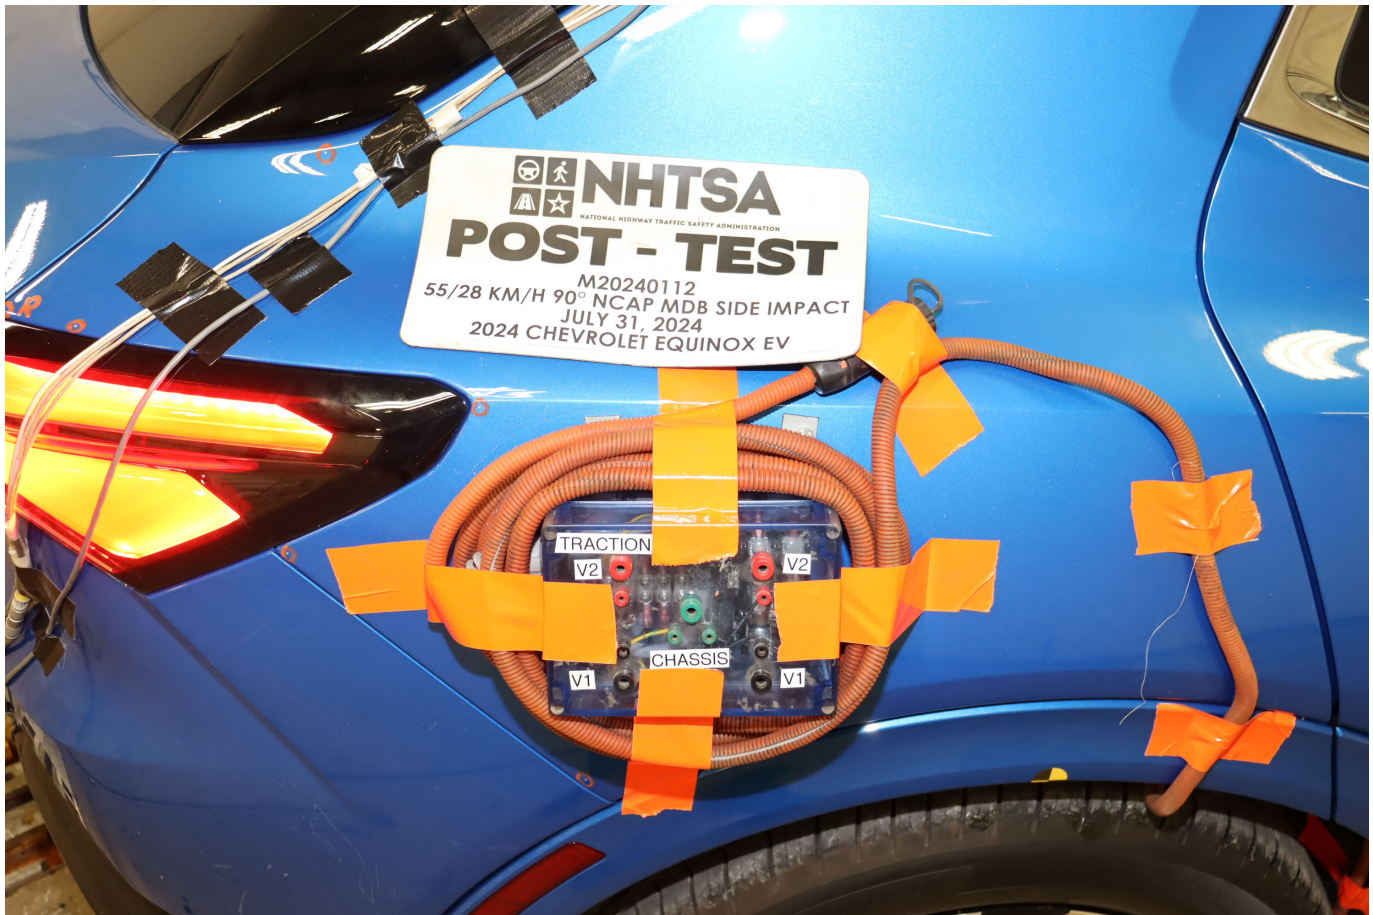
Photo No. 305-25 - Post-Impact View of Installed Test Interface Port

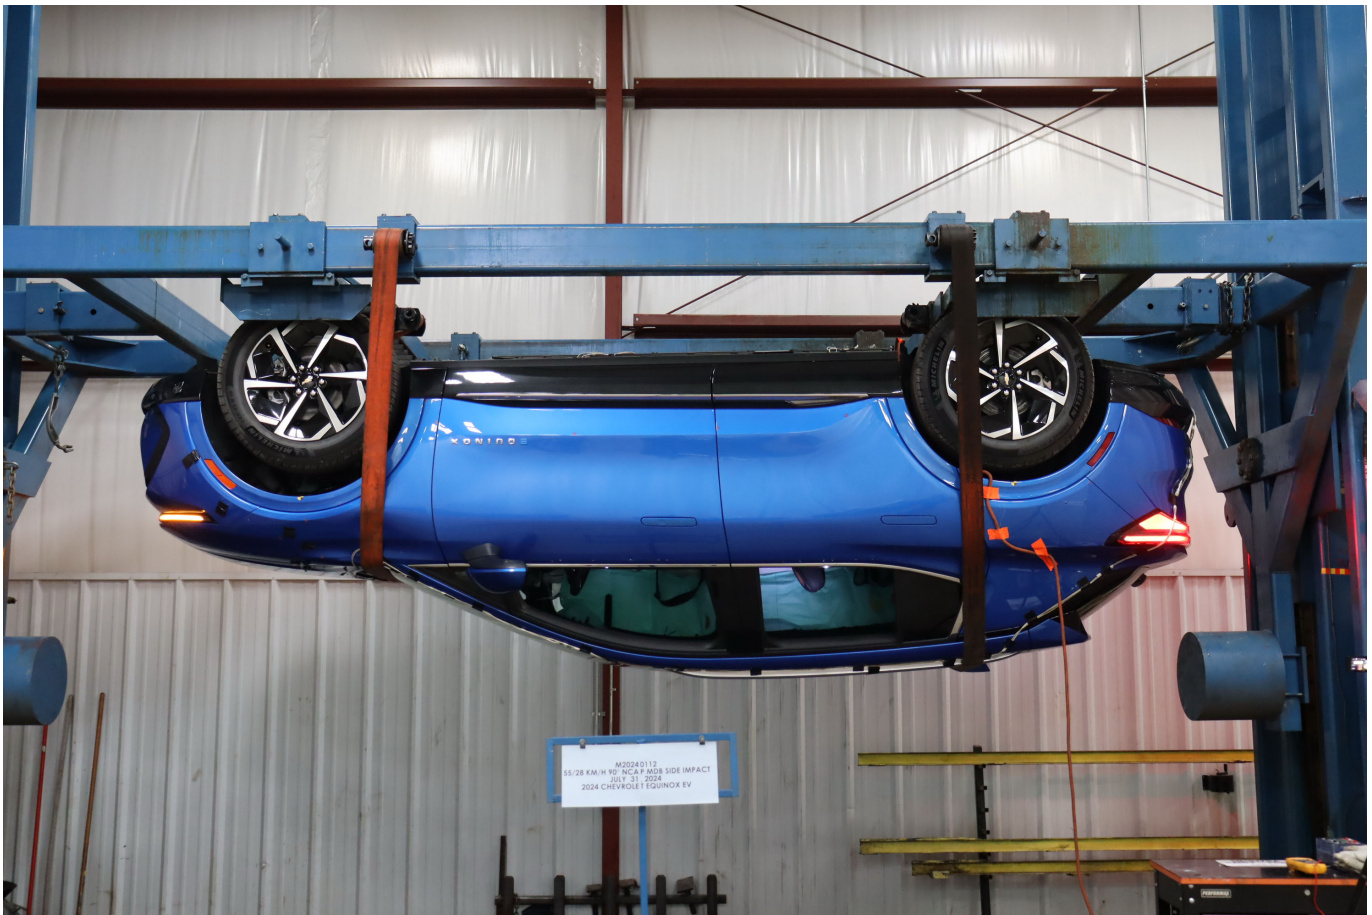
Photo No. 305-29 - FMVSS No. 305 Static Rollover at 180 Degrees

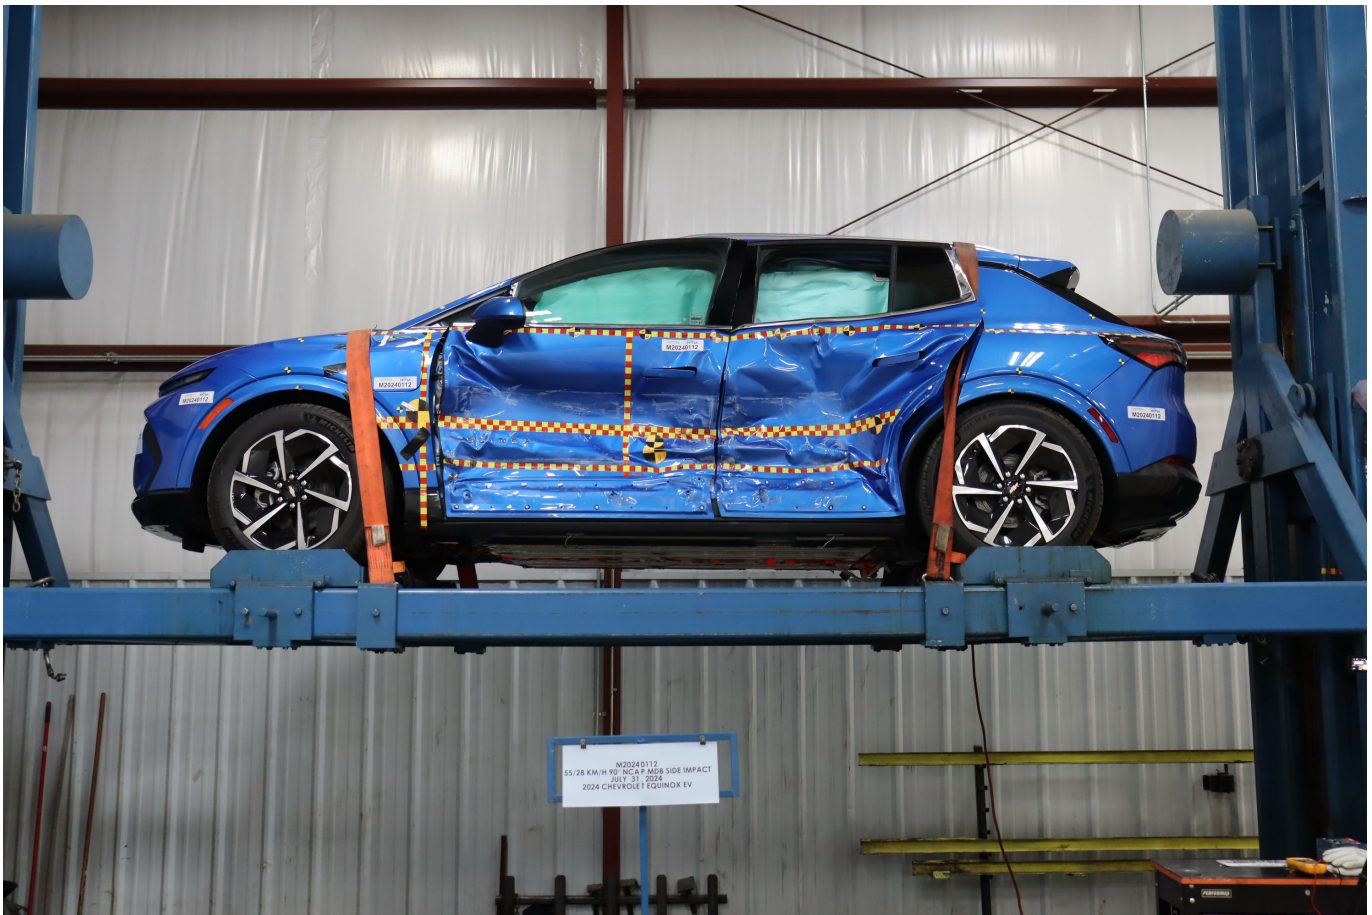
Photo No. 305-31 - FMVSS No. 305 Static Rollover at 360 Degrees
