REPORT NUMBER: SideNCAPPole-MGA-24-023

**NEW CAR ASSESSMENT PROGRAM (NCAP)
Side Impact Pole Test**

**GENERAL MOTORS DE MEXICO, S. DE R.L. DE C.V.
2024 Chevrolet Equinox EV 2LT 5-Door SUV
NHTSA No.: M20240111**

**MGA RESEARCH CORPORATION
5000 Warren Road
Burlington, WI 53105**

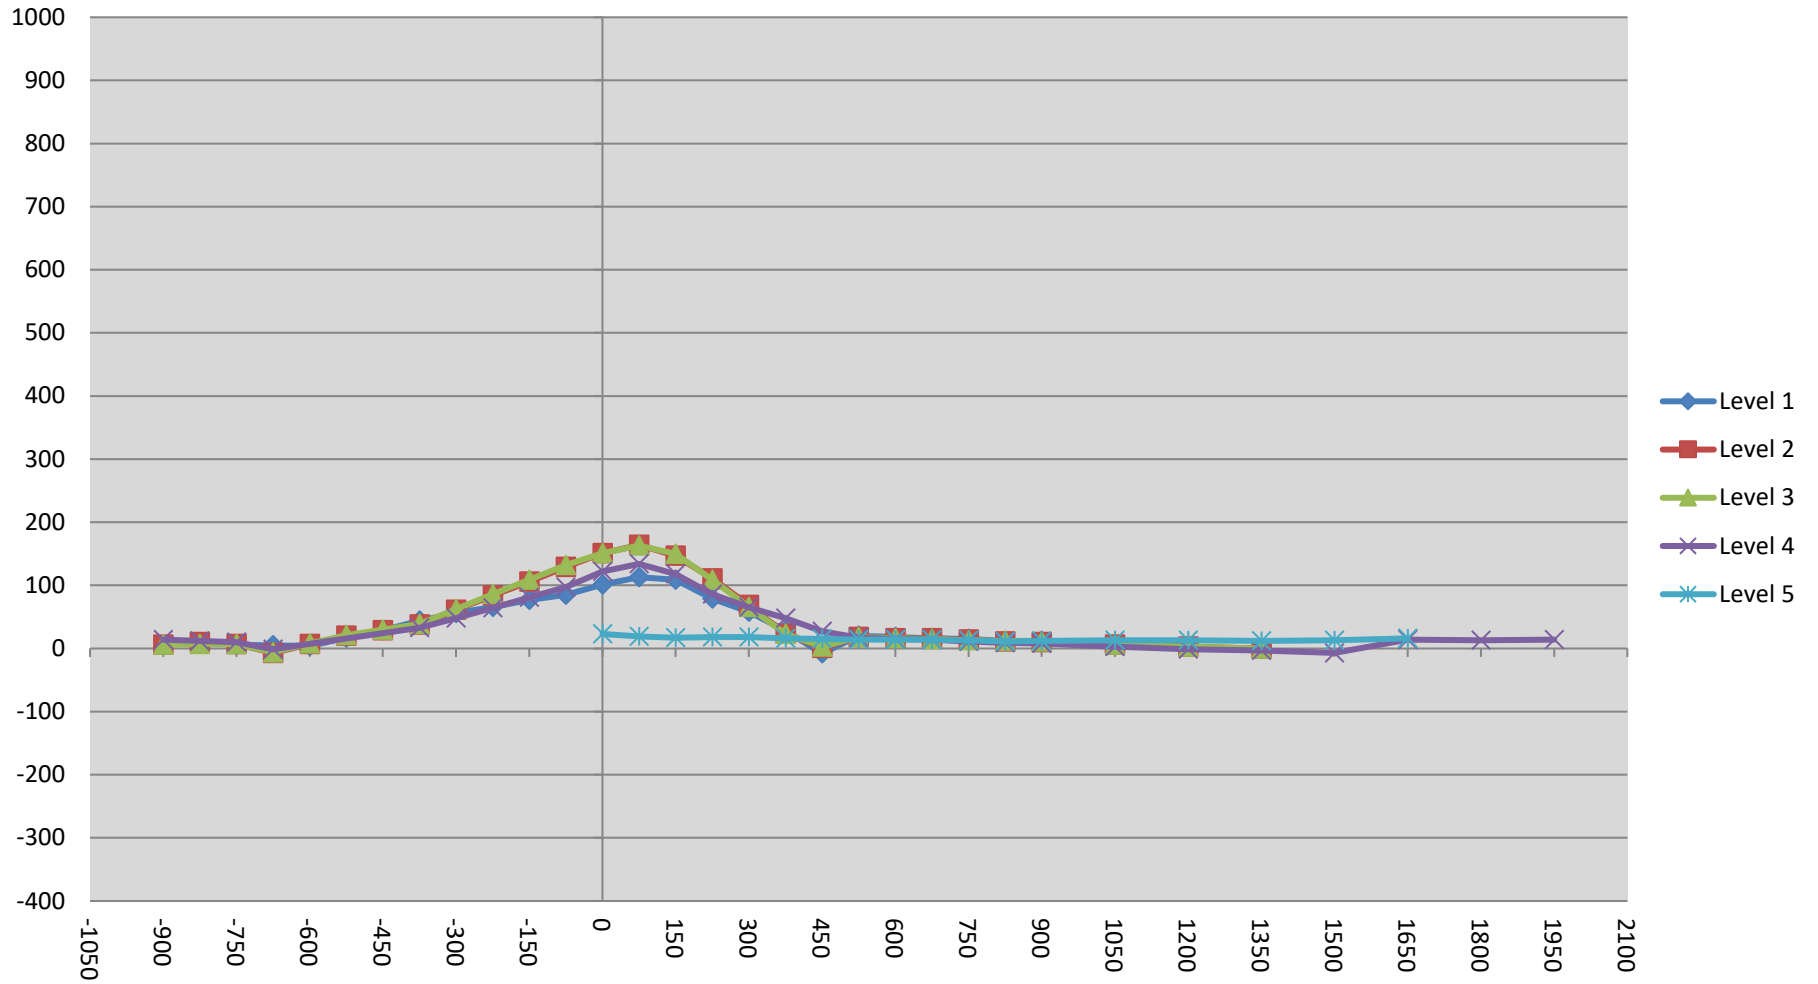
DATA SHEET NO. 10 (CONTINUED)
TEST VEHICLE EXTERIOR CRUSH MEASUREMENTS

Pre-test measurements are taken when the vehicle is in the “As Tested” weight condition. Vehicle measurements forward of the vertical impact reference line are negative. The crush profile grid is established prior to the test based on an estimated impact point.

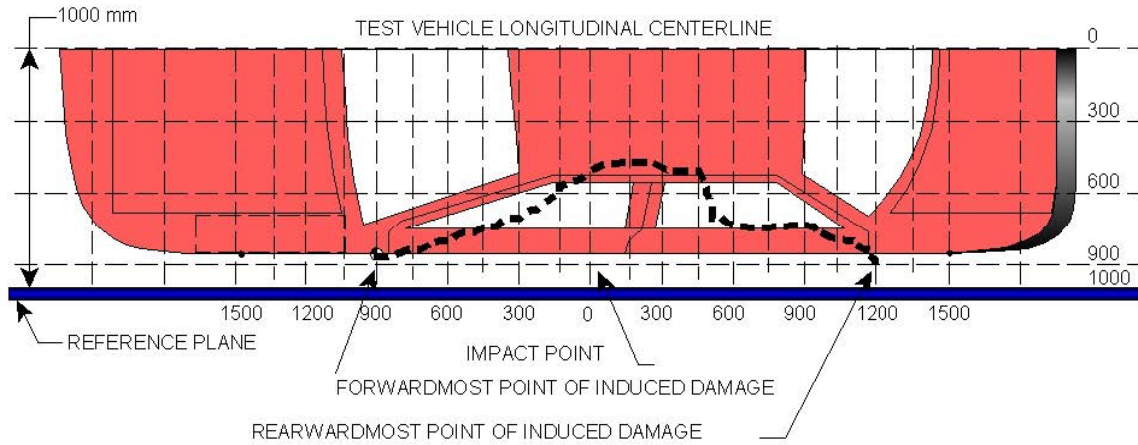
VEHICLE DAMAGE PROFILE DISTANCES

DPD	Distance from Impact Point (mm)	Level	Pre-Test (mm)	Post-Test (mm)	Max. Static Crush (mm)
1	450	3	69	66	3
2	263	3	153	65	88
3	30	3	218	65	153
4	-218	3	148	66	82
5	-455	3	94	66	28
6	-675	3	51	57	-6

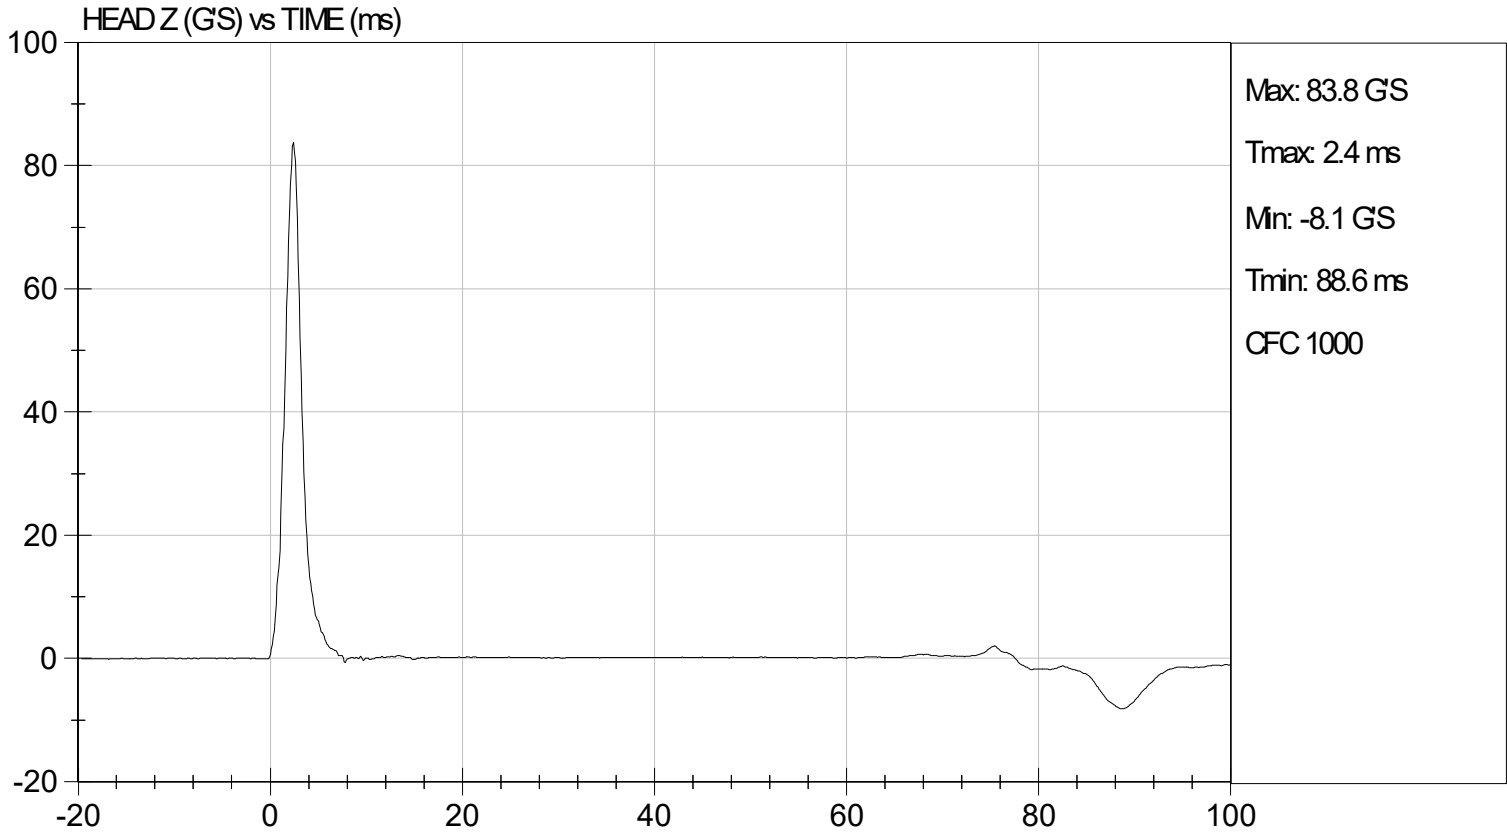
Tested Parameter	Units	Specification	Result	Pass/Fail
Laboratory Temperature	deg C	20.6 to 22.2	21.3	Pass
Laboratory Relative Humidity	%	10 to 70	43	Pass
Peak Resultant Acceleration	G's	115 to 137	127	Pass
Peak Longitudinal Acceleration	G's	+/- 15	-4.5	Pass
Unimodal	N/A	Yes	Yes	Pass
Oscillations	N/A	<15%	Yes	Pass
Overall Test Results				Pass

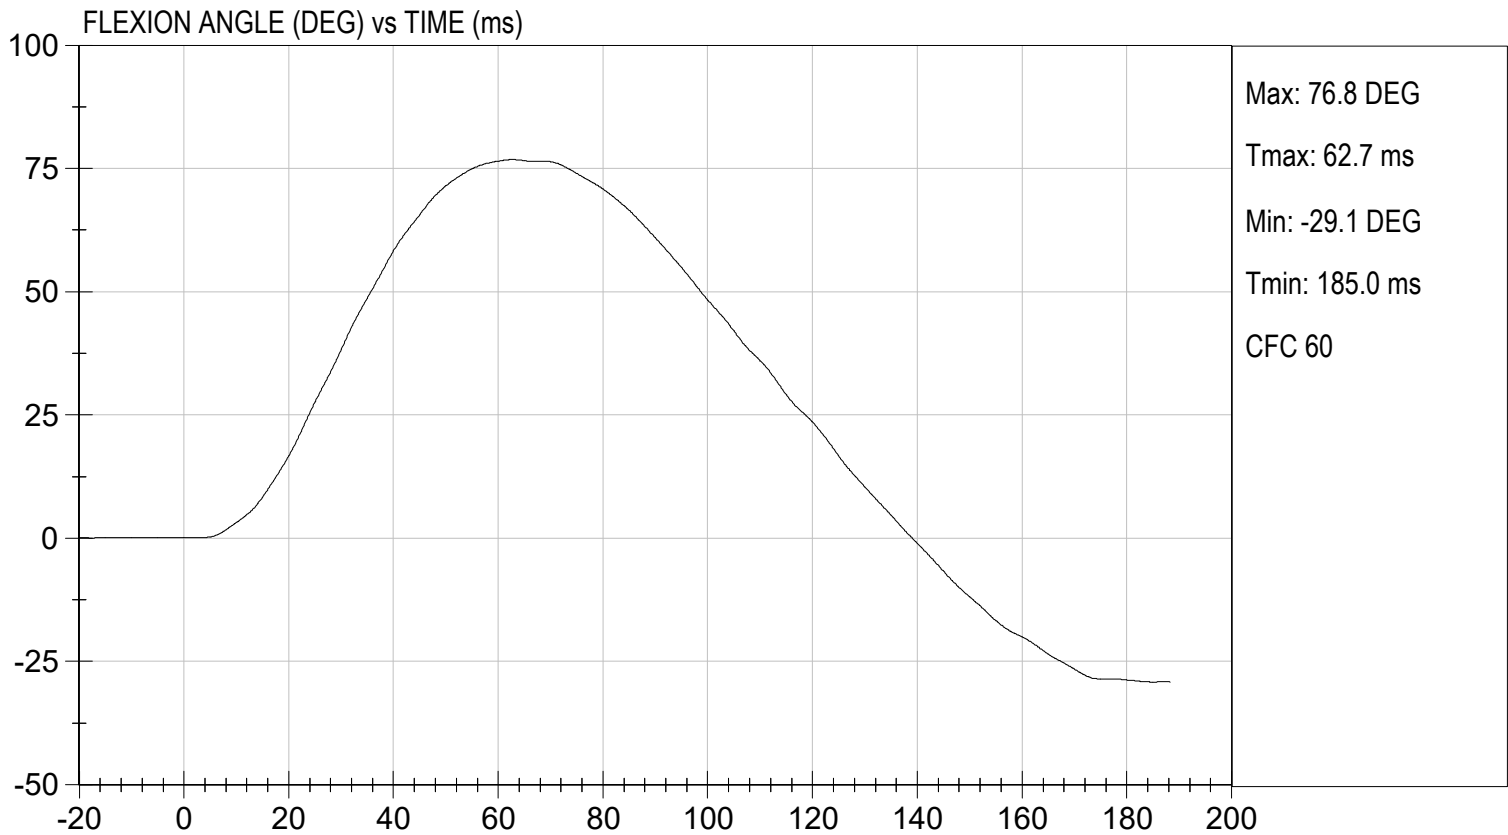
Tested Parameter	Units	Specification	Result	Pass/Fail	
Temperature	deg C	20.6 to 22.2	21.5	Pass	
Humidity	%	10 to 70	45	Pass	
Impact Velocity	m/s	5.51 to 5.63	5.53	Pass	
Pendulum Velocity	10 ms	m/s	2.20 to 2.80	2.41	Pass
	15 ms	m/s	3.30 to 4.10	3.55	Pass
	20 ms	m/s	4.40 to 5.40	4.98	Pass
	25 ms	m/s	5.40 to 6.10	5.73	Pass
	25-100 ms	m/s	5.50 to 6.20	5.73	Pass
Maximum D-Plane Rotation	deg	71 to 81	77	Pass	
Time of Maximum D-Plane Rotation	ms	50 to 70	63	Pass	
Maximum Occipital Condyle Moment	Nm	-44 to -36	-38	Pass	
Time of Moment Decay to 0 Nm	ms	102 to 126	120	Pass	
Overall Test Results				Pass

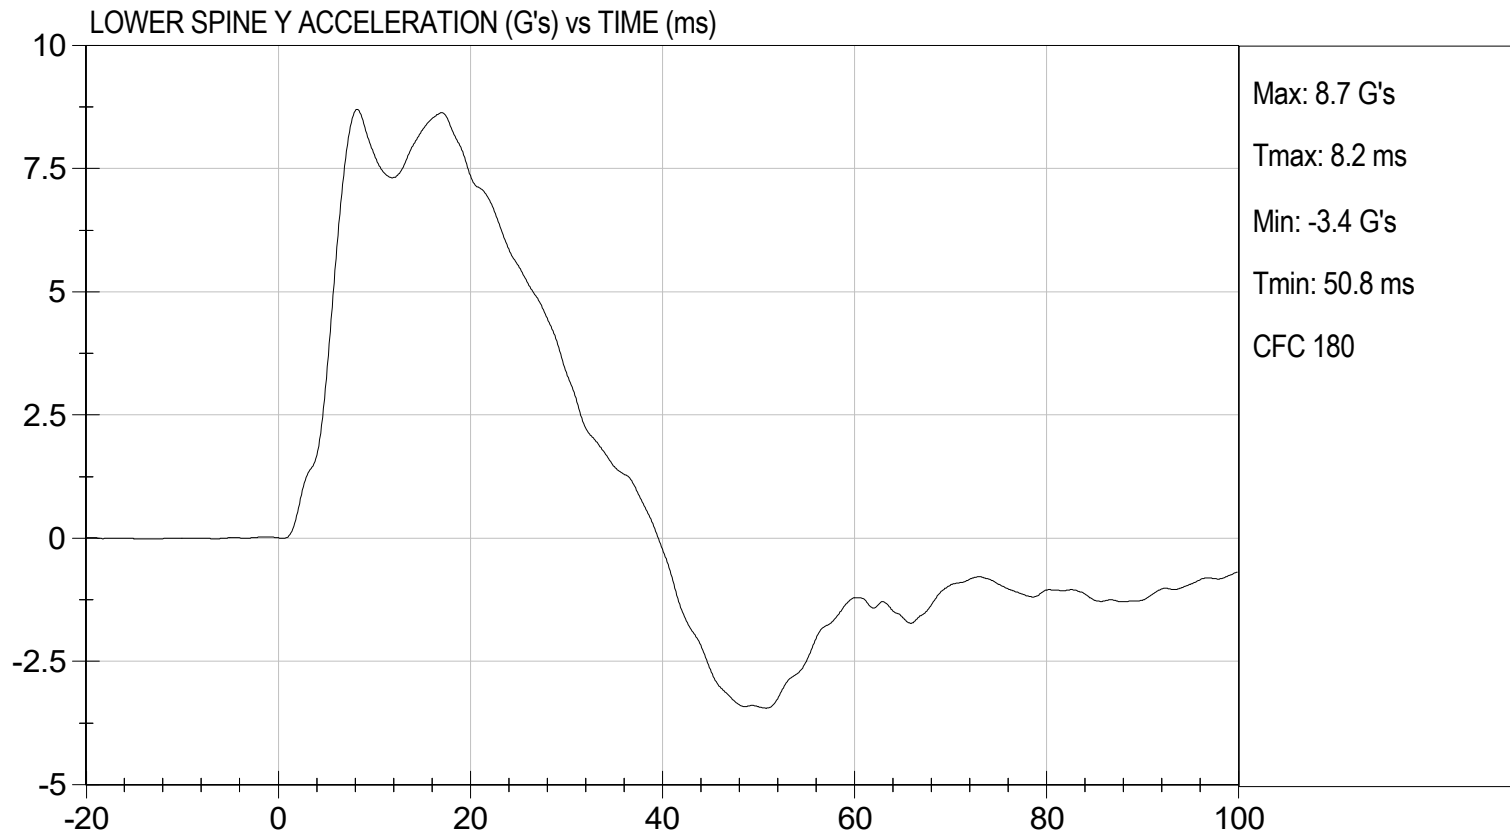
Tested Parameter	Units	Specification	Result	Pass/Fail
Temperature	deg C	20.6 to 22.2	21.3	Pass
Humidity	%	10 to 70	43	Pass
Impact Velocity	m/s	4.20 to 4.40	4.21	Pass
Maximum Probe Acceleration	G's	14 to 18	15	Pass
Upper Rib Displacement	mm	32 to 40	39	Pass
Middle Rib Displacement	mm	39 to 45	44	Pass
Lower Rib Displacement	mm	35 to 43	39	Pass
Upper Spine (T1) Y Acceleration	G's	13 to 17	14	Pass
Lower Spine (T12) Y Acceleration	G's	7 to 11	9	Pass
Overall Test Results				Pass

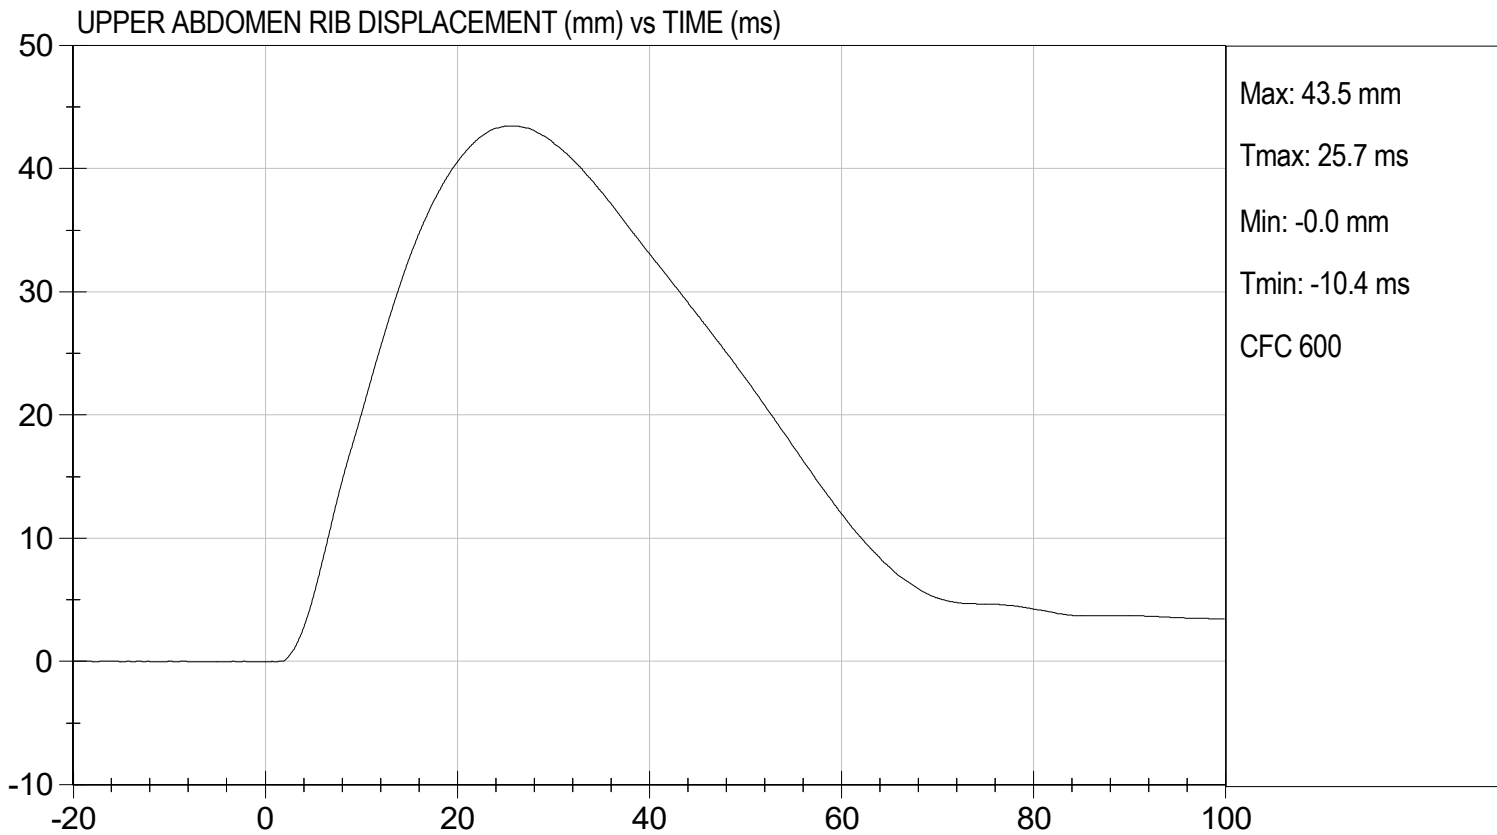
Tested Parameter	Units	Specification	Result	Pass/Fail
Temperature	deg C	20.6 to 22.2	21.3	Pass
Humidity	%	10 to 70	44	Pass
Impact Velocity	m/s	4.20 to 4.40	4.30	Pass
Maximum Probe Acceleration	G's	12 to 16	13	Pass
Upper Abdomen Rib Displacement	mm	36 to 47	43	Pass
Lower Abdomen Rib Displacement	mm	33 to 44	39	Pass
Lower Spine (T12) Y Acceleration	G's	9 to 14	11	Pass
Overall Test Results				Pass

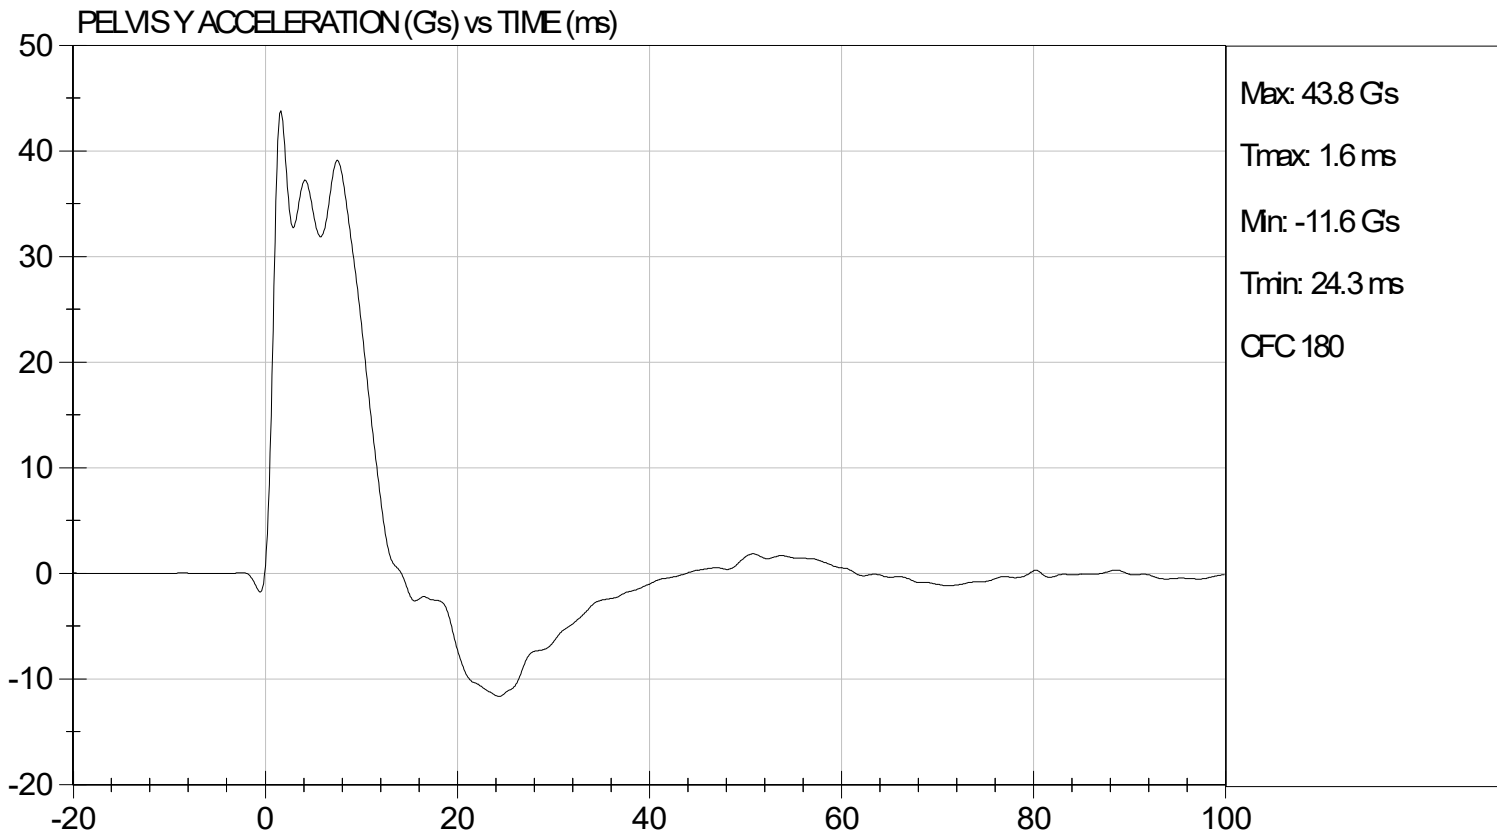
Tested Parameter	Units	Specification	Result	Pass/Fail
Temperature	deg C	20.6 to 22.2	21.2	Pass
Humidity	%	10 to 70	42	Pass
Impact Velocity	m/s	6.60 to 6.80	6.68	Pass
Maximum Probe Acceleration	G's	38 to 47	44	Pass
Pelvis Y Acceleration After 6 ms	G's	34 to 42	39.1	Pass
Peak Acetabulum Force	N	3600 to 4300	4,125	Pass
Overall Test Results				Pass

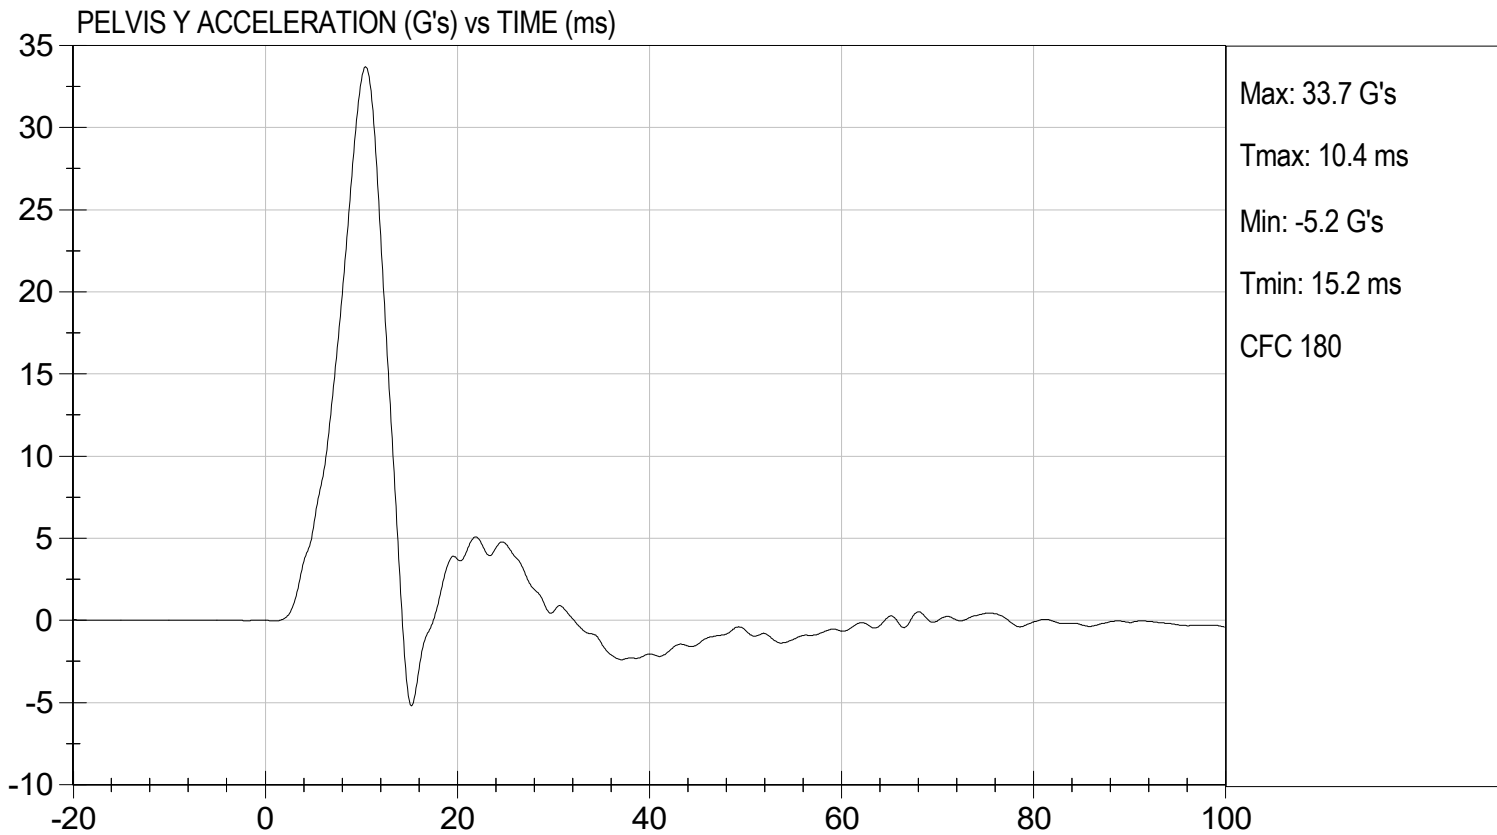
Tested Parameter	Units	Specification	Result	Pass/Fail
Temperature	deg C	20.6 to 22.2	21.3	Pass
Humidity	%	10 to 70	43	Pass
Impact Velocity	m/s	4.20 to 4.40	4.27	Pass
Maximum Probe Acceleration	G's	36 to 45	42	Pass
Pelvis Y Acceleration	G's	28 to 39	34	Pass
Peak Pelvis Iliac Force	N	4100 to 5100	4,915	Pass
Overall Test Results				Pass
