**REPORT NUMBER: SideNCAPMDB-MGA-24-026**

**NEW CAR ASSESSMENT PROGRAM (NCAP)  
Moving Deformable Barrier Side Impact Test**

**GENERAL MOTORS DE MEXICO, S. DR R.L. DE C.V.  
2024 Honda Prologue EX 5-Door SUV  
NHTSA No.: O20245305**

**MGA RESEARCH CORPORATION  
5000 Warren Road  
Burlington, WI 53105**

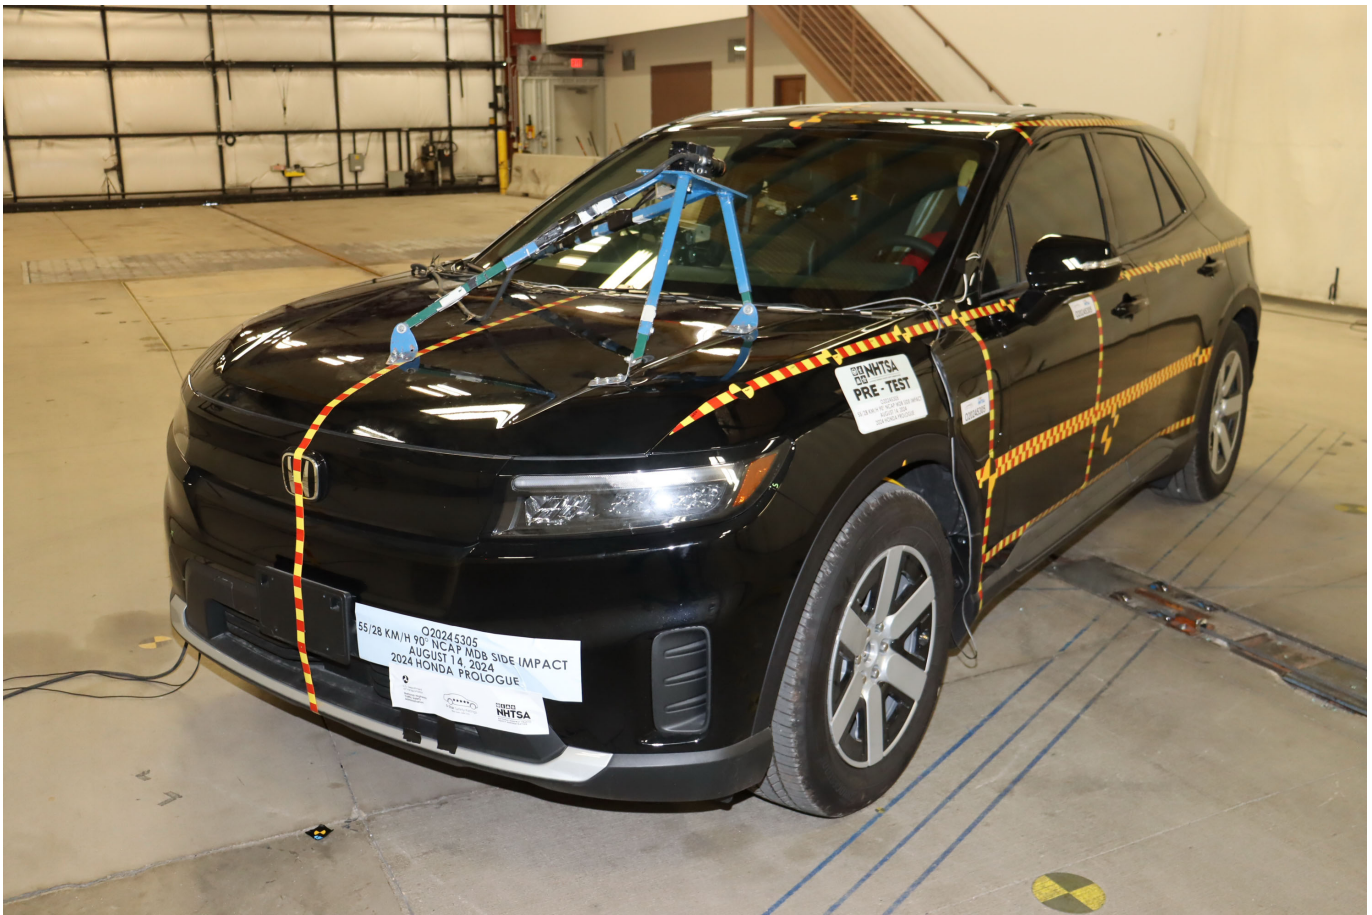
Photo No. 004 - Post-Test Frontal View of Test Vehicle

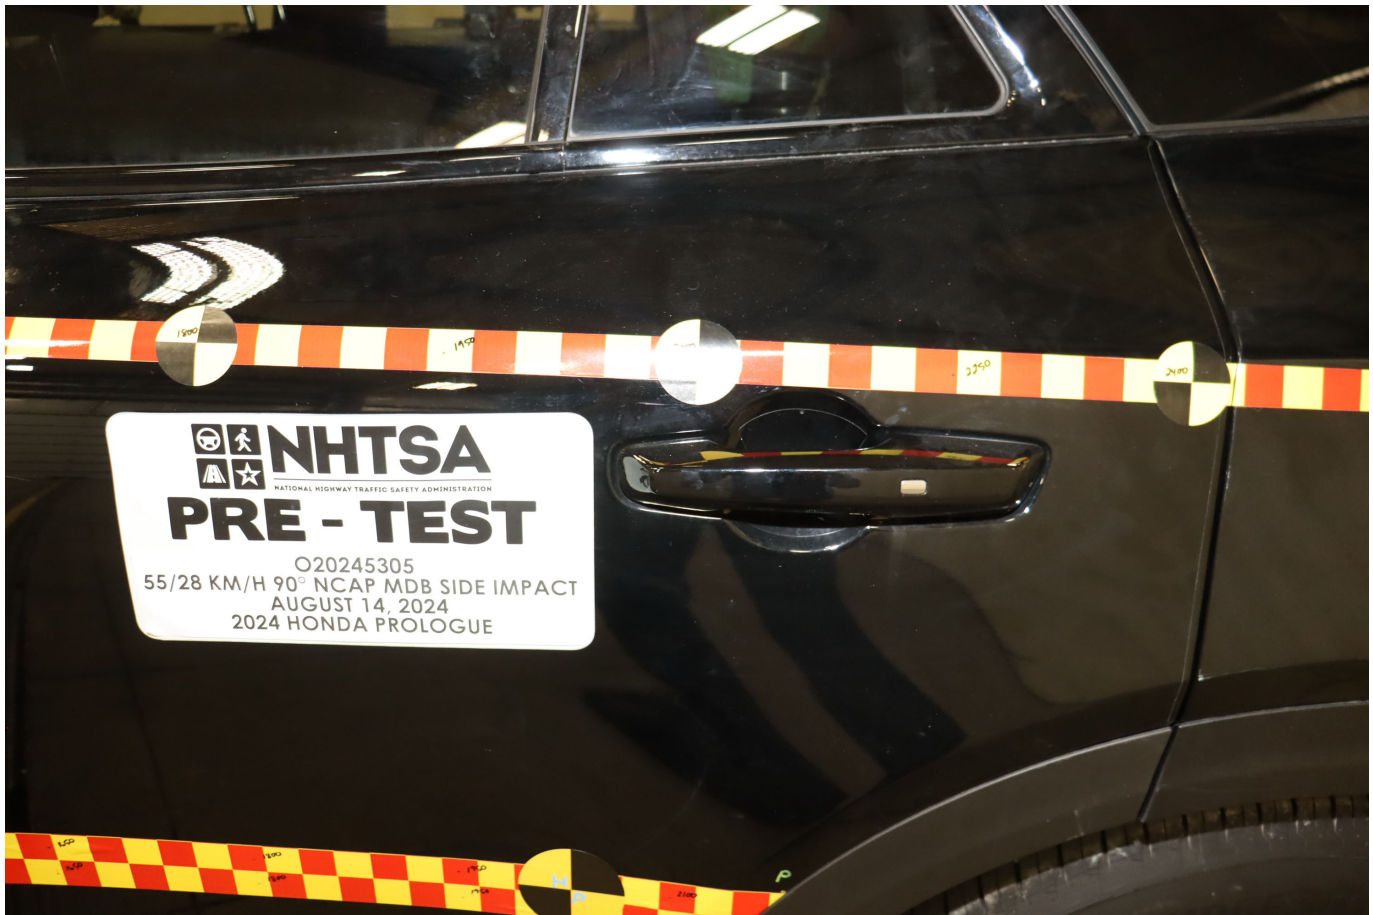
Photo No. 022 - Post-Test Left Front Door Latch Close-Up

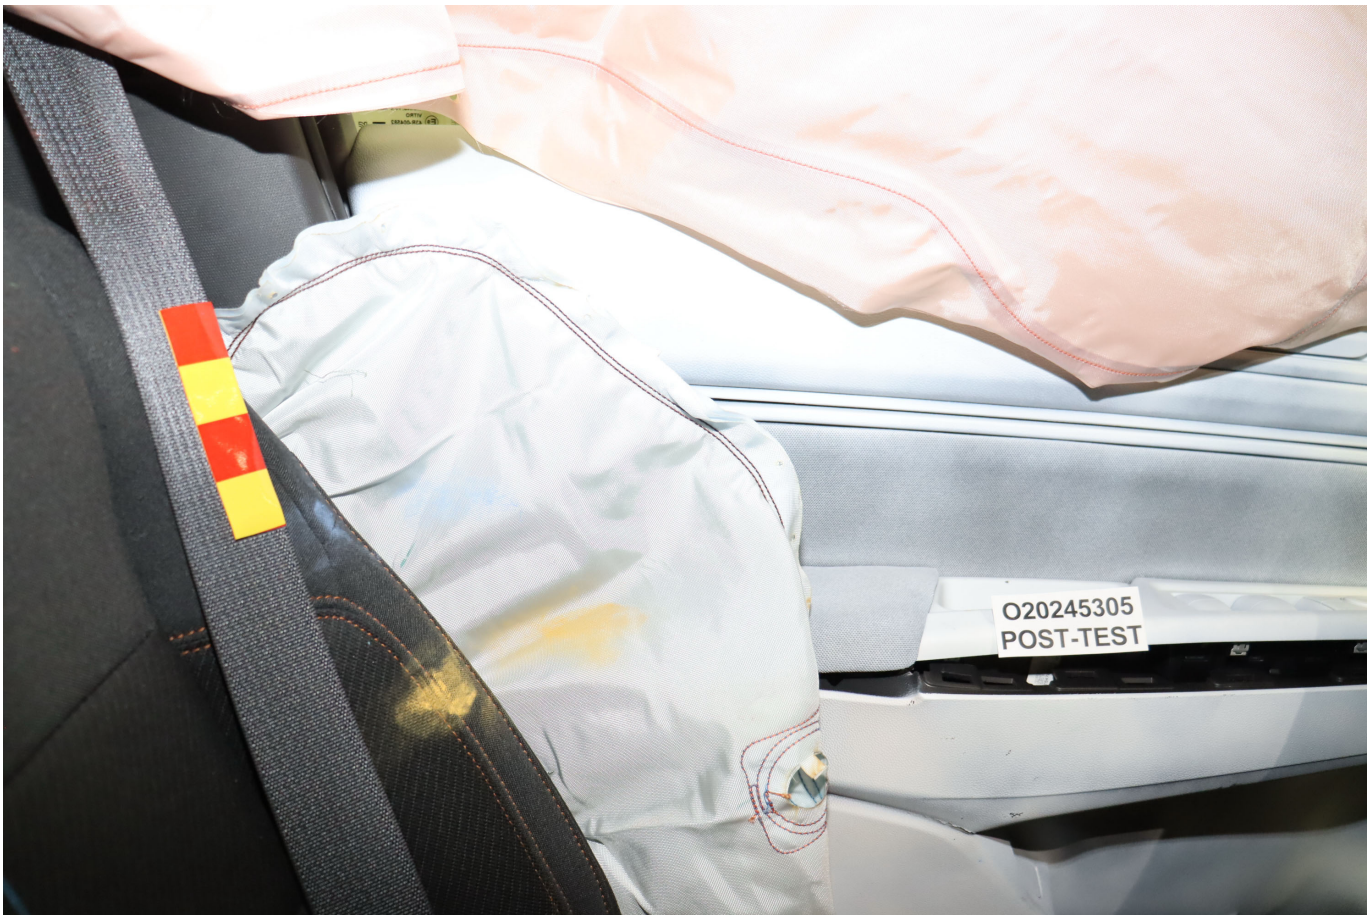
Photo No. 050 - Post-Test Driver Dummy Close-Up Torso Contact with Vehicle Interior View

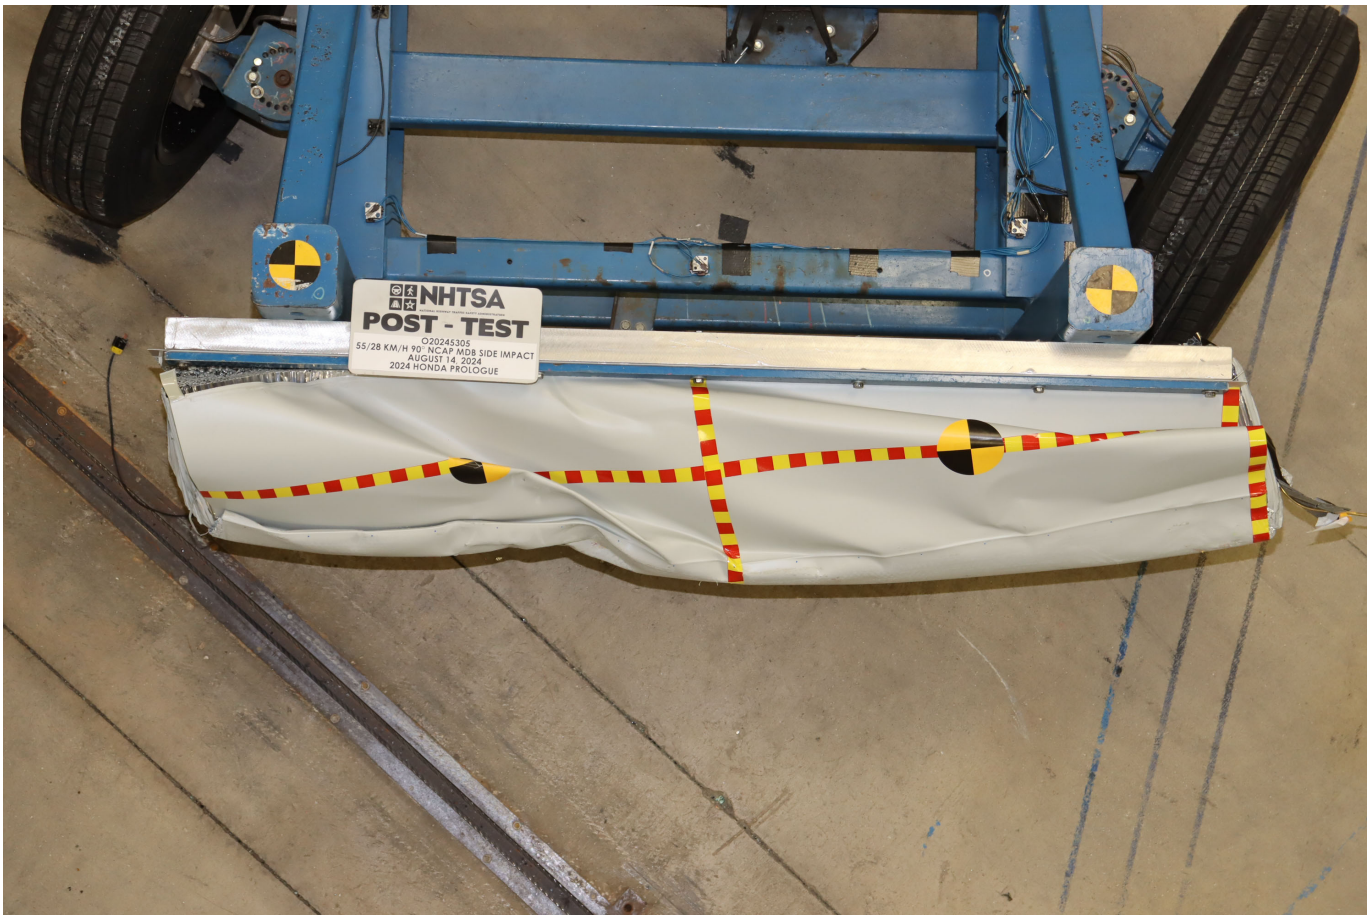
Photo No. 087 - Post-Test Top View of MDB Impactor Face

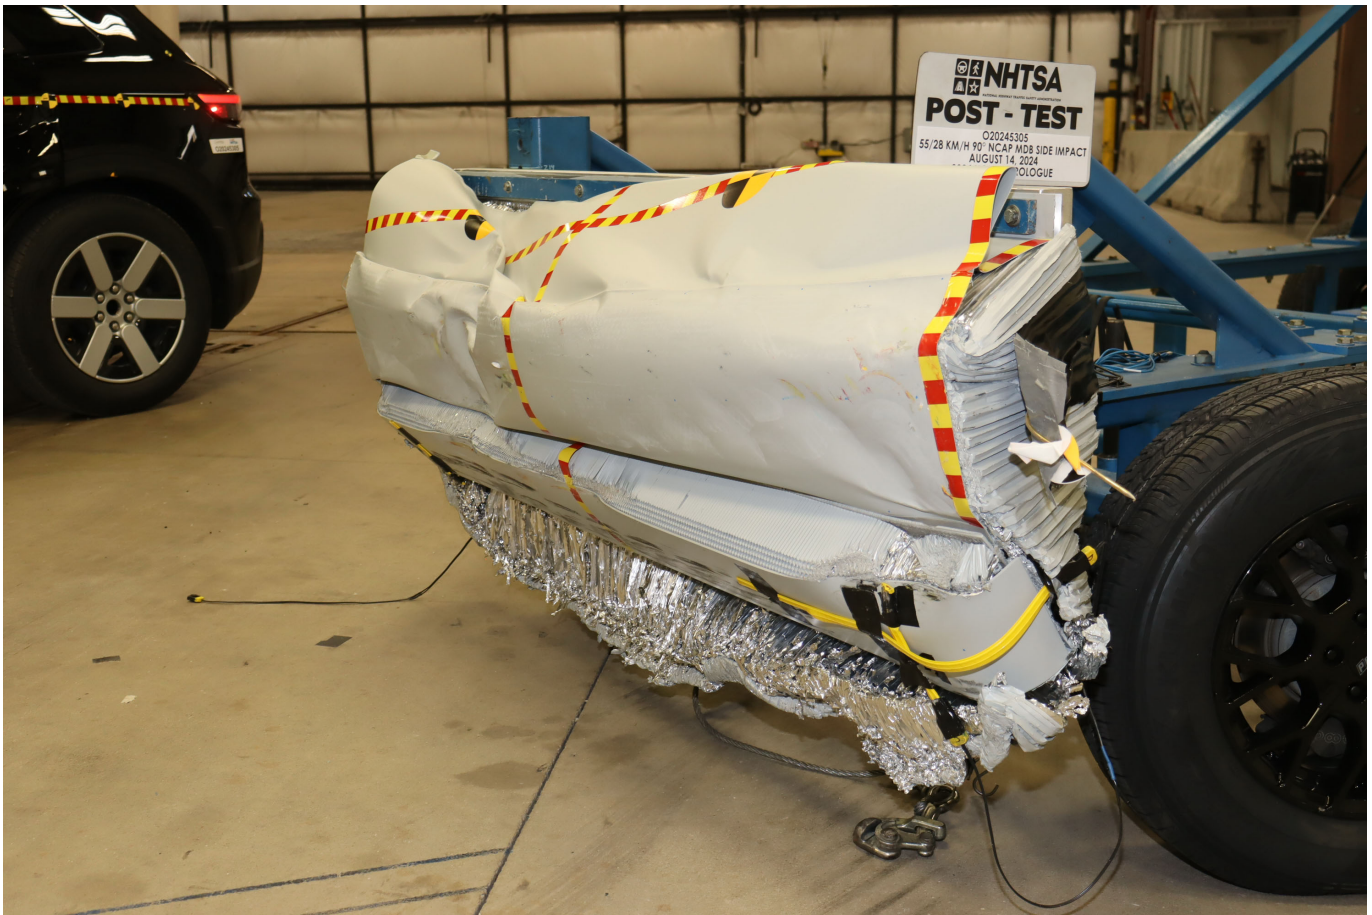
Photo No. 089 - Post-Test Left Side View of MDB Impactor Face

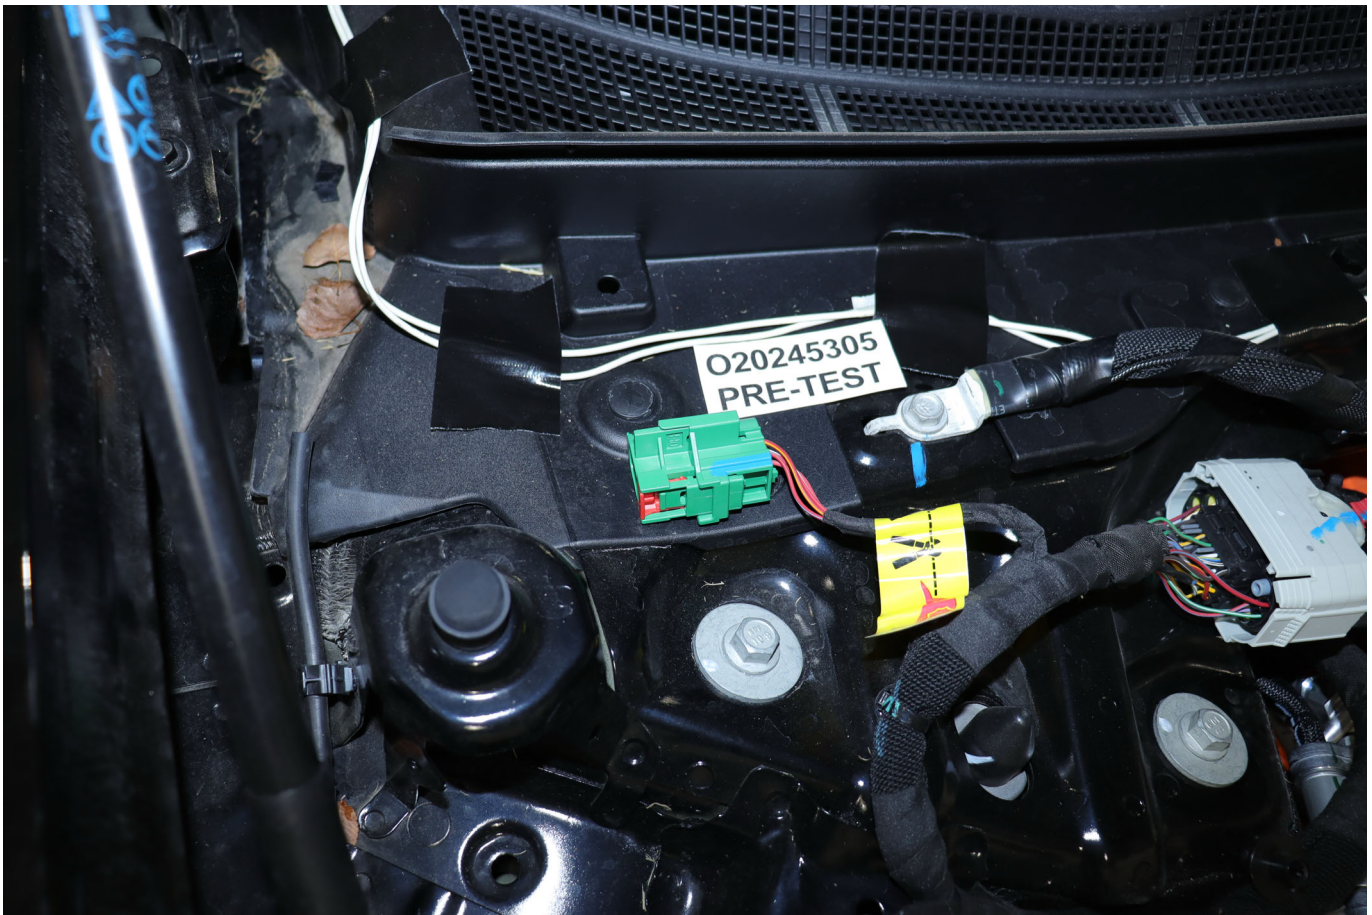
Photo No. 305-06 - Manual High Voltage Service Disconnect in Place

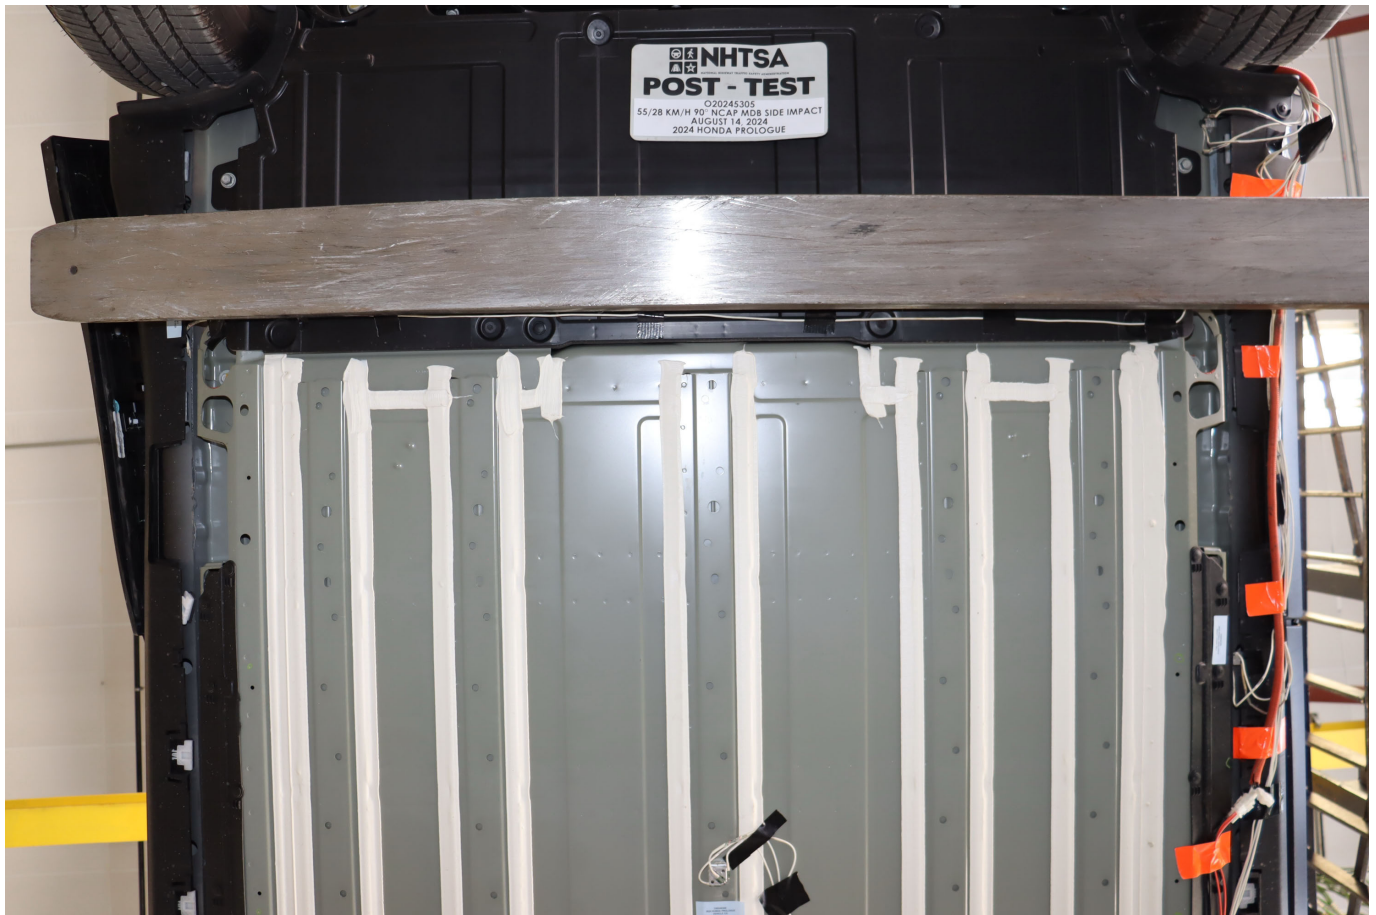
Photo No. 305-10 - Post-Impact Front View of Propulsion Battery

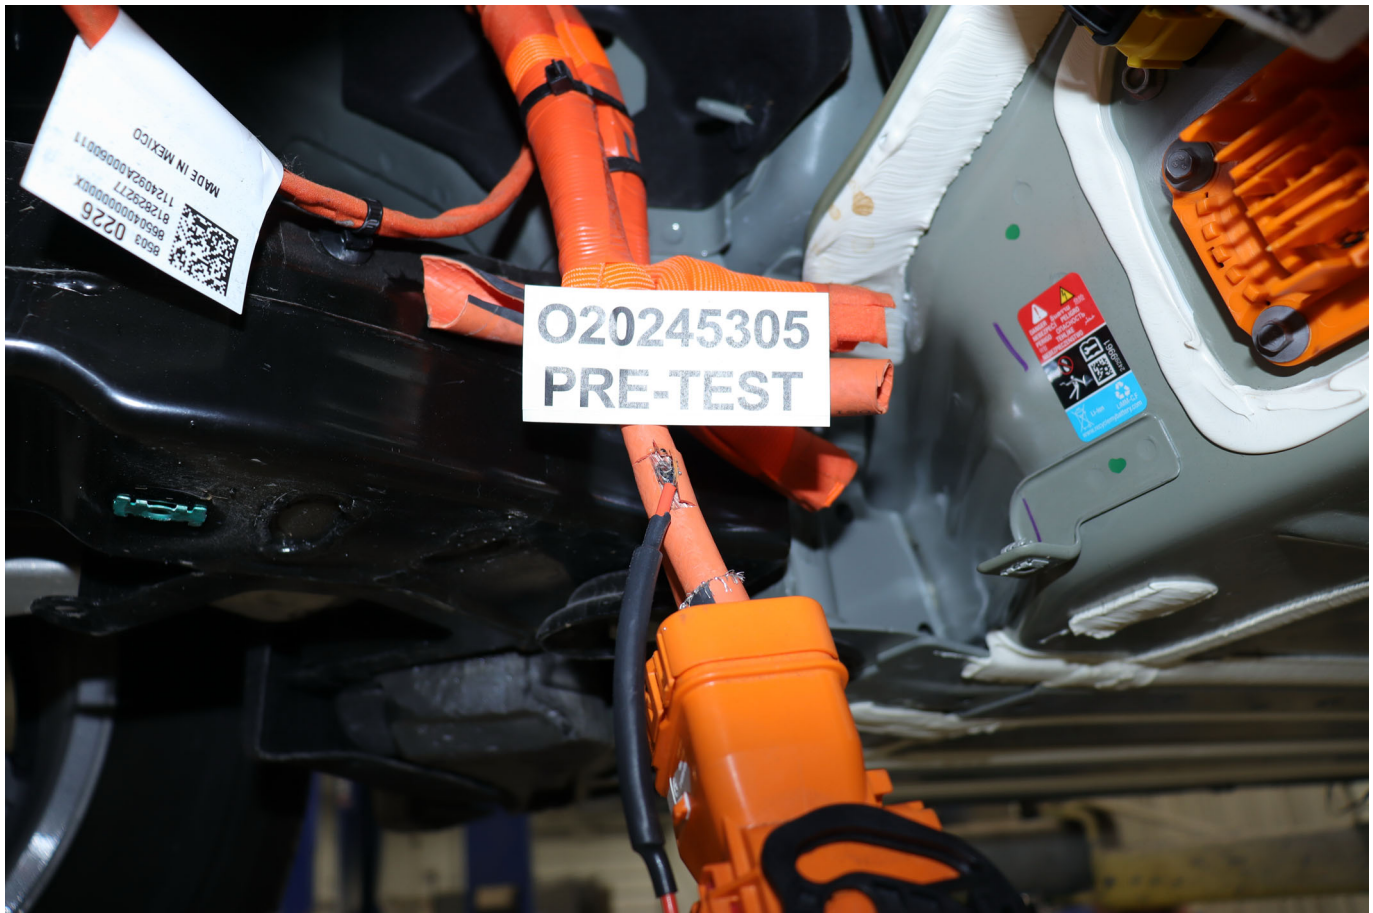
Photo No. 305-22 - Pre-Impact View of High Voltage Leads Attached

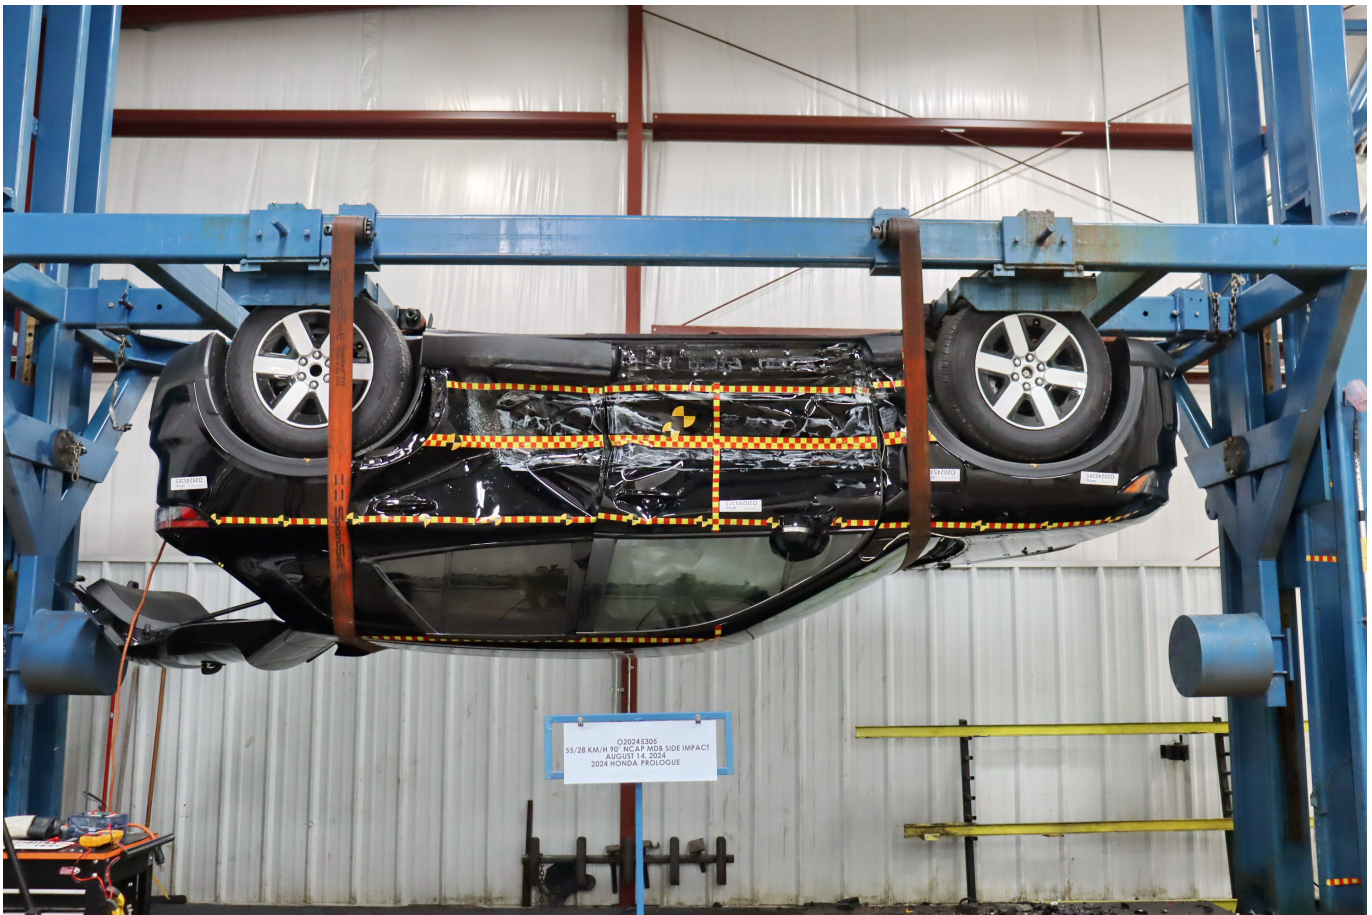
Photo No. 305-28 - FMVSS No. 305 Static Rollover at 90 Degrees
