**REPORT NUMBER: SideNCAPPole-KAR-24-010**  
**NEW CAR ASSESSMENT PROGRAM (NCAP)**  
**SIDE IMPACT POLE TEST**

**FORD MOTORS CO.**  
**2024 FORD RANGER 4-DOOR SUPERCREW TRUCK**

**NHTSA No: Q20240203**

**FINAL REPORT**

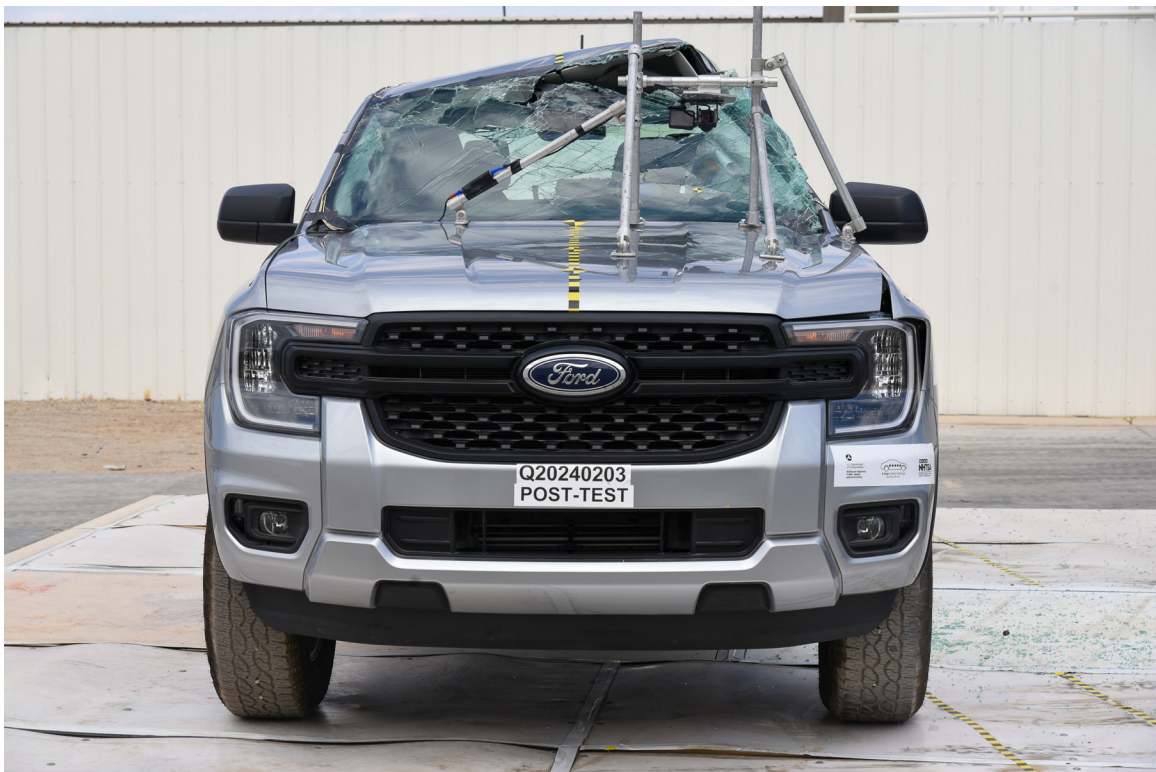
FIGURE 4. Post-Test Frontal View of Test Vehicle

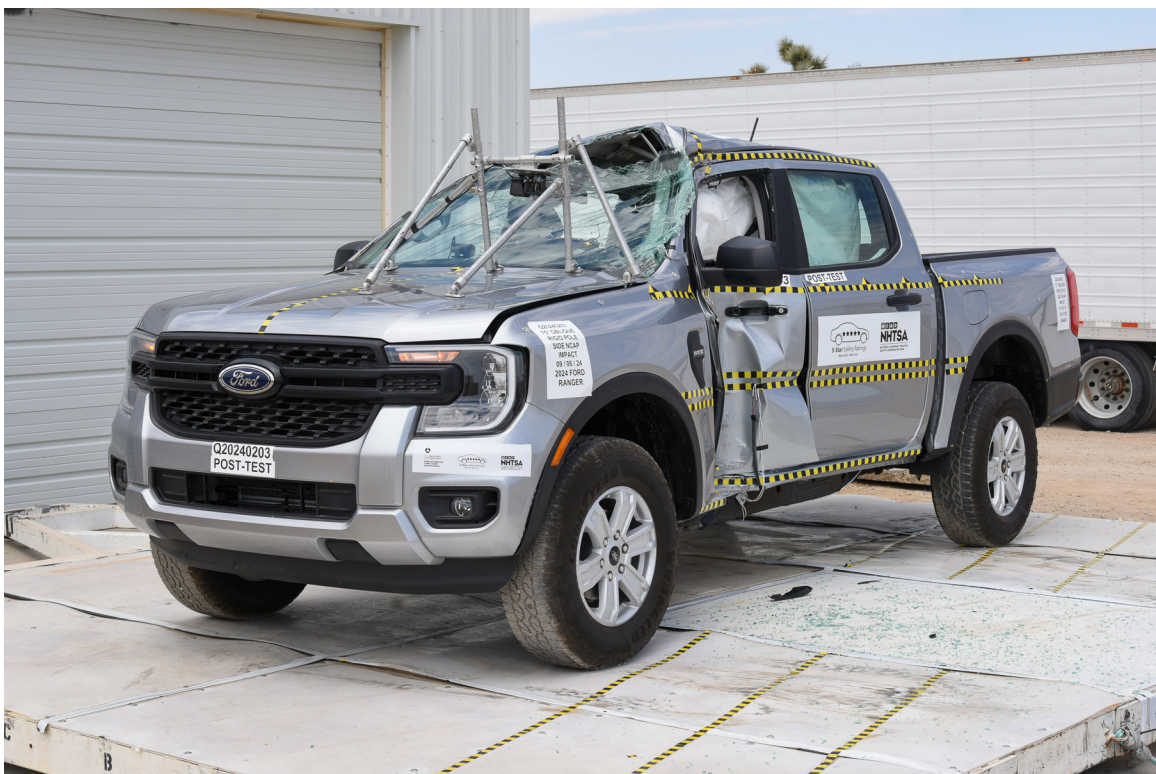
FIGURE 6. Post-Test Left Front 3/4 View of Test Vehicle

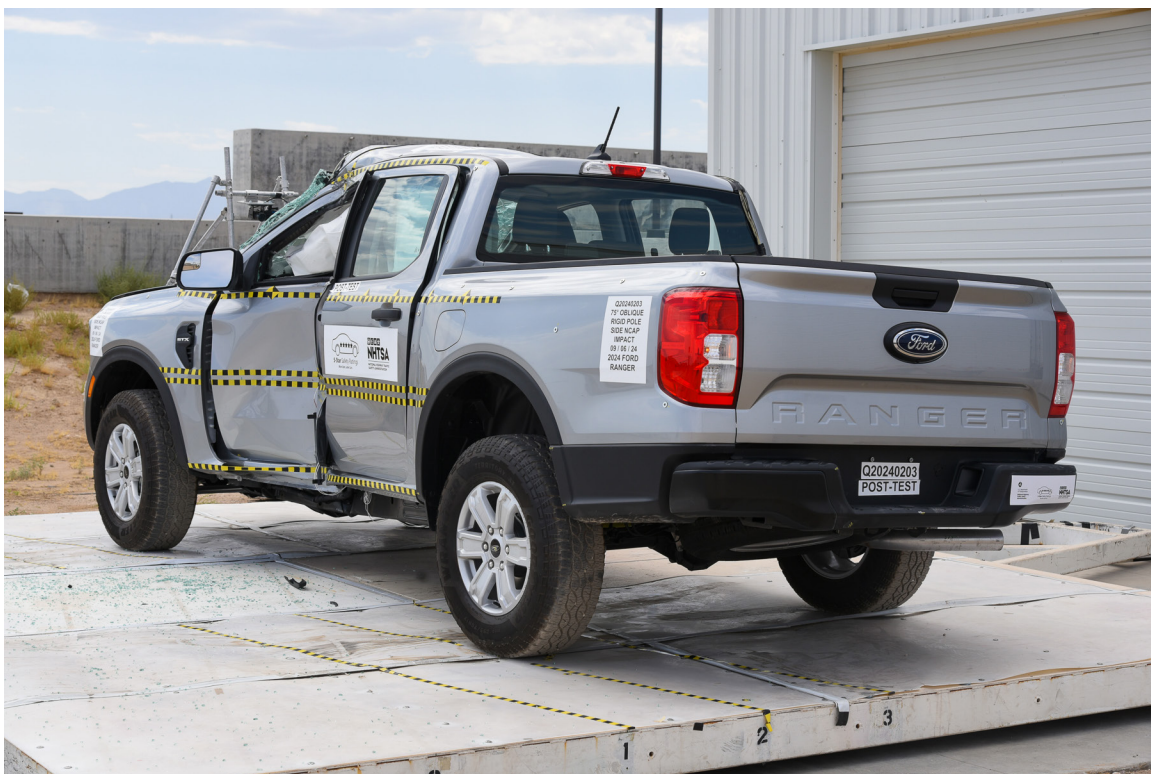
FIGURE 10. Post-Test Left Rear 3/4 View of Test Vehicle

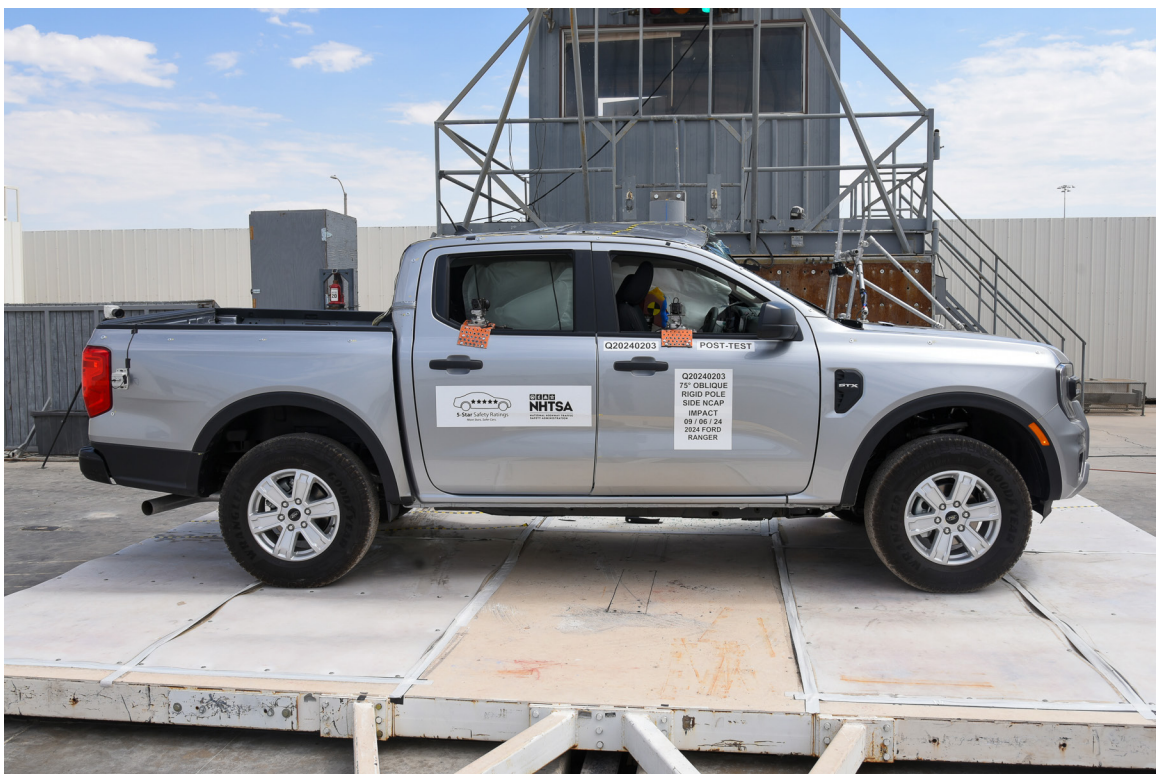
FIGURE 14. Post-Test Right Side View of Test Vehicle

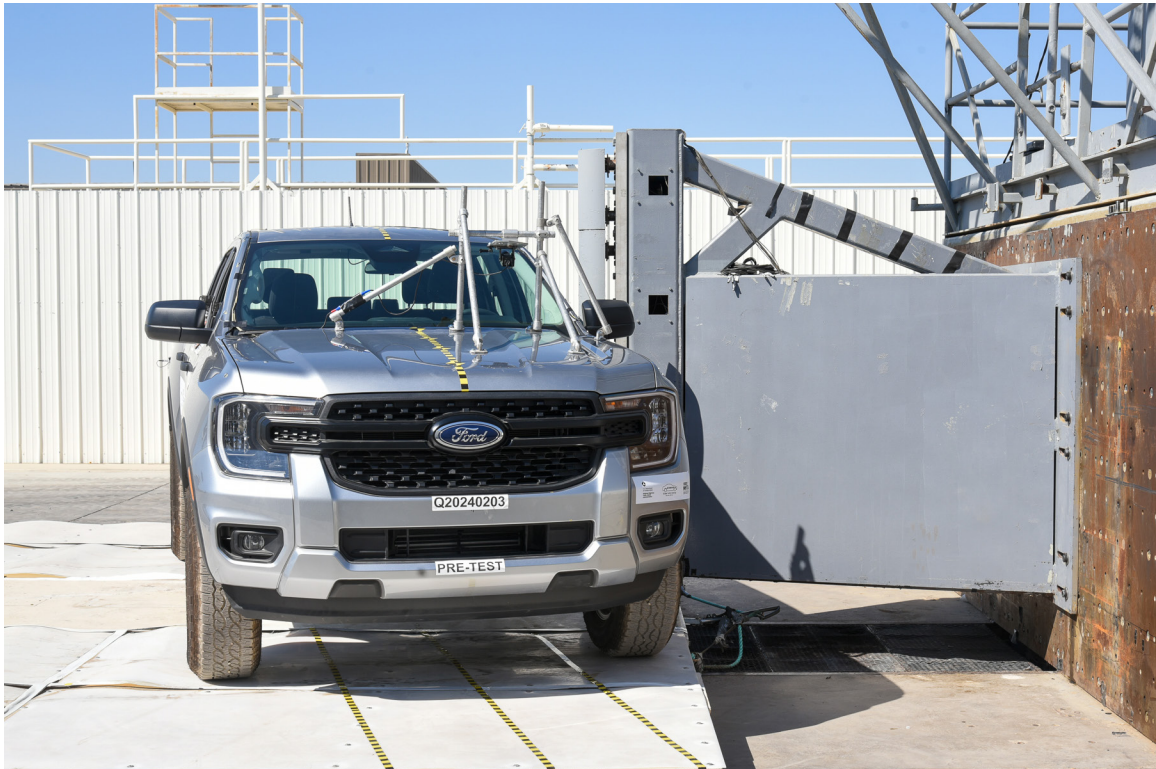
FIGURE 17. Pre-Test Left Side View of Pole Positioned Against Side of Vehicle

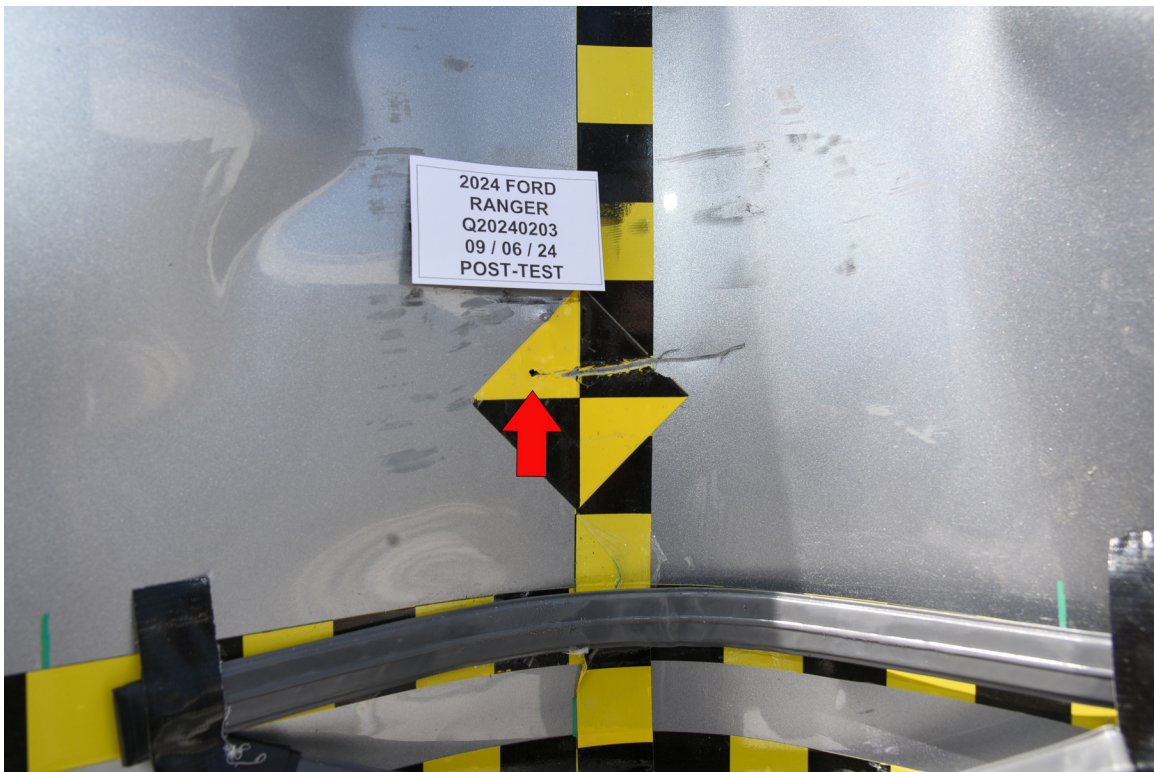
FIGURE 20. Post-Test Close-Up View of Impact Point Target Showing Impact Location

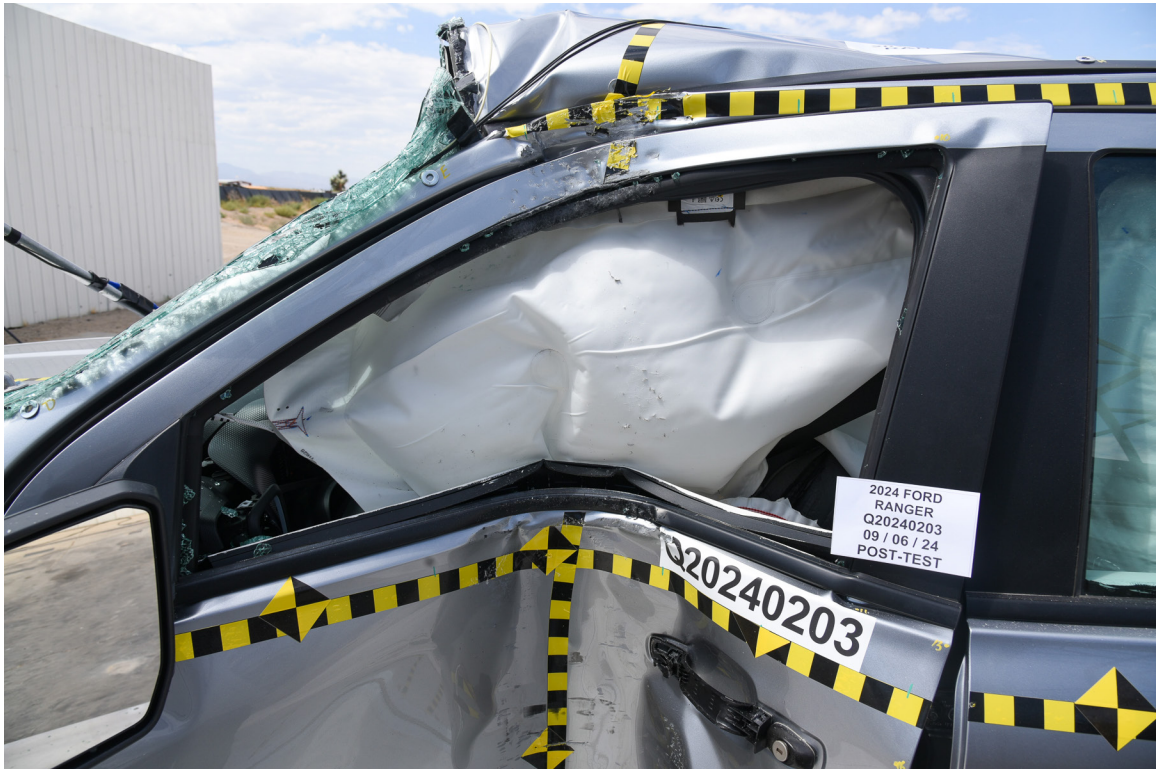
FIGURE 25. Post-Test Left Side View of Dummy Shoulder and Door Top View

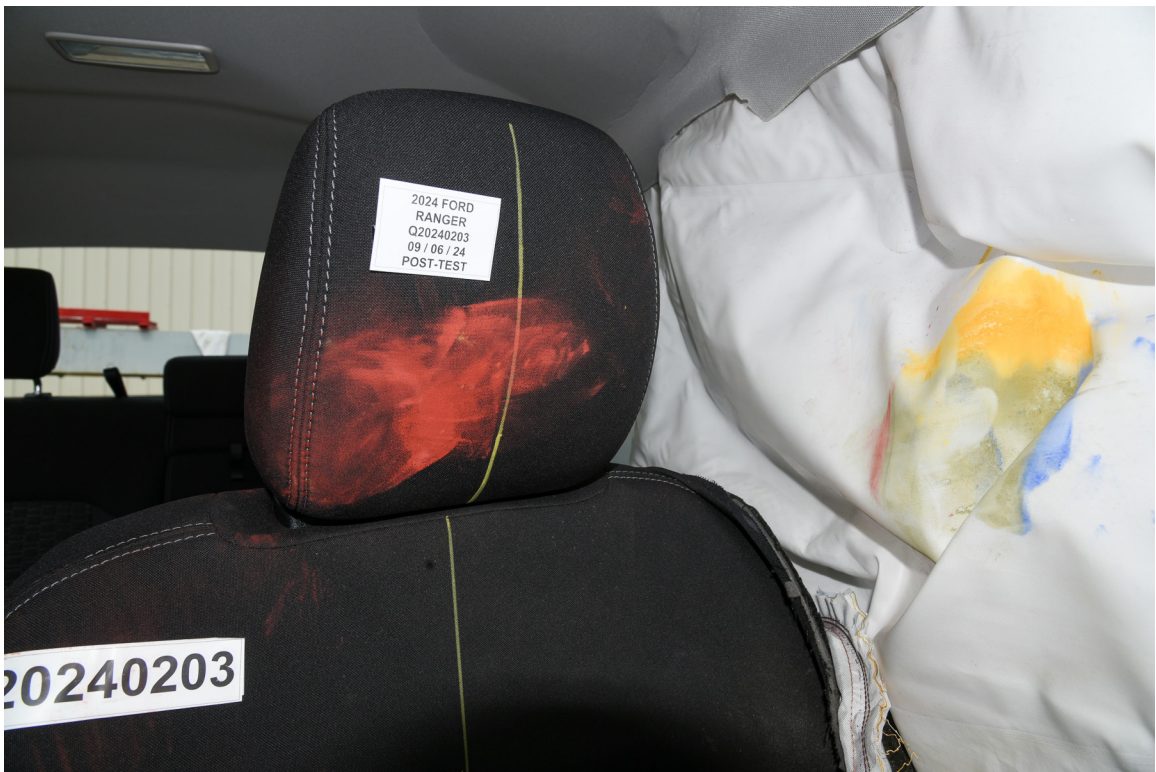
FIGURE 46. Post-Test Dummy Close-Up Head Contact With Vehicle Interior View

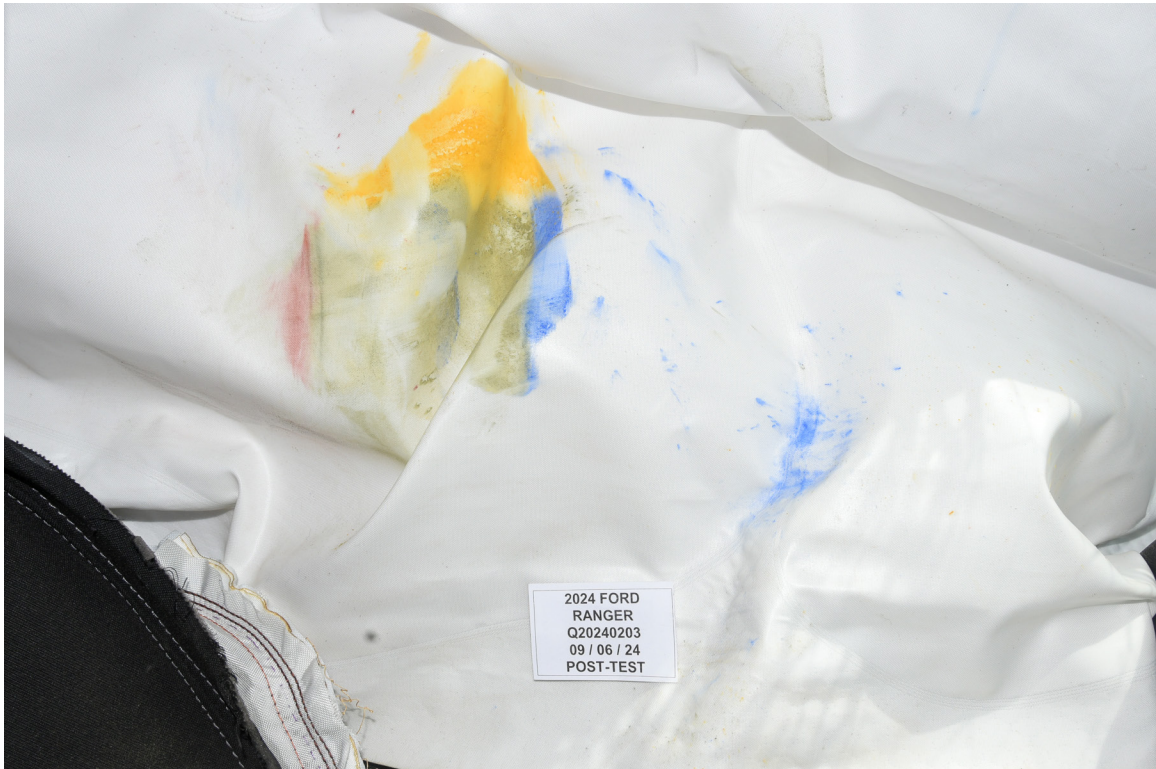
FIGURE 47. Post-Test Dummy Close-Up Head Contact With Side Air Bag View

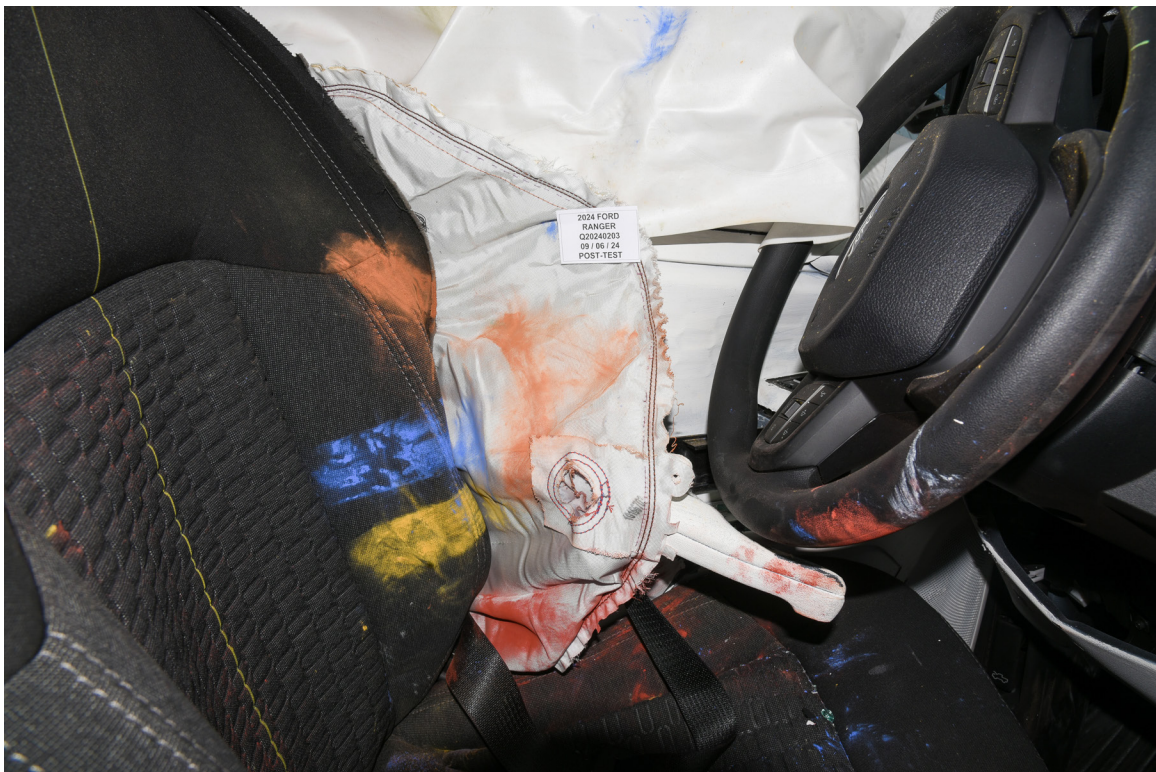
FIGURE 48. Post-Test Dummy Close-Up Torso Contact With Vehicle Interior View

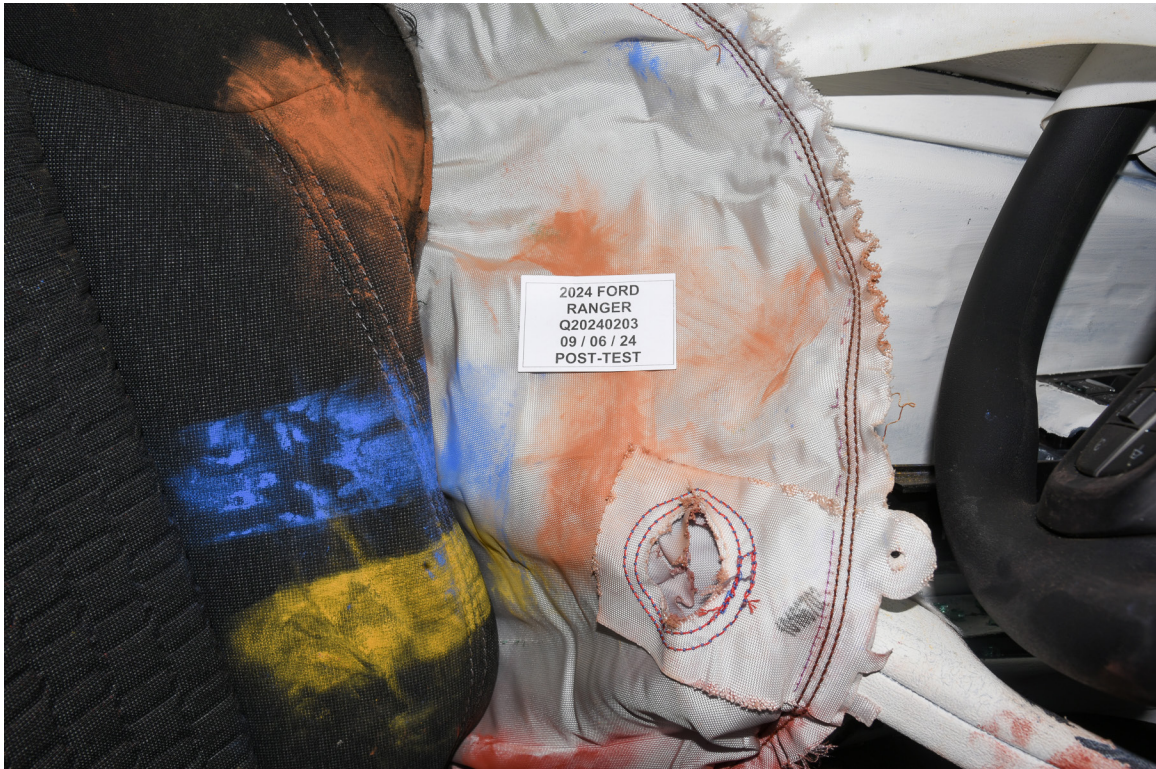
FIGURE 49. Post-Test Dummy Close-Up Torso Contact With Side Air Bag View

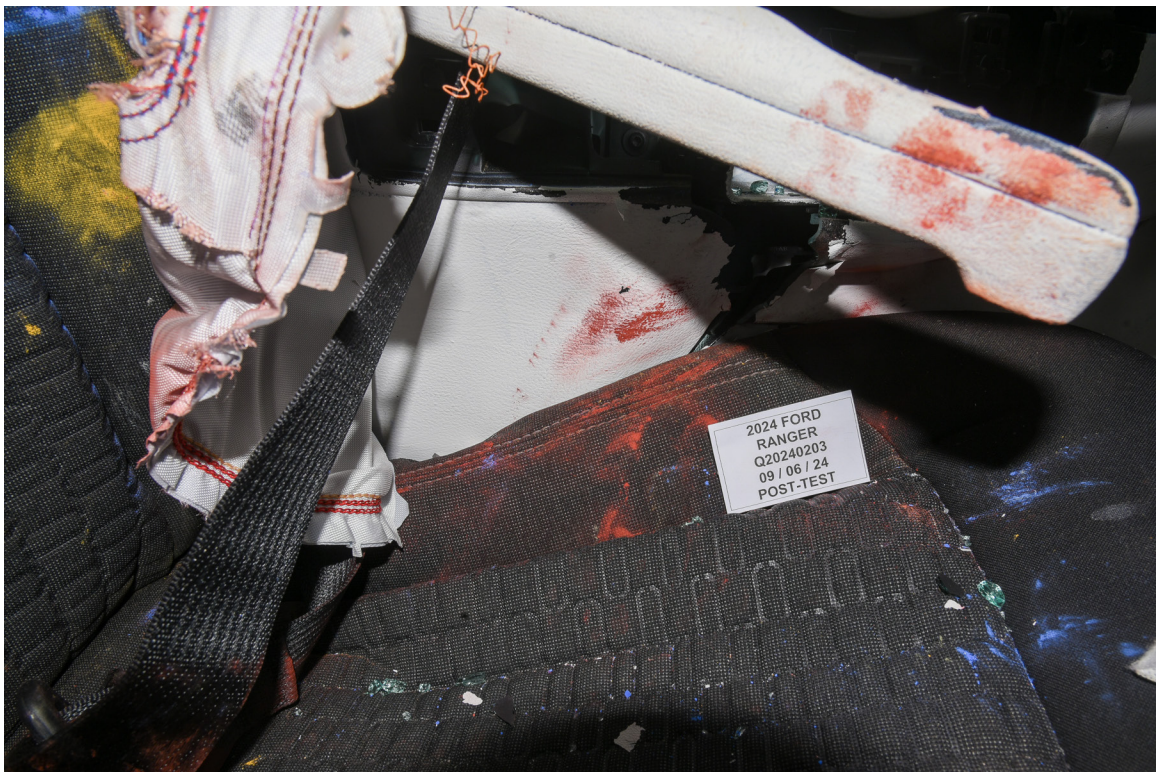
FIGURE 50. Post-Test Dummy Close-Up Pelvis Contact With Vehicle Interior View

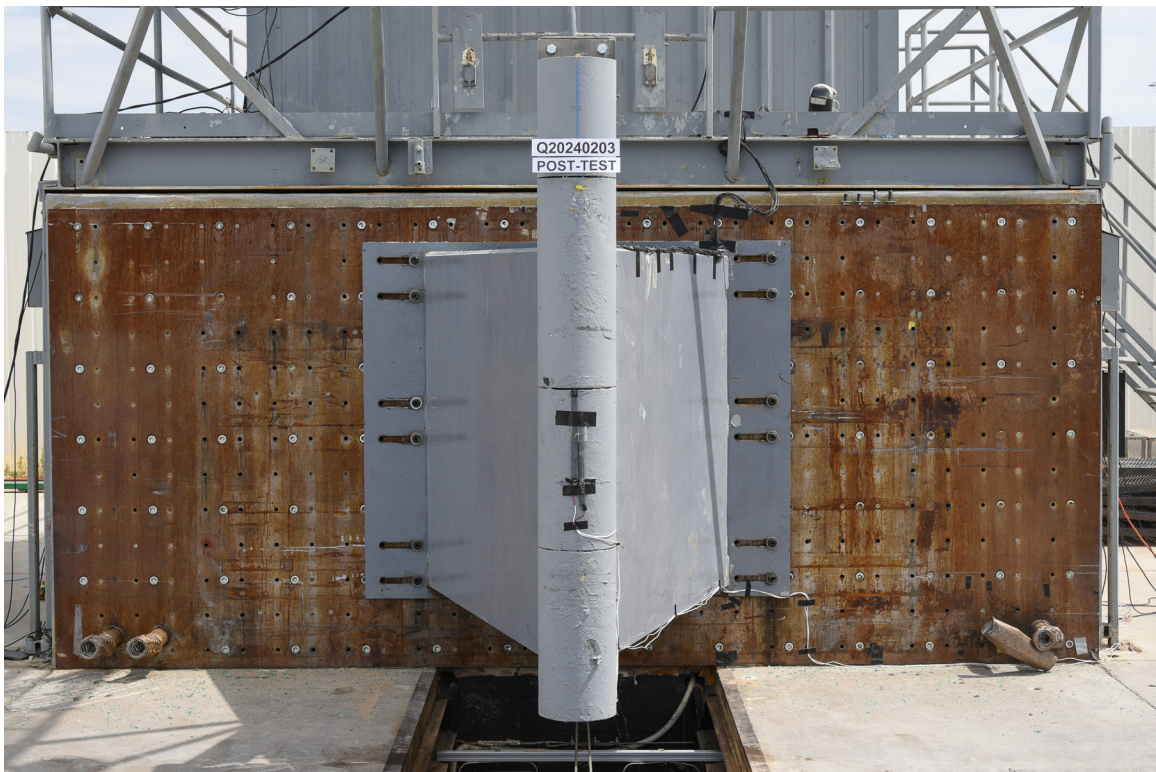
FIGURE 60. Post-Test Pole Barrier Front View

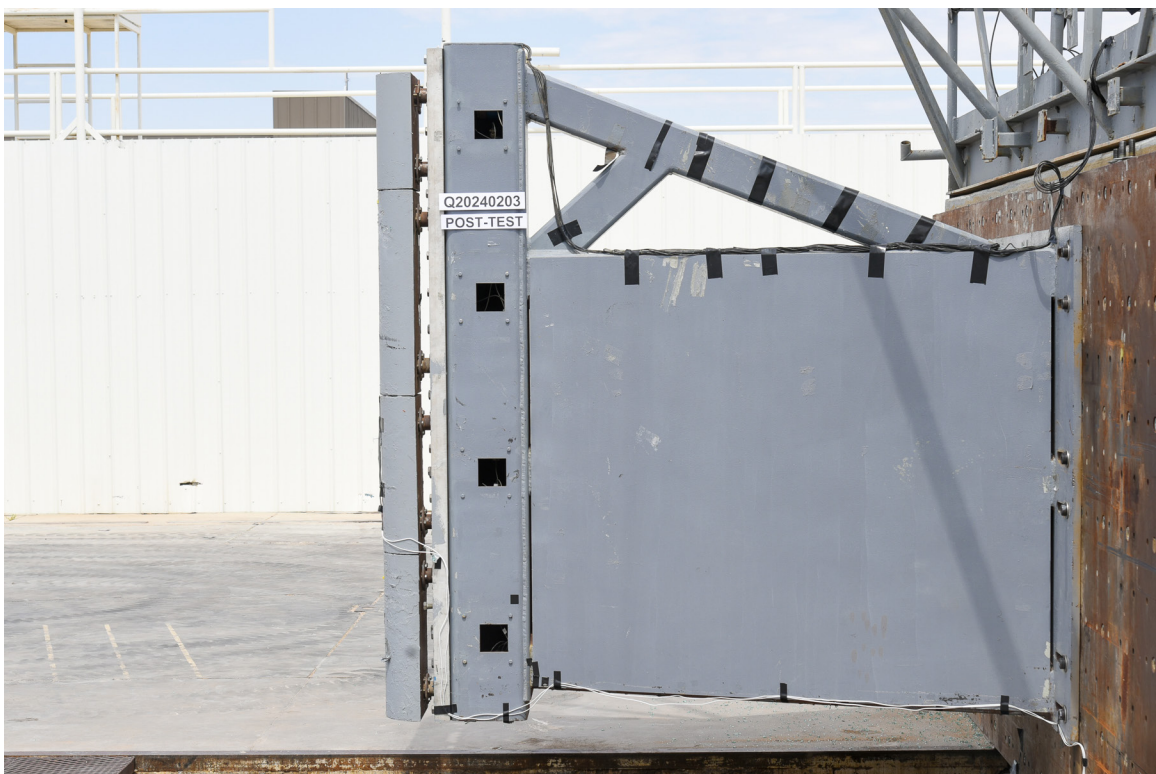
FIGURE 62. Post-Test Pole Barrier Side View

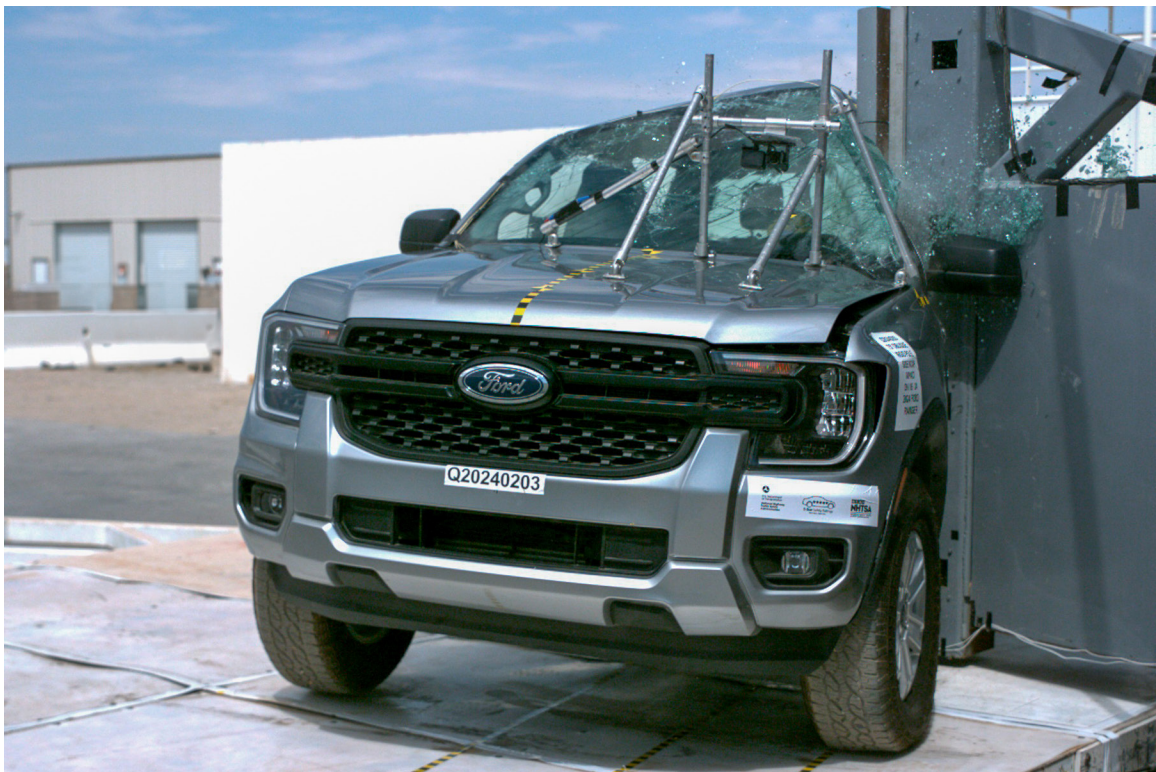
FIGURE 70. Impact Event
