**REPORT NUMBER: SPNCAP-CAL-010**

**NEW CAR ASSESSMENT PROGRAM (NCAP)  
SIDE IMPACT POLE TEST**

**SAIC General Motors Corporation Limited for General Motors LLC  
2024 Buick Envision  
5 Door SUV**

**NHTSA No: M20240117**

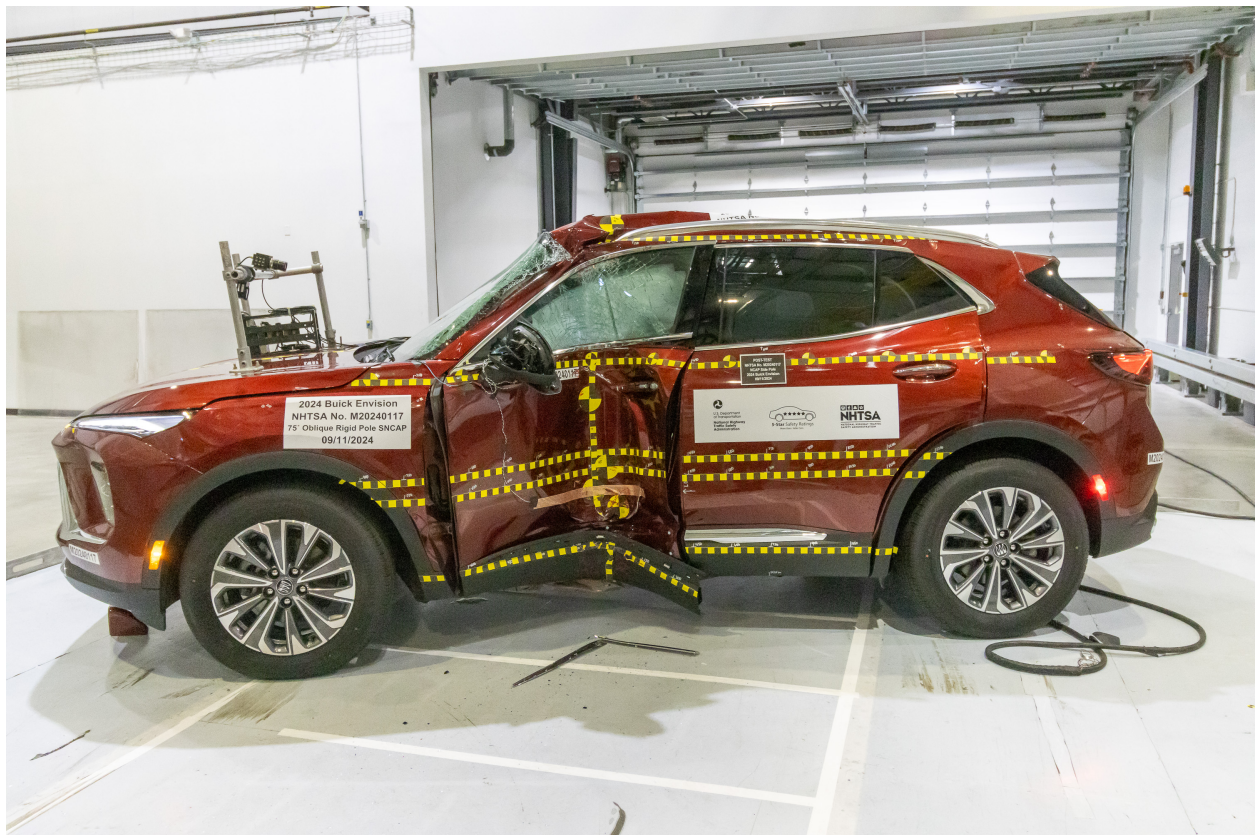
**Figure A-8: Post-Test Left Side View of Test Vehicle**

| Critical Areas of Performance | Observations and Conclusions |
|---|---|
| Windshield Damage | Cracked throughout with separation along Driver A-pillar and roof |
| Side Window Damage | Cracked throughout |

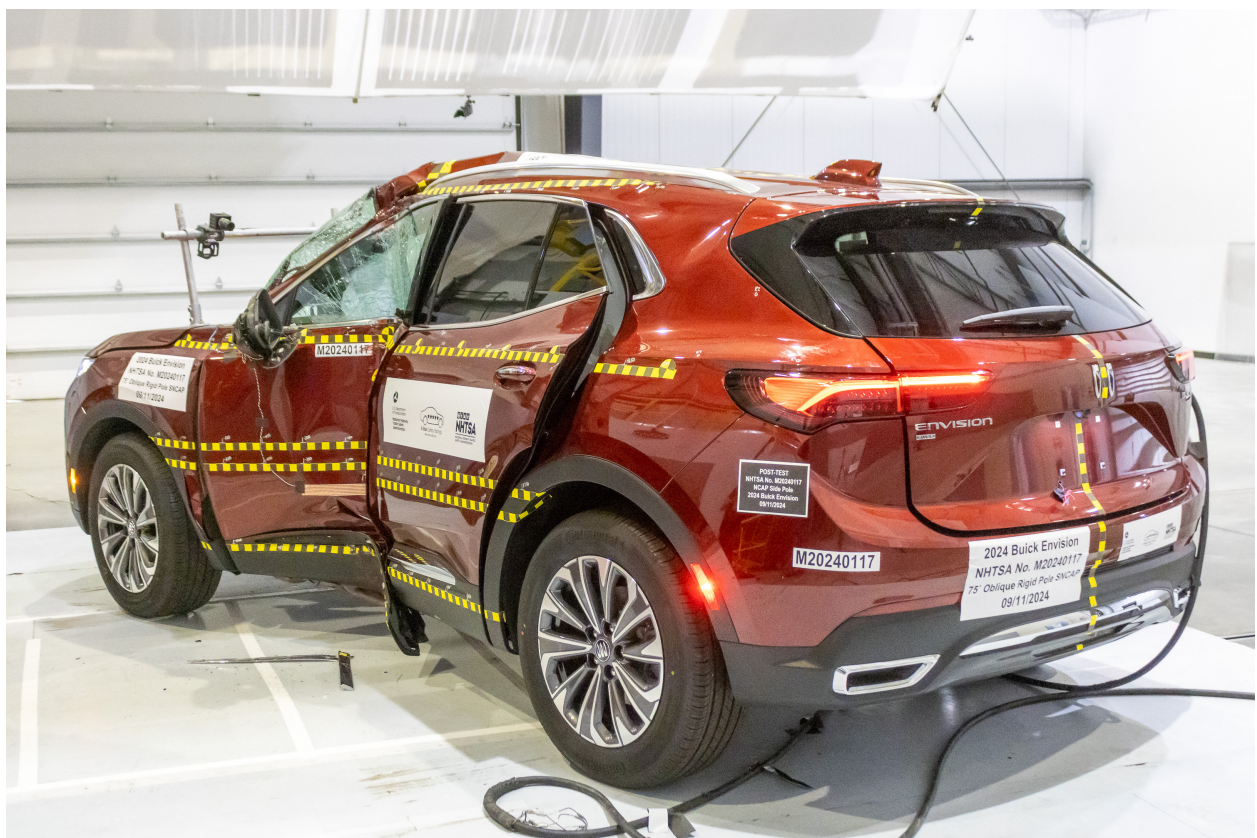
**Figure A-10: Post-Test Left Rear  $\frac{3}{4}$  View of Test Vehicle**

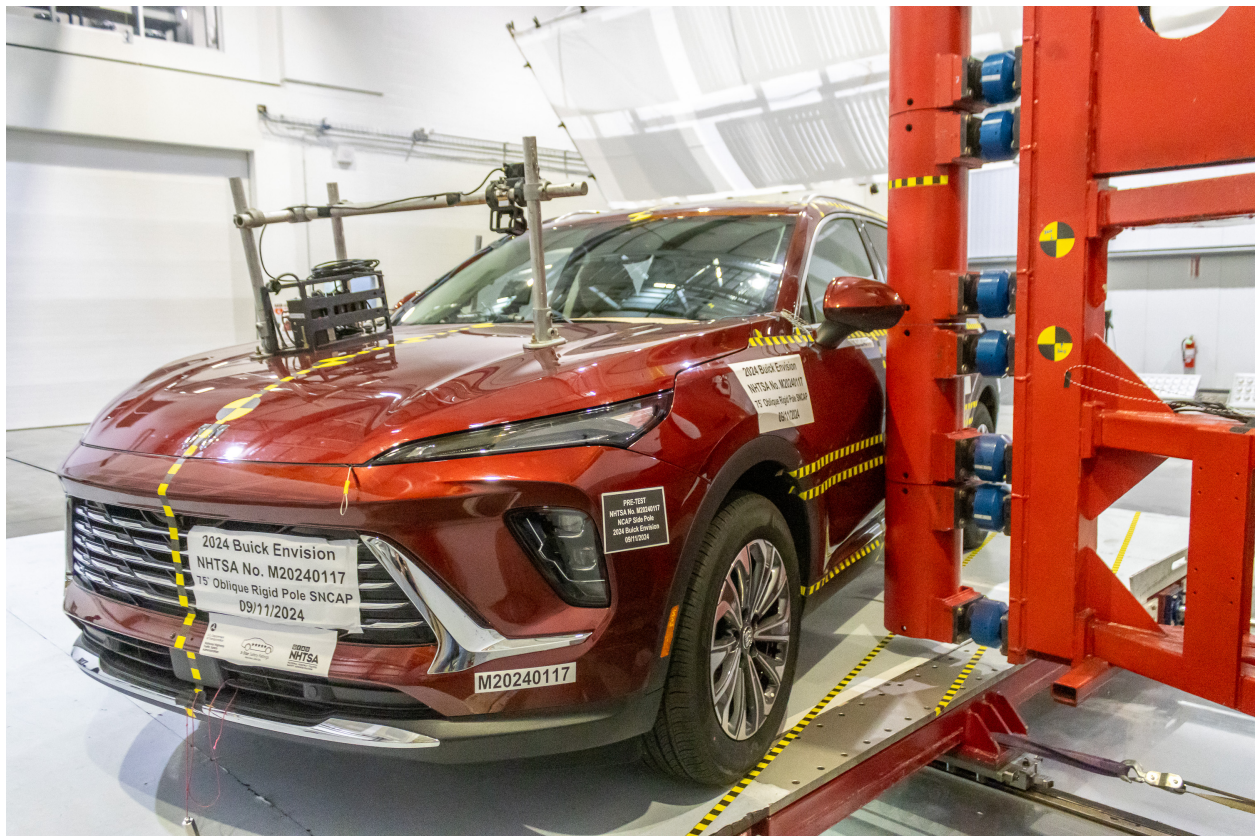
**Figure A-17: Pre-Test Left Side View of Pole Positioned Against Side of Vehicle**

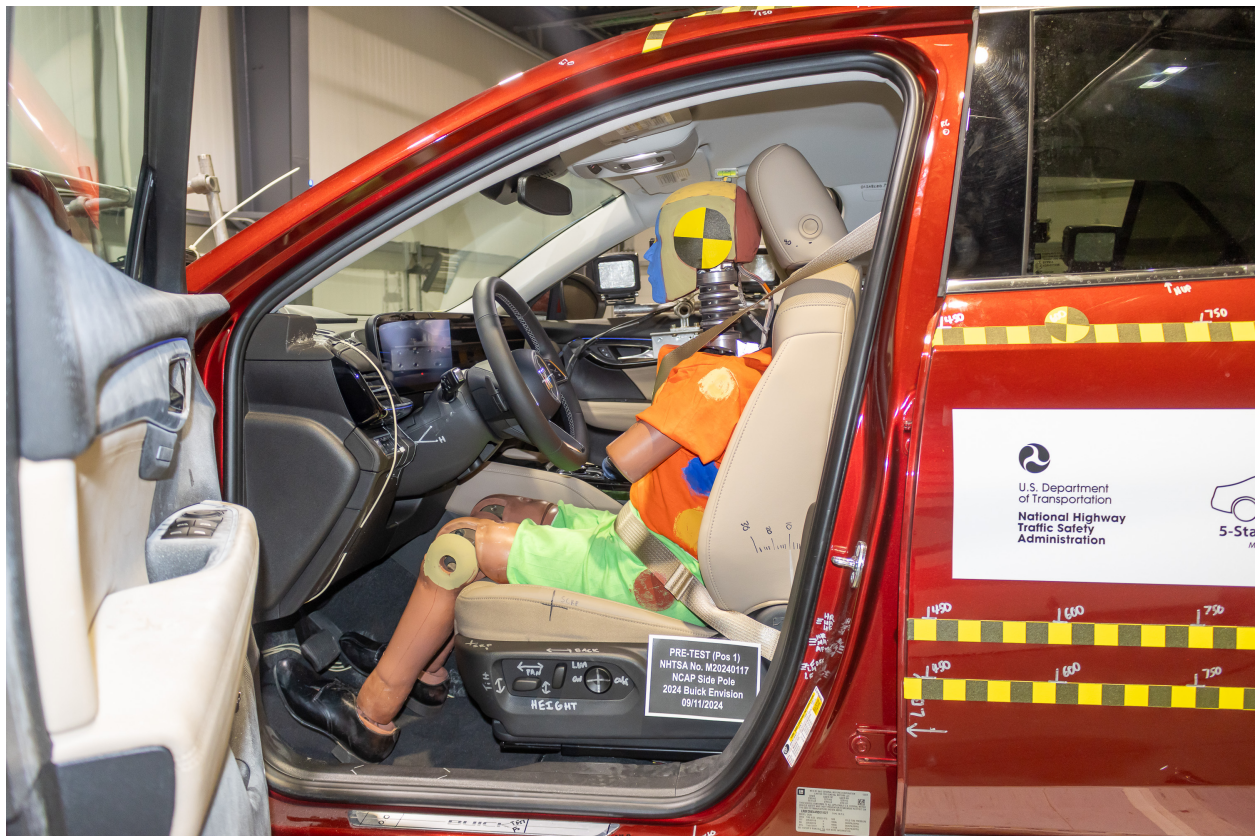
**Figure A-23: Pre-Test Left Side View of Dummy Showing Belt and Chalking**

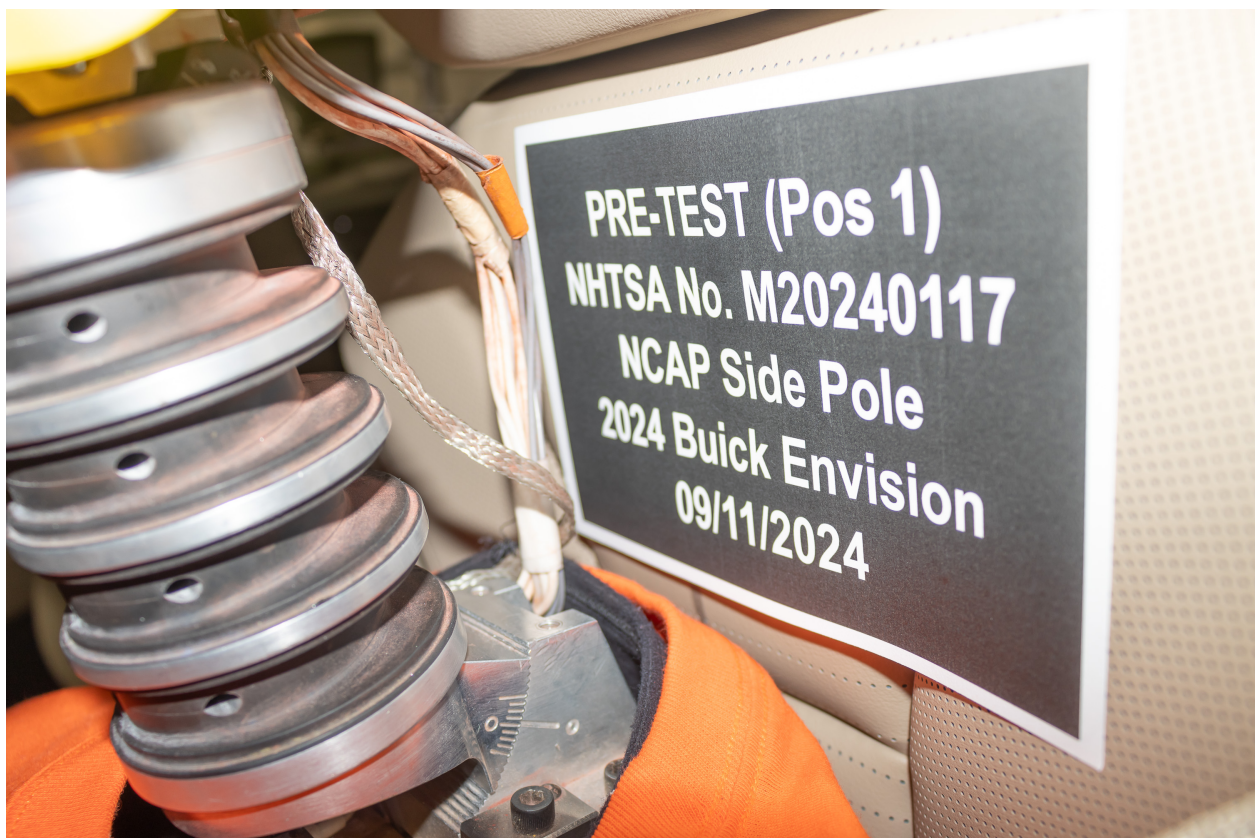
**Figure A-30: Pre-Test Left Side View of Dummy's Neck Showing Position of Adjustable Neck Bracket**

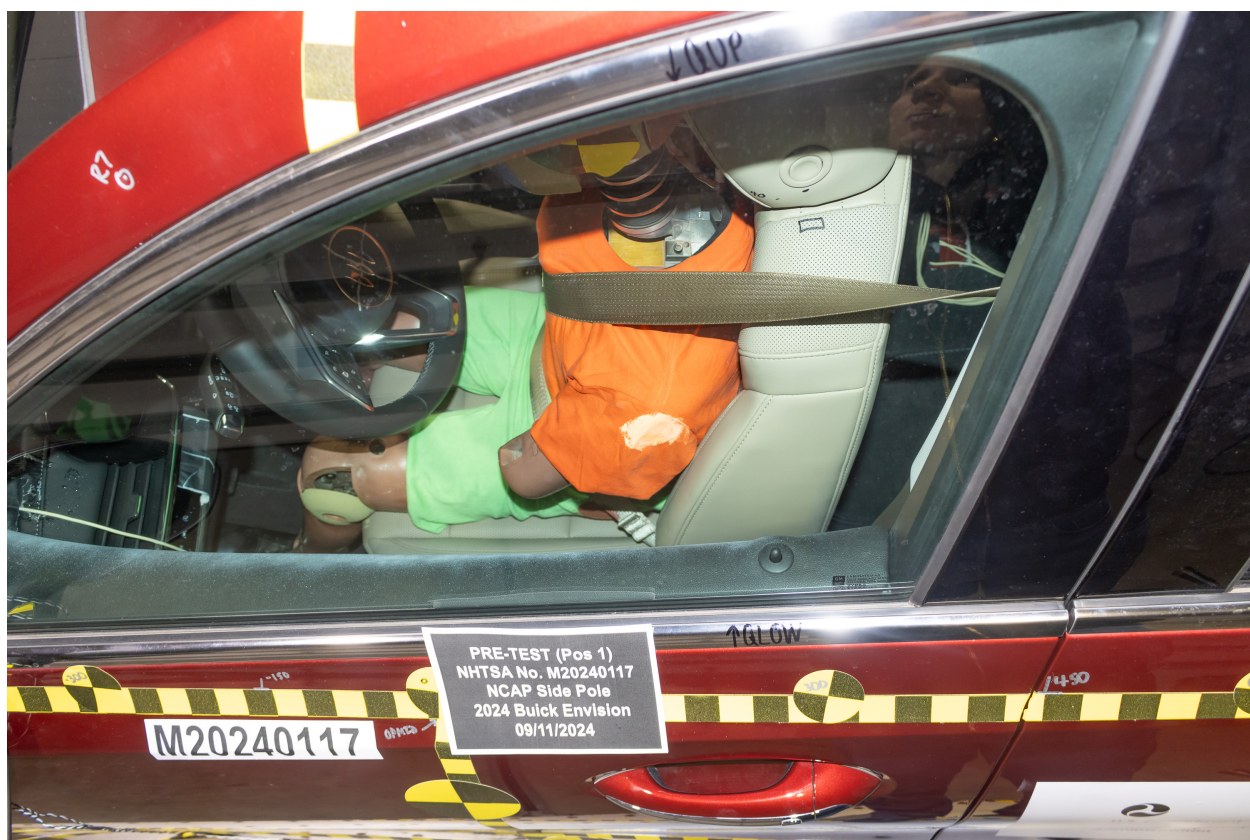
**Figure A-40: Pre-Test Dummy and Door Clearance View**

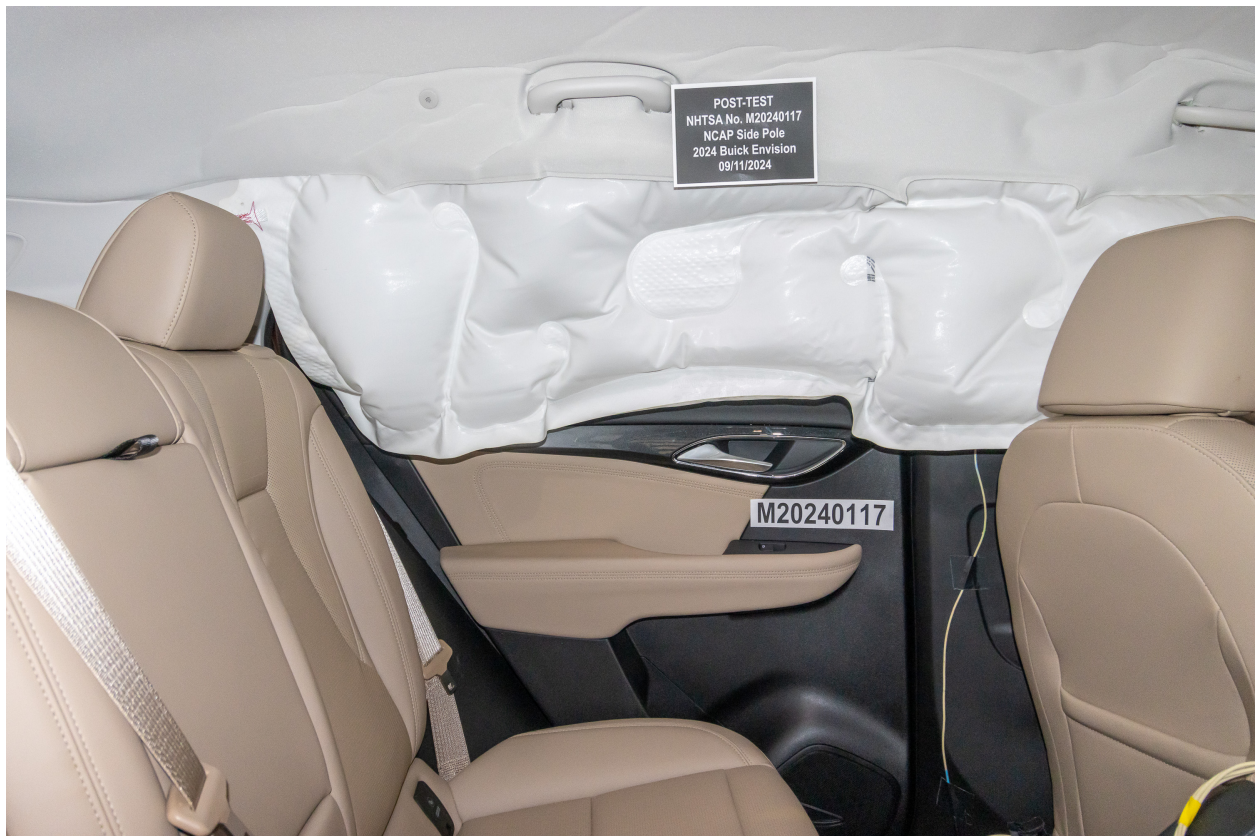
**Figure A-54: Post-Test Inner Rear Passenger Torso Air Bag Deployment View**
