**REPORT NUMBER: SPNCAP-CAL-24-010**

**NEW CAR ASSESSMENT PROGRAM (NCAP)  
SIDE IMPACT POLE TEST**

**General Motors LLC  
2024 Chevrolet Traverse  
5 Door SUV**

**NHTSA No: M20240107**

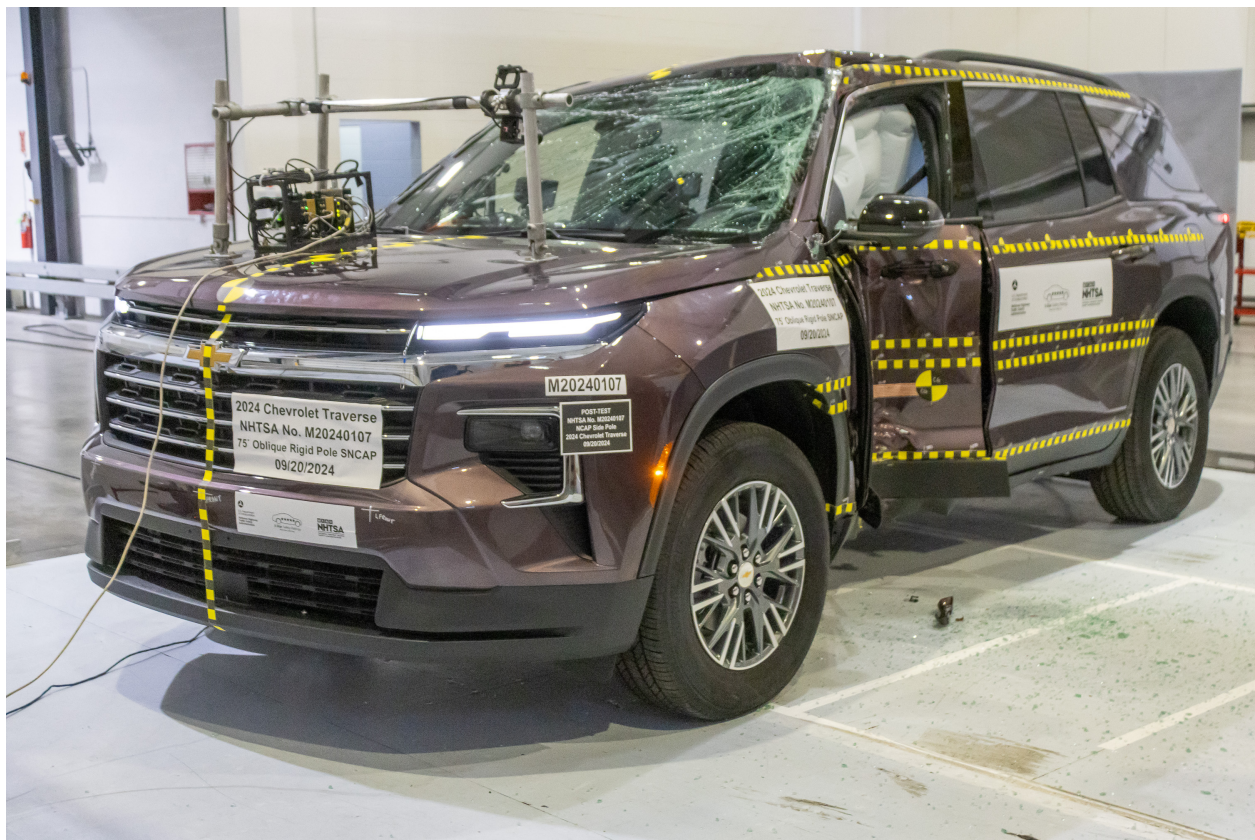
**Figure A-6: Post-Test Left Front  $\frac{3}{4}$  View of Test Vehicle**

| Critical Areas of Performance | Observations and Conclusions |
|---|---|
| Windshield Damage | Cracked throughout with separation along Driver A-Pillar and roof |
| Side Window Damage | Driver window shattered |

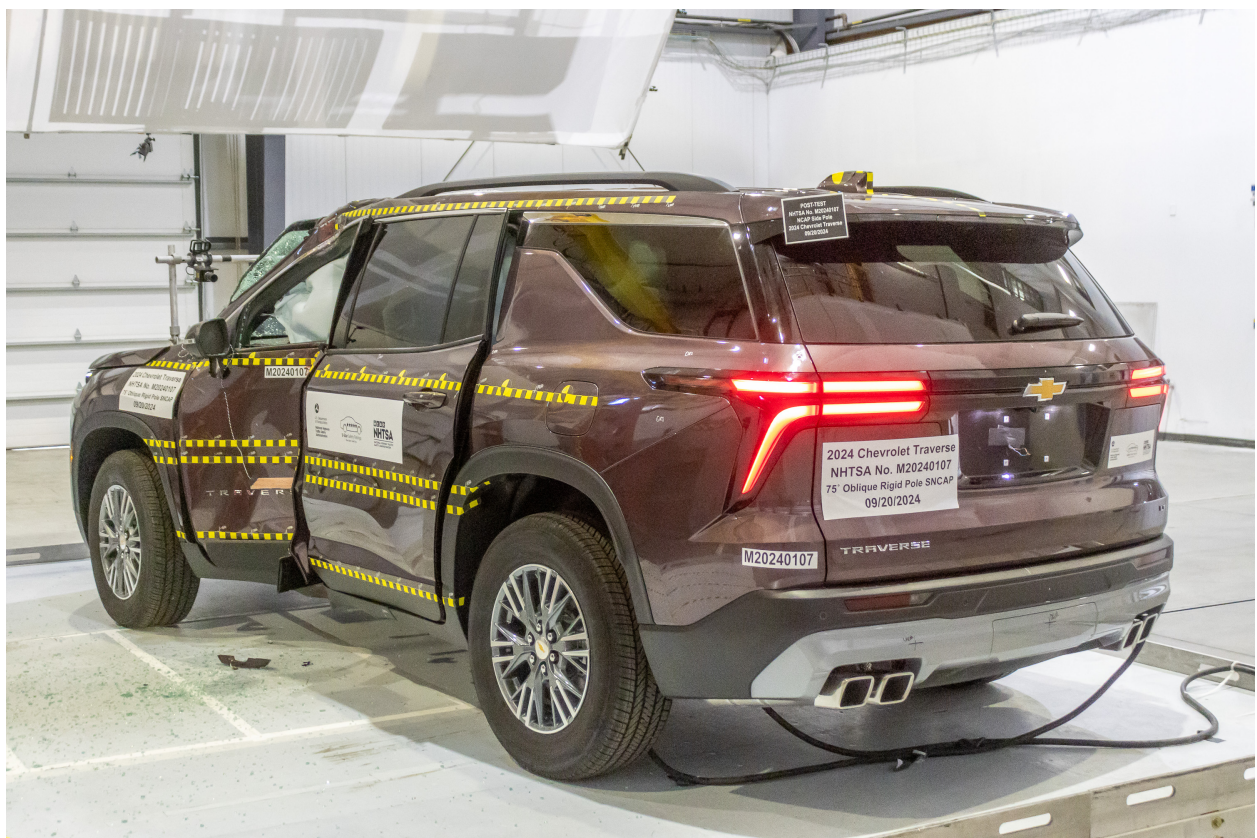
**Figure A-10: Post-Test Left Rear  $\frac{3}{4}$  View of Test Vehicle**

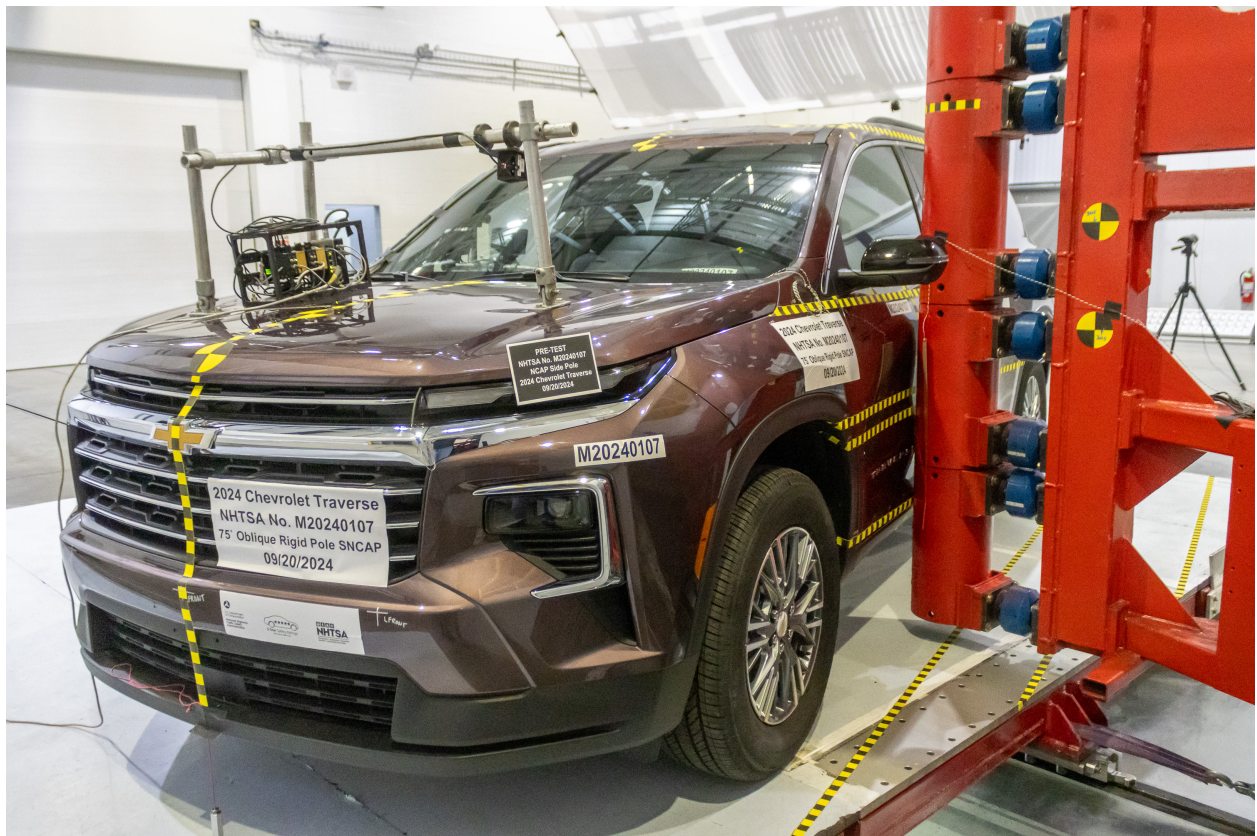
**Figure A-17: Pre-Test Left Side View of Pole Positioned Against Side of Vehicle**

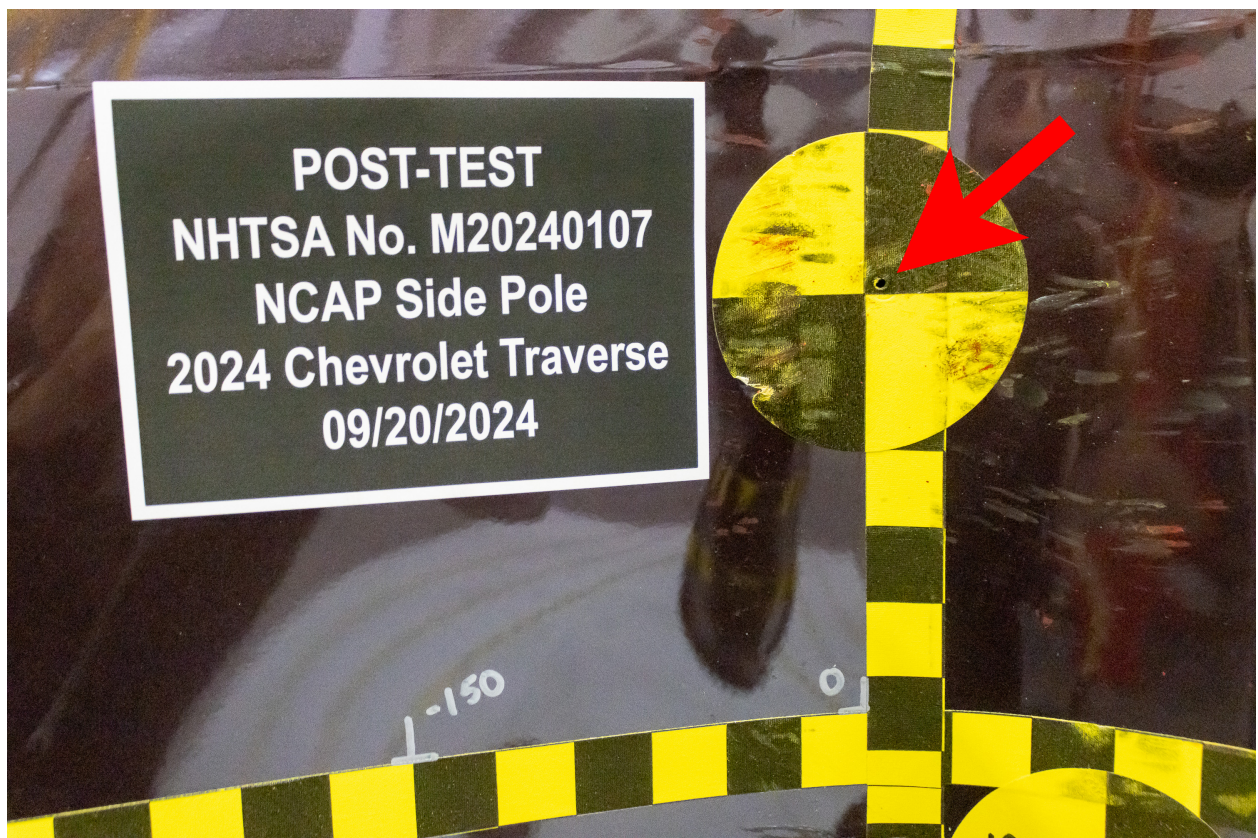
Figure A-20: Post-Test Close-Up View of Impact Point Target Showing Impact Location

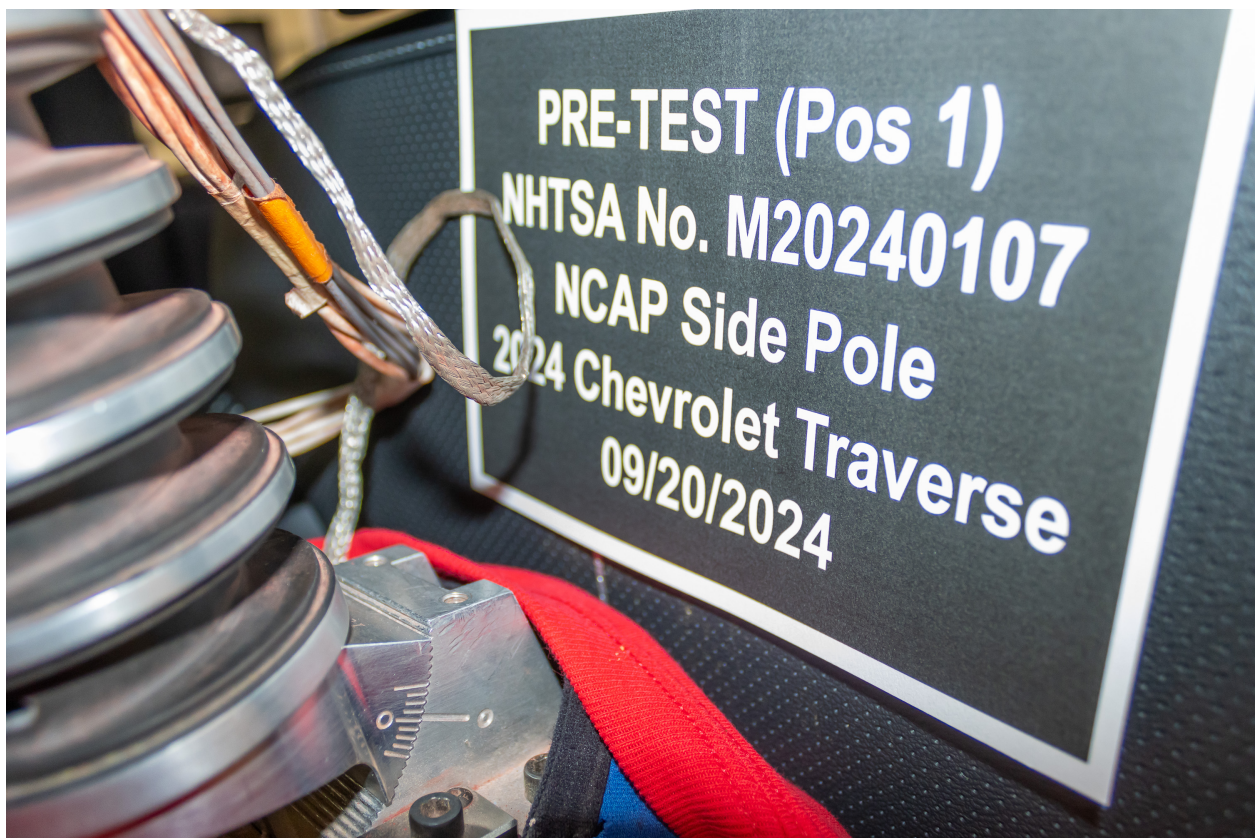
Figure A-30: Pre-Test Left Side View of Dummy's Neck Showing Position of Adjustable Neck Bracket

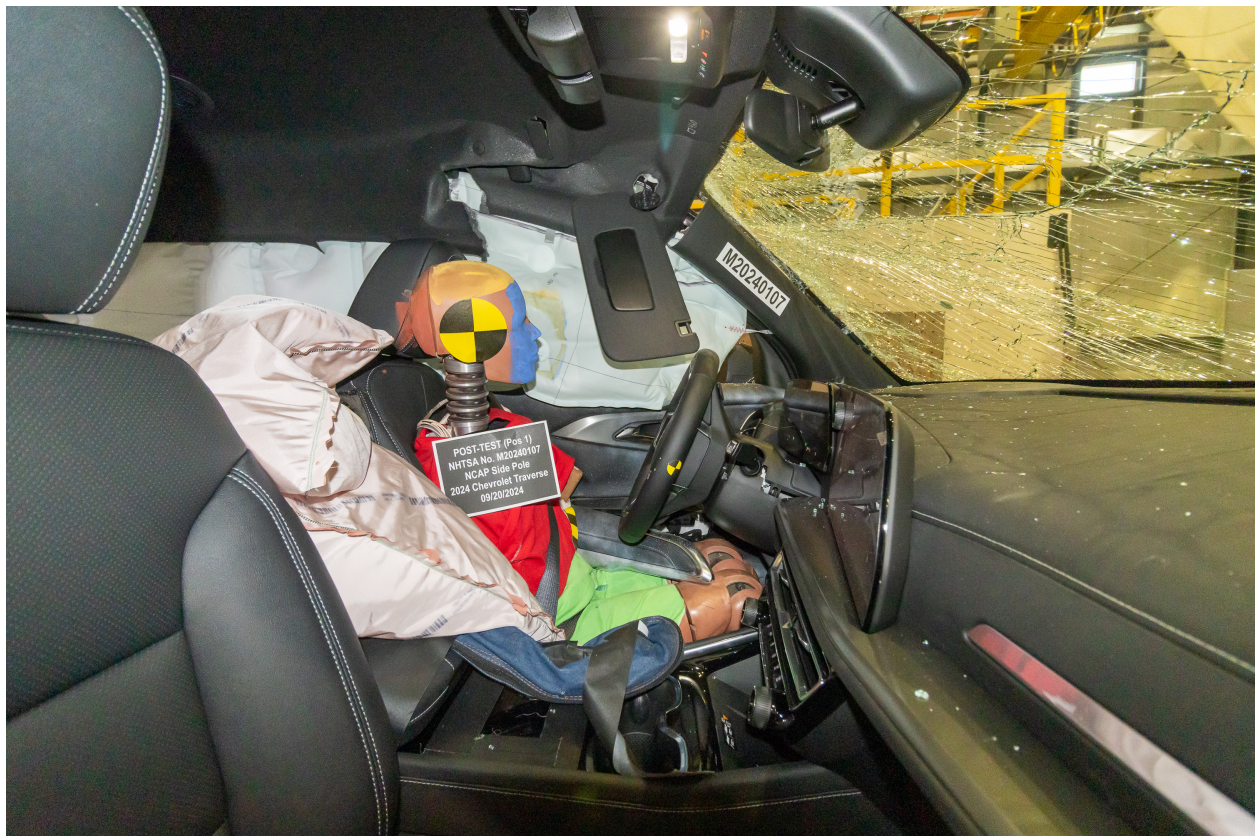
**Figure A-43: Post-Test Right Side View of Dummy and Front Seat of Occupant Compartment**

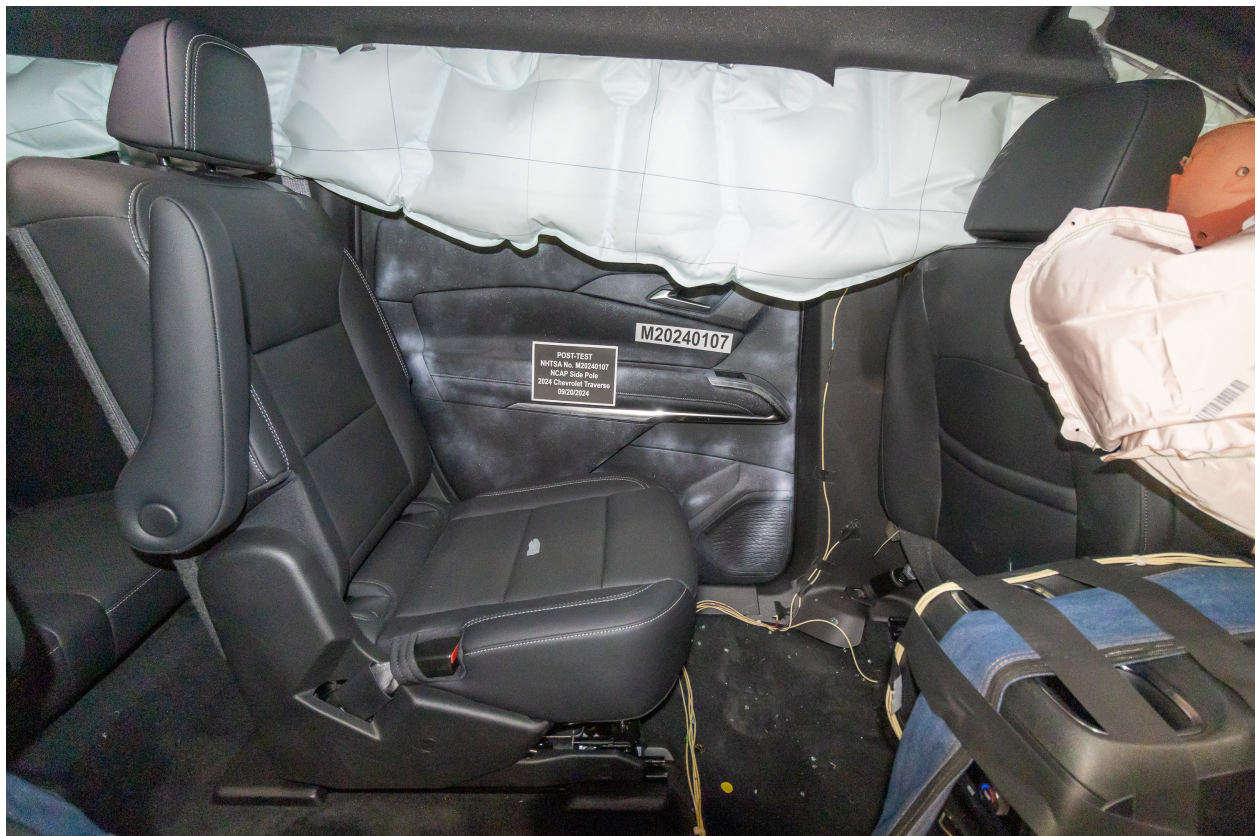
**Figure A-54: Post-Test Inner Rear Passenger Torso Air Bag Deployment View**

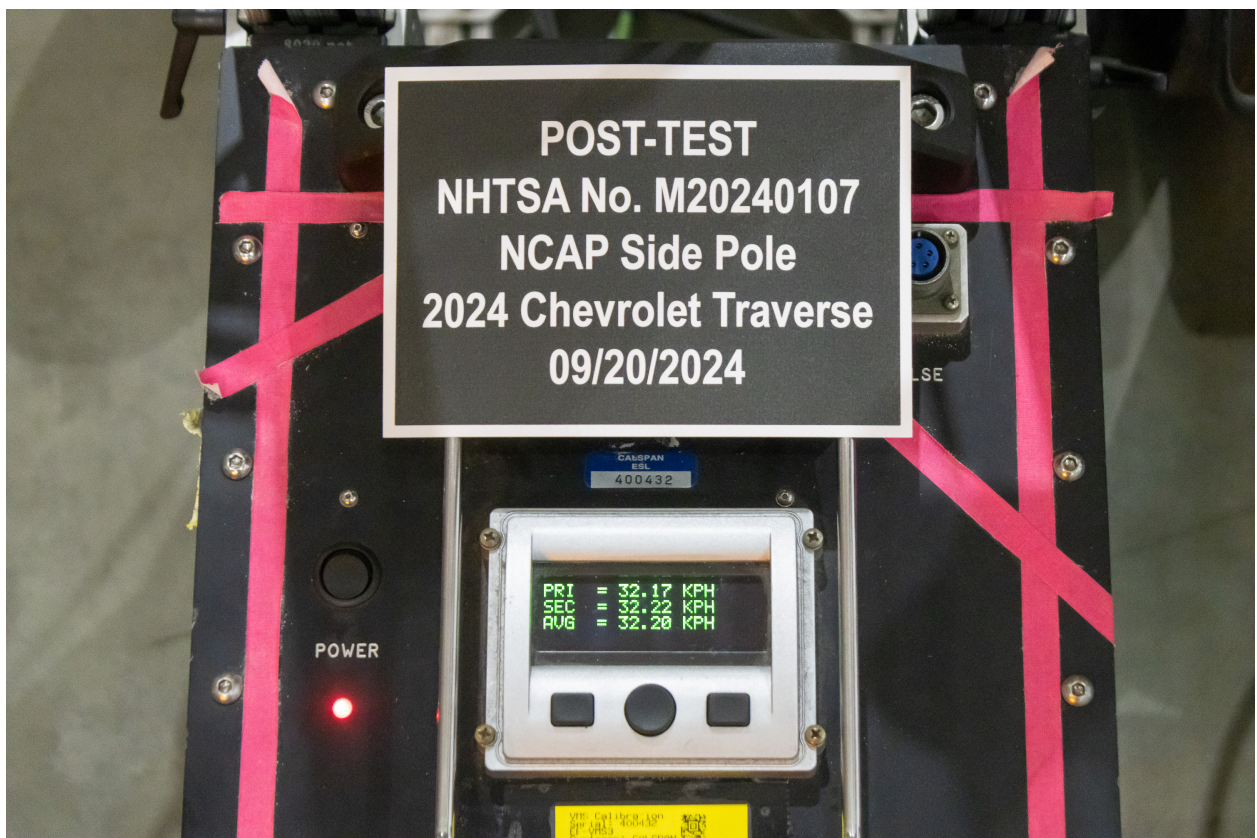
Figure A-64: Post-Test Primary and Redundant Speed Trap Read-Out
