**REPORT NUMBER: SideNCAPPole-MGA-24-032**

**NEW CAR ASSESSMENT PROGRAM (NCAP)  
Side Impact Pole Test**

**TOYOTA MOTOR MANUFACTURING DE GUANAJUATO, S.A. DE C.V.  
2024 Toyota Tacoma SR Double Cab Pickup Truck  
NHTSA No.: M20245104**

**FINAL REPORT**

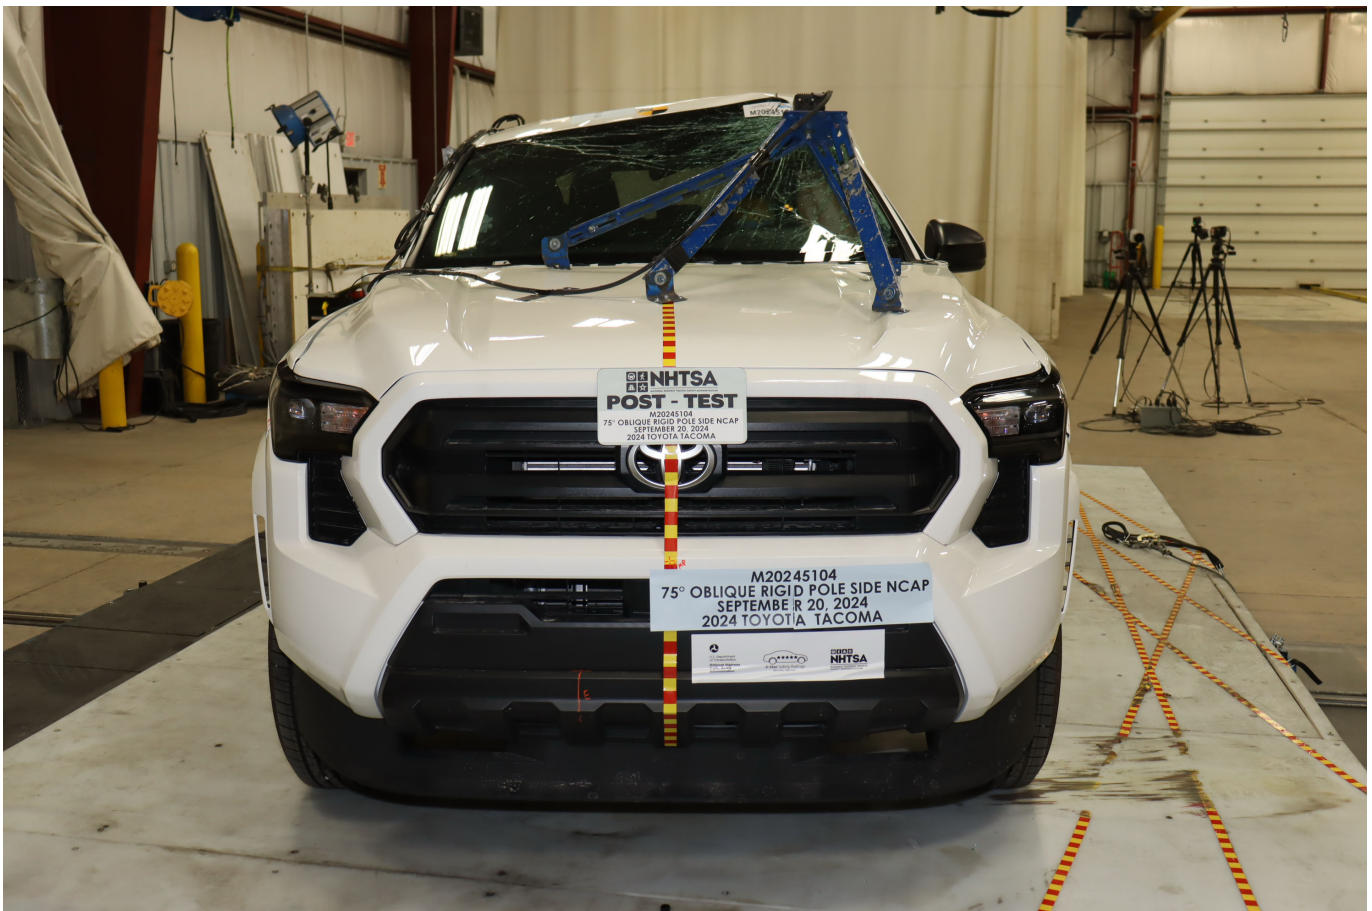
Photo No. 004 - Post-Test Frontal View of Test Vehicle

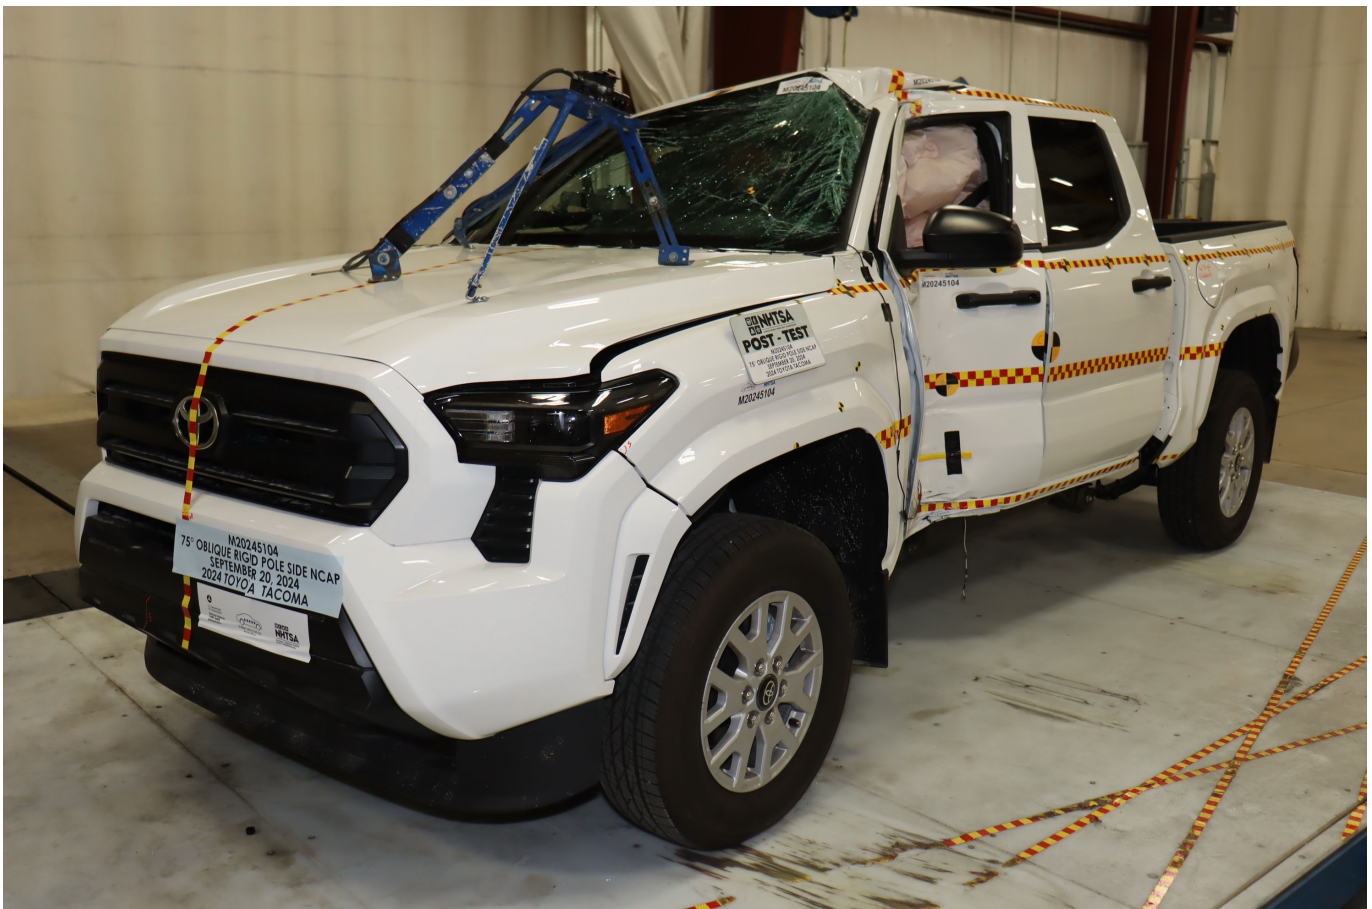
Photo No. 006 - Post-Test Left Front Three-Quarter View of Test Vehicle

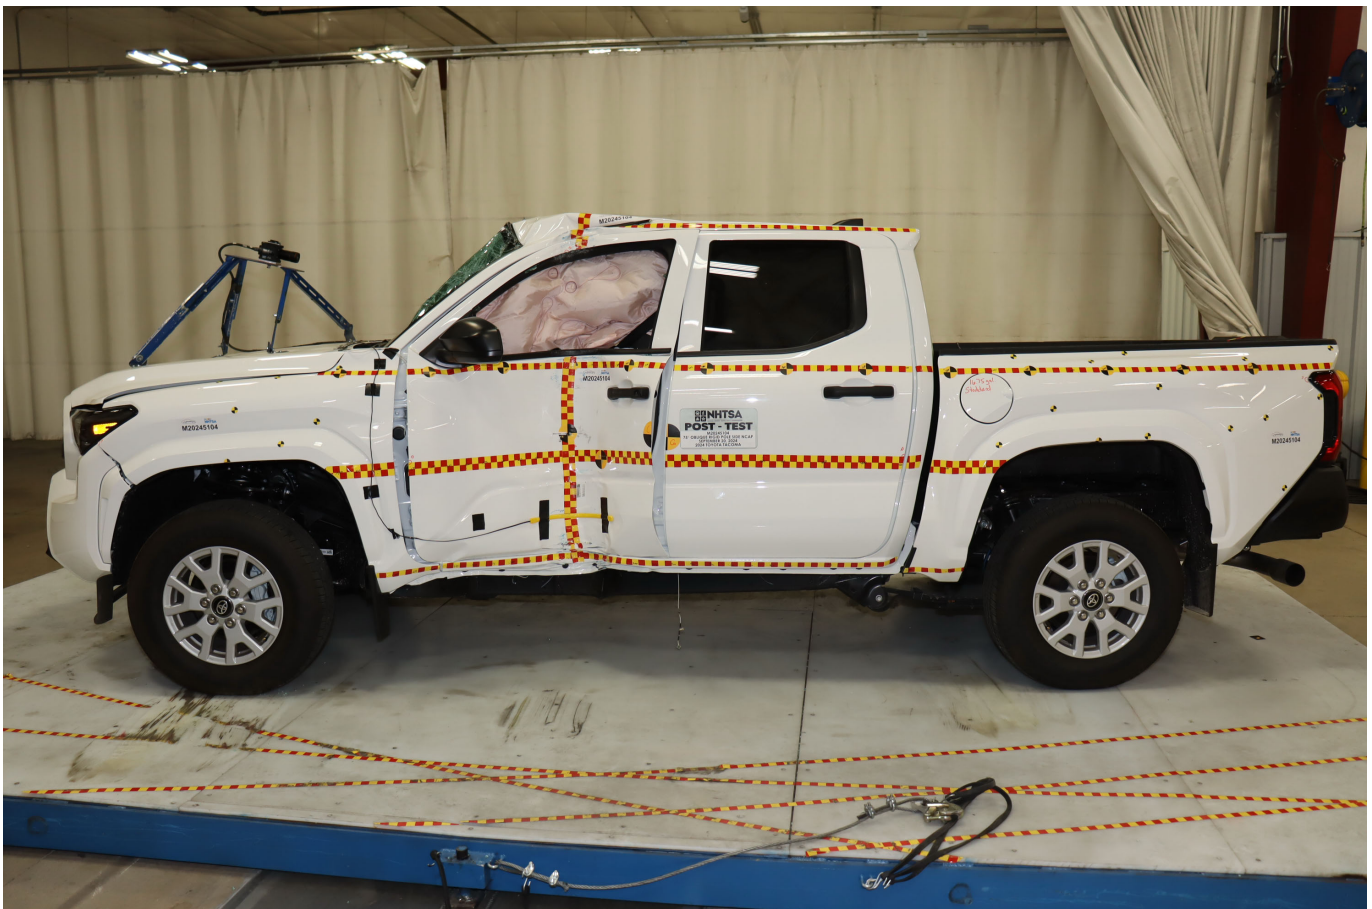
Photo No. 008 - Post-Test Left Side View of Test Vehicle

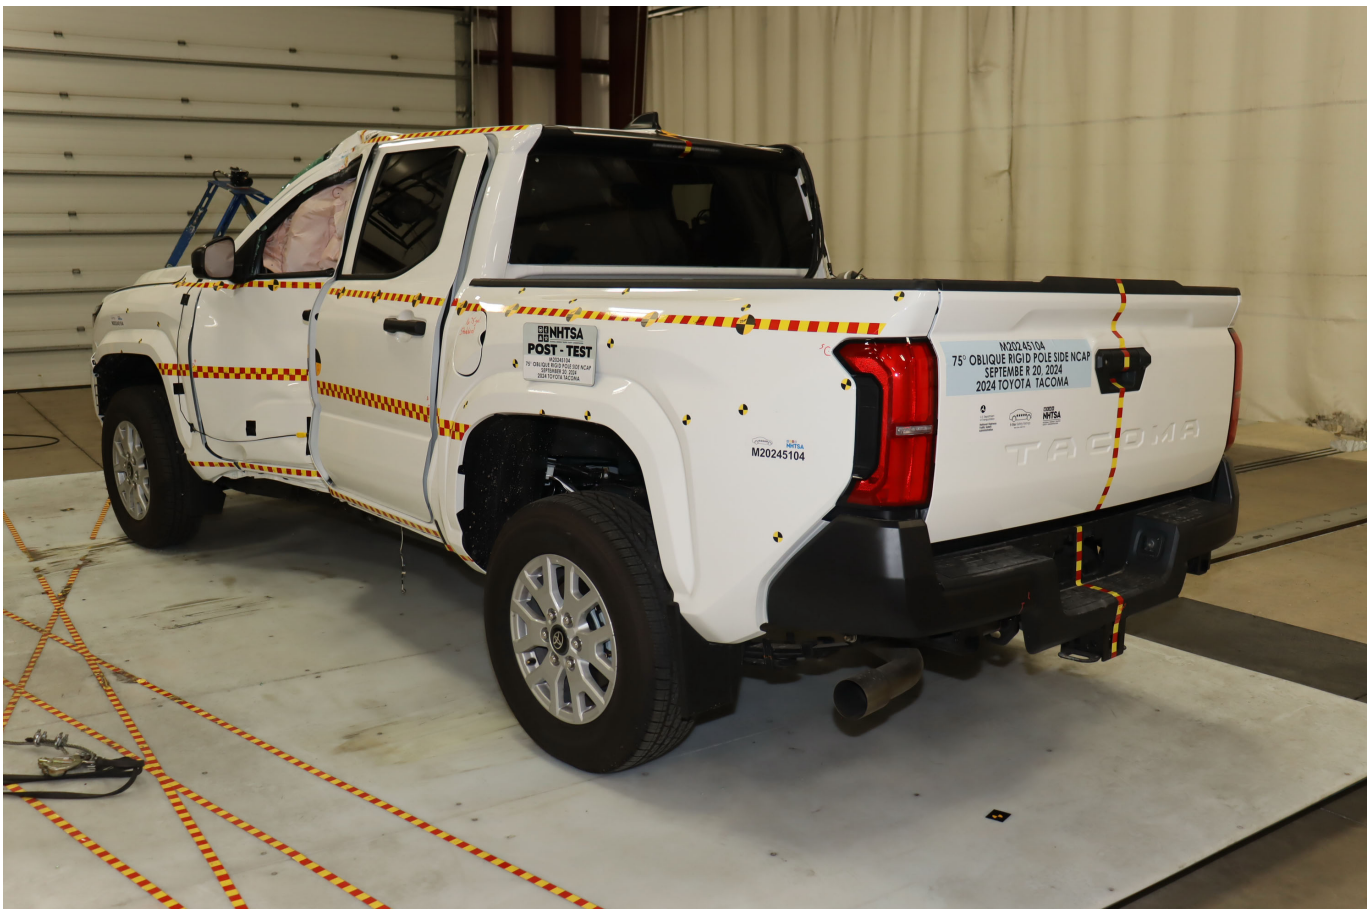
Photo No. 010 - Post-Test Left Rear Three-Quarter View of Test Vehicle

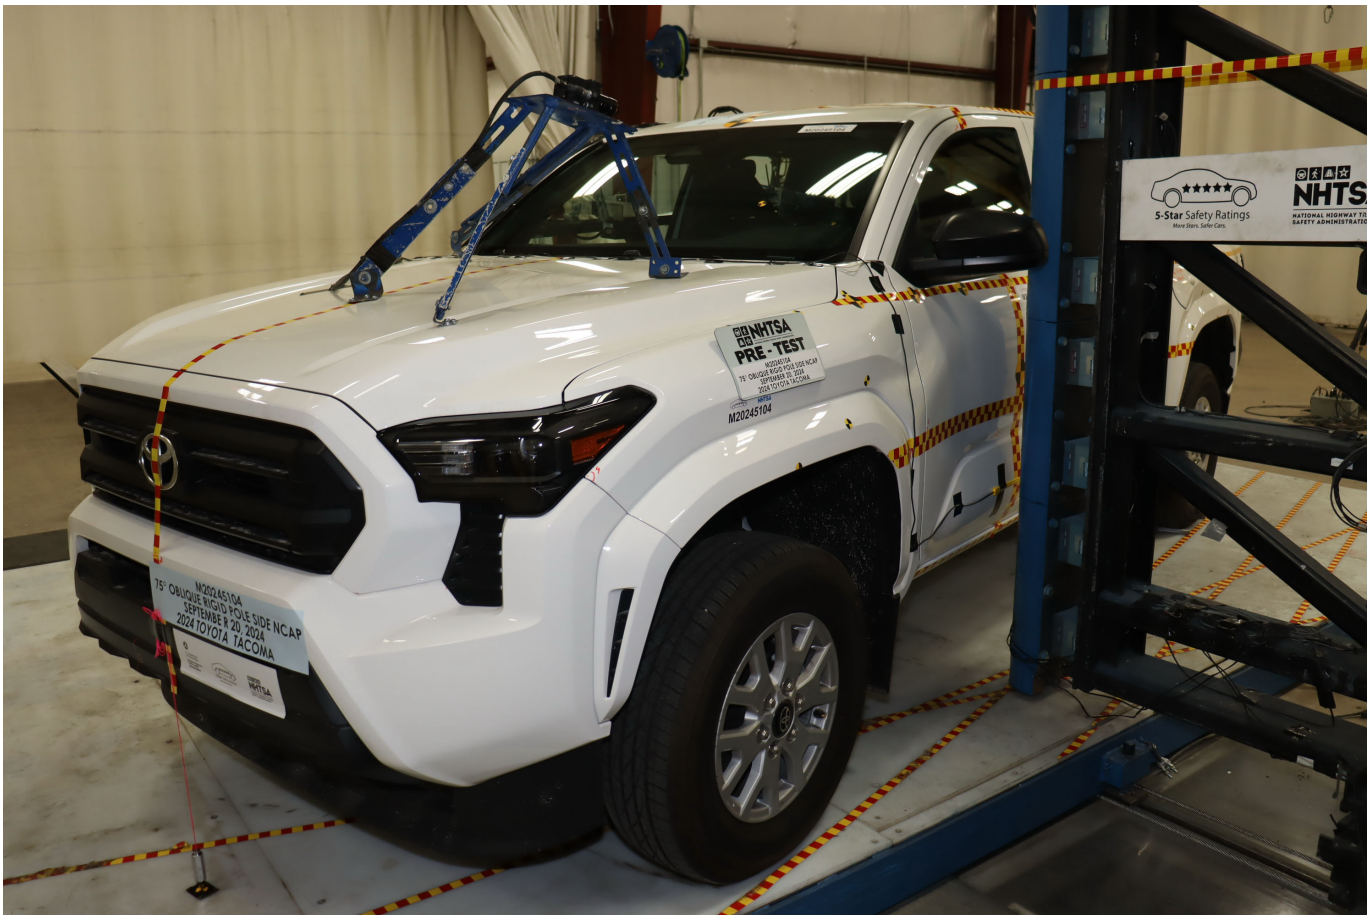
Photo No. 017 - Pre-Test Left Side View of Pole Positioned Against Side of Vehicle

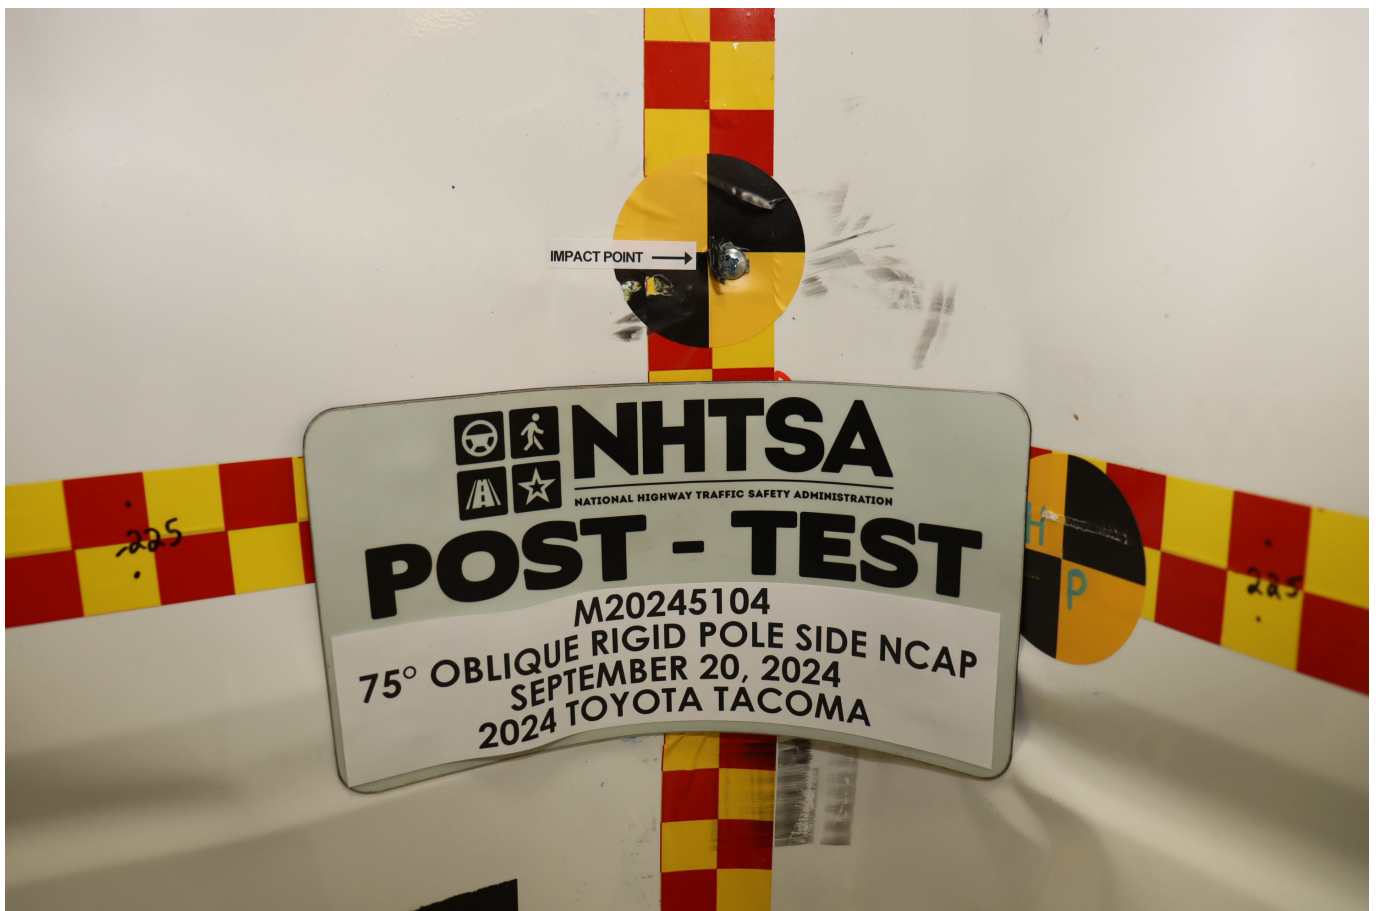
Photo No. 020 - Post-Test Close-Up View of Impact Point Target Showing Impact Location

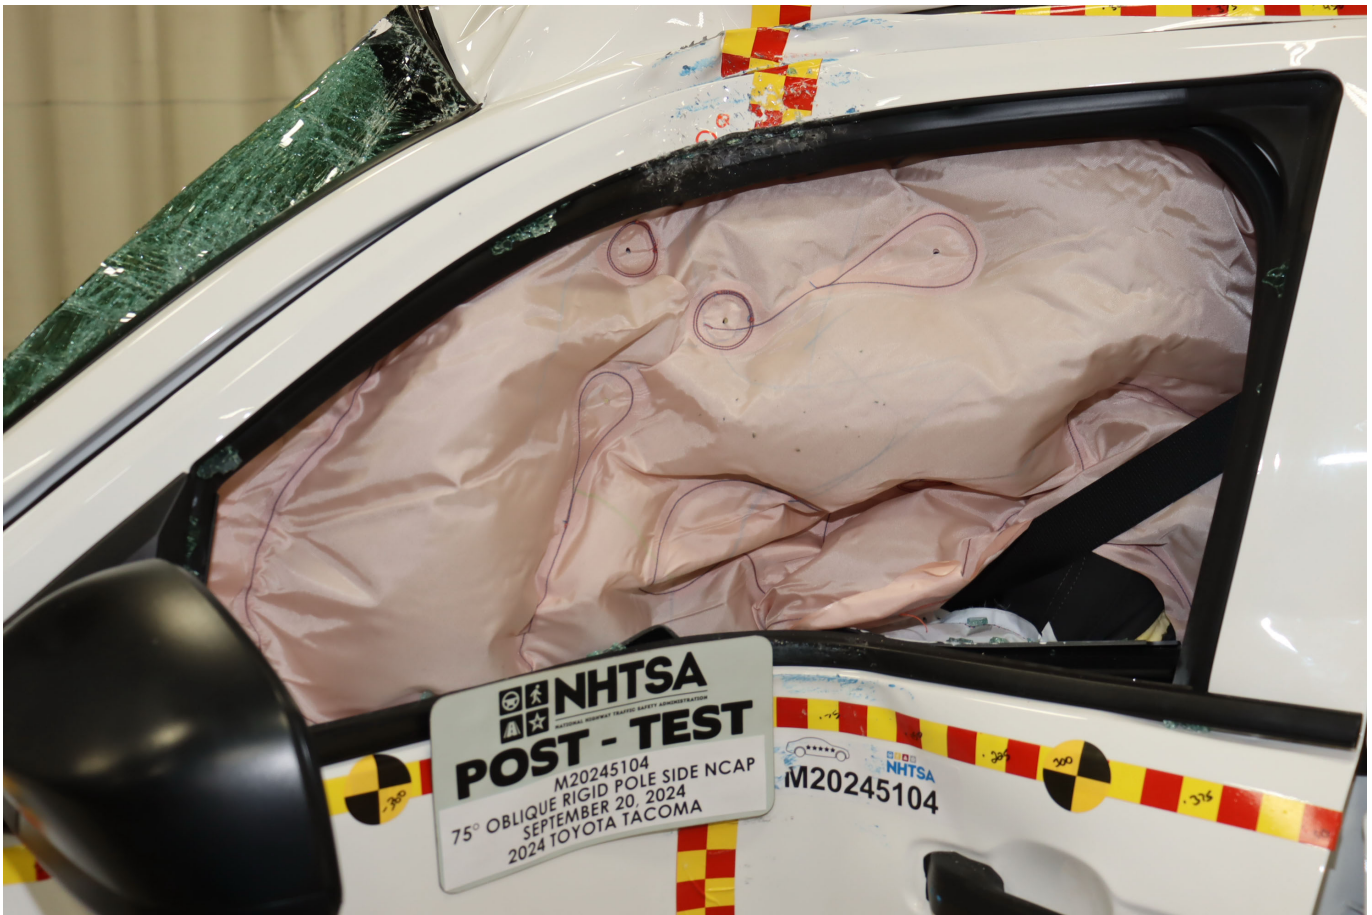
Photo No. 025 - Post-Test Left Side View of Dummy Shoulder and Door Top View

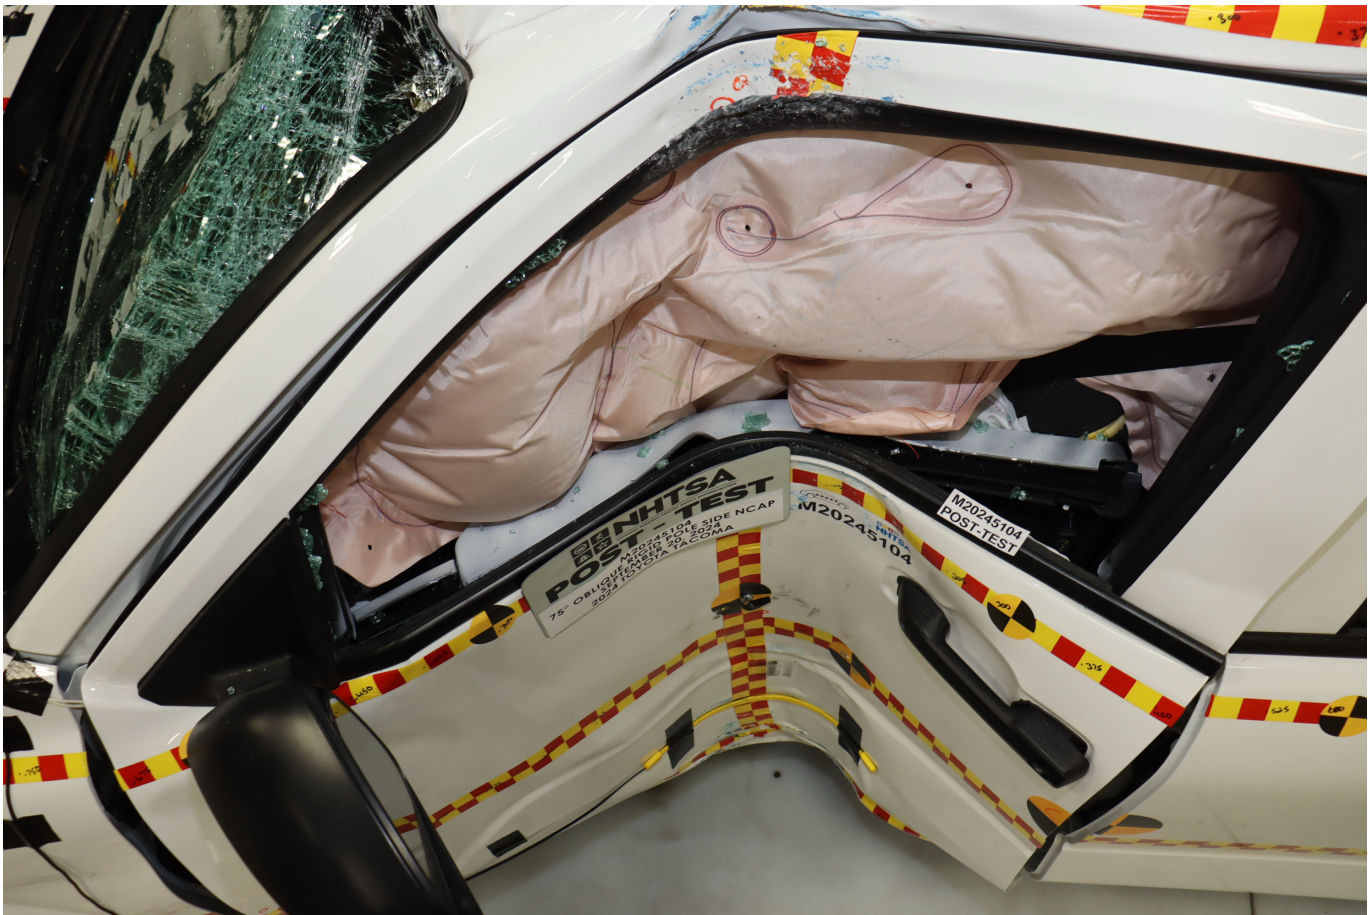
Photo No. 041 - Post-Test Dummy and Door Clearance View

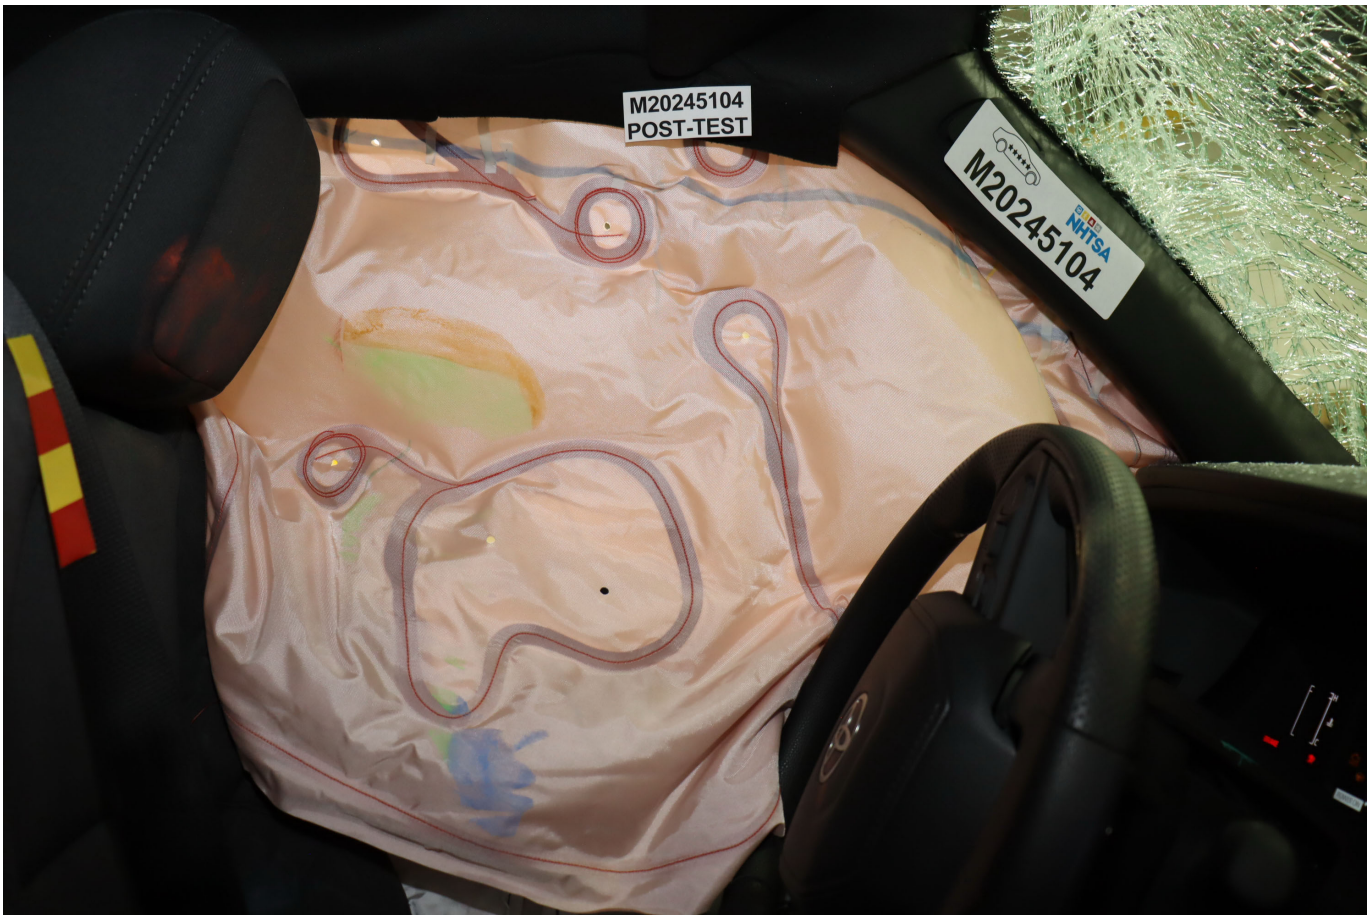
Photo No. 047 - Post-Test Dummy Close-Up Head Contact with Side Air Bag View

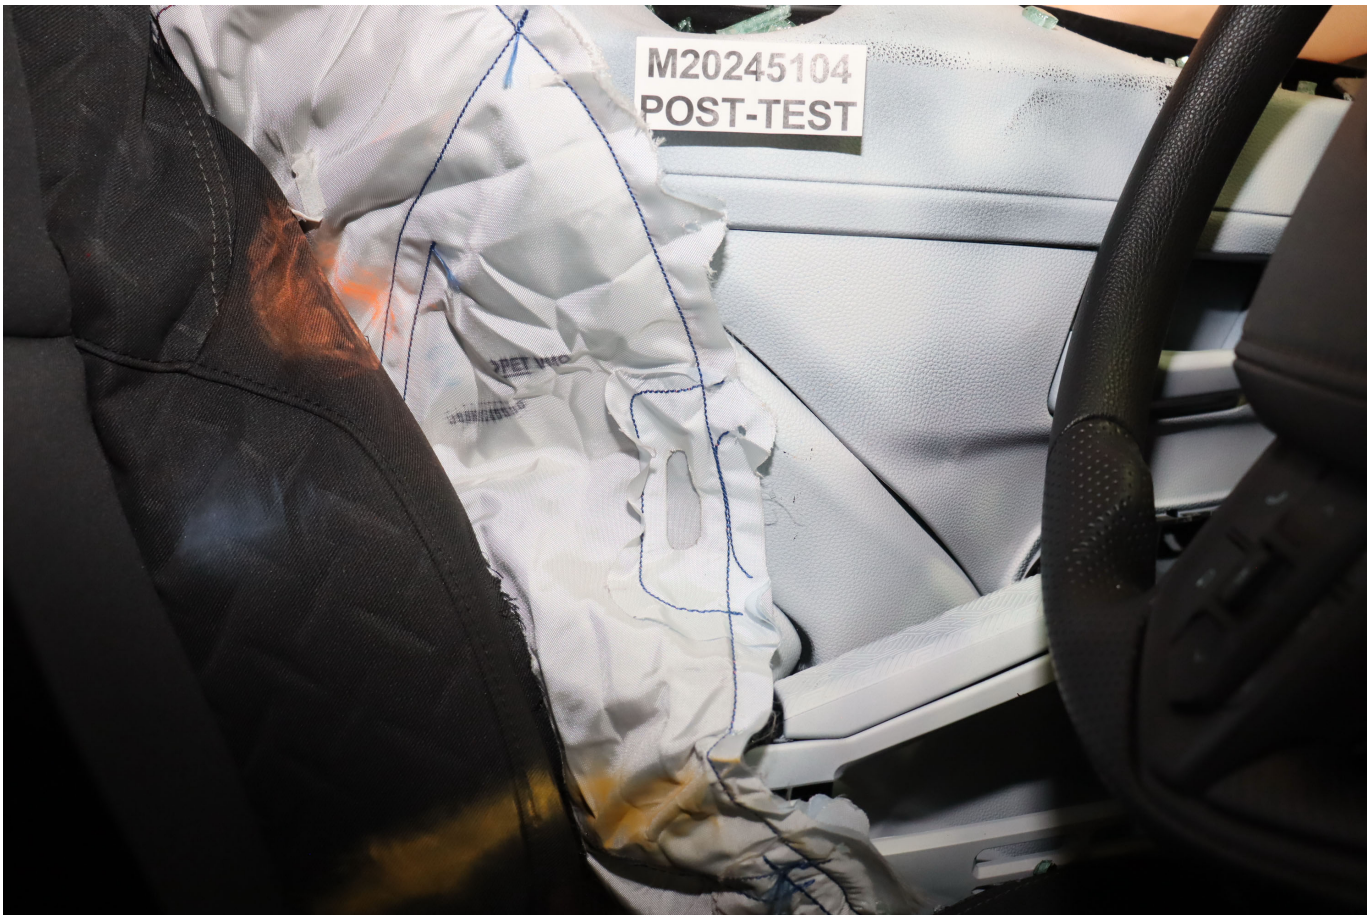
Photo No. 049 - Post-Test Dummy Close-Up Torso Contact with Side Air Bag View

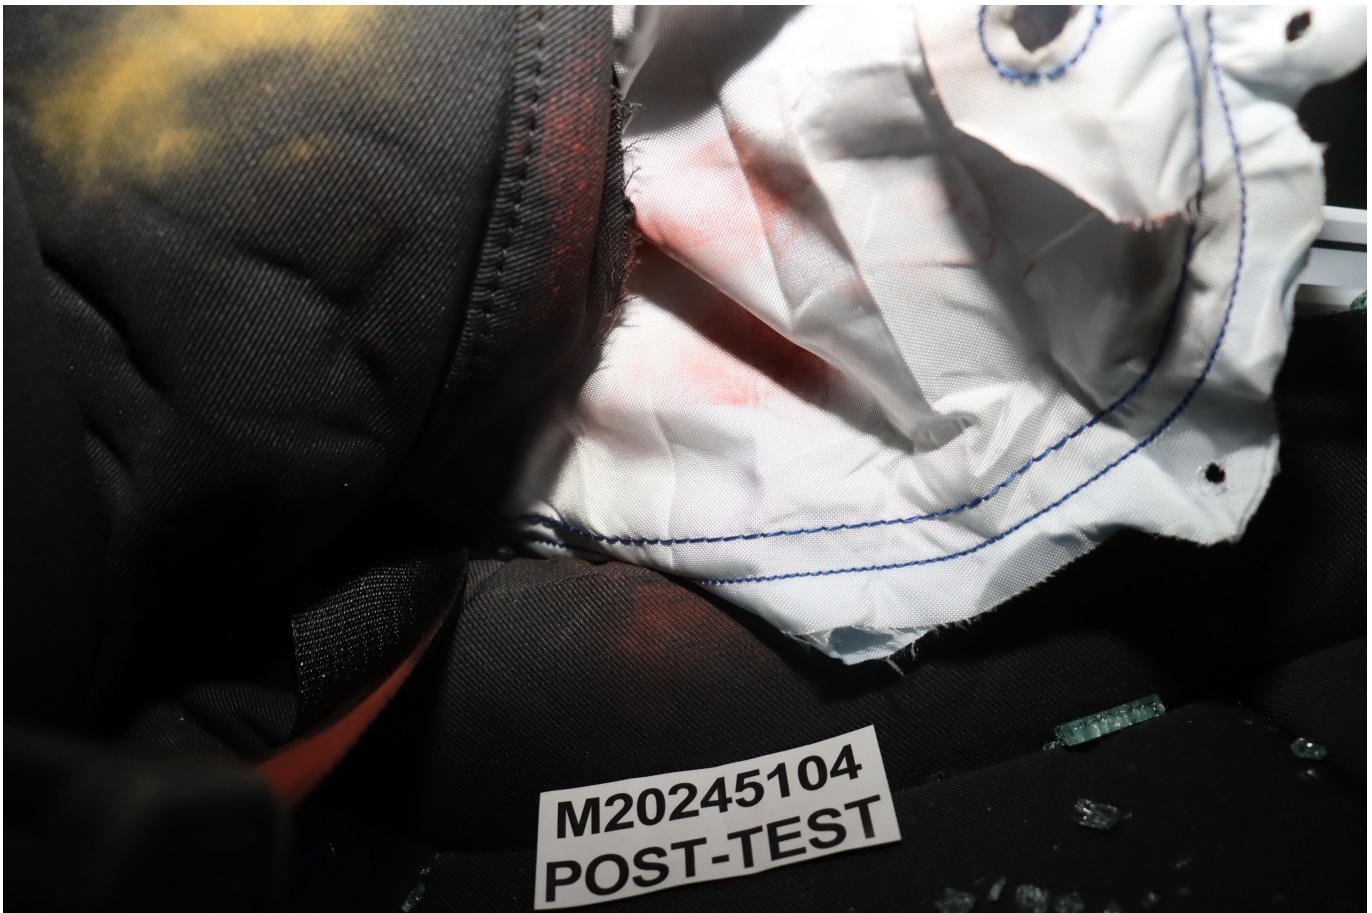
Photo No. 051 - Post-Test Dummy Close-Up Pelvis Contact with Side Air Bag View

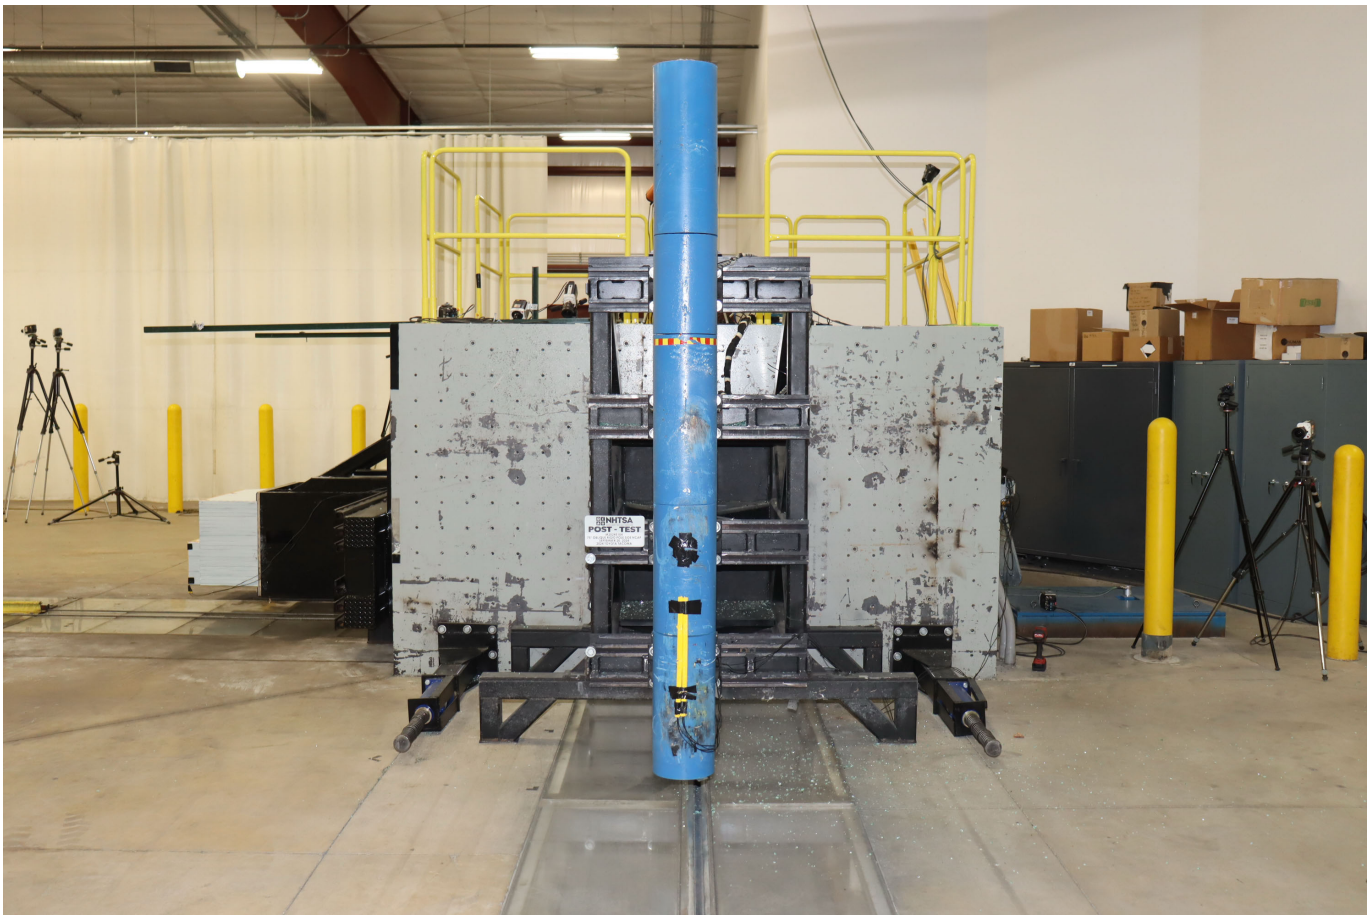
Photo No. 060 - Post-Test Pole Barrier Front View

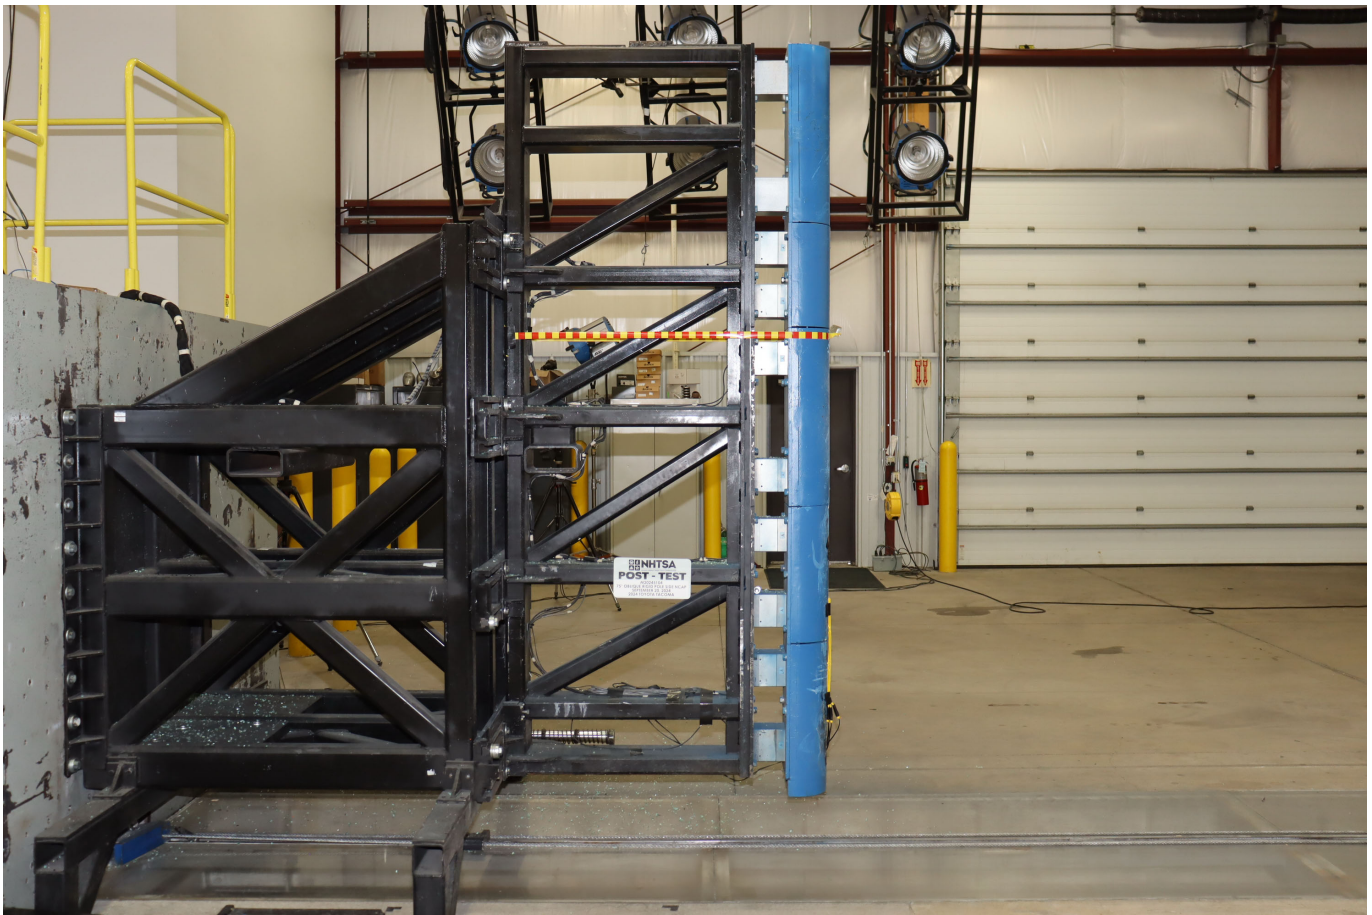
Photo No. 062 - Post-Test Pole Barrier Side View

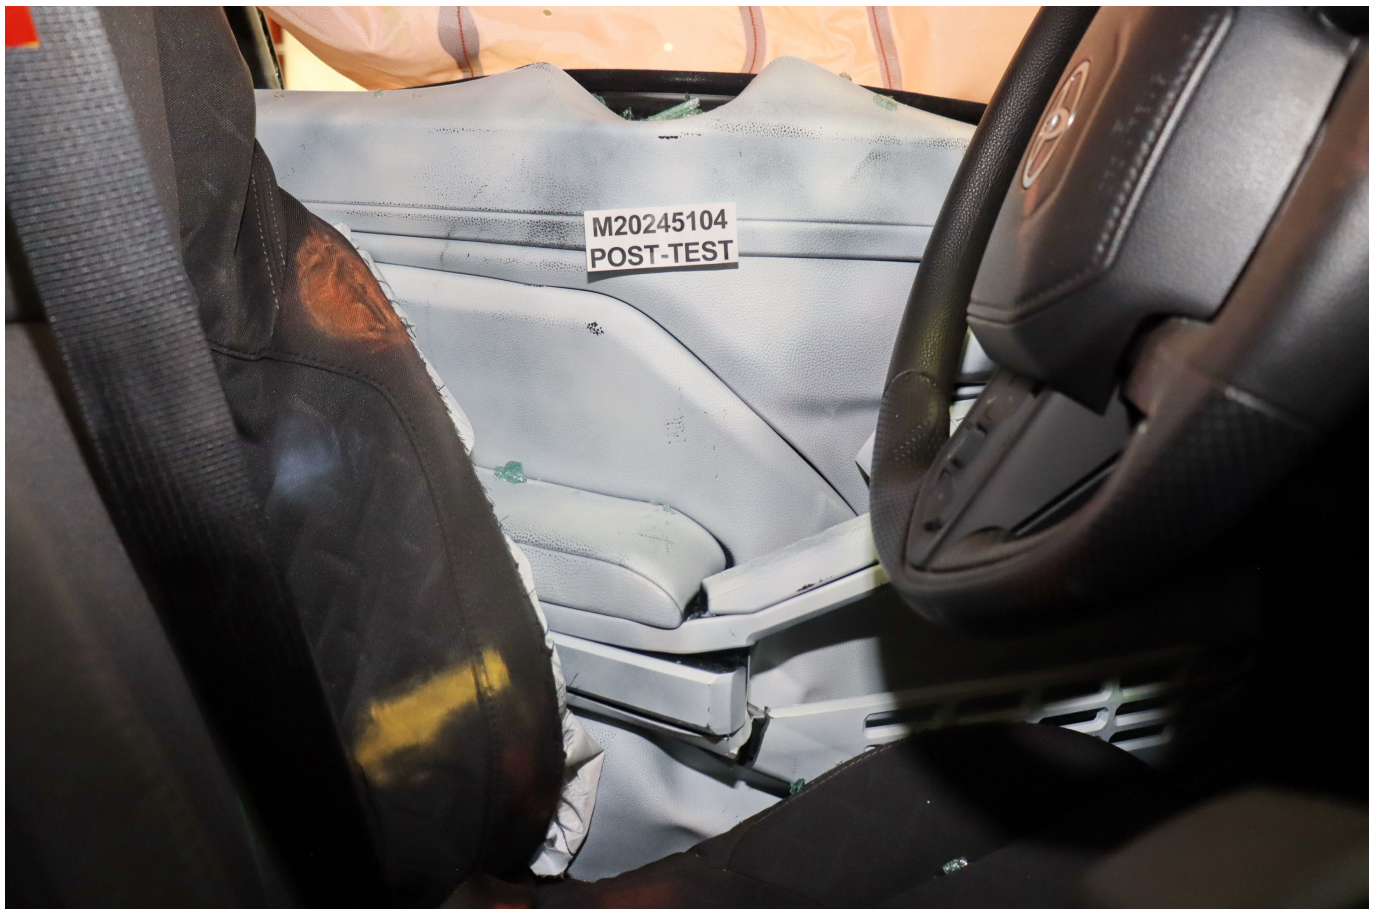
Photo No. 073 - Post-Test View of Shattered Vehicle Inner Door Panel

| Critical Areas of Performance | Observations and Conclusions |
|---|---|
| Side Window Damage | LF window broken |
