**REPORT NUMBER: NCAP-MGA-25-003**

**NEW CAR ASSESSMENT PROGRAM (NCAP)  
Frontal Barrier Impact Test**

**TOYOTA MOTOR MANUFACTURING, KENTUCKY, INC.  
2025 Toyota Camry HEV SE 4-Door Sedan  
NHTSA No.: O20255100**

**MGA RESEARCH CORPORATION  
5000 Warren Road  
Burlington, WI 53105**

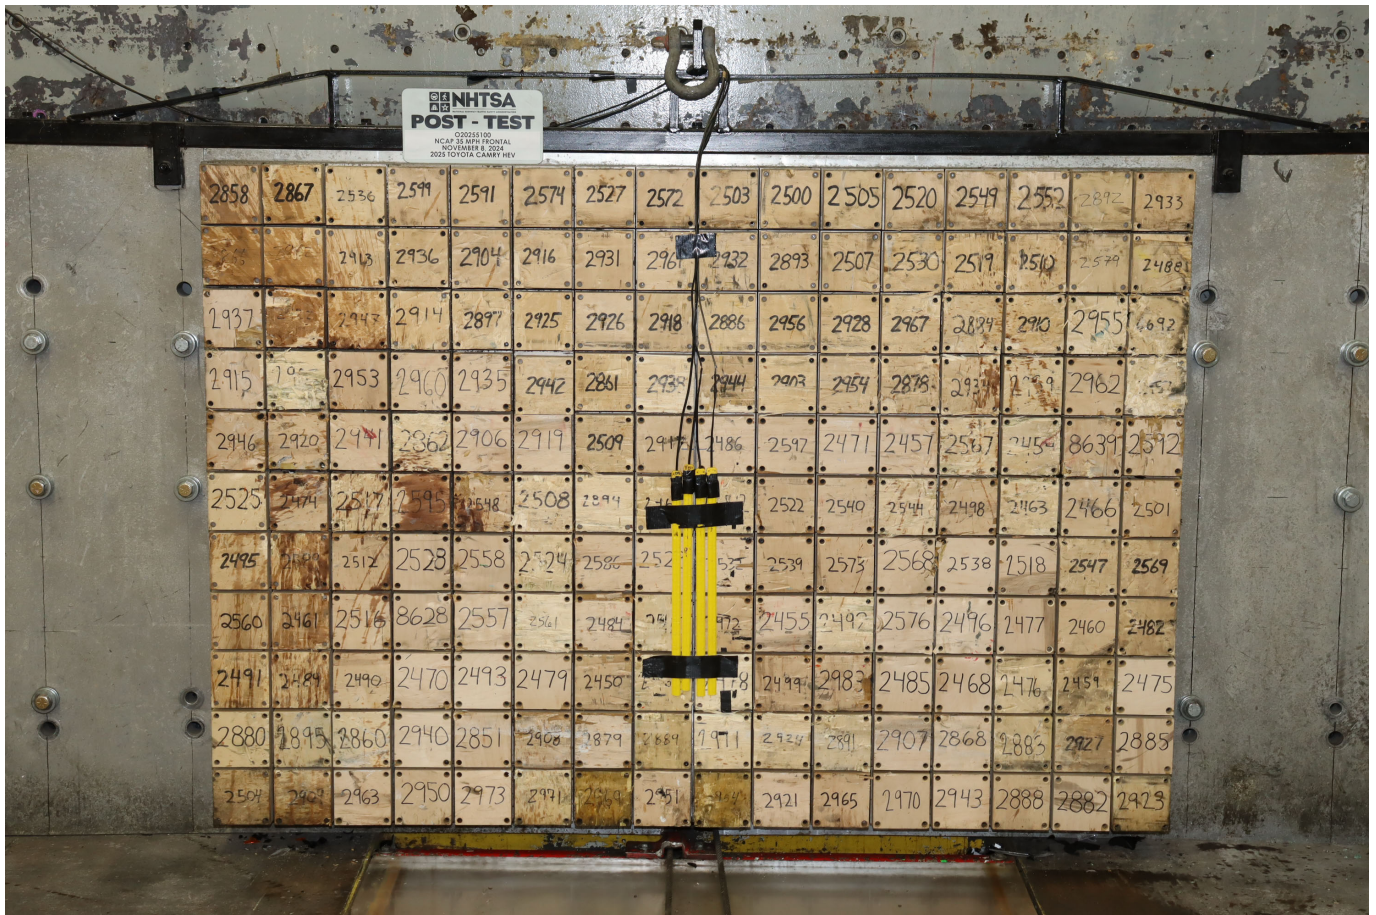
Photo No. 003 - Post-Test Load Cell Wall

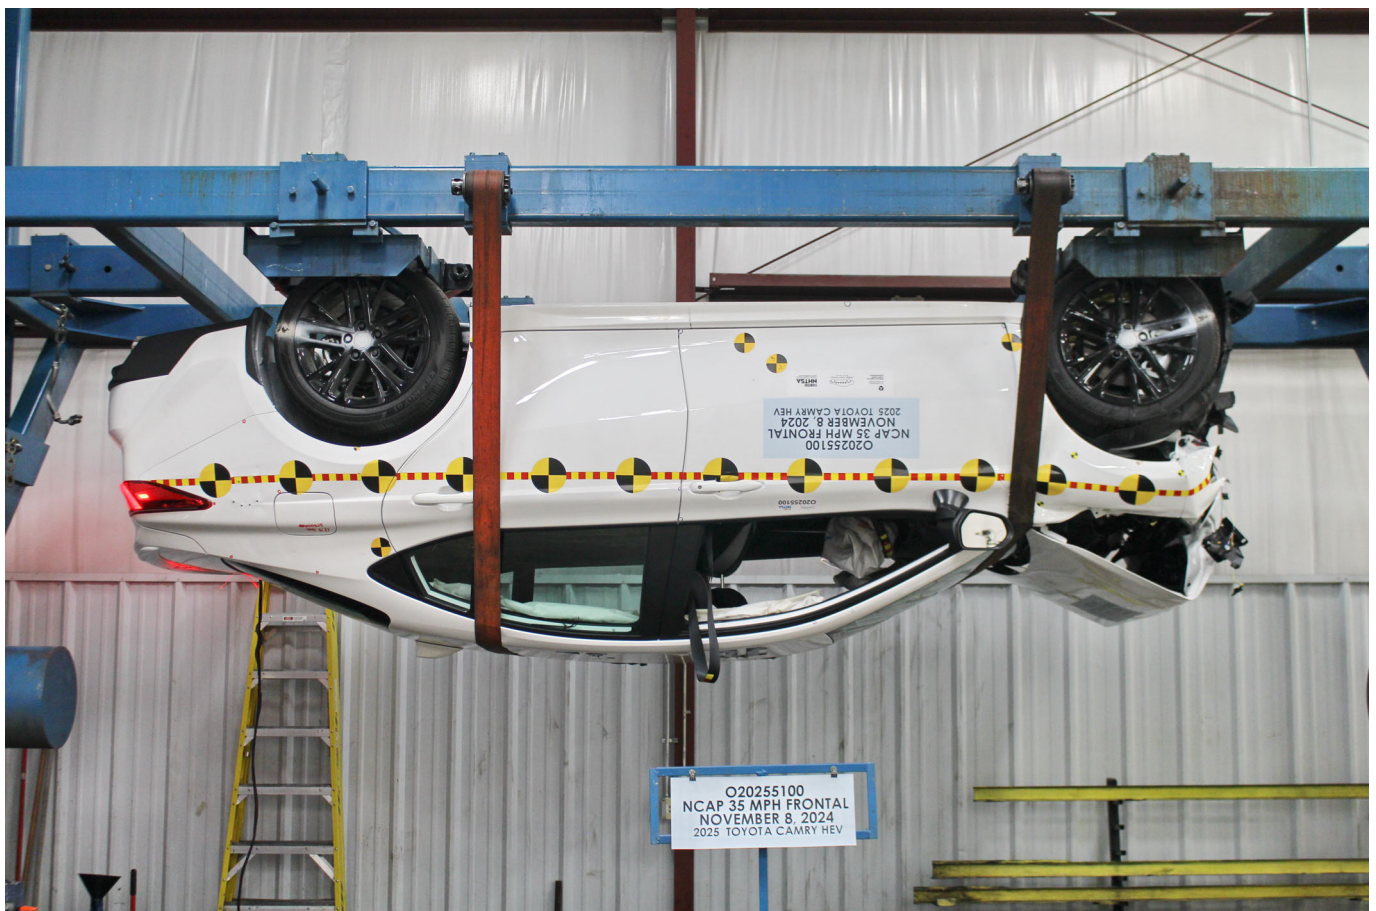
Photo No. 078 - Vehicle at 90 Degrees on Static Rollover Device

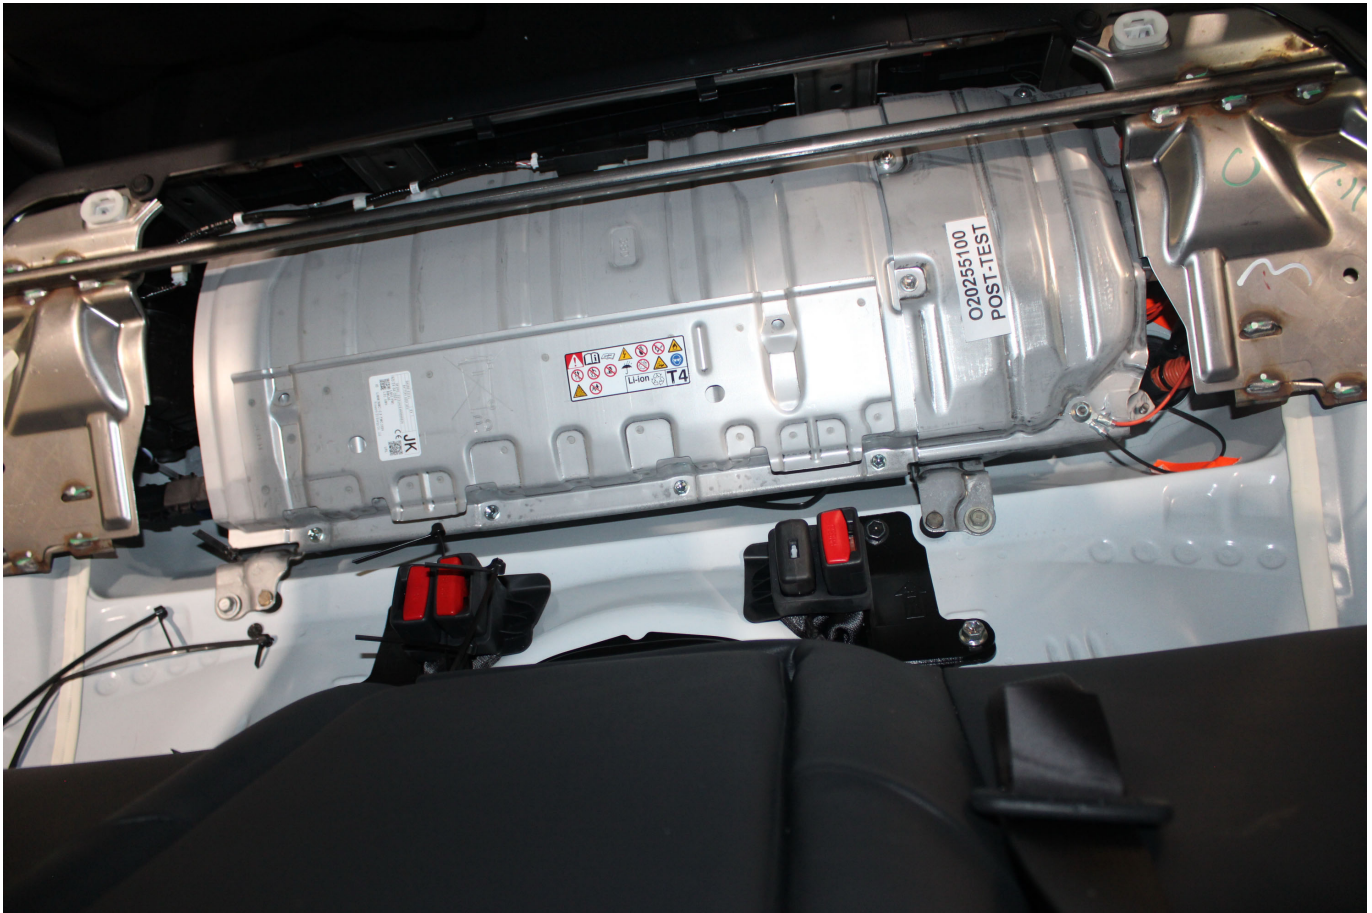
Photo No. 305-10 - Post-Impact Front View of Propulsion Battery

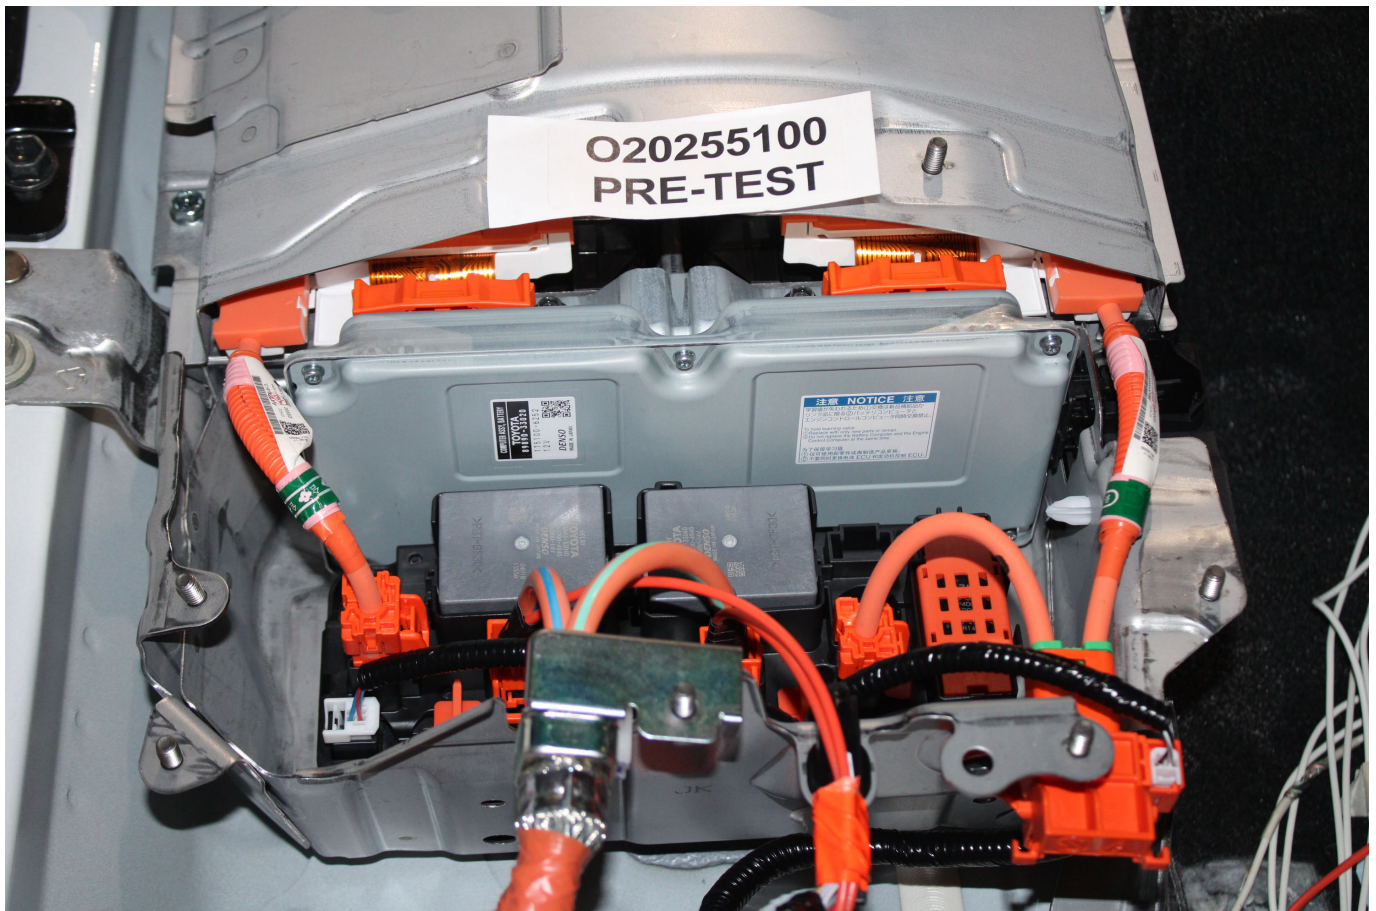
Photo No. 305-17 - Post-Impact View of Electric Propulsion Drive
