**REPORT NUMBER: NCAP-CAL-24-009**

**NEW CAR ASSESSMENT PROGRAM (NCAP)  
FRONTAL BARRIER IMPACT TEST**

**Hyundai Motor Manufacturing Alabama, LLC.  
2024 Hyundai Santa Fe  
5 Door SUV**

**NHTSA No: M20244200**

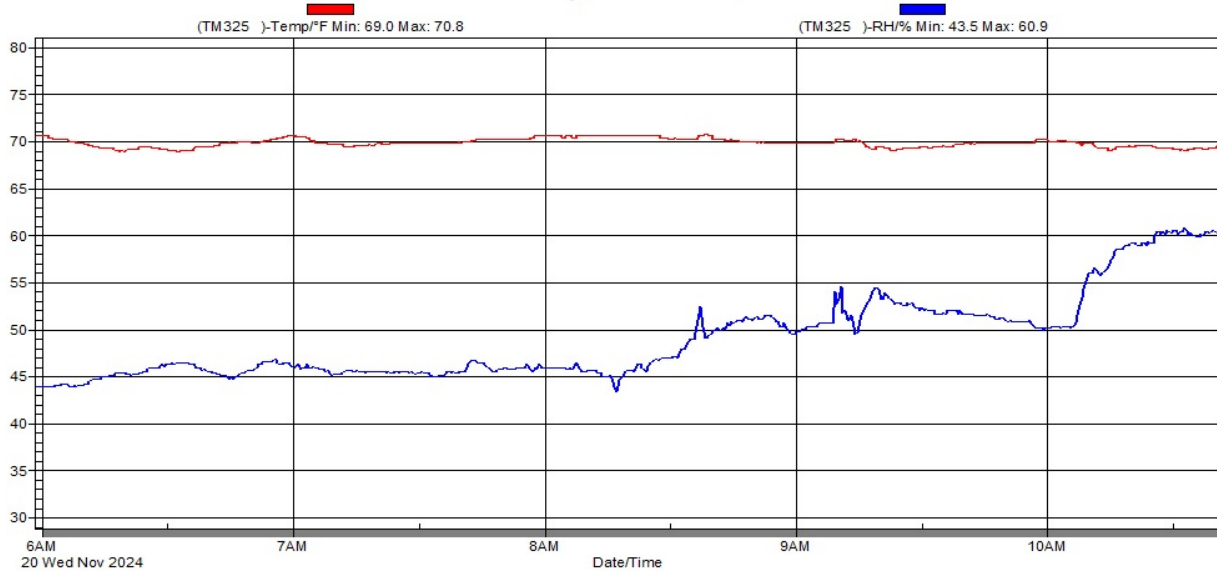
***Temperature and Humidity Stabilization Chart/Data for Dummies and Test Vehicle***

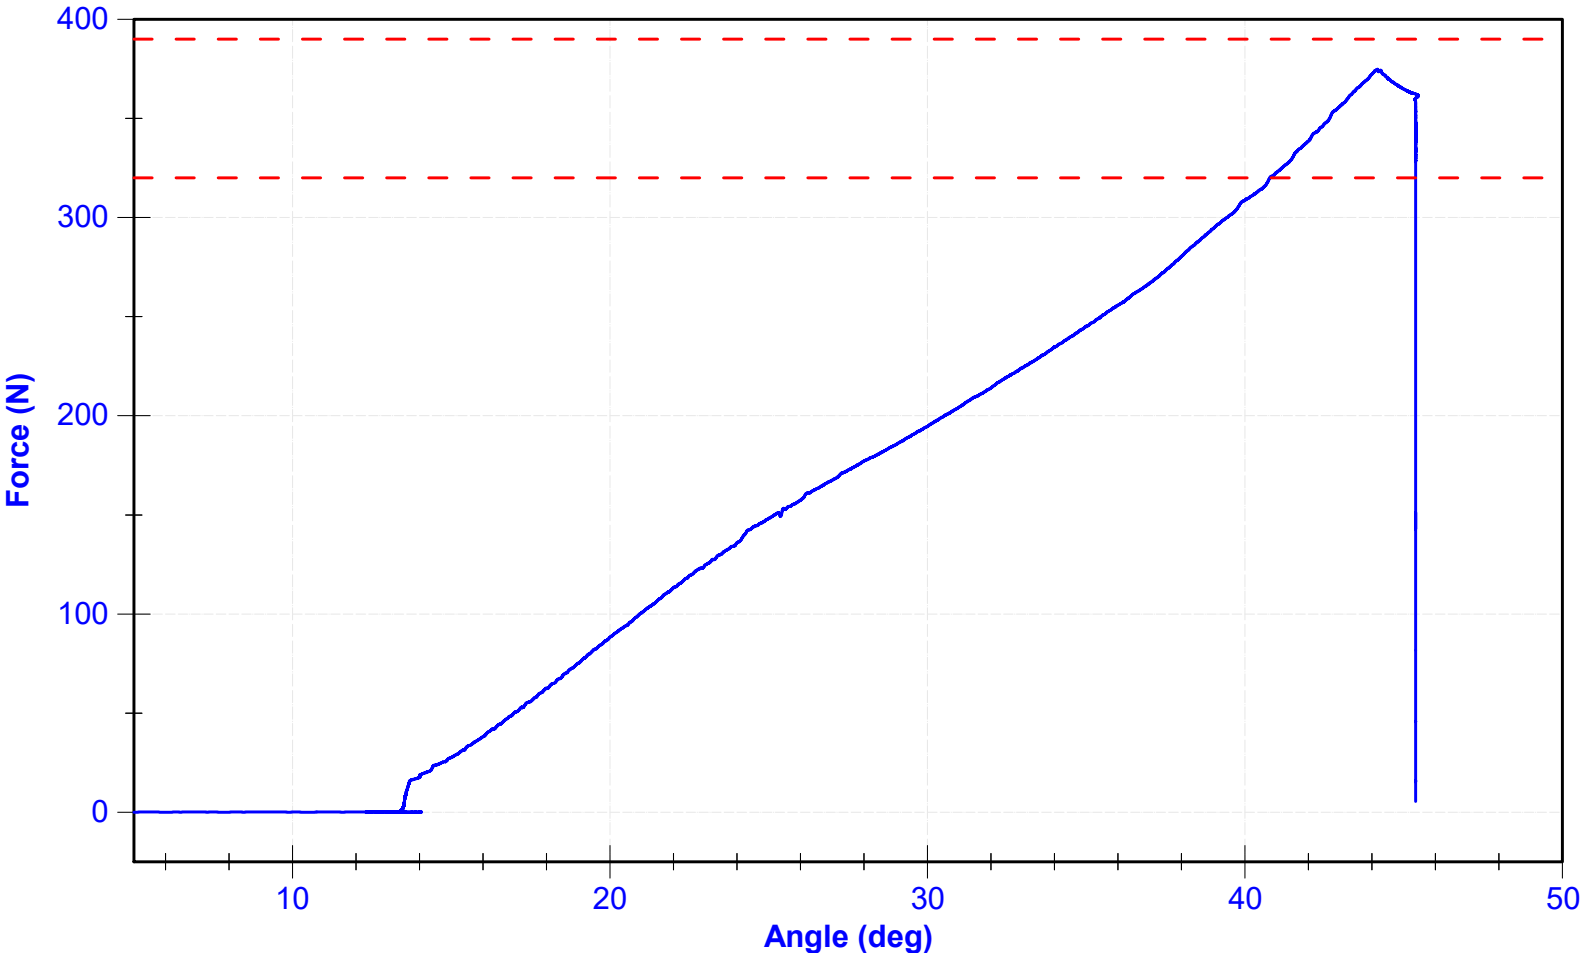
Test Parameter	Minimum Specification	Maximum Specification	Unit	Result	Pass/Fail
Temperature	18.6	25.6	°C	20.6	Pass
Humidity	10	70	%	35	Pass
Initial Angle	0	20	deg	13.1	Pass
Force at 45 Degrees	320	390	N	374.8	Pass
Return Angle Relative to Initial	0	8	deg	4.4	Pass

**Force vs. Displacement**
