REPORT NUMBER: SPNCAP-CAL-24-013

**NEW CAR ASSESSMENT PROGRAM (NCAP)
SIDE IMPACT POLE TEST**

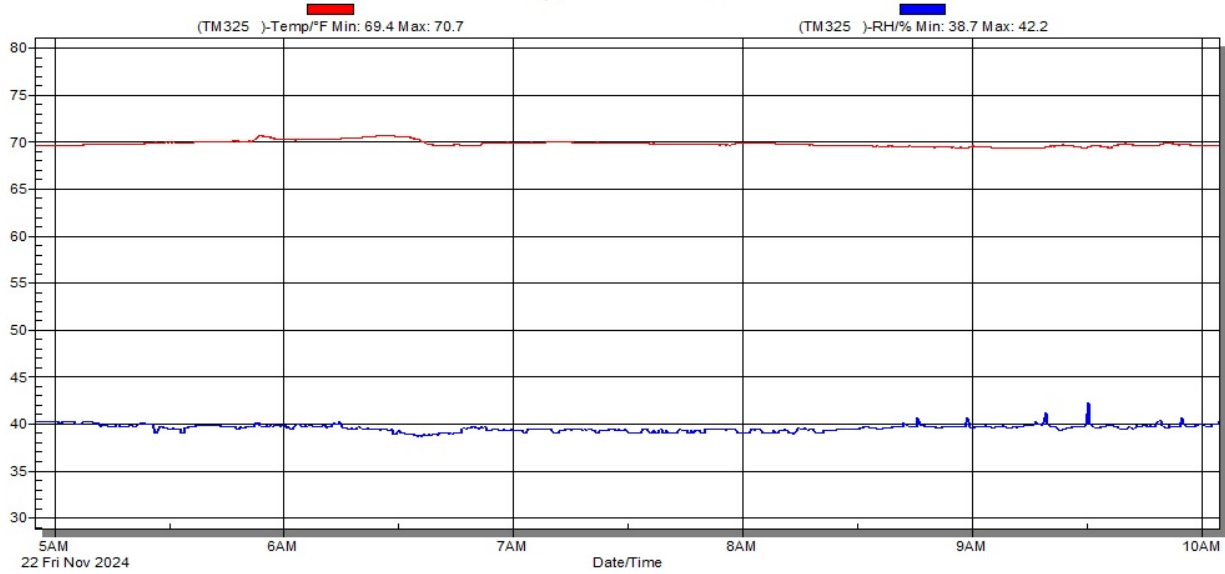
Temperature and Humidity Stabilization Chart/Data for Dummies and Test Vehicle
