**REPORT NUMBER: SideNCAPPole-KAR-24-012**  
**NEW CAR ASSESSMENT PROGRAM (NCAP)**  
**SIDE IMPACT POLE TEST**

**SUBARU CORPORATION**  
**2025 SUBARU FORESTER 5-DOOR MPV**

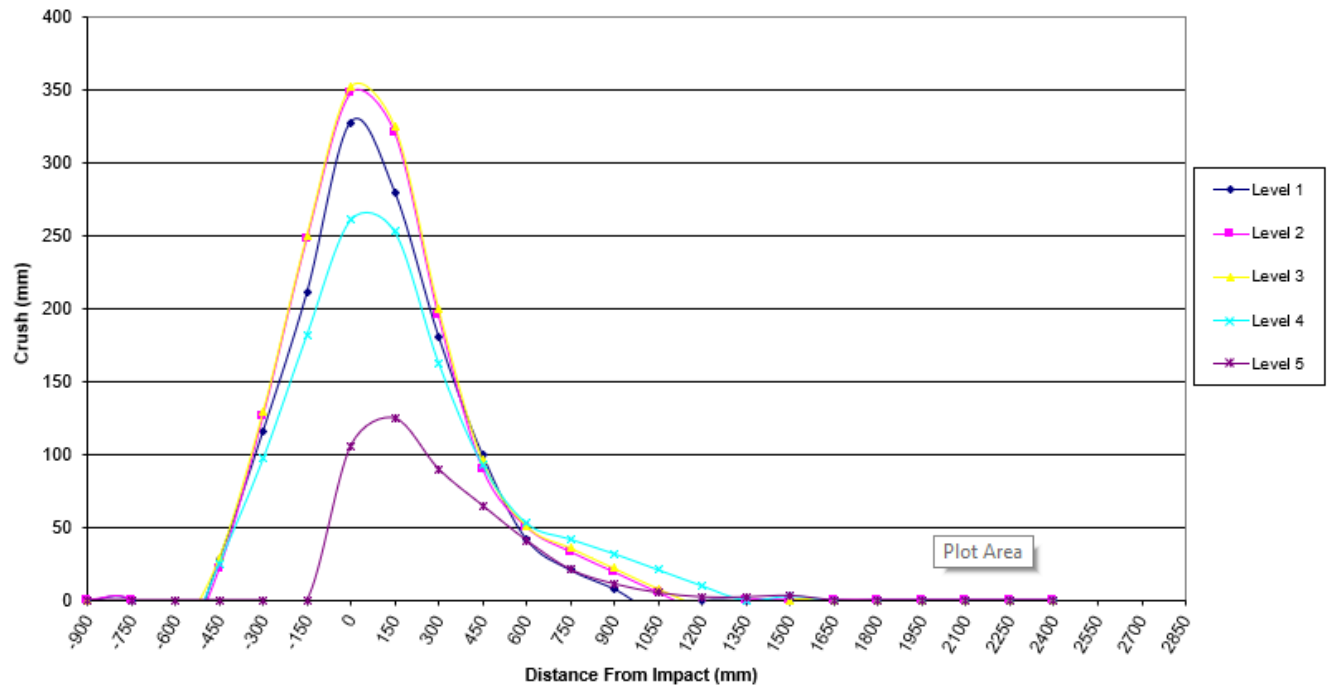
## DATA SHEET NO. 11

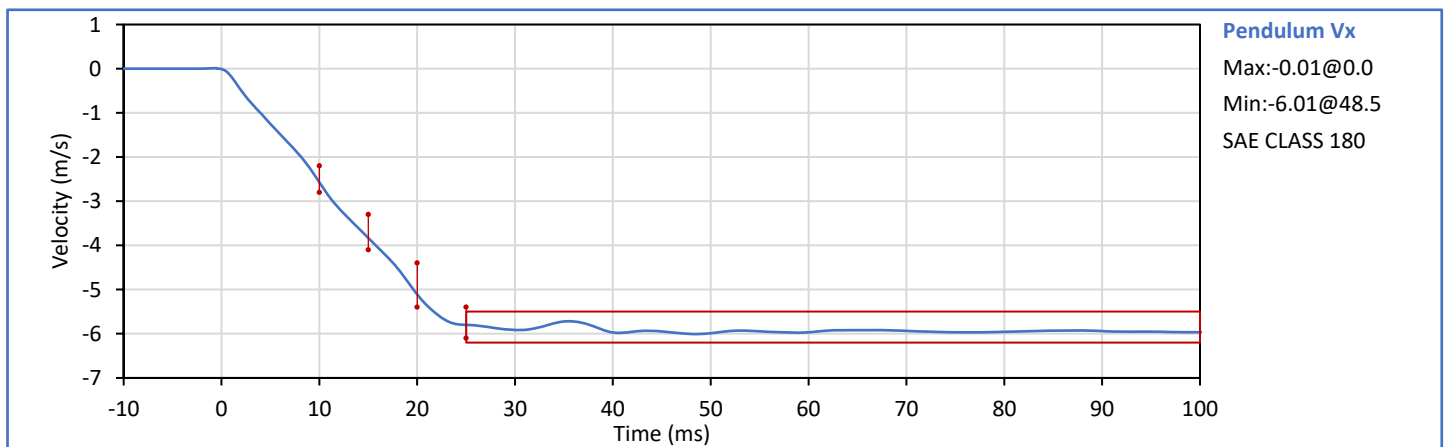
| Tested Parameter | Units | Spec. Low | Spec. High | Result | Pass/Fail |
|---|---|---|---|---|---|
| | | | | Overall Test Results | Pass |

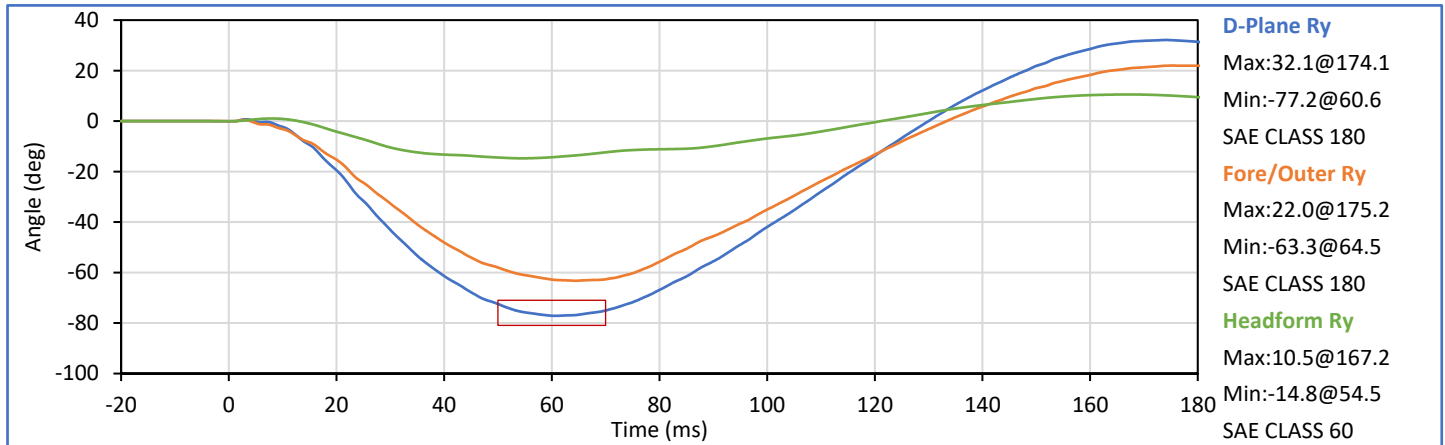
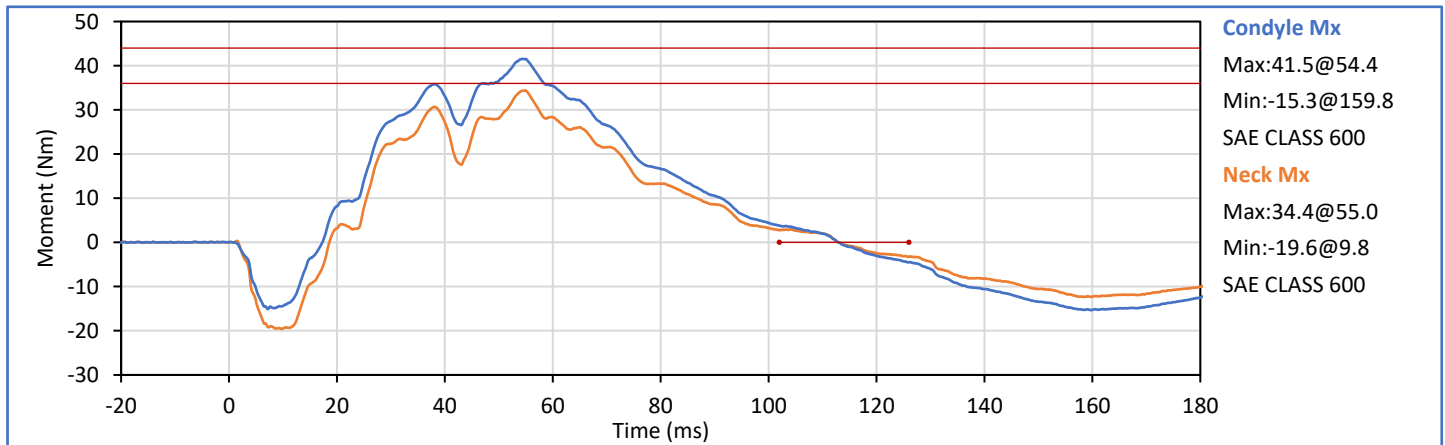
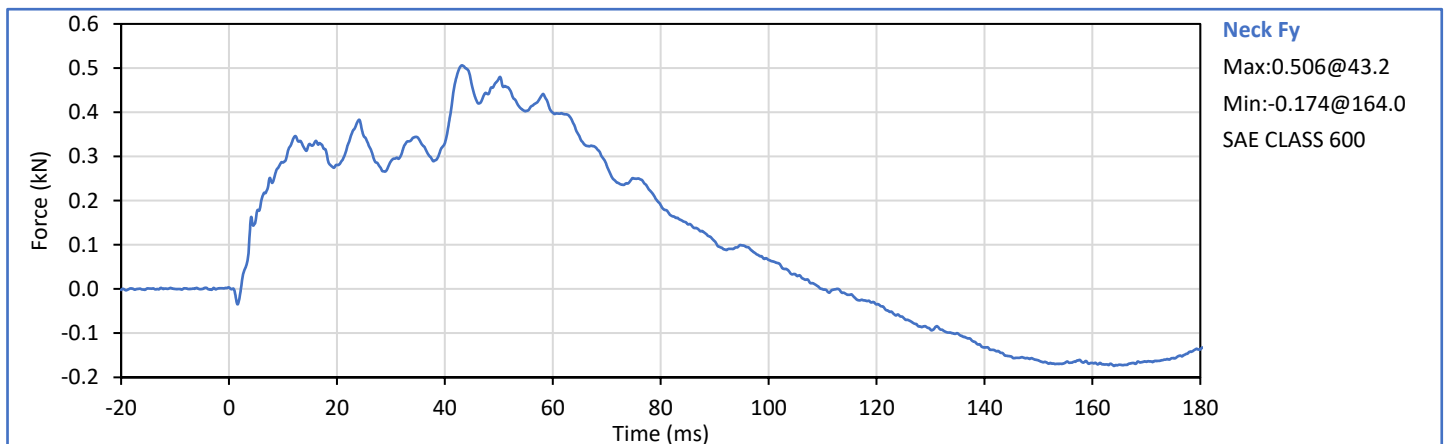
| Tested Parameter | Units | Spec. Low | Spec. High | Result | Pass/Fail |

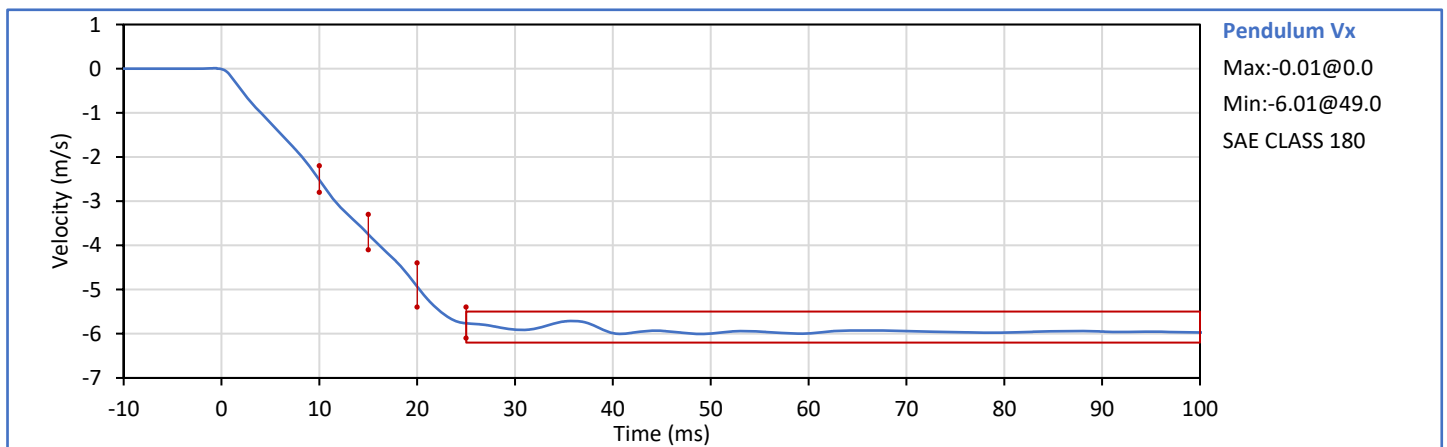
| Tested Parameter | Units | Spec. Low | Spec. High | Result | Pass/Fail |
|---|---|---|---|---|---|
| | | | | Overall Test Results | Pass |
