REPORT NUMBER: NCAP-MGA-25-010

**NEW CAR ASSESSMENT PROGRAM (NCAP)
Frontal Barrier Impact Test**

**NISSAN MOTOR CO., LTD.
2025 Nissan Frontier SV Crew Cab LWB 4x4 4-Door Pickup Truck
NHTSA No.: M20255203**

**MGA RESEARCH CORPORATION
5000 Warren Road
Burlington, WI 53105**

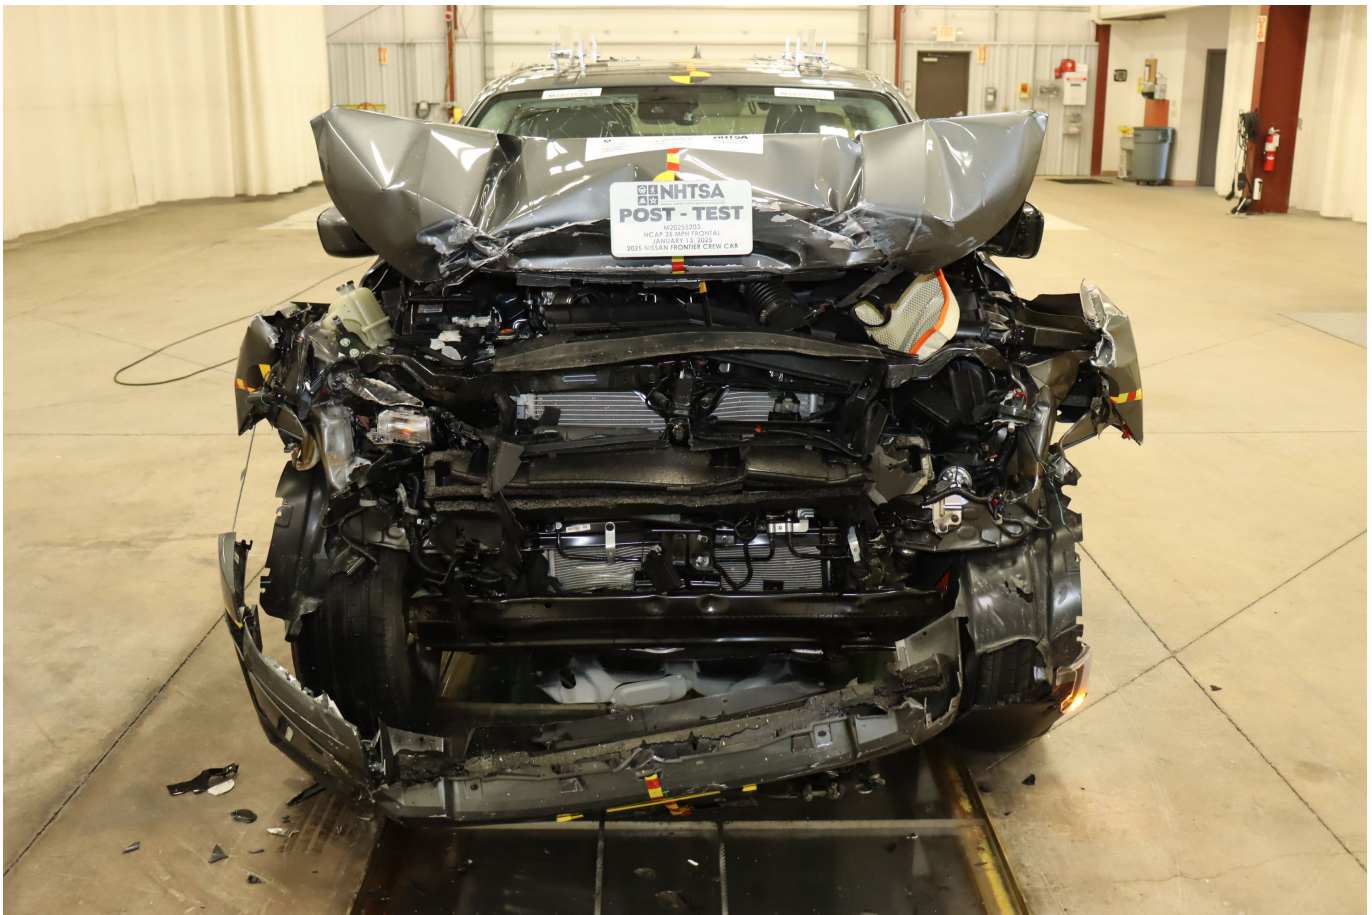
Photo No. 009 - Post-Test Front View of Test Vehicle

The maximum static crush of the vehicle was 545 mm located to the right of the vehicle centerline and both the driver and passenger side doors remained closed during the impact event and were operable after the impact.

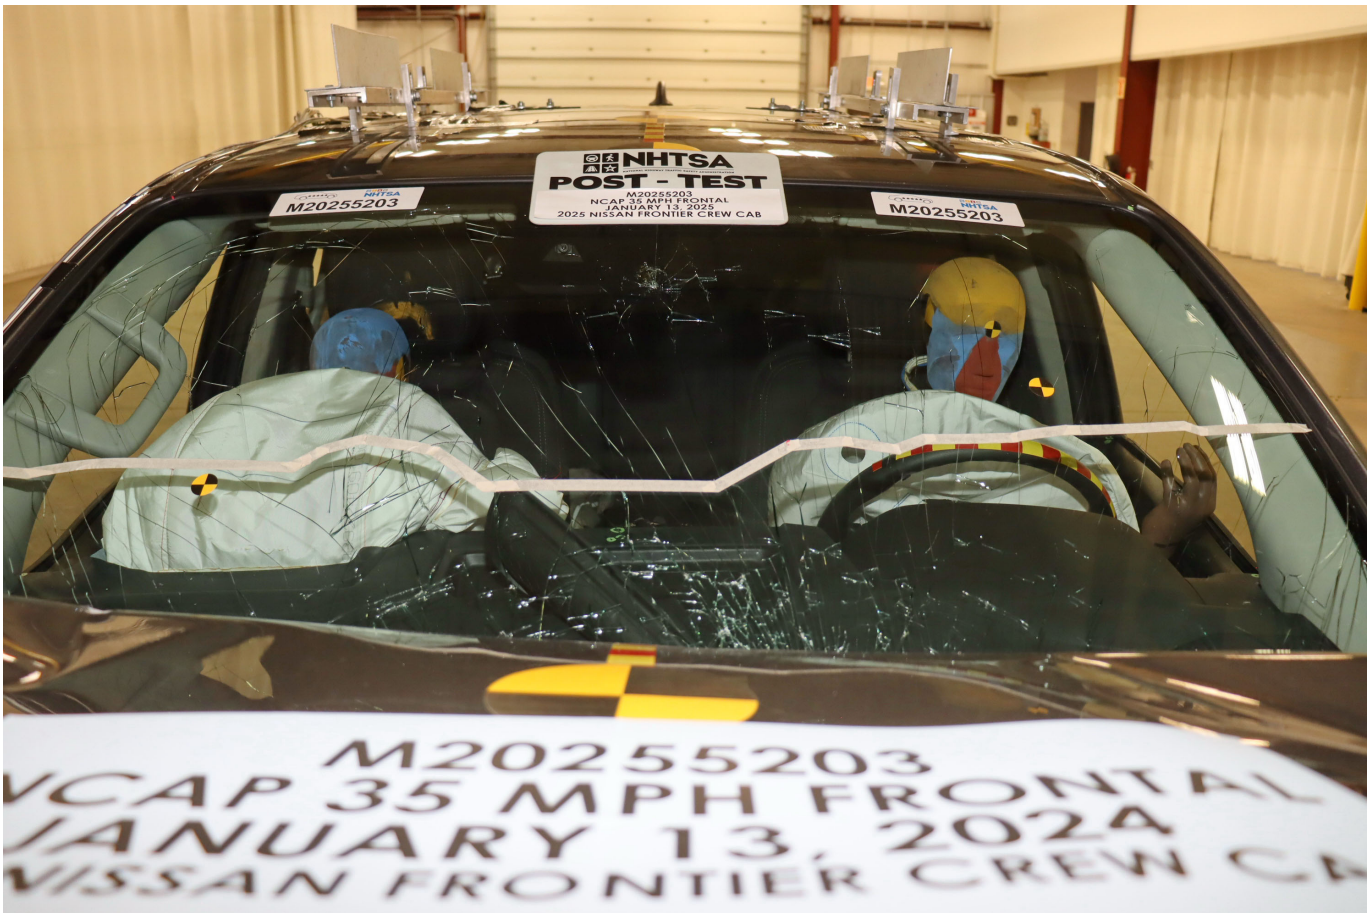
Photo No. 019 - Post-Test Windshield View

There was 100 percent windshield retention and no intrusion into the protected zone of the windshield during the event. There was no Stoddard Solvent leakage after the event or during any phase of the static rollover.

| Critical Areas of Performance | Observations and Conclusions |
|---|---|
| Windshield Damage | Cracked along bottom edge |

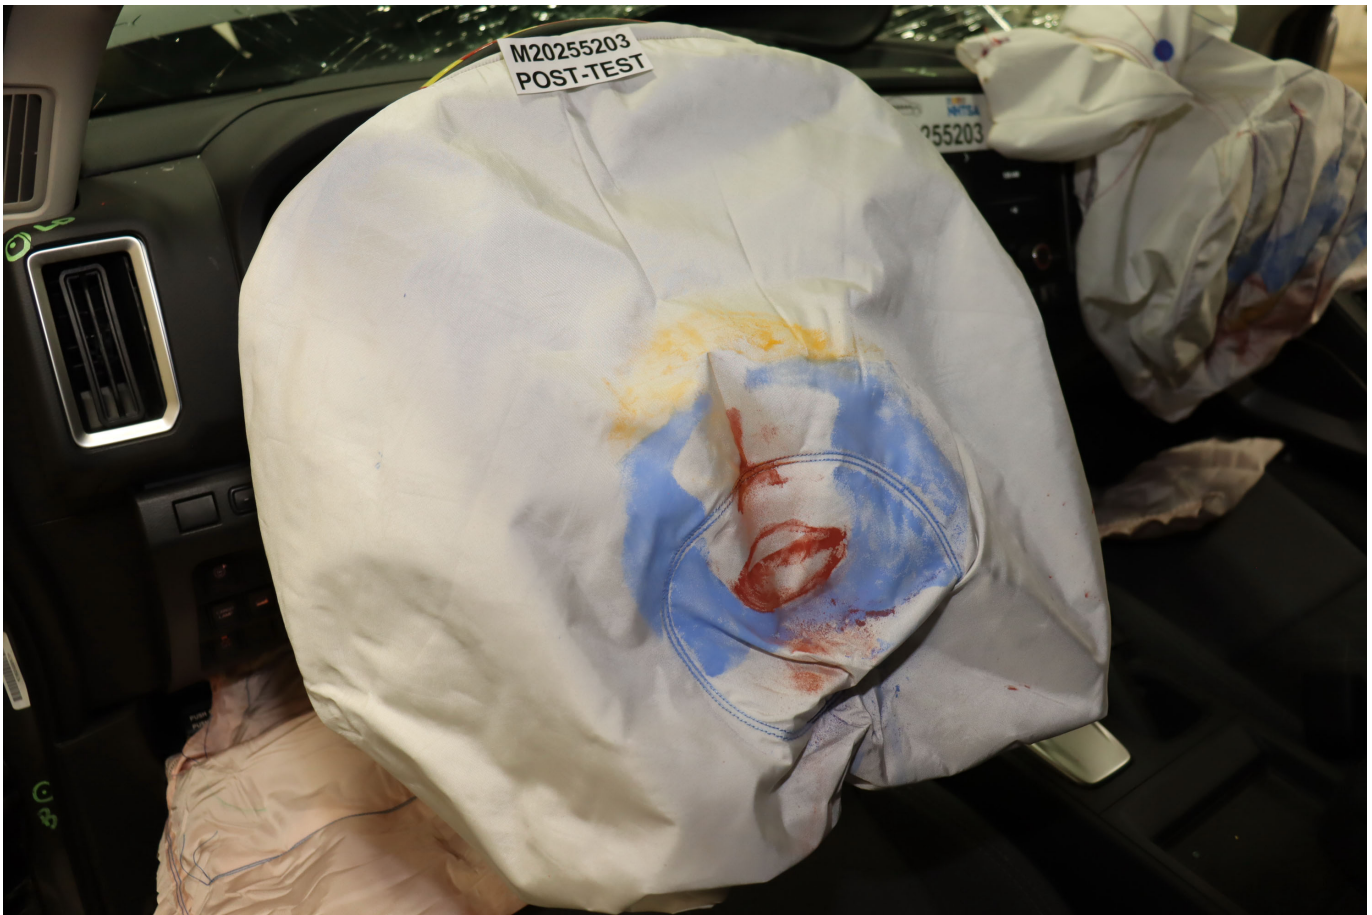
Photo No. 049 - Post-Test Driver Dummy Contact with Airbag

The driver's visible contact points were as follows: The driver's head contacted the airbag. The driver's head also contacted the headrest. The driver's knees contacted the knee airbag.

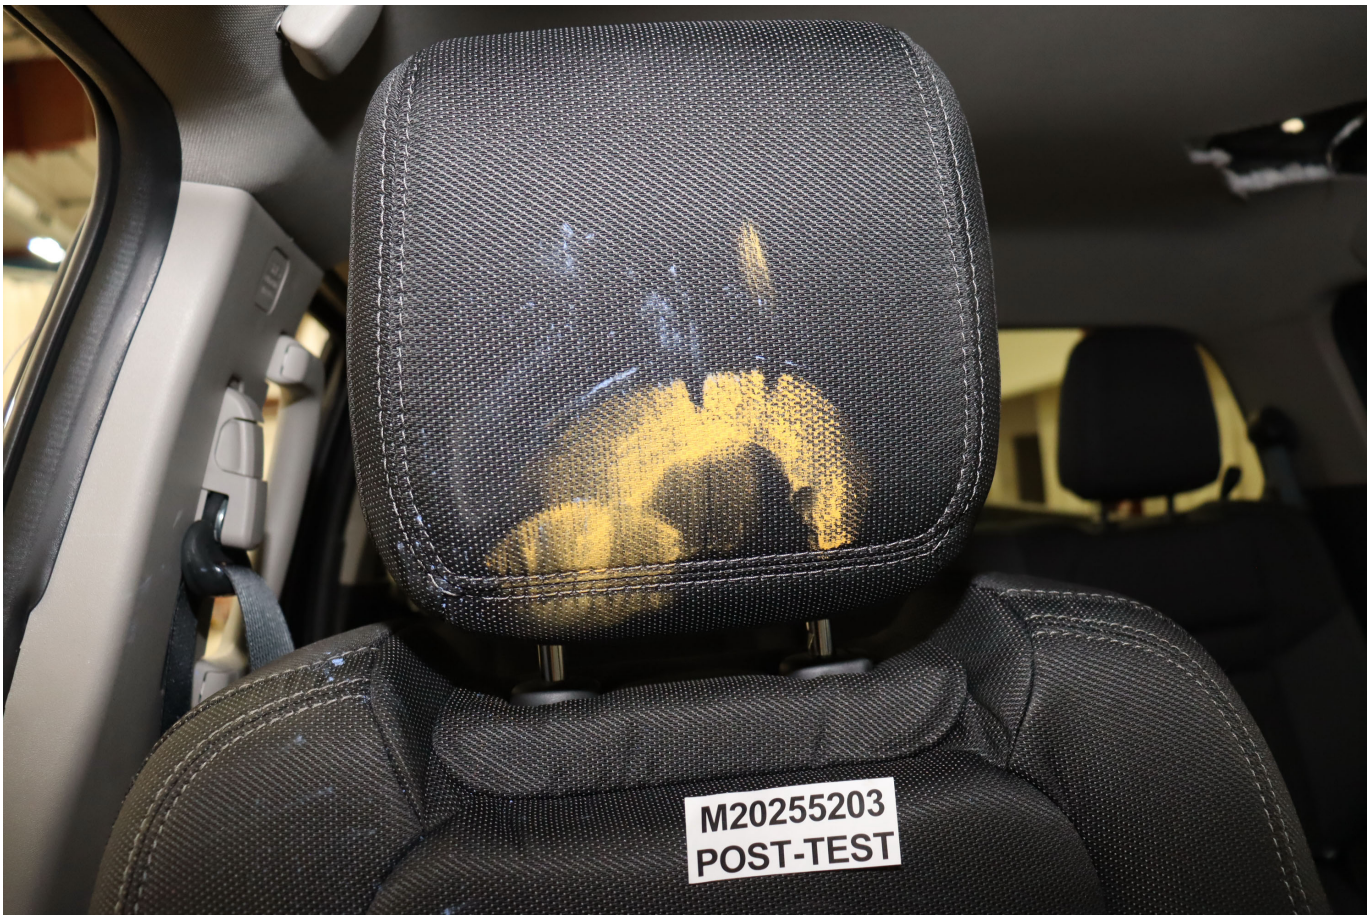
Photo No. 073 - Post-Test Passenger Dummy Contact with Headrest

The passenger's visible contact points were as follows: The passenger's head contacted the airbag. The passenger's head also contacted the headrest. The passenger's knees contacted the knee airbag.
