**REPORT NUMBER: NCAP-MGA-25-013**

**NEW CAR ASSESSMENT PROGRAM (NCAP)  
Frontal Barrier Impact Test**

**TOYOTA MOTOR MANUFACTURING, INDIANA, INC.  
2025 Toyota Grand Highlander XLE AWD 5-Door SUV  
NHTSA No.: M20255110**

**MGA RESEARCH CORPORATION  
5000 Warren Road  
Burlington, WI 53105**

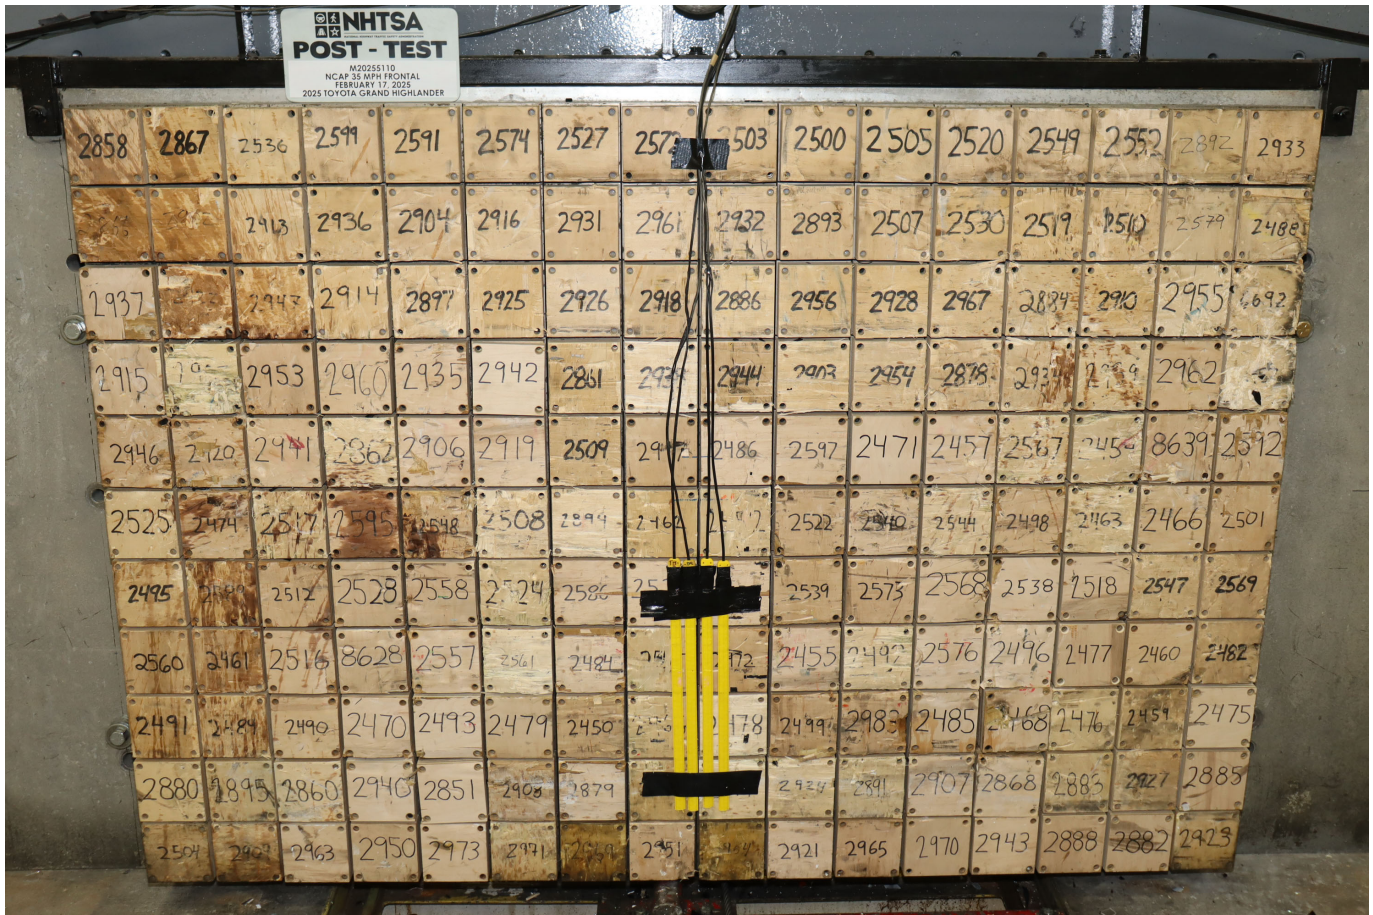
Photo No. 003 - Post-Test Load Cell Wall

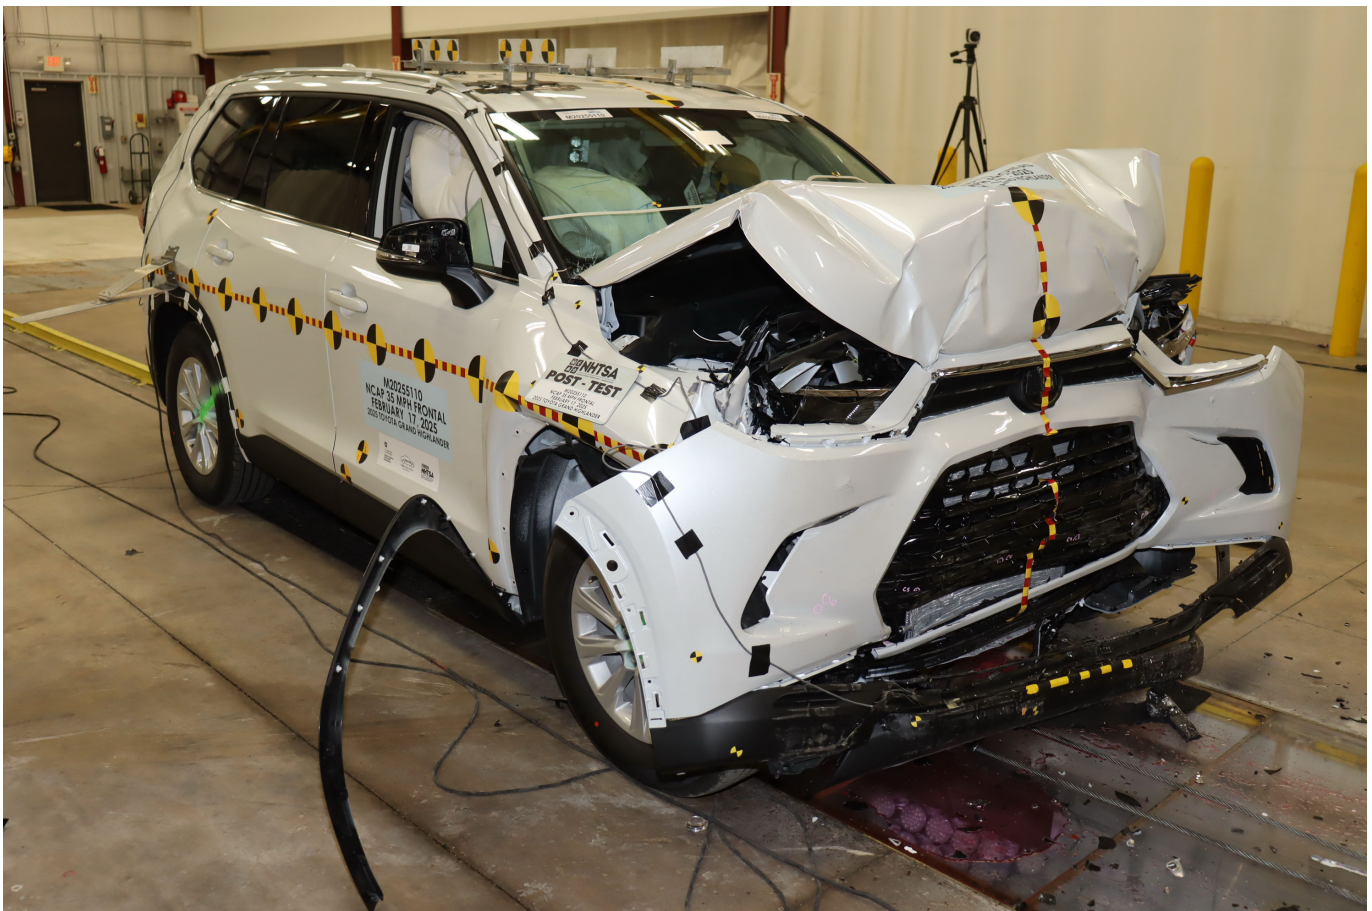
Photo No. 015 - Post-Test Right Front 3-4 View

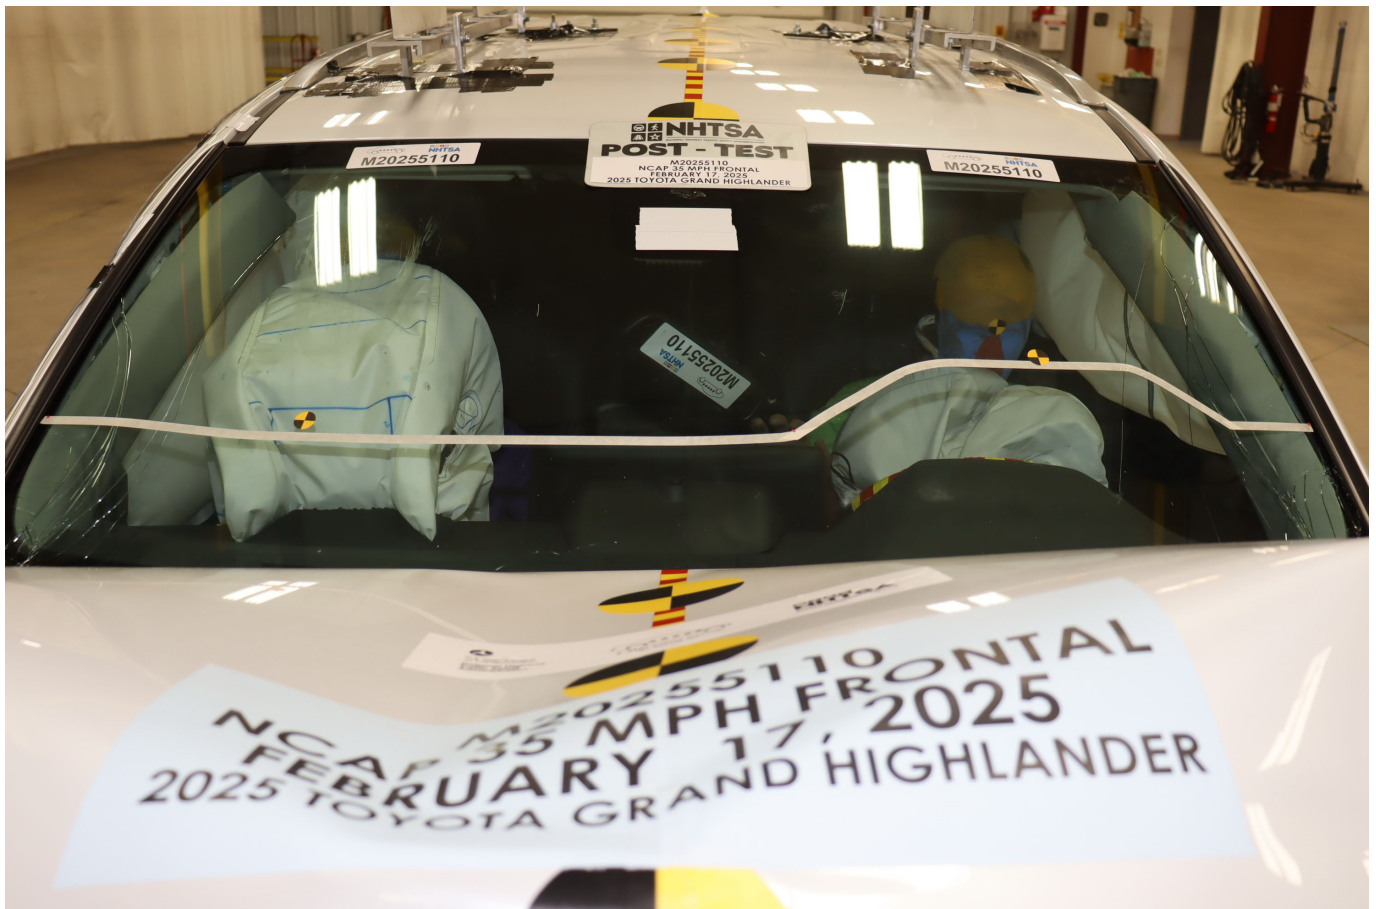
Photo No. 019 - Post-Test Windshield View

| Critical Areas of Performance | Observations and Conclusions |
|---|---|
| Windshield Damage | Cracked by hood corners |

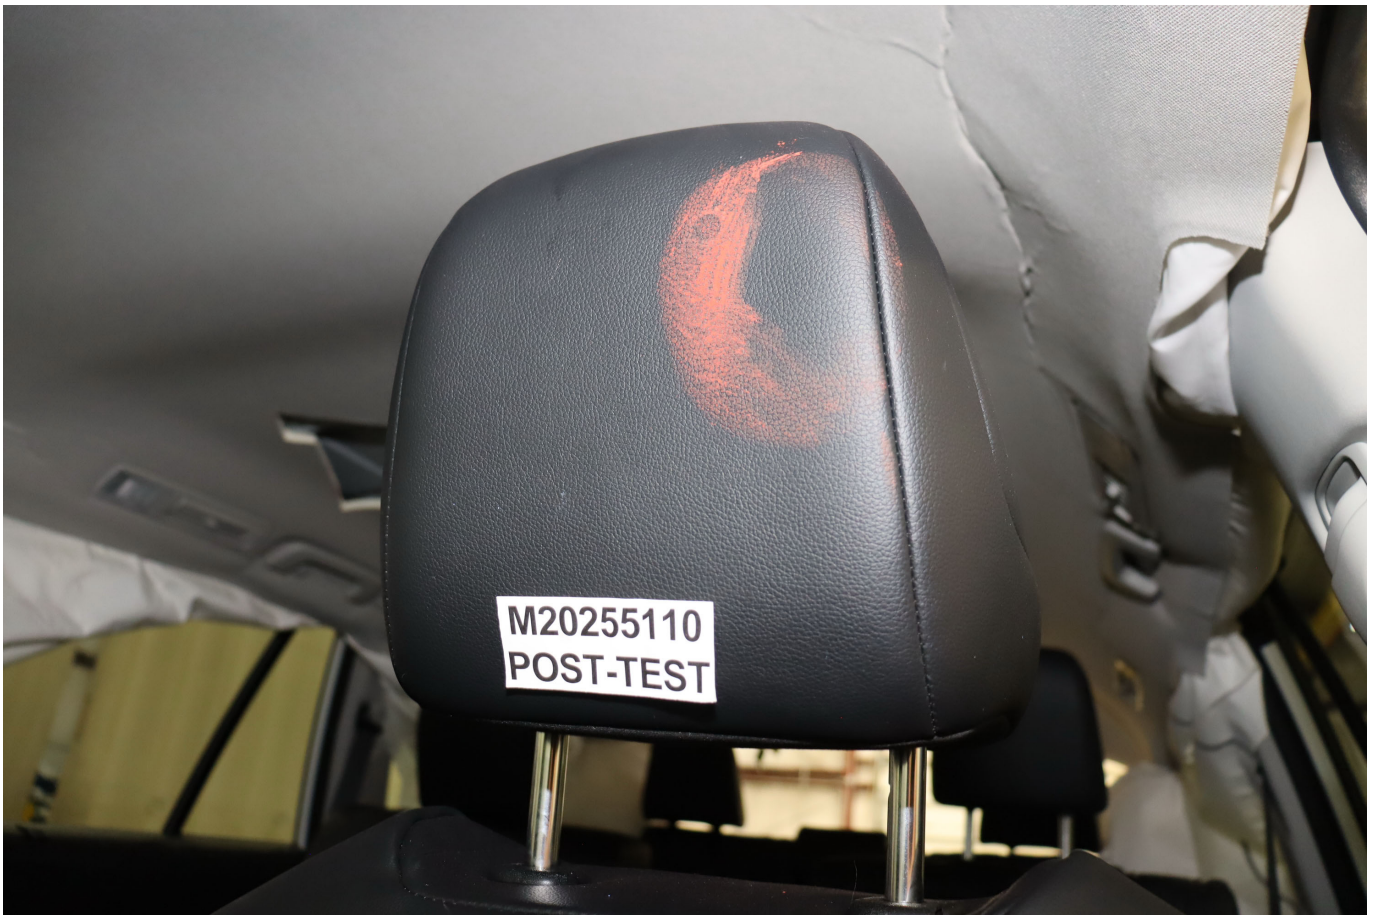
Photo No. 050 - Post-Test Driver Dummy Contact with Headrest

The driver's visible contact points were as follows: The driver's head contacted the airbag. The driver's head also contacted the headrest. The driver's knees contacted the knee airbag.

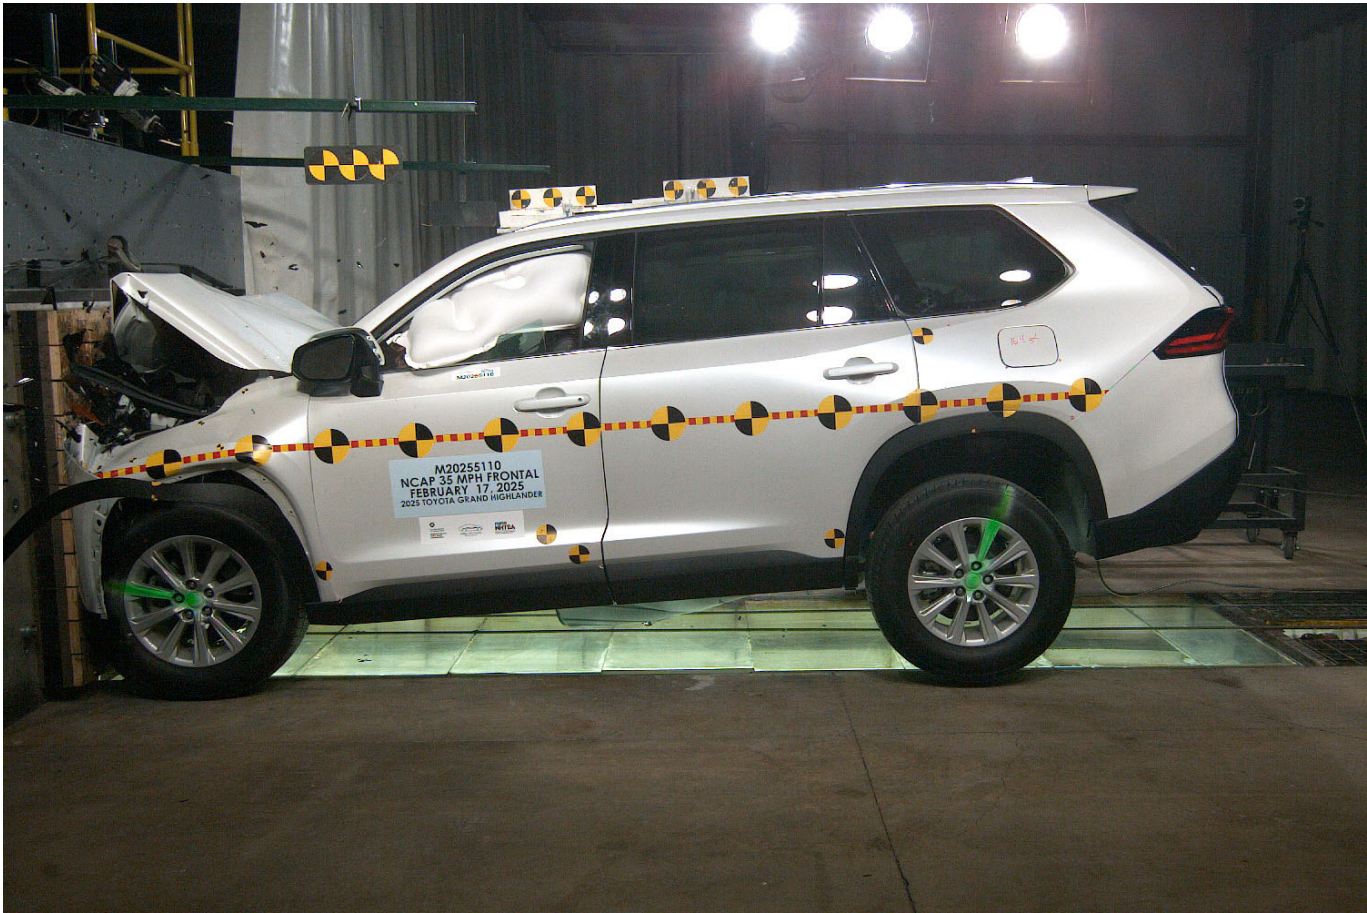
Photo No. 082 - 2025 Toyota Grand Highlander XLE AWD 5-Door SUV Frontal Impact Event

A load cell barrier consisting of 176 load cells was impacted by a 2025 Toyota Grand Highlander XLE AWD 5-Door SUV at a velocity of 56.17 km/h. The test was performed at MGA Research Corporation on February 17, 2025. Pre-test and post-test photographs of the vehicle and dummies can be found in Appendix A.
