**REPORT NUMBER: SideNCAPPole-MGA-24-033**

**NEW CAR ASSESSMENT PROGRAM (NCAP)  
Side Impact Pole Test**

**TOYOTA MOTOR MANUFACTURING, INDIANA, INC.  
2024 Toyota Grand Highlander 4WD Limited 5-Door SUV  
NHTSA No.: M20245101**

**MGA RESEARCH CORPORATION  
5000 Warren Road  
Burlington, WI 53105**

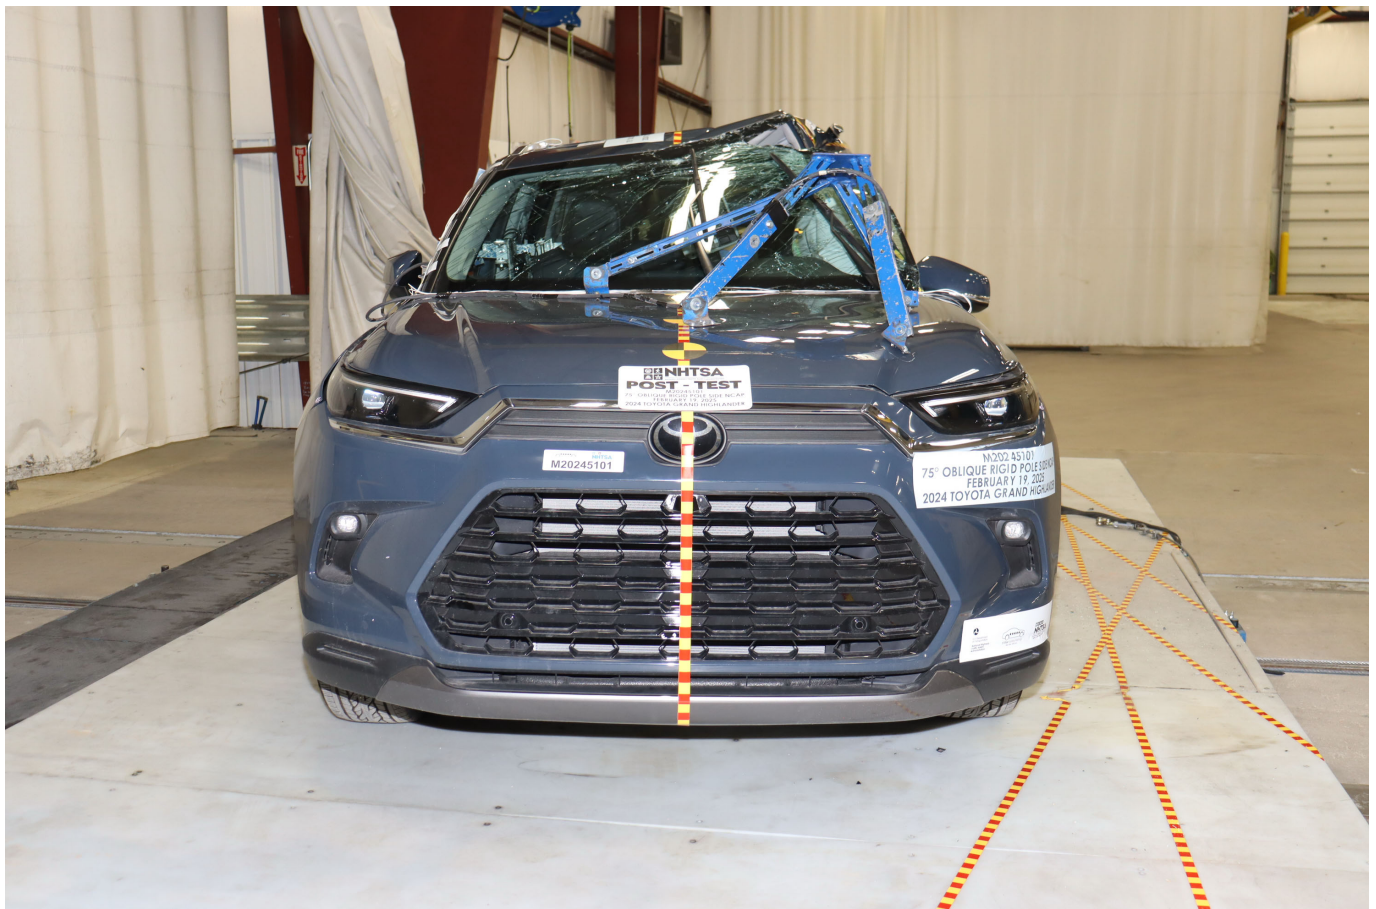
Photo No. 004 - Post-Test Frontal View of Test Vehicle

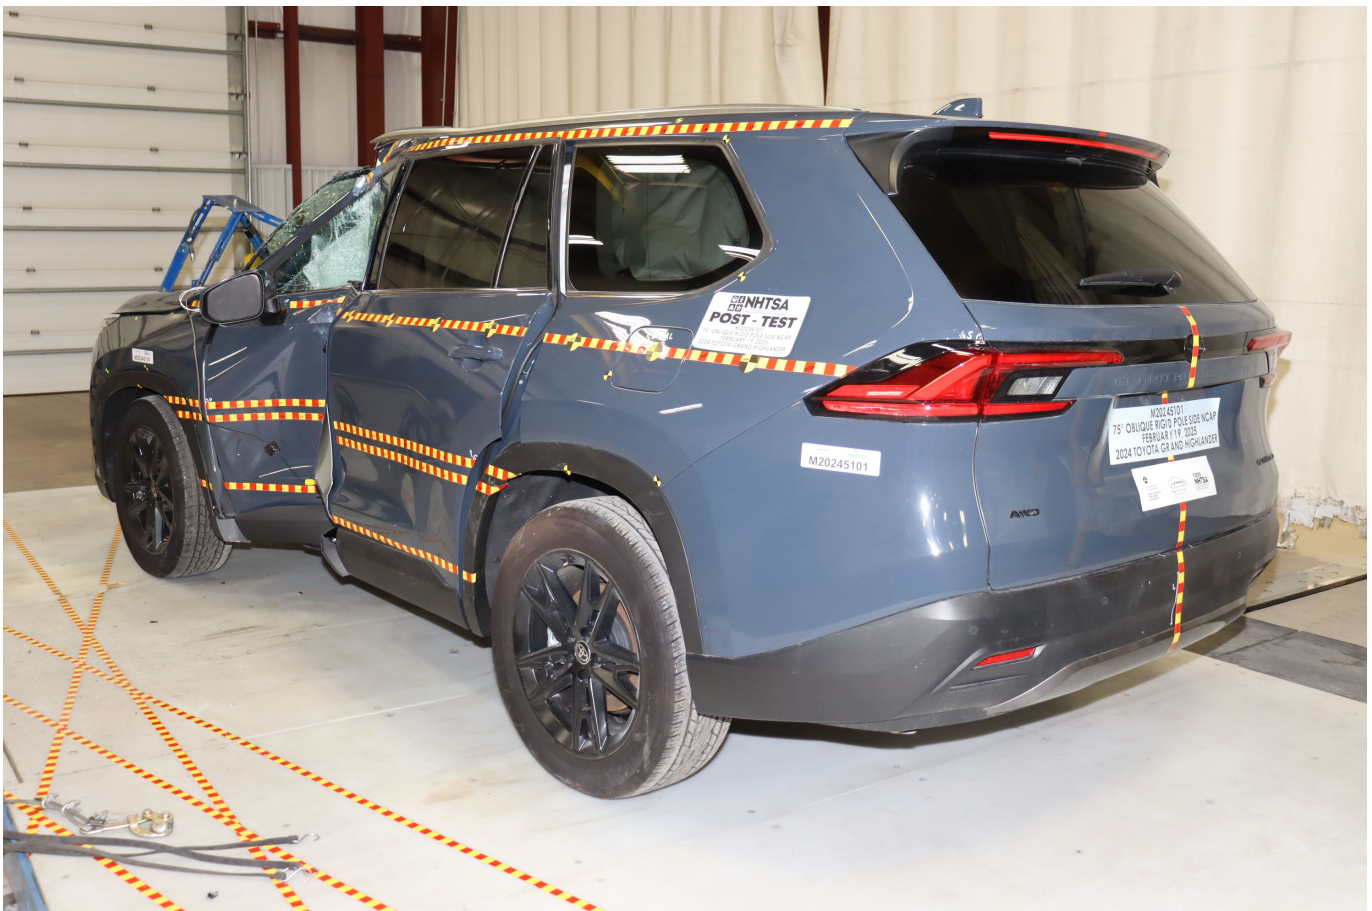
Photo No. 010 - Post-Test Left Rear Three-Quarter View of Test Vehicle

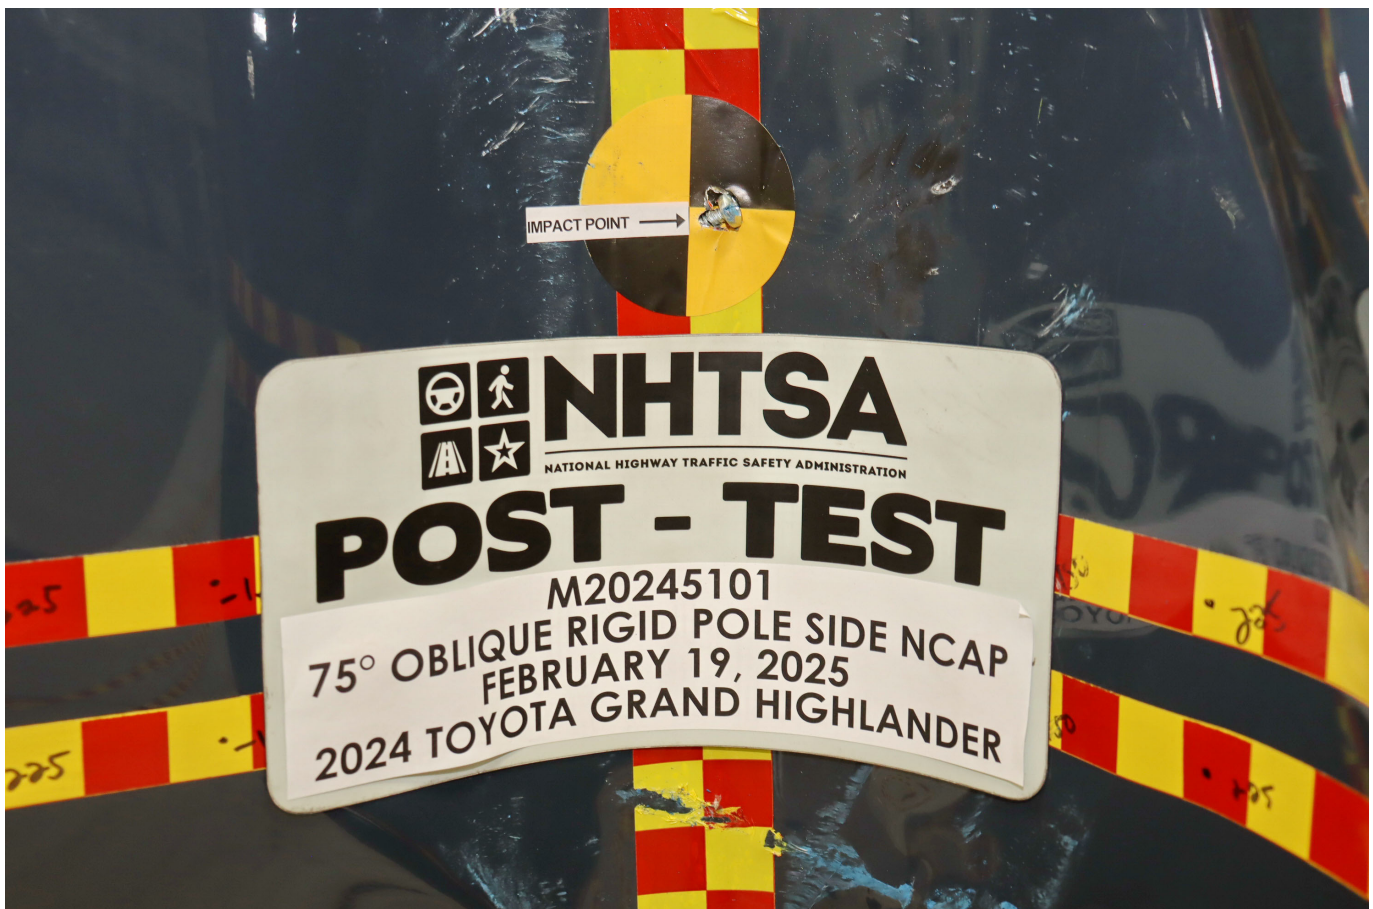
Photo No. 020 - Post-Test Close-Up View of Impact Point Target Showing Impact Location

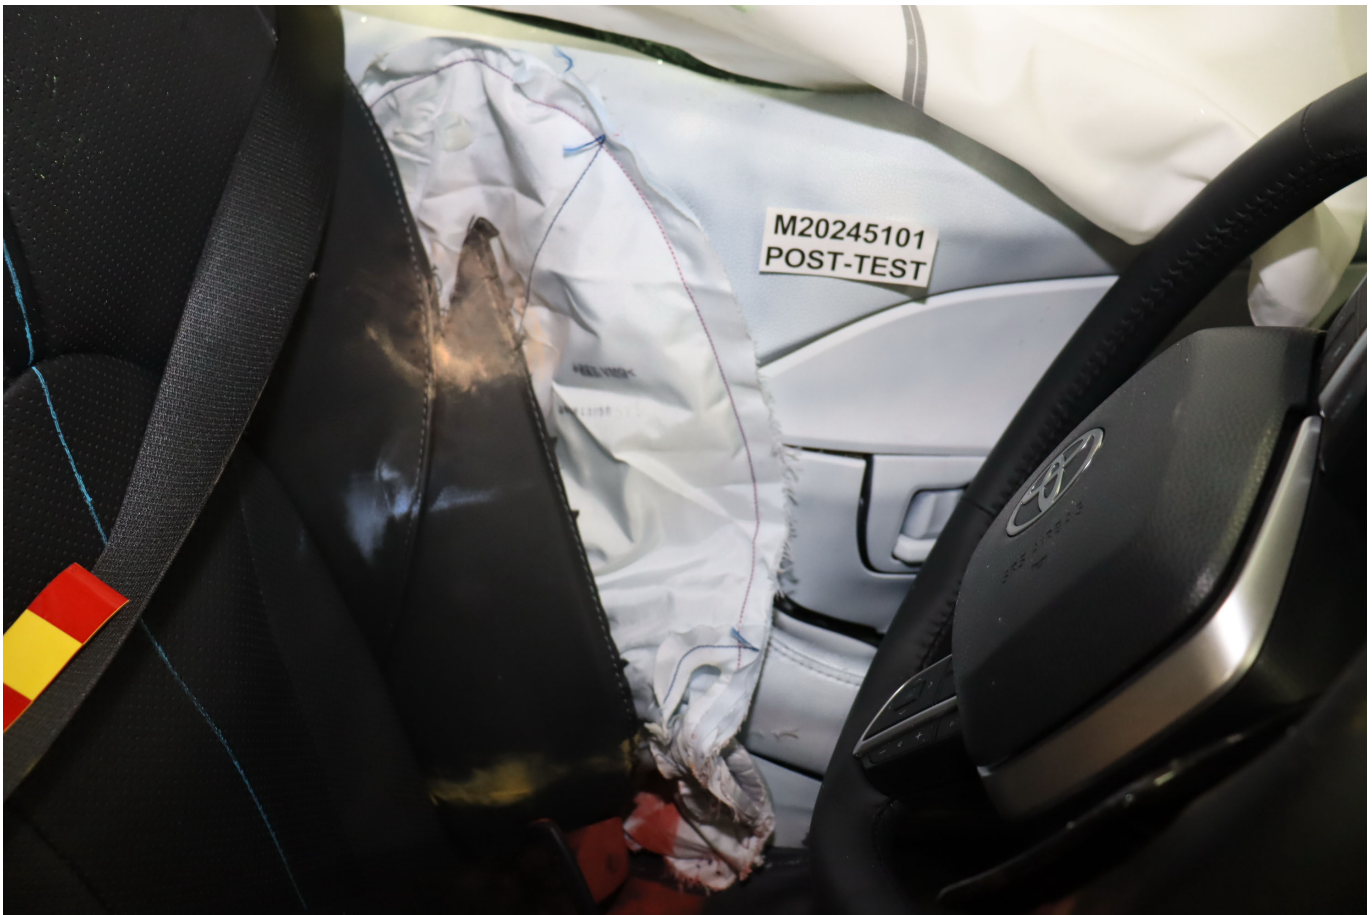
Photo No. 049 - Post-Test Dummy Close-Up Torso Contact with Side Air Bag View

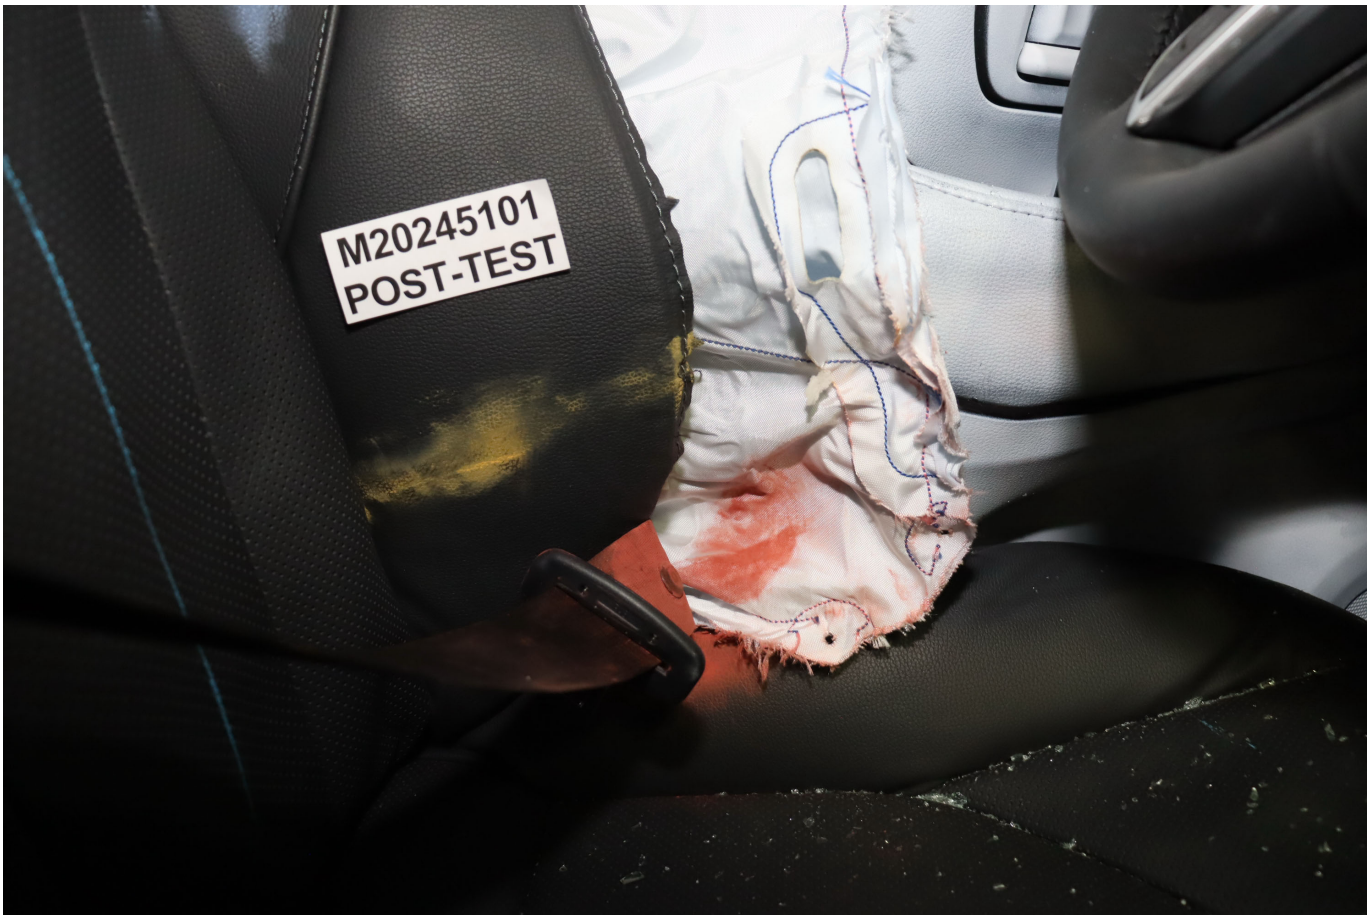
Photo No. 051 - Post-Test Dummy Close-Up Pelvis Contact with Side Air Bag View

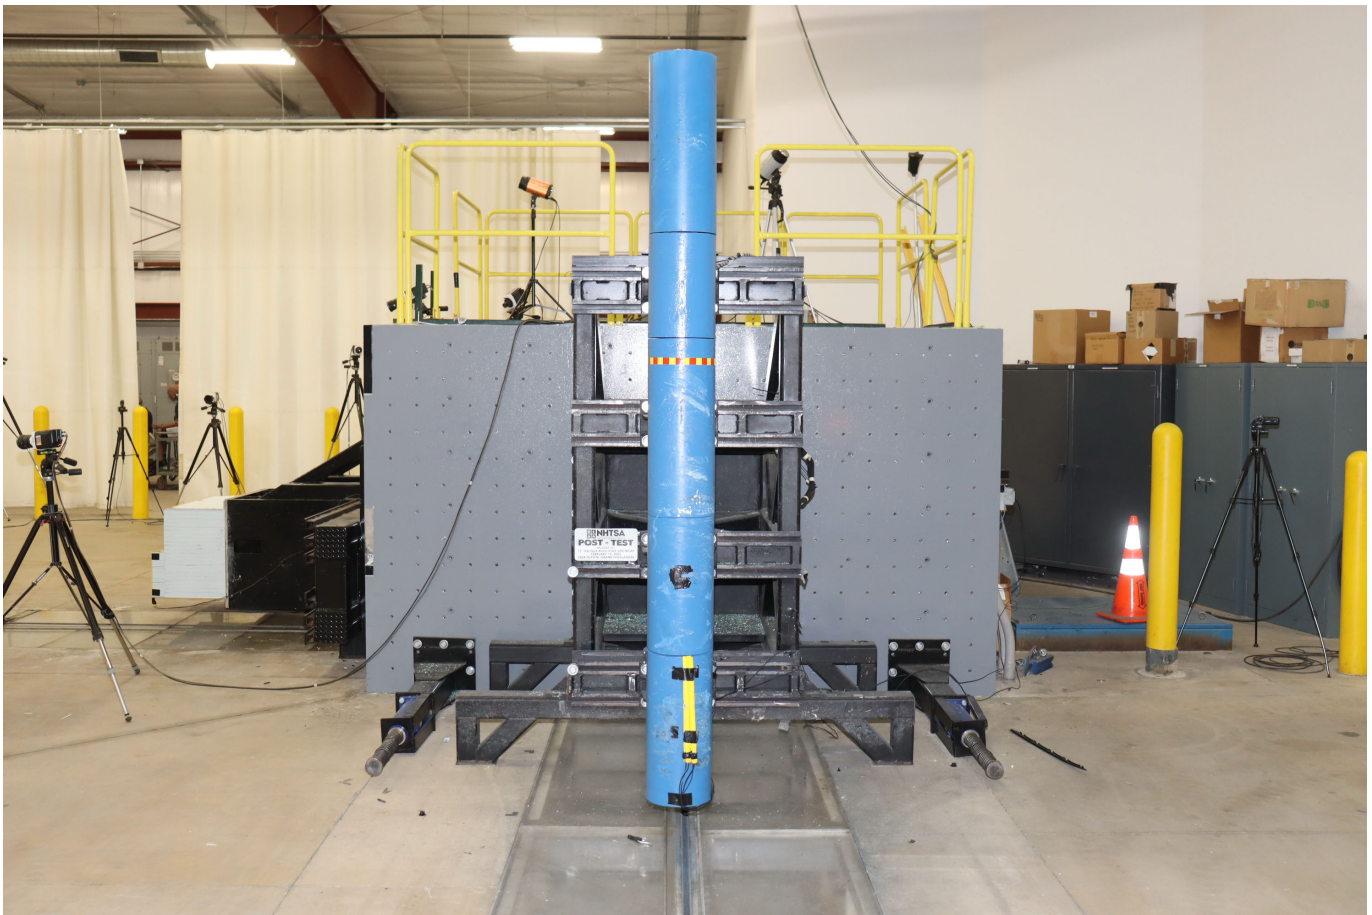
Photo No. 060 - Post-Test Pole Barrier Front View

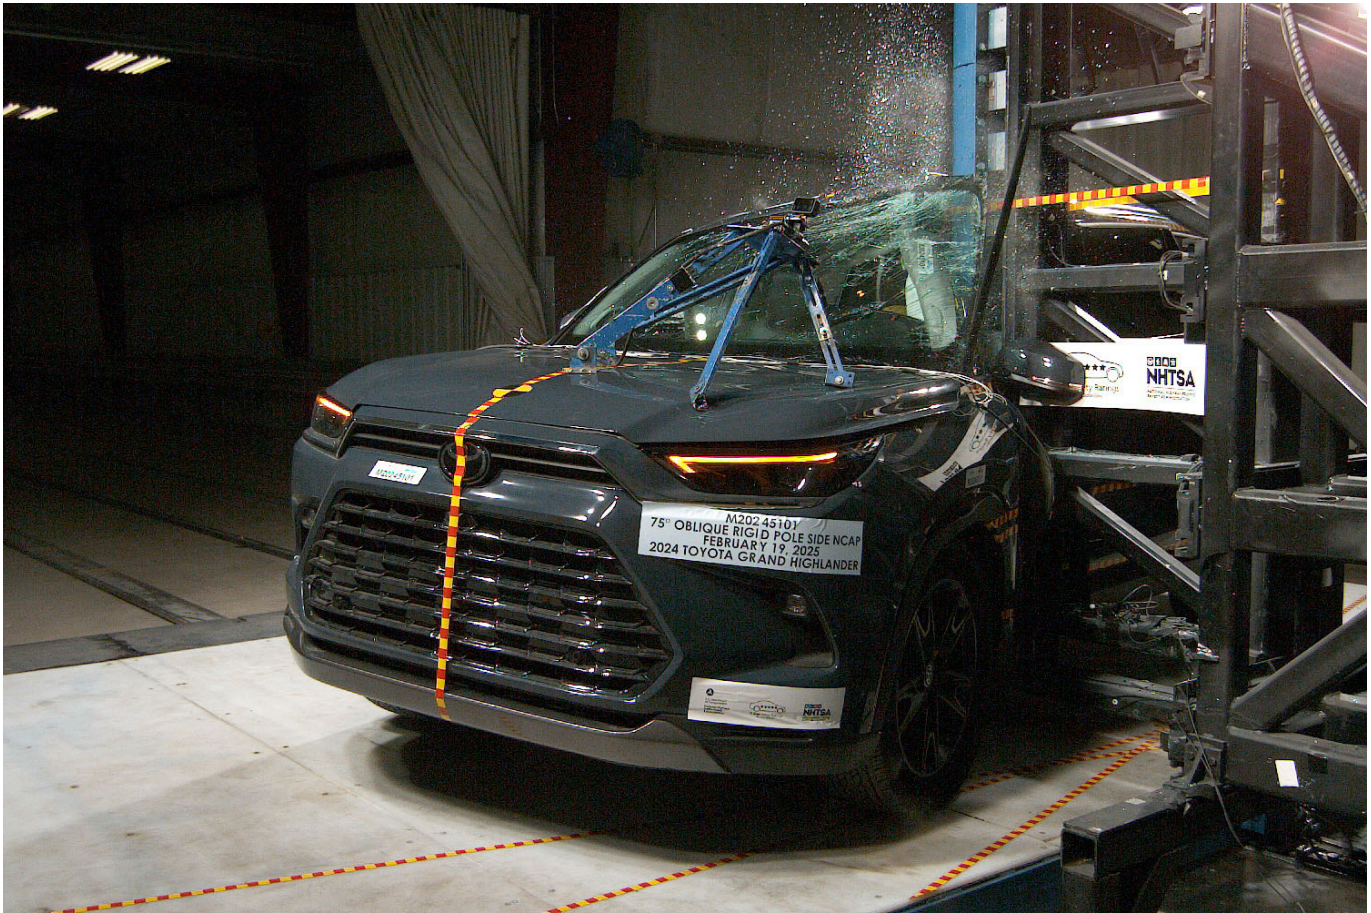
Photo No. 070 - Impact Event

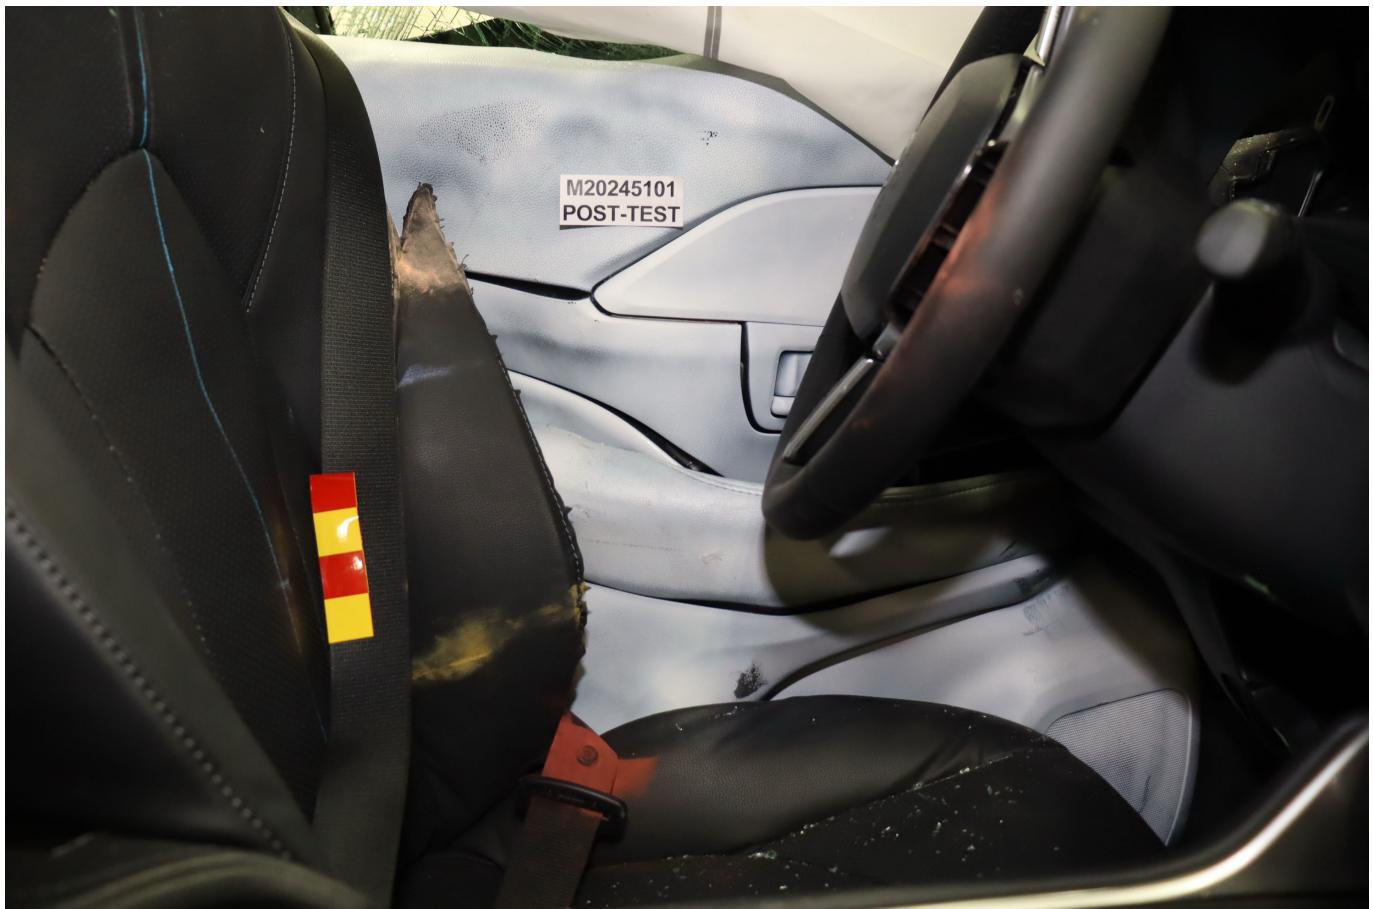
Photo No. 073 - Post-Test View of Shattered Vehicle Inner Door Panel

| Critical Areas of Performance | Observations and Conclusions |
|---|---|
| Side Window Damage | LF window cracked |
