REPORT NUMBER: SideNCAPMDB-MGA-25-015

**NEW CAR ASSESSMENT PROGRAM (NCAP)
Moving Deformable Barrier Side Impact Test**

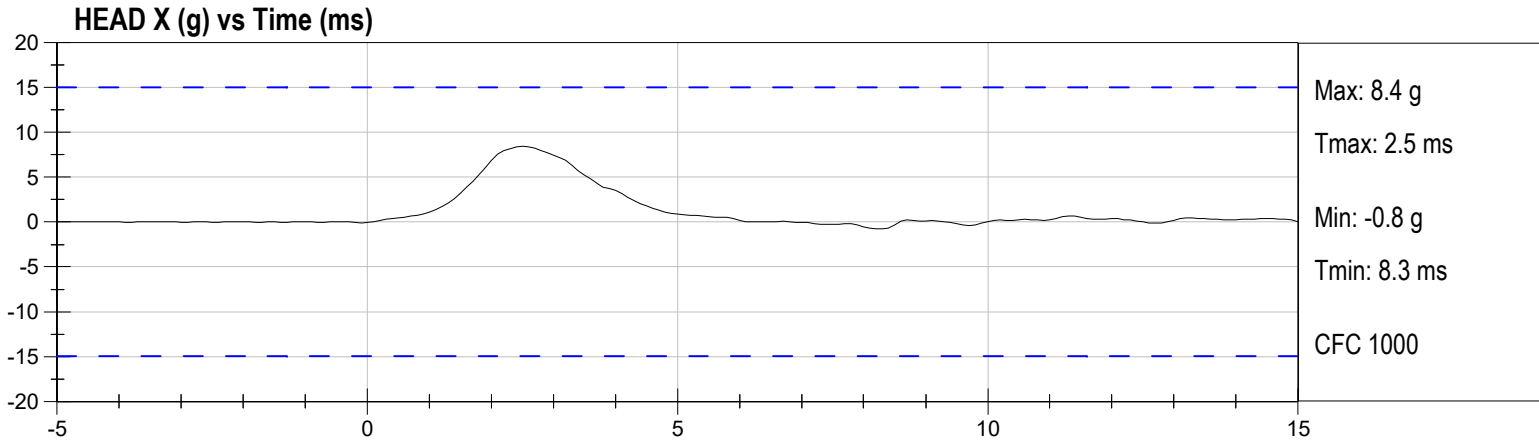
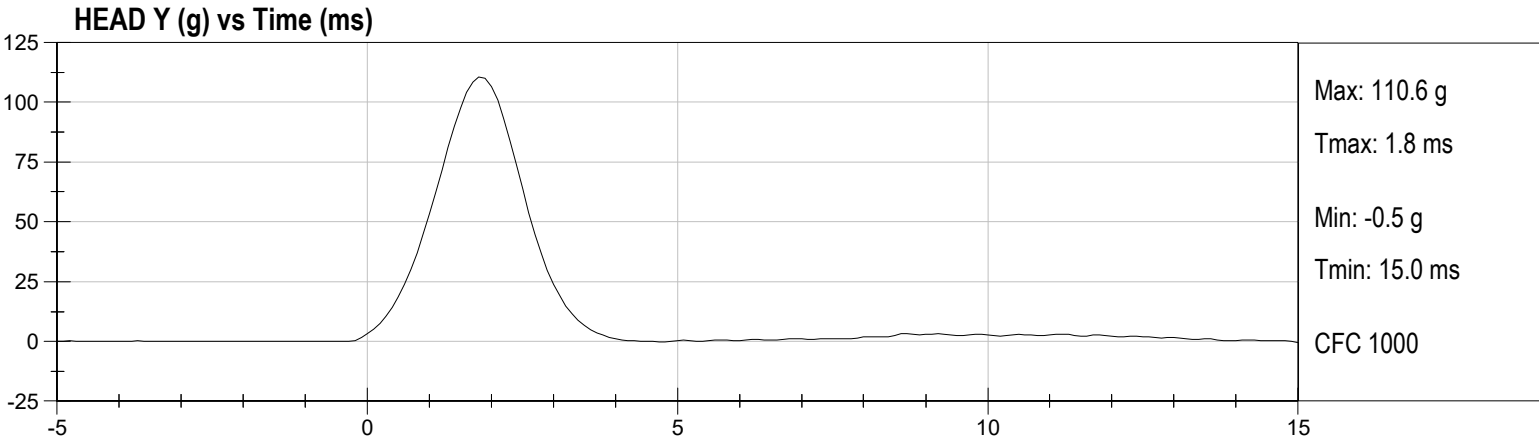
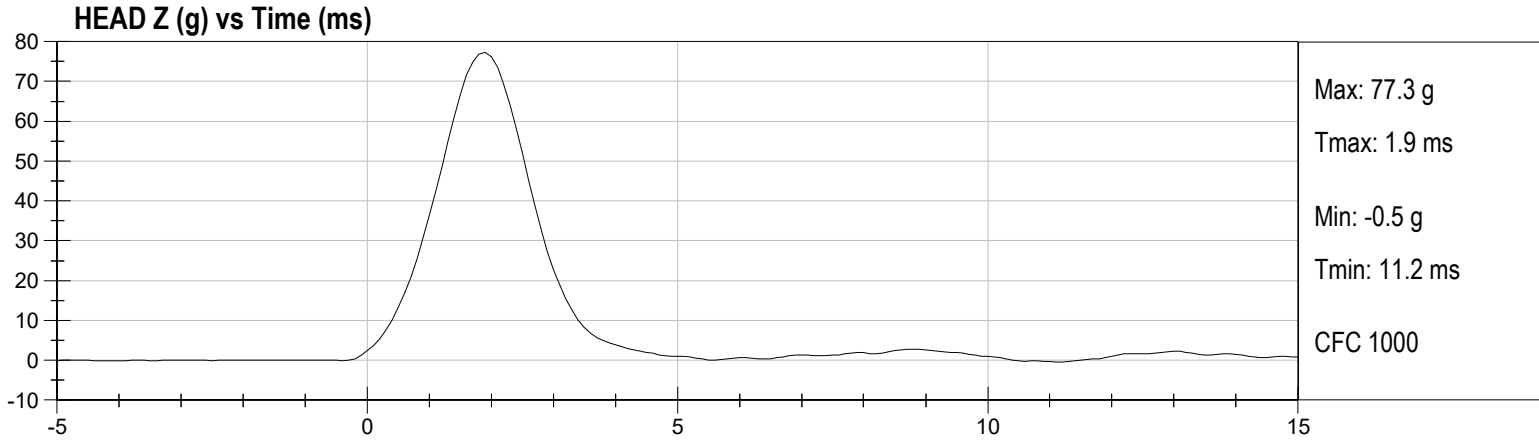
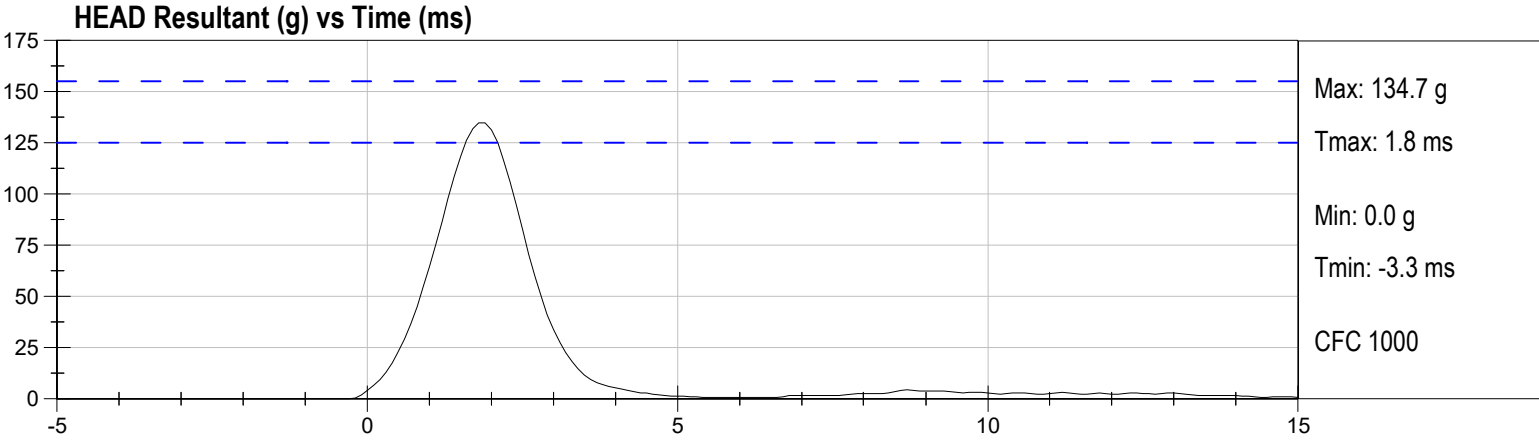
Channel	Manufacturer	Serial Number	Calibration Date	Calibration Due Date
HEAD X	Endevco	T30974	11/25/2024	5/27/2025
HEAD Y	Endevco	T30975	11/25/2024	5/27/2025
HEAD Z	Endevco	T30976	11/25/2024	5/27/2025

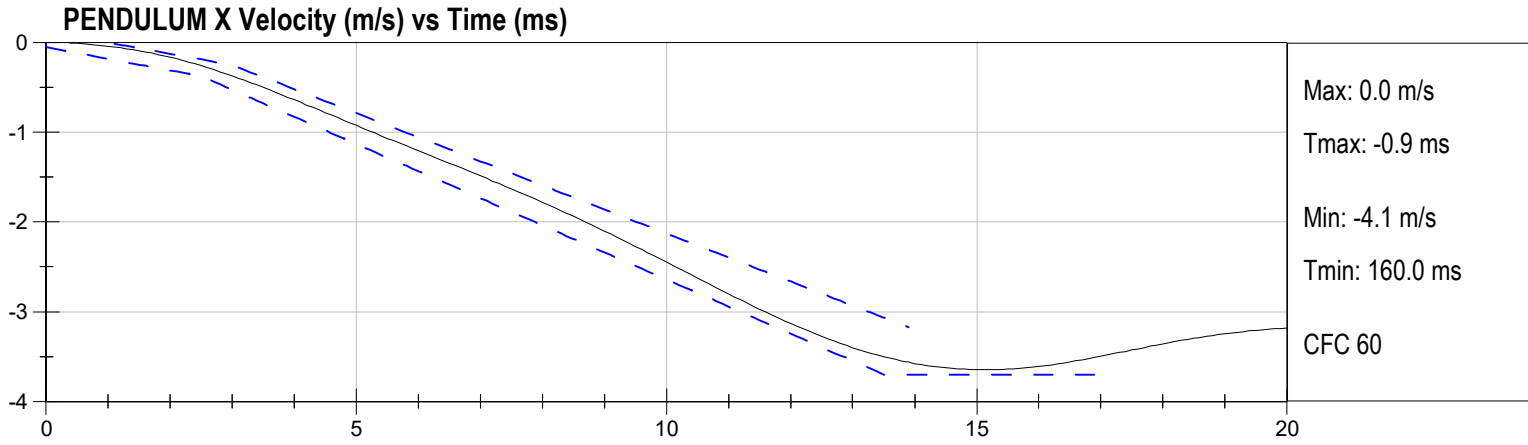
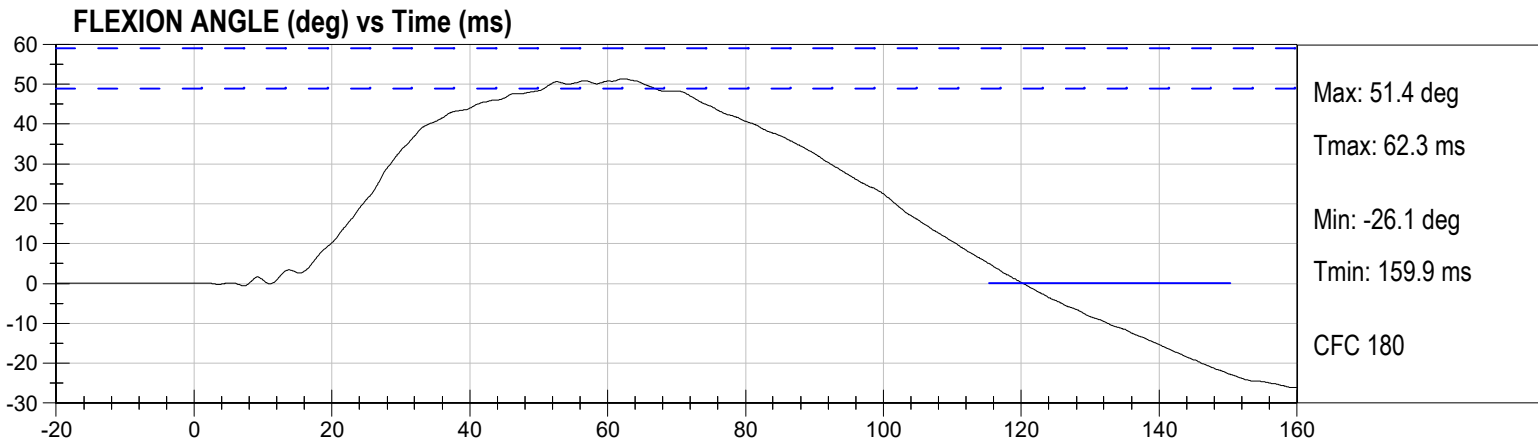
Channel	Manufacturer	Serial Number	Calibration Date	Calibration Due Date
PEND. ACCEL.	Endevco	AH5P1	01/13/2025	7/15/2025
POT. B - REAR	Spectrol	025_es2	01/13/2025	7/15/2025
POT. A - FRONT	Spectrol	027_es2	01/13/2025	7/15/2025
POT. C - HEADFORM	Spectrol	028_es2	01/13/2025	7/15/2025

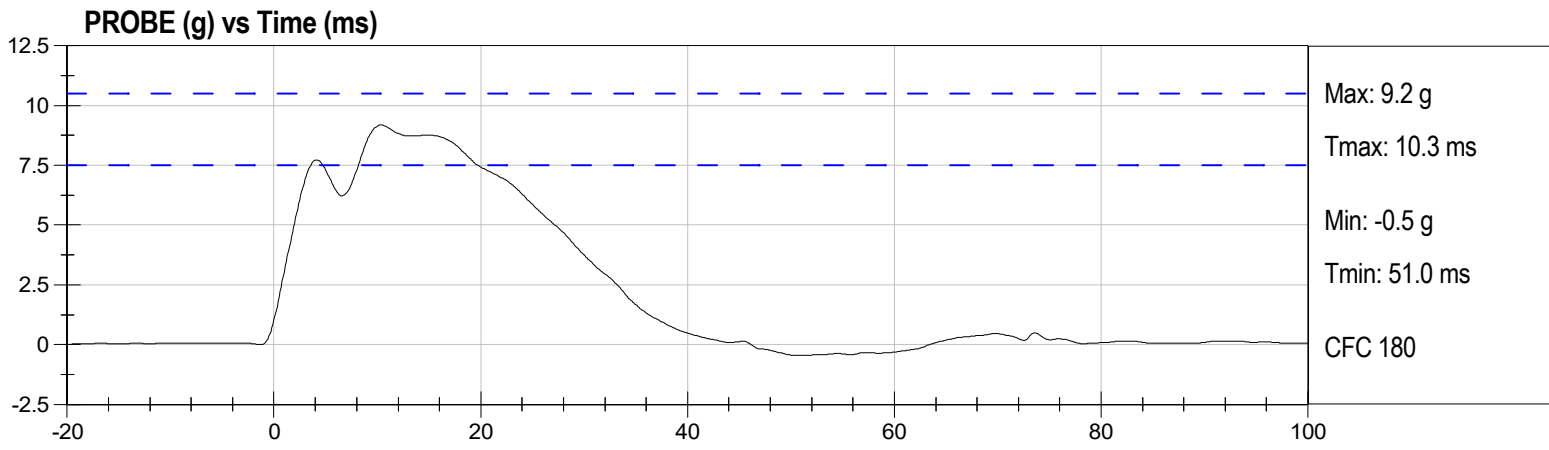
Channel	Manufacturer	Serial Number	Calibration Date	Calibration Due Date
PROBE	Endevco	P79577	09/18/2024	3/20/2025

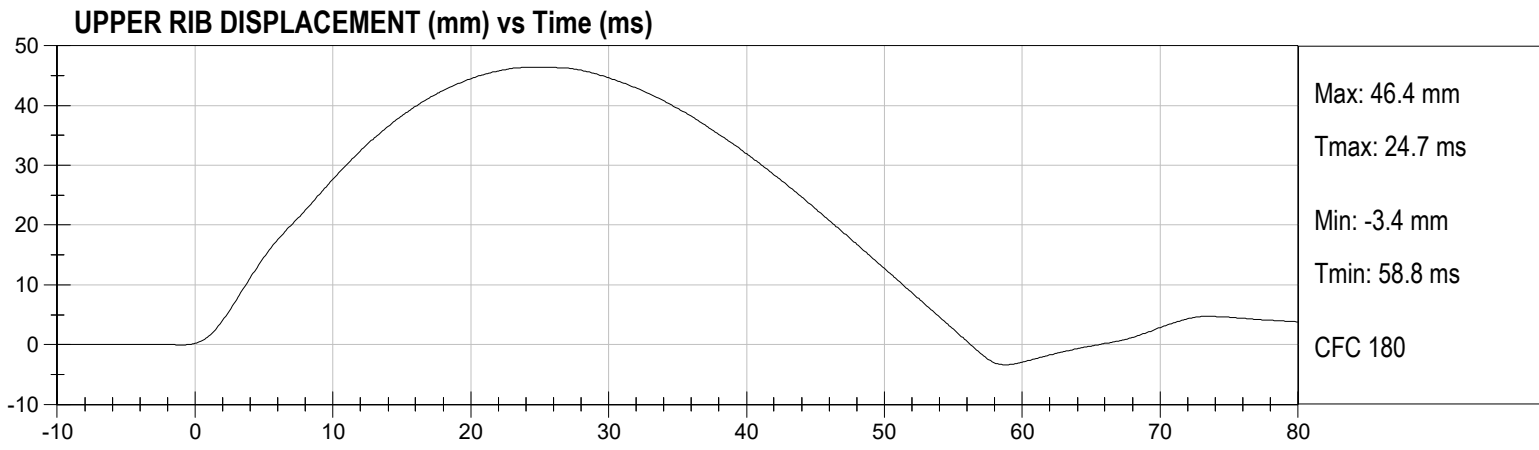
Channel	Manufacturer	Serial Number	Calibration Date	Calibration Due Date
UPPER RIB DISPLACEMENT	Honeywell	G236	11/21/2024	5/23/2025

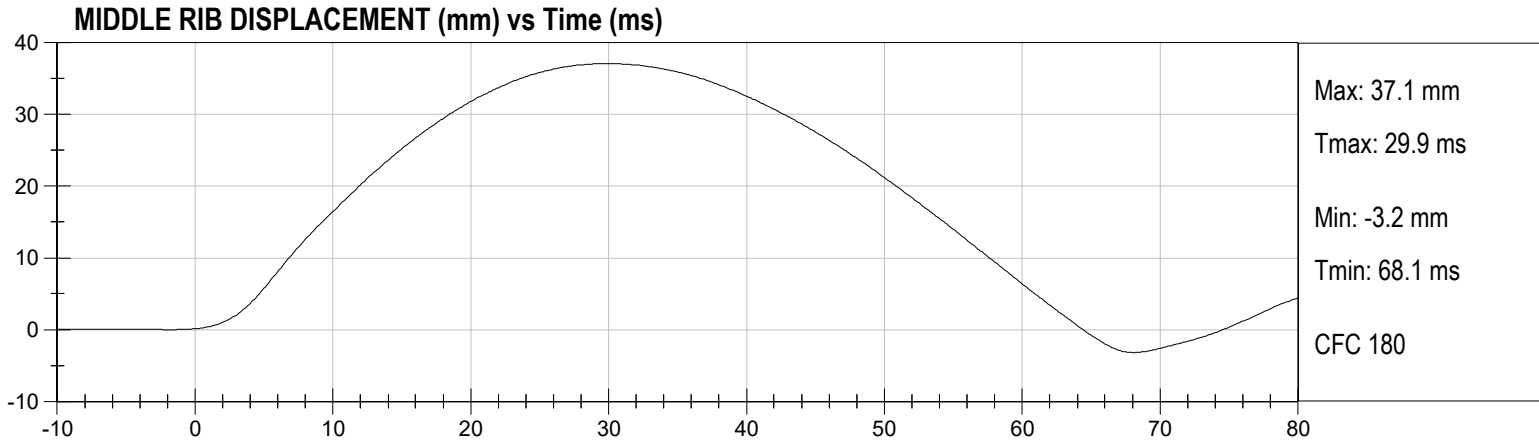
Channel	Manufacturer	Serial Number	Calibration Date	Calibration Due Date
MIDDLE RIB DISPLACEMENT	Honeywell	G368	11/21/2024	5/23/2025

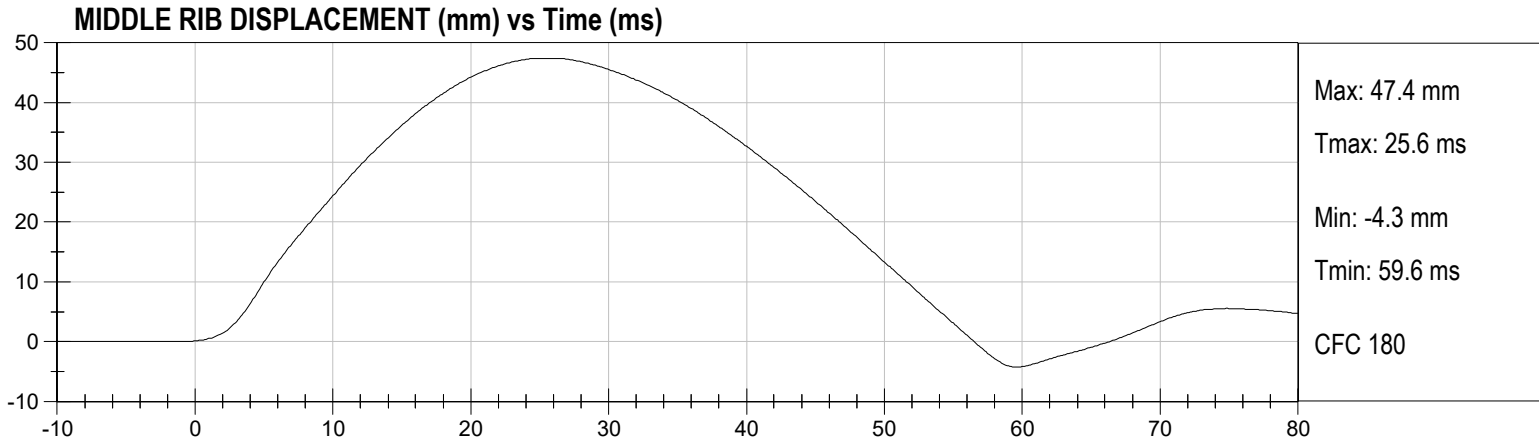
Channel	Manufacturer	Serial Number	Calibration Date	Calibration Due Date
MIDDLE RIB DISPLACEMENT	Honeywell	G368	11/21/2024	5/23/2025

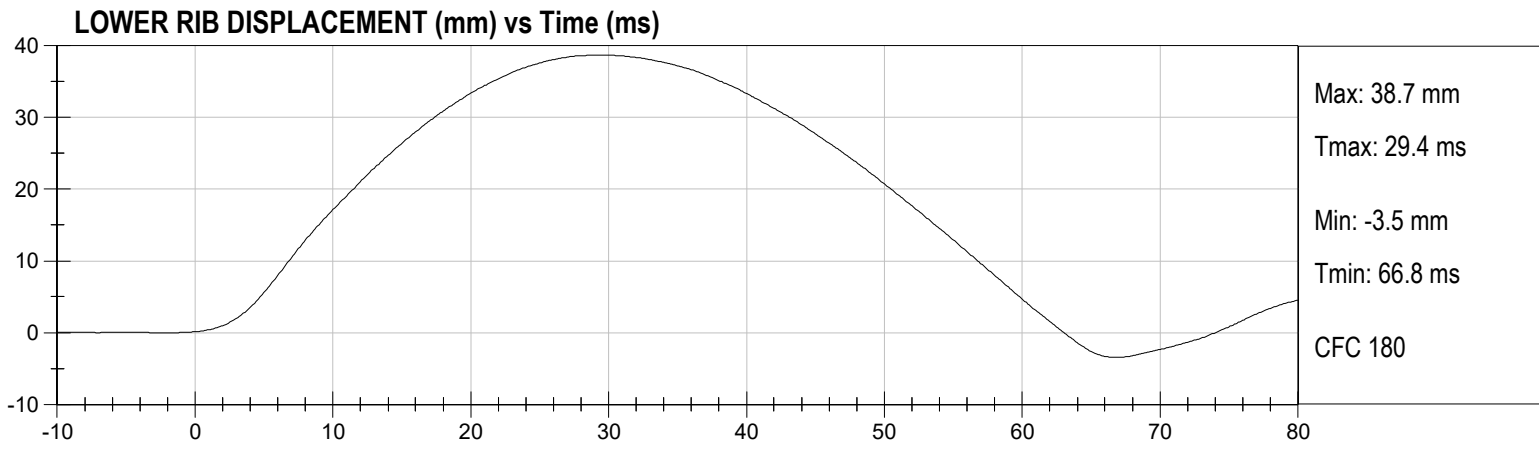
Channel	Manufacturer	Serial Number	Calibration Date	Calibration Due Date
LOWER RIB DISPLACEMENT	Honeywell	G164	11/21/2024	5/23/2025

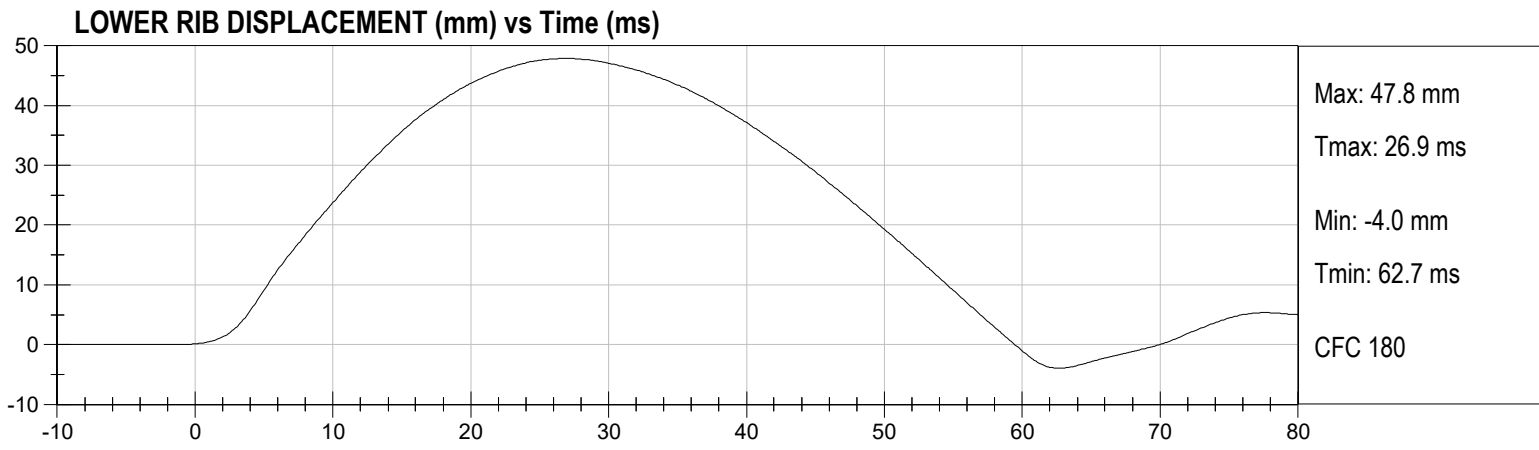
Channel	Manufacturer	Serial Number	Calibration Date	Calibration Due Date
LOWER RIB DISPLACEMENT	Honeywell	G164	11/21/2024	5/23/2025

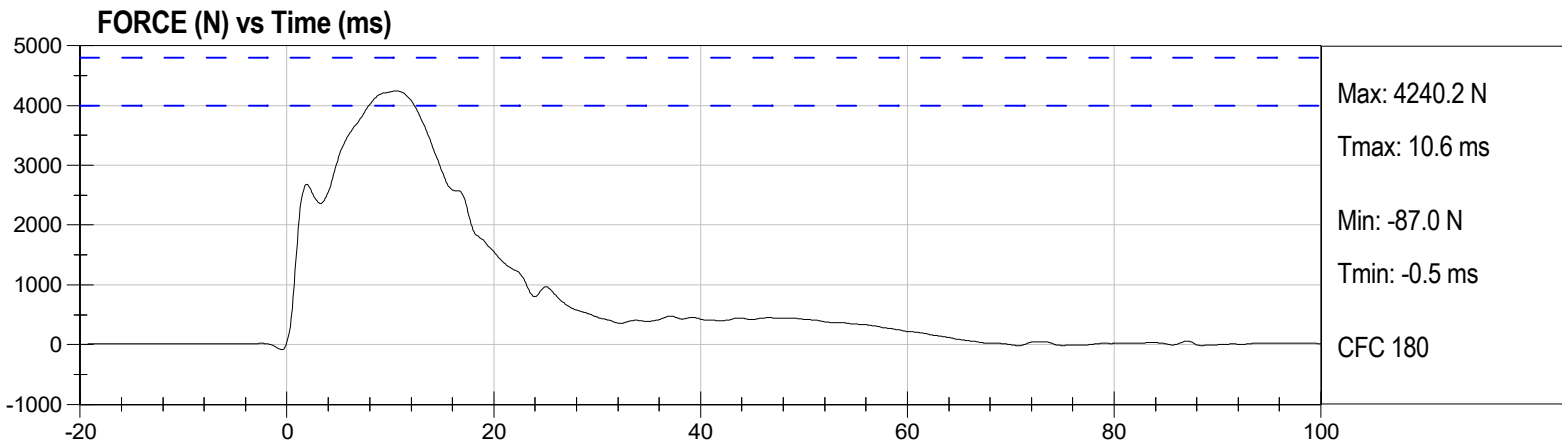
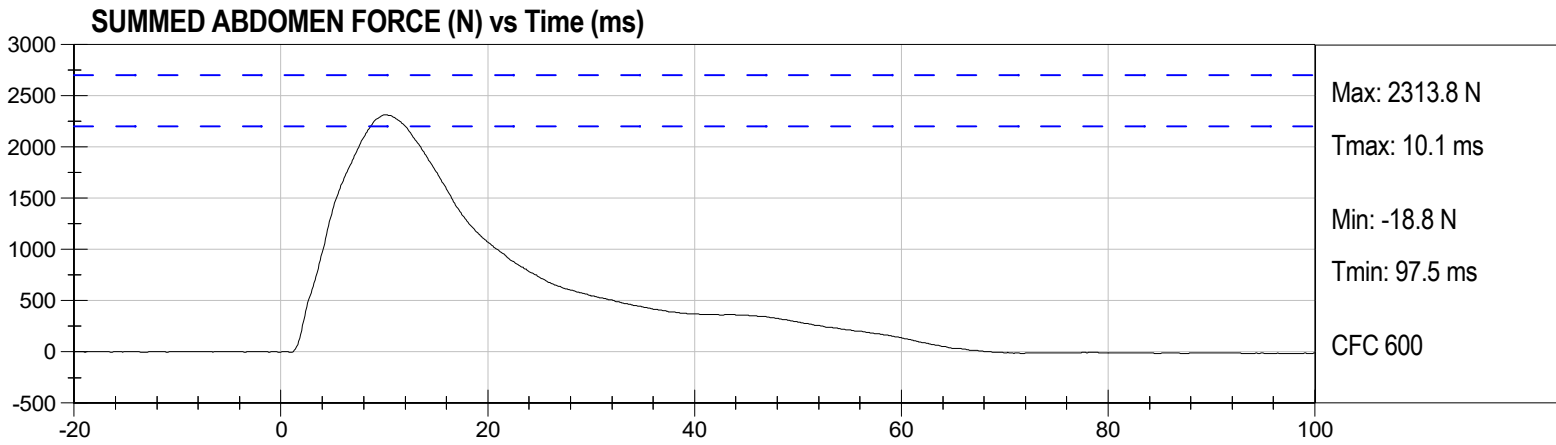
FRONT ABDOMEN FY (N) vs Time (ms)

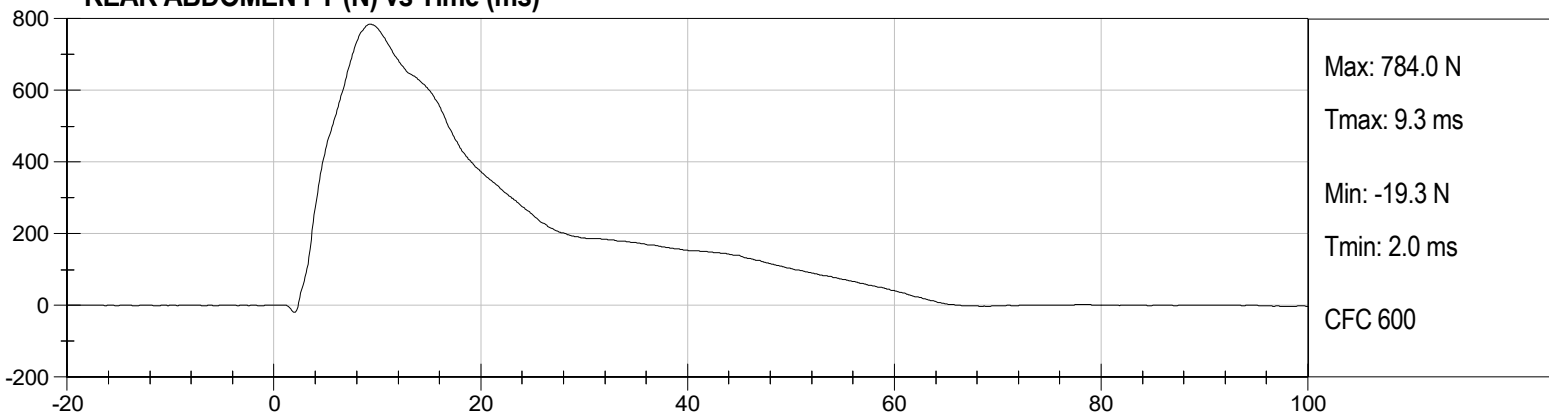
REAR ABDOMEN FY (N) vs Time (ms)

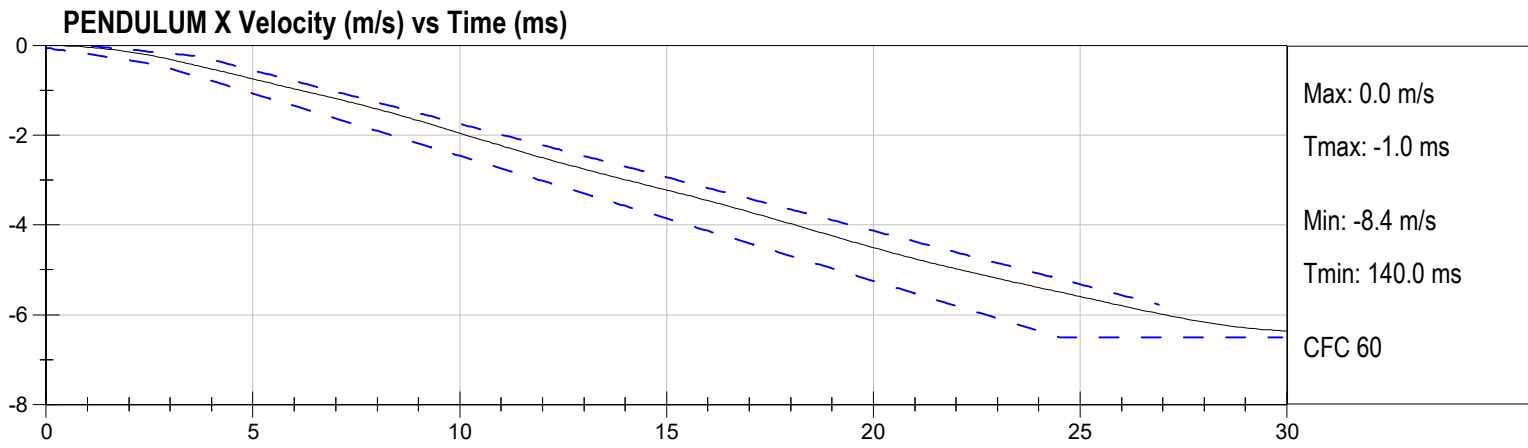
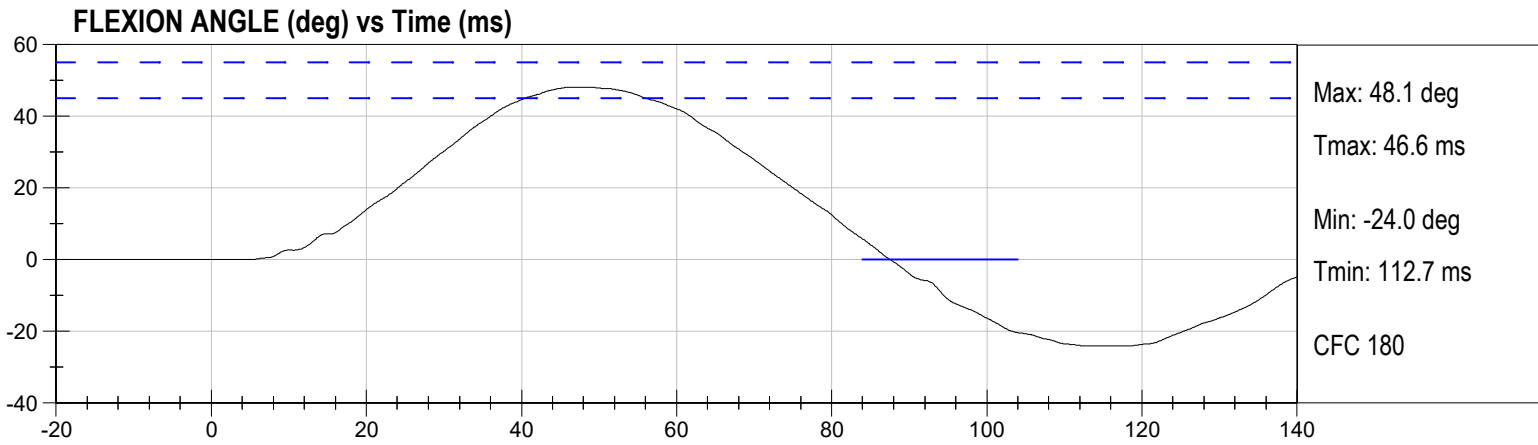
Channel	Manufacturer	Serial Number	Calibration Date	Calibration Due Date
PEND. ACCEL.	Endevco	AH5P1	01/13/2025	7/15/2025
POT. B - REAR	Spectrol	025_es2	01/13/2025	7/15/2025
POT. A - FRONT	Spectrol	027_es2	01/13/2025	7/15/2025
POT. C - HEADFORM	Spectrol	028_es2	01/13/2025	7/15/2025

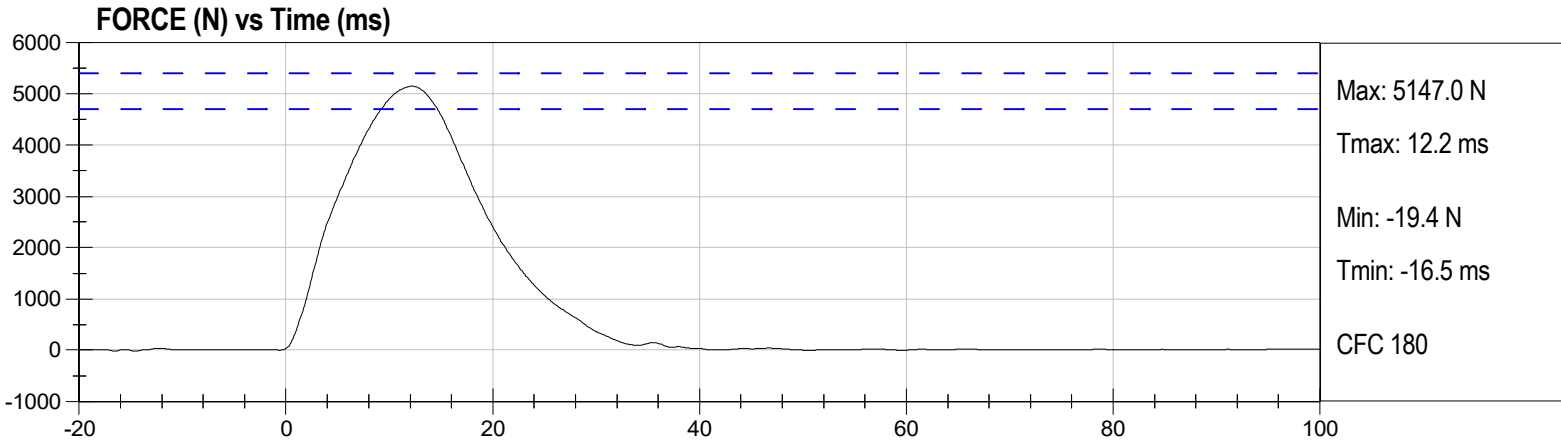
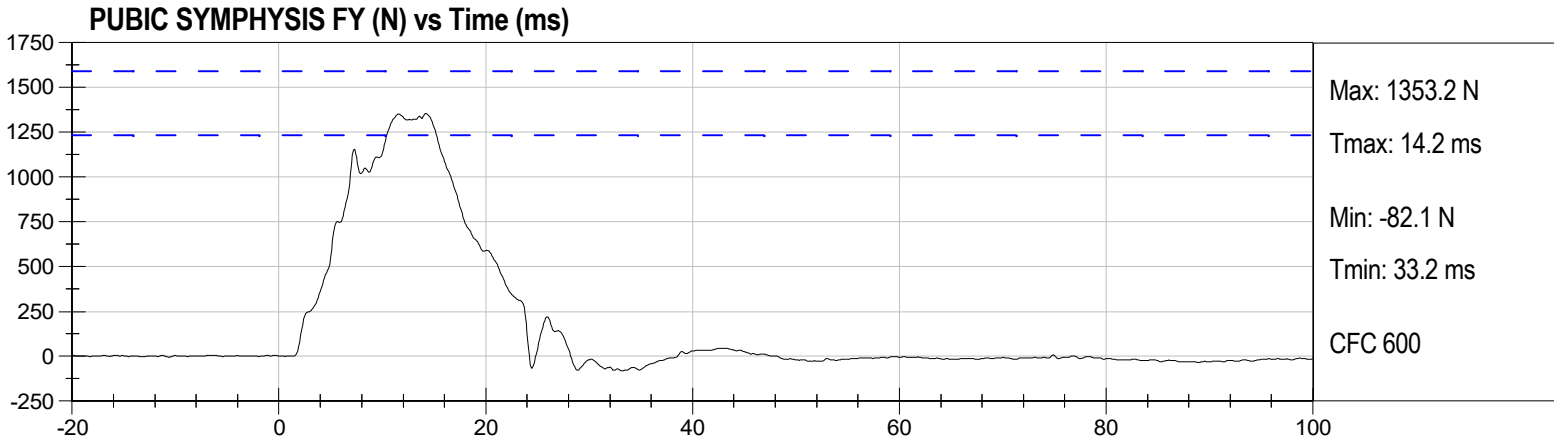
Channel	Manufacturer	Serial Number	Calibration Date	Calibration Due Date
PROBE	Endevco	P79577	09/18/2024	3/20/2025
PUBIC SYMPHYSIS FY	Denton	PG461FY	01/20/2025	1/20/2026

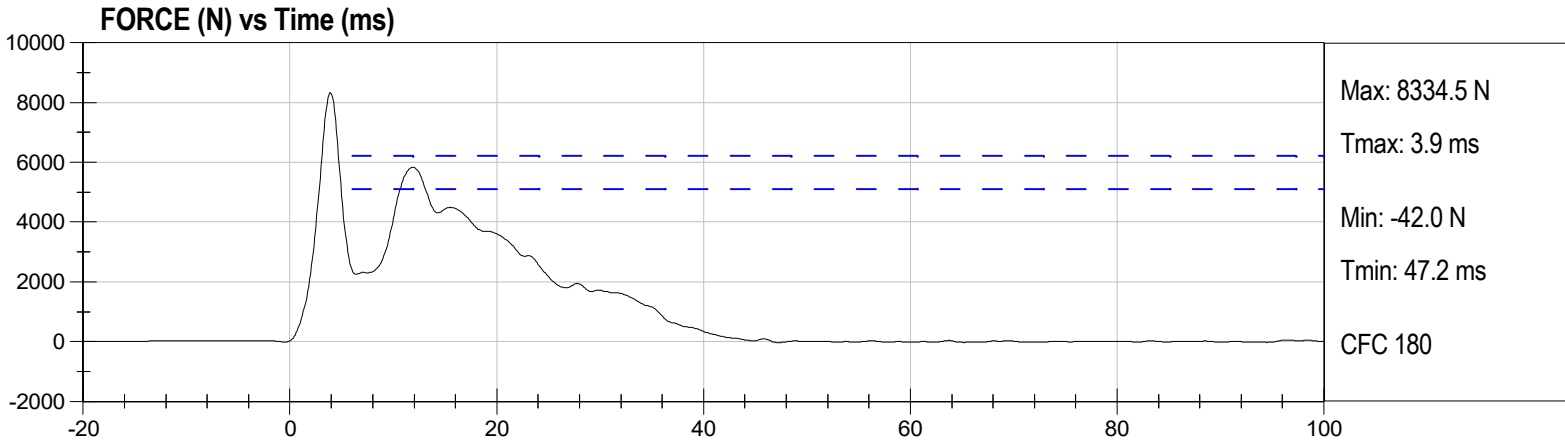
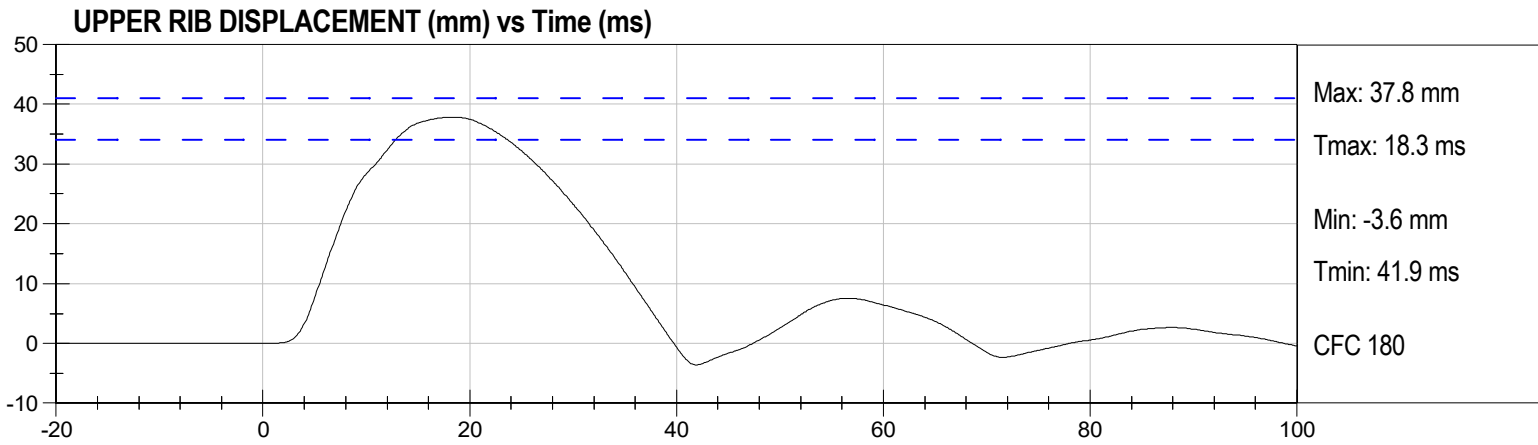
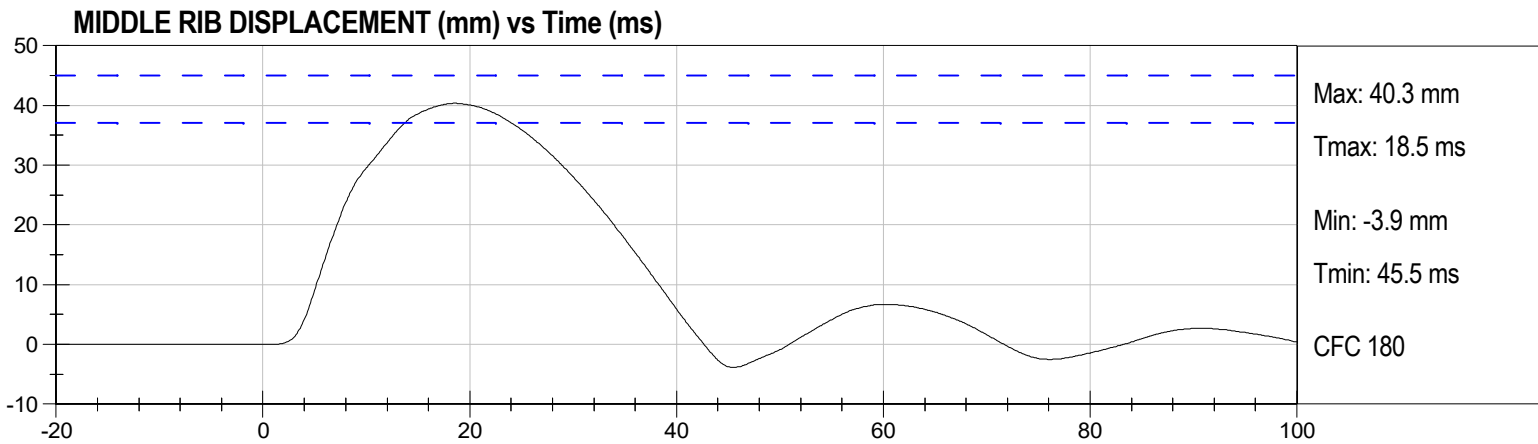
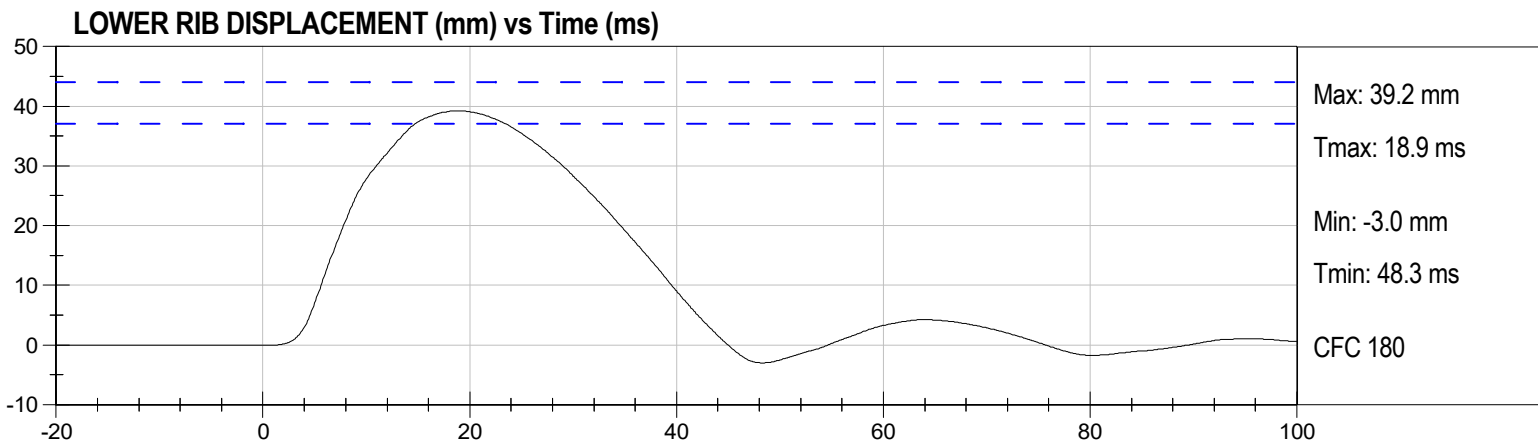
QUALIFICATION TEST RESULTS

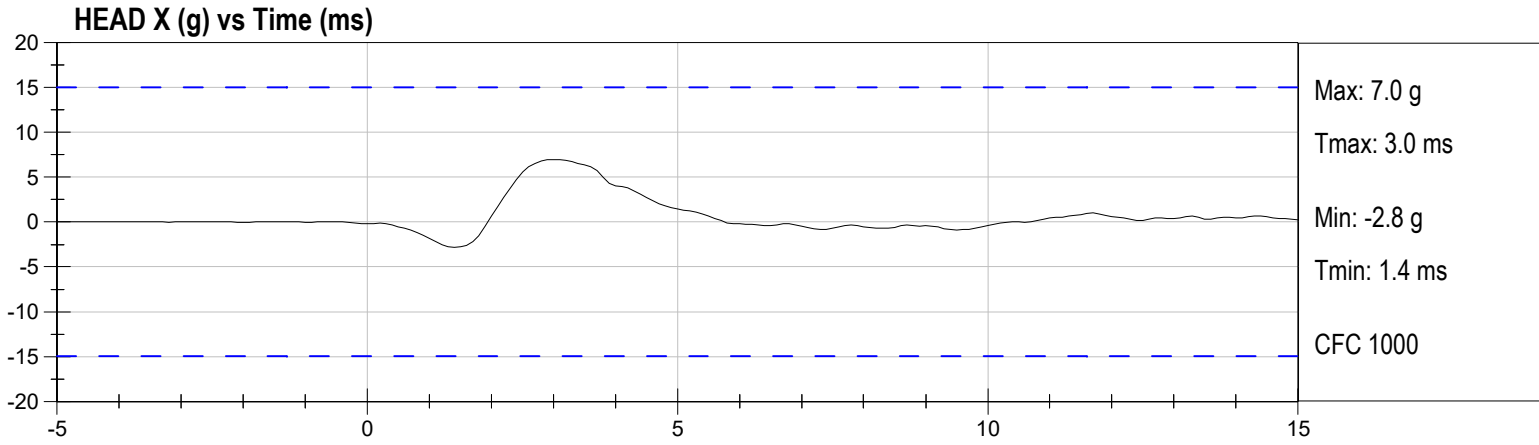
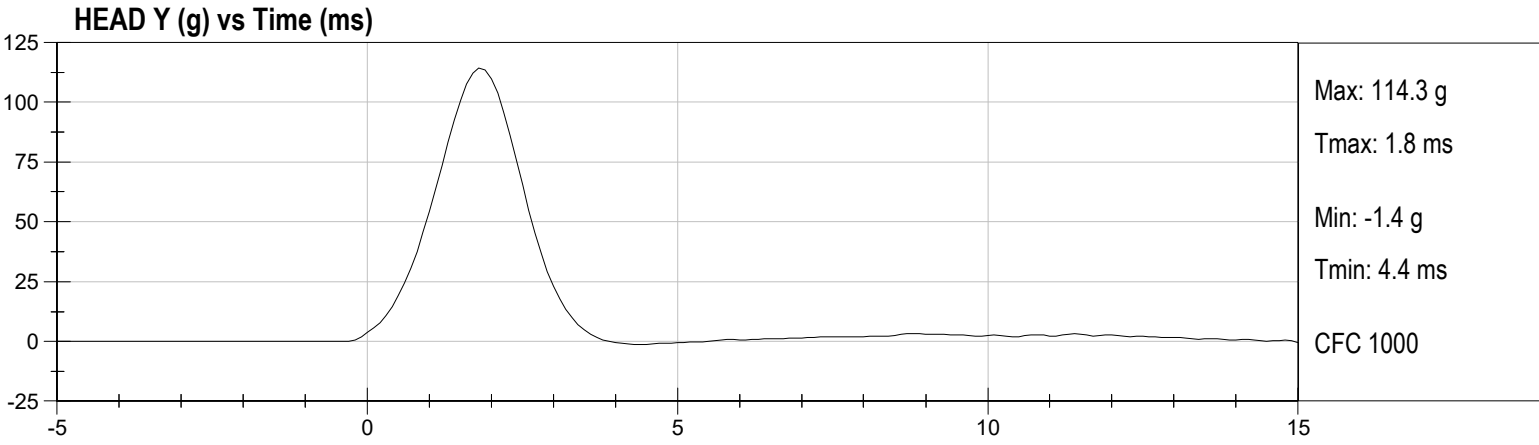
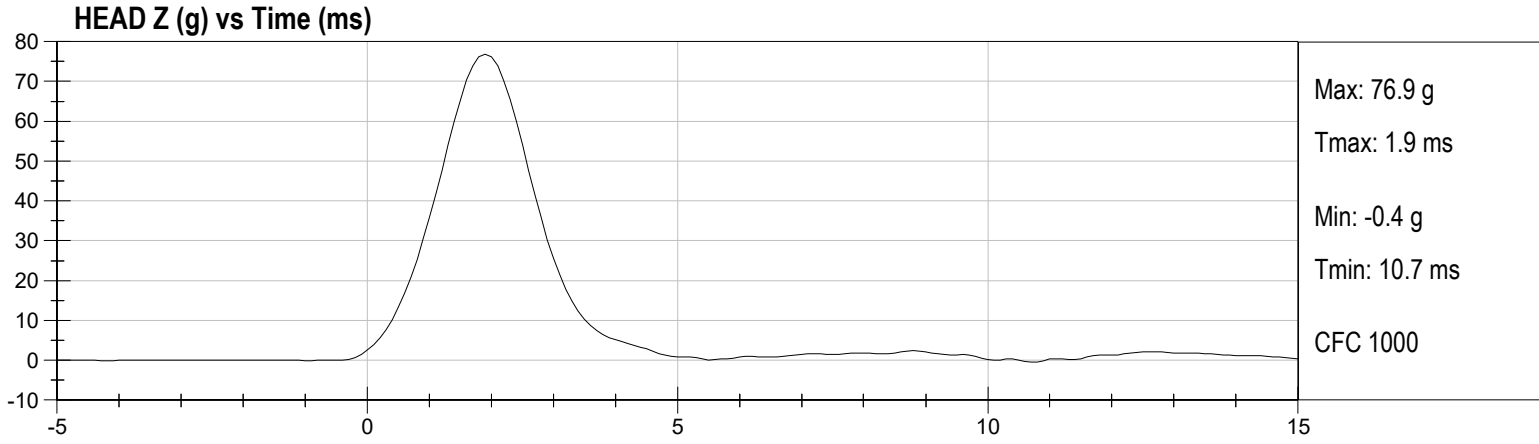
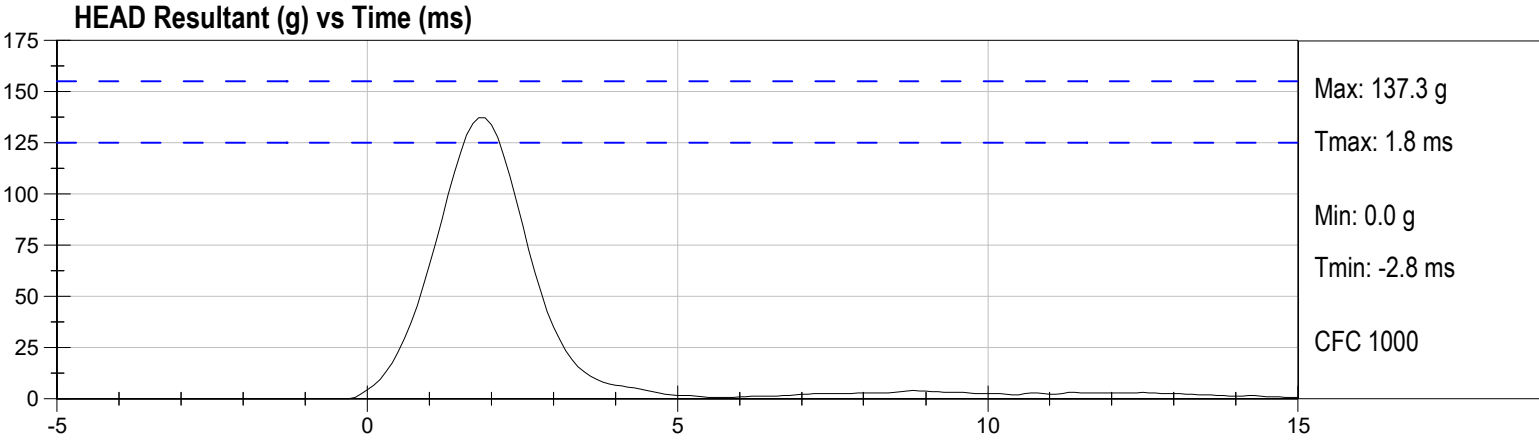
Channel	Manufacturer	Serial Number	Calibration Date	Calibration Due Date
HEAD X	Endevco	P78728	02/24/2025	8/26/2025
HEAD Y	Endevco	P78732	02/24/2025	8/26/2025
HEAD Z	Endevco	P78739	02/24/2025	8/26/2025

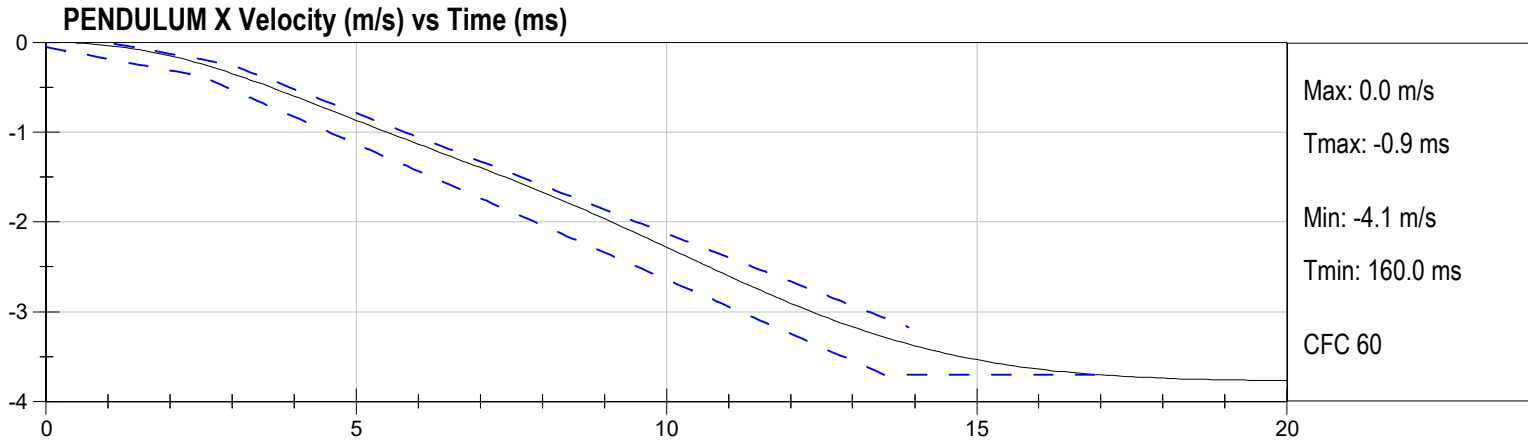
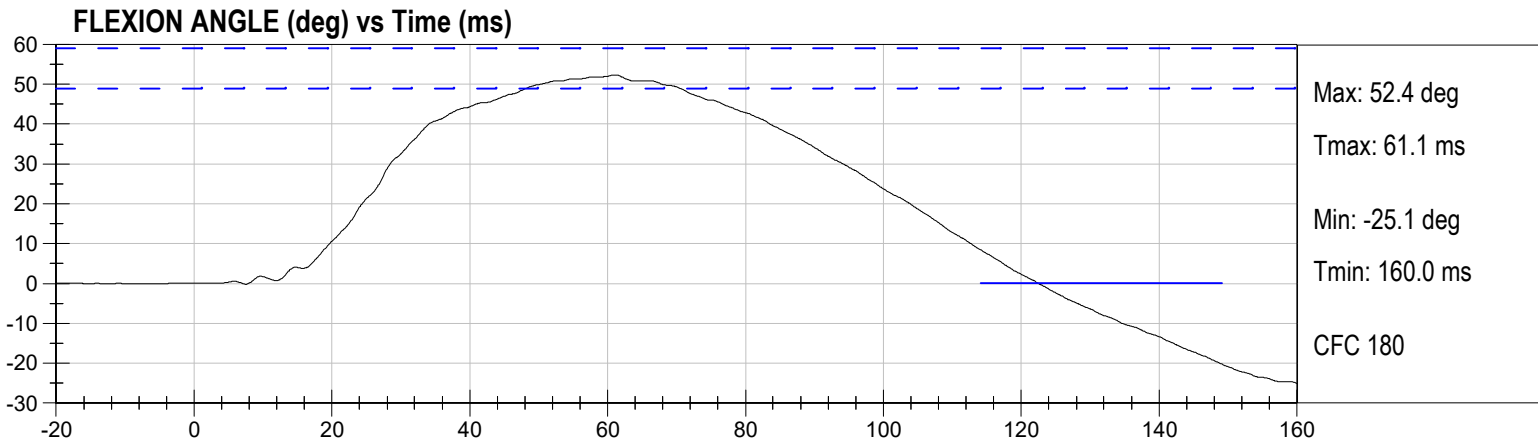
Channel	Manufacturer	Serial Number	Calibration Date	Calibration Due Date
PEND. ACCEL.	Endevco	AH5P1	01/13/2025	7/15/2025
POT. B - REAR	Spectrol	025_es2	01/13/2025	7/15/2025
POT. A - FRONT	Spectrol	027_es2	01/13/2025	7/15/2025
POT. C - HEADFORM	Spectrol	028_es2	01/13/2025	7/15/2025

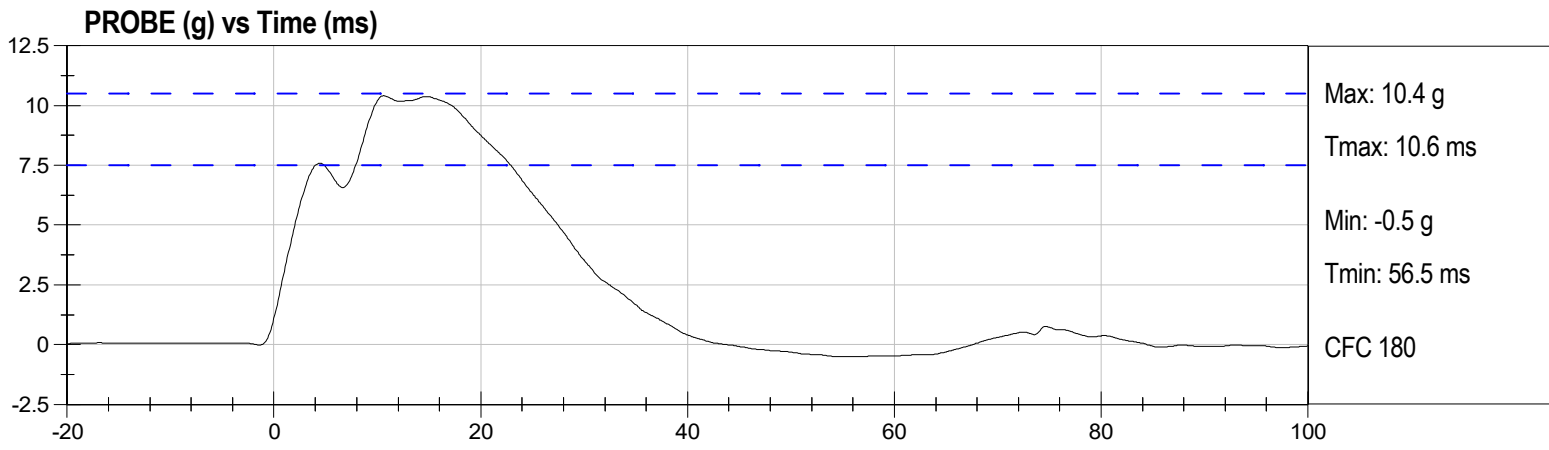
Channel	Manufacturer	Serial Number	Calibration Date	Calibration Due Date
PROBE	Endevco	P79577	09/18/2024	3/20/2025

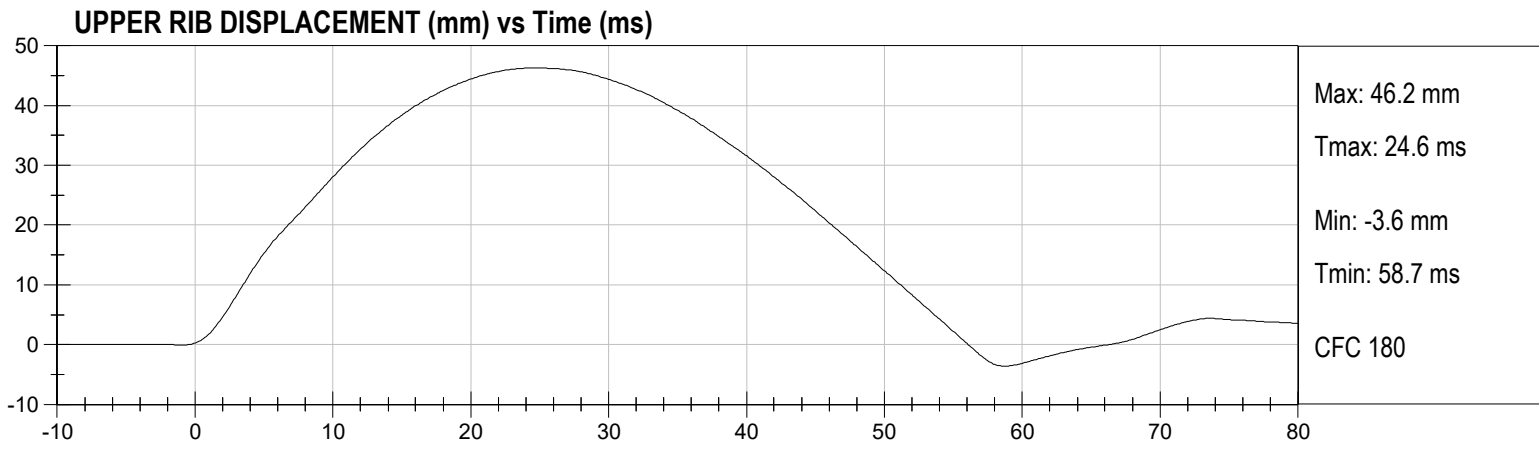
Channel	Manufacturer	Serial Number	Calibration Date	Calibration Due Date
UPPER RIB DISPLACEMENT	Honeywell	G236	11/21/2024	5/23/2025

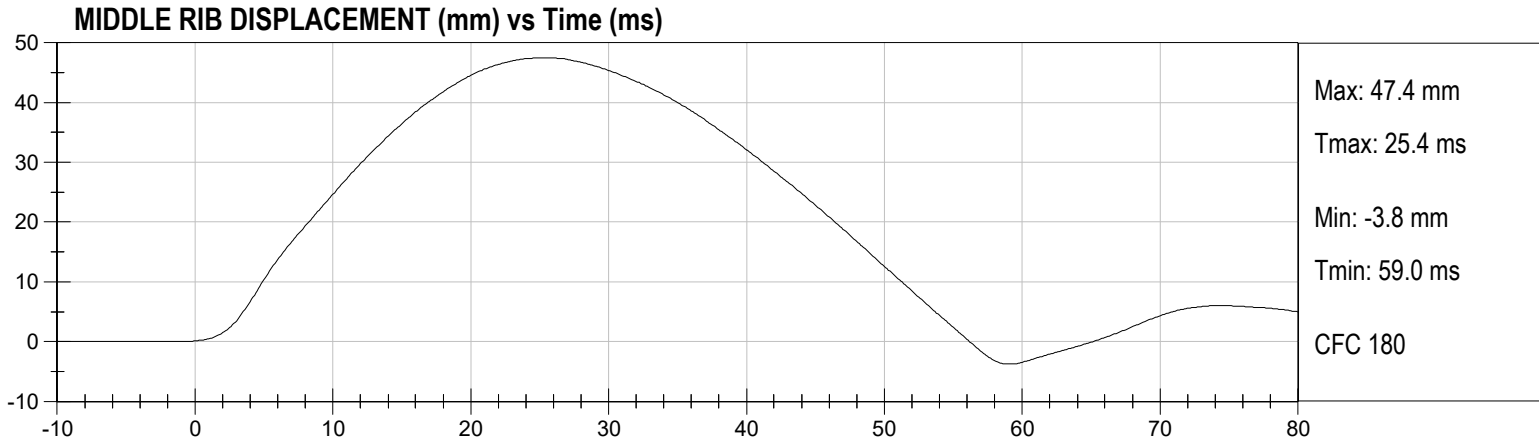
Channel	Manufacturer	Serial Number	Calibration Date	Calibration Due Date
MIDDLE RIB DISPLACEMENT	Honeywell	G368	11/21/2024	5/23/2025
